# DETERMINE ISS SOYUZ ORBITAL MODULE BALLISTIC LIMITS FOR STEEL PROJECTILES HYPERVELOCITY IMPACT TESTING

Hypervelocity Impact Technology Group (HVIT)  
Astromaterials Research and Exploration Science (ARES) Directorate  
Human Exploration Science Office, KX

July 2013

Prepared for the  
**ISS Systems Engineering and Integration Office**

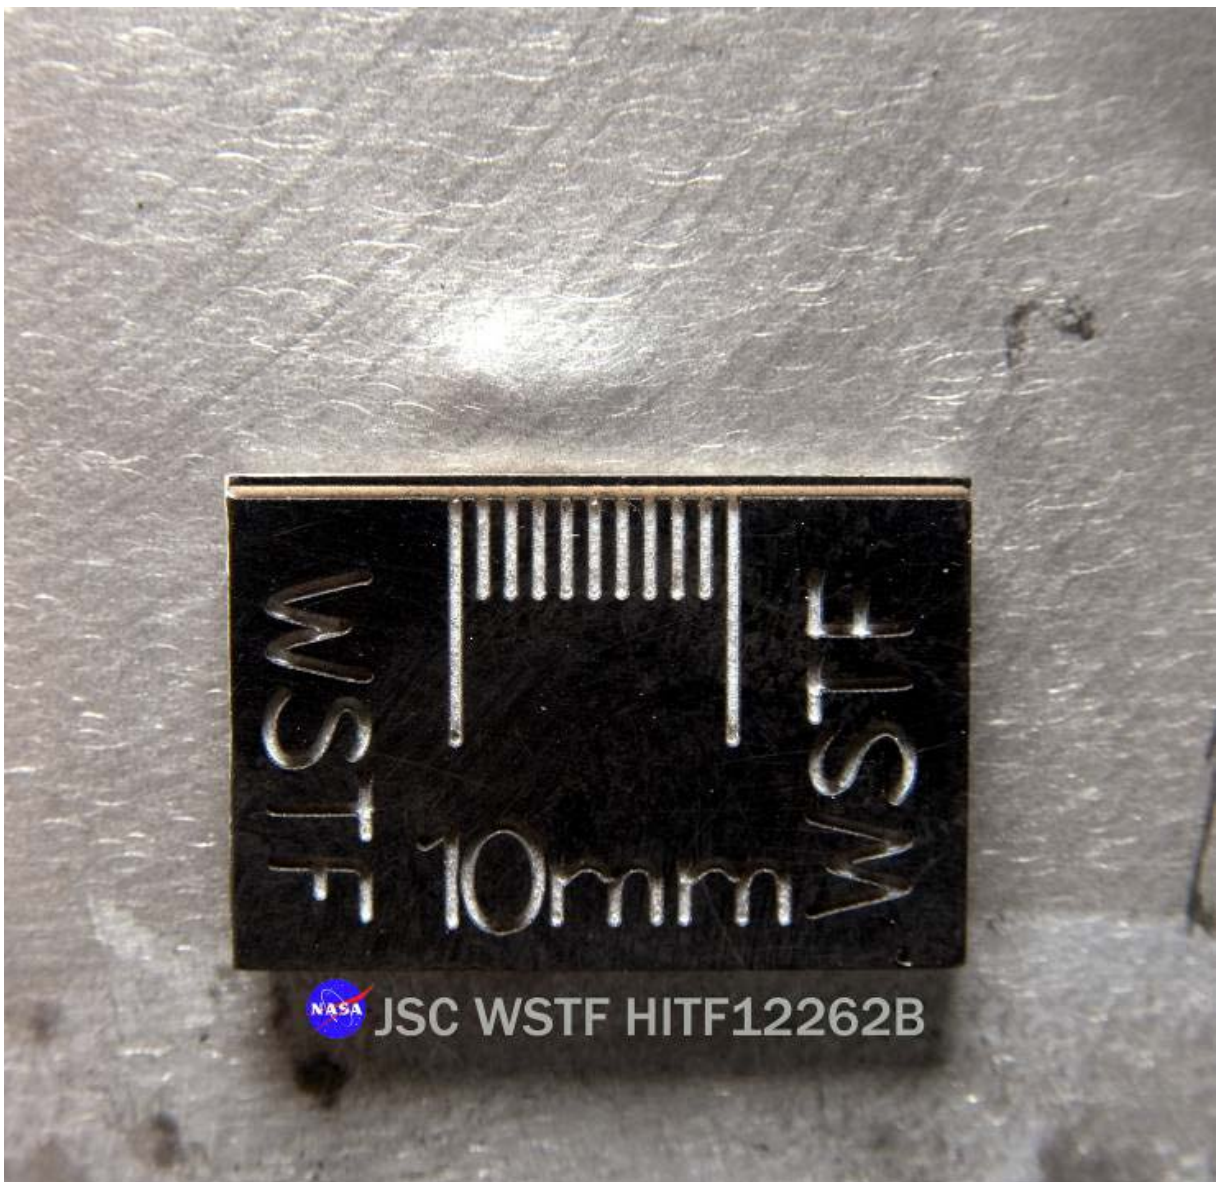
Test #6B, HITF12262

Figure 113: Al 5456-0 Rear Wall (Back) for ISS Soyuz Orbital Module Test #6B

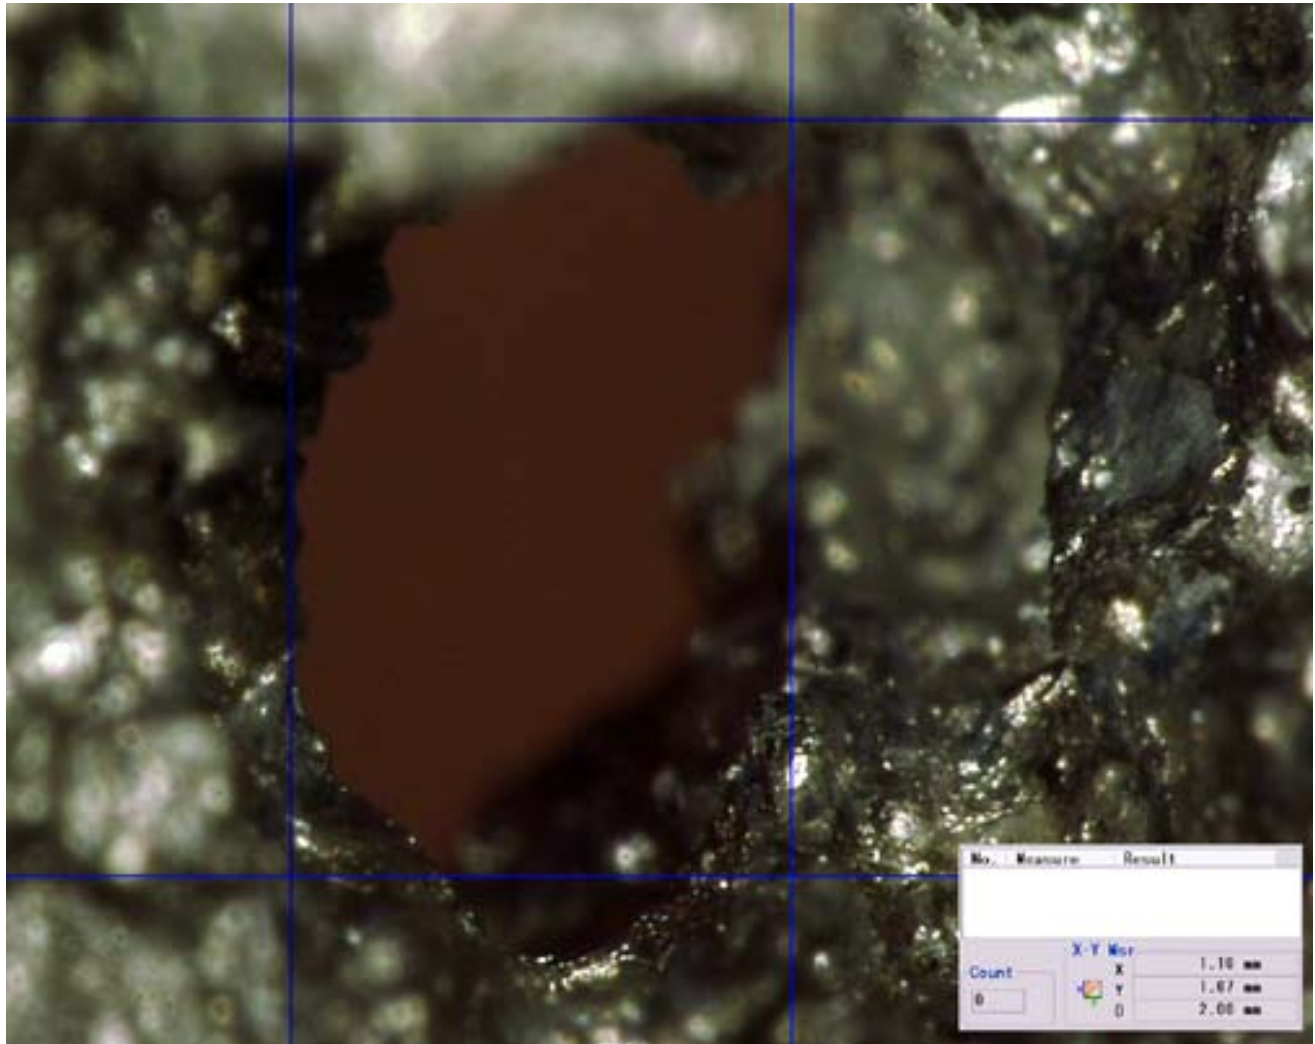
**Test #7, [HITF12263 Rear Wall](#)**

Test No.	Actual Projectile Diameter (mm)	Actual Projectile Mass (g)	Actual Impact Velocity (km/s)	Impact Angle (deg)	Results
7 <a href="#">HITF12263</a>	1.49	0.01332	6.23	30	<p><b>Fail</b></p> <p>Beta cloth entry damage = 1.40mm x 2.03mm hole  Mylar Film damage = 19.09mm x 13.97mm hole  Fiberglass entry damage = 5.06mm x 7.27mm hole  Al 6061 Foil damage = 6.26mm x 4.02mm hole  Fiberglass exit damage = 12.13mm x 12.38mm hole  MLI exit damage = 6.69mm x 8.17mm hole  Al 6061-T6 plate damage = 6.93mm x 7.23mm hole  Al 5456-0 RW damage = 1.10mm x 1.67mm hole  Al 2024-T3 WP damage = 0.188mm x 0.166mm x 0.07mm deep crater &amp; several smaller</p>
8 <a href="#">HITF12264</a>	1.29	0.00859	4.90	30	<p><b>Pass</b></p> <p>Beta cloth entry damage = 1.29mm x 1.71mm hole  Mylar Film damage = 19.30mm x 22.42mm hole  Fiberglass damage = 3.49mm x 5.23mm hole  Al 6061 Foil damage = 5.51mm x 4.47mm hole  Fiberglass damage = 7.60mm x 10.60mm hole  MLI exit damage = 4.73mm x 6.56mm hole  Al 6061-T6 plate damage = 3.83mm x 4.45mm hole  Al 5456-0 RW damage = 1.09mm x 1.10mm x 1.14mm deep crater of many with a 0.32mm high bump on back  Al 2024-T3 WP damage = no damage</p>

**Figure 125: AI 5456-0 Rear Wall Layer 8 Front of ISS Soyuz OM Test #7  
(Keyence 3D Microscope Image)**

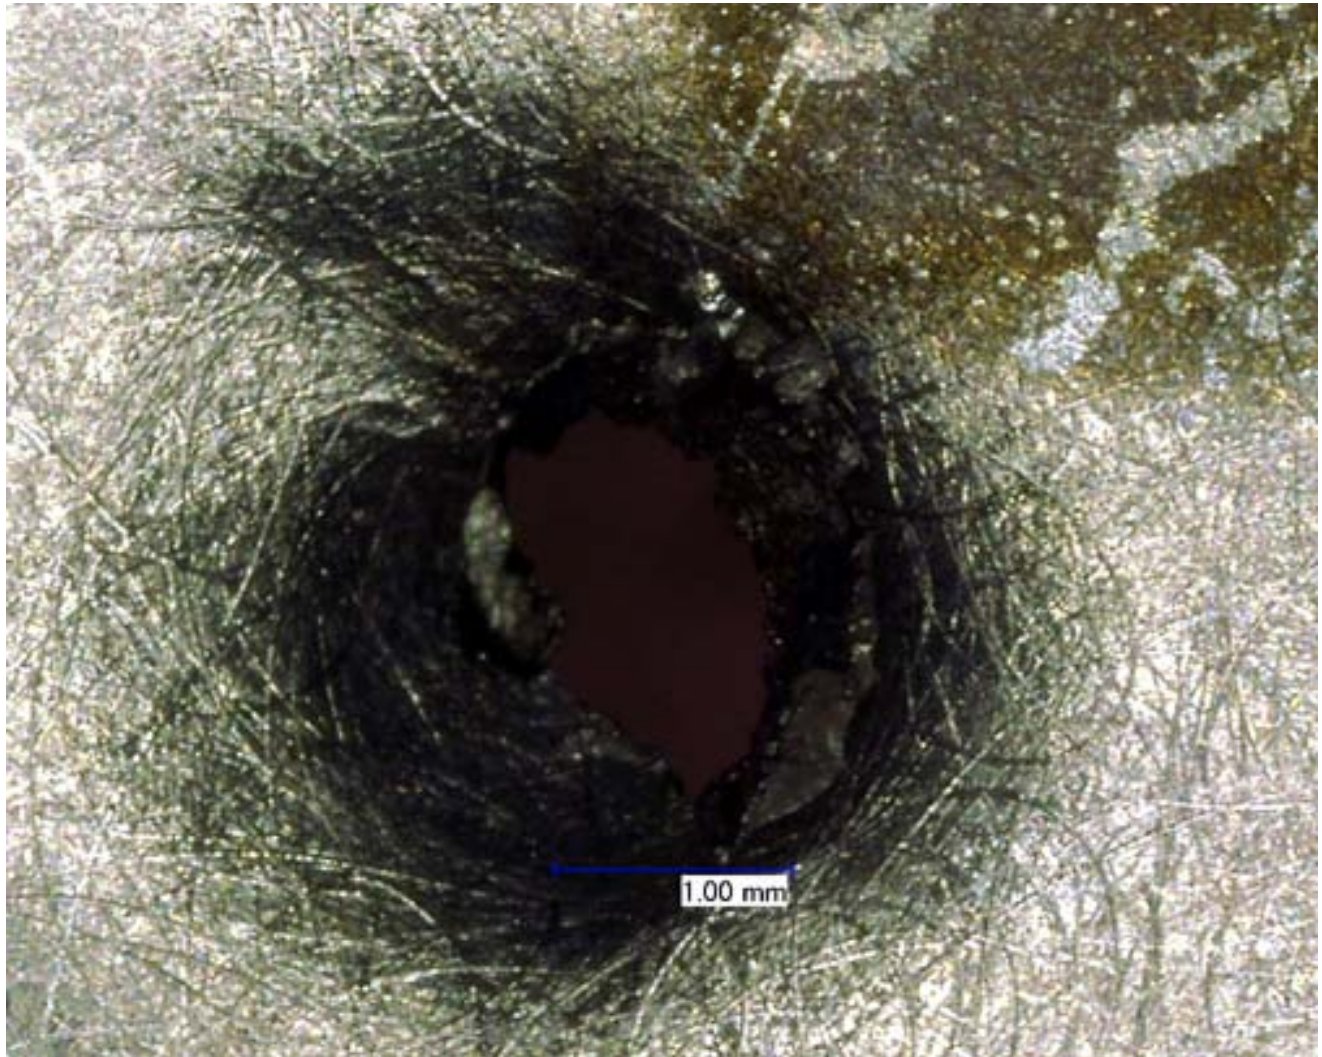
**Test #7, HITF12263**

**Figure 126: AI 5456-0 Rear Wall Layer 8 Back of ISS Soyuz OM Test #7  
(Keyence 3D Microscope Image)**

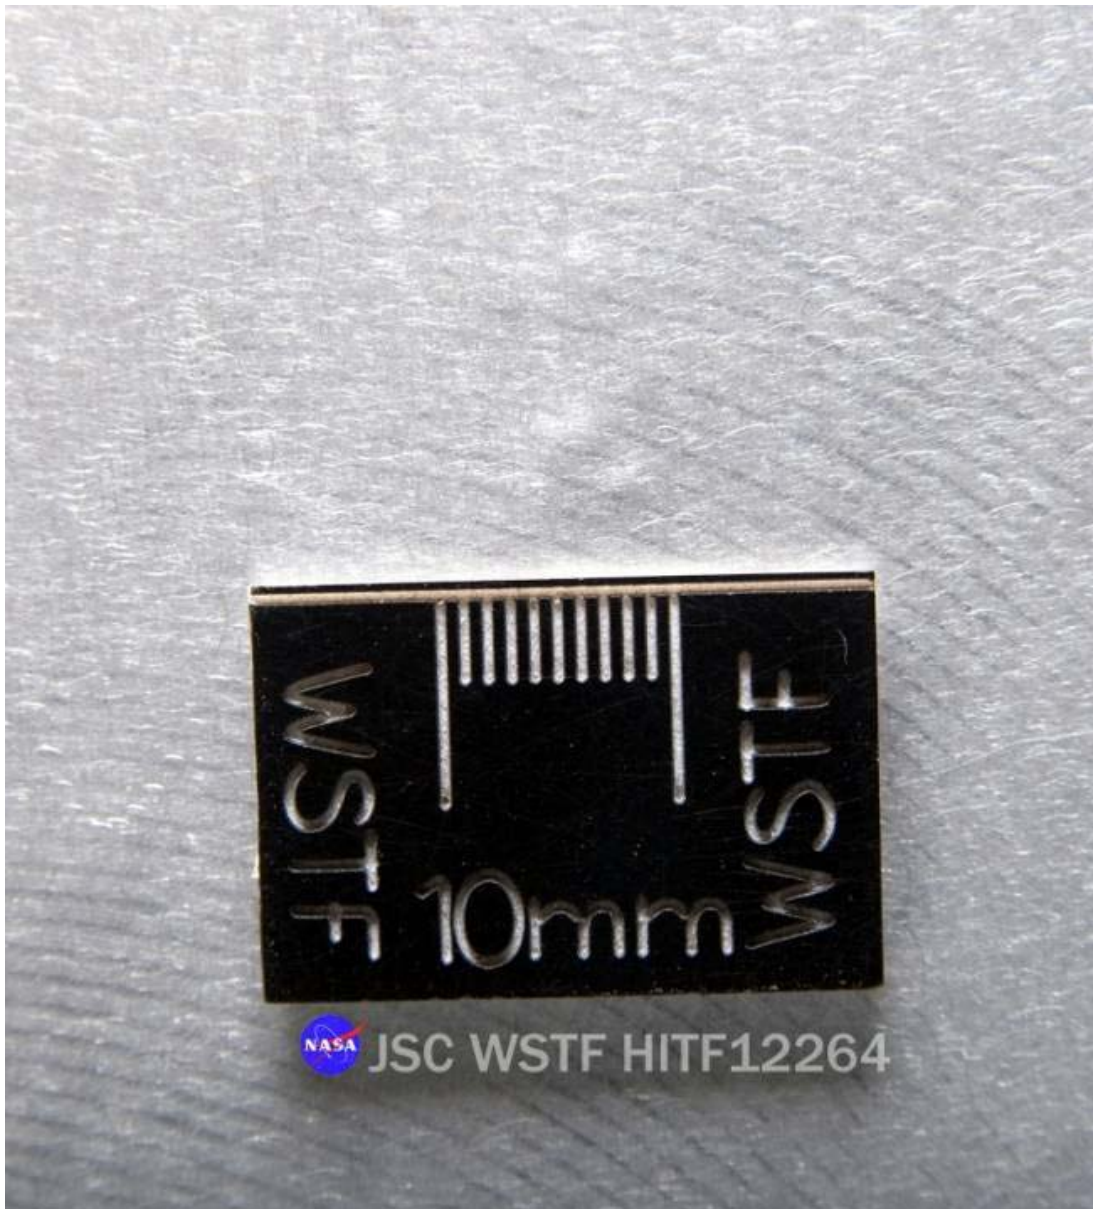
Test #8, HITF12264

Figure 146: Al 5456-0 Rear Wall (Back) for ISS Soyuz Orbital Module  
Test #8

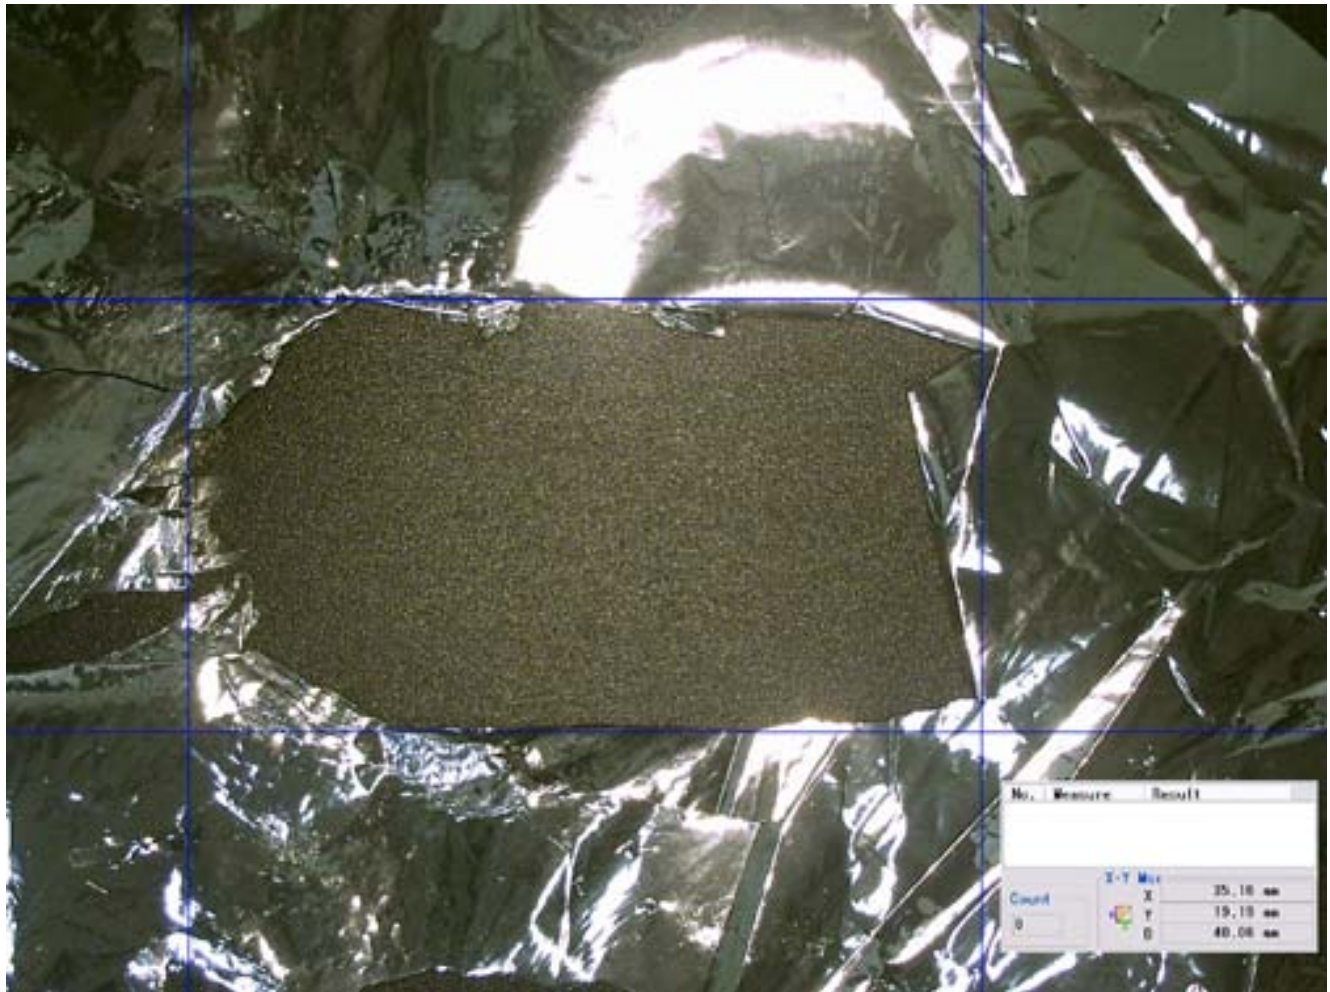
## Test #9, HITF12265

9 <a href="#">HITF12265</a>	1.6	0.01615	7.14	45	<p><b>Fail</b></p> <p>Beta cloth entry damage = 5.49mm x 17.51mm hole  Mylar Film damage = 35.16mm x 19.19mm hole  Fiberglass damage = 13.55 x 14.32mm hole  Al 6061 Foil damage = 9.50 x 14.24mm hole  Fiberglass damage = 14.57 x 16.36mm hole  MLI exit damage = 8.51mm x 11.30mm hole  Al 6061-T6 plate damage = 8.93mm x 9.57mm hole  Al 5456-0 RW damage = 1.50 x 2.39mm hole  Al 2024-T3 WP damage = 31mm x 30mm area of aluminum specks</p>
10 <a href="#">HITF12266</a>	1.39	0.01075	3.19	30	<p><b>Fail</b></p> <p>Beta cloth entry damage = 1.56mm x 1.50mm hole  Mylar Film damage = 13.80mm x 15.43mm hole  Fiberglass damage = 2.67 x 2.27mm hole  Al 6061 Foil damage = 2.50 x 2.74mm hole  Fiberglass damage = 2.45 x 2.93mm hole  MLI exit damage = 3.83mm x 4.66mm hole  Al 6061-T6 plate damage = 2.53mm x 2.92mm hole  Al 5456-0 RW damage = 2.84 x 3.09mm hole  Al 2024-T3 WP damage = 1.48mm x 1.93mm x 0.089mm deep crater &amp; many smaller</p>

Figure 151: Mylar Film Layer 2 of ISS Soyuz OM Test #9  
(Keyence 3D Microscope Image)

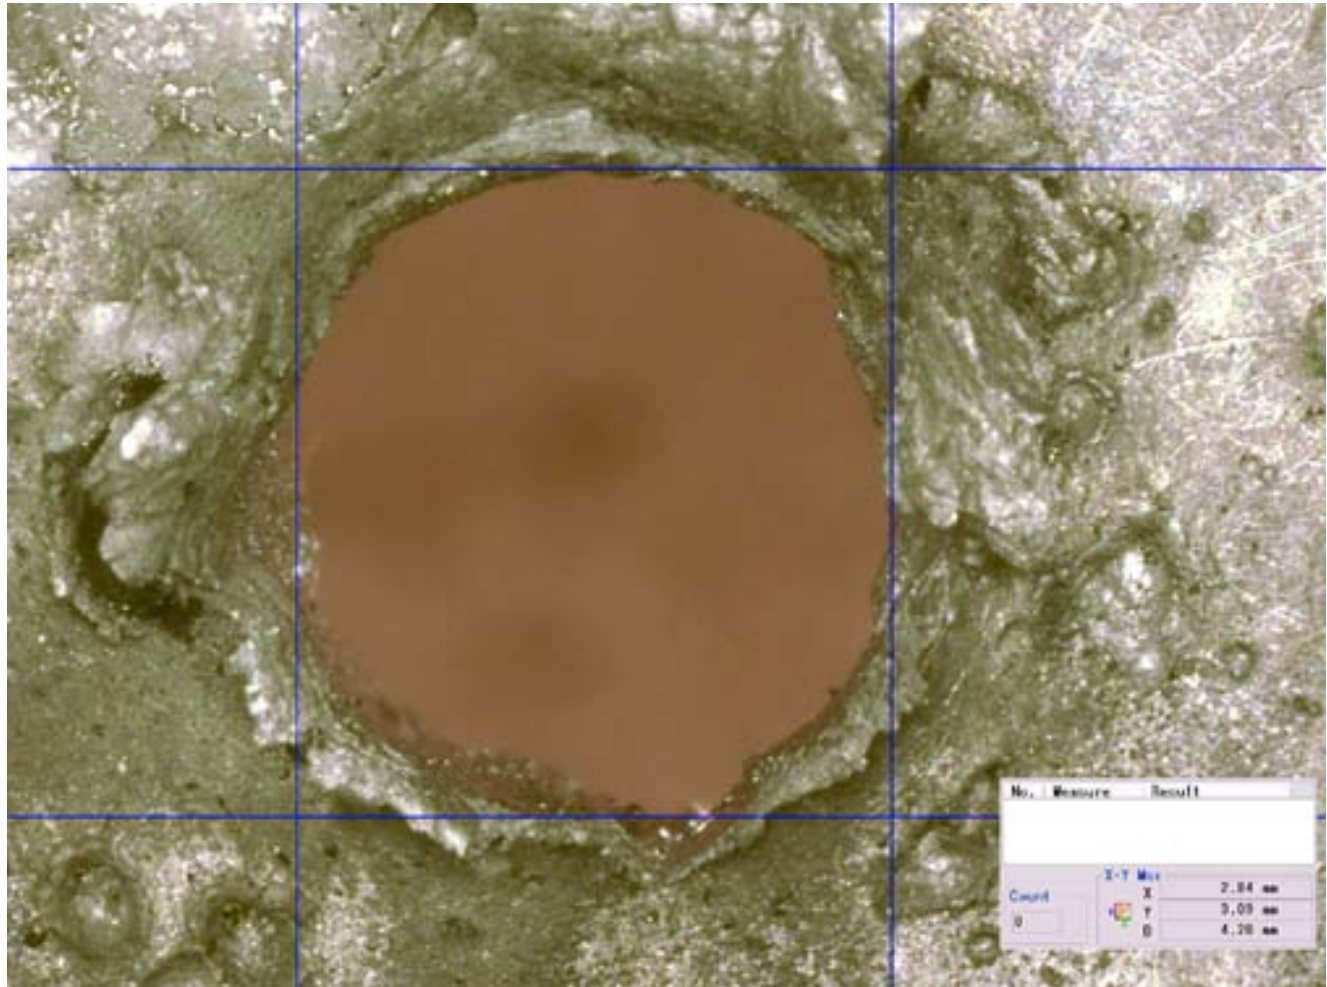
**Test #10, [HITF12266 Rear Wall](#)**

**Figure 173: Al 5456-0 Rear Wall Layer 8 Front of ISS Soyuz OM Test #10  
(Keyence 3D Microscope Image)**

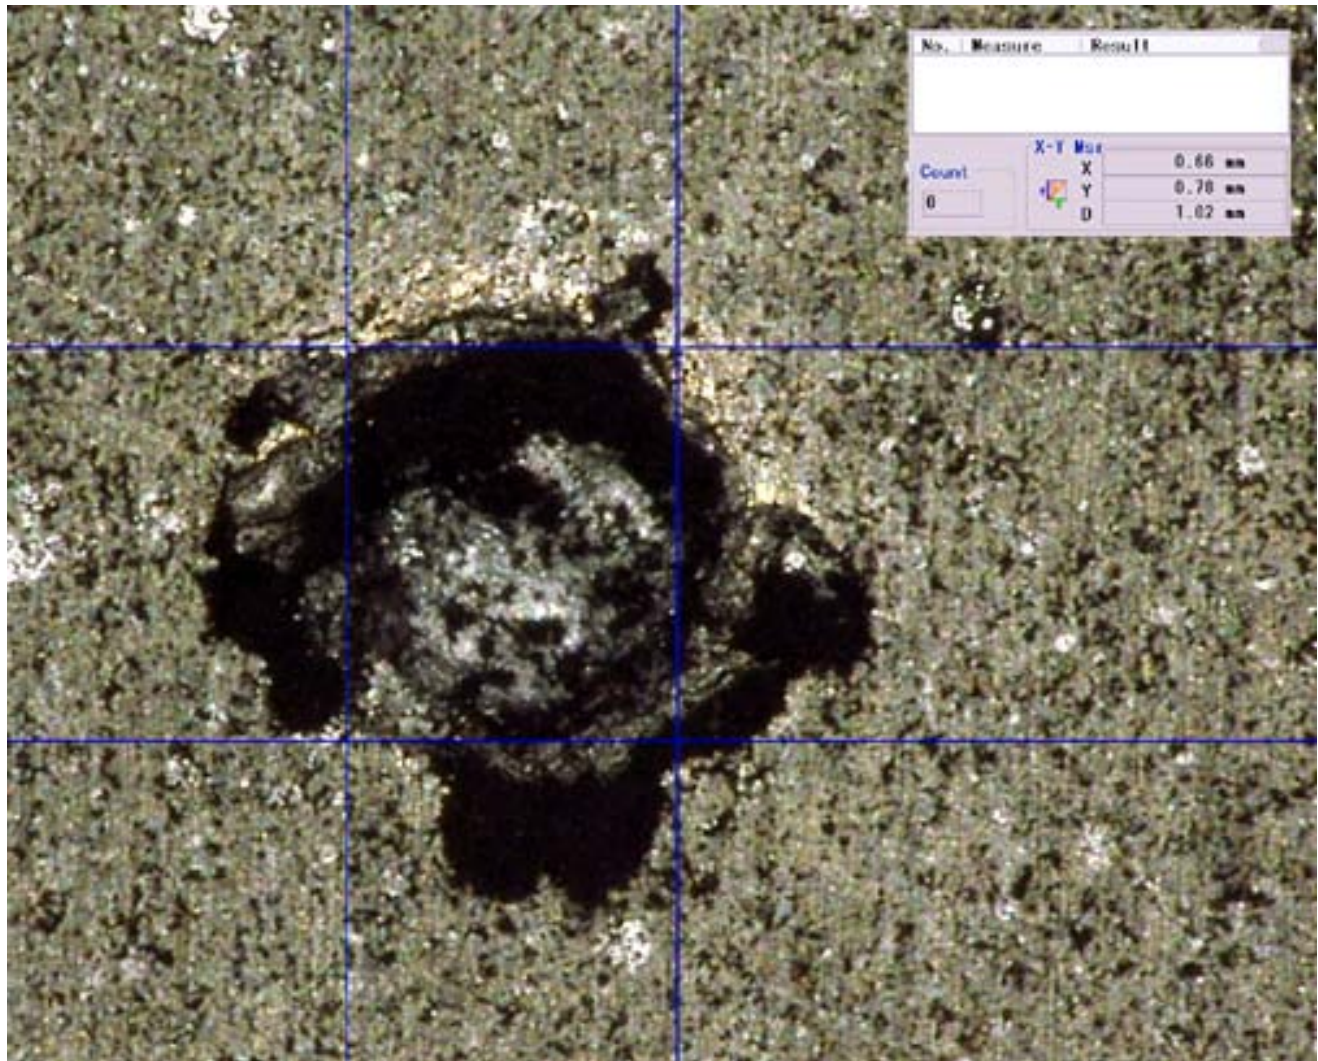
**Test #11, HITF12271**

Test No.	Actual Projectile Diameter (mm)	Actual Projectile Mass (g)	Actual Impact Velocity (km/s)	Impact Angle (deg)	Results
11 <a href="#">HITF12271</a>	1.5	0.01331	6.14	45	<p><b>Fail</b></p> <p>Beta cloth entry damage = 1.60mm x 2.05mm hole  Mylar Film damage = 52.09mm x 24.07mm hole  Fiberglass damage = 7.83mm x 9.30mm hole  Al 6061 Foil damage = 6.22 x 7.26mm hole  Fiberglass damage = 6.31 x 6.85mm hole  MLI exit damage = 13.47mm x 18.16mm hole  Al 6061-T6 plate damage = 7.36mm x 10.58mm hole  Al 5456-0 RW damage = 1.96mm x 2.69mm hole  Al 2024-T3 WP damage = 0.66mm x 0.78mm x 0.15mm deep crater &amp; several smaller</p>
12 <a href="#">HITF12272</a>	1.4	0.01074	6.17	45	<p><b>Pass</b></p> <p>Beta cloth entry damage = 1.49mm x 1.97mm hole  Mylar Film damage = 18.24mm x 27.07mm hole  Fiberglass damage = 3.89 x 6.40mm hole  Al 6061 Foil damage = 5.09 x 6.25mm hole  Fiberglass damage = 4.56 x 5.38mm hole  MLI exit damage = 13.22mm x 19.74mm hole  Al 6061-T6 plate damage = 6.98mm x 10.45mm hole  Al 5456-0 RW damage = 0.88mm x 1.17mm x 0.98mm deep crater with a 0.48mm high bump on back  Al 2024-T3 WP damage = no damage</p>

**Figure 193: Witness Plate of ISS Soyuz OM Test #11  
(Keyence 3D Microscope Image)**

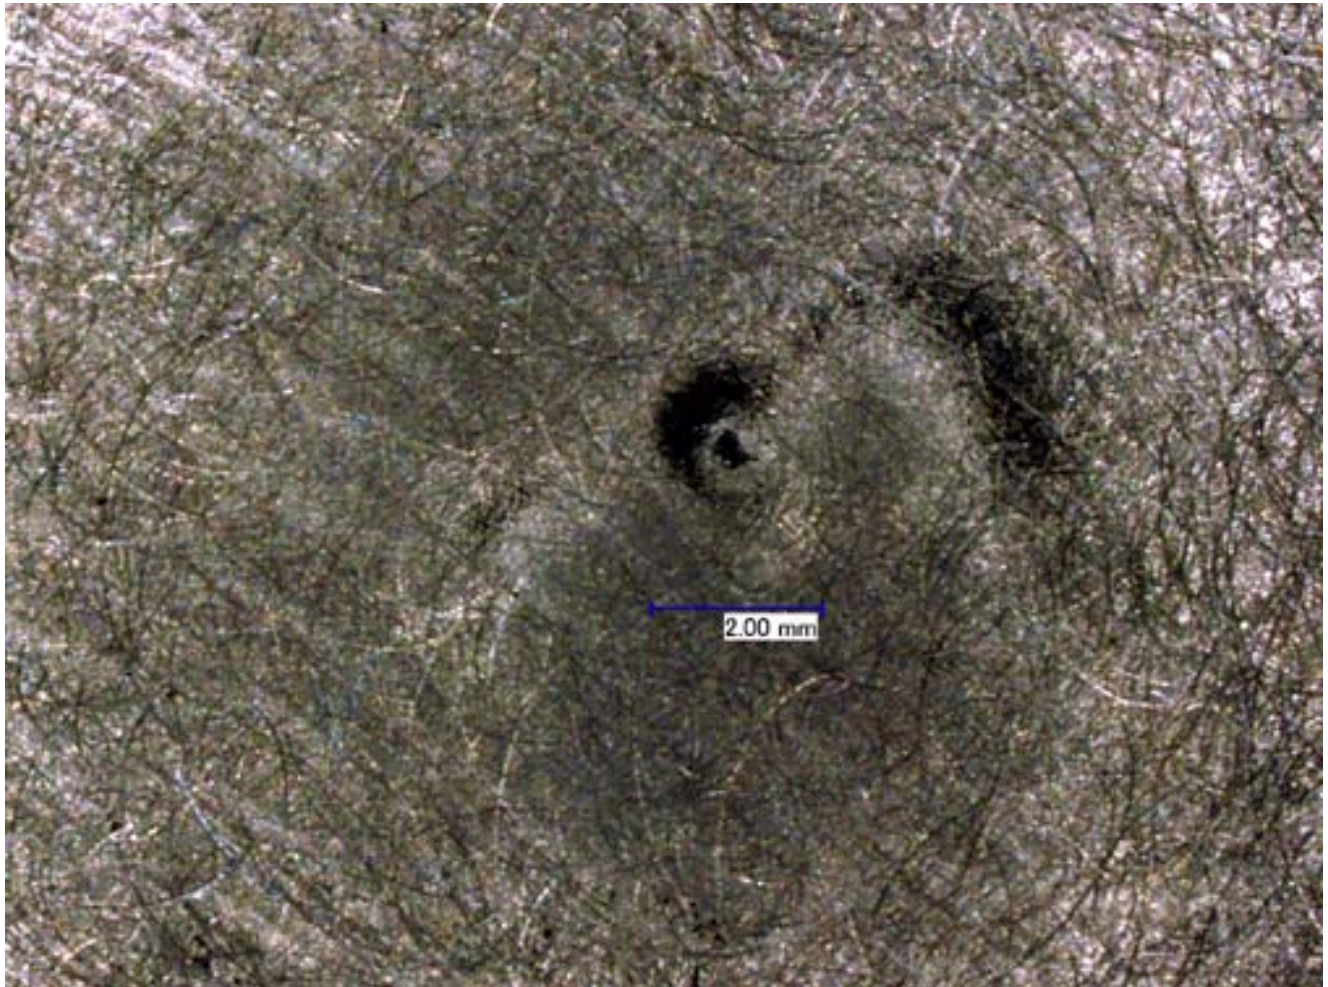
**Test #12, HITF12272**

**Figure 211: AI 5456-0 Rear Wall Layer 8 Back of ISS Soyuz OM Test #12  
(Keyence 3D Microscope Image)**

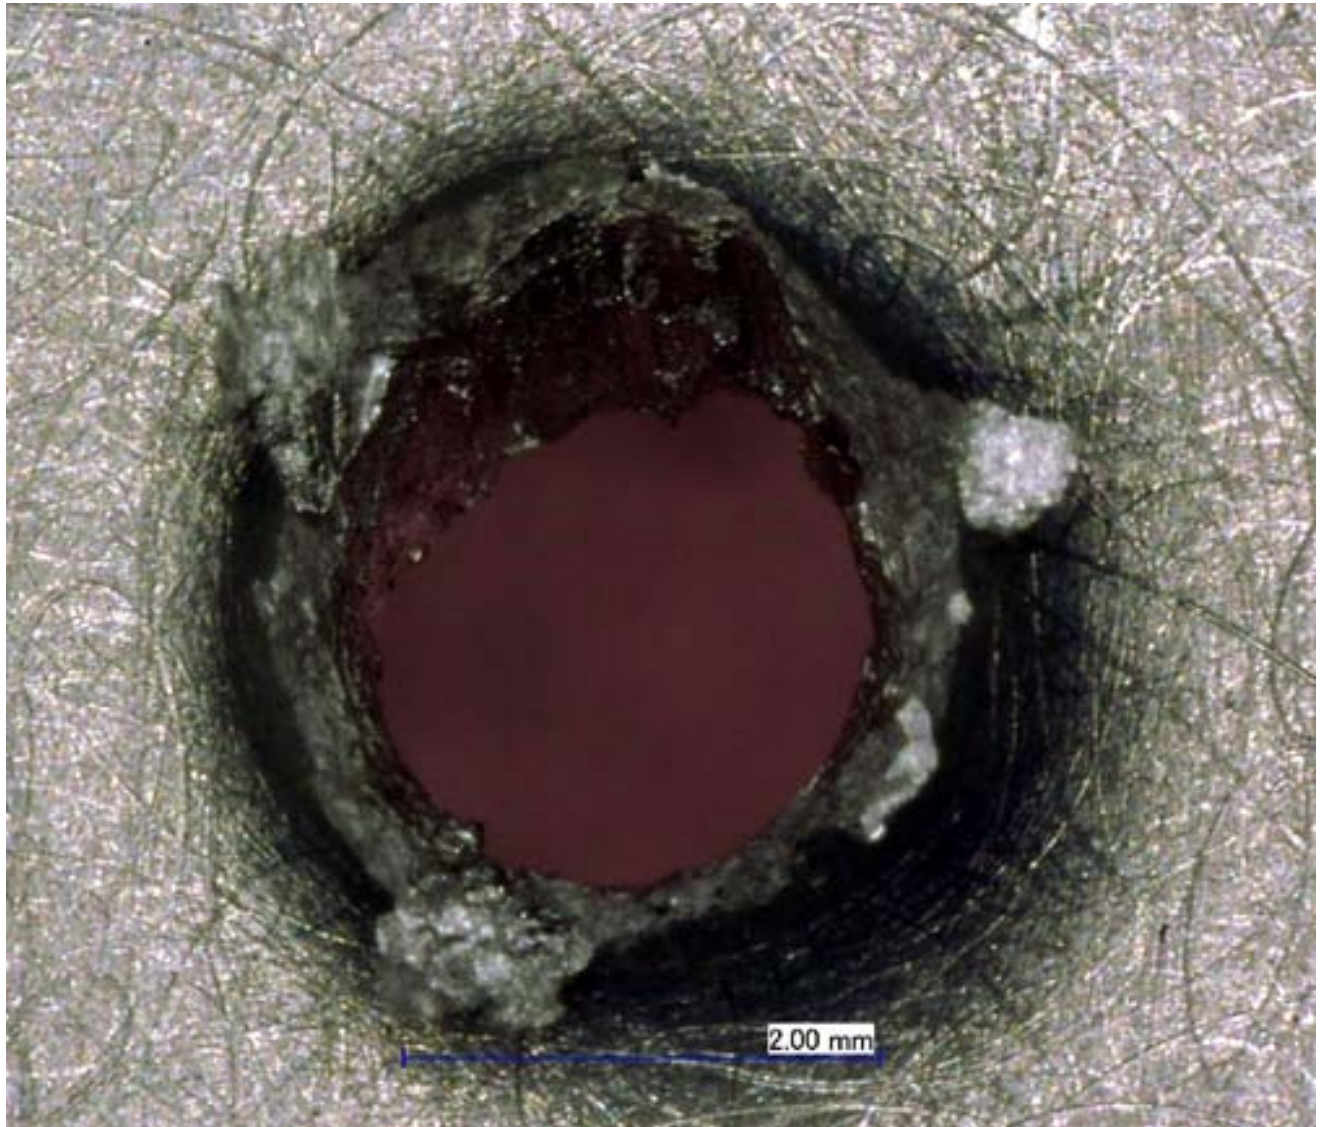
**Test #13B, HITF12273**

13B <a href="#">HITF12273</a>	1.29	0.00863	2.87	30	<p><b>Fail</b></p> <p>Beta cloth entry damage = 1.39mm x 1.35mm hole  Mylar Film damage = 6.54mm x 5.89mm hole  Fiberglass damage = 2.42mm x 2.98mm hole  Al 6061 Foil damage = 2.53mm x 2.50mm hole  Fiberglass damage = 2.84mm x 2.95mm hole  MLI exit damage = 3.03mm x 4.17mm hole  Al 6061-T6 plate damage = 2.05mm x 2.48mm hole  Al 5456-0 <a href="#">RW damage</a> = 2.23mm x 2.33mm hole  Al 2024-T3 WP damage = 0.64mm x 0.74mm x 0.1mm deep crater &amp; several smaller</p>
6B <a href="#">HITF12262</a>	1.49	0.01332	7.14	30	<p><b>Pass</b></p> <p>Beta cloth entry damage = 1.97mm x 1.72mm hole  Mylar Film damage = 24.76mm x 31.83mm hole  Fiberglass entry damage = 7.66mm x 11.22mm hole  Al 6061 Foil damage = 8.67mm x 6.48mm hole  Fiberglass exit damage = 12.33mm x 11.26mm hole  MLI exit damage = 8.01mm x 8.64mm hole  Al 6061-T6 plate damage = 6.66mm x 5.18mm hole  Al 5456-0 <a href="#">RW damage</a> = 0.97mm x 1.11mm x 1.09mm deep crater of many with a 0.94mm high bump on back  Al 2024-T3 WP damage = no damage</p>

**Figure 226: Al 5456-0 Rear Wall Layer 8 Back of ISS Soyuz OM Test #13B  
(Keyence 3D Microscope Image)**

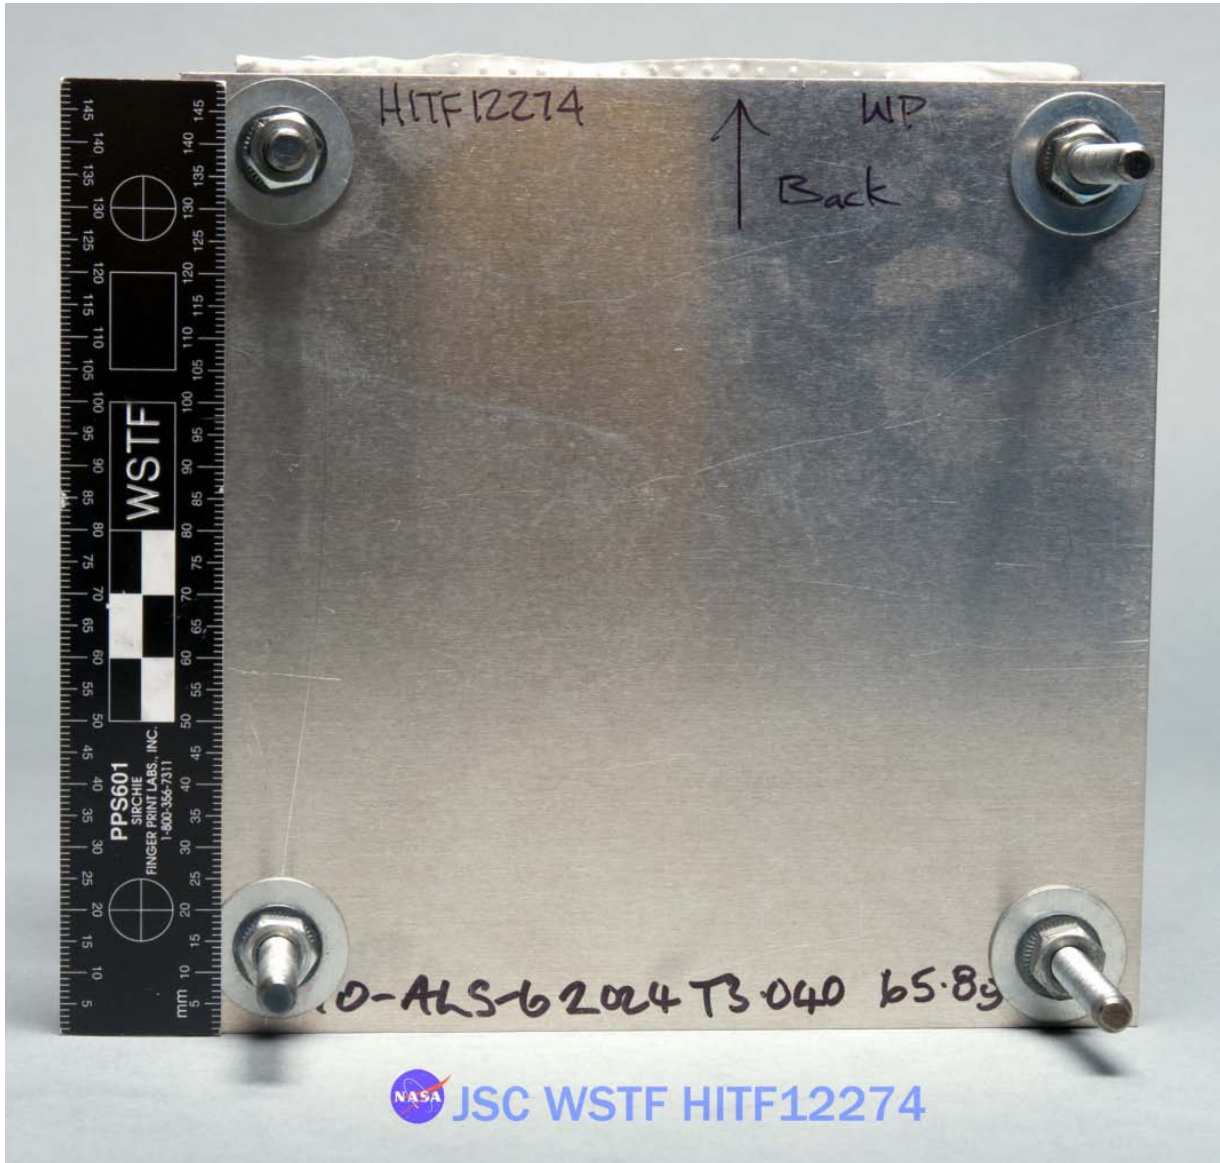
Test #14, HITF12274

14 <a href="#">HITF12274</a>	1.3	0.00864	4.18	45	<p><b>Fail</b></p> <p>Beta cloth entry damage = 1.43mm x 1.87mm hole  Mylar Film damage 33.26 x 22.20mm hole  Fiberglass damage = 3.10 x 5.92mm hole  Al 6061 Foil damage = 2.95 x 4.06mm hole  Fiberglass damage = 3.46 x 4.32mm hole  MLI exit damage = 5.07mm x 6.72mm hole  Al 6061-T6 plate damage = 3.05mm x 5.04mm hole  Al 5456-0 RW damage = 0.87mm x 0.99mm hole  Al 2024-T3 WP damage = 0.50mm x 0.85mm x 0.056mm deep crater</p>
15C <a href="#">HITF12275</a>	1.0	0.00400	3.93	45	<p><b>Pass</b></p> <p>Beta cloth entry damage = 1.23mm x 1.68mm hole  Mylar Film damage 24.03 x 20.59mm hole  Fiberglass damage = 1.72 x 2.52mm hole  Al 6061 Foil damage = 2.23 x 3.04mm hole  Fiberglass damage = 2.20 x 3.15mm hole  MLI exit damage = 4.10mm x 5.64mm hole  Al 6061-T6 plate damage = 2.70mm x 3.95mm hole  Al 5456-0 RW damage = 1.10mm x 1.21mm hole  Al 2024-T3 WP damage = no damage</p>

Figure 249: Back Witness Plate View of ISS Soyuz Orbital Module Test #14

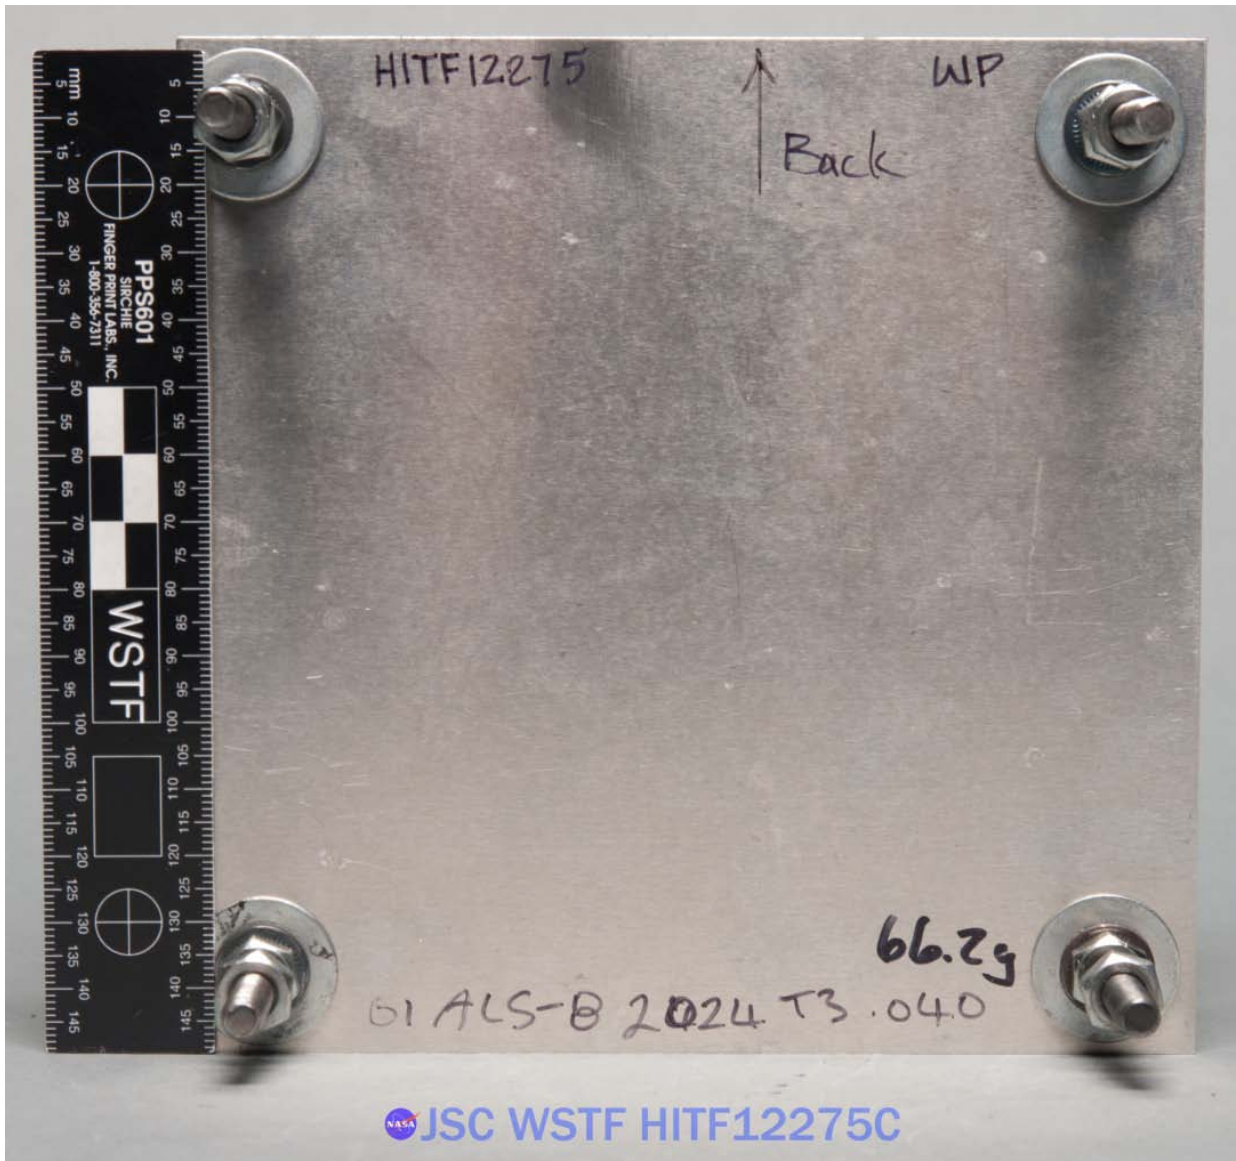
Test #15C, HITF12275

Figure 263: Back Witness Plate View of ISS Soyuz Orbital Module Test #15C

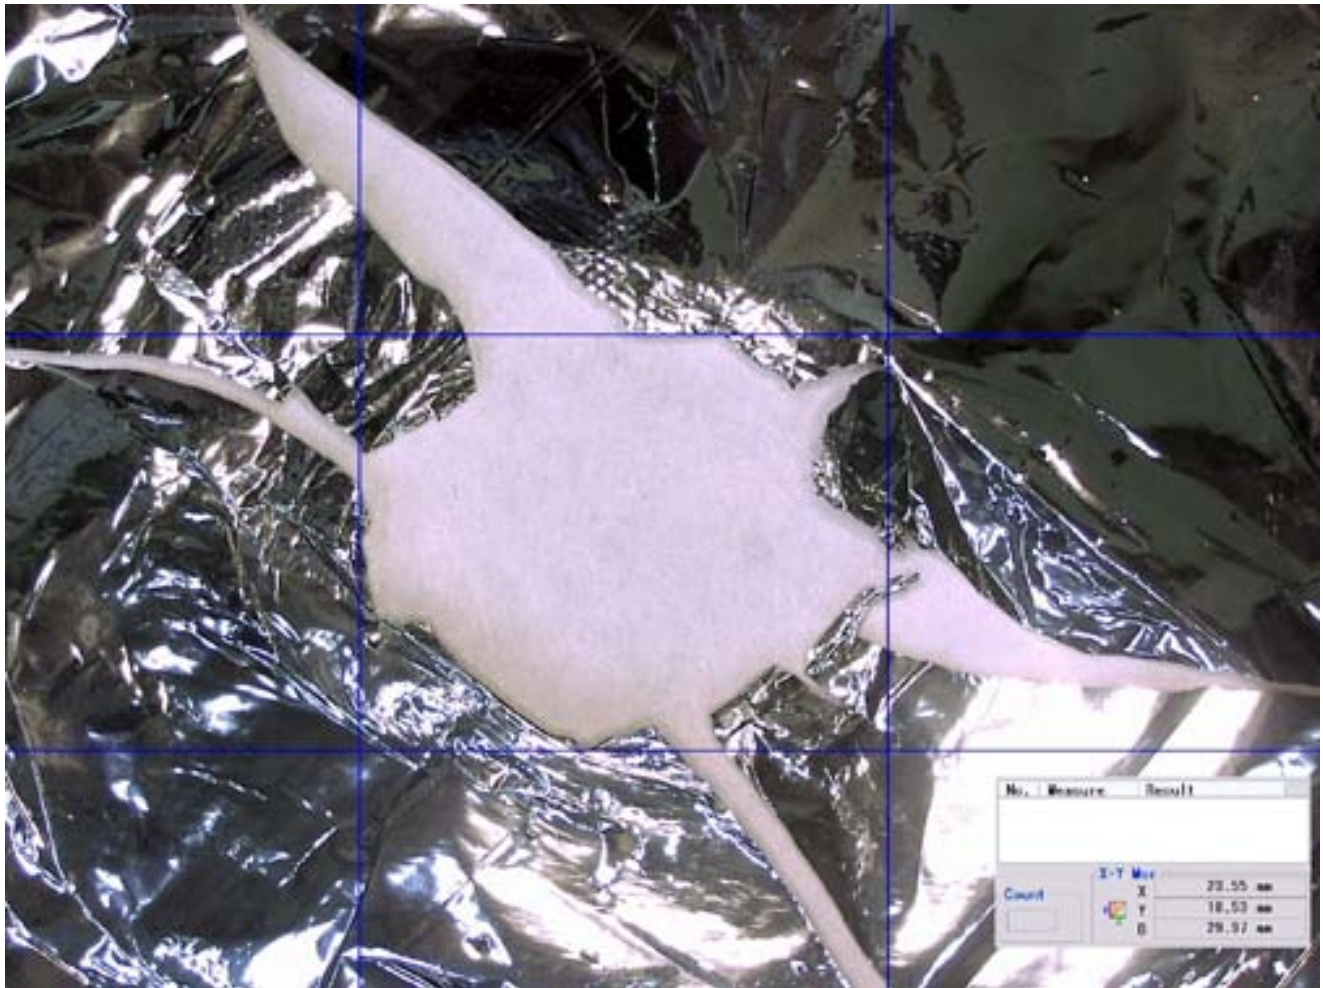
## Test #16, HITF12276

Test No.	Actual Projectile Diameter (mm)	Actual Projectile Mass (g)	Actual Impact Velocity (km/s)	Impact Angle (deg)	Results
16 <a href="#">HITF12276</a>	1.6	0.01610	7.00	30	<p><b>Fail</b></p> <p><b>Beta cloth entry damage</b> = 1.69mm x 1.84mm hole  <b>Mylar Film damage</b> 23.55 x 18.53mm hole  <b>Fiberglass damage</b> 10.23 x 10.29mm hole  <b>Al 6061 Foil damage</b> = 7.72 x 5.93mm hole  <b>Fiberglass damage</b> 11.36 x 12.23mm hole  <b>MLI exit damage</b> = 8.75mm x 9.62mm hole  <b>Al 6061-T6 plate damage</b> = 6.66mm x 7.91mm hole  <b>Al 5456-0 RW damage</b> = 1.77mm x 1.75mm hole  <b>Al 2024-T3 WP damage</b> = 52mm x 63mm area of aluminum specks</p>
17 <a href="#">HITF12277</a>	1.5	0.01331	4.83	30	<p><b>Fail</b></p> <p><b>Beta cloth entry damage</b> = 1.66mm x 1.70mm hole  <b>Mylar Film damage</b> 15.62 x 12.15mm hole  <b>Fiberglass damage</b> = 3.63 x 4.03mm hole  <b>Al 6061 Foil damage</b> = 4.32 x 5.02mm hole  <b>Fiberglass damage</b> = 4.62 x 5.64mm hole  <b>MLI exit damage</b> = 6.47mm x 7.43mm hole  <b>Al 6061-T6 plate damage</b> = 4.63mm x 6.11mm hole  <b>Al 5456-0 RW damage</b> = 2 holes largest is 1.54mm x 2.20mm  <b>Al 2024-T3 WP damage</b> = 0.487mm x 0.536mm x 0.372mm deep crater &amp; many smaller</p>

Figure 268: Mylar Film Layer 2 of ISS Soyuz OM Test #16  
(Keyence 3D Microscope Image)

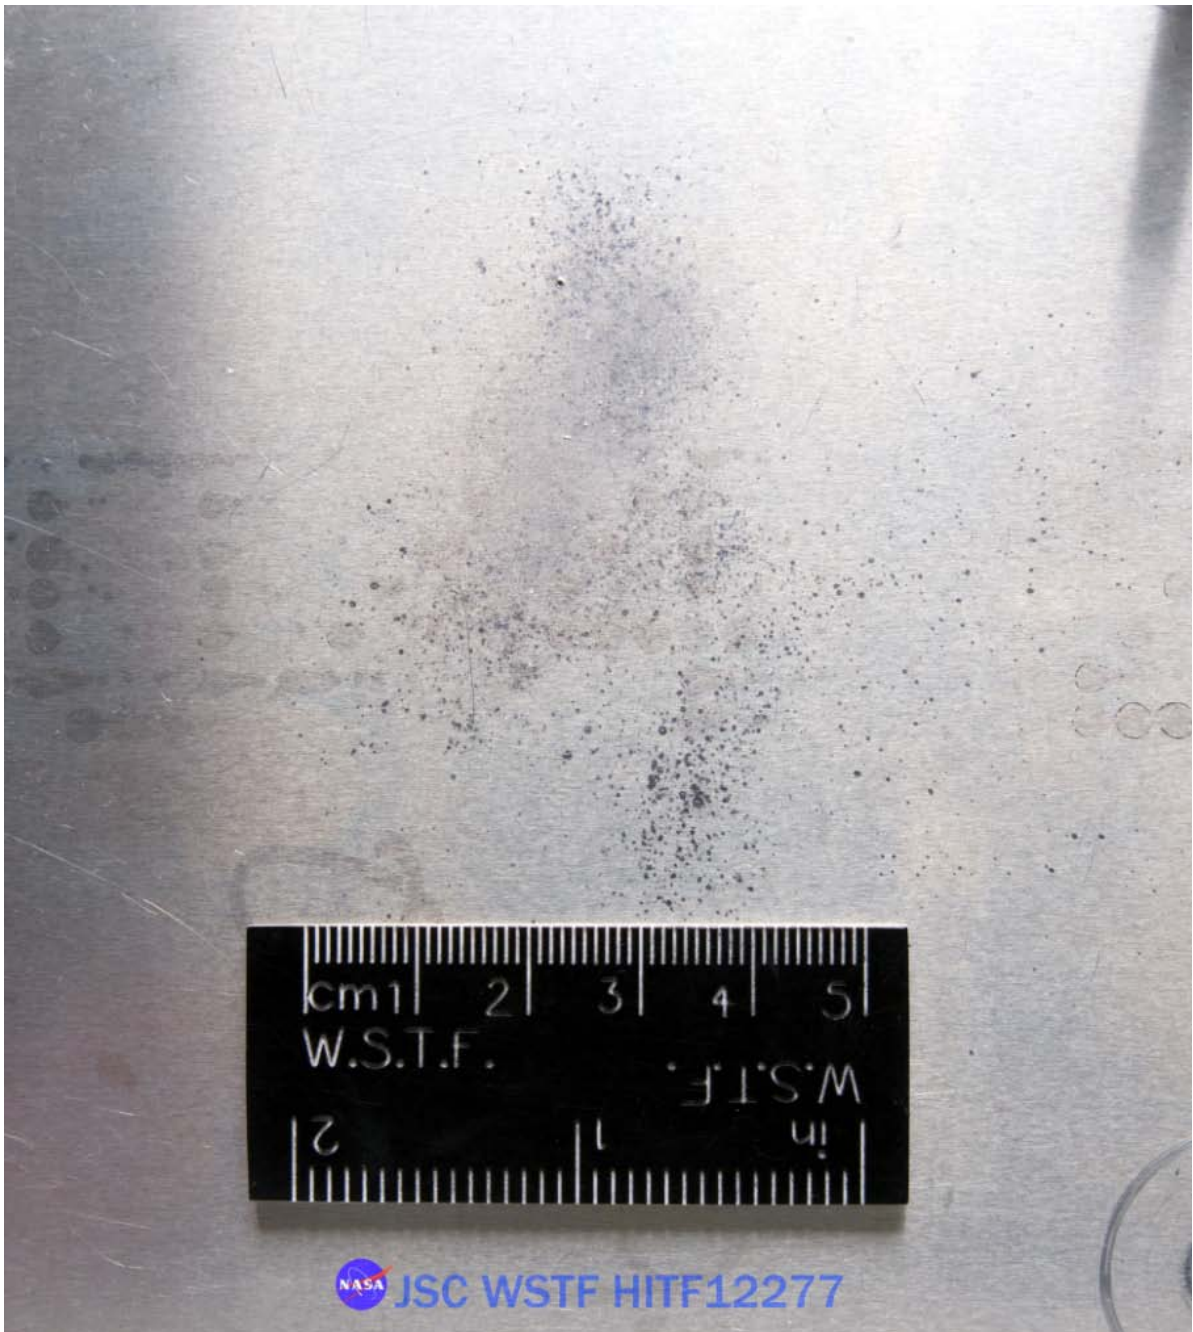
Test #17, HITF12277

Figure 297: Front Close-up Witness Plate View of ISS Soyuz Orbital Module Test #17
