# Investigation of International Space Station Major Constituent Analyzer Anomalous ORU 02 Performance

Ben D. Gardner<sup>1</sup>, David E. Burchfield<sup>2</sup>, Andrew Pargellis<sup>3</sup>, Phillip M. Erwin<sup>4</sup> and Souzan Thoresen<sup>5</sup>  
*United Technologies Aerospace Systems, Pomona, California, 91767*

**The Major Constituent Analyzer (MCA) is a mass spectrometer based system that measures the major atmospheric constituents on the International Space Station. In 2011, two MCA ORU 02 analyzer assemblies experienced premature on-orbit failures. These failures were determined to be the result of off-nominal ion source filament performance. Recent product improvements to ORU 02 designed to improve the lifetime of the ion pump also constrained the allowable tuning criteria for the ion source filaments. This presentation describes the filament failures as well as the corrective actions implemented to preclude such failures in the future.**

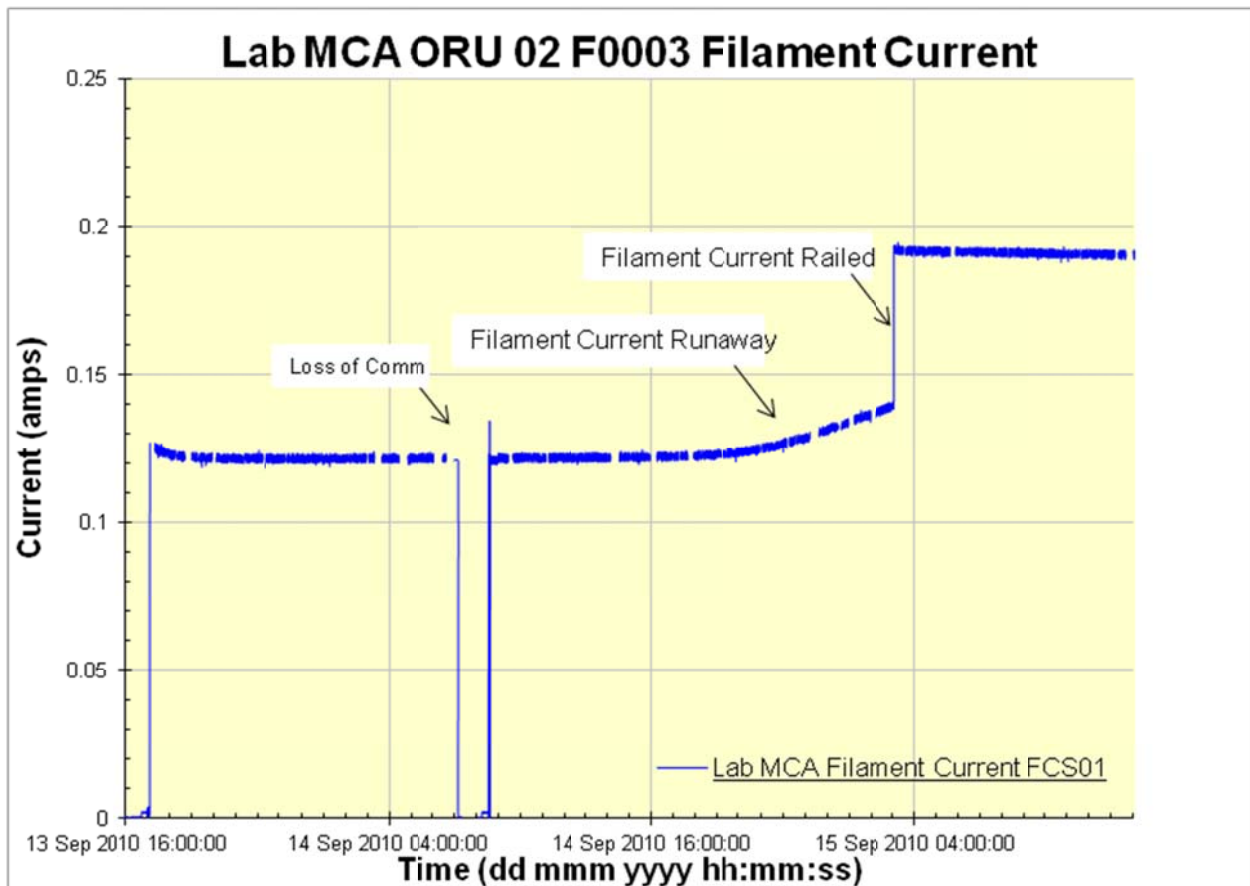
**Figure 2:** ORU 02 F0003 filament current over time, showing the rise that eventually railed at the maximum available current.

Subsequent to this initial Filament 1 failure, the unit was stopped and then restarted. At that time, Filament 1 passed Active Built-in Test (ABIT) during startup, but railed again a short time later. The ORU 02 was stopped and placed in Life Extending Mode (LEM). When it was restarted again on 9/21, Filament 1 did not pass ABIT and the unit completed startup on Filament 2. Subsequent to the failure of Filament 1, operation of ORU 02 Filament 2 was checked to determine whether the ORU 02 was likely to have any useful on-orbit life. It was decided to perform a one-week evaluation, and Filament 2 was activated on 9/30/2010. Upon completing the evaluation it was judged that Filament 2 would not likely have the infant mortality problems of Filament 1. Operation of the MCA with this ORU 02 was then discontinued due to problems with the CSCI 4.24 firmware, and ISS MCA operations switched to

On May 13, 2011, ORU 02 F0003 was reactivated. The ORU operated for 24 days on Filament 2 before Filament 2 also failed. The symptom detected by the built-in test firmware was a lack of electrometer output, meaning that the electrometer sensor readings were zero. The symptoms indicated that the filament was consuming power while no ions were being generated, suggesting that something was interfering with electrons getting out of the electron gun. The MCA was operating using firmware CSCI 4.18 at the time of this failure. Firmware CSCI 4.18 has a filament current limit of 450 mA, so the Built-In Test (BIT) did not fail due to high filament current.

The two filament failures of ORU 02 F0003 were decidedly different – for Filament 1 a positive trend in filament current developed after a day of operation and, after rising steadily for 8 hours the filament current suddenly transitioned to the power supply’s maximum output. Filament 2 showed no hint of instability over twentyfour days of operation prior to its transition to maximum power. Another nuance to the failures was that, while Filament 1 was at maximum power, the ion source continued to generate ions – nitrogen and oxygen signals were reduced but non-zero. When Filament 2 failed there were no ions produced in the source and all electrometer signals went to zero.

These signatures pointed to Filament 1 being driven over a period of hours to a point of operation where the control loop circuitry lost the capacity to generate sufficient electrons from the filament, and consequently drove the filament to maximum power. Electron Gun 2 simply stopped producing electrons altogether.

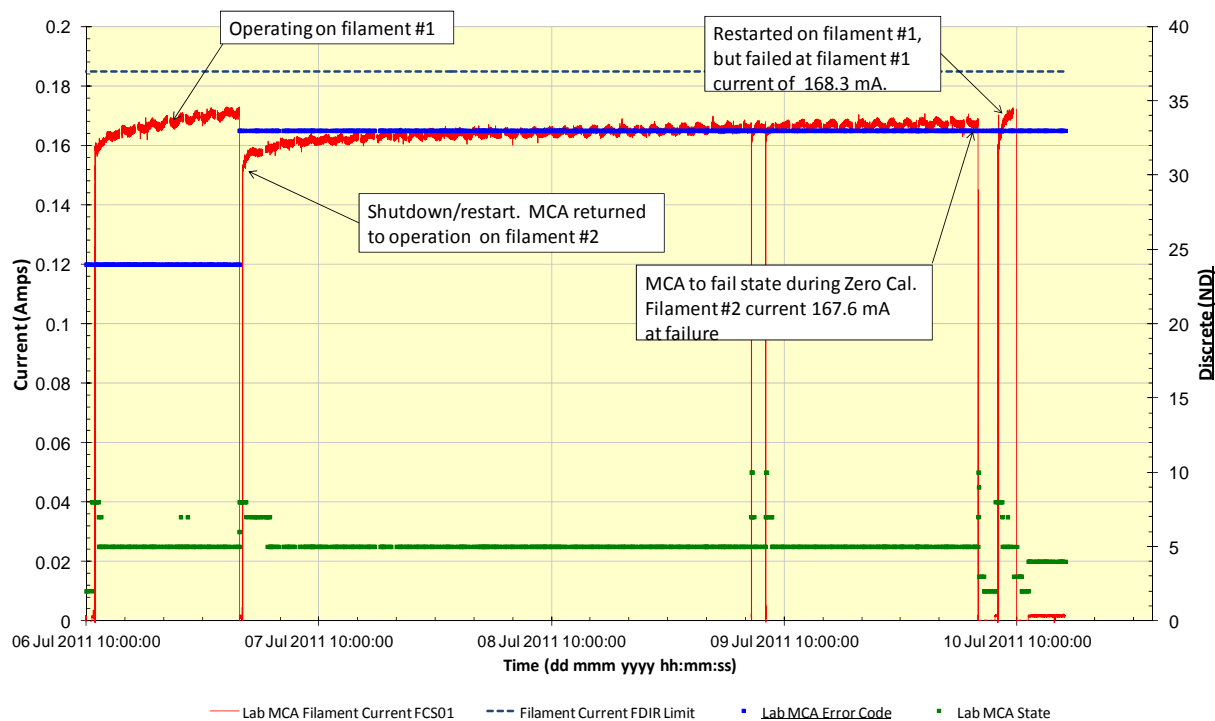
The Lab MCA was activated with the refurbished ORU 02 F0001 on 7/6/2011. The MCA operated on Filament 1 for 14+ hours. During this time, filament current rose steadily (but not linearly) from approx. 156 mA to 171 mA. The ORU then experienced a shutdown and restarted automatically. MCA came back up on Filament 2. Data indicate Filament 1 failed ABIT during restart. Filament high current FDIR limit was set by Range Limit Command (RLC) to 185 mA. Telemetry of Filament 1 current was 156 mA shortly after activation and 172 mA at shutdown, so the FDIR limit did not appear to have been reached. The FDIR limit of 185 mA was set in order to automatically protect the filament from a high current condition.

Filament 2 continued running, with gradually increasing current until 7/10 06:01. The ORU 02 then failed during a zero cal. During zero cal, the filament is briefly turned off and then is turned back on. It has been found that filament current overshoots its steady state value during turn on and then normally comes back down to the steady state value within about 30 seconds. It is suspected that since the steady state value was about 168 mA and the FDIR limit was 185 mA, the filament current went above the FDIR limit during this overshoot.

**Figure 3:** ORU 02 F0001 filament current shown in blue.

The failure symptoms of ORU 02 F0001 included characteristics that had not been previously observed, including apparent random restarts, occasional transitions to fail state, and the instrument switching between filaments on some restarts. These characteristics became important after the filament currents exceeded 160mA, suggesting that they were associated with filaments that were being driven into control loop saturation. That both filaments had positive current trends over time and one filament was eventually observed to go into runaway suggested that for both of these electron guns the underlying behavior was associated with control loop instability due to SCL.

The headroom to SCL was very thin for this analyzer due to a combination of factors that included: a very low-flow sample inlet frit; a small bias in the ion gun alignment that dropped the source efficiency about 30%, and lower-than average electron acceleration voltage. The first two terms increased the demand on the electron guns, forcing them to operate at  $29\ \mu\text{A}$  in order to ionize enough sample to generate the required ion currents at the detectors. The third term, dropping the electron acceleration voltage from a nominal 137 to 125V, yielded nearly a 20% drop in SCL, from about  $40\ \mu\text{A}$  to approximately  $32\ \mu\text{A}$ . As long as the electron guns remained perfectly tuned the roughly ten percent margin between the operating point and the SCL current was not important. However, the guns were poised to go into runaway if gun transmission efficiency dropped by more than 10% or the filament diameter dropped by more than 10%.

As the filaments neared runaway, nuances in ORU 02 F0001's operation led to the observed transitions to fail state and random restarts. When a filament runs into SCL, no amount of additional heat can provide the current being demanded by the control loop; the control electronics run the filament to maximum power in approximately 10 ms. A logic circuit in the filament control board automatically shuts off the filament power if it exceeds 250 mA. For this ORU 02, this circuit was tripping at the onset of runaway, causing the output of the ion source to go to zero. The firmware responds to a stopped ion source by initiating a restart if a filament shuts down during operation. If, however, the filament is disabled by the logic circuit during built-in test, the firmware marks the filament as dead and starts up the alternate filament. In both cases however, it was a transition to runaway exceeding the 250 mA threshold as the base behavior and the transitions too place too quickly to be observed in the 0.5 Hz MCA output telemetry data.

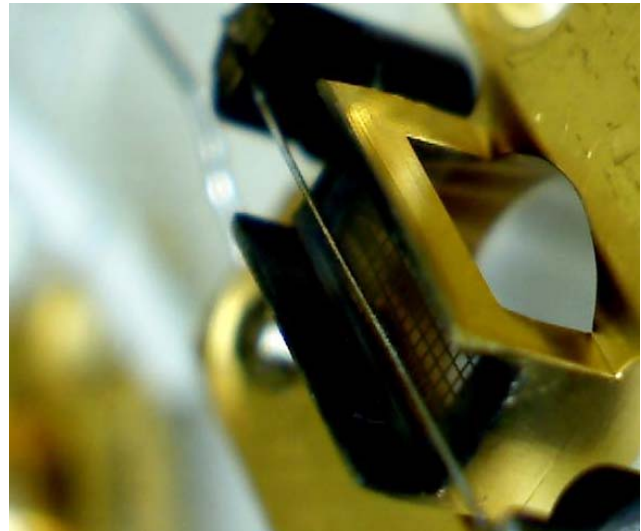
Upon disassembly of the source it was found that the SCL had dropped well below 40  $\mu$ A for Electron Gun 1 by excessive oxidation of the filament. Electron gun inner surfaces were found coated with a black substance, confirmed by x-ray photoelectron spectroscopy and plasma etching to be a greater than 350 nm thick deposit of tungsten oxides. Figure 4 shows the filament block assembly, with the inner gold-passivated surfaces completely masked by the oxide deposit. Less obvious in the figure is that the filament wire has been etched such that the center of the wire is less than 3.7 mils in diameter.

**Figure 4:** ORU 02 F0003 filament block assembly. Note that all surfaces with a direct view of the filament appear coated with a thick deposit of tungsten oxide, while those surfaces facing away from the filament or otherwise masked show the base gold color of the assembly.

The presence of oxides and lack of nitrogen in the deposit material suggest that either too much pure oxygen was admitted to the instrument during source tuning or the filament was heated before the analyzer's vacuum system was sufficiently dry. In vacuum tubes, small amounts of water vapor can lead to catalytic etching of tungsten filaments through something known as the water cycle<sup>8</sup>. The water signal was on-scale during that first day of operation on-orbit, implying that regardless of the source of oxygen, the etching had to be largely complete prior to installation on-orbit.

Filament 1's failure left a significant deposit of tungsten oxide on the inner surfaces of Electron Gun 1. The deposit did not seriously affect operation of the gun's electrostatic lenses; tungsten oxide is sufficiently conductive to prevent charge buildup that might otherwise detune the gun. However this conductive debris, in a microgravity environment, could explain the sudden failure of the second electron gun.

- Better control of air and water vapor control procedures during the various stages of manufacturing in which the filaments are operated, as well as during installation on orbit, to prevent filament oxidation.
- Operating the filaments for additional time prior to tuning the ion sources, minimizing the effect that stress-relaxation might shift filaments off-focus on orbit.
- Evaluating the electron gun performance as a function of demand to demonstrate that the SCL has not been degraded in optimizing other gun tuning voltages, with additional performance requirements implemented during final testing
