Oxidation Embrittlement Observed in SiC/SiC Composites

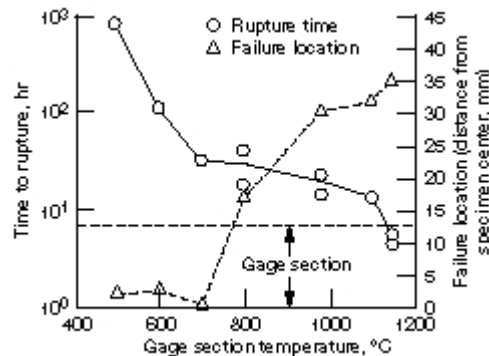
Stress rupture data for [0°/90°] DuPont enhanced chemical vapor infiltration SiC/Nicalon SiC composite as a function of gage section temperature at a creep stress of 83 MPa. Also shown is the failure location as a function of gage section temperature.

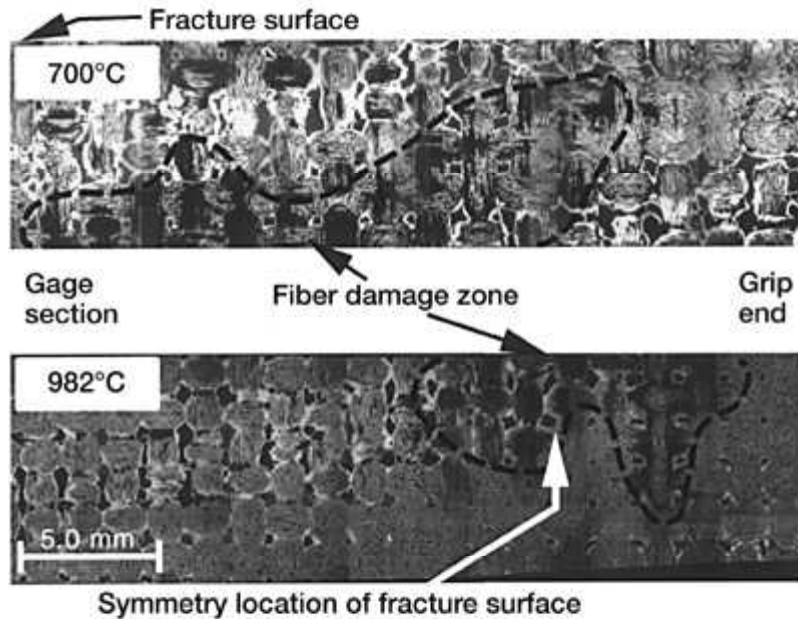
Metallurgical examination of failed specimens revealed an environmentally assisted material degradation operating in the 700 to 800 °C range. The photomicrographs show the distribution of damage in two specimens tested at the same stress but different gage section temperatures. In the views shown, the sections are polished in the thickness direction, showing the broad specimen face. The loading direction is horizontal. In the 700 °C specimen, creep damage is distributed throughout the uniformly heated test section. However, in the 982 °C specimen, damage is concentrated only at the point outside the gage section where the temperature was found to be 700 to 800 °C; less damage occurred within the hotter gage section. Both specimens failed because of an aggressive environmental attack of the SiC fibers at location where the temperature was in the 700 to 800 °C range.

Creep damage distribution of two [0°/90°] DuPont enhanced chemical vapor infiltration SiC/Nicalon SiC specimens tested at a stress of 83 MPa. The damaged fiber tows were found throughout the gage section of the 700 °C specimen. However, for the 982 °C specimen, the damage was concentrated at the point outside of the gage section where the temperature was 700 to 800 °C.
