NASA/TM—1999-209077

Aerospace Mechanisms and Tribology Technology: Case Study

K. Miyoshi
Glenn Research Center, Cleveland, Ohio

CASE STUDY: GALILEO SPACECRAFT AND HIGH-GAIN ANTENNA DEPLOYMENT ANOMALY

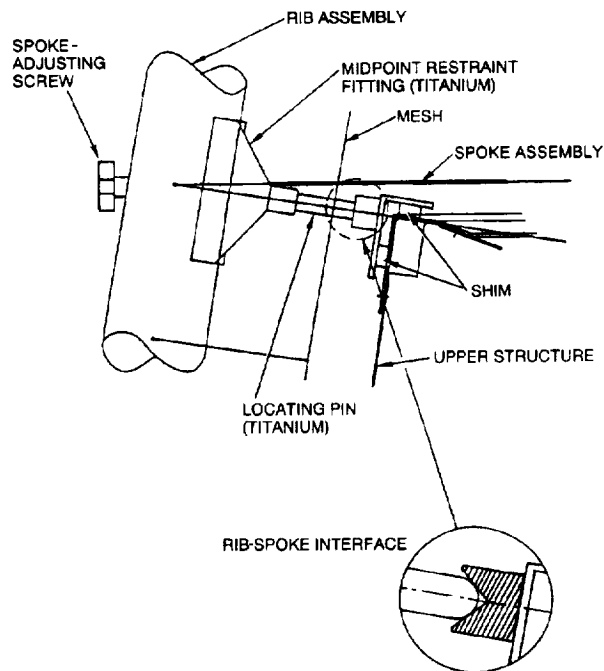
More than 100 people contributed to testing, simulation, analysis, consultation, and review. After a thorough analysis of the telemetry and ground testing and analysis, the investigation attributed the problem to the sticking of 3 of the antenna's 18 ribs in the stowed (or closed) position due to high friction between their standoff pins (locating pins) and their sockets (fig. 2). The other ribs are partially open (fig. 3). The anomaly review team is confident that nothing is broken and that three adjacent antenna ribs are stuck to the central tower by friction in their paired stand-off pins, which are likely misaligned enough that one pin binds the upper side of its socket and its mate the lower side (fig. 4).

Figure 2.—Rib-spoke interface on Galileo spacecraft high-gain antenna.

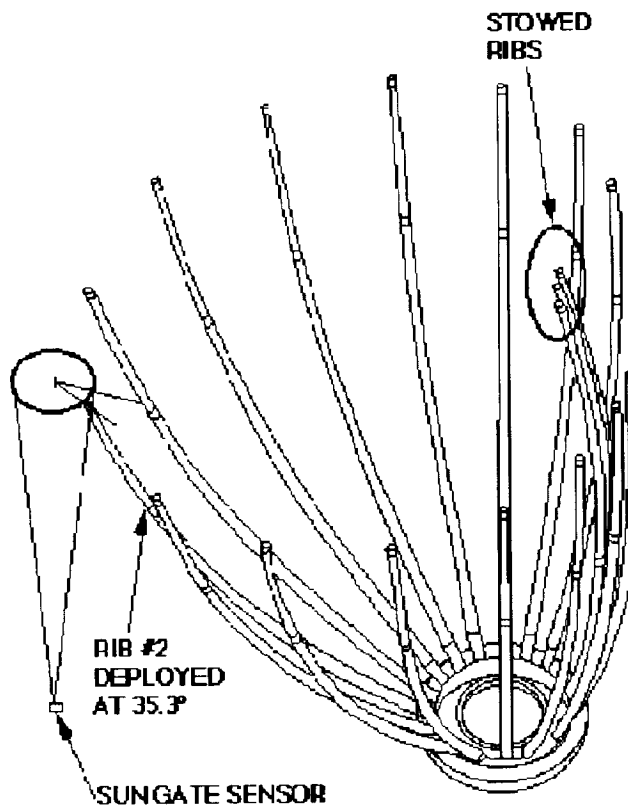
On April 11, 1991, when the Sun-to-spacecraft distance was large enough to present no thermal danger to the antenna, the Galileo spacecraft began to deploy its high-gain antenna under computer-sequence control. Within minutes Galileo's flight team, watching spacecraft telemetry 37 million miles away on Earth, could see that something was wrong: The motors had stalled and something had stuck. The antenna, the 4.8-m mesh paraboloid stretched over 18 umbrella-like ribs, had opened only part way.

Figure 3.—Ribs of Galileo high-gain antenna, showing three stuck in stowed position.

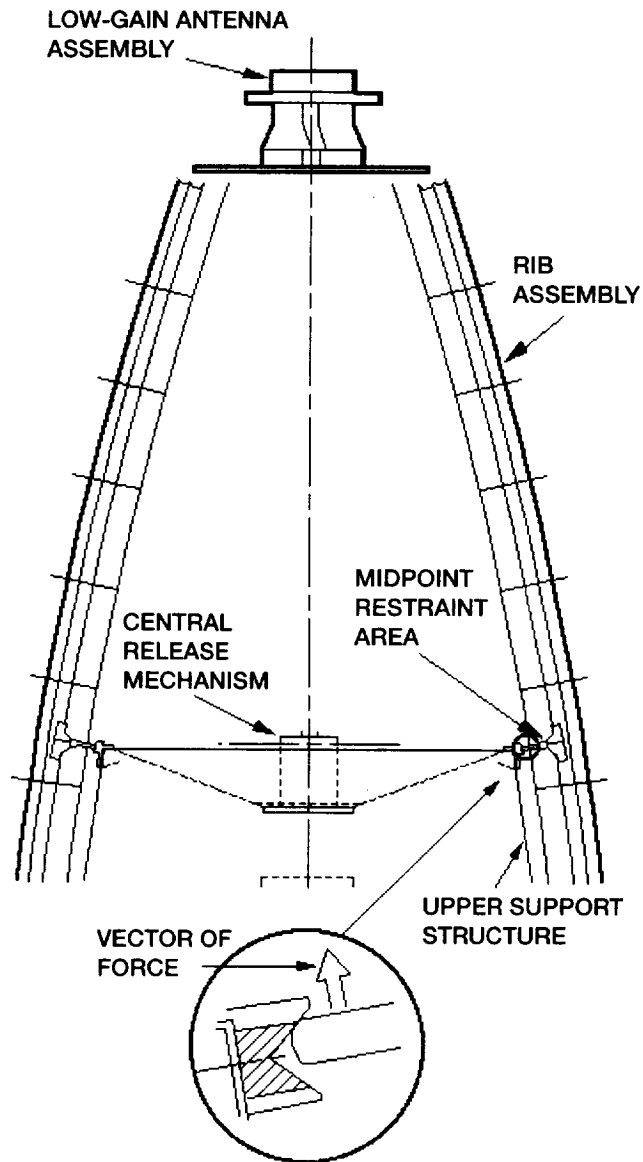
Figure 4.—Standoff pin misaligned in its socket.

This attribution led, in turn, to the hypothesis that repeated thermal cycling, warm-cool-warm-cool, could walk the paired pins out, freeing the ribs. The spacecraft was maneuvered to warm the high-gain antenna by solar heating and to cool it in the shade. These warming and cooling cycles, unfortunately, did not release the stuck ribs.

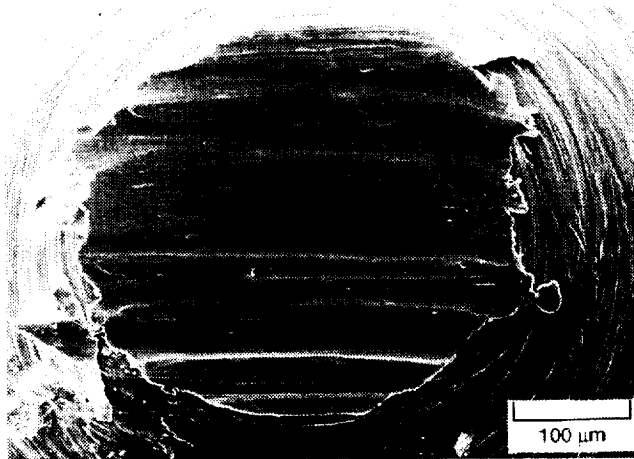
Contact between unlubricated Ti-6Al-4V pin and high-nickel-content superalloy disk: Scanning electron microscopy (SEM) photomicrographs and energy dispersion x-ray analysis (EDX) spectra of the wear damage produced on an unlubricated Ti-6Al-4V pin and on a high-nickel-content superalloy disk after 100 passes at a load of 2.5 N are presented in figures 10 to 13. Figure 10 shows that substantial plastic deformation occurred on the pin. Large wear debris particles formed by plastic deformation and ductile fracture of the Ti-6Al-4V pin are present around the wear scar. Also, plastically deformed grooves and clogged wear debris are present on the wear scar of the pin. Closer SEM examination and EDX analysis of the wear debris showed it to be composed primarily of elements from the Ti-6Al-4V pin (fig. 11) and of small amounts of chromium, iron, and nickel from the disk. Note that abnormally high friction (1.45) was observed when relatively large wear debris clogged the sliding interface.

Figure 10.—Wear scar on unlubricated Ti-6Al-4V pin after sliding against high-nickel-content superalloy disk at 2.5 N in vacuum.

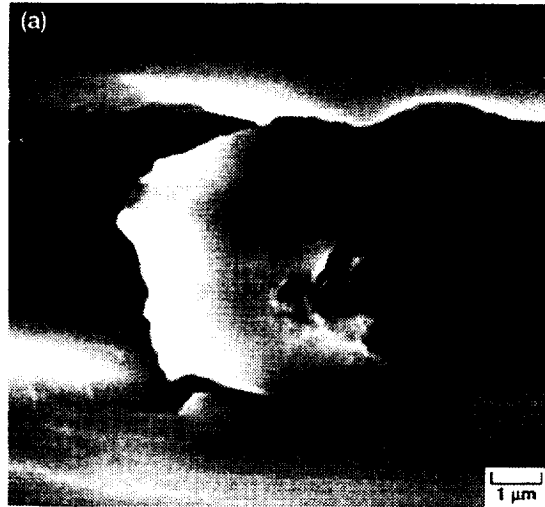
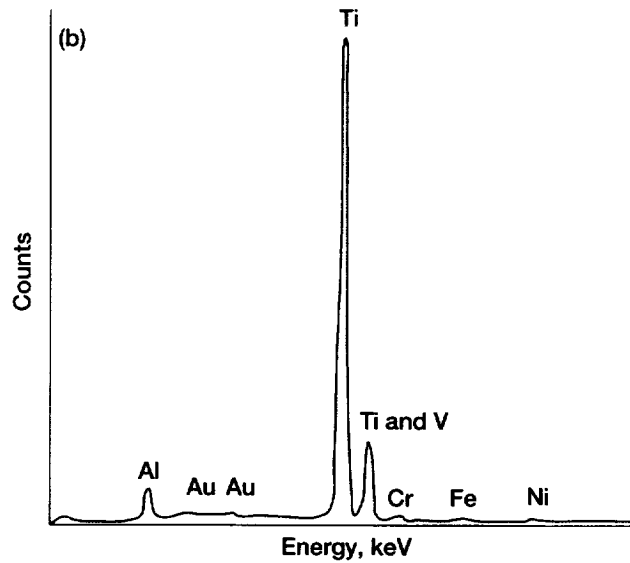
Figure 11.—Clogged wear debris on wear scar on unlubricated Ti-6Al-4V pin after sliding against high-nickel-content superalloy disk at 2.5 N in vacuum. (a) Secondary electron SEM image. (b) Spot EDX analysis. (Thin gold film used to reduce charging of mount is responsible for gold signal in spectrum.)

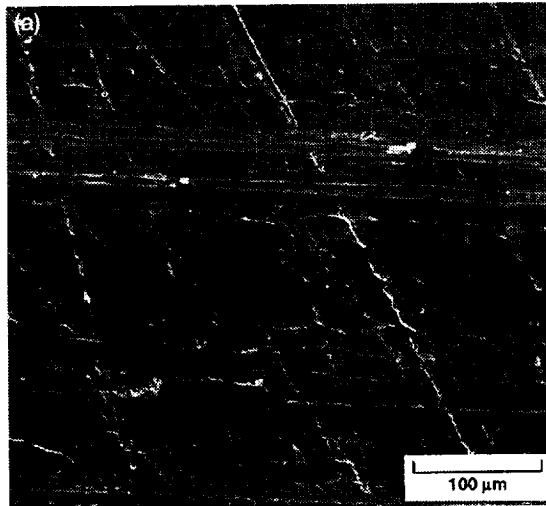
Figures 12 and 13 show Ti-6Al-4V patches on the wear track of the high-nickel-content disk. The transferred patches occupied a quite large area fraction of the overall wear track. Thus, severe damage, often called scuffing, scoring, or galling, occurred in the contact between the unlubricated Ti-6Al-4V and the high-nickel-content superalloy in vacuum (refs. 3 to 5).

Figure 12.—Wear track on high-nickel-content superalloy disk after sliding by Ti-6Al-4V pin at 2.5 N in vacuum, showing transferred patches of Ti-6Al-4V. (a) Secondary electron SEM image. (b) Backscatter electron SEM image.

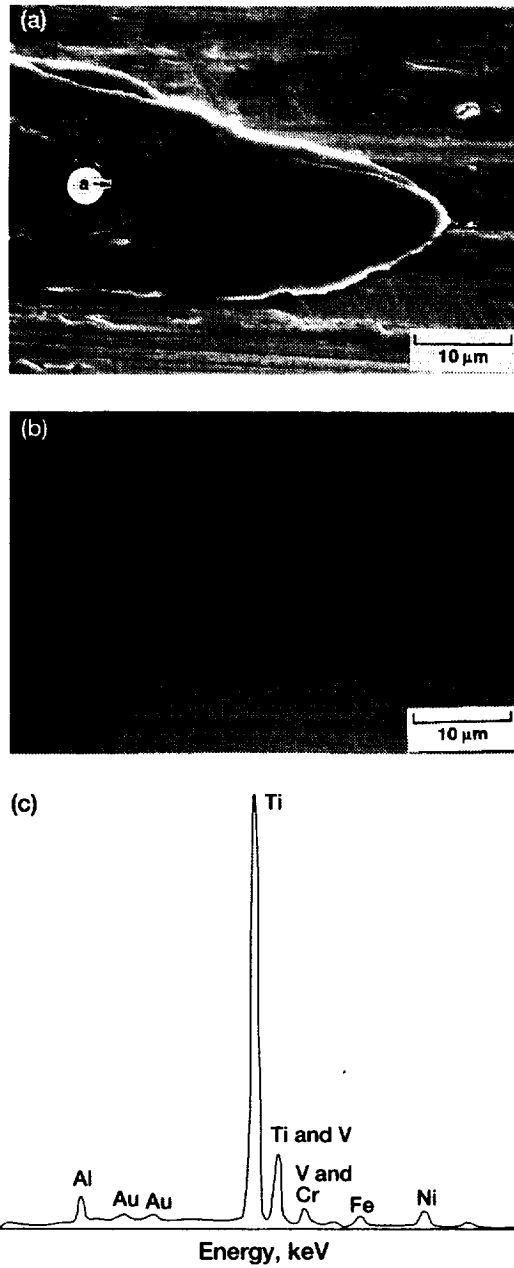
Figure 13.—Large transferred patch of Ti-6Al-4V on high-nickel-content superalloy disk after sliding by Ti-6Al-4V pin at 2.5 N in vacuum, showing transferred patches of Ti-6Al-4V. (a) Secondary electron SEM image. (b) Backscatter electron SEM image. (c) EDX spectrum of transferred film on disk. (Data taken at point indicated in part (a). Thin gold film used to reduce charging of mount is responsible for gold signal in spectrum.)

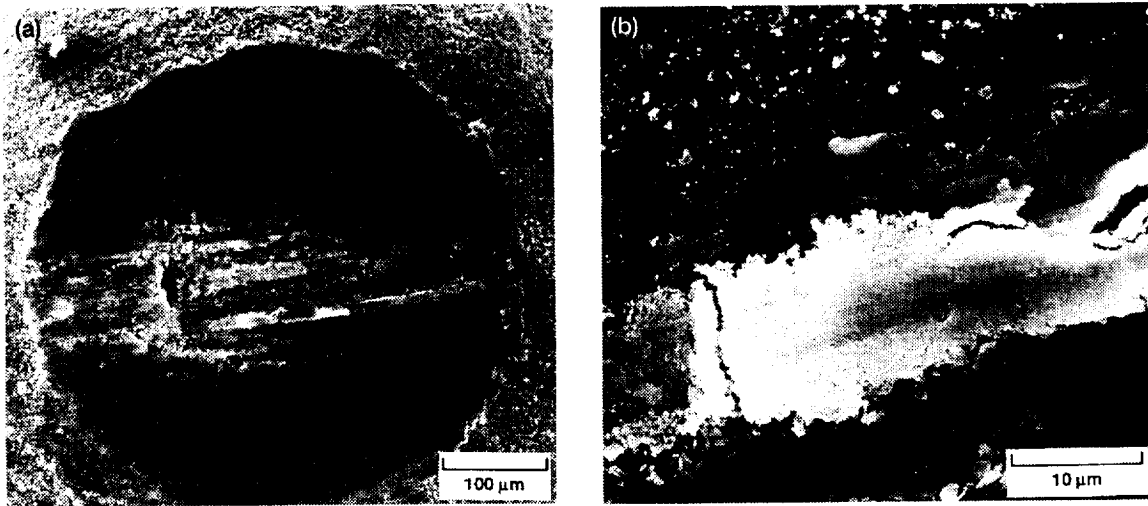
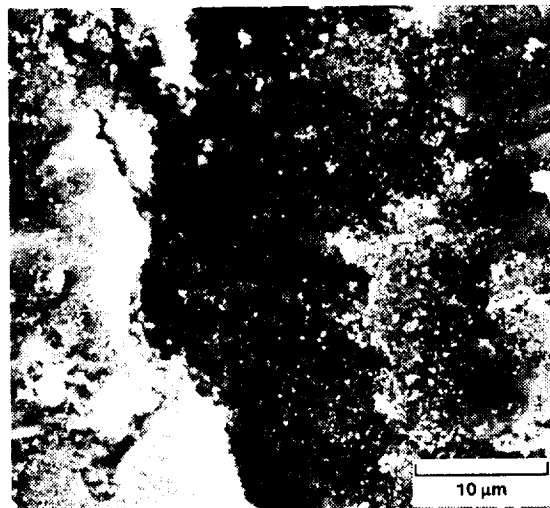
Contact between dry-film-lubricated Ti-6Al-4V pin and high-nickel-content superalloy disk worn in vacuum and rerun in vacuum: SEM photomicrographs of the worn surfaces of a dry-film-lubricated Ti-6Al-4V pin after sliding against a high-nickel-content superalloy disk in vacuum and later rerun in vacuum show surface smearing, tearing, and spalling of the film lubricant (figs. 14 to 17). The wear damage, which resulted from fatigue of the dry-film lubricant, is often called spalling (refs. 3 to 5).

Figure 14(a) shows the relatively smooth burnished surfaces in the upper and lower regions of the wear scar and the rougher surface at the center of the wear scar. Closer SEM examination and EDX analysis of the wear damage at the center of the wear scar showed that the flake-like wear debris (fig. 14(b)) resulted from surface smearing and tearing of the dry-film lubricant. EDX analysis of the flake-like debris indicated that it mainly contained the elements of the MoS₂ lubricant. Figure 14(c) shows a crater (dark area) where fragments of the dry-film lubricant were removed and the Ti-6Al-4V was exposed. The EDX analysis of the crater indicated that it mainly contained elements of the Ti-6Al-4V pin. Interestingly, even with the spalling to the extent of removal and fragmentation of the dry-film lubricant was minimal, even though flakes of the dry-film lubricant occupied most of the overall wear scar.

Figure 14.—Wear scar on dry-film-lubricated Ti-6Al-4V pin after sliding against high-nickel-content superalloy disk in vacuum. (a) Low-magnification overview showing relatively smooth surfaces at upper and lower areas with spalling and tearing at center. (b) Surface smearing and tearing at center resulting in particles separating from surface in form of flakes. (c) Spalling at center.

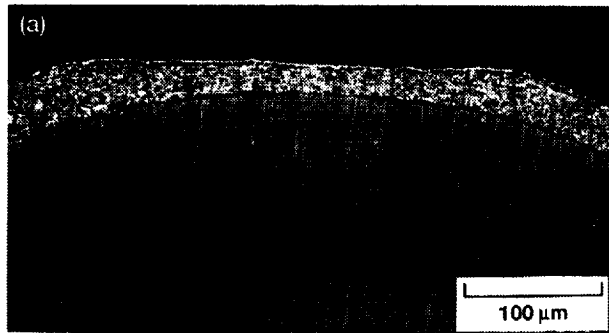
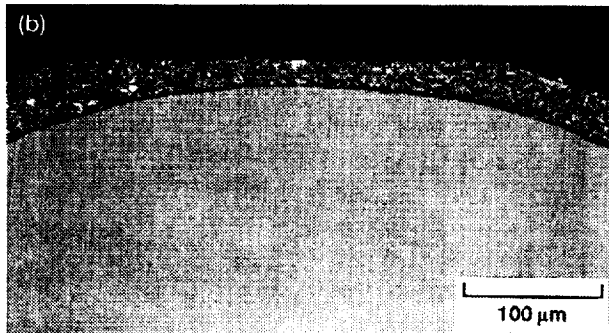
Figures 15 and 16 show a tapered cross section of the worn surface of the dry-film-lubricated Ti-6Al-4V pin at an angle of 45° to the worn surface. The cross-section SEM photomicrographs clearly indicate that most of the dry-film lubricant remained even after ~170 000 passes in vacuum. The film thickness of the remaining lubricant was ~15 μm. Close SEM examination revealed dense, amorphous material in the area right underneath the worn surface (fig. 16(a)).

Figure 15.—Tapered cross section of worn surface of dry-film-lubricated Ti-6Al-4V pin at 45° angle to worn surface. (a) Secondary electron SEM image. (b) Back-scatter electron SEM image.

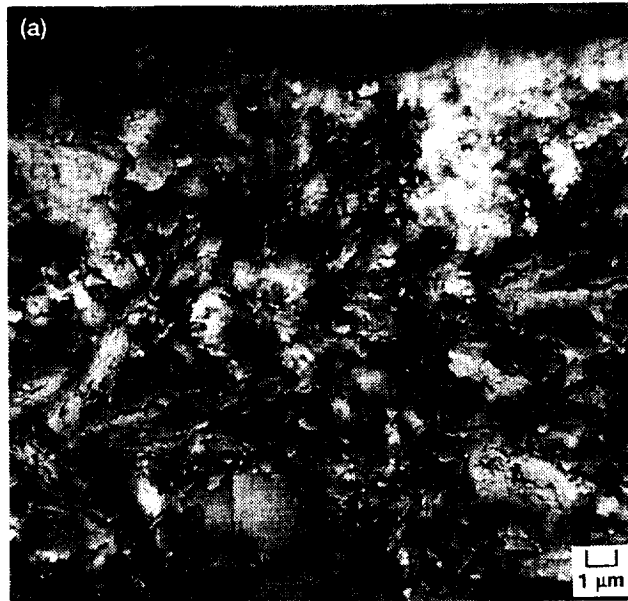
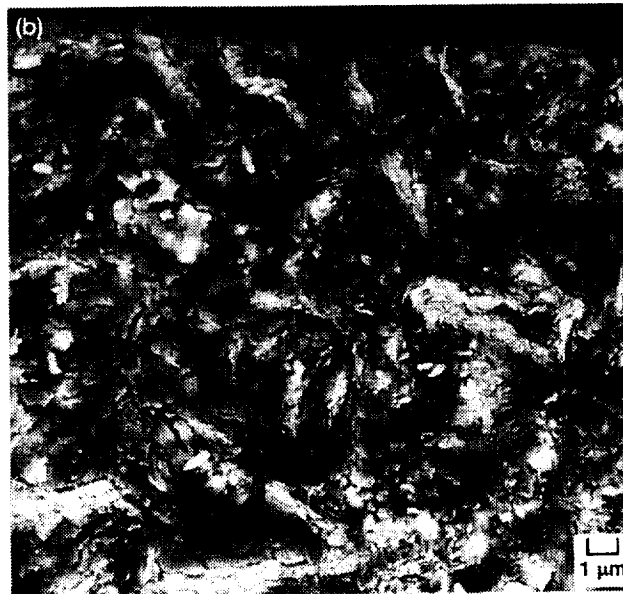
Figure 16.— Backscatter electron SEM image, showing comparison of microstructures. (a) Tapered cross section of worn surface. (b) Tapered cross section of as-coated area of dry-film lubricant.

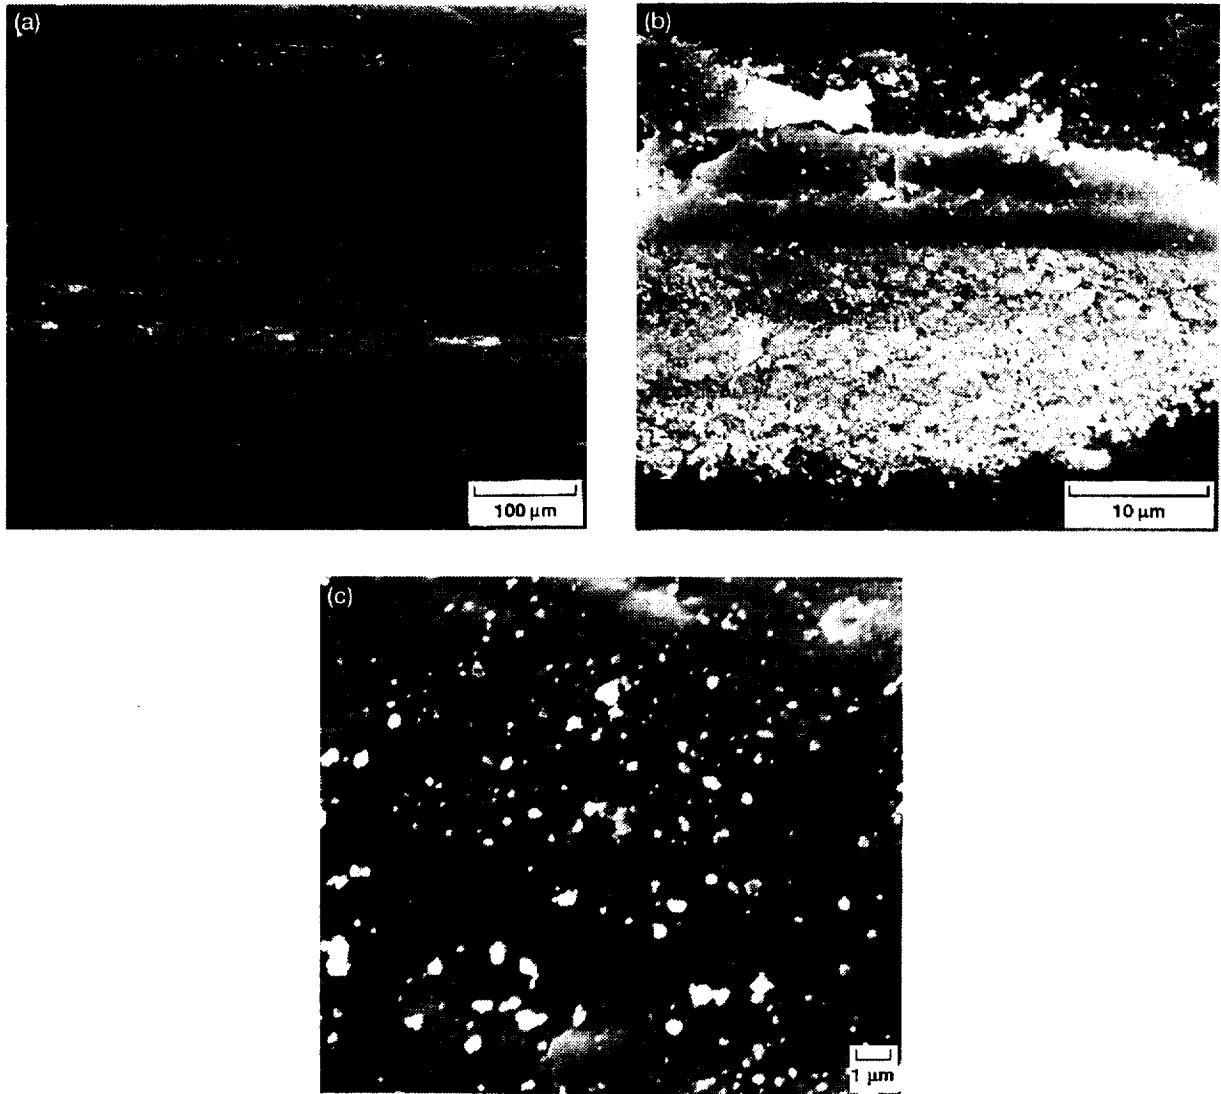
Figure 17(a) shows the relatively smooth wear track on the high-nickel-content superalloy disk with transferred patches of the dry-film lubricant observed (even in the low-magnification view) mainly at the center of the wear track. Closer SEM examination of the center and upper regions of the track showed the transferred wear particles and patches to be in the form of flakes and powders (figs. 17(b) and (c)).

Figure 17.—Wear track on high-nickel-content superalloy disk after sliding by dry-film-lubricated Ti-6Al-4V pin in vacuum. (a) Low-magnification overview. (b) Detailed view showing transferred patches at center. (c) Detailed view showing powder-like wear debris of dry-film lubricant.

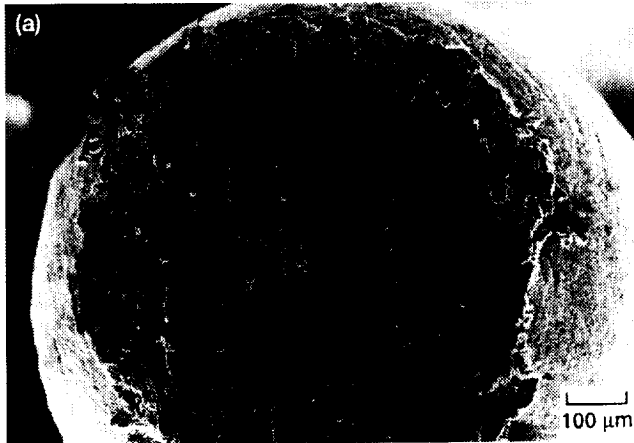
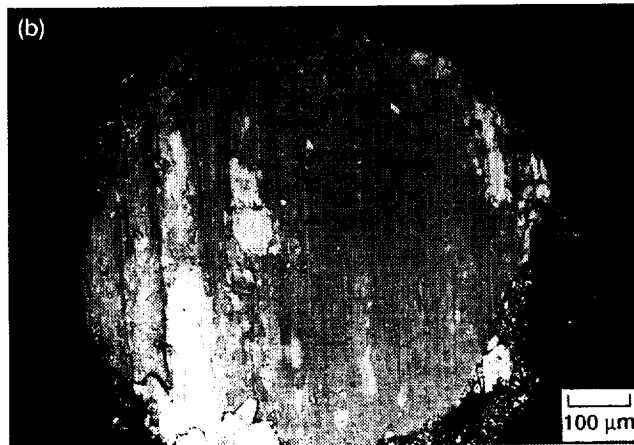
Contact between dry-film-lubricated Ti-6Al-4V pin and high-nickel-content superalloy disk worn in humid air and rerun in vacuum: SEM photomicrographs and EDX spectra of the worn surfaces of a dry-film-lubricated Ti-6Al-4V pin and a high-nickel-content superalloy disk run in humid air for 700 passes and then rerun in vacuum for 100 passes are shown in figures 18 to 24. Figure 18 shows that both plastic deformation and ductile fracture occurred in the dry-film-lubricated Ti-6Al-4V pin. The backscatter photomicrograph (fig. 18(b)) reveals three different materials: (1) the light areas show where the transferred patches from the disk stayed on the Ti-6Al-4V pin, (2) the grayer areas show the Ti-6Al-4V substrate with no dry-film lubricant present, and (3) the salt-and-pepper areas around the edge of the wear scar show the dry-film lubricant. In addition to the major elements of the disk material the transferred patches also contained elements such as molybdenum and sulfur from the lubricant (fig. 19(a)). On the other hand, the gray areas contained only the elements of Ti-6Al-4V pin (fig. 19(b)).

Thus, the worn surfaces of the pin and disk first run in humid air and then rerun in vacuum were completely different from the pin and disk surfaces run only in vacuum. The surfaces worn in humid air (figs. 18 and 20) exhibited galling accompanied by severe surface damage and extensive transfer of the Ti-6Al-4V to the high-nickel-content superalloy disk, or vice versa.

Figure 18.—Wear scar on dry-film-lubricated Ti-6Al-4V pin after sliding against high-nickel-content disk in humid air and then rerun in vacuum.

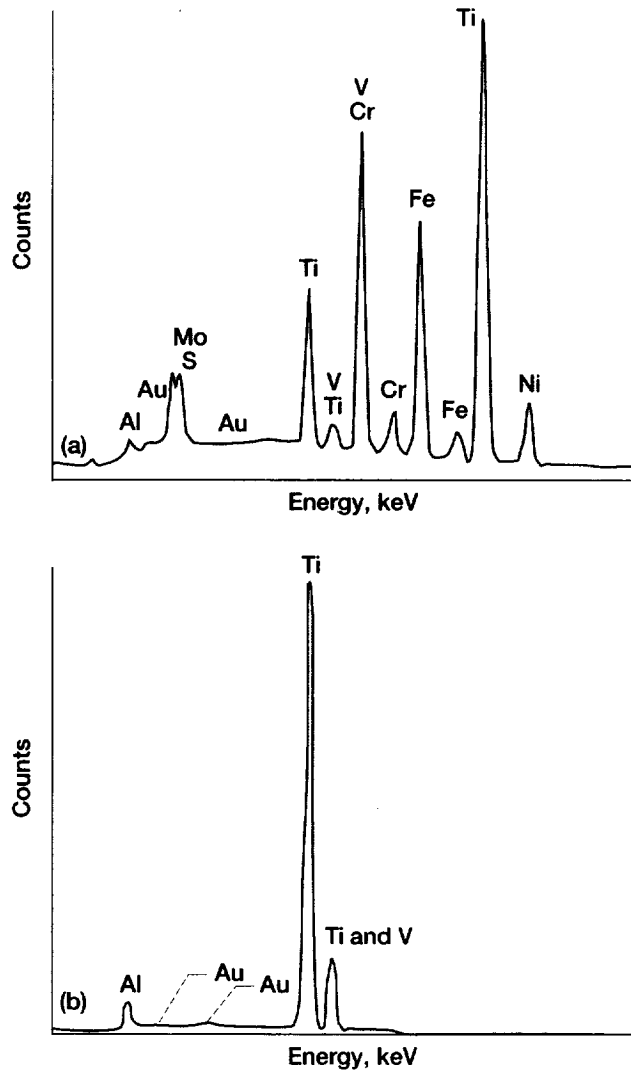
Figure 19.—EDX analysis of wear scar on dry-film-lubricated Ti-6Al-4V pin after sliding against high-nickel-content superalloy disk in humid air and then rerun in vacuum. (Thin gold film used to reduce charging of mount is responsible for gold signal in spectra.)

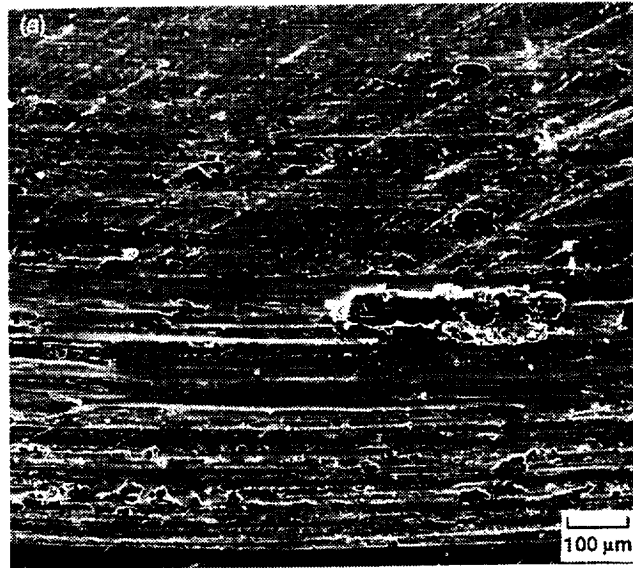
The large patches on the disk wear track in figure 20(a) are also apparent in the backscatter photomicrograph of figure 20(b), which indicated the dark areas to be the transferred patches from the Ti-6Al-4V pin. Further, EDX analysis (fig. 21(a)) of the transferred patch showed that it mainly contained elements of the Ti-6Al-4V pin with a small amount of elements from the MoS₂ dry-film lubricant. The rest of the areas in the wear track contained relatively smaller amounts of elements from the Ti-6Al-4V pin and the MoS₂ dry-film lubricant (fig. 21(b)). Closer SEM examination (fig. 22) of the wear track revealed extensive plastic shearing of the high-nickel-content superalloy disk.

Figure 20.—Wear track on high-nickel-content superalloy disk after sliding by dry-film-lubricated Ti-6Al-4V pin in humid air and then rerun in vacuum.

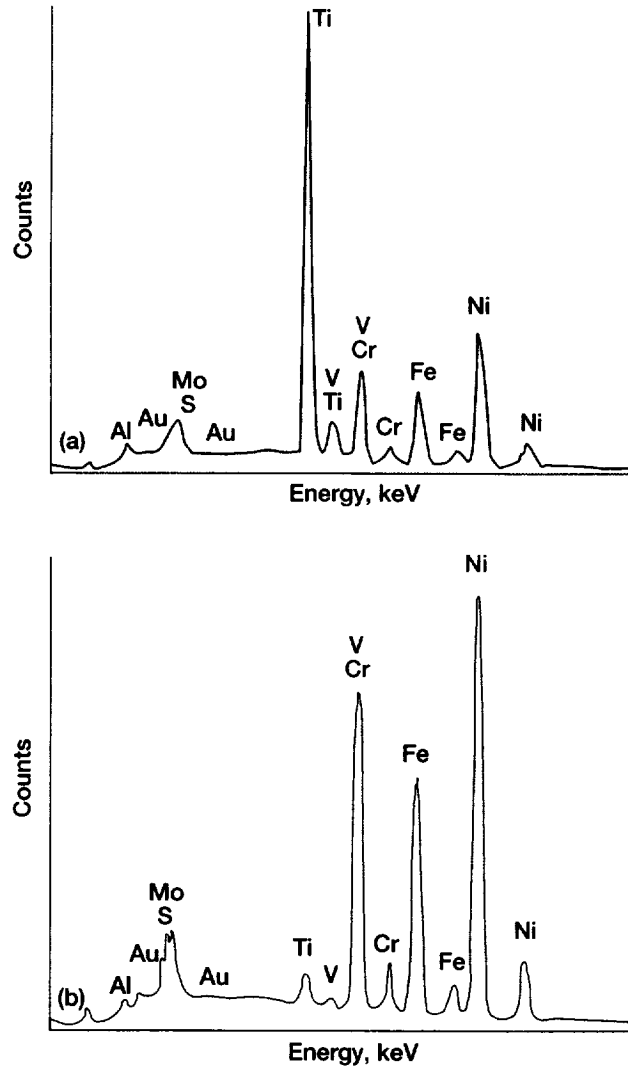
Figure 21.—EDX analysis of wear track on high-nickel-content superalloy disk after sliding by dry-film-lubricated Ti-6Al-4V pin in humid air and then rerun in vacuum. (Thin gold film used to reduce charging of mount is responsible for gold signal in spectra.)

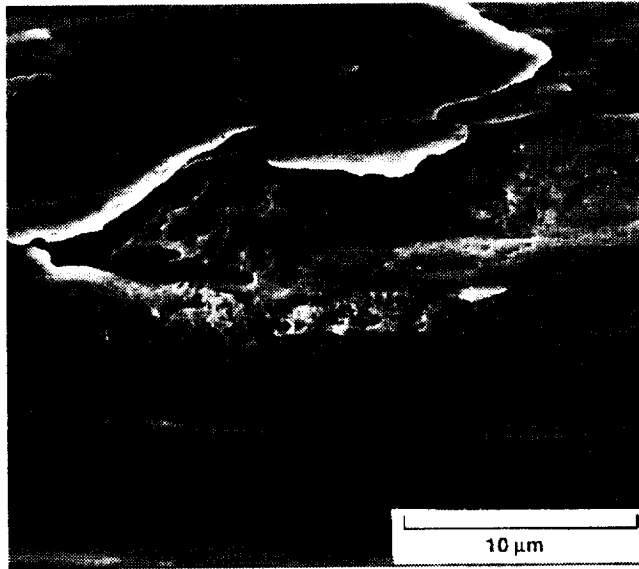
Figure 22.—SEM photomicrograph of wear track showing extensive plastic shearing in high-nickel-content superalloy disk after sliding by dry-film-lubricated Ti-6Al-4V pin in humid air and then rerun in vacuum.

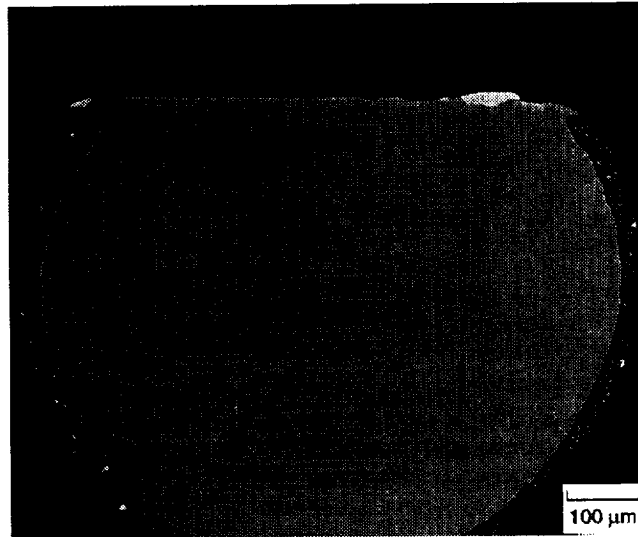
Figure 23, a tapered cross section of the worn surface of the dry-film-lubricated Ti-6Al-4V pin shows clearly that the dry-film lubricant was not present on the worn surface. Further, in the overview photomicrograph extrusion out of the wear scar and transferred patches of the disk material are also well defined because of effective atomic number contrast. In figure 24 plastic deformation of the Ti-6Al-4V pin (extrusion out of the wear scar) and local solid-state welding (cold welding) between the Ti-6Al-4V pin and transferred patches of the disk material (often called scuffing or scoring) are well defined in the backscatter photomicrographs.

Figure 23.—Overview (backscatter electron SEM image) of tapered cross section at 45° angle to worn surface of dry-film-lubricated Ti-6Al-4V pin after sliding against high-nickel-content superalloy disk in humid air and then rerun in vacuum, showing extrusion out of wear scar, transferred patches of high-nickel-content superalloy, and no dry-film lubricant on worn surface.

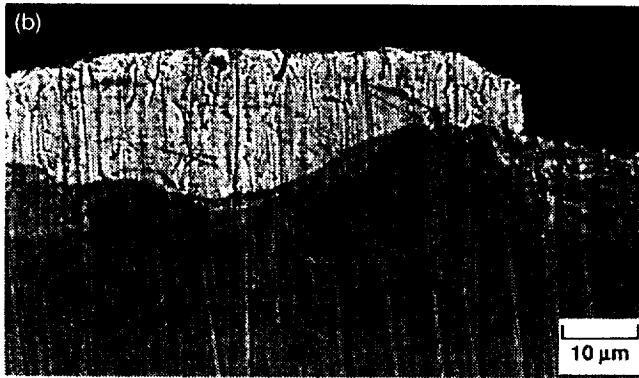
Figure 24.— Backscatter electron SEM images of tapered cross section of worn surface of dry-film-lubricated Ti-6Al-4V pin after sliding against high-nickel-content superalloy disk in humid air and then rerun in vacuum. (a) Showing extrusion out of wear scar. (b) Showing transferred patch of high-nickel-content superalloy on worn surface of dry-film-lubricated Ti-6Al-4V pin.
