# SOHO MISSION INTERRUPTION JOINT NASA/ESA INVESTIGATION BOARD

**SOHO Mission Interruption Joint NASA/ESA  
Investigation Board**

**Final Report**

**August 31, 1998**

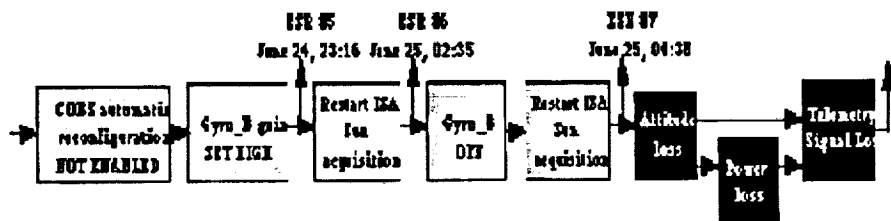
Diagram 1. Failure Event Tree - Top Level

The first two errors were contained in predefined command sequences executed from the Ground System, while the last error was a decision to send a command to the spacecraft in response to unexpected telemetry. The sequence of these errors and their relationship to the triggered-ESRs are graphically depicted in Diagram 1.

Following the momentum management maneuver, Gyro B, which is used for fault detection, was erroneously left in its high gain setting, resulting in an indicated roll rate of 20 times greater than actual. **The incorrect gain was due to an error in another predefined command sequence; this error resulted in an on-board fault detection output that triggered an ESR.** This ESR, the 5th since launch, occurred at 7:16 PM EDT (23:16 UT), June 24, 1998.

During ESR-5, the control Gyro A was not active because of the first error referenced above; however, there is no evidence or belief that any anomalous spacecraft behavior had occurred. As per design, the ESR event resulted in a reconfiguration of the gyros. Gyro A replaced Gyro C as the roll gyro used for the ESR thruster-based control mode, while Gyro B remained configured as the fault detection gyro. The error in Gyro B's gain was discovered and corrected, but the Gyro A despun status was not identified.

After transitioning to the ISA mode as part of the normal ESR recovery sequence, the attitude control system began integrating the gyro drift rate bias associated with the still despun Gyro A. After 15 minutes, this resulted in roll thruster firings intended to null the apparent (but non-existent) roll attitude error. In less than one minute, the roll rate was sufficiently high to trigger the Gyro B based fault detection once again, resulting in ESR-6 at 10:35 PM EDT (02:35 UT), June 24, 1998.

Although the spacecraft remained Sun-pointing within nominal limits and was therefore in a power-positive and thermally-safe attitude, the state of the spacecraft was precarious at this point in time. It had an anomalous roll rate and was depending on a deactivated gyro for roll control in both ESR and ISA modes. The personnel on the ground were not aware of either of these facts at that time. Gyro C was correctly configured to the ACU since the reconfiguration at ESR-5. Gyro B was active and on-line for fault detection, and it was correctly measuring the anomalous roll rate. A rapid decision was made that Gyro B was faulty because its output disagreed with the rate indicated by Gyro A. This decision led to the commanding off of Gyro B.

During ESR-6 recovery, Ground Operations commanded the spacecraft to ISA mode. In ISA, the attitude control system resumed firing roll thrusters in an attempt to null the attitude error associated with the electrical rate bias term of the despun Gyro A. Gyro B and the associated fault detection were now inactive. The increasing roll rate eventually resulted in pitch and yaw Sun-pointing errors that exceeded a prescribed limit of five degrees, resulting in ESR-7 at 12:38 AM EDT (04:38 UT), June 25, 1998. Due to the gyroscopic cross-coupling torques caused by pitch and yaw thruster firings, and the absence of true roll rate indications, the ESR controller was no longer stable, and the spacecraft attitude diverged. **The incorrect diagnosis of a Gyro B fault and the subsequent ground response to this diagnosis ultimately resulted in loss of attitude control, subsequent loss of telemetry, and loss of power and thermal control.** Loss of telemetry occurred at 12:43:56 AM EDT (04:43:56 UT), June 25, 1998. It can not be determined whether this loss was a consequence of insufficient power or a loss of communication link caused by spacecraft attitude.
