# DEGRADATION OF HUBBLE SPACE TELESCOPE METALLIZED TEFLON® FEP THERMAL CONTROL MATERIALS

Patricia A. Hansen, Jacqueline A. Townsend  
NASA/Goddard Space Flight Center  
Greenbelt, Maryland 20771

## ABSTRACT

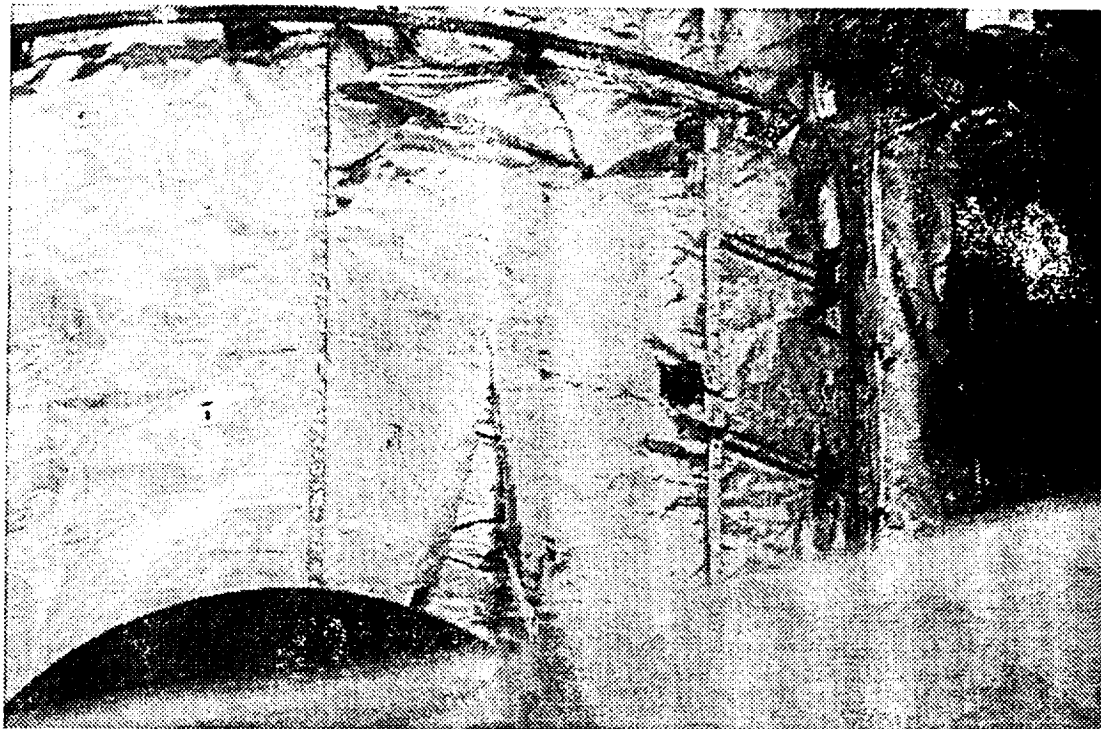
**5.1 On-Orbit** During the HST SM2, damage of the MLI was observed on the +V3 side (sun side) with several large cracks in the light shield MLI outer layer (above the stowed High Gain Antenna). This large crack is shown in Figure 3. Upon further visual observations of the vehicle, additional cracks were seen on all MLI surfaces. Cracking of the MLI outer layer was seen all over the telescope, with the most damage seen on the LS, SSM Bay 8, SSM Bay 7, and SSM Bay 10. The SSM Bay 8 is shown in Figure 4; the MLI is cracked around most of the bay perimeter, and the MLI appears as though it is partially detached and lifted away from the telescope.

Figure 3: Light Shield MLI Cracks

Although the damage to the MLI was visually dramatic, there was no measurable thermal effect due to the cracks and the exposure of the DAK to the telescope environment. However, during the SM2 mission, a program decision was made to reconfigure flown MLI patches to patch the worst of these damaged areas.

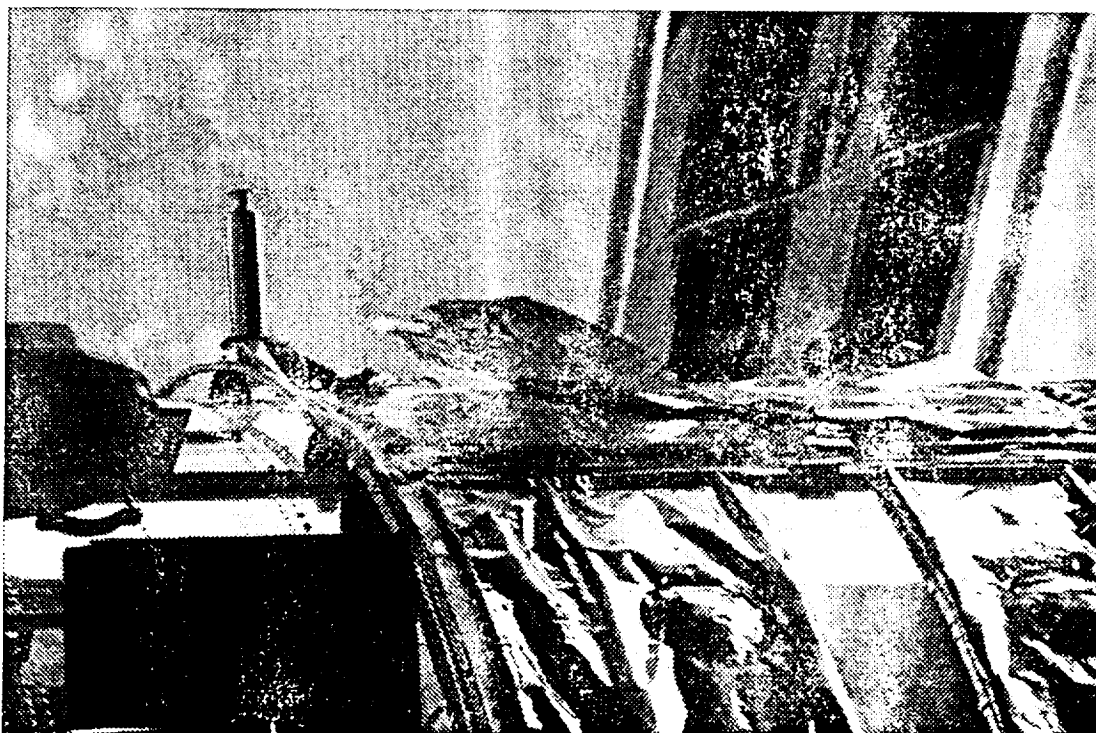
Figure 4: SSM Bay 8 MLI Crack

Prior to patching the corners of the SSM Bay 8 MLI, the astronauts performed two tests: a Velcro® cycling and Teflon® FEP bend test. The Velcro®, attaching the MLI blanket to the bay, was cycled to determine its integrity – was it still attached to the telescope substrate and did the hook still hold the pile securely? The astronauts reported that the Velcro® appeared to be securely fastened to the vehicle substrate and the hook seemed to hold the pile securely. The astronauts also bent a piece of the Teflon® FEP over on itself to determine if manipulating it during the patching process would cause significant damage. The astronauts reported that the Teflon® FEP did not crack.

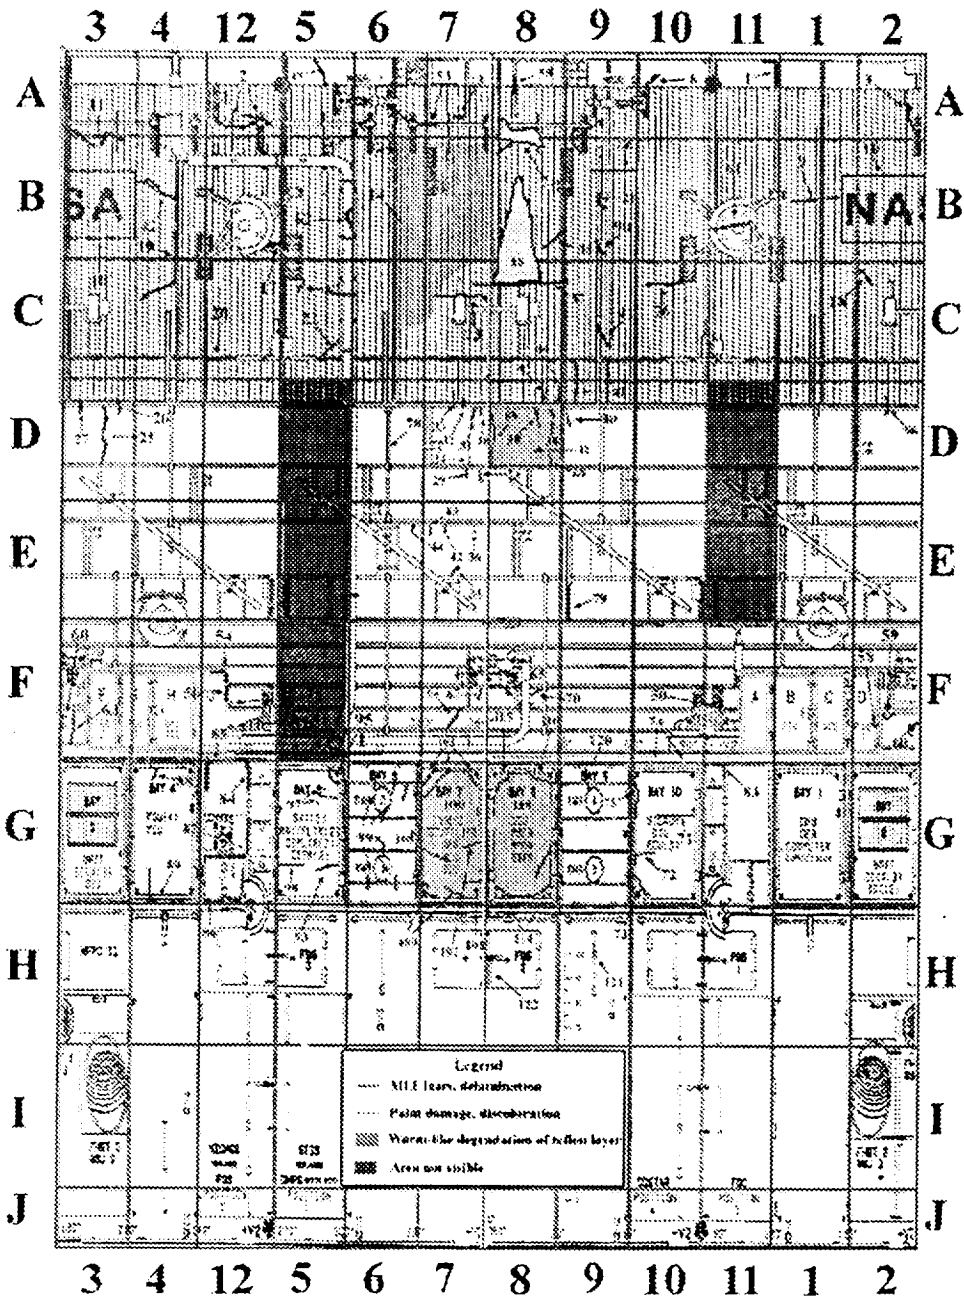
**5.2 Damage Map** Post mission analysis of the photographic documentation indicated that the MLI outer layer was cracked extensively on all MLI surfaces. The cracks were noticeably larger and more numerous on the sun side (+V3) of the telescope. The cracks in the FEP Teflon on the anti-sun side (-V3) of the telescope tended to start and end at stress

concentration points. Whereas, the cracks on the sun side (+V3) of the telescope start at stress concentration points and either end where two cracks meet or in the middle of an MLI blanket.

Figure 5 shows a map of the MLI damage, using SM2 photo documentation (Reference 3). This map depicts the damage and notes where the cracks have opened on the LS and SSM bays. The location of the features on the map is approximate and shown for illustration purposes only. The most important item to note is that the damage is seen all over the vehicle and is noticeably worse on the sun side (+V3).

Figure 5: HST Thermal Control Subsystem Degradation Map

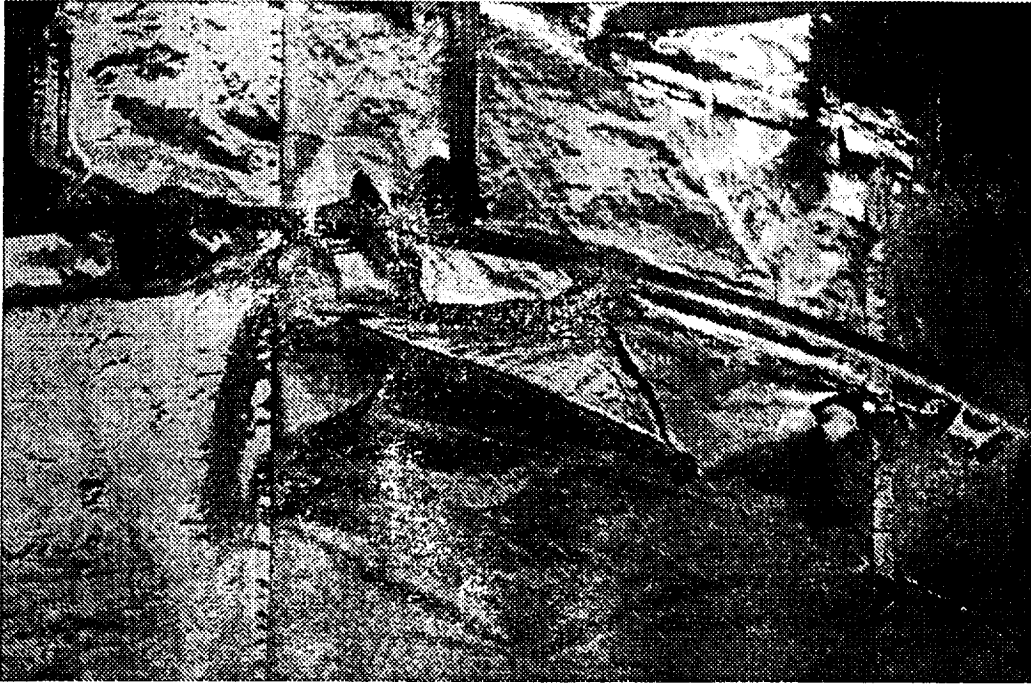
**6.1 MLI Sample** An MLI sample, shown in Figure 6, was taken from the upper LS crack prior to patching the area. The LS MLI cracks are shown with patches installed in Figure 7. The sample was cut right to left with a change in the initial direction of the cut as the astronauts realized they were cutting through the sample. The sample is shown flat in Figure 8; the astronaut cuts, on-orbit cracks and handling cracks are identified. The sample was handled carefully and stored in an EVA trash bag for the duration of the EVA. The trash bag was transferred to the crew cabin and the sample was placed in a reclosable polyethylene bag and stowed in a middeck locker for the duration of the mission. The sample was requested as an early destow item and was turned over to the HST project within 6 hours of the Orbiter landing.

**7.1 MLI Sample** The MLI sample was characterized through exhaustive mechanical, thermal, chemical, and optical testing. The testing revealed several changes to the mechanical, chemical and thermal properties of the MLI. Details of these tests may be found in References 4-7. The on-orbit cracks are nearly featureless indicating that they occurred very slowly under low load and in the presence of a damaging environmental factor. This crack mechanism is

similar to stress-corrosion cracking in metals and slow crack growth in ceramics. The material shows significant reduction in ultimate strength and elongation, indicating through-thickness embrittlement of the Teflon<sup>®</sup> FEP. The surface of the Teflon<sup>®</sup> FEP is de-fluorinated from interaction with the orbital environment. Increases in the solar absorptance of the Teflon<sup>®</sup> FEP correlate well with the number of days spent in space, rather than with equivalent solar hours. The aluminum backing is cracked in a "mud tiling" pattern due to the difference in thermal expansion of the Teflon<sup>®</sup> FEP and the aluminum and the 40,000 thermal cycles HST experienced. It is expected that the condition of the MLI will continue to degrade, and that it will be fragile by the next servicing mission.

Figure 6: Upper Light Shield MLI Crack (SM2 Sample)

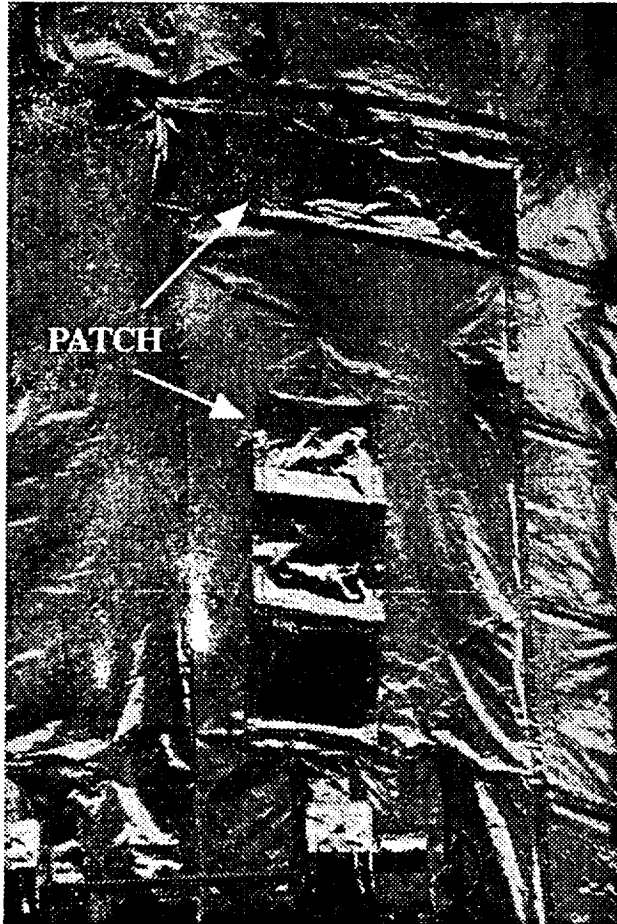
Figure 7: HST Light Shield MLI Cracks with Patches Installed

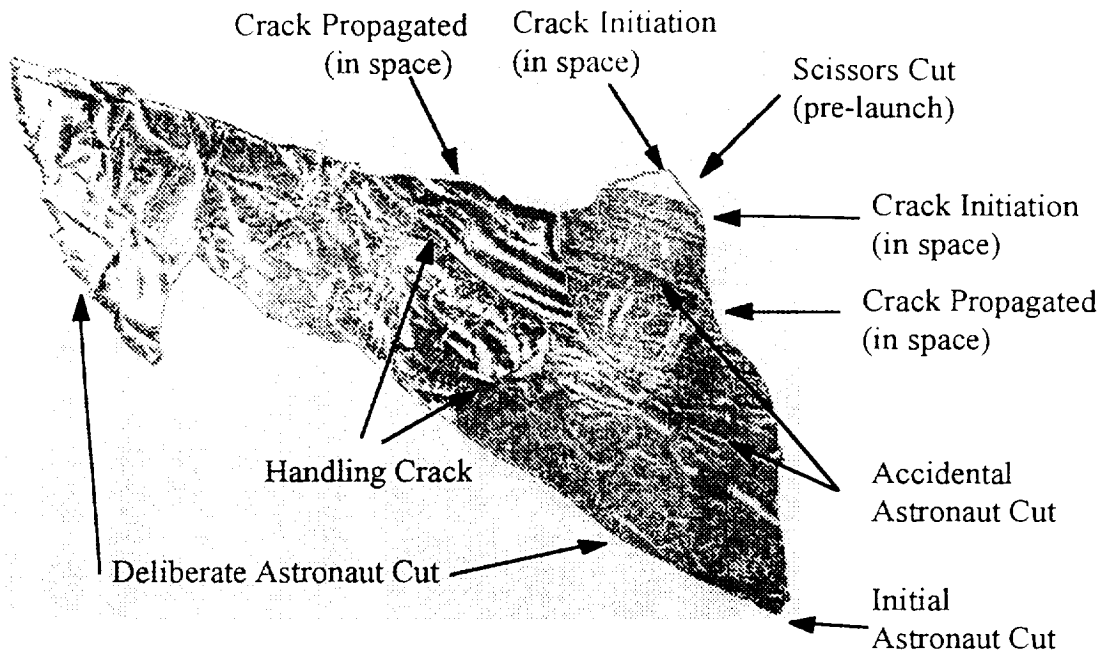
Figure 8: SM2 Teflon FEP

Sample

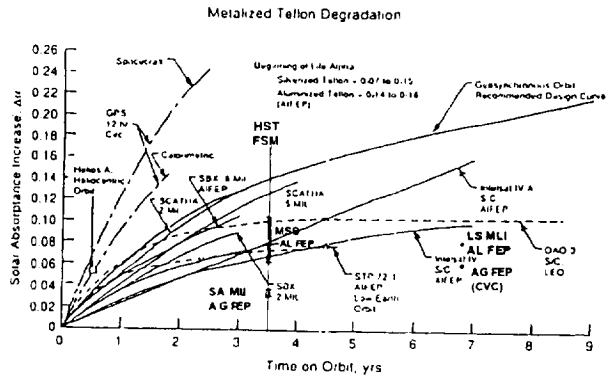
**7.2 Radiator Sample** The radiator sample was characterized through exhaustive mechanical, thermal, chemical, and optical testing. Testing of the CVC sample showed that the solar absorptance of the bonded silver Teflon<sup>®</sup> FEP on the AS of HST has increased. Flight temperature data plots of the maximum and minimum temperatures over several years show an increase of the maximum temperatures to indicate a solar absorptance increase whereas the minimum temperatures remained constant to indicate no emittance change (or no Teflon<sup>®</sup> FEP thickness decrease). As with the MLI, the Teflon<sup>®</sup> FEP bonded to the aft shroud is embrittled, and the silver backing is extensively cracked. The application process used (the angle of application and rubbing to insure adhesion), has been shown to induce cracking in the metal layer. The acrylic adhesive can bleed through the cracks and then darken in the presence of UV and VUV, thus increasing the absorptance of the film. Post mission ground testing has shown that removing the release strip from the Teflon<sup>®</sup> FEP tape caused a significant amount of cracking of the silver even before application to the substrate.

Additional exposure of the CVC sample to ultraviolet radiation showed that the solar absorptance did not continue to degrade. However, newly bonded 5 mil Teflon<sup>®</sup> FEP, exposed at the same time to ultraviolet radiation experienced a significant increase in solar absorptance during the first 2000 hours of exposure. The newly bonded Teflon<sup>®</sup> FEP was bonded using both standard techniques and a "gentle" technique to minimize the cracking of the silver. The standard technique produced the largest increase in the solar absorptance; however, the "gentle" technique still produced a significant absorptance increase. This indicated that the techniques used to bond the Teflon<sup>®</sup> FEP to the substrate causes the silver to break in the application process and thus allows the adhesive to darken under exposure to ultraviolet radiation. Using a Teflon<sup>®</sup> wand to smooth the Teflon<sup>®</sup> FEP also caused localized absorptance increases. The expected degradation of the HST TCS (increase in solar absorptance) is given in Figure 9 with the CVC sample degradation indicated.

Figure 9: HST Solar Absorbance Measurements versus Predictions
