RESULTS OF A CYCLIC LOAD TEST OF AN RB-47E AIRPLANE

MEMORANDUM 3-15-59L

By Wilber B. Huston

SUMMARY

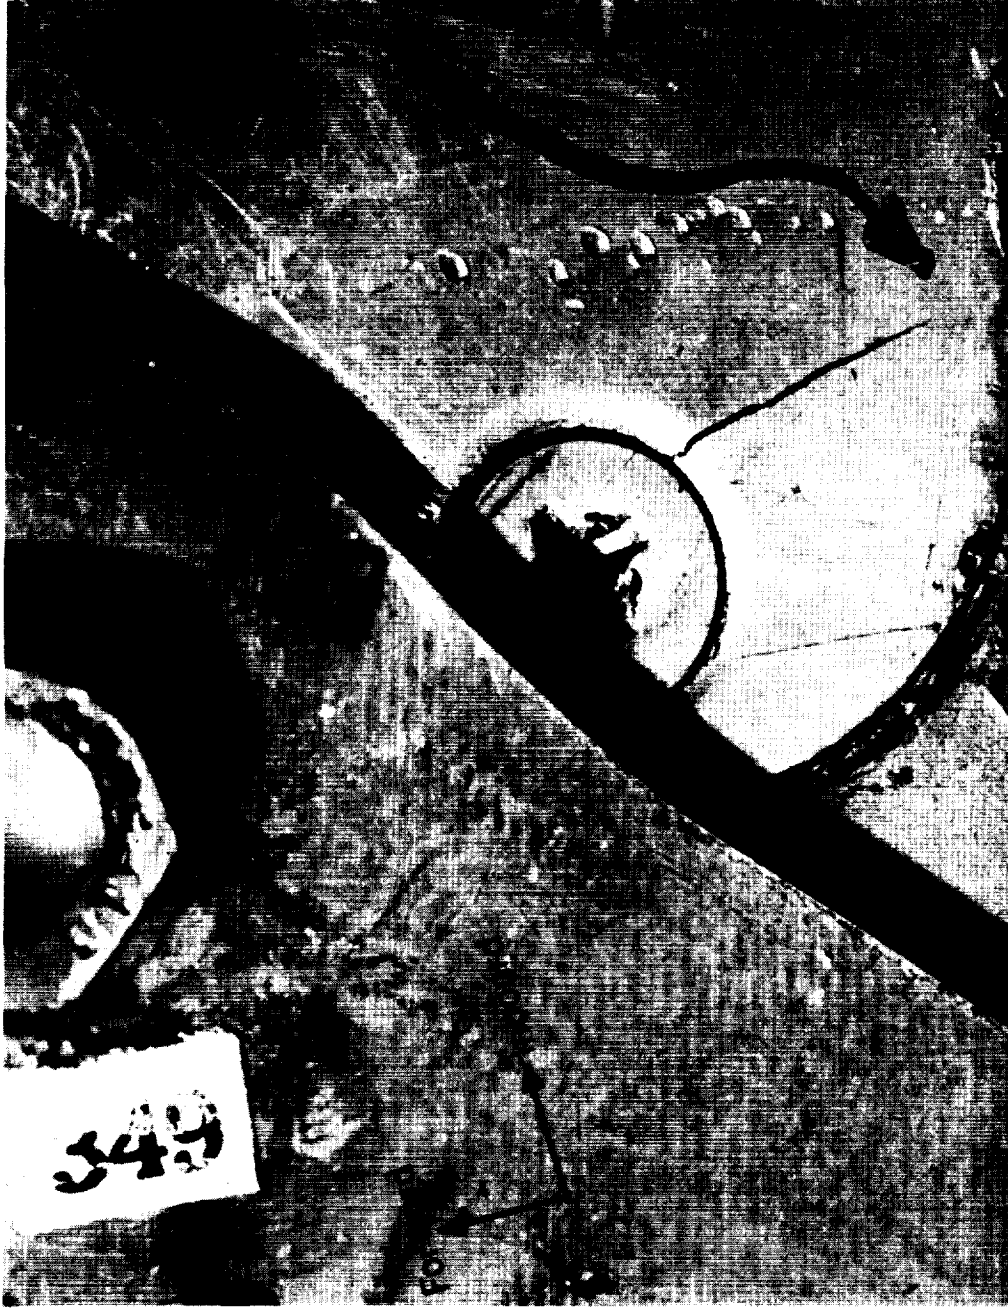
L-59-179
Figure 12.- Crack in left trailing-edge skin just aft of hole 401. Photograph made at low-gust maximum, spectrum 9.

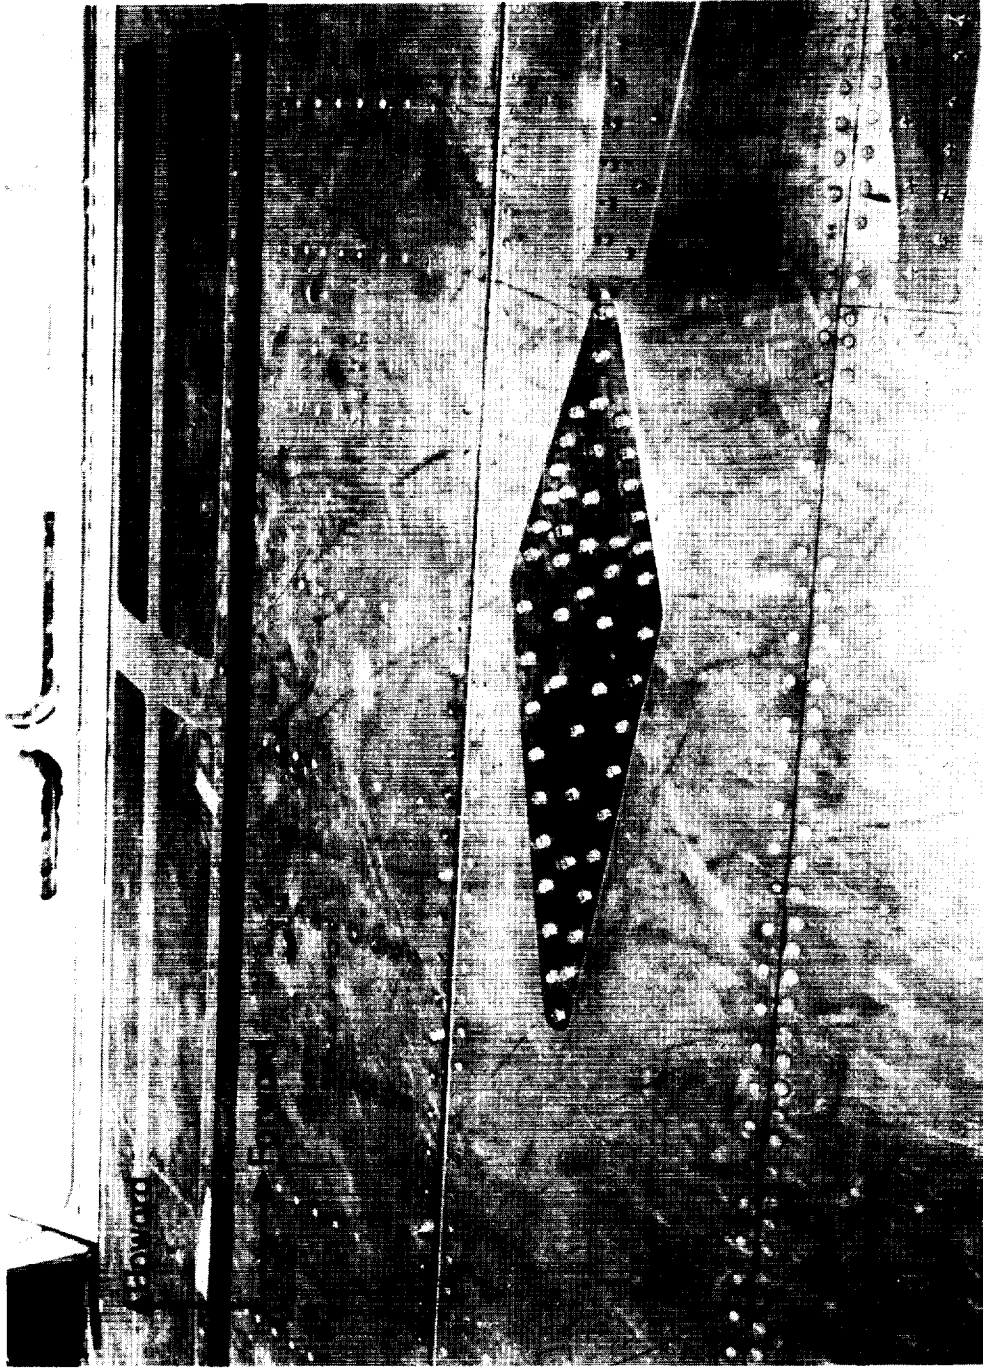
(b) Reinforcement plate installed during inspection 9. L-59-55.1

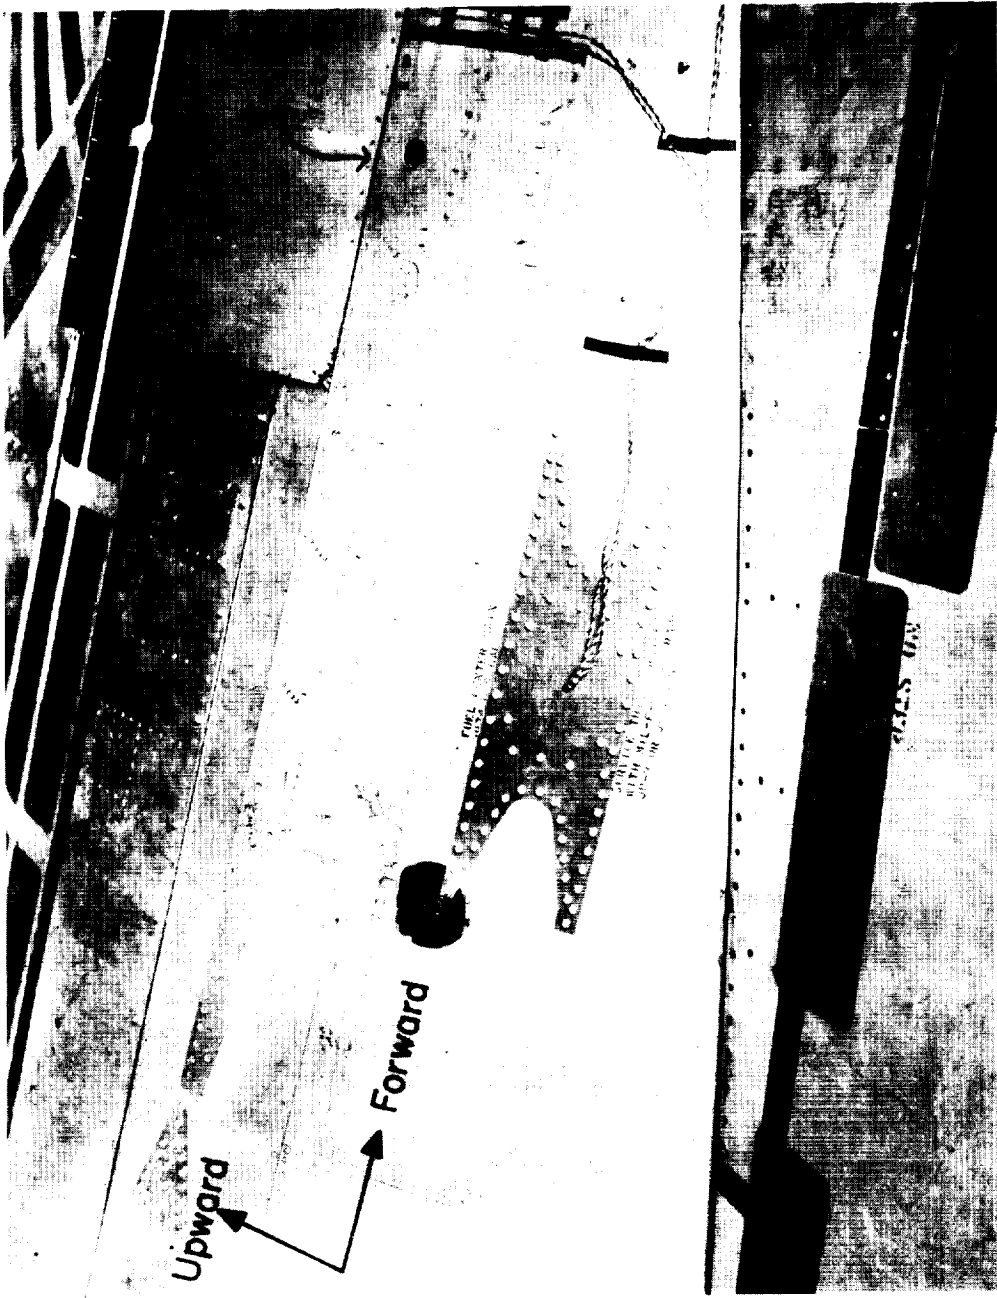
(b) Fishtail-doubler repair, inspection 12. L-58-1312a.1

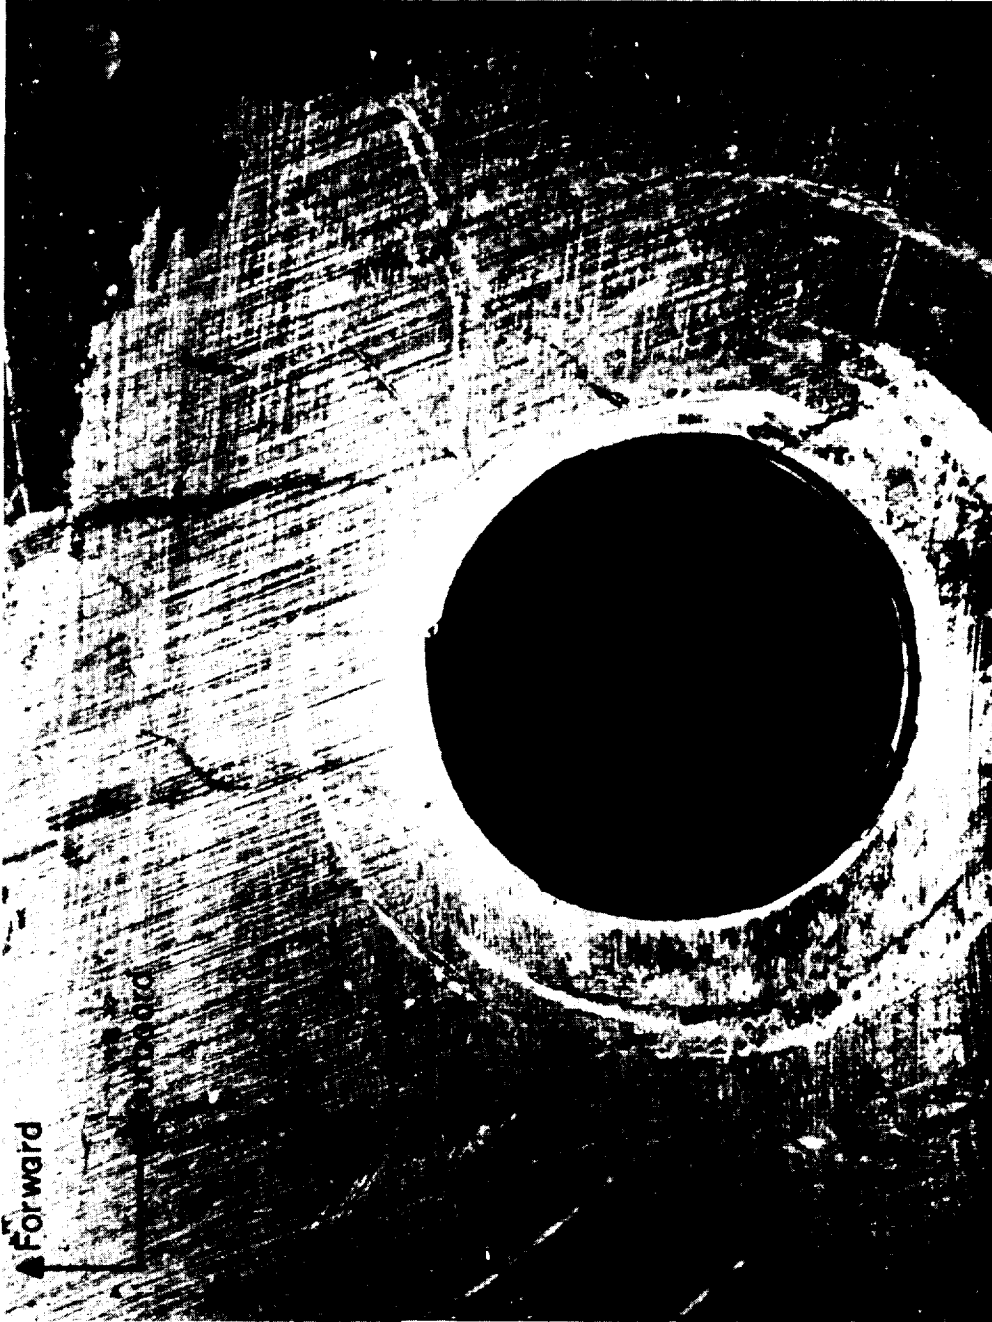
The first crack in a wing splice developed at the left B.L. 45 area in a rear outboard finger of the reinforcement. This crack area, item 15, is pictured in figure 19(a) and was found at spectrum 26. An additional crack, item 16, in this area was found at spectrum 28. No cracks were found in the wing splices at W.S. 354 during the program.

15. 1/4-inch crack found in the outboard finger of the reinforcing plate at bolt hole 406 at left B.L. 45. See figure 19(a).	The hole in the finger was enlarged to include the crack and hole left open. See figure 19(b).
Inspection 14	16. 1/4-inch crack was found in the outboard finger of the reinforcing plate at bolt hole 410 at left B.L. 45.	No repair was made.

(a) Crack as found during inspection 13, following spectrum 26. L-59-188

Figure 19.- Crack in outboard finger of splice at hole 406 at left buttock line 45.

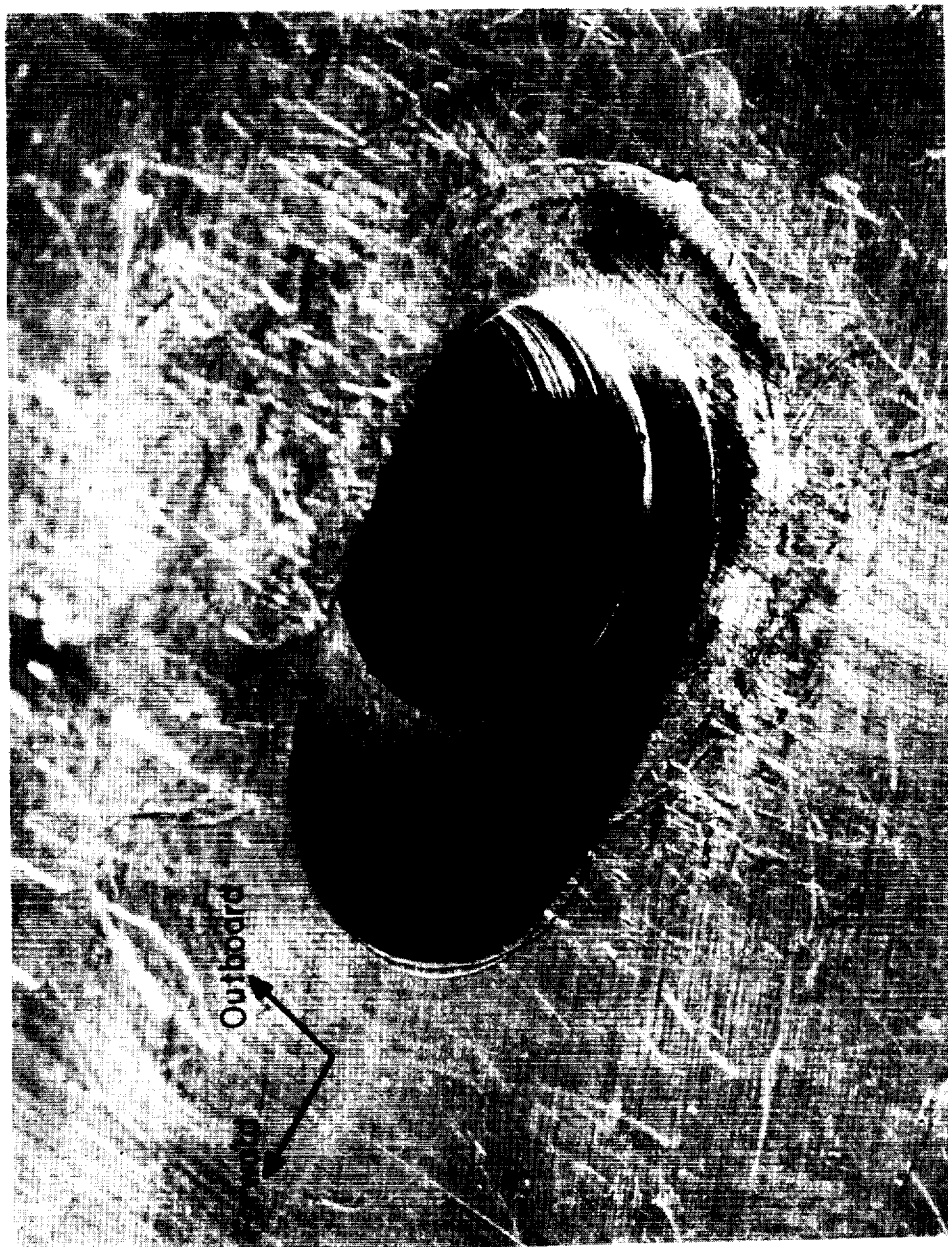
(b) Repair. Hole double drilled and contour smoothed. L-59-189

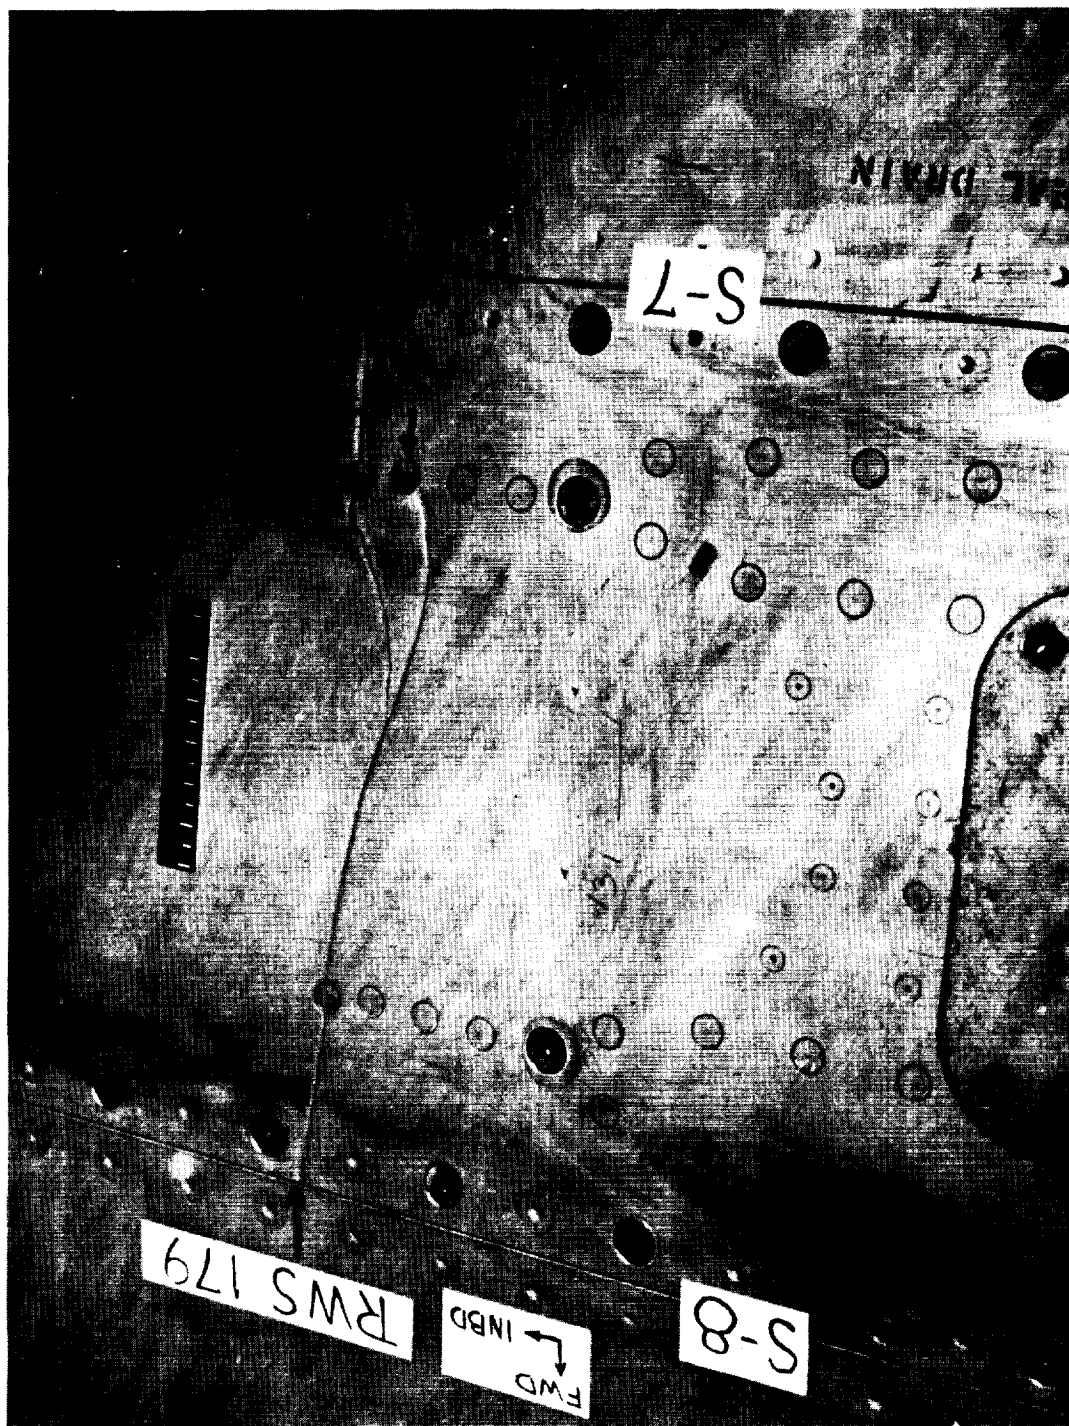
During the application of the 90 percent limit loading of spectrum 29, the right wing closeout panel failed. The failure was marked by a clearly audible report just as the applied load reached the load maximum. The wing was returned to the droop position by dropping the ram pressure to zero. Inspection of this crack area (item 19) showed that the whole of the lower closeout panel had failed at W.S. 179 between stiffeners 7 and 8 (see fig. 20), a distance of 21 inches, and that the inboard rivets at the ends of the fingers on the doubler of the hole for the water-injection-pump access door were involved. The crack is clearly evident in the droop position because of the marked necking-down of the material at the lower surface. Preliminary inspection of spars and stringers in the crack area has revealed no secondary failures associated with this crack.

Because of the magnitude of the crack at right W.S. 179, and because of the number of cracks which had developed in the fingers of the B.L. 45 splice, as well as in the fuselage crown-skin reinforcing plate, it was considered that further cyclic loading would not contribute to the objectives of the program. Cyclic loading was, therefore, terminated.

L-58-1060a
Figure 20.- Crack in right wing closeout panel at wing station 179. Spectrum 29.
