NASA TECHNICAL MEMORANDUM

NASA TM SX-1076

RESPONSE OF A WB-47E AIRPLANE TO RUNWAY ROUGHNESS AT EIELSON AFB, ALASKA, SEPTEMBER 1964

by Garland J. Morris and Albert W. Hall
Langley Research Center
Langley Station, Hampton, Va.

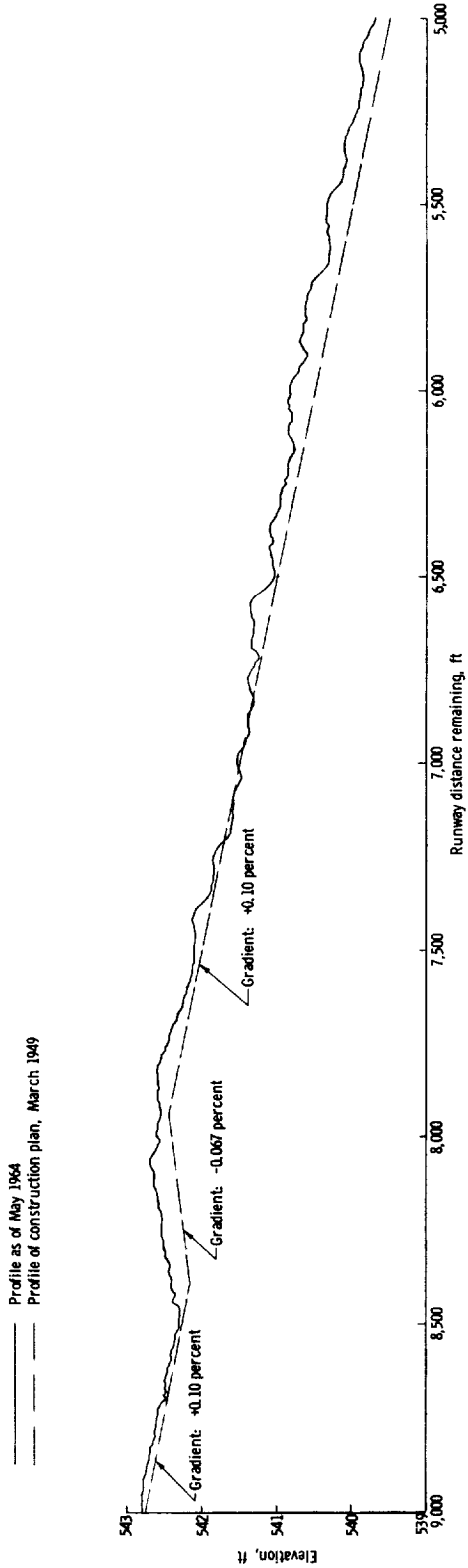
Figure 3.- Elevation profile for center line of runway 3L, Eielson AFB, Alaska (U.S. Air Force survey).

The test runway, identified as runway 31 in one direction and as 13 in the other, is 14,500 feet long. A detailed profile of the entire runway is not available; however, the profile of a 4000-foot portion of runway 31 between 9000 feet and 5000 feet is shown in figure 3. Throughout this paper the runway locations will be given in terms of the 1000-foot markers (distance remaining) along runway 31. This profile is based on an Air Force survey made along the center line of the runway at 10-foot intervals during May 1964. The gradients to which the runway was constructed in 1949 are also shown.

A large long-wavelength bump in the runway is evident where two positive gradients of about 0.10 percent are joined by a negative gradient of about 0.07 percent at approximately the 8500-foot and 8000-foot stations. This portion of the runway has been the subject of the majority of the roughness complaints; especially those stemming from difficulties encountered in maintaining control of the airplane. Shorter wavelength irregularities such as those at the 8500-, 8100- and 7800-foot locations within this region are the apparent source of the objectionable responses. Examination of the profile beyond this location indicates the presence of a number of surface irregularities, such as those at 7400, 7250, and 6600 feet, which also might be expected to result in substantial airplane response.

In view of the foregoing discussion, it is thought that two aspects of the roughness should be considered in determining the extent of repairs which may be deemed necessary to the runway. First, in order to reduce the pilot-compartment accelerations, repairs to a number of sections of the runway apparently would be required as indicated by the results in figure 6. Second, the pitching oscillations (which appear to be the cause for concern) could apparently be alleviated significantly by eliminating the bumps or irregularities between the 8500- and 7200-foot stations.

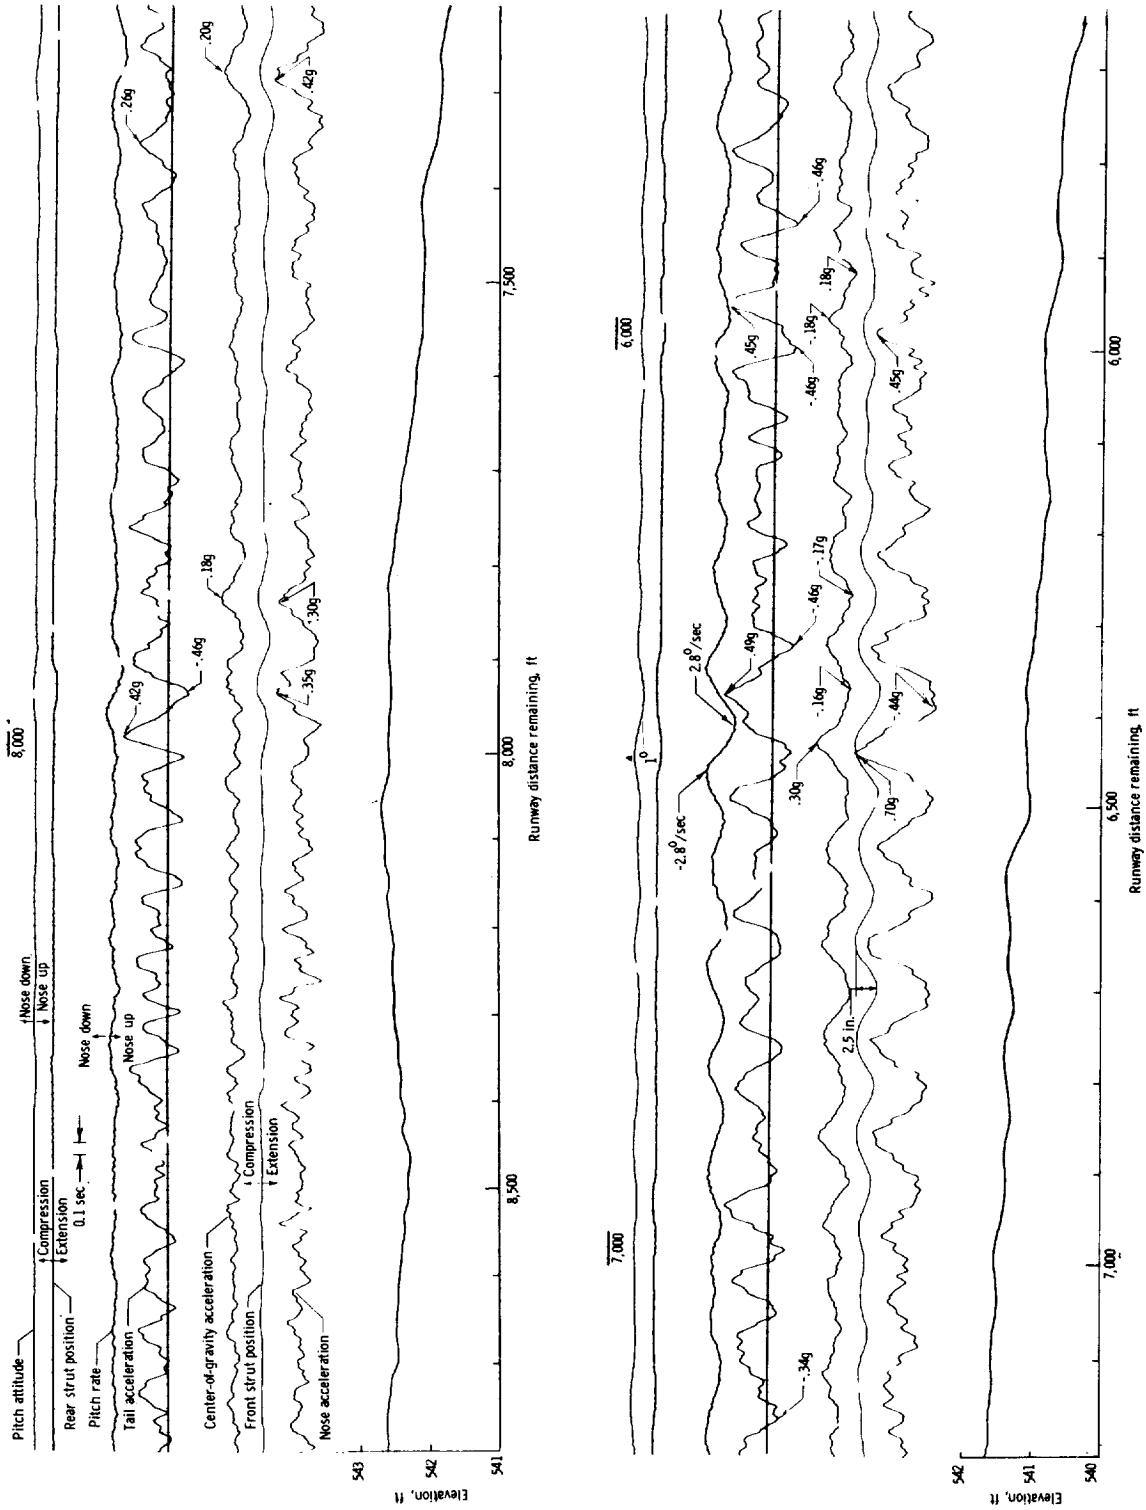
Figure 4.- Elevation variation of runway 31 and resulting airplane response at 75 knots taxiing speed.

Sample records of the responses of the airplane are shown in figures 4 and 5. These results were obtained during runs 4 and 8 (table I) for which taxiing speeds were 75 and 100 knots, respectively. The runway profile shown below the records indicates the approximate runway stations at which the responses were measured. The responses shown in the figures are airplane pitch attitude, pitch rate, and normal acceleration at the nose, center of gravity, and tail, as well as front- and rear-landing-gear strut positions. The magnitudes of several of the peak responses are indicated. The values of acceleration are in terms of incremental g units above (+) and below (-) the static 1.0g value. Airplane pitch attitude shown in figures 4 and 5 is referred to the static attitude (wing angle of attack approximately 8°) at the beginning of each run.

Examination of figures 4 and 5 shows several points of interest relative to the airplane responses to the runway roughness. It is evident that the roughness caused substantial acceleration response continually during the traverses of the runway and that certain locations along the runway are more conducive to high responses than are other locations. For example, figure 4 shows that, for the 75-knot taxiing speeds, the roughness near the 8000-foot location resulted in pilot-compartment accelerations as high as 0.35g. Likewise, the roughness between 7000 feet and 6300 feet caused sustained pitching motions and pilot compartment accelerations as high as 0.7g and -0.44g. The responses cited were

at a frequency of approximately 1.25 cps. Responses at this frequency and speed would be excited by runway irregularities having wavelengths of approximately 100 feet.

Several major frequency response modes are evident in figures 4 and 5 with frequencies ranging from around 0.8 cps to 4.0 cps. The wavelengths of runway irregularities which have the greatest effect on airplane response at these frequencies depend on the taxiing speed. For example, at a taxiing speed of 150 knots, runway irregularities having wavelengths of 316 feet and 63 feet would be expected to cause large response at 0.8 cps and 4.0 cps, respectively, whereas at 75 knots wavelengths of 158 feet and 32 feet would likely cause the most response at these frequencies. In addition to the dependence of the airplane response over a particular area on taxiing speed, the response on one area can be dependent on aircraft motions that were started by the previous area. The effect of speed is illustrated in figures 4 and 5 where a considerable response is shown near the 8000-foot station at a speed of 75 knots, but very little response to this area is shown at 100 knots. In each case the greatest response is caused by the rough area near the 6500-foot station.

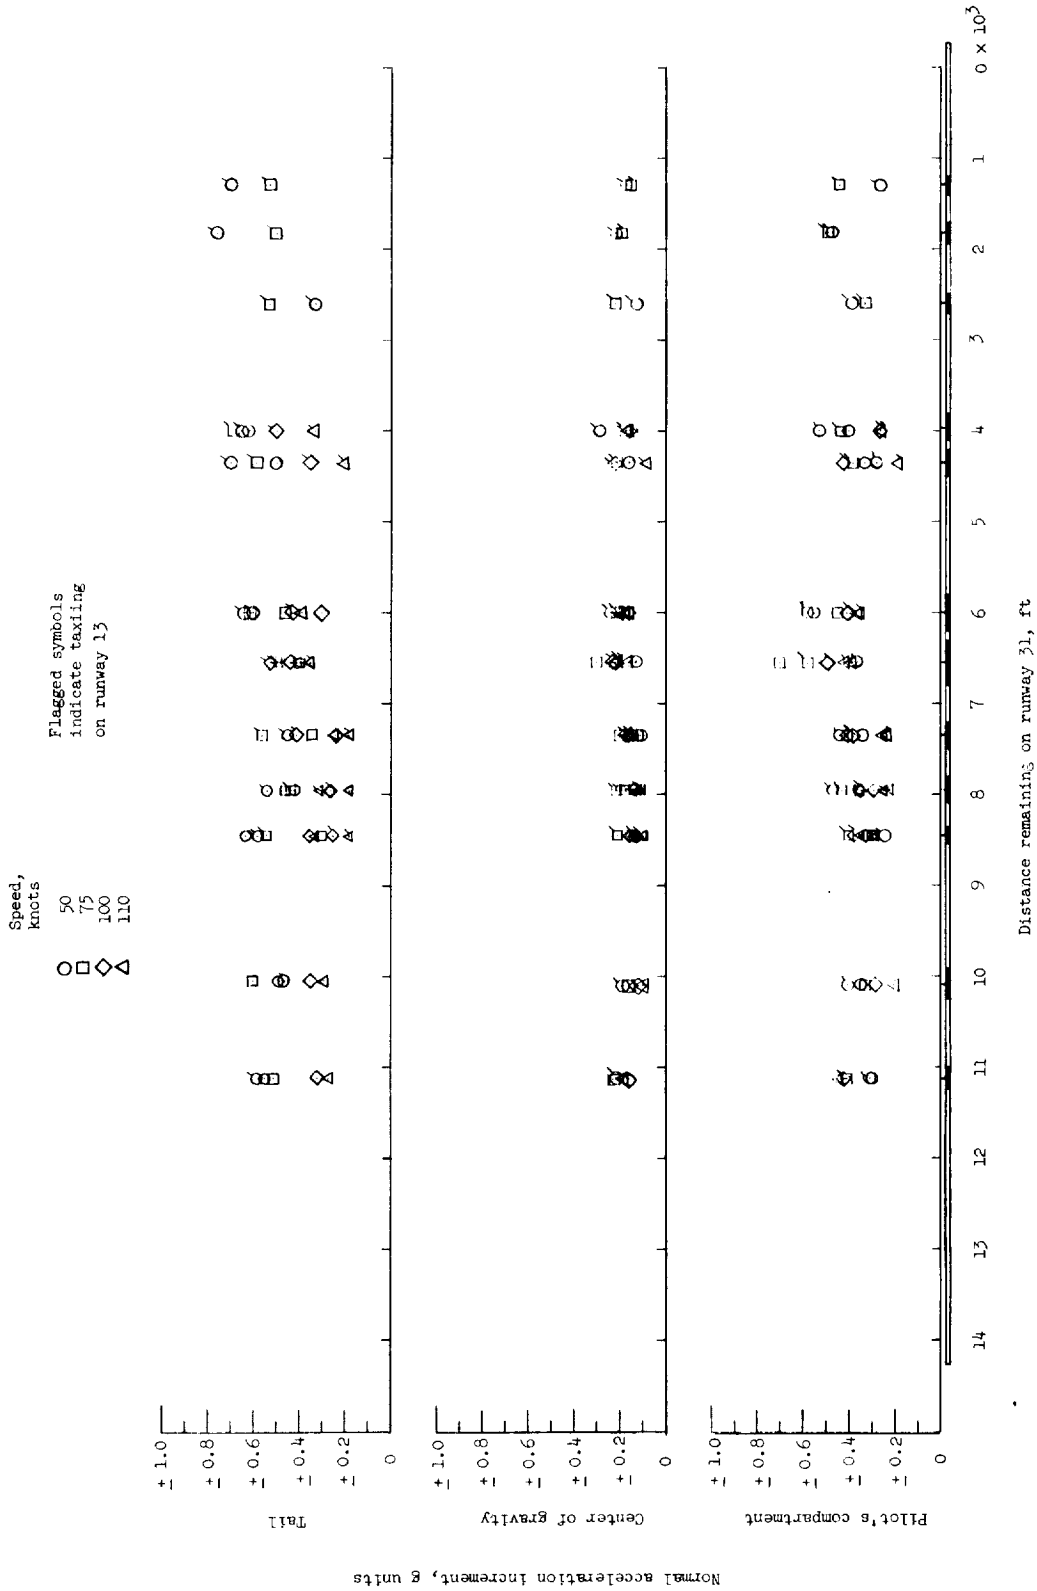
Figure 6.- Maximum acceleration response of airplane measured during taxiing on various sections of runway 31.

The peak values of the accelerations at the pilot's compartment (nose), the center of gravity, and the tail (table I) are plotted in figure 6 at the midpoint of each of the 12 sections of runway judged to have caused the major responses. It is noted that the acceleration of the pilot's compartment exceeded 0.4g in each of the areas during traverse at one or more of the four taxi speeds. Based on the acceleration of the pilot's compartment, the roughest area is between 6700 feet and 6300 feet.

Comparison of the results in figure 6 for taxiing in the two directions on the runway does not show a significant effect of taxi direction on the responses. In addition, results of two taxi runs on either side of the center line were not significantly different from those shown in figure 6. Thus, it is not believed that the roughness can be alleviated by operating on either side of the center line.

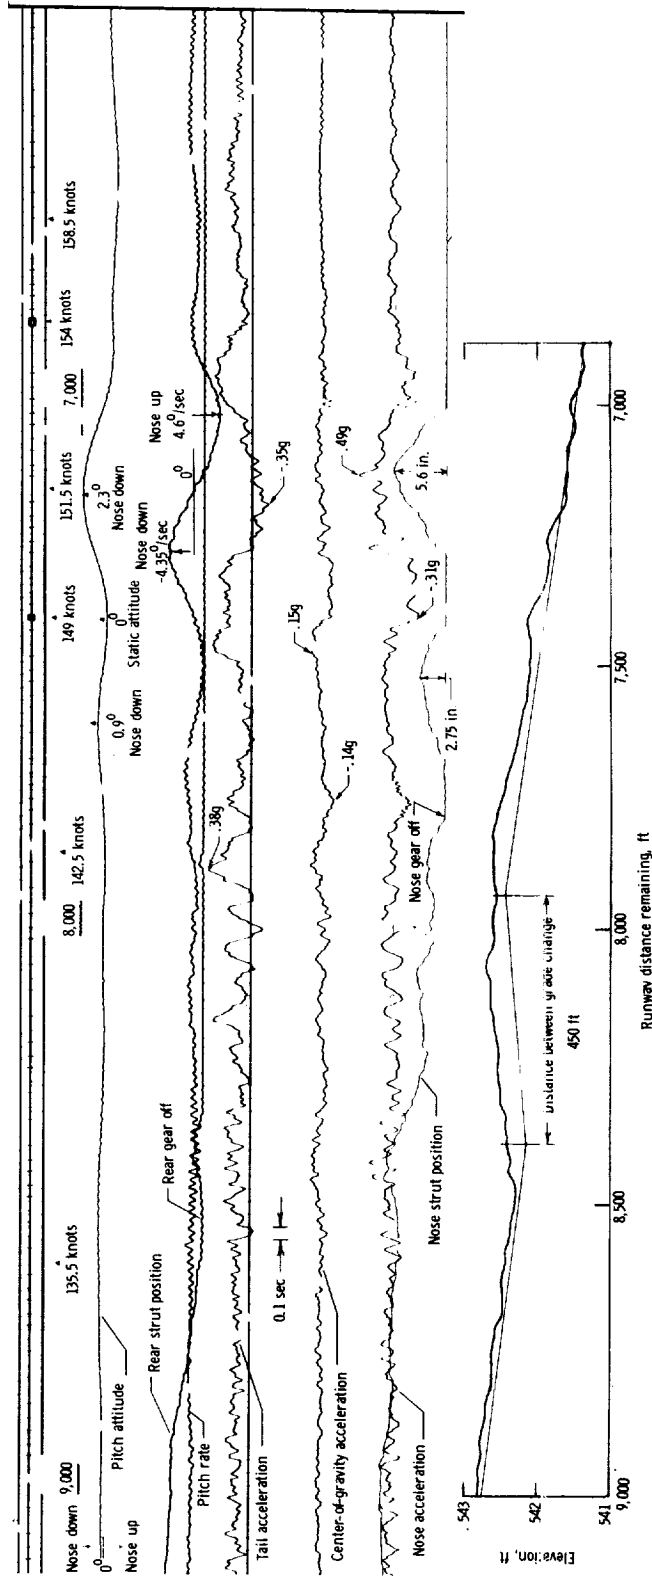
(a) First take-off. (Rear wheels lift off first.)

First take-off.- Examination of the airplane-response time histories for the first take-off (fig. 7(a)) shows that the rear wheels lifted off first at about the 8500-foot runway position while the airspeed was approximately 135 knots. The rear wheels remained off the runway for the remainder of the take-off except for momentary contact at about 8400 feet and 7800 feet.

During this take-off (fig. 7(a)), the nose gear first left the runway at the break in the profile at about 7800 feet. Between this location and the final lift-off at 7000 feet, a pitch oscillation existed such that the nose wheel was alternately in and out of contact with the runway. Thus, both gears were off the ground for about 0.5 second near 7800 feet with an airspeed of approximately 143 knots and again near 7400 feet with an airspeed of 149 knots. The airspeed at final lift-off was 153 knots, which is in good agreement with the handbook value of 152 knots.

The acceleration response in the pilot's compartment (fig. 7(a)) was less than $\pm 0.25g$ except during the last 500 feet of travel where maximum accelerations of $-0.31g$ and $0.49g$ were experienced. These peak accelerations were associated with the pitching motions of the airplane and the attendant alternating contact of the nose gear with the runway. The pitch attitude response during the take-off was in the nose-down direction and a maximum value of 2.3° less than the normal ground attitude was experienced during the pitch oscillation prior to lift-off. Control motions were not recorded during these tests; therefore, it is not known whether there were inadvertent or deliberate elevator control motions to either increase or damp this oscillation.

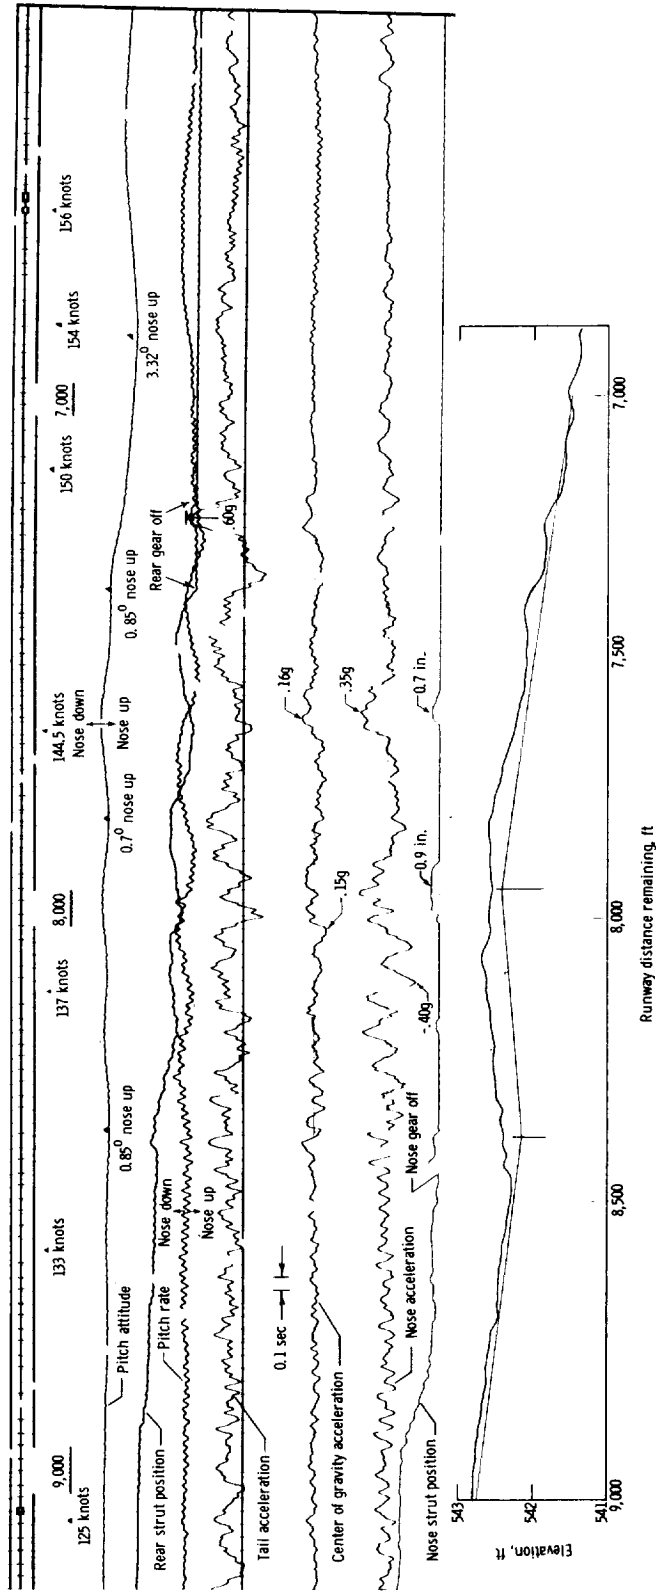
(b) Second take-off. (Front wheels lift off first.)

Second take-off.- Examination of the airplane response time histories for the second take-off (fig. 7(b)) shows that the front wheels lifted off first at about the 8500-foot runway position at an airspeed of approximately 134 knots. The front wheels were off the runway for the remaining take-off distance except for momentary contact at four locations (near 8400, 8200, 8000, and 7600 feet) due to a slight pitching motion of the airplane.

The bump at the 7400-foot location caused the airplane to become completely airborne at a speed and attitude which were too low to maintain flight so that the rear wheels hit the next bump at 7300 feet. At this point, the airspeed was about 148 knots and the attitude was about 2° above normal. Although the lift-off speed was 4 knots below handbook lift-off speed, the airplane was able to maintain flight from this point on.

The acceleration response in the pilot's compartment was less than $\pm 0.25g$ except during the final stages of the take-off where maximum accelerations of $-0.40g$ and $0.35g$ were experienced. Thus, the maximum acceleration response

during the second take-off was not significantly different from that experienced during the first take-off (-0.31g and 0.49g).
