NASA MEMO 3-3-59E

PERFORMANCE OF TWO BORON-MODIFIED S-816 ALLOYS IN  
A TURBOJET ENGINE OPERATED AT 1650° F

By William J. Waters, Robert A. Signorelli,  
and James R. Johnston

Lewis Research Center  
Cleveland, Ohio

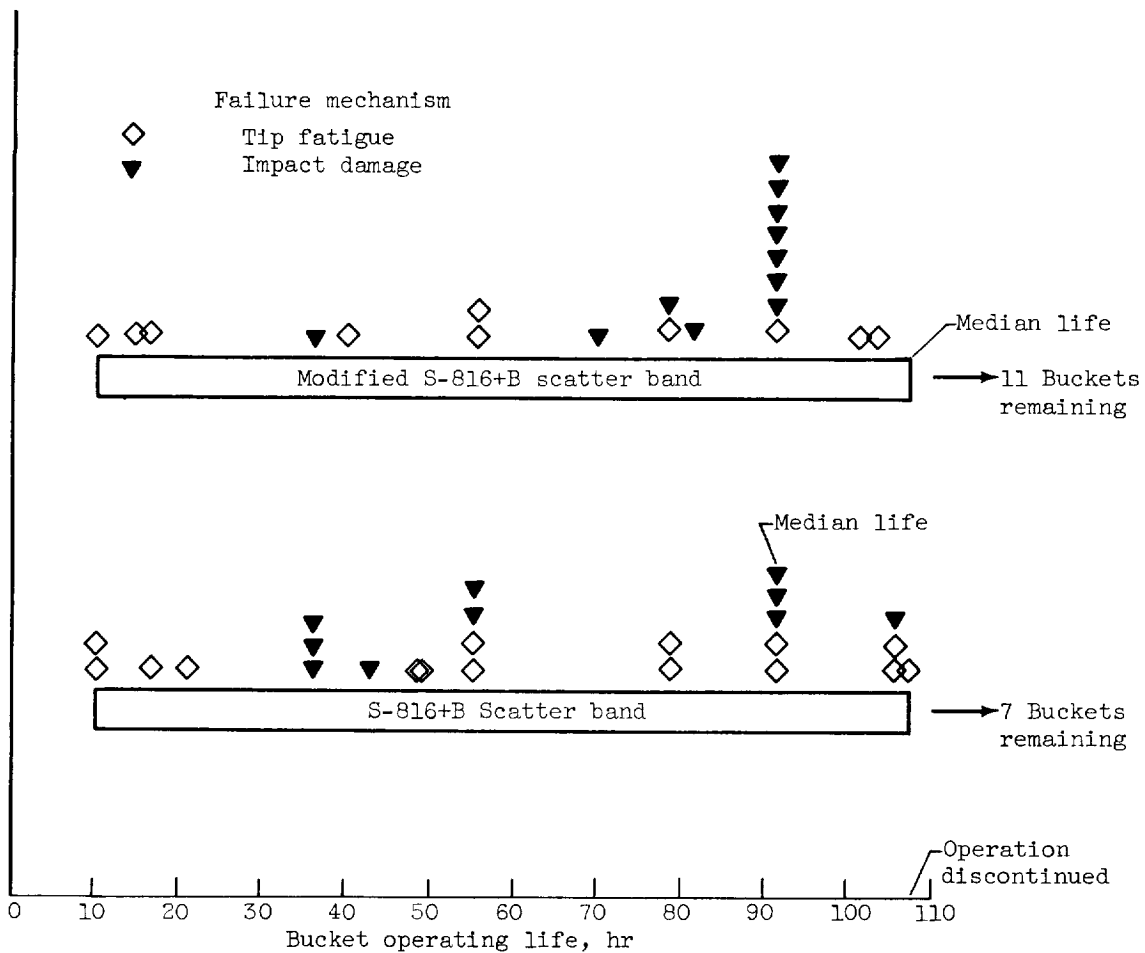
Figure 6 shows the failure times and mechanisms for turbine buckets of both alloys. Failures of both S-816+B and modified S-816+B buckets began after only 10 hours of engine operation and continued at various intervals throughout the test. The test was discontinued after  $107\frac{1}{2}$  hours of operation, at which time 74 percent of the S-816+B buckets and 58 percent of the modified S-816+B buckets had failed.

Failures occurred by two mechanisms during the test. These were tip fatigue and impact damage induced in other buckets by the tip failures. The engine performance of S-816+B and modified S-816+B buckets was similar, although the modified S-816+B buckets appeared to be slightly superior on the basis of median life. In the computation of median lives, only bucket tip failures were included. Modified S-816+B had a median life of  $107\frac{1}{2}$  hours, while S-816+B had a median life of  $91\frac{1}{2}$  hours.

Figure 6. - Performance of S-816+B and modified S-816+B turbine buckets at 1650° F in J33-9 turbojet engine.

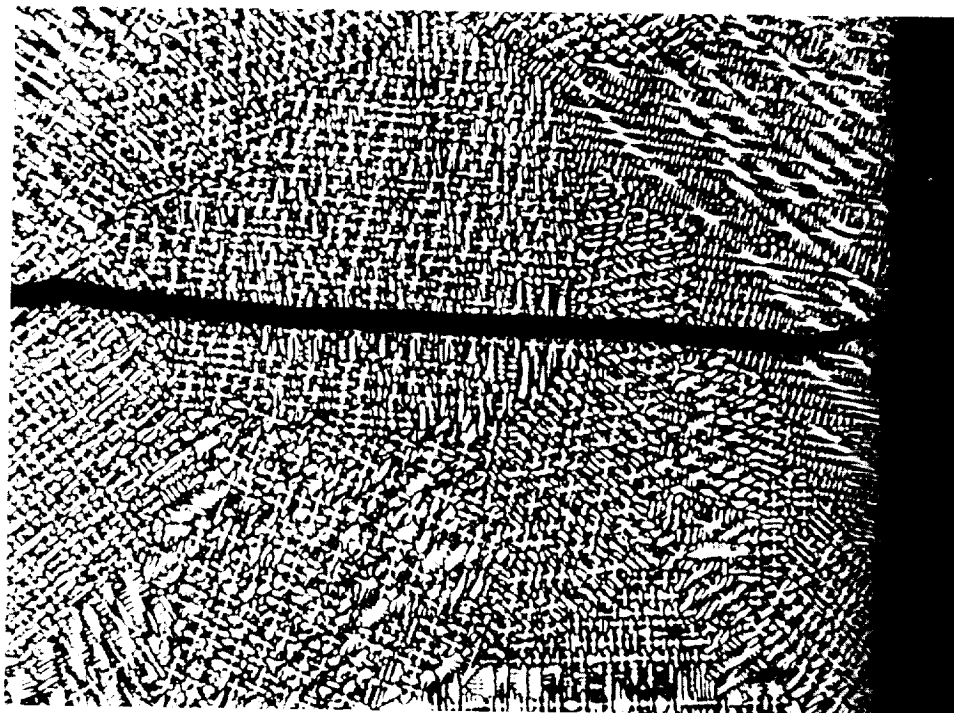
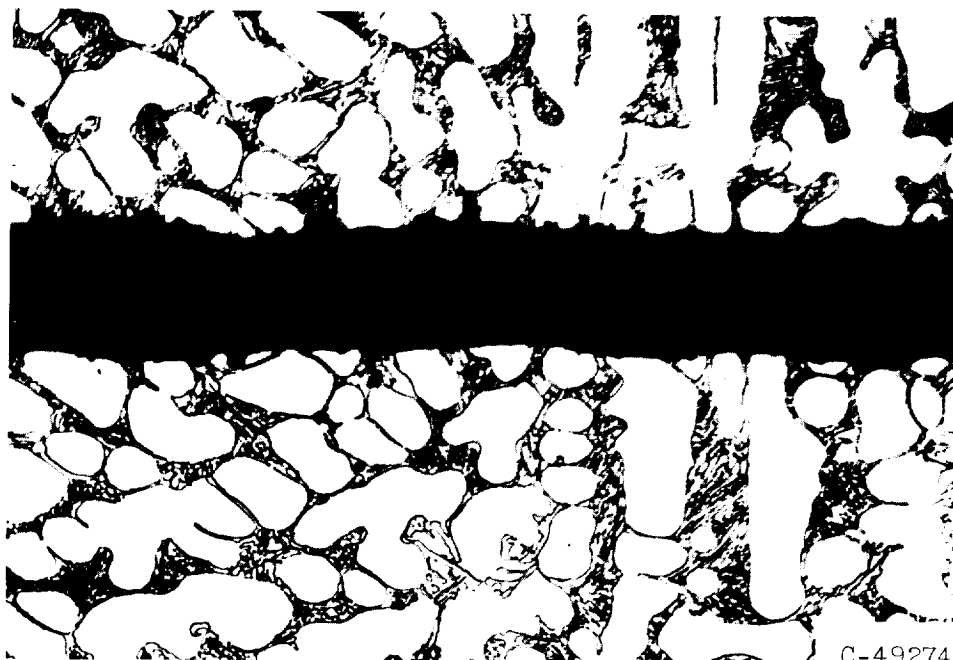
Microexamination revealed that the trailing-edge cracks were trans-crystalline, which is typical of those caused by mechanical fatigue. Figure 8 is a photomicrograph of a crack in a typical failed bucket.

Figure 8. - Typical trailing-edge fatigue cracks in engine-operated turbine bucket. Etchant, 20 cc water, 20 cc glycerine, 10 cc nitric acid, and 5 cc hydrogen fluoride.

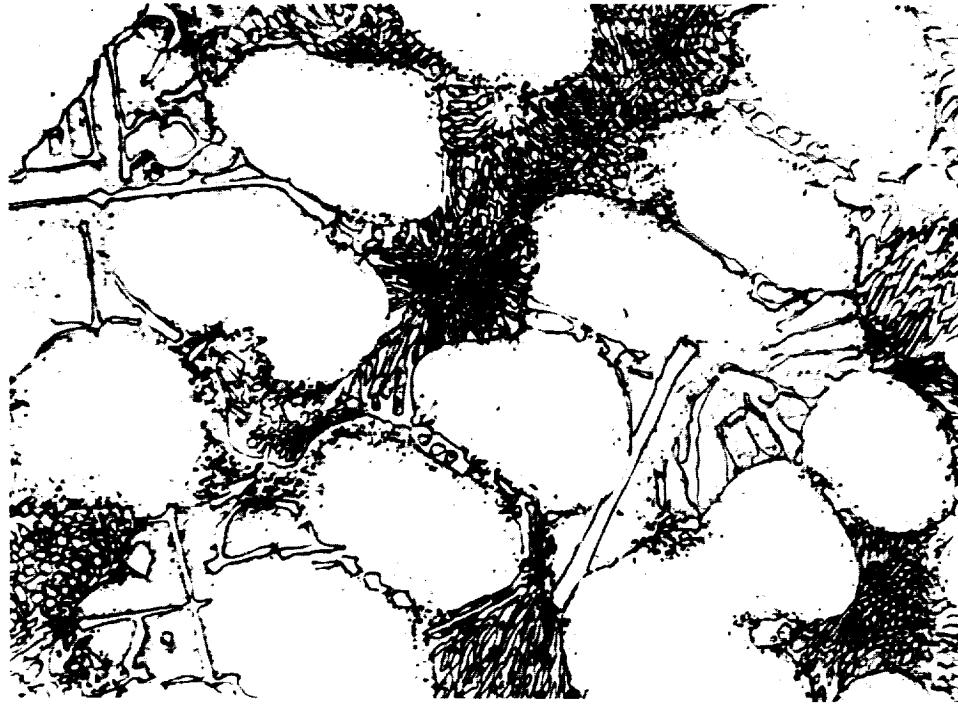
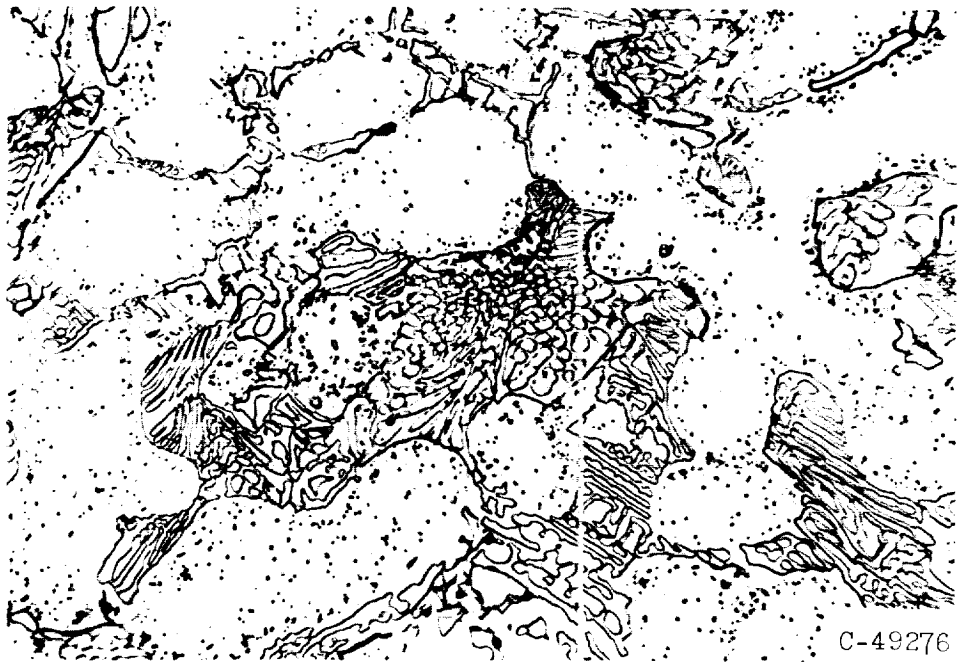
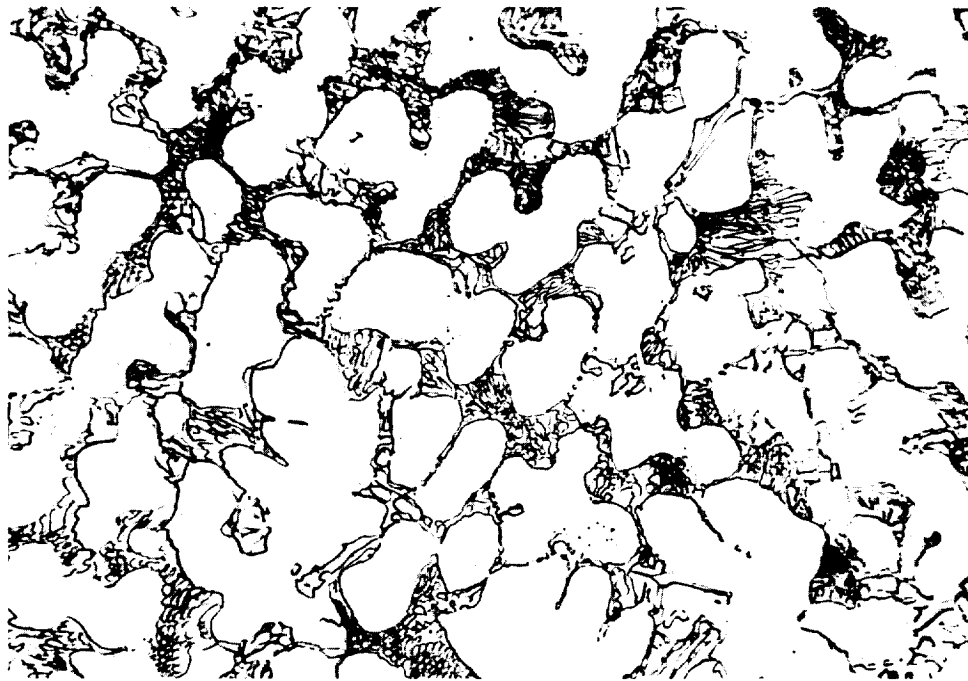
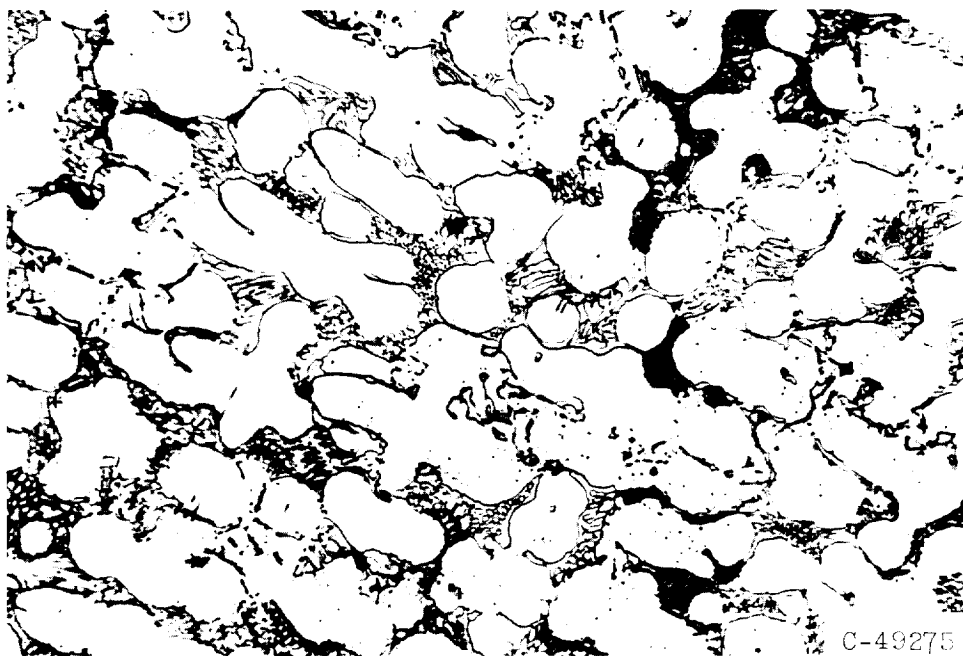
Photomicrographs of engine-operated buckets of both alloys are shown in figure 12. Precipitation in the matrix increased with increased engine operating times at 1650° F. Modified S-816+B appears to be the more stable of the two alloys in that precipitates apparently formed at a slower rate.

Figure 12. - Effect of 1650<sup>o</sup> F engine operation on alloys.  
Etchant, 20 cc water, 20 cc glycerine, 10 cc nitric acid,  
5 cc hydrogen fluoride. X750.
