NASA MEMO 4-7-59E

ENGINE OPERATING CONDITIONS THAT CAUSE THERMAL -  
FATIGUE CRACKS IN TURBOJET -ENGINE BUCKETS

By James R. Johnston, John W. Weeton, and Robert A. Signorelli

Lewis Research Center  
Cleveland, Ohio

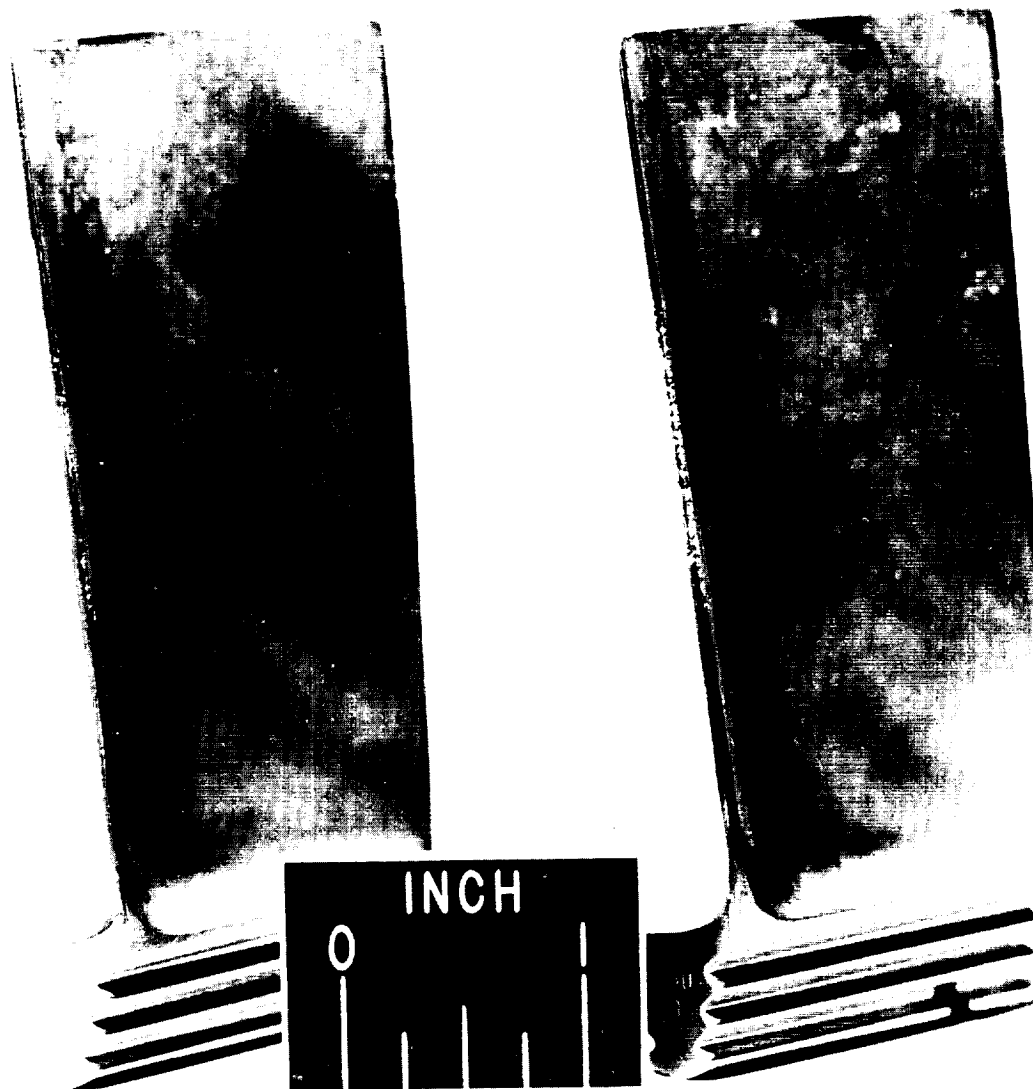
(a) Inspection, 115 starts.

During the normal-start - stop test, cracks were first observed in the M-252 buckets at 85 cycles and in the S-816 buckets at 295 cycles. At the end of the test (425 cycles), 84 percent of the M-252 buckets and about 9 percent of S-816 buckets were cracked. A series of photographs was taken (figs. 3(a), (b), and (c)) of a typical group of M-252 buckets to indicate the type of cracks observed and to show the extent of crack propagation. In general, the cracks in M-252 propagated gradually to an appreciable depth; the maximum depth of the deeper cracks was 1/8 inch. The cracks in S-816 were less severe, usually about 1/32 inch or less in depth. Many cracks propagated to their maximum depth relatively early in the test.

Figure 3. - Progression of cracks in M-252 buckets during start-stop test.

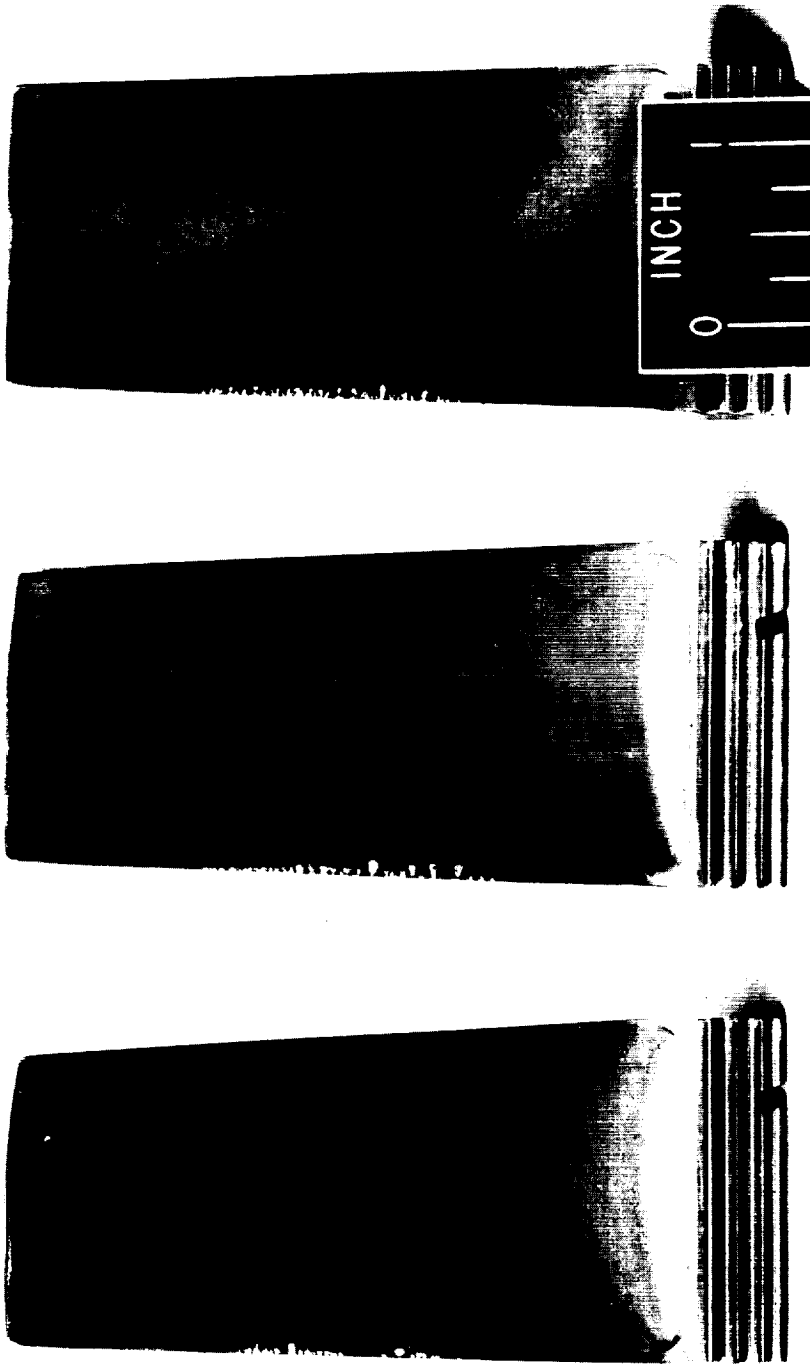
(b) Inspection, 205 starts.

Figure 3. - Continued. Progression of cracks in M-252 buckets during start-stop test.

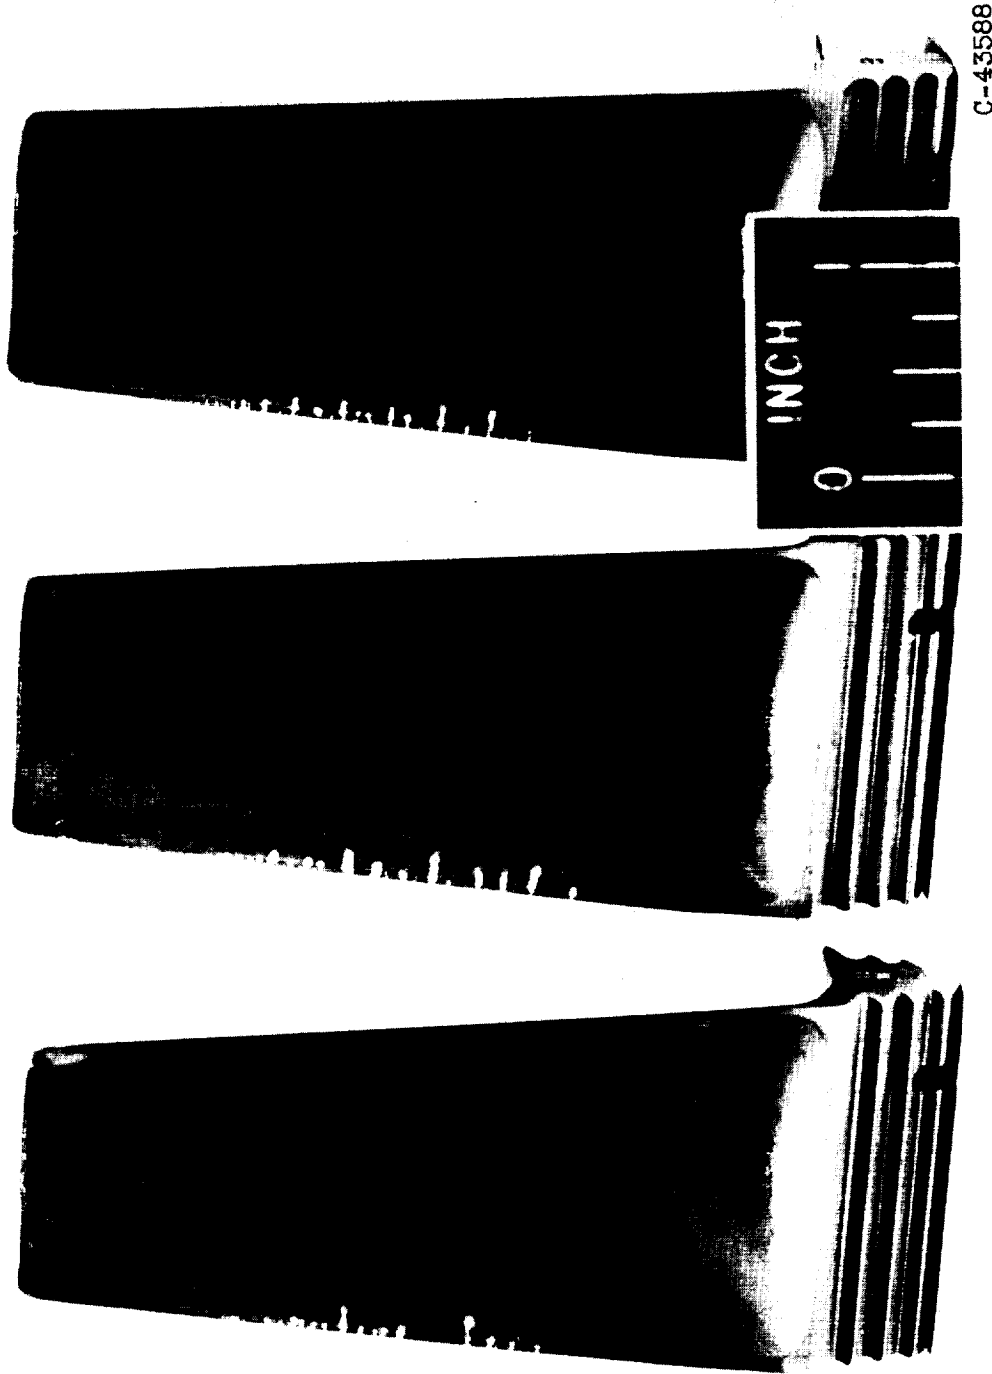
(c) Inspection, 425 starts.

Figure 3. - Concluded. Progression of cracks in M-252 buckets during start-stop test.

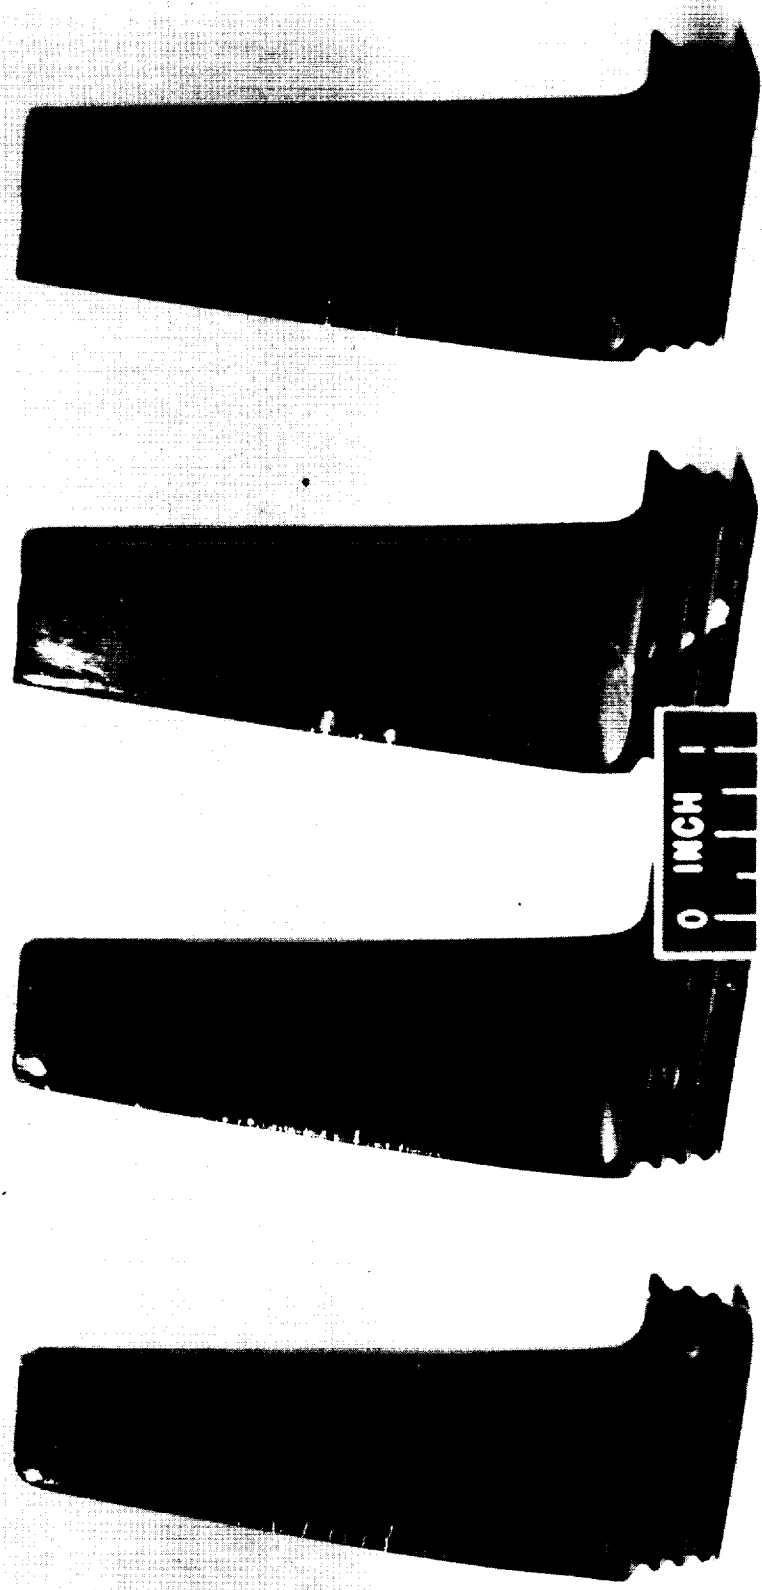
(a) Inspection, 100 starts, 25 hours.

During the start - rated-speed - stop test (in which 15 min of rated-speed operation were added to each start-stop cycle), cracks were first noted in the M-252 buckets at 40 cycles and in the S-816 buckets at 63 cycles. At the end of the test (200 cycles and 50 hr at rated speed), cracks were observed in 76 percent and 32 percent of the M-252 and the S-816 buckets, respectively. Figure 4 shows the leading-edge cracking in typical M-252 and S-816 buckets during this test. The maximum depth of crack propagation was 3/8 inch in the M-252 and 1/2 inch in the S-816 buckets. These deep cracks were not typical of all the buckets. The average maximum crack depth for all the cracked buckets in this test was about 3/32 inch for M-252 and about 1/8 inch in S-816. None of the cracks propagated to complete fracture.

Figure 4. - Progression of cracks in M-252 and S-816 buckets during start - rated-speed - stop test.

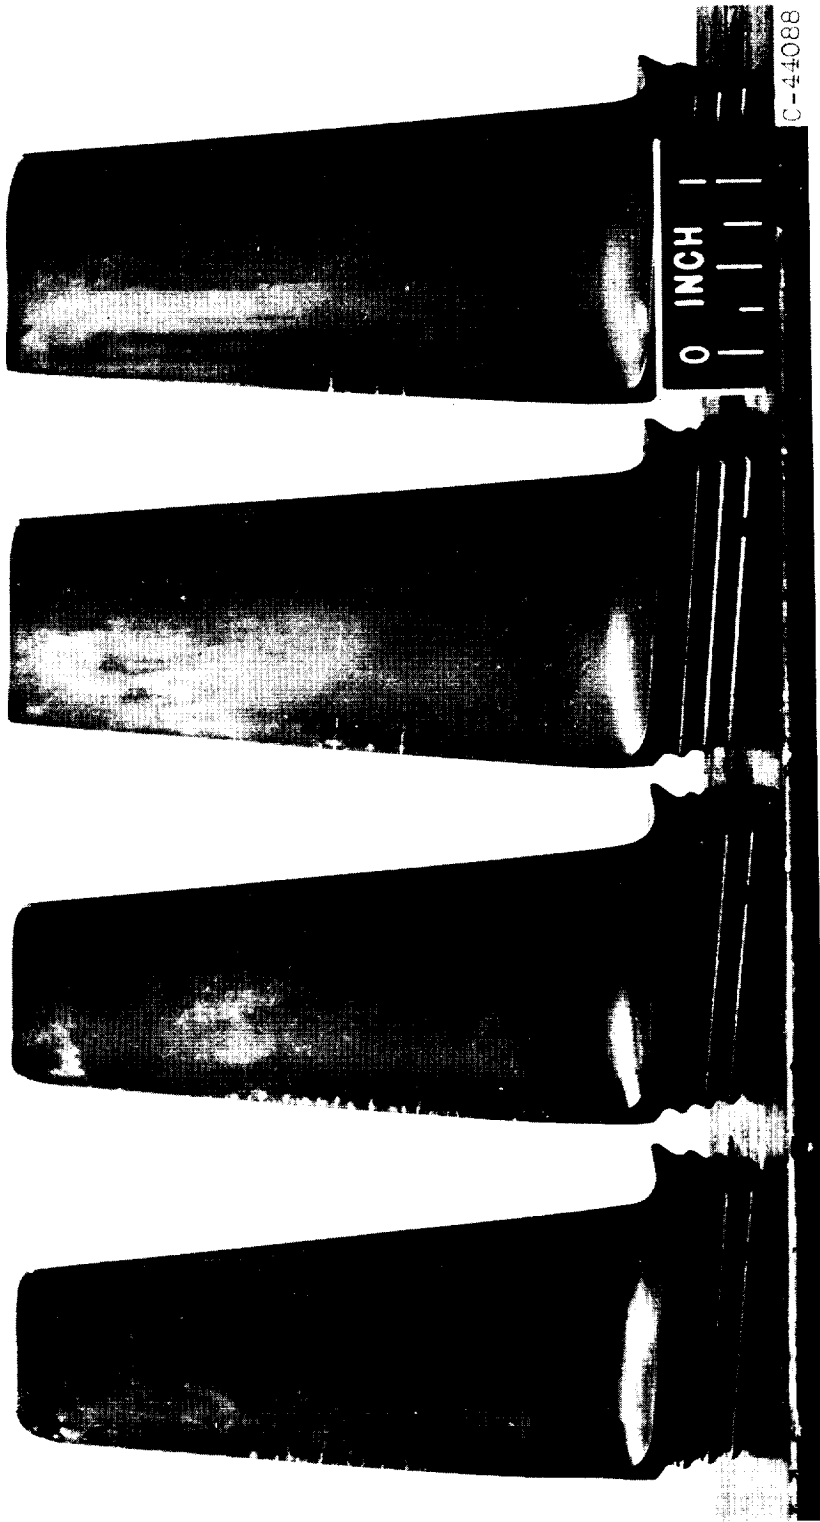
(b) Inspection, 200 starts, 50 hours.

Figure 4. - Concluded. Progression of cracks in M-252 and S-816 buckets during start - rated-speed - stop test.

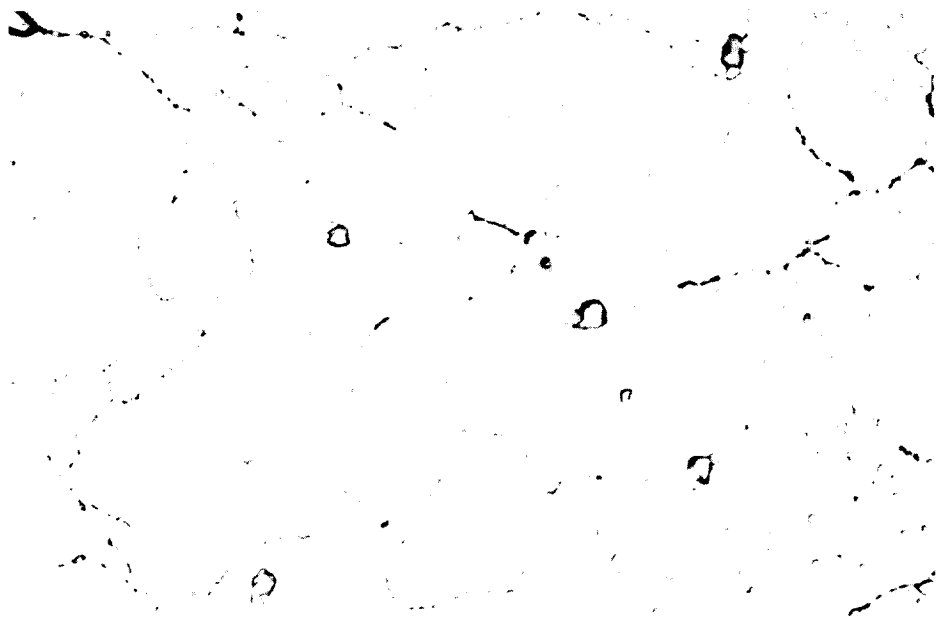
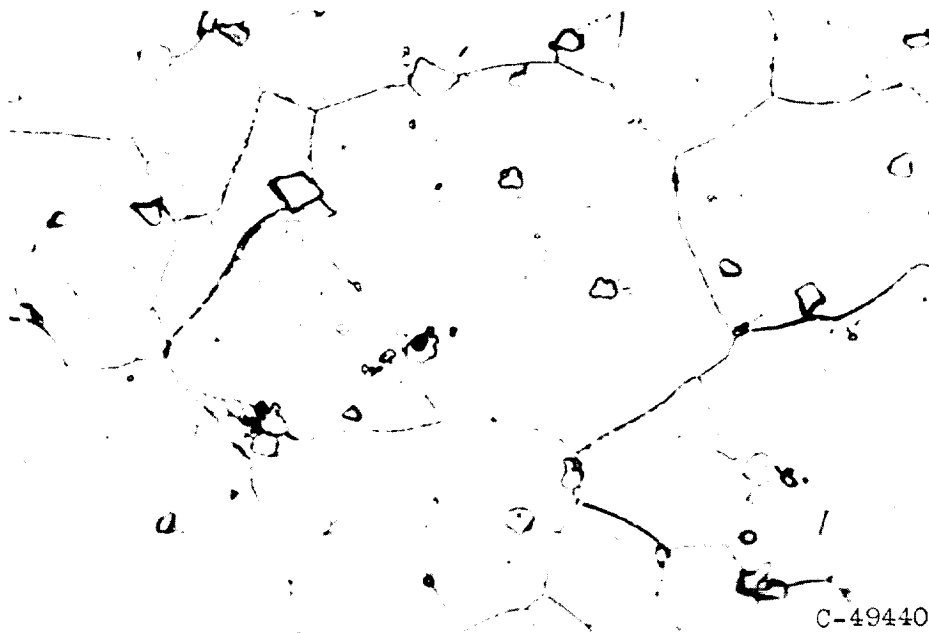
(a) Cycle: start, 5 minutes at idle, and stop.

run in the start-stop test (fig. 6(a)) exhibit agglomeration and spheroidization of grain boundary precipitates, but the hyphenation of grain boundaries is more pronounced in M-252. The S-816 bucket indicates a slight tendency to form precipitation along slip lines. Figure 6(b) shows the microstructure of cracked buckets after operation in the engine test in which 15 minutes of rated time were added to each start-stop cycle. In the case of M-252, the microstructure is not greatly different from that of the bucket from the start-stop test, but there appears to be slightly more matrix precipitation along residual grain boundaries. The microstructure of the S-816 bucket from the start - rated-speed - stop test contains definite evidence of overaging. In addition to the grain boundary hyphenation, there is considerable matrix precipitation, especially along slip lines.

Figure 6. - Microstructures of buckets after engine testing. X750.

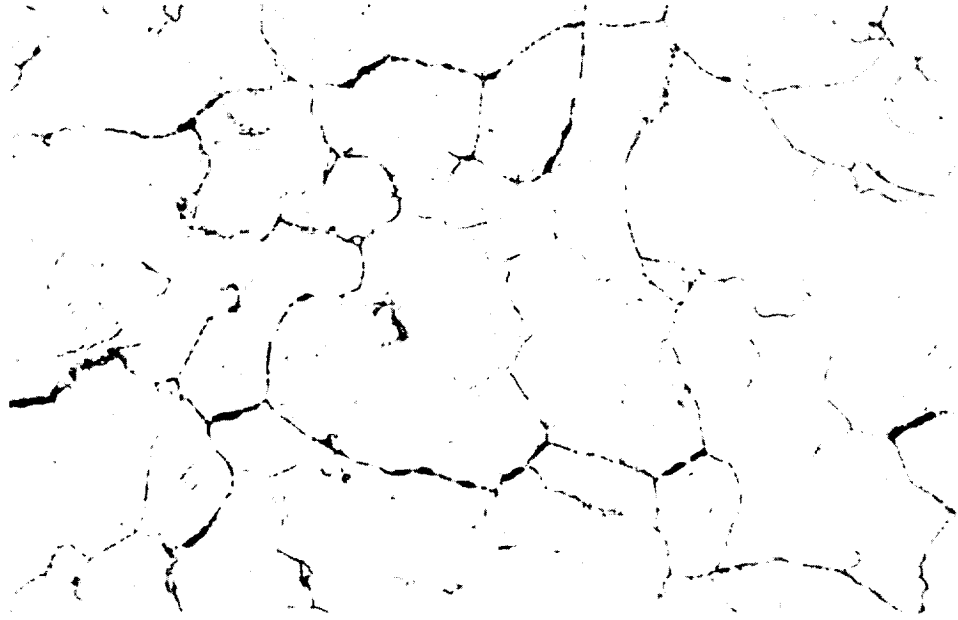
(b) Cycle: start, 15 minutes at rated speed, and stop.

Buckets of both M-252 and S-816 from the start - rated-speed - stop test contained clusters of voids along the grain boundaries in areas close to the leading edge. Some of these voids are apparent in the photomicrographs of figure 6(b). There was no significant evidence of voids in either alloy operated in the start-stop engine test.

The hypothesis of localized creep damage at the leading edge is supported by the appearance of voids in the grain boundaries (fig. 6(b)) of buckets run in the start - rated-speed - stop test. These voids are sometimes noted in rupture specimens (ref. 4) and are considered to be evidence of third-stage creep. Similar voids also have been noted in buckets which failed by a similar mechanism in other engine tests (ref. 5). Since the voids occur only in the areas close to the leading edge where the high thermal stresses are induced during starts, it seems reasonable to associate the creep damage with the stresses that arise as a result of engine starts.

Figure 6. - Concluded. Microstructures of buckets after engine testing. X750.
