An Insidious Mode of Oxidative Degradation in a SiC-SiC Composite

Linus U.J.T. Ogbuji
NASA Lewis Research Center
Cleveland, OH 44135

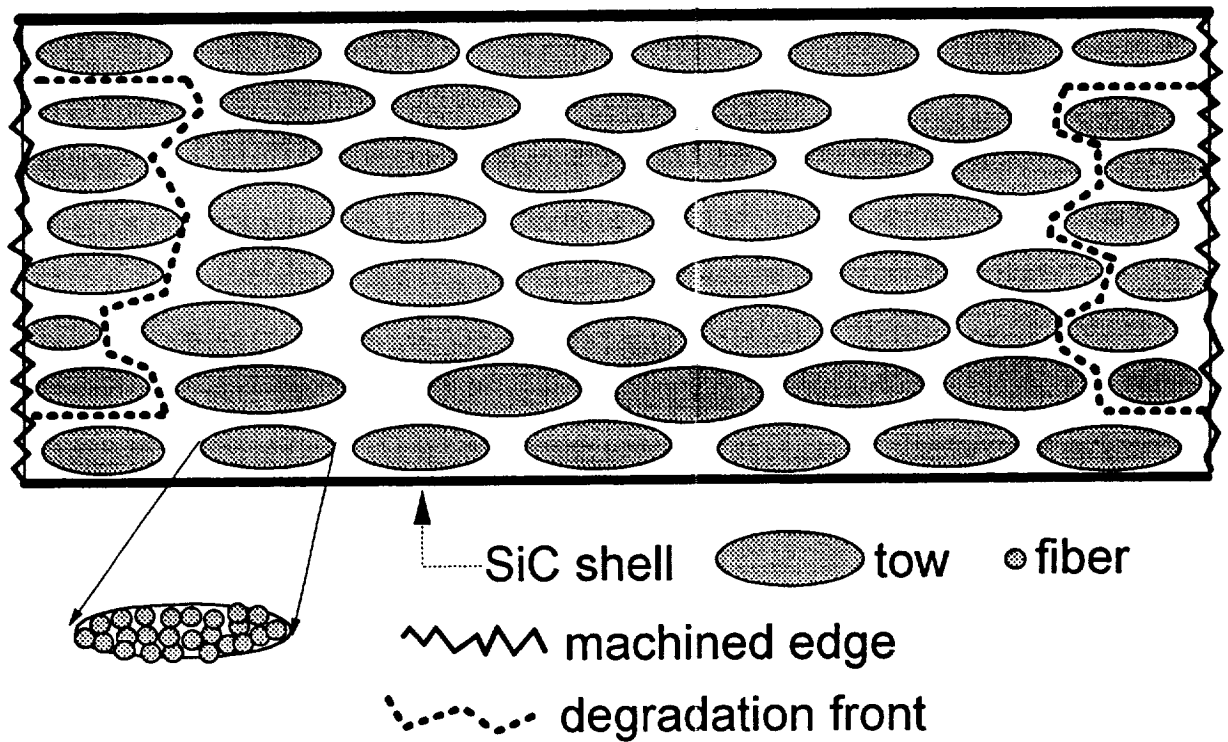
- Fig. 1 Schematic cross-sectional diagram of the SiC-SiC composite, illustrating degradation in a static ambient. Damage initiates at the surface and progresses inward, tow-by-tow.

Fig. 1 Schematic diagram illustrating the inward advance of environmental degradation, one tow at a time, expected (and often observed) in SiC-SiC composites.

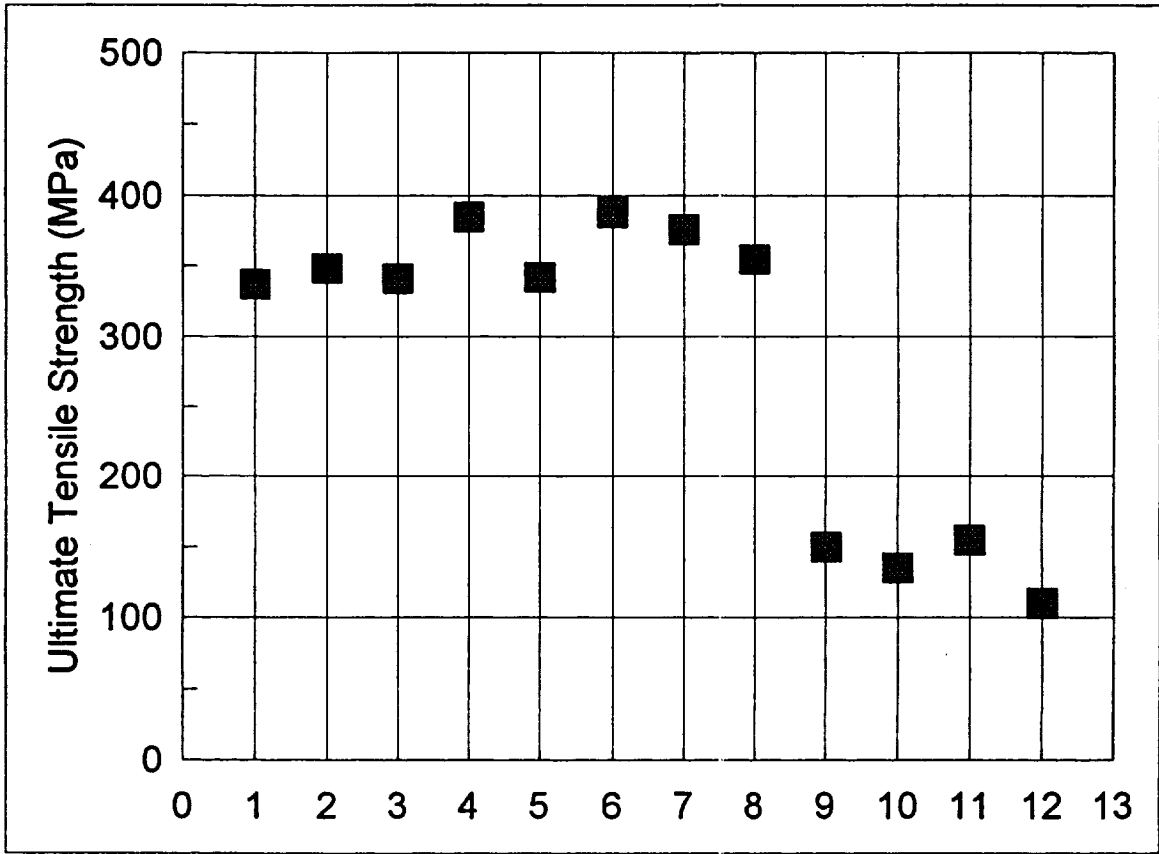
(1) The residual strengths and fracture strains of the SiC-SiC samples appear in Table 1, and the residual strengths are also shown charted in Figure 2. The relevant exposures of the samples are summarized in Table 1.

The differences of treatment or placement between the 4 burner rig samples is indicated in Table 1. A plot of the failure strains, not shown, was essentially identical to Figure 2. It is also clear from Table 1 that the trend of ϵ_f exactly parallels the trend of σ_u . The agreement between those two trends lends confidence to our interpretation of degradation effects in these materials. Clearly, the results fall into two categories. In the first category are the ultimate tensile strengths of the first eight samples, which are essentially the same and well within 15% of the as-received strength (of Sample 1). In the second category are the samples exposed in the burner rig (last four samples in Figure 2), which failed at 30-40% of the as-received strength. In other words, the material retained its strength after every furnace oxidation, but exhibited a dramatic drop in strength and fracture strain (60% and 90%, respectively) after a burner rig exposure.

It is apparent from Table 1 and Figure 2 that the role of H₂O content of the oxidizing ambient in promoting degradation is not straight-forward. This is clearer in Fig. 3 where residual strength is shown against moisture content. The sharp dip for the three burner rig samples (at 10% moisture content) and the apparent lack of a trend for the other samples clearly indicate an anomaly which is not attributable to moisture content alone. The trends indicate that, in the furnace oxidation exposures, the effect of increasing moisture content is minimal, while, in the burner rig, some other factor is contributing more than moisture content to the degradation. The close agreement in the results for all burner rig samples suggest that the factors that were varied in the rig (sample orientation the presence or absence of a nominal stress) had no significant impact on the degradation. We note, also,

- Fig. 2 A chart of residual strength of SiC-SiC bars: as received (# 1), and following oxidation at 800°C in room ambient (#s 2,3) or in 30% H_2O +70% O_2 to 90% H_2O +10% O_2 (#s 4-8), or in a Mach 0.3 burner rig (#s 9-12). Only the burner rig caused significant loss of strength.

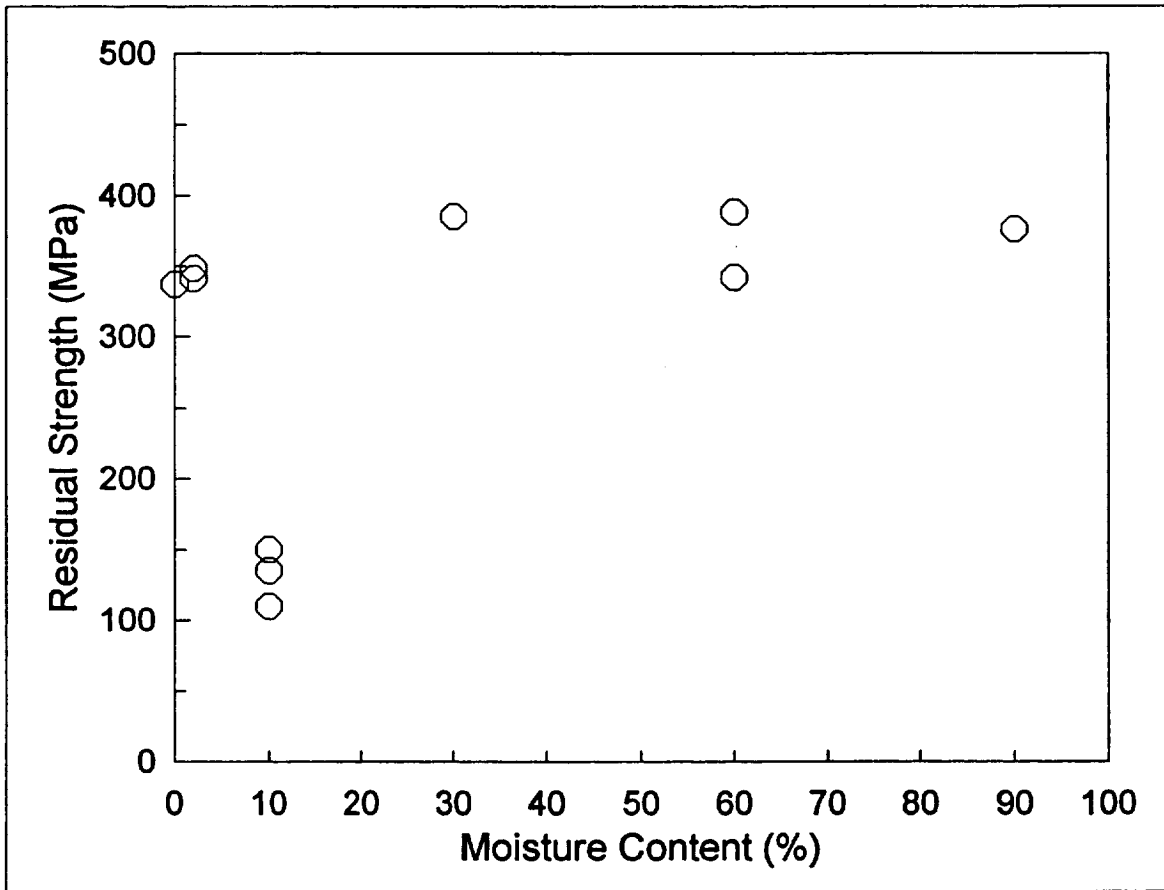
Figures 2 and 3 are not to be interpreted to mean that this material is strongly resistant to degradation by moisture. They merely show that, under the conditions investigated here, especially the rather short times, the effect of moisture is not as pronounced as some other effects we shall highlight shortly. (It is probable that, under the static-to-slow oxidant flow conditions in a furnace, 500 hours is too short a duration for moisture effects to become

- Fig. 3 A chart of the same results as residual strength versus ambient moisture content. Again, the only significant strength loss occurred in the burner rig (10% moisture).
