NASA/TP-97-206257

The Characteristics of Fatigue Damage in the Fuselage Riveted Lap Splice Joint

Robert S. Piascik
Langley Research Center, Hampton, Virginia

November 1997

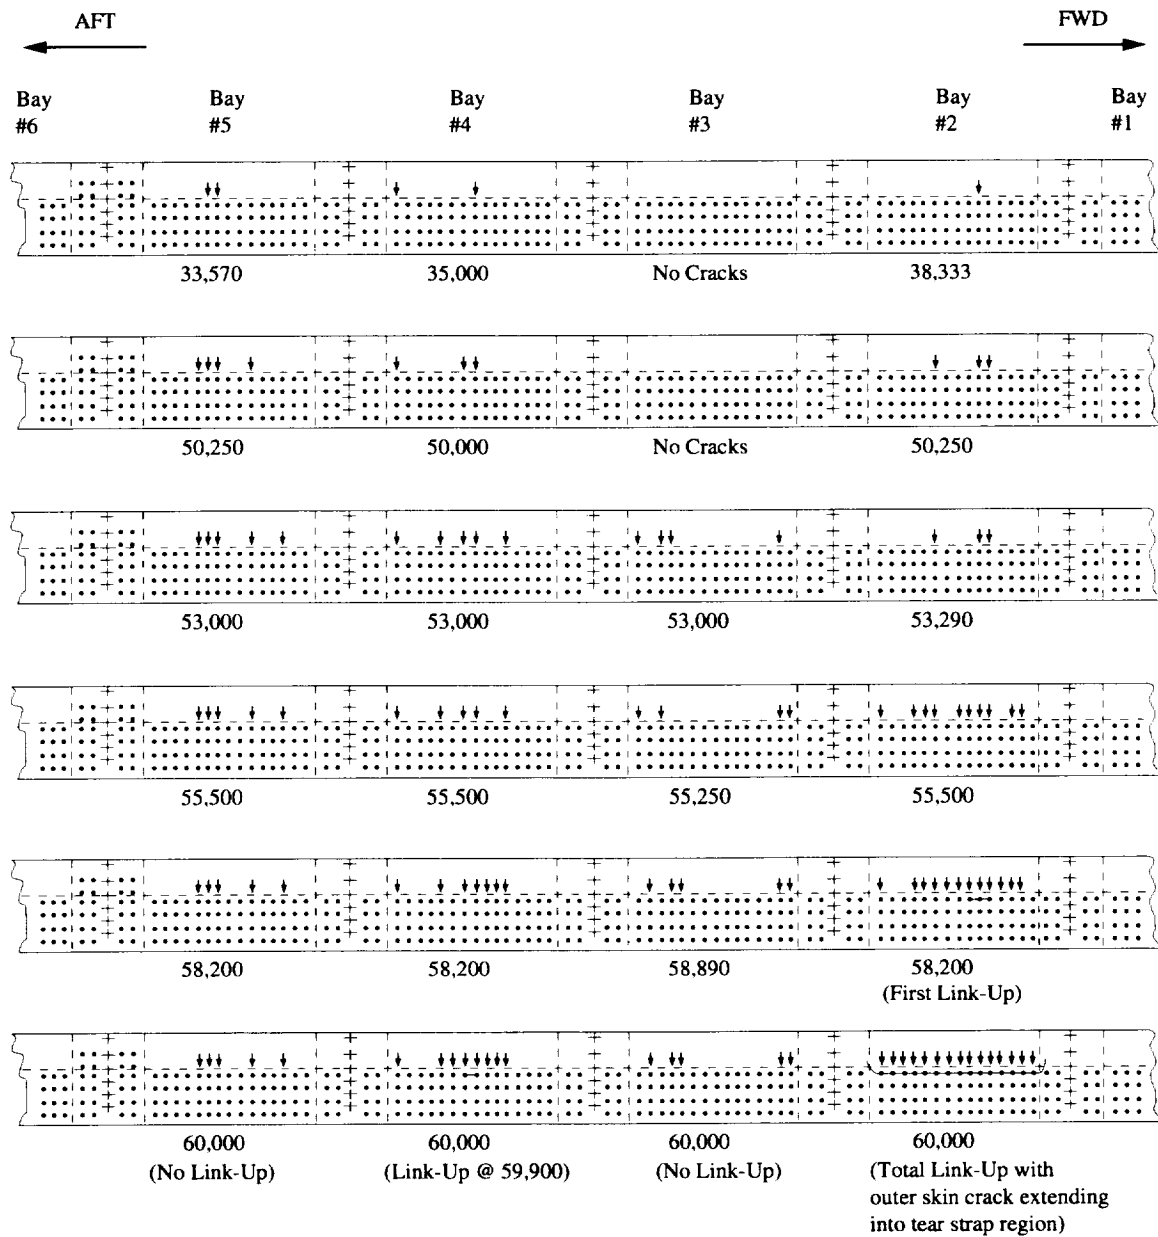
The small arrows in Figure 2.1 mark the locations of visible rivet hole cracks detected during *in situ* visual examinations conducted during the full-scale fuselage pressure test. Summarized is the chronology of cracking from first detection of cracking in bay 5 at 33,750 cycles, to the total link-up of bay 2 cracks at 60,000 pressurizations. It should be noted that all visible rivet hole cracking detected within this 6 bay region was limited to the upper rivet row. After the initial 20,000 pressure cycles, *in situ* outer skin surface visual inspections were conducted at intervals of about 1700 cycles.¹ The first evidence of lap splice outer skin fatigue cracking was observed along the upper rivet row near the middle of bay 5 after accumulating 33,570 pressurizations. Visible cracks were observed in bays 4 and 2 after 35,000 and 38,333 cycles, respectively. No further visible cracking was noted until after 50,000 cycles. The first evidence of fatigue crack link-up was detected in bay 2 at 58,200 cycles. An additional 300 pressurization cycles were performed, totaling 58,500 cycles, before cracks at all upper rivet row locations in bay 2 had grown together (link-up), forming a single long crack. The long crack measured 18.85 inches (47.9 cm) in length and extended along the entire upper row of rivets in bay 2 and terminated at the tear straps. At 59,900 cycles, bay 4 exhibited crack link-up between two upper rivet row rivet hole locations. Upon completing the full scale fuselage fatigue test at 60,000 cycles, 33 of the total 60 upper rivet row hole locations in bays 2, 3, 4 and 5 exhibited visible cracks along the outer surface of the fuselage skin. No visible cracks were detected along other rivet rows. The six bay panel of lap splice joint containing visible MSD was removed from the fuselage test article for a detailed teardown inspection at LaRC. Reported herein is a detailed description of the results of all examinations conducted on the six bay panel at LaRC.

Figure 2.1 The schematics show the results of the *in situ* inspection. Arrows indicate rivet hole locations that contain visible fatigue cracks. Cycle counts associated with the visual observations are located below each schematic. Crack link-up occurred in bay 2 and bay 4.

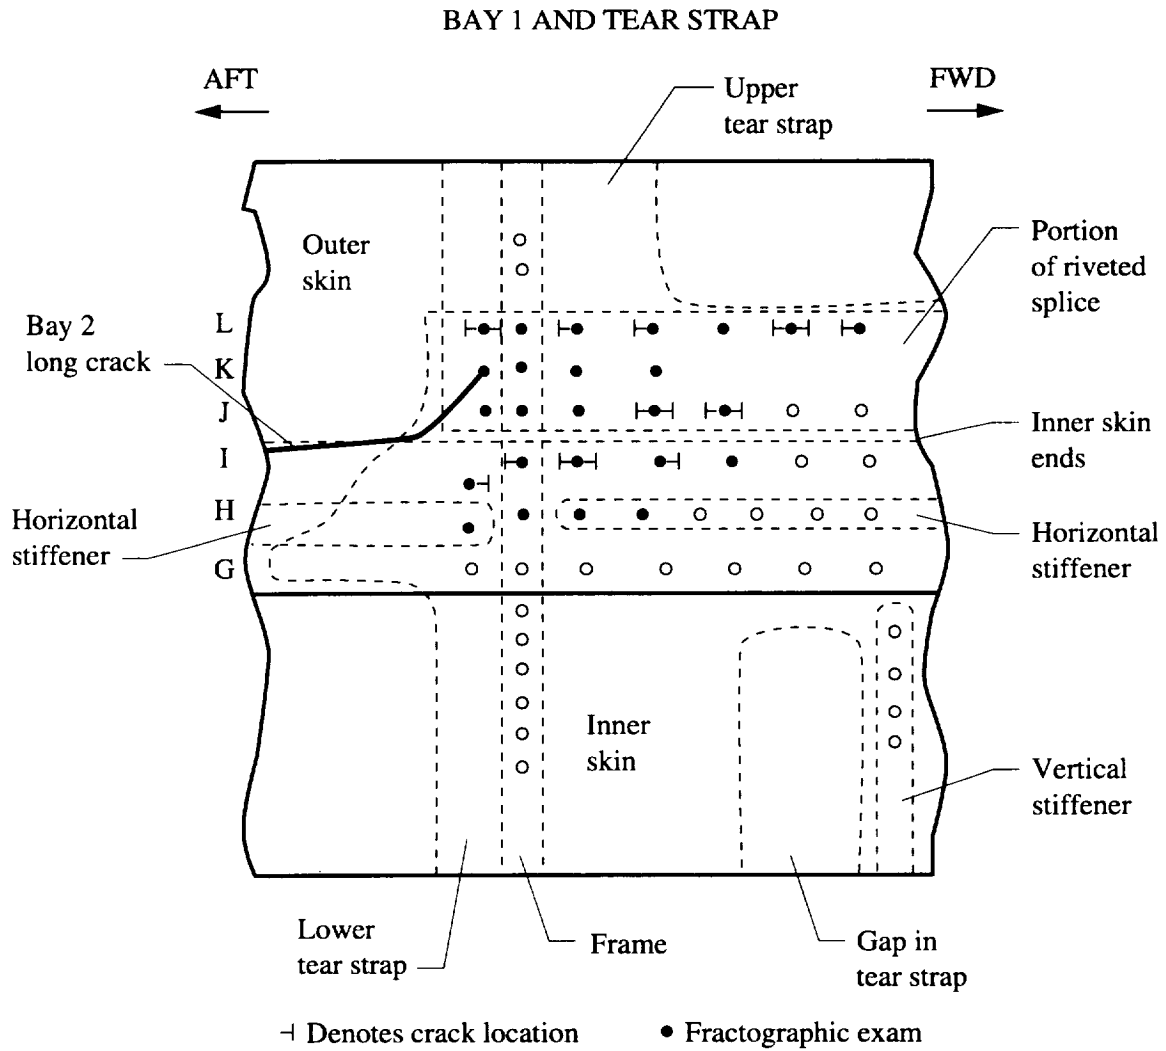
Figure 6.1 The schematic shows the location of all fatigue cracks found in the bay 1 tear strap and lap splice joint regions by destructive examination. Fractographic examinations were performed on the hole locations marked by the solid circles. Note the dark solid line that marks the location of the long crack extending from bay 2.

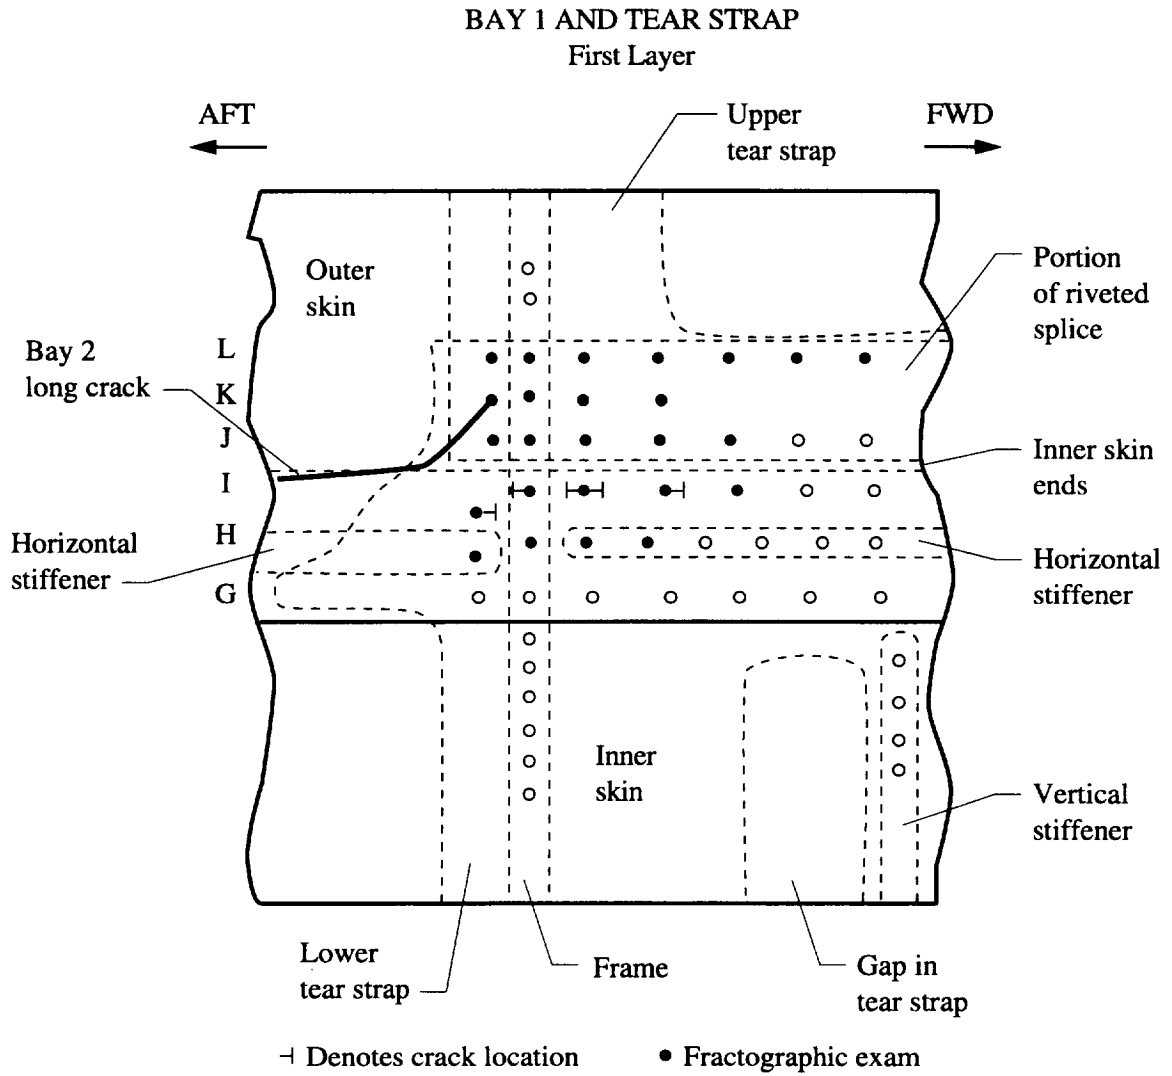
Figure 6.2 The schematic shows the location of fatigue cracks found in the first layer (outer skin) of the bay 1 tear strap and lap splice joint regions by destructive examination. One end of the long bay 2 fatigue crack (dark solid line) extended into this region.

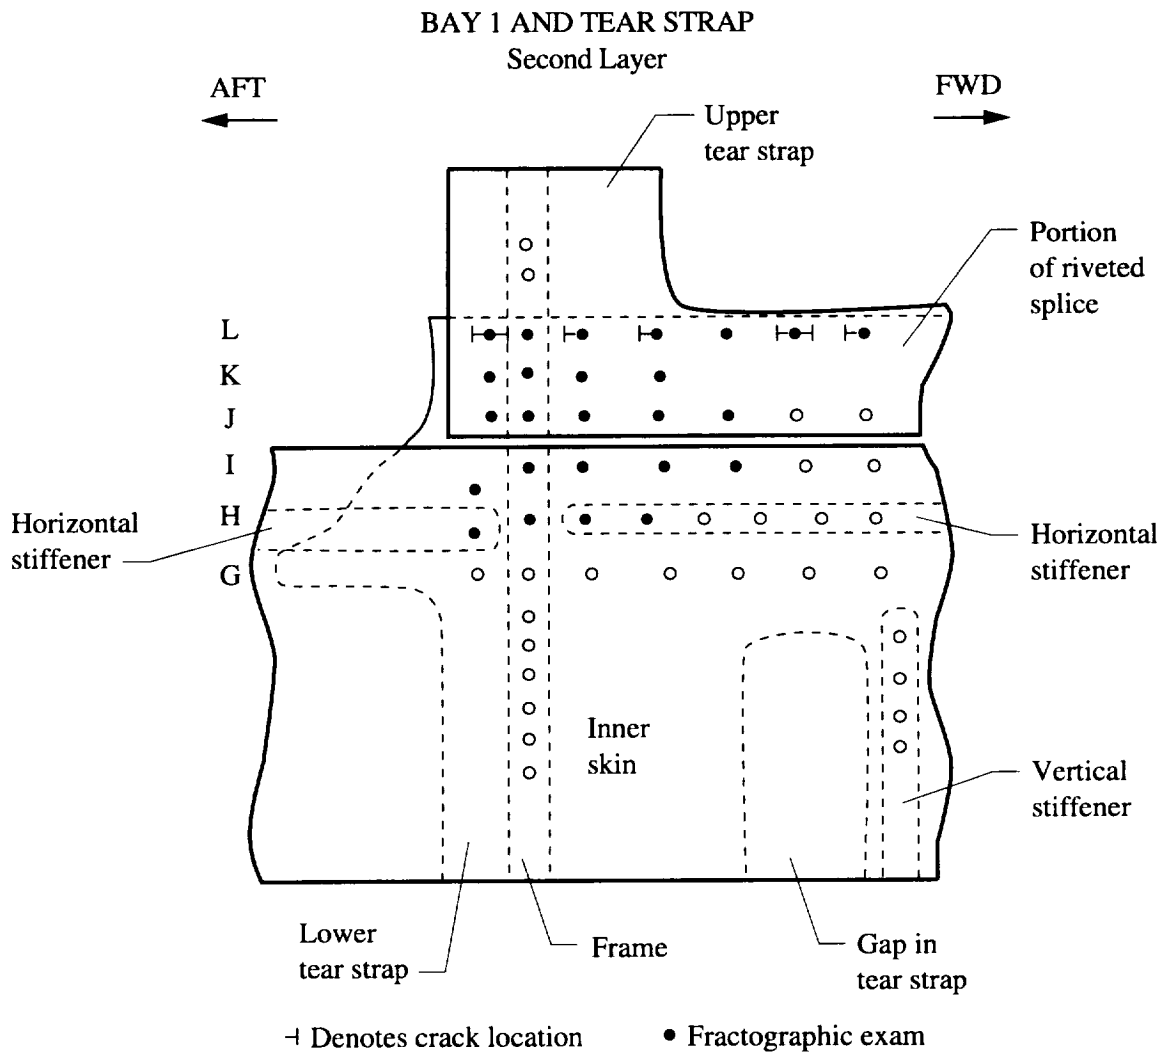
Figure 6.3 The schematic shows the location of fatigue cracks found in the second layer (upper tear strap and inner skin) of the bay 1 tear strap and lap splice joint regions by destructive examination.

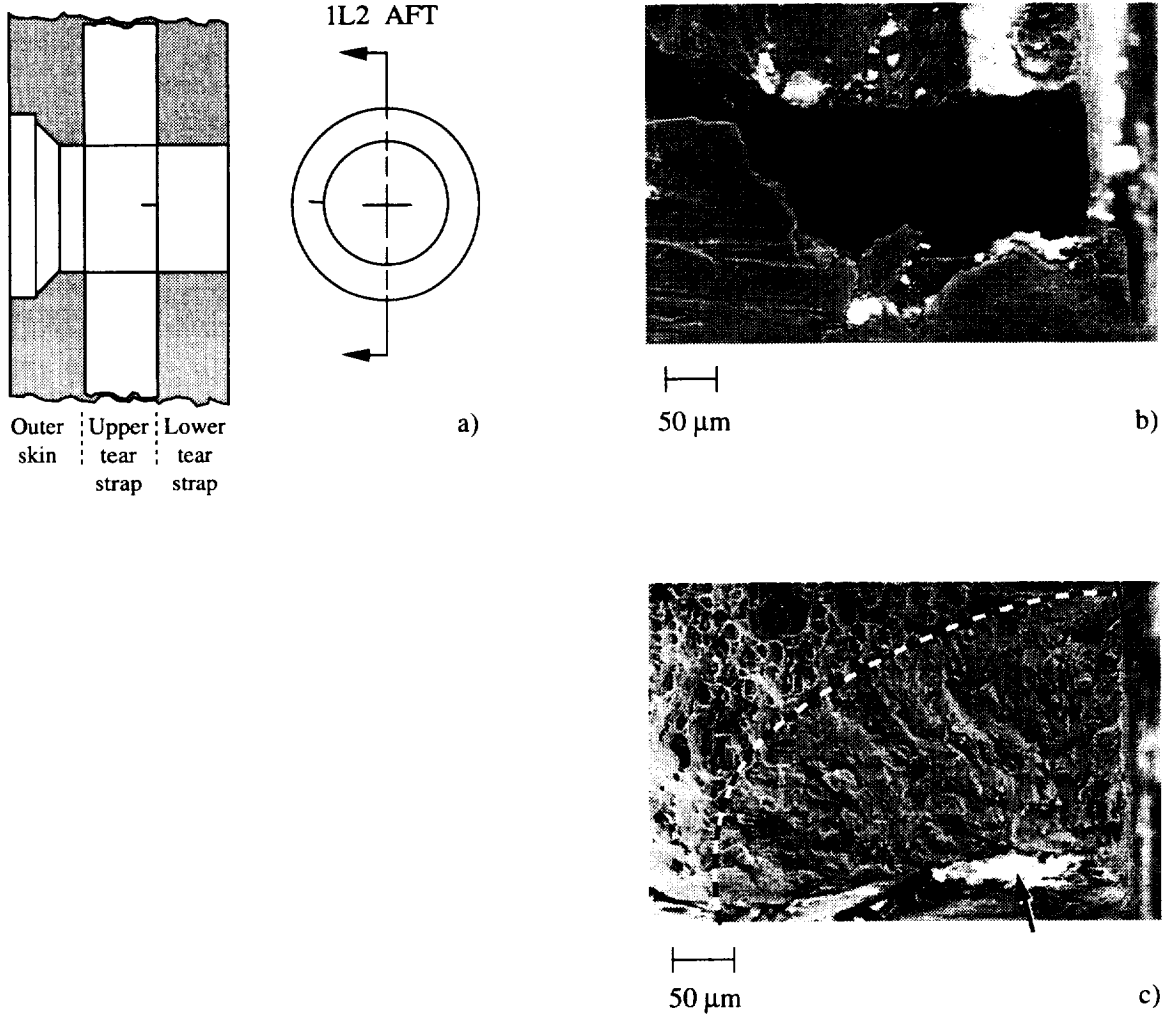
Figure 6.13 a) The schematic shows the rivet hole 1L2 configuration and the location of the upper tear strap fatigue crack oriented in the aft direction slightly above the 9 o'clock position. b) The SEM micrograph shows the corner fatigue crack that has been partially opened during the destructive examination. The surface normal to the fatigue crack is the hole inside surface. This surface exhibits a roughened morphology and oxide debris is observed adjacent to the crack lip. The white color of this debris is associated with electronic charging during the SEM examination and is typically caused by nonconducting surface oxides. c) The SEM micrograph shows the fatigue crack region after final fracture of the specimen. The dashed line marks the fatigue crack front. An arrow marks the likely region of crack initiation which exhibits a rough surface containing oxide debris (white region).

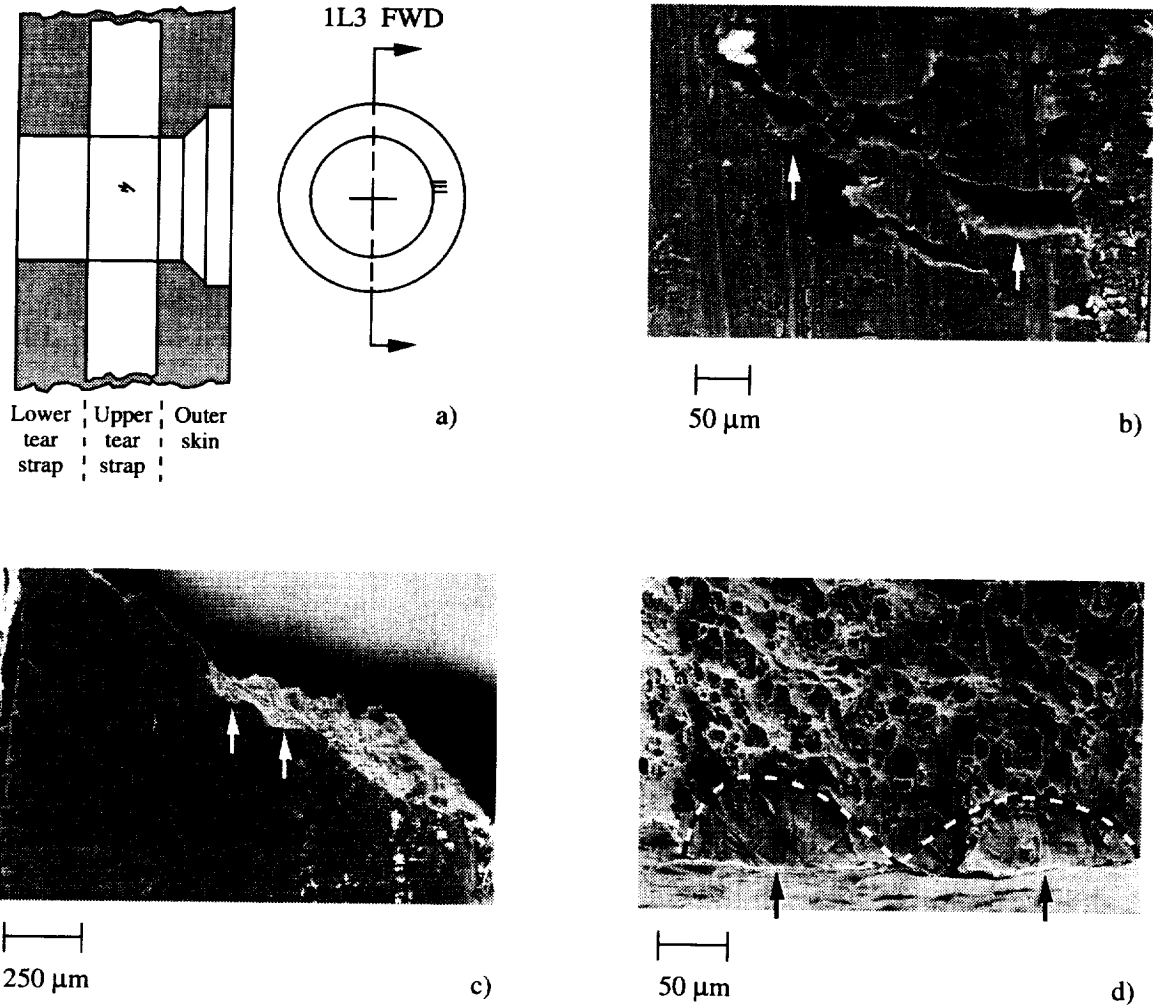
Figure 6.14 a) The schematic shows the rivet hole 1L3 configuration and the location of the upper tear strap fatigue crack oriented in the forward direction at about the 3 o'clock position. b) The SEM micrograph shows the surface fatigue cracks that have been partially opened during the destructive examination. Note the vertical marking on the inside surface of the hole. These markings suggest possible disturbed surface metal in the region of crack initiation marked by the arrows. c) The SEM micrograph shows the fatigue crack location within the rivet hole after the specimen was fractured. Arrows mark approximate regions of fatigue crack initiation. d) The SEM micrograph shows the fatigue fracture surface. The dashed line marks the fatigue crack front. Arrows mark approximate regions of fatigue crack initiation.

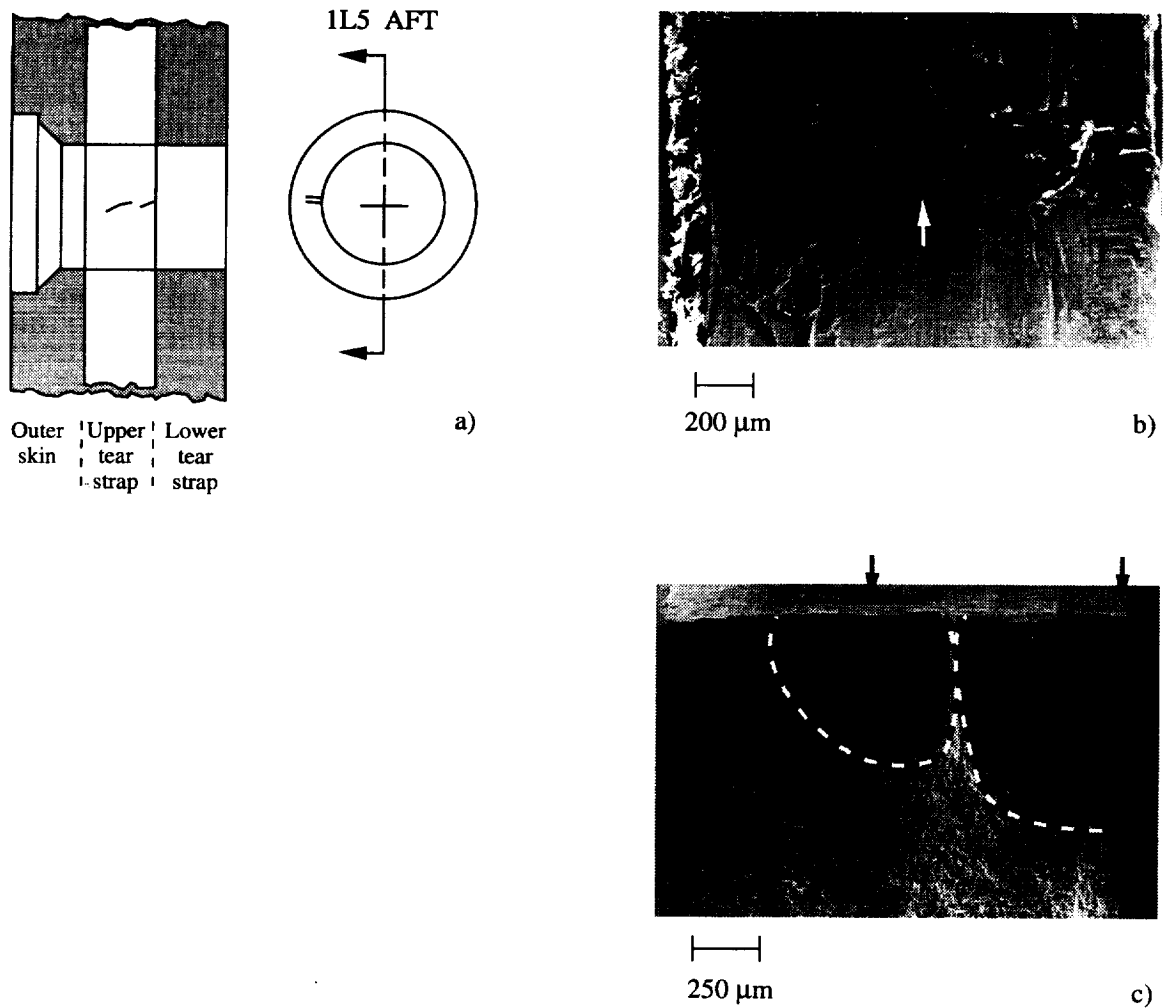
Figure 6.16 a) The schematic shows the rivet hole 1L5 configuration and the location of the upper tear strap fatigue cracks oriented in the aft direction and about the 9 o'clock position. b) The SEM micrograph shows the multiple surface and corner fatigue cracks that have been partially opened during the destructive examination. Arrows mark approximate sites of crack initiation. c) The SEM micrograph shows the fatigue fracture surface of the corner and surface crack. The dashed line marks the fatigue crack front. Note that crack-to-crack interaction has altered the shape of each crack front (marked by dashed lines). Arrows mark the approximate location of crack initiation.

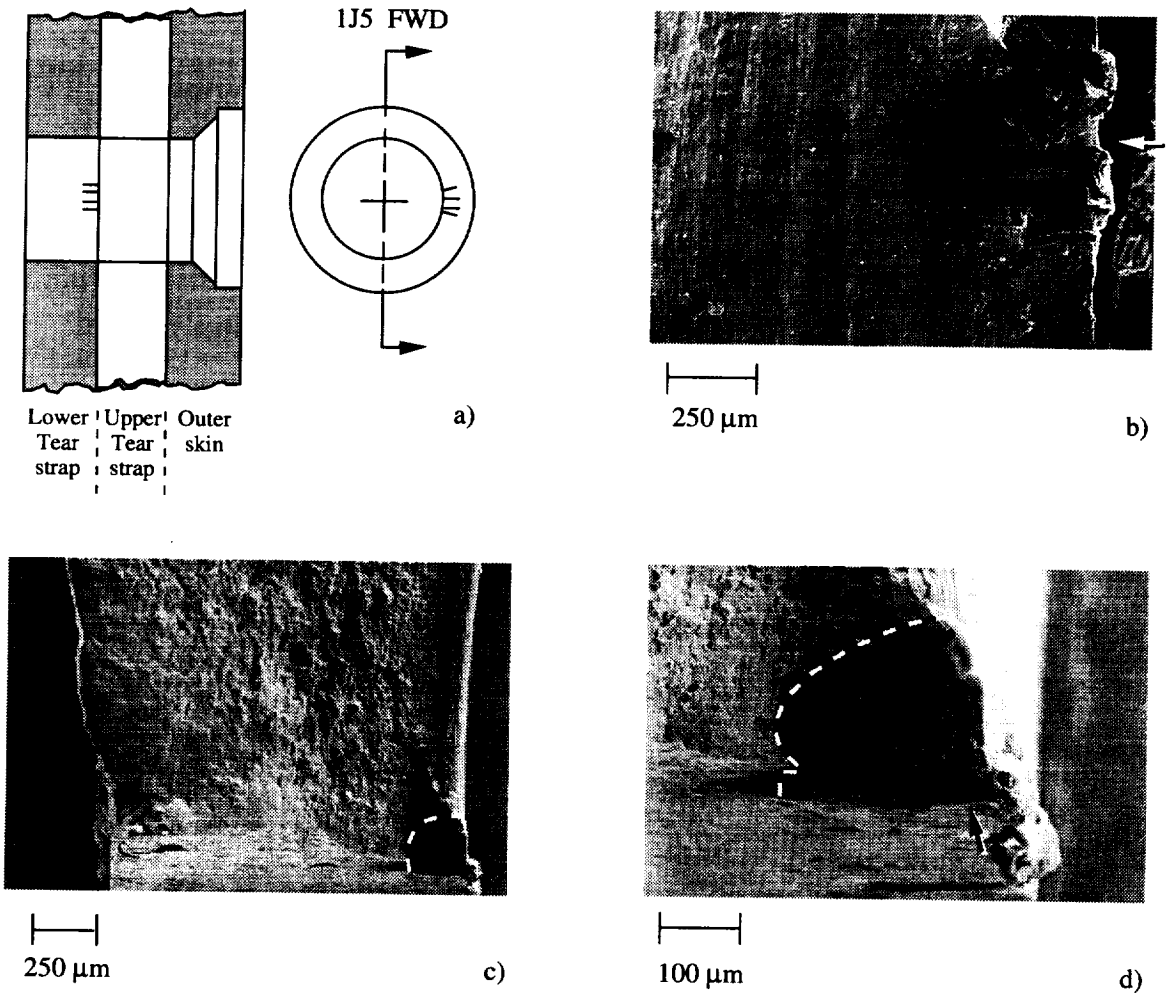
Figure 6.22 a) The schematic shows the rivet hole 1J5 configuration and the location of the multiple lower tear strap corner fatigue cracks oriented in the forward direction and about the 3 o'clock position. b) The SEM micrograph of the rivet hole surface shows the region that contains multiple corner cracks. Note the corner burrs near the likely point of crack initiation. The arrow marks the position of the fracture shown in Figures 6.22.c and 6.22.d. c) The SEM micrograph shows the fracture surface of the corner crack marked by the arrow in Figure 6.22.b. The dashed line marks the fatigue crack front. d) The SEM micrograph shows the fracture surface of the corner crack in Figure 6.22.c at higher magnification. The dashed line marks the fatigue crack front and the arrow marks the likely site of fatigue crack initiation.

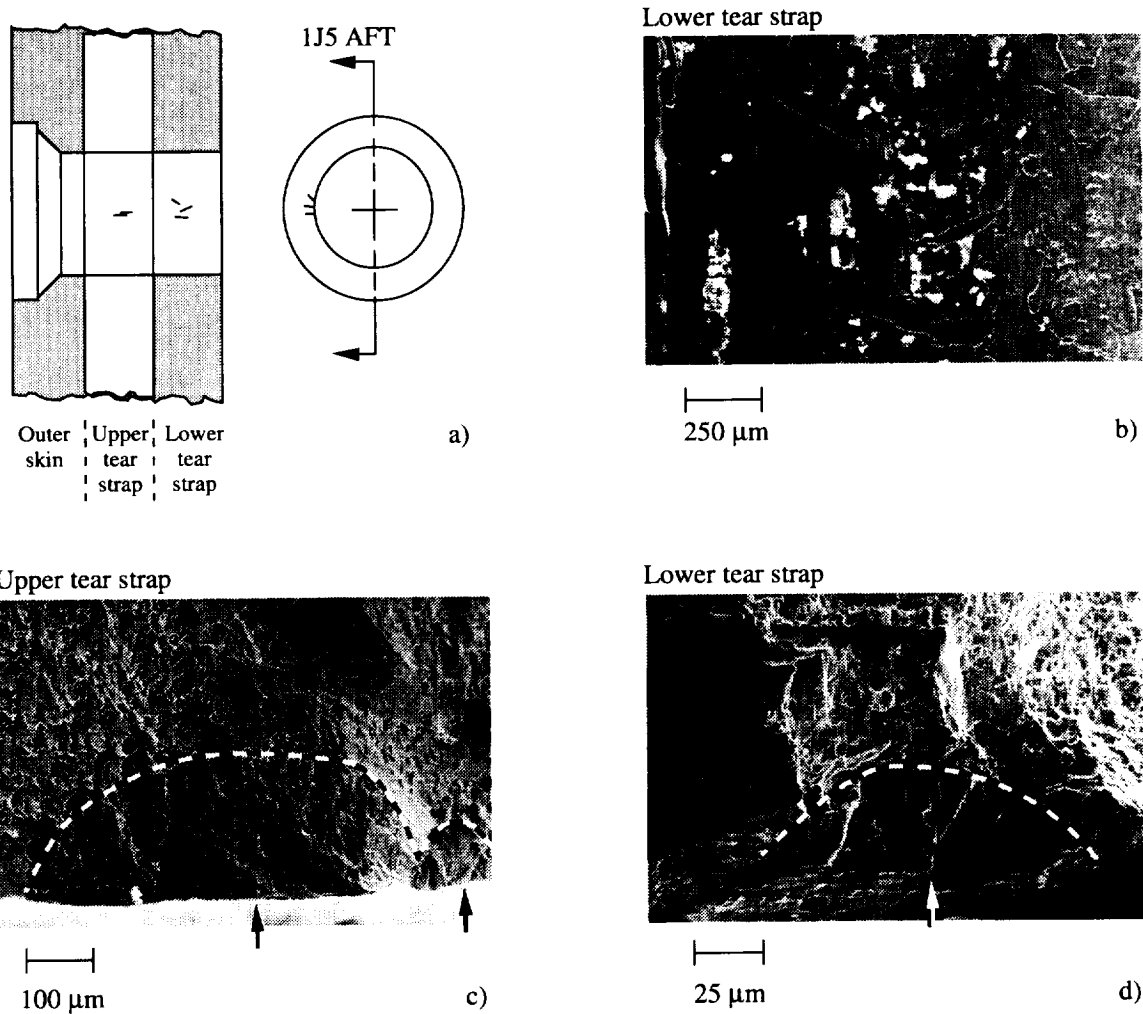
Figure 6.23 a) The schematic shows the rivet hole 1J5 configuration and the location of upper and lower tear strap fatigue cracks oriented in the aft direction and about the 9 o'clock position. b) The SEM micrograph shows the inside surface of the lower tear strap rivet hole and multiple fatigue surface cracks partially opened as a result of the destructive examination straining operation. c) The SEM micrograph shows the fatigue fracture surface of the upper tear strap rivet hole surface cracks. The dashed line marks the fatigue crack front and arrows mark the likely sites of fatigue crack initiation. The irregular shape of the crack front is a due to multiple crack coalescence. d) The SEM micrograph shows the fatigue fracture surface of the lower tear strap rivet hole surface crack (upper most crack in Figure 6.23.b). An arrow marks the site of crack initiation.

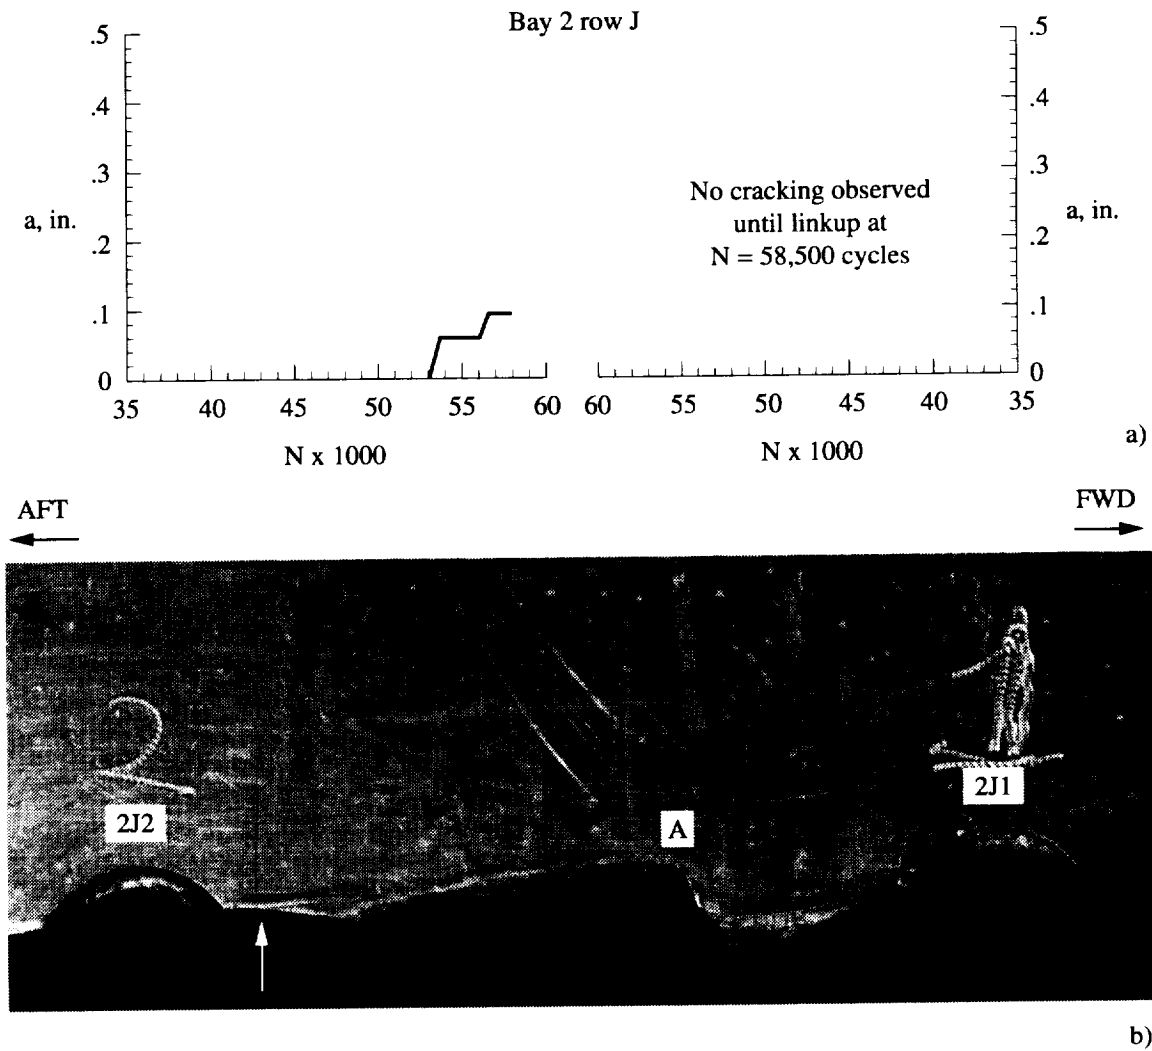
Figure 7.8 a) The figure is a plot of outer skin crack length (a) measured from the rivet outside diameter versus pressurization cycles (N). *In situ* visual crack length measurements were taken during pressure testing. Fatigue crack growth plots are shown for crack segments 2J1 aft and 2J2 forward. No visual cracks were observed from rivet hole 2J1 until after crack link-up ($N=60,000$ cycles). b) The photograph shows the upper portion of the outer skin crack surface between rivet holes 2J1 and 2J2. An arrow marks the approximate final position of the fatigue crack noted (visually) prior to crack link-up. Region A is the likely position where both cracks linked. Most of the crack surface shown in Figure 7.8.b exhibits a roughened appearance. This slant fracture region is characteristic of ductile tearing produced by relatively high crack tip stress intensity. The slant fracture region contain scratches normal to the direction of crack propagation indicative of fracture surface contact resulting from mode III displacement.

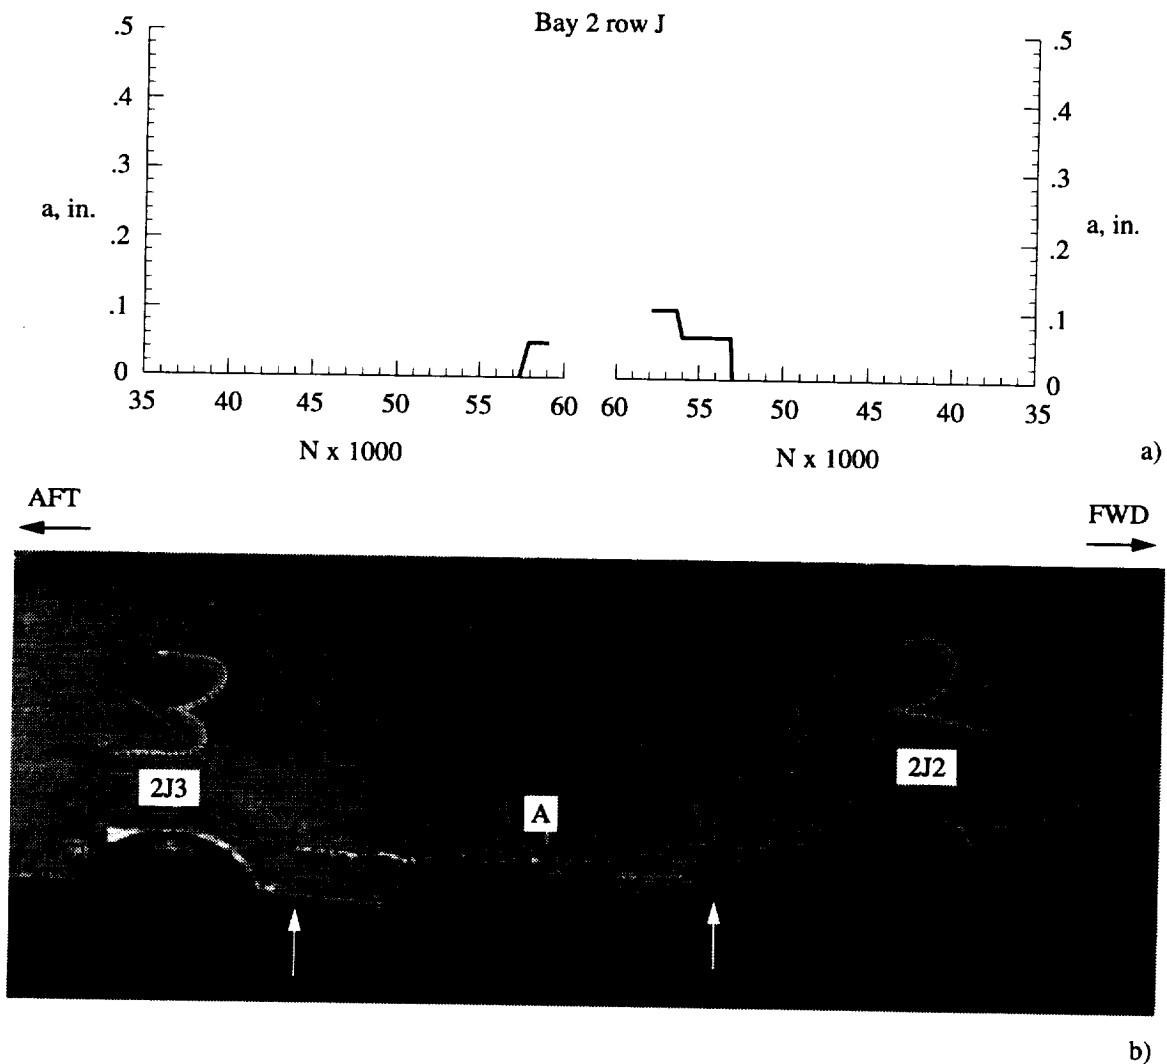
Figure 7.9 a) The figure is a plot of outer skin crack length (a) measured from the rivet outside diameter versus pressurization cycles (N). *In situ* visual crack length measurements were taken during pressure testing. Fatigue crack growth plots are shown for crack segments 2J2 aft and 2J3 forward. b) The photograph shows the upper portion of the outer skin crack surface between rivet holes 2J2 and 2J3. Arrows mark the approximate final position of the fatigue cracks noted (visually) prior to crack link-up. Region A is the likely position where both cracks linked. Most of the crack surface shown in Figure 7.9.b exhibits a roughened appearance. This slant fracture region is characteristic of ductile tearing produced by relatively high crack tip stress intensity. The slant fracture region contains scratches normal to the direction of crack propagation indicative of fracture surface contact resulting from mode III displacement.

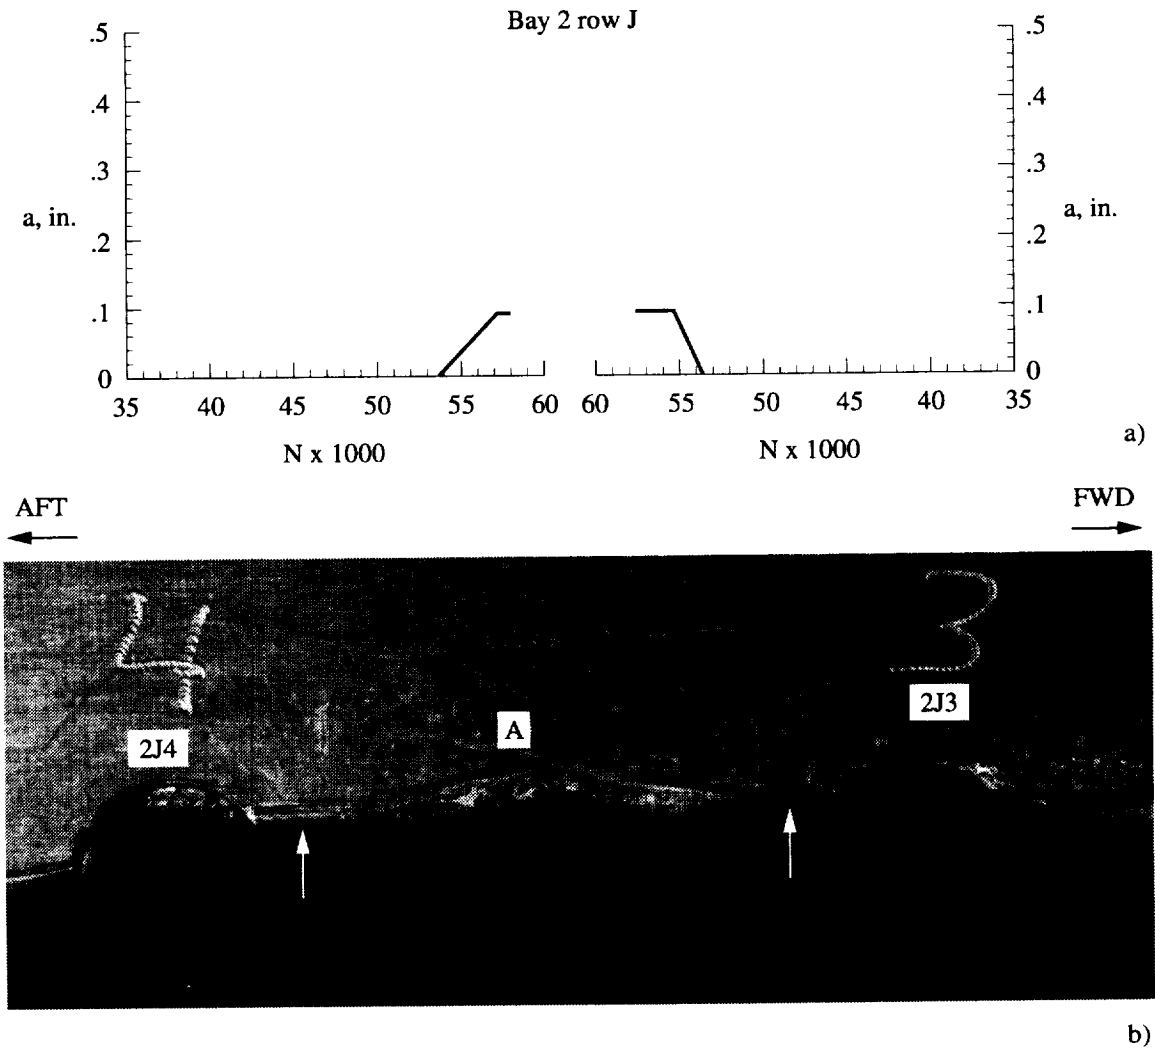
Figure 7.10 a) The figure is a plot of outer skin crack length (a) measured from the rivet outside diameter versus pressurization cycles (N). *In situ* visual crack length measurements were taken during pressure testing. Fatigue crack growth plots are shown for crack segments 2J3 aft and 2J4 forward. b) The photograph shows the upper portion of the outer skin crack surface between rivet holes 2J3 and 2J4. Arrows mark the approximate final position of the fatigue cracks noted (visually) prior to crack link-up. Region A is the likely position where both cracks linked. Most of the crack surface shown in Figure 7.10.b exhibits a roughened appearance. This slant fracture region is characteristic of ductile tearing produced by relatively high crack tip stress intensity. The slant fracture region contains scratches normal to the direction of crack propagation indicative of fracture surface contact resulting from mode III displacement.

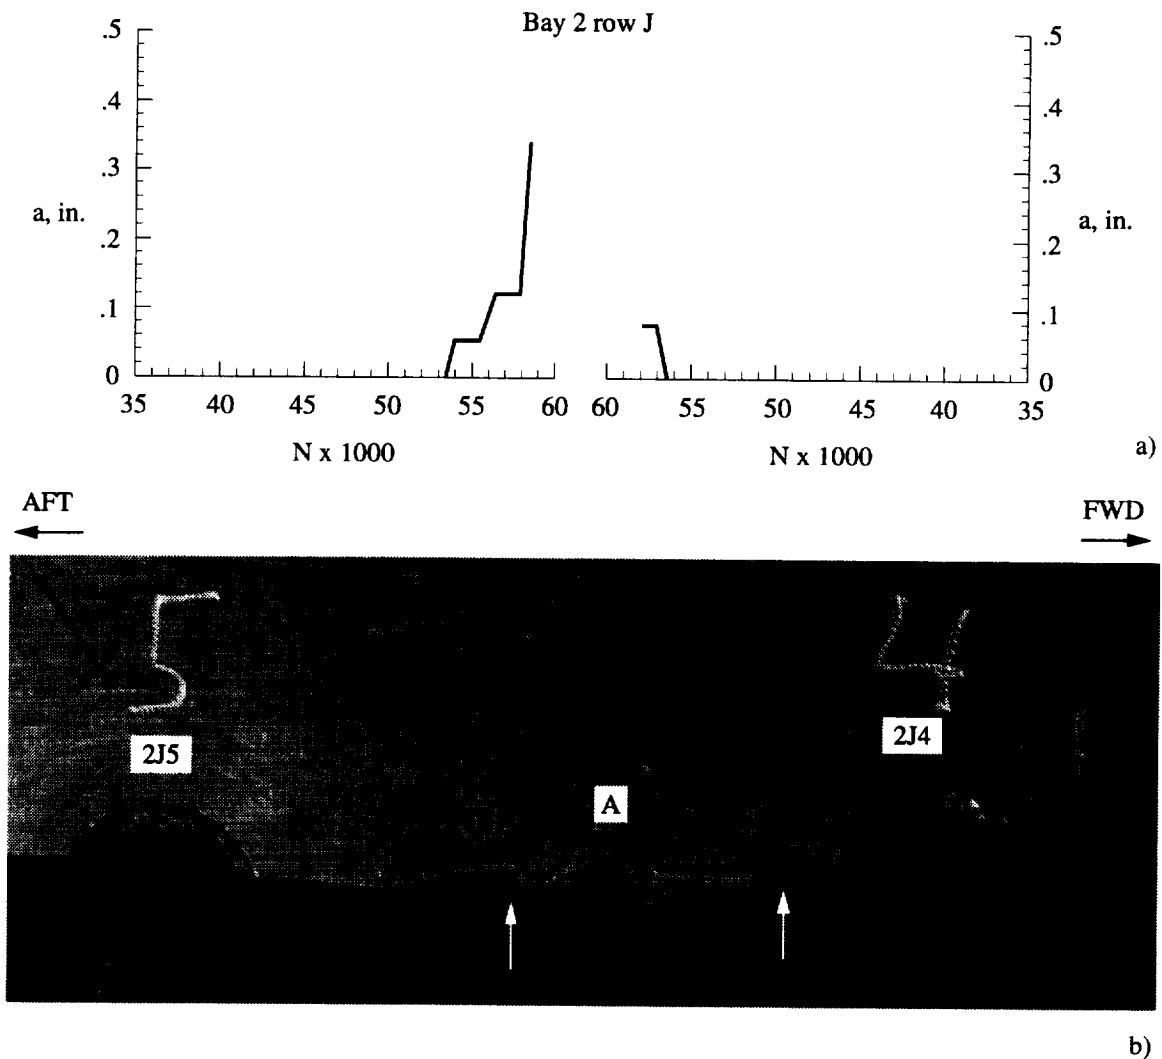
Figure 7.11 a) The figure is a plot of outer skin crack length (a) measured from the rivet outside diameter versus pressurization cycles (N). *In situ* visual crack length measurements were taken during pressure testing. Fatigue crack growth plots are shown for crack segments 2J4 aft and 2J5 forward. The plot for hole 5 shows that very rapid crack growth occurred just prior to crack link-up. b) The photograph shows the upper portion of the outer skin crack surface between rivet holes 2J4 and 2J5. Arrows mark the approximate final position of the fatigue cracks noted (visually) prior to crack link-up. Region A is the likely position where both cracks linked. Most of the crack surface shown in Figure 7.11.b exhibits a roughened appearance. This slant fracture region is characteristic of ductile tearing produced by relatively high crack tip stress intensity. The slant fracture region contains scratches normal to the direction of crack propagation indicative of fracture surface contact resulting from mode III displacement.

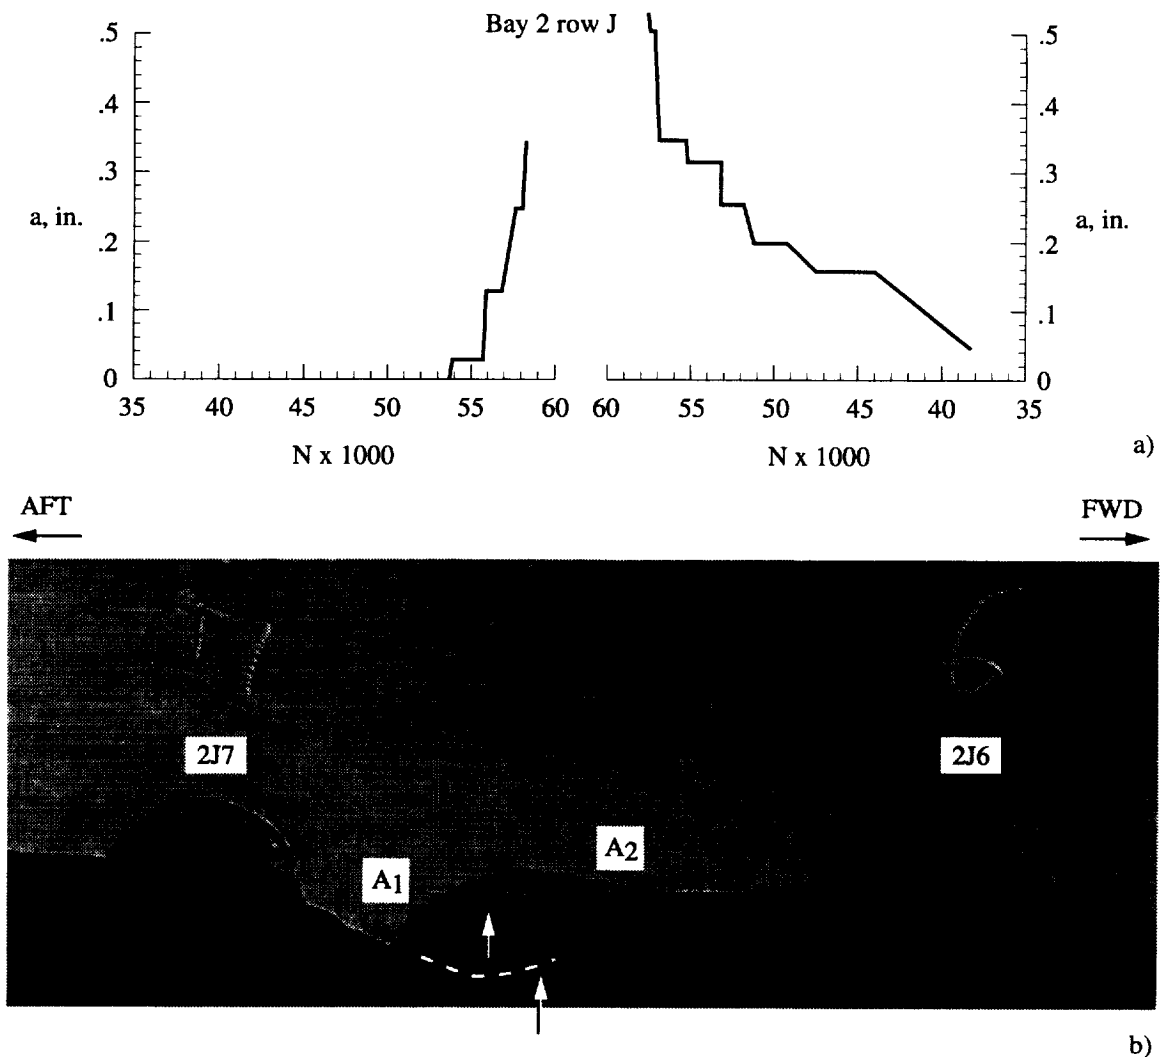
Figure 7.13 a) The figure is a plot of outer skin crack length (a) measured from the rivet outside diameter versus pressurization cycles (N). *In situ* visual crack length measurements were taken during pressure testing. Fatigue crack growth plots are shown for crack segments 2J6 aft and 2J7 forward. The plots for hole 2J6 and 2J7 show that very rapid crack growth occurred just prior to crack link-up. b) The photograph shows the upper portion of the outer skin crack surface between rivet holes 2J6 and 2J7. This region is shown in Figure 7.7.b prior to the destructive examination. Arrows mark the approximate final position of the fatigue cracks noted (visually) prior to crack link-up. Dashed lines represent the approximate path of the crack that propagated from hole 7. Regions A1 or A2 are the likely positions for crack link-up. Most of the crack surface shown in Figure 7.13.b exhibits a roughened appearance. This slant fracture region is characteristic of ductile tearing produced by relatively high crack tip stress intensity. The slant fracture region contains no scratches normal to the direction of crack propagation observed in other rivet hole regions. This suggests that this region was captured by the rivets and link-up occurred before large mode III displacement resulted from pillowing.

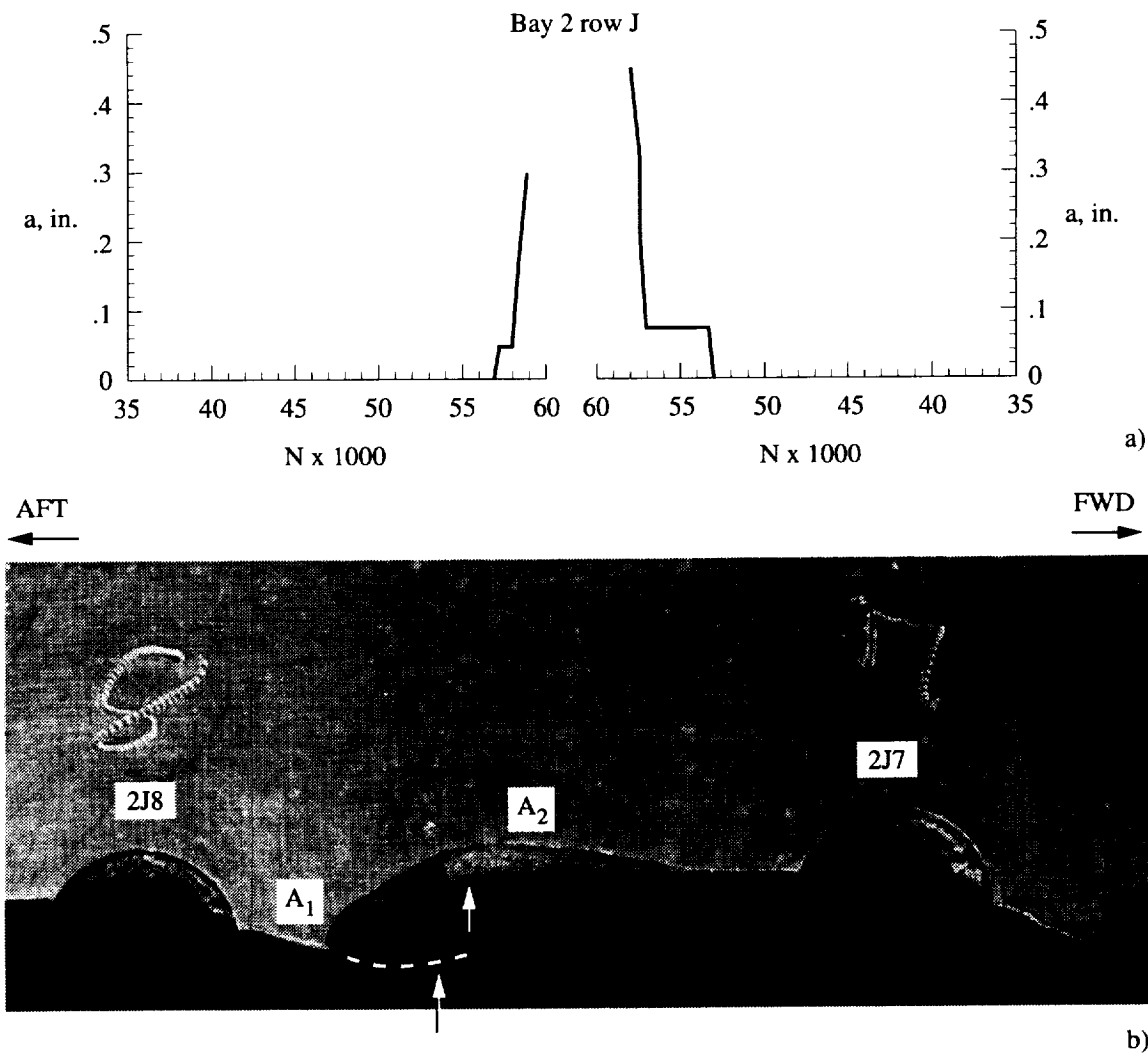
Figure 7.14 a) The figure is a plot of outer skin crack length (a) measured from the rivet outside diameter versus pressurization cycles (N). *In situ* visual crack length measurements were taken during pressure testing. Fatigue crack growth plots are shown for crack segments 2J7 aft and 2J8 forward. The plots for hole 2J7 and 2J8 show that very rapid crack growth occurred just prior to crack link-up. b) The photograph shows the upper portion of the outer skin crack surface between rivet holes 2J7 and 2J8. Arrows mark the approximate final position of the fatigue cracks noted (visually) prior to crack link-up. A dashed line represents the approximate path of the crack that propagated from hole 2J8. Regions A1 or A2 are the likely positions for crack link-up. Most of the crack surface shown in Figure 7.14.b exhibits a roughened appearance. This slant fracture region is characteristic of ductile tearing produced by relatively high crack tip stress intensity. The slant fracture region contains no scratches normal to the direction of crack propagation observed in other rivet hole regions. This suggests that this region was captured by the rivets and link-up occurred before large mode III displacement resulted from pillowing.
