NASA/TP-97-206257

The Characteristics of Fatigue Damage in the Fuselage Riveted Lap Splice Joint

Robert S. Piascik
Langley Research Center, Hampton, Virginia

November 1997

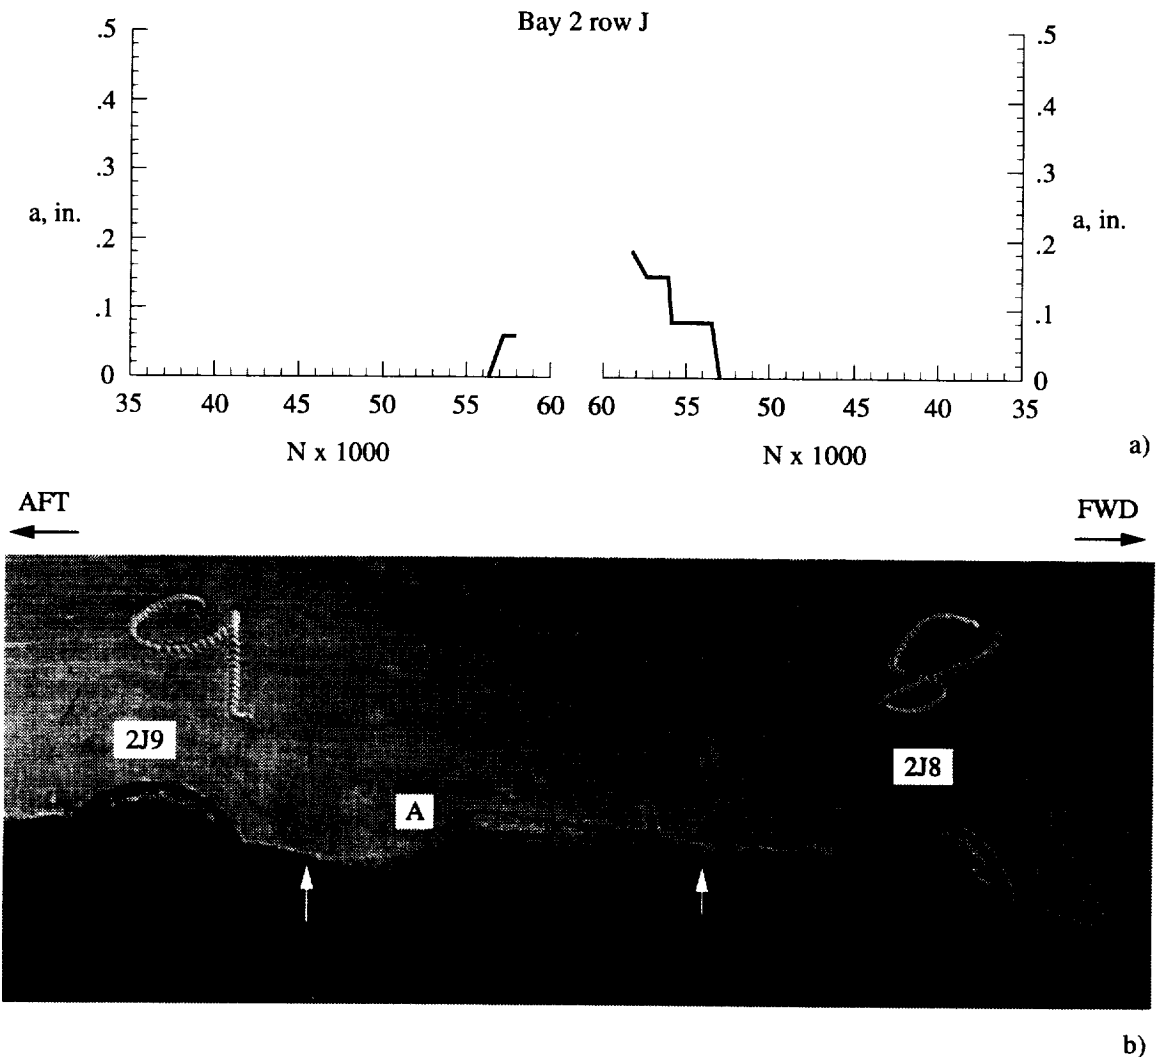
Figure 7.15 a) The figure is a plot of outer skin crack length (a) measured from the rivet outside diameter versus pressurization cycles (N). *In situ* visual crack length measurements were taken during pressure testing. Fatigue crack growth plots are shown for crack segments 2J8 aft and 2J9 forward. b) The photograph shows the upper portion of the outer skin crack surface between rivet holes 2J8 and 2J9. Arrows mark the approximate final position of the fatigue cracks (noted visually) prior to crack link-up. Region A is the location where both cracks had linked. Most of the crack surface shown in Figure 7.15.b exhibits a roughened appearance. This slant fracture region is characteristic of ductile tearing produced by relatively high crack tip stress intensity. The slant fracture region contains scratches normal to the direction of crack propagation indicative of fracture surface contact resulting from mode III displacement.

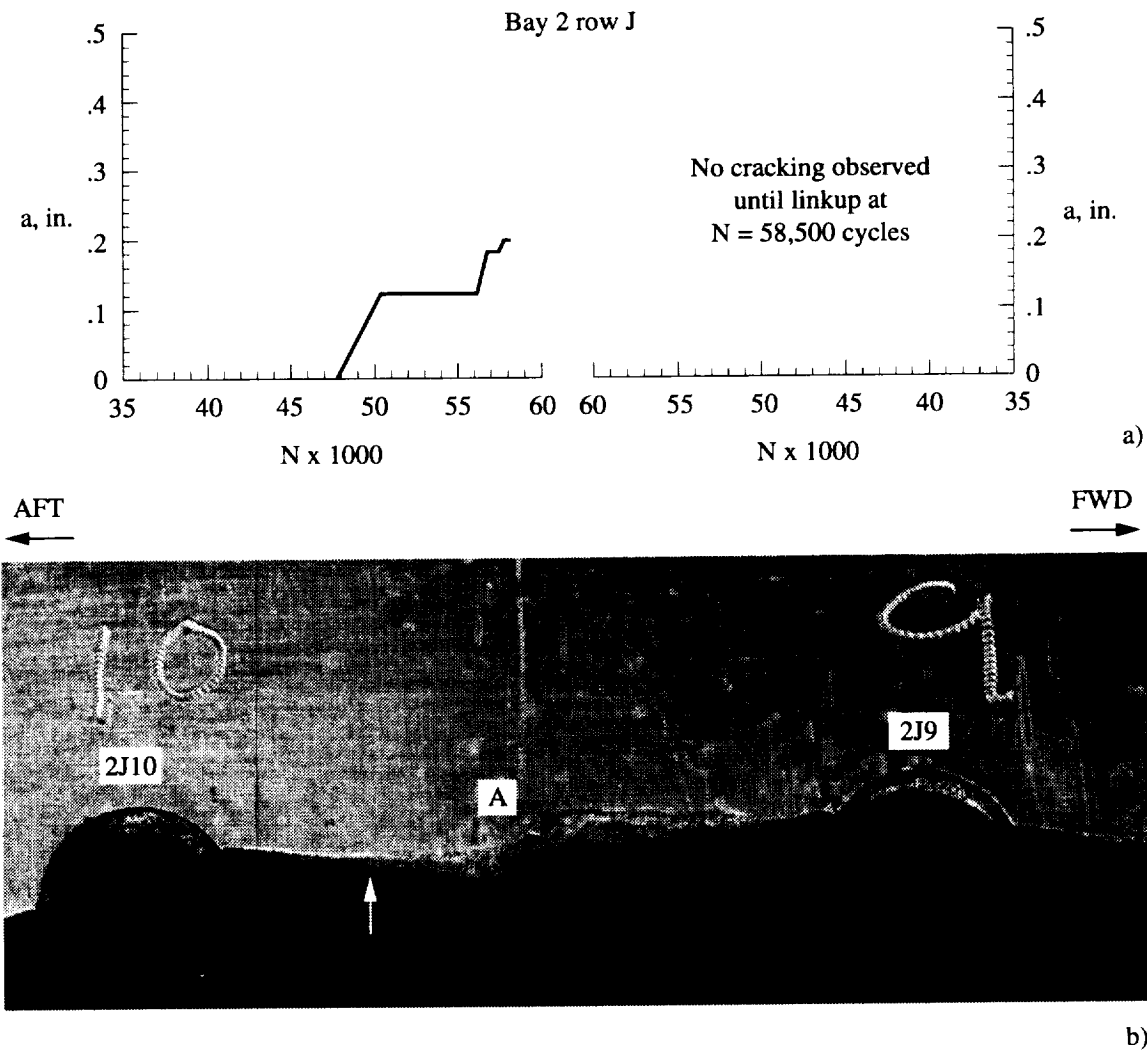
Figure 7.16 a) The figure is a plot of outer skin crack length (a) measured from the rivet outside diameter versus pressurization cycles (N). *In situ* visual crack length measurements were taken during pressure testing. Fatigue crack growth plots are shown for crack segments 2J9 aft and 2J10 forward. No visible cracks were observed from rivet hole 2J9 until after crack link-up. b) The photograph shows the upper portion of the outer skin crack surface between rivet holes 2J9 and 2J10. The arrow marks the approximate final position of the fatigue crack (noted visually) prior to crack link-up. Region A is the location where both cracks had linked. Most of the crack surface shown in Figure 7.16.b exhibits a roughened appearance. This slant fracture region is characteristic of ductile tearing produced by relatively high crack tip stress intensity. The slant fracture region contains scratches normal to the direction of crack propagation indicative of fracture surface contact resulting from mode III displacement.

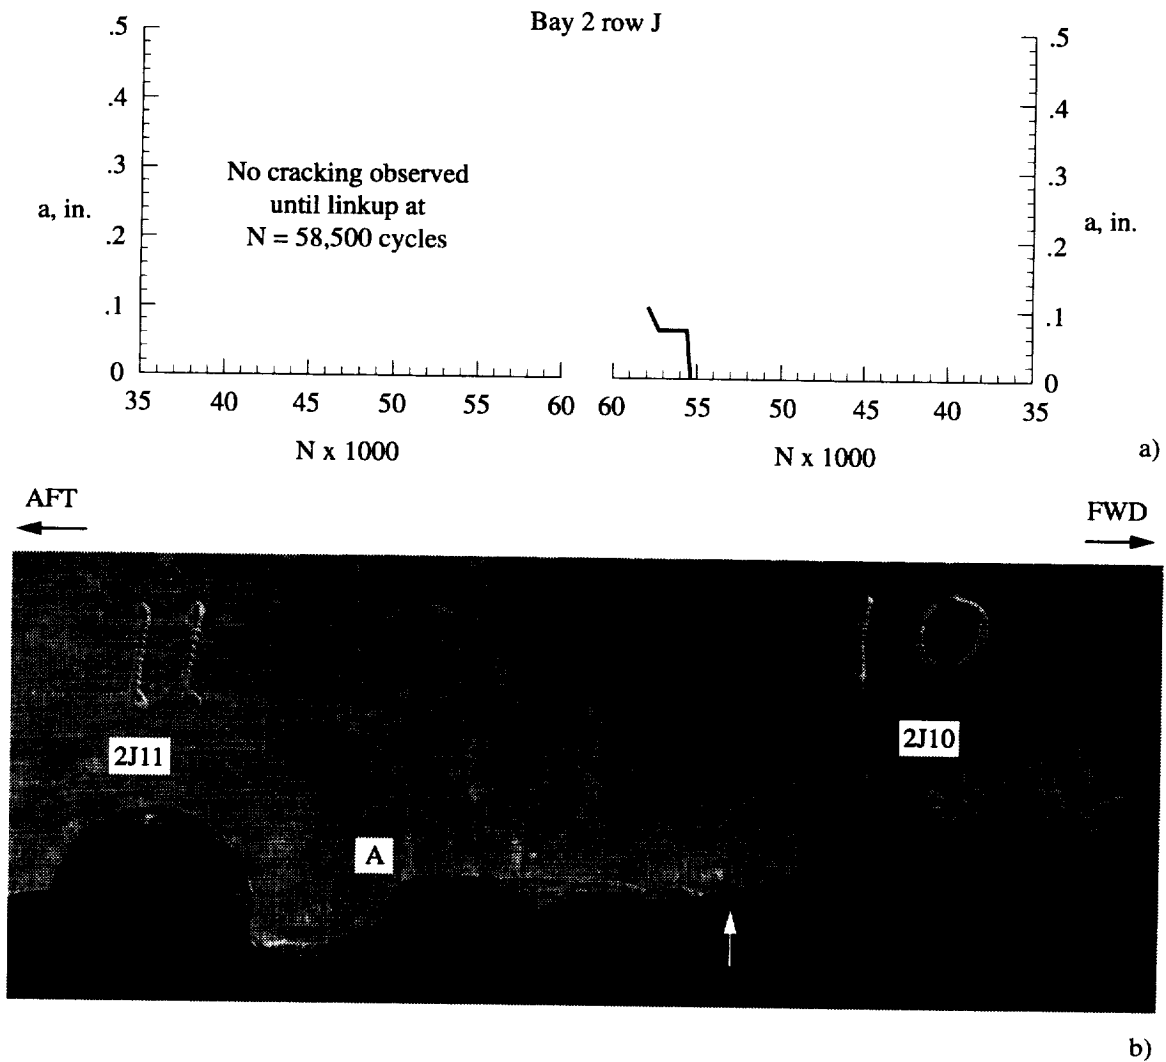
Figure 7.17 a) The figure is a plot of outer skin crack length (a) measured from the rivet outside diameter versus pressurization cycles (N). *In situ* visual crack length measurements were taken during pressure testing. Fatigue crack growth plots are shown for crack segments 2J10 aft and 2J11 forward. No visible cracks were observed from rivet hole 2J11 until after crack link-up. b) The photograph shows the upper portion of the outer skin crack surface between rivet holes 2J10 and 2J11. An arrow marks the approximate final position of the fatigue crack (noted visually) prior to crack link-up. Region A is the location where both cracks had linked. Most of the crack surface shown in Figure 7.17.b exhibits a roughened appearance. This slant fracture region is characteristic of ductile tearing produced by relatively high crack tip stress intensity. The slant fracture region contains scratches normal to the direction of crack propagation indicative of fracture surface contact resulting from mode III displacement.

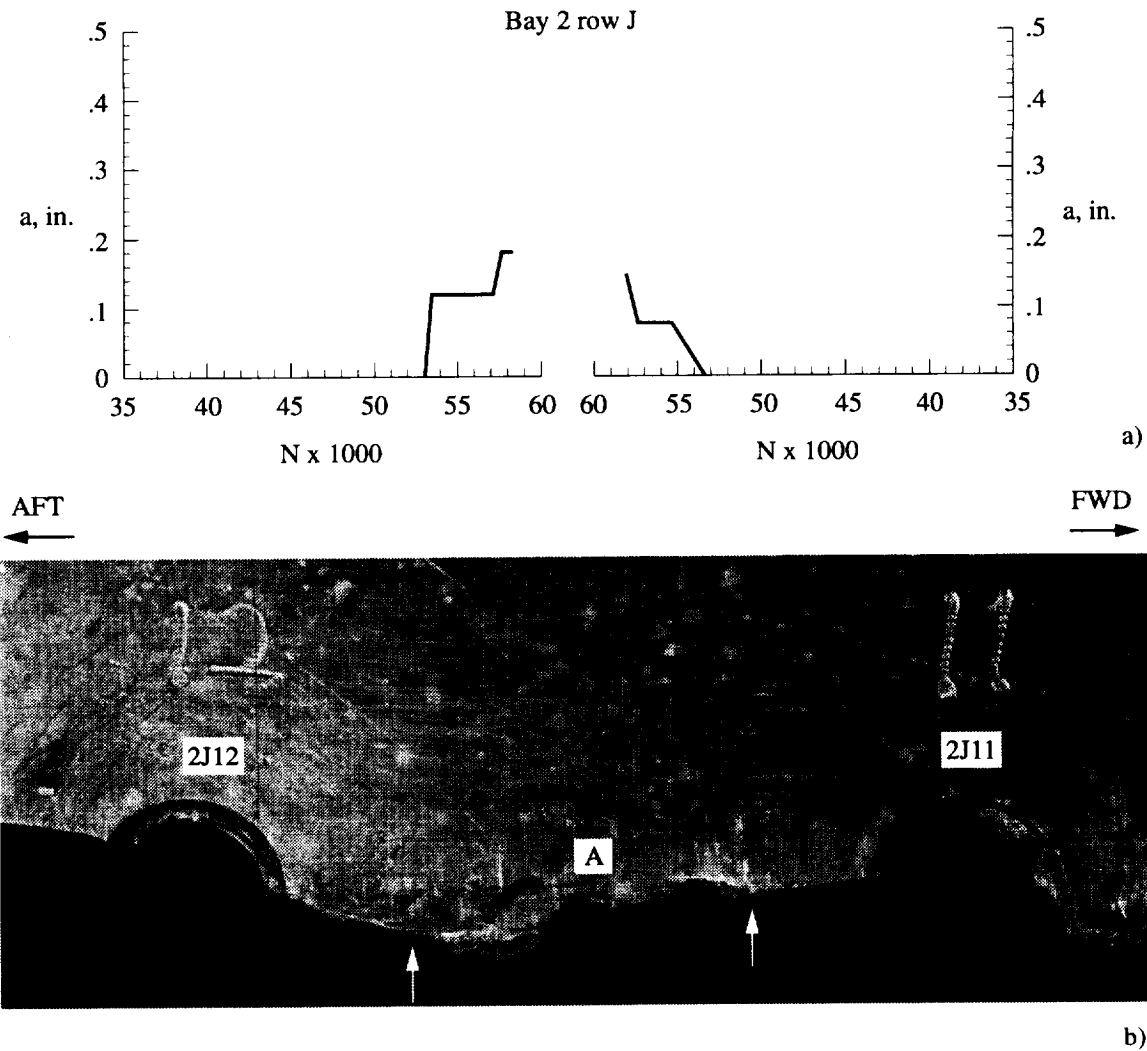
Figure 7.18 a) The figure is a plot of outer skin crack length (a) measured from the rivet outside diameter versus pressurization cycles (N). *In situ* visual crack length measurements were taken during pressure testing. Fatigue crack growth plots are shown for crack segments 2J11 aft and 2J12 forward. b) The photograph shows the upper portion of the outer skin crack surface between rivet holes 2J11 and 2J12. Arrows mark the approximate final position of the fatigue cracks (noted visually) prior to crack link-up. Region A is the location where both cracks had linked. Most of the crack surface shown in Figure 7.18.b exhibits a roughened appearance. This slant fracture region is characteristic of ductile tearing produced by relatively high crack tip stress intensity. The slant fracture region contains scratches normal to the direction of crack propagation indicative of fracture surface contact resulting from mode III displacement.

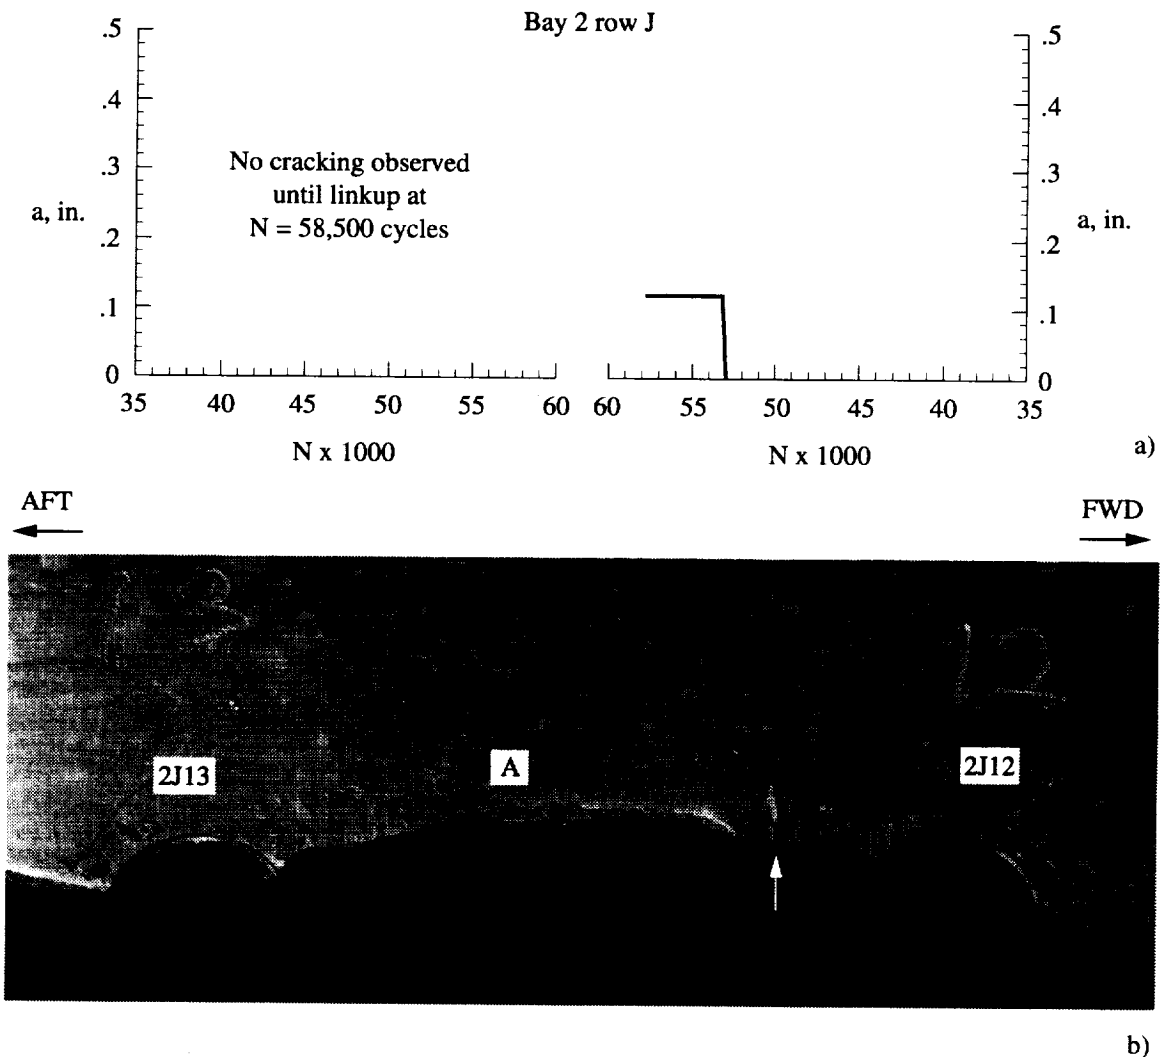
Figure 7.19 a) The figure is a plot of outer skin crack length (a) measured from the rivet outside diameter versus pressurization cycles (N). *In situ* visual crack length measurements were taken during pressure testing. Fatigue crack growth plots are shown for crack segments 2J12 aft and 2J13 forward. No visible cracks were observed from rivet hole 2J13 until after crack link-up. b) The photograph shows the upper portion of the outer skin crack surface between rivet holes 2J12 and 2J13. The arrow marks the approximate final position of the fatigue crack (noted visually) prior to crack link-up. Region A is the likely location for crack link-up. Most of the crack surface shown in Figure 7.19.b exhibits a roughened appearance. This slant fracture region is characteristic of ductile tearing produced by relatively high crack tip stress intensity. The slant fracture region contains scratches normal to the direction of crack propagation indicative of fracture surface contact resulting from mode III displacement.

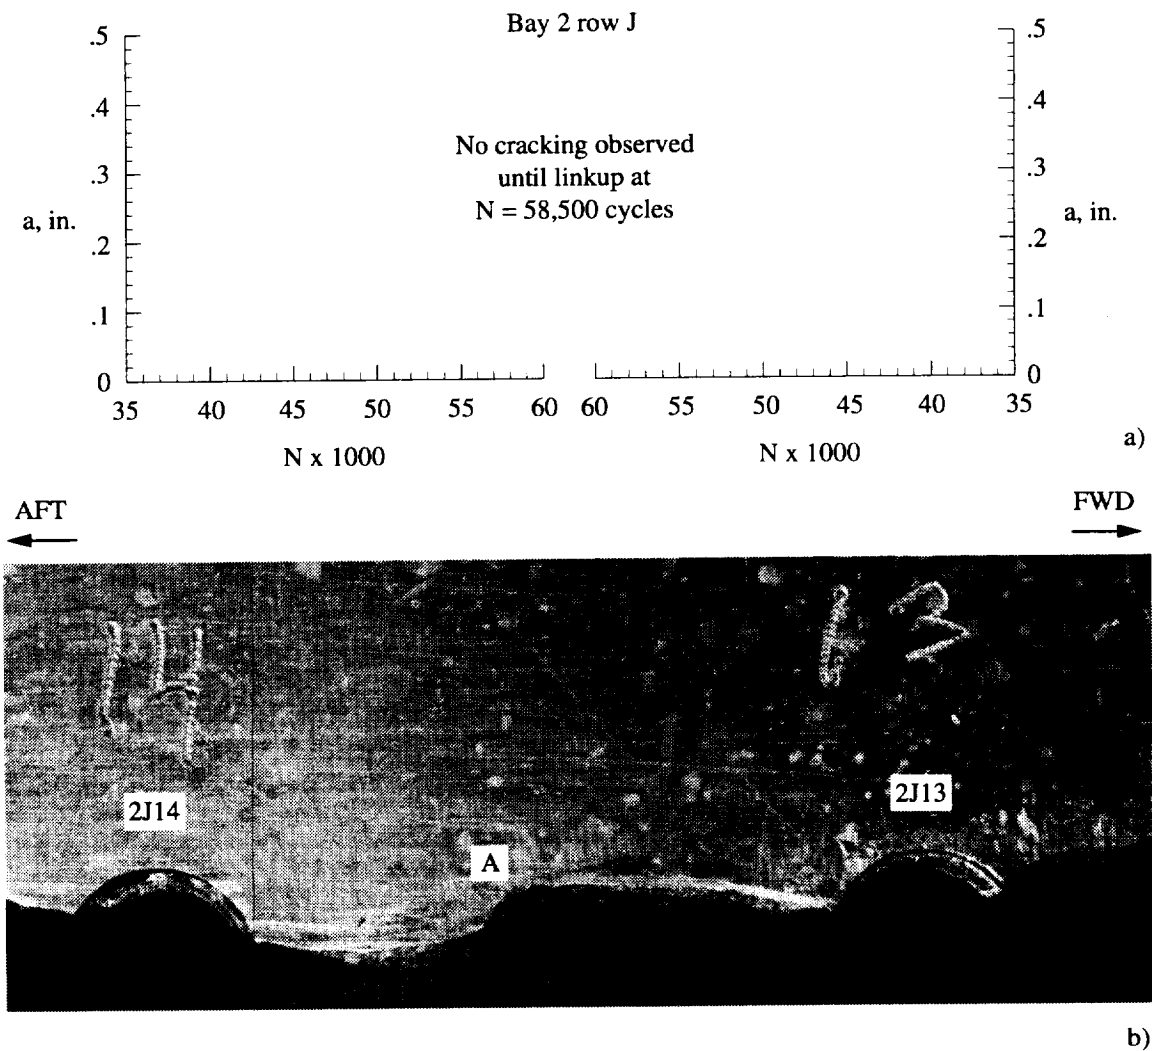
Figure 7.20 a) No visible cracks were observed between rivet holes 2J13 and 2J14 until after crack link-up. b) The photograph shows the upper portion of the crack surface between rivet holes 2J13 and 2J14. Region A is the likely location for crack link-up. Most of the crack surface shown in Figure 7.20.b exhibits a roughened appearance. This slant fracture region is characteristic of ductile tearing produced by relatively high crack tip stress intensity. The slant fracture region contains scratches normal to the direction of crack propagation indicative of fracture surface contact resulting from mode III displacement.

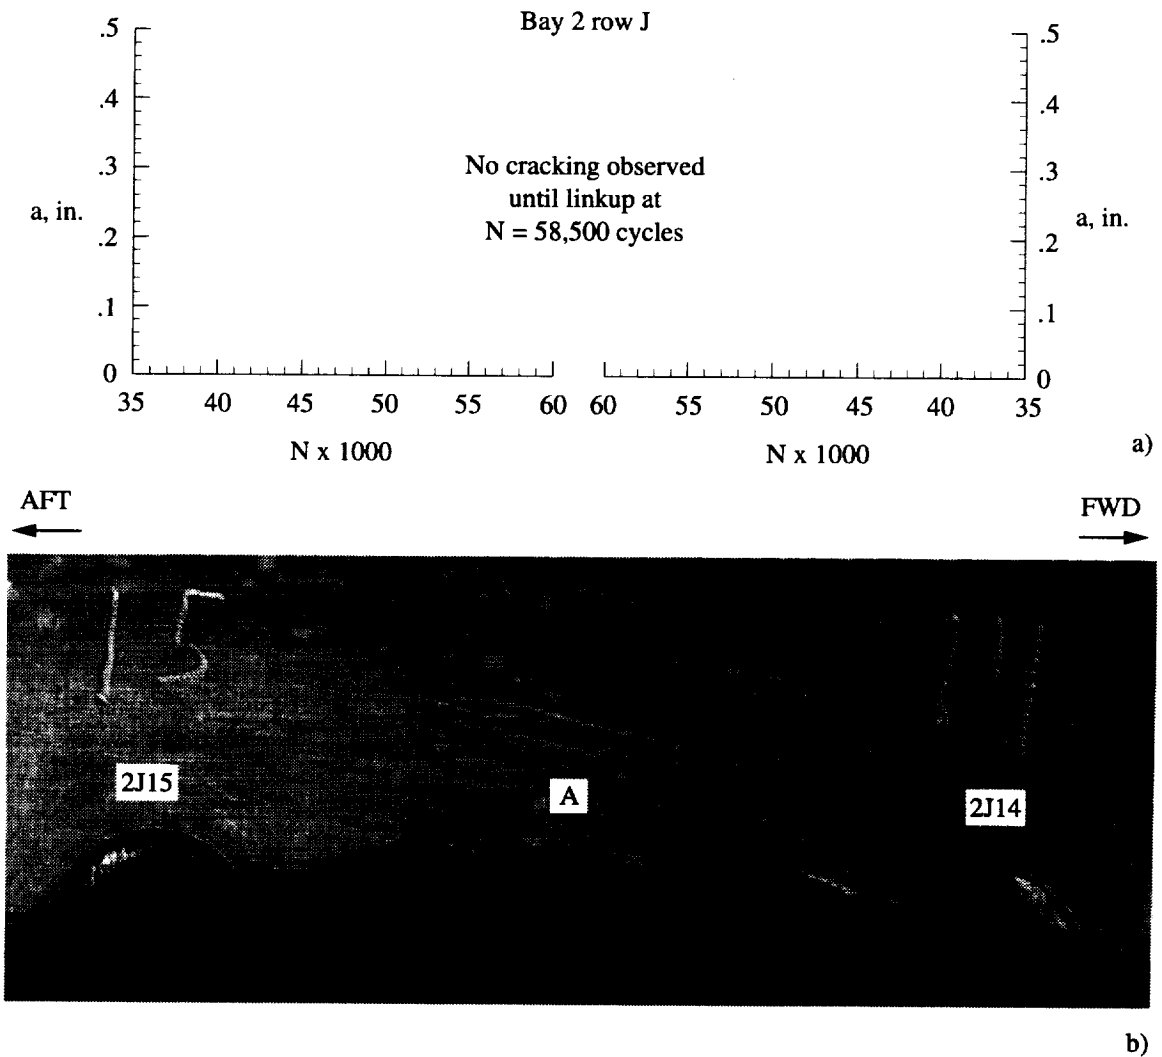
Figure 7.21 a) No visible cracks were observed between rivet holes 2J14 and 2J15 until after crack link-up. b) The photograph shows the upper portion of the crack surface between rivet holes 2J14 and 2J15. The region of crack link-up is less defined between holes 2J14 and 2J15, thus no crack link-up region is defined in Figure 7.21.b. Most of the crack surface shown in Figure 7.21.b exhibits a roughened appearance. This slant fracture region is characteristic of ductile tearing produced by relatively high crack tip stress intensity. The slant fracture region contains scratches normal to the direction of crack propagation indicative of fracture surface contact resulting from mode III displacement.

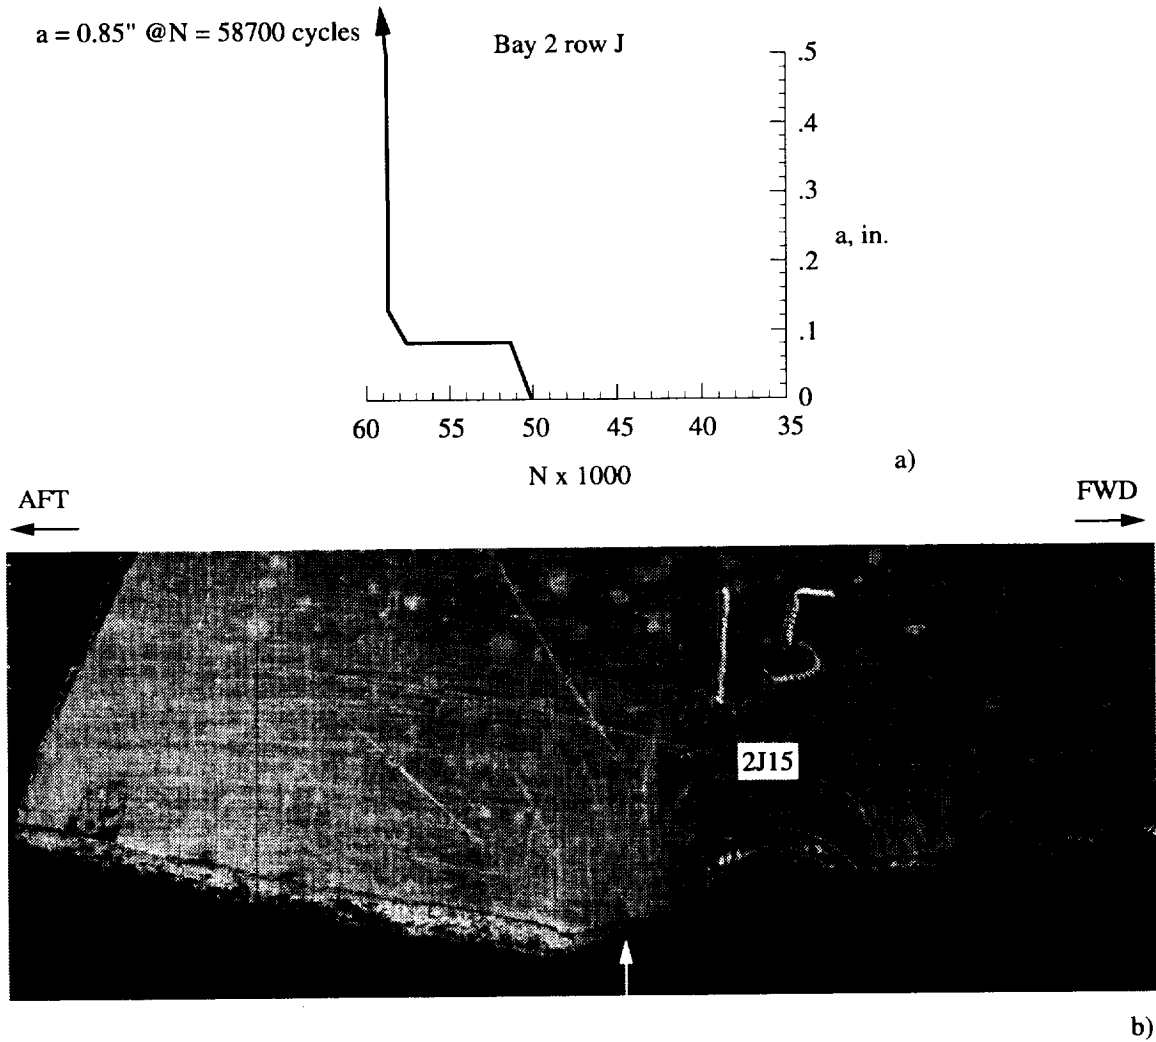
Figure 7.22 a) The figure is a plot of outer skin crack length (a) measured from the rivet outside diameter versus pressurization cycles (N). *In situ* visual crack length measurements were taken during pressure testing. The plot shown for crack segments 2J4 aft reveals that crack growth was very rapid prior to terminating in the tear strap region. b) The photograph shows the upper portion of the outer skin crack surface from hole 2J15. The arrow marks the approximate final position of the fatigue crack (noted visually) prior to crack link-up. Most of the crack surface shown in Figure 7.22.b exhibits a roughened appearance. This slant fracture region is characteristic of ductile tearing produced by relatively high crack tip stress intensity. The slant fracture region contains scratches normal to the direction of crack propagation indicative of fracture surface contact resulting from mode III displacement.

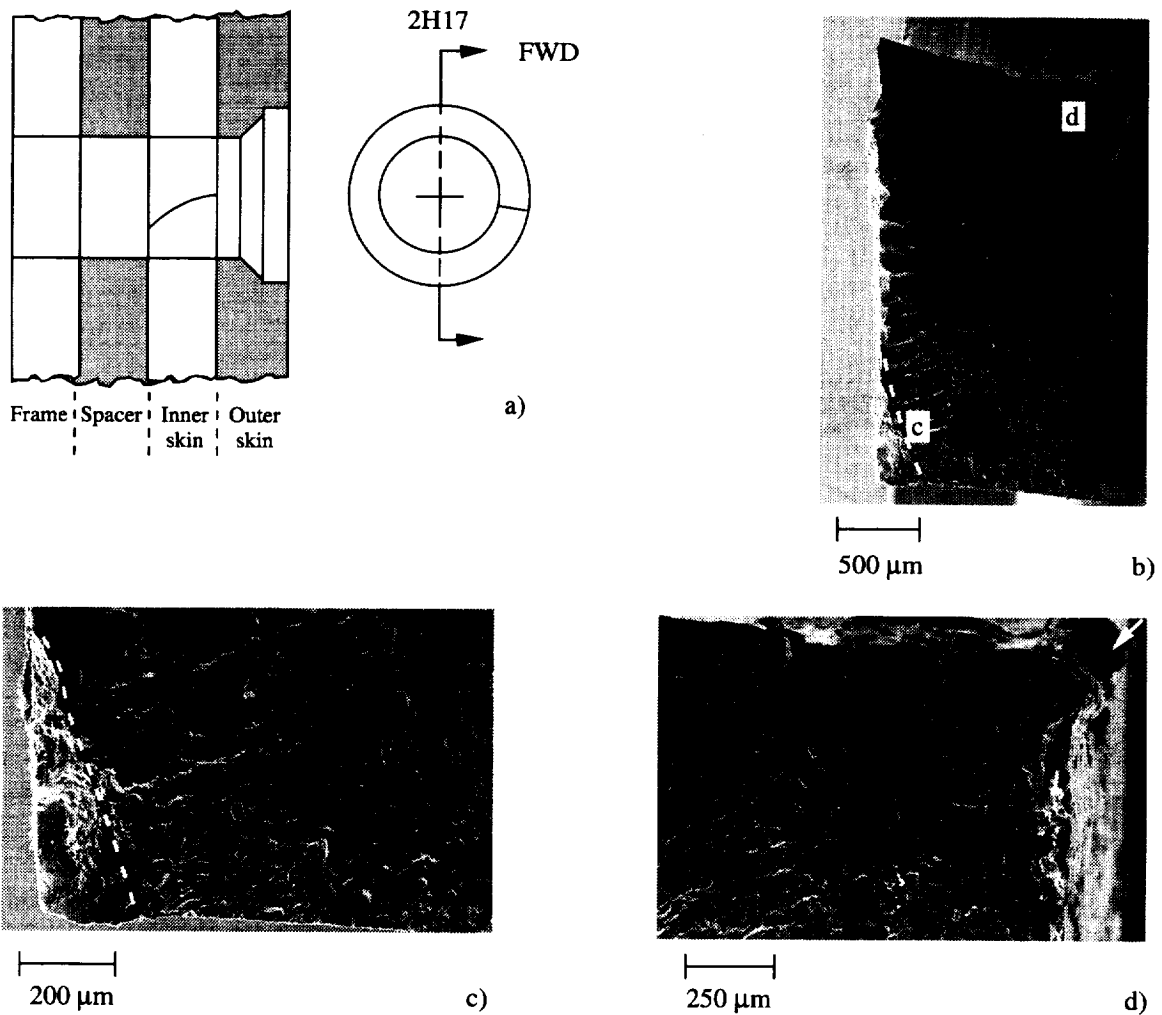
Figure 7.31 a) The schematic shows the rivet hole 2H17 configuration and the location of the inner skin fatigue crack oriented in the forward direction and about the 3 o'clock position. b) The SEM micrograph shows the fatigue crack fracture surface (the direction of crack propagation is from top to bottom of the figure) at the inner skin rivet hole which is located at the top of the micrograph. The fatigue crack was cut during the removal of the specimen from the panel and a portion of the fatigue crack surface is not shown in the figure. c) The SEM micrograph shows the fatigue crack surface at region "c" in Figure 7.31.b. The dashed line marks the remainder of the fatigue crack front. The crack front configuration suggests that the crack extends farther along the outboard surface of the inner skin compared to the inboard surface. d) The SEM micrograph shows the crack initiation region near the outboard corner of the rivet hole (region "d" in Figure 7.31.b). The region of crack initiation (arrow) along the outboard faying surface exhibits disturbed metal.

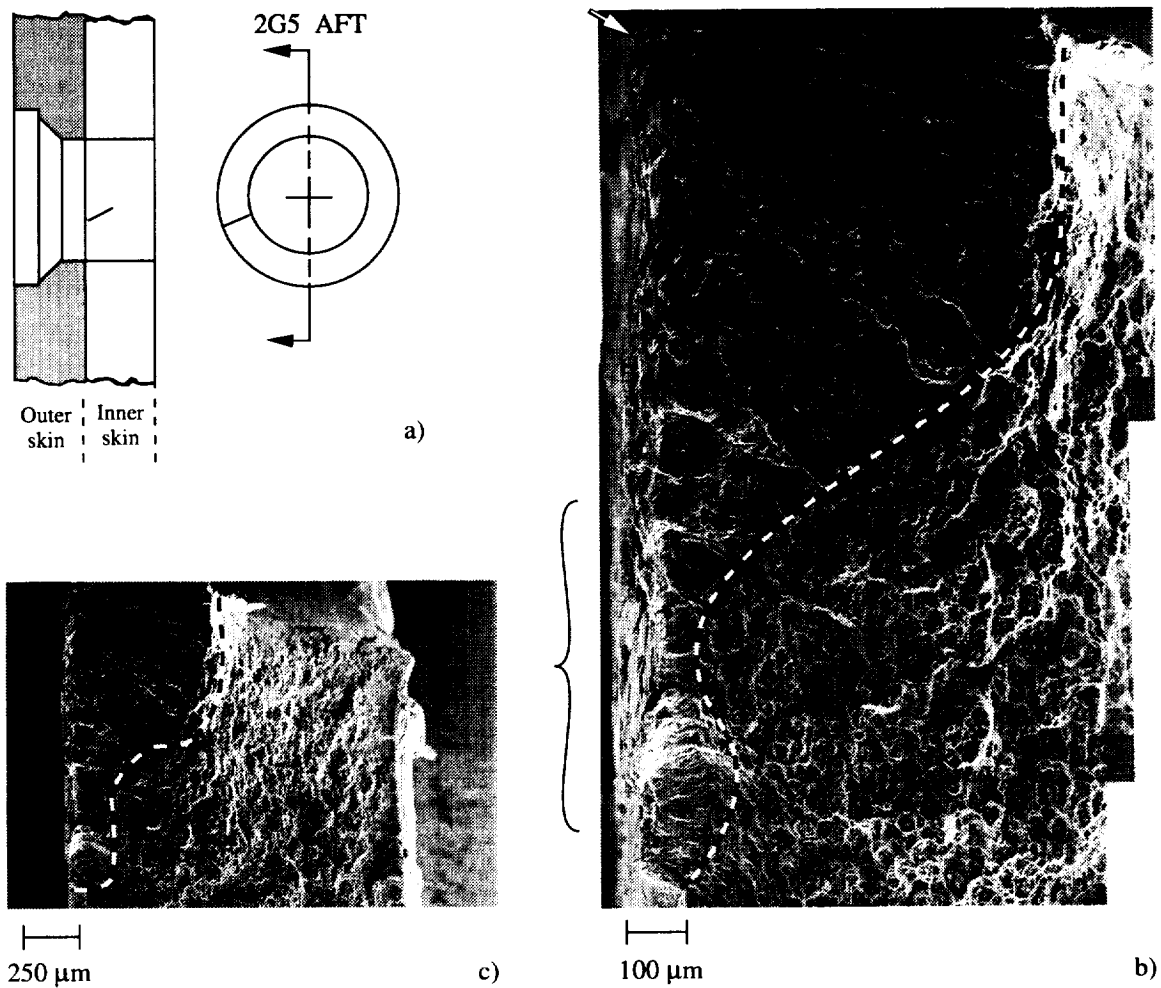
Figure 7.38 a) The schematic shows the rivet hole 2G5 configuration and the location of the inner skin fatigue crack oriented in the aft direction and slightly below the 9 o'clock position. b) The SEM micrograph shows the fatigue crack fracture surface that extends along the faying surface (left of micrograph). The rivet hole is located at the top of the micrograph. The dashed line marks the fatigue crack front. The crack front geometry suggests that a number of surface fatigue cracks initiated along the faying surface and have coalesced to form a nonsemicircular shaped fatigue crack front. Possible crack initiation sites are marked by an arrow at the corner and a bracket along the faying surface. c) The SEM micrograph shows the relationship of the fatigue crack surface with the rivet hole (top) and inboard skin surface. The dashed line marks the fatigue crack front.

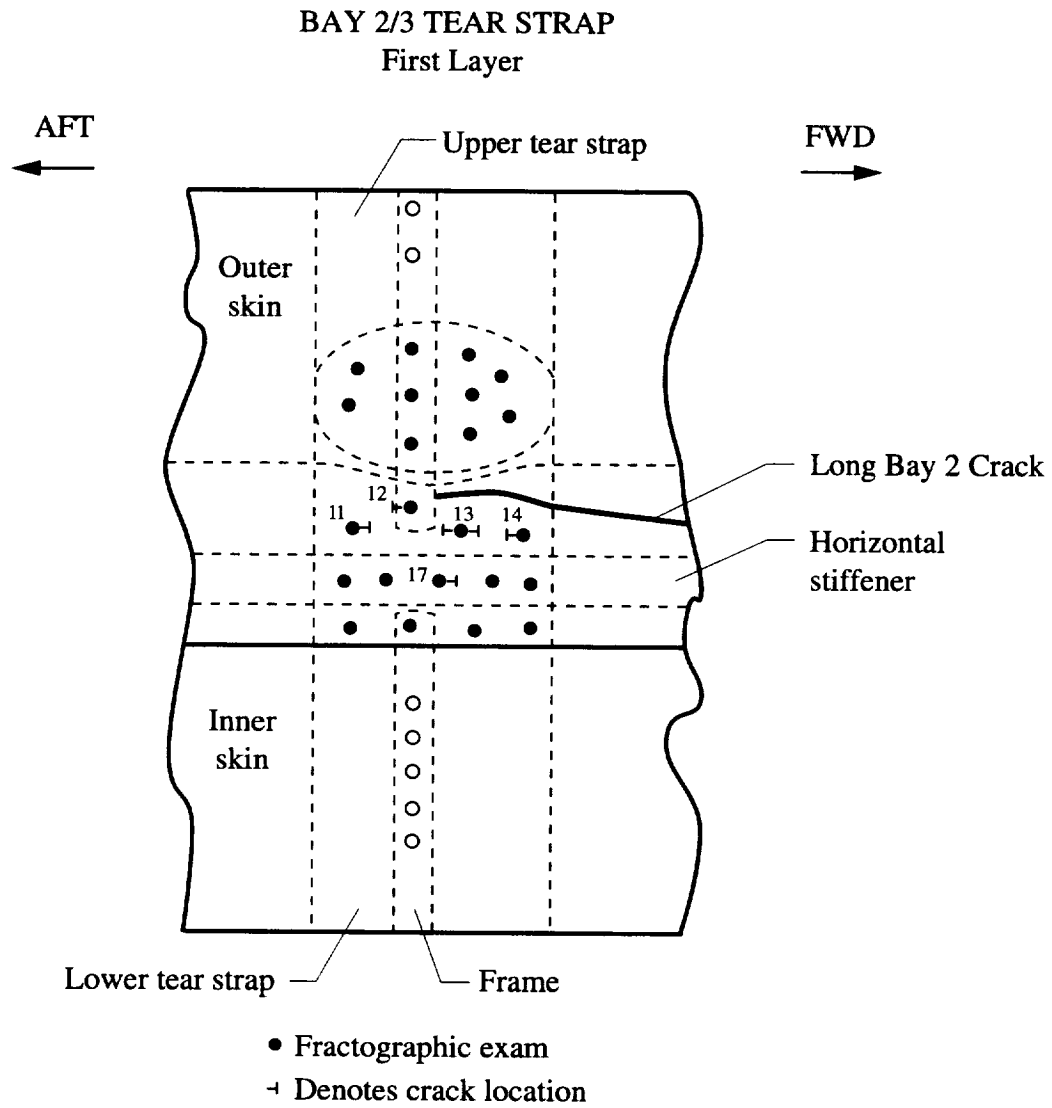
Figure 8.2 The schematic shows the location of fatigue cracks found in the first layer (outer skin) of the bay 2/3 tear strap by destructive examination. The solid dark line depicts one end of the long bay 2 crack extending into the tear strap.

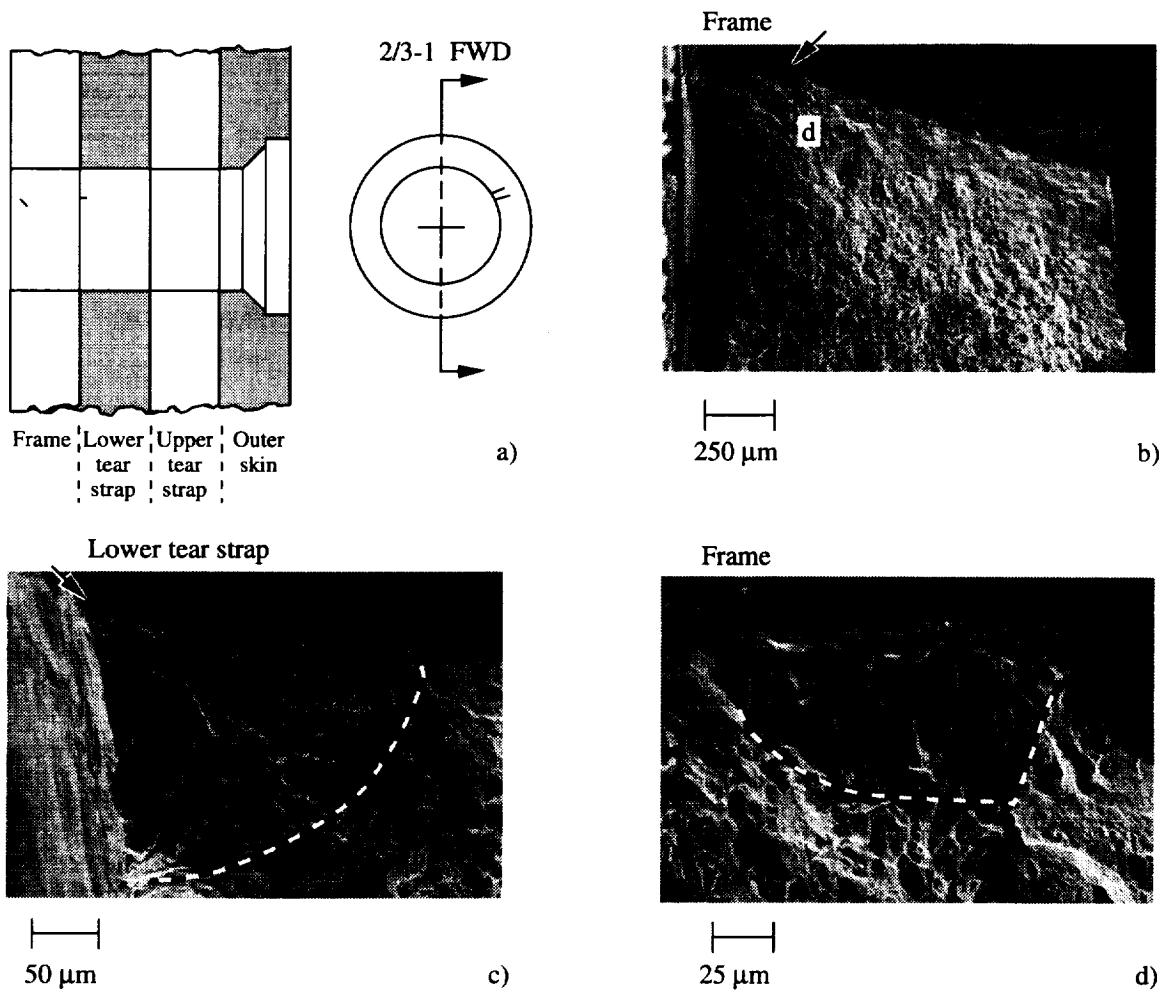
Figure 8.12 a) The schematic shows the rivet hole 2/3-1 configuration and the location of lower T.S. and frame fatigue cracks oriented in the forward direction and about the 2 o'clock position. b) The SEM micrograph shows the location of a small fatigue crack located (arrow) at the inside surface of the rivet hole. The rivet hole is located at the top of the micrograph. c) The SEM micrograph shows the fatigue crack located on the inboard corner of the lower T.S. rivet hole. The rivet hole is located at the top of the micrograph. d) The SEM micrograph shows the fatigue fracture surface of region "d" in Figure 8.12.b at high magnification.

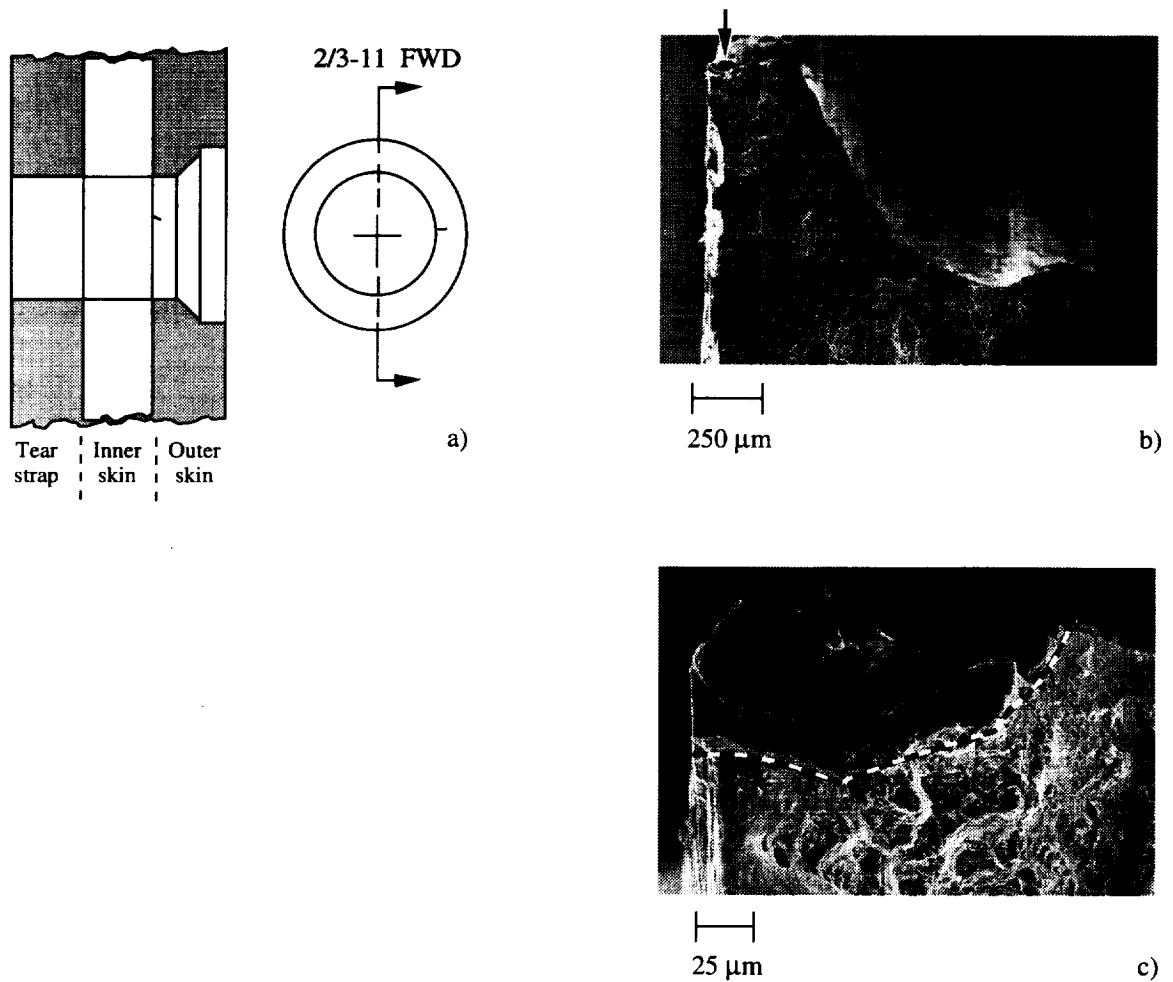
Figure 8.24 a) The schematic shows the rivet hole 2/3-11 configuration and the location of the outer skin fatigue crack oriented in the forward direction and above 3 o'clock position. b) The SEM micrograph shows the countersink region of the rivet hole. The arrow marks the location of the small fatigue crack at the rivet hole shank region. c) The SEM micrograph shows the small fatigue crack at the region marked by the arrow in Figure 8.24.b at high magnification.

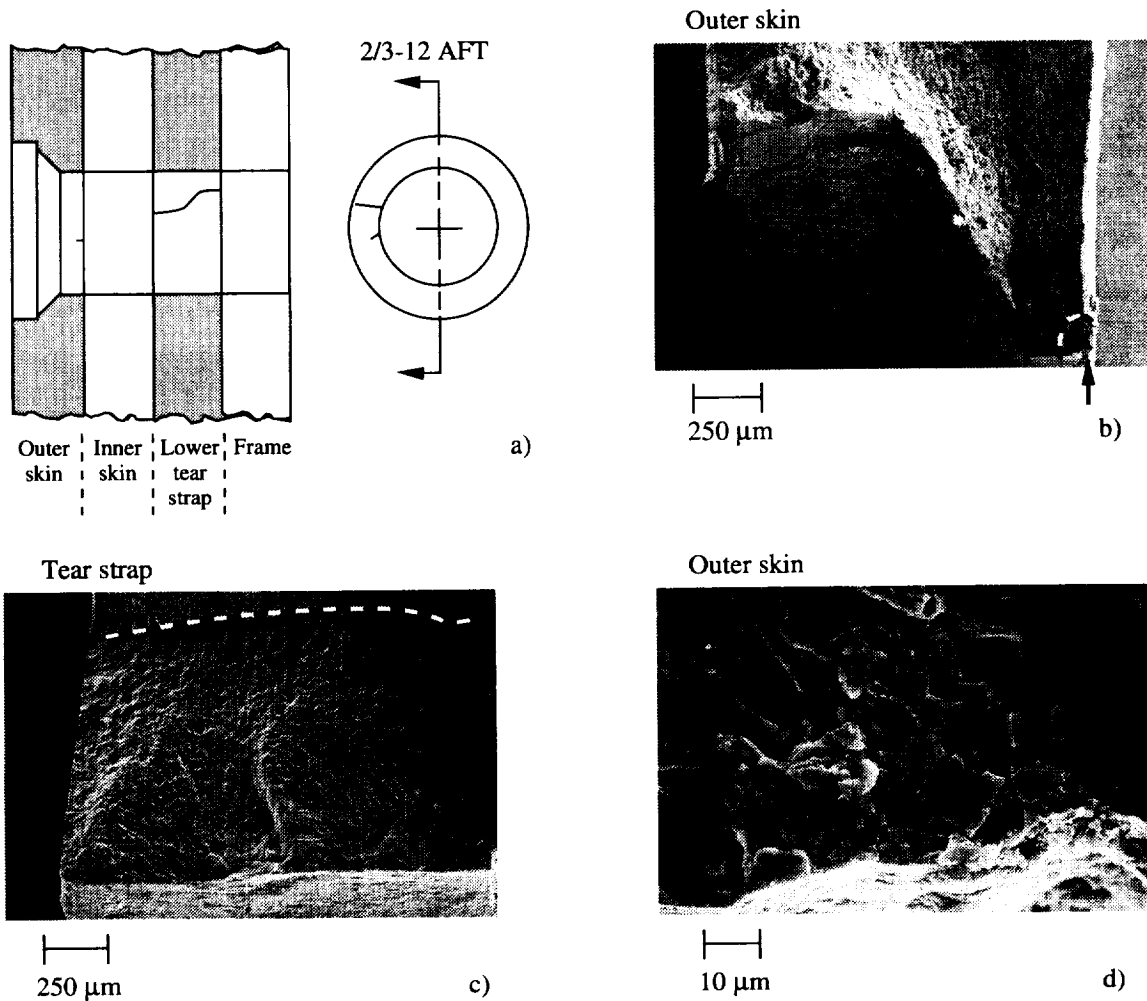
Figure 8.25 a) The schematic shows the rivet hole 2/3-12 configuration and the location of one outer skin fatigue crack and one lower T.S. fatigue crack oriented in the aft direction and at about the 9 and 10 o'clock positions, respectively. b) The SEM micrograph shows the fatigue crack fracture surface (arrow) located at the shank region of the rivet hole contained in the outer skin. The dashed line marks the fatigue crack front. c) The SEM micrograph shows the through-thickness fatigue crack that has propagated from the rivet hole (bottom on Figure 8.35.c) in the lower T.S. The dashed line marks the fatigue crack front. d) The SEM micrograph shows the crack initiation region marked by arrow in Figure 8.25.b.

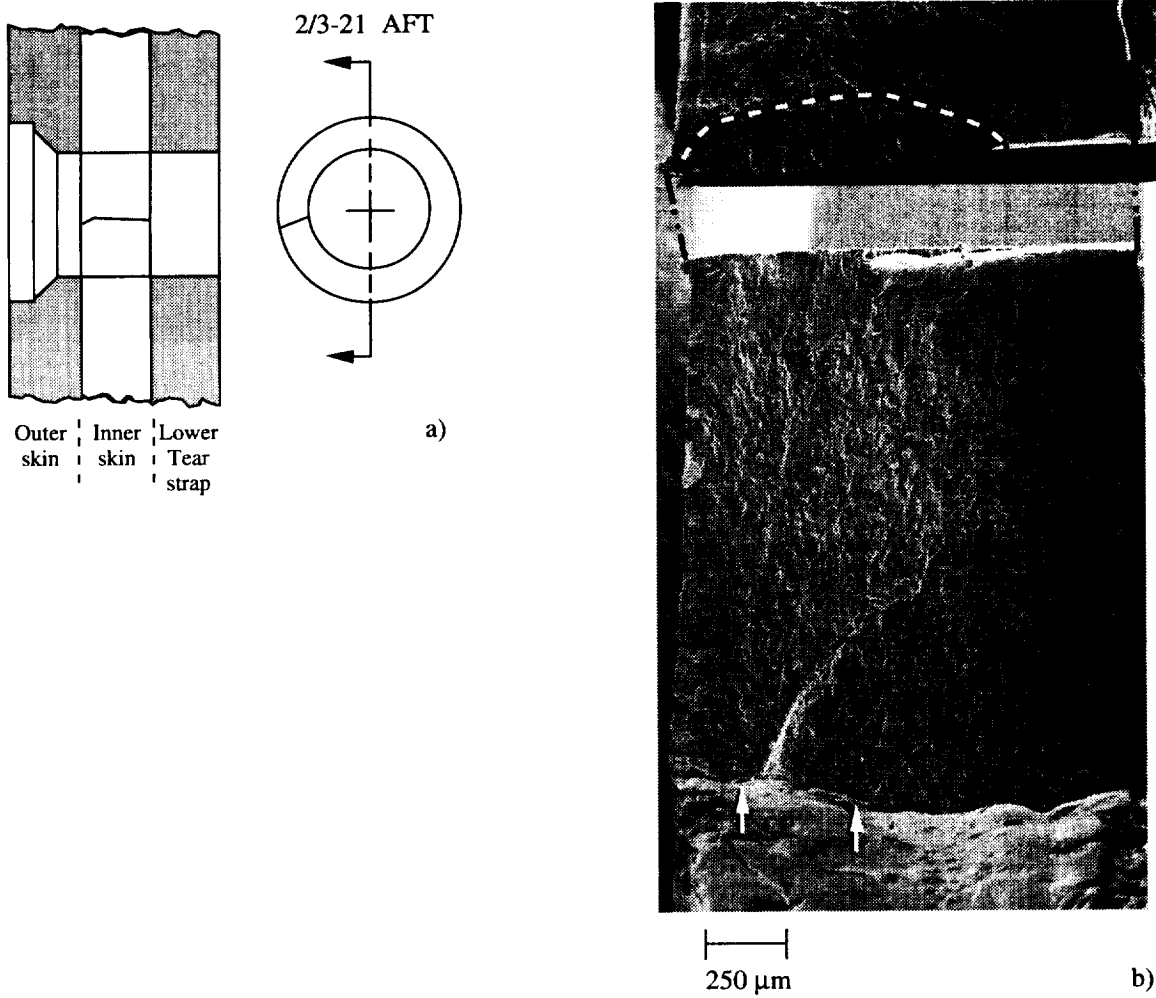
Figure 8.33 a) The schematic shows the rivet hole 2/3-21 configuration and the location of the inner skin fatigue crack oriented in the aft direction and below the 9 o'clock position. b) The SEM micrograph shows the inner skin through thickness fatigue crack fracture surface. The crack initiated at multiple sites (arrows) at the rivet hole (bottom of the micrograph). Here, the fracture surface was inadvertently cut during the destructive examination. A second specimen containing the remainder of the fatigue fracture surface is located at the top of the micrograph. The dashed line marks part of the fatigue crack front.

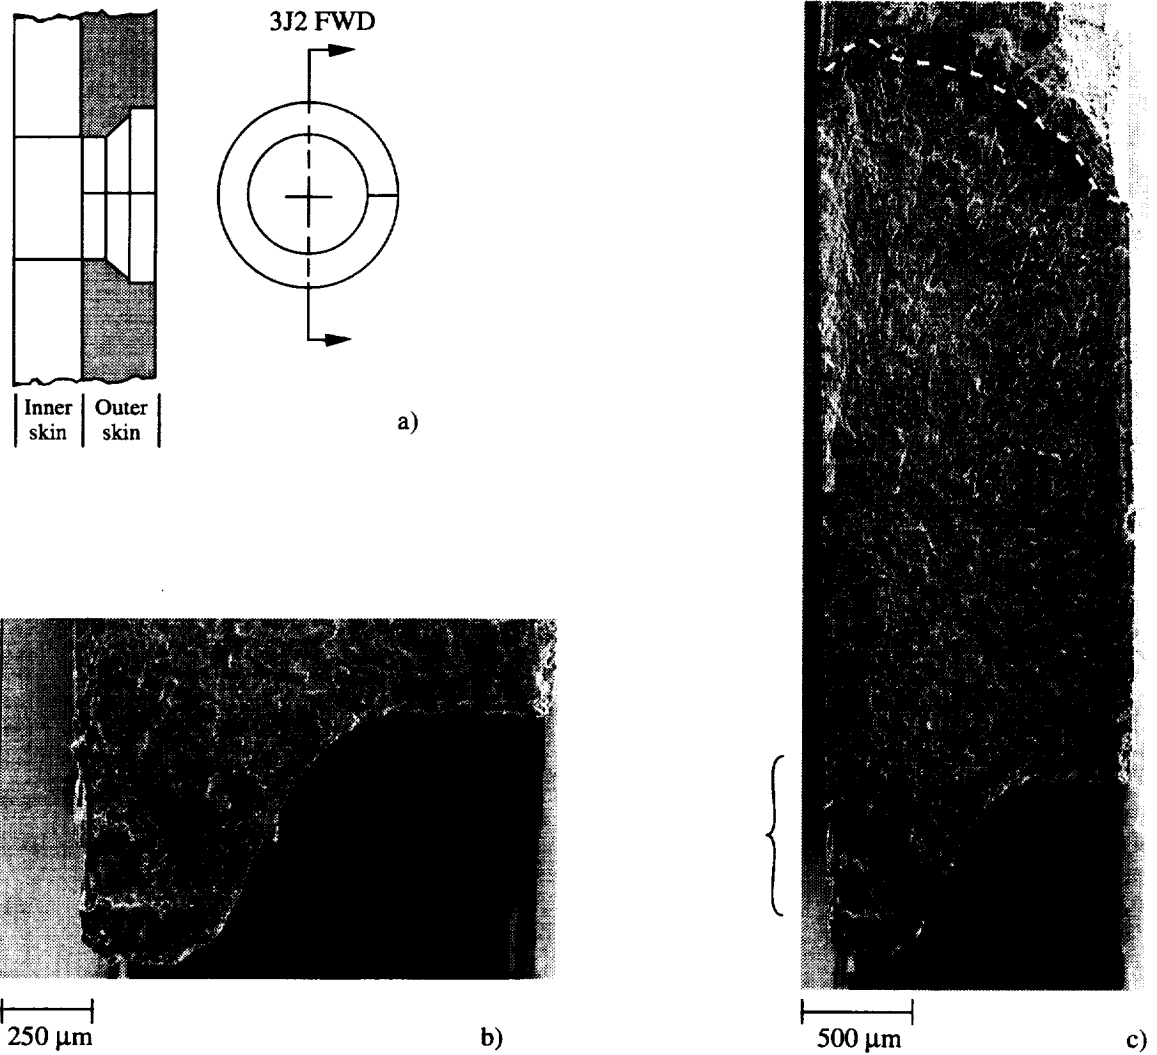
Figure 9.11 a) The schematic shows the rivet hole 3J2 configuration and the location of the outer skin fatigue crack oriented in the forward direction and about the 3 o'clock position. b) The SEM micrograph shows the fatigue fracture surface at the rivet hole (bottom of micrograph). c) The SEM micrograph shows the shank region of the through-thickness fatigue crack and the rivet hole (bottom of the micrograph). The dashed line marks the fatigue crack front and the bracket shows the likely region of initiation.
