NASA/TP-97-206257

The Characteristics of Fatigue Damage in the Fuselage Riveted Lap Splice Joint

Robert S. Piascik
Langley Research Center, Hampton, Virginia

November 1997

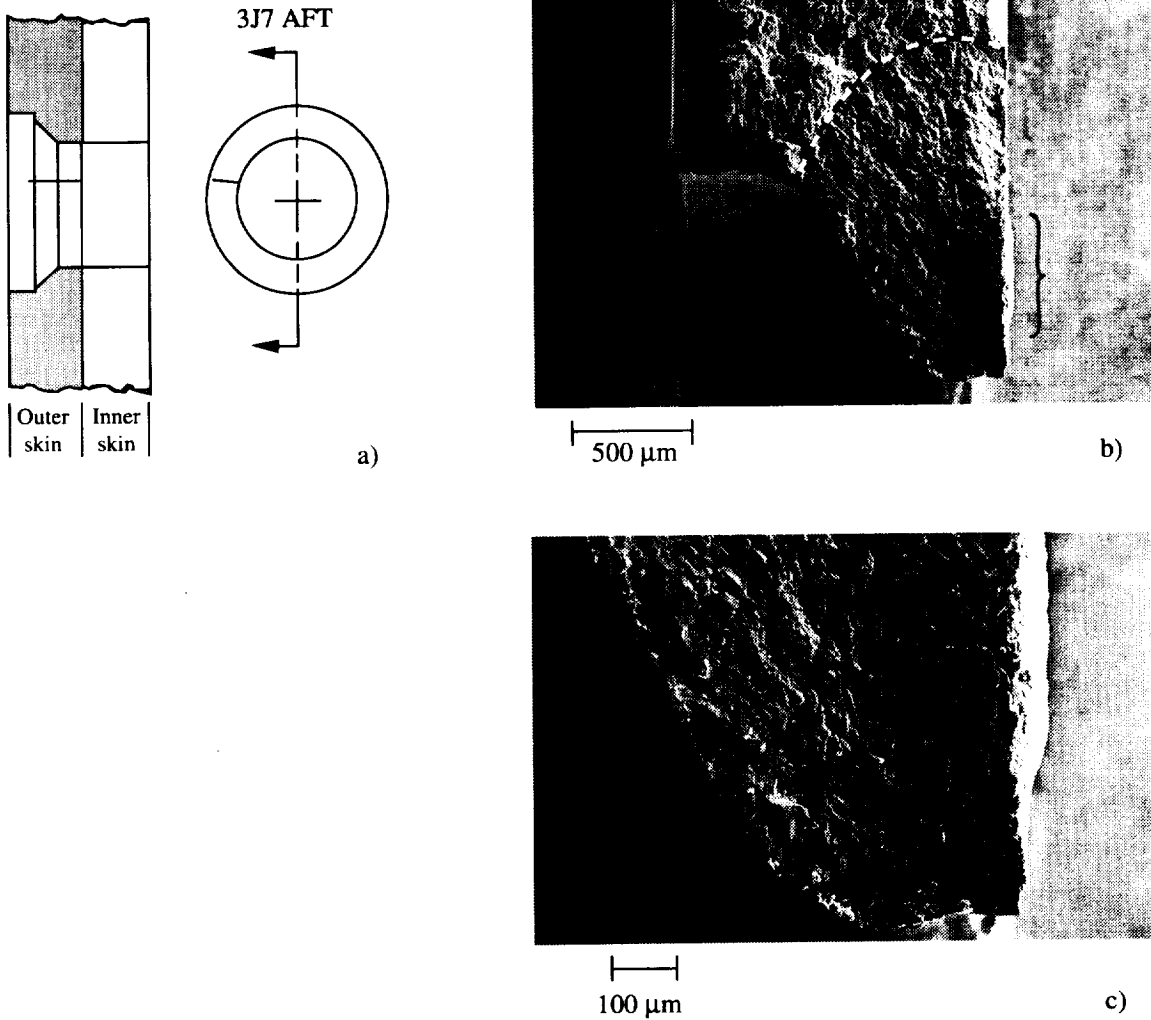
Figure 9.20 a) The schematic shows the rivet hole 3J7 configuration and the location of the outer skin fatigue crack oriented in the aft direction above the 9 o'clock position. b) The SEM micrograph shows the fatigue crack at the rivet hole (bottom). The bracket shows the likely crack initiation region along the faying surface and the dashed line marks the fatigue crack front. c) The SEM micrograph shows the fatigue crack fracture surface at the rivet hole shank region.

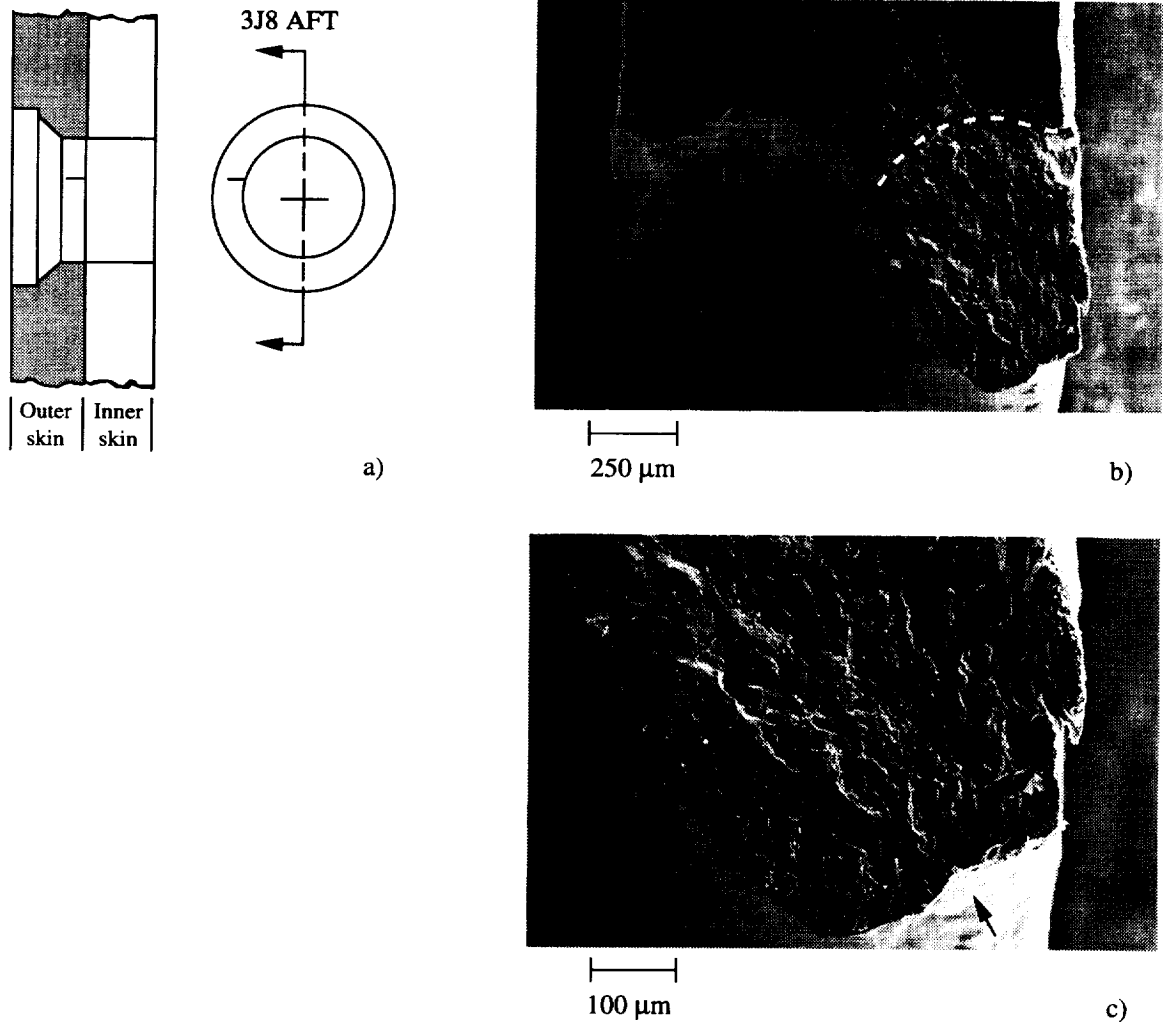
Figure 9.21 a) The schematic shows the rivet hole 3J8 configuration and the location of the outer skin fatigue crack oriented in the aft direction and about the 10 o'clock position. b) The SEM micrograph shows the fatigue crack at the rivet hole (bottom). The dashed line marks the fatigue crack front. c) The SEM micrograph shows the fatigue crack fracture surface at the rivet hole shank region. The arrow marks the likely region of crack initiation.

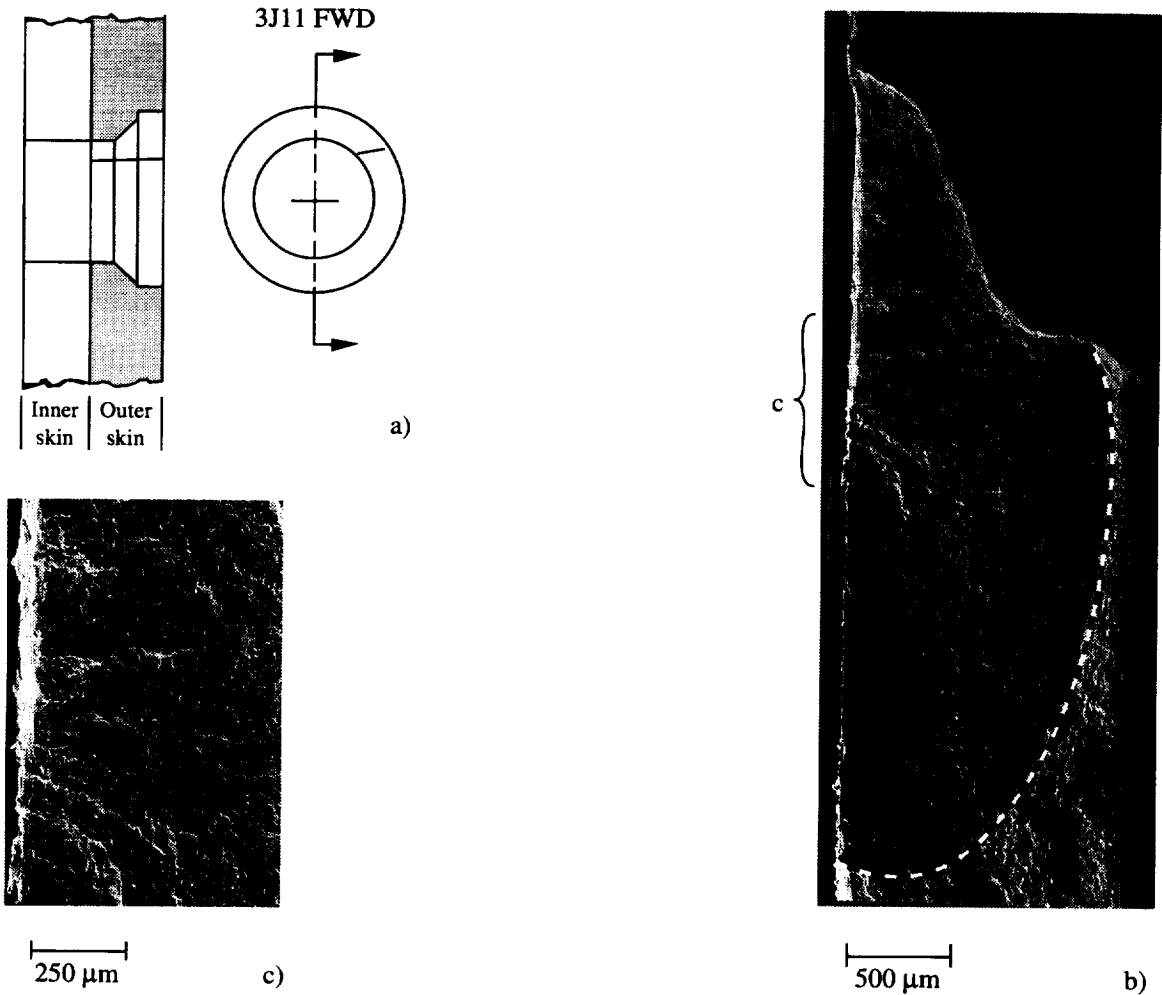
Figure 9.26 a) The schematic shows the rivet hole 3J11 configuration and the location of the outer skin fatigue crack oriented in the forward direction and about the 2 o'clock position. b) The SEM micrograph shows the fatigue crack at the rivet hole (top). The bracket locates the region of crack initiation along the faying surface and the dashed line marks the fatigue crack front. c) The SEM micrograph shows the crack initiation region "c" in Figure 9.26.b.

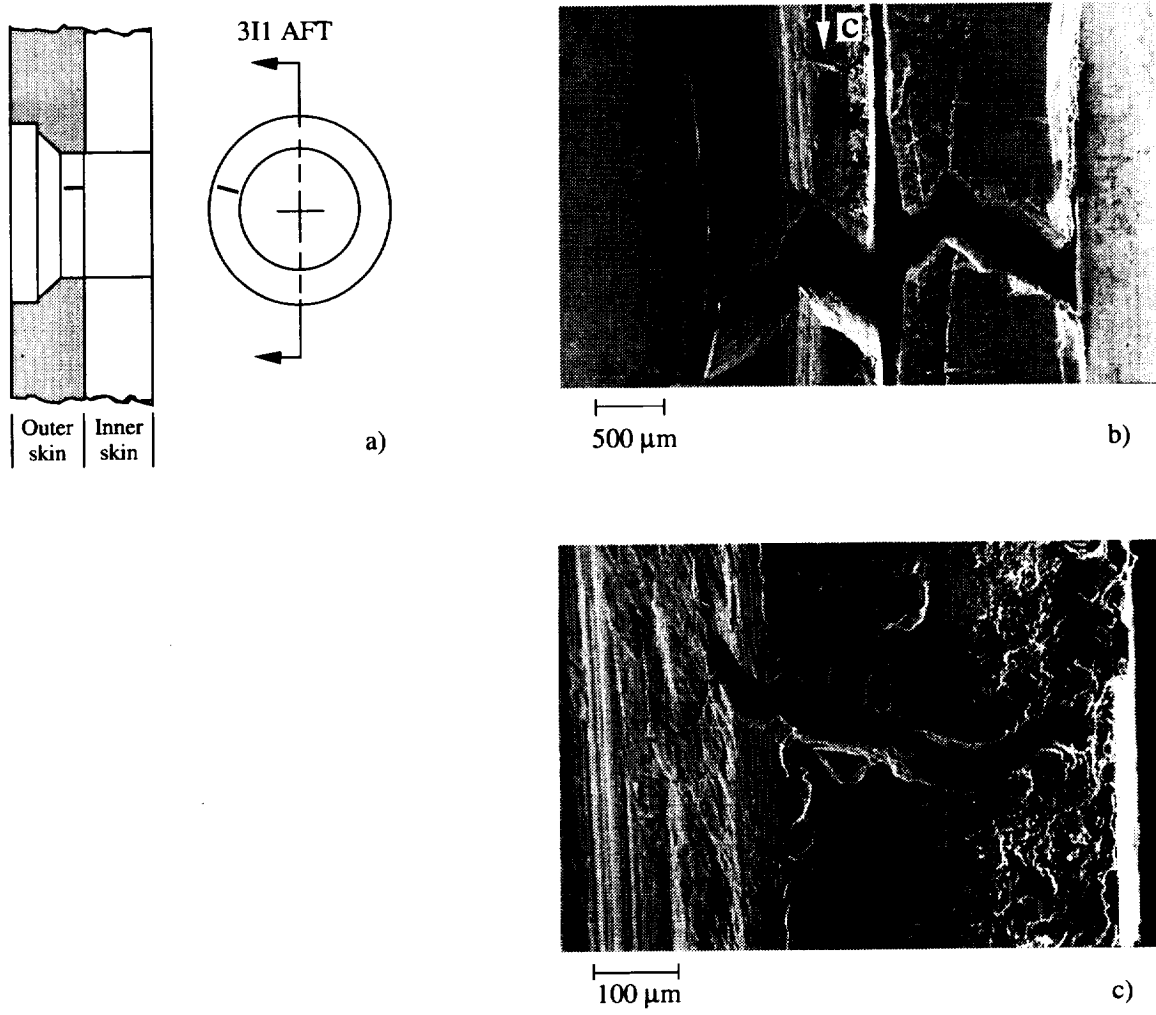
Figure 9.33 a) The schematic shows the rivet hole 3II configuration and the location of the outer skin fatigue crack oriented in the aft direction and about the 10 o'clock position. b) The SEM micrograph shows the partially strained to failure specimen oriented as shown in Figure 9.33.a.; shown is the outer skin on the left and the inner skin to the right. The partially opened outer skin fatigue crack is identified by the arrow. c) The SEM micrograph shows region "c" in Figure 9.33.b at high magnification. The fatigue crack was partially opened during the destructive examination. SEM examination into the opened crack confirmed transgranular fatigue crack growth.

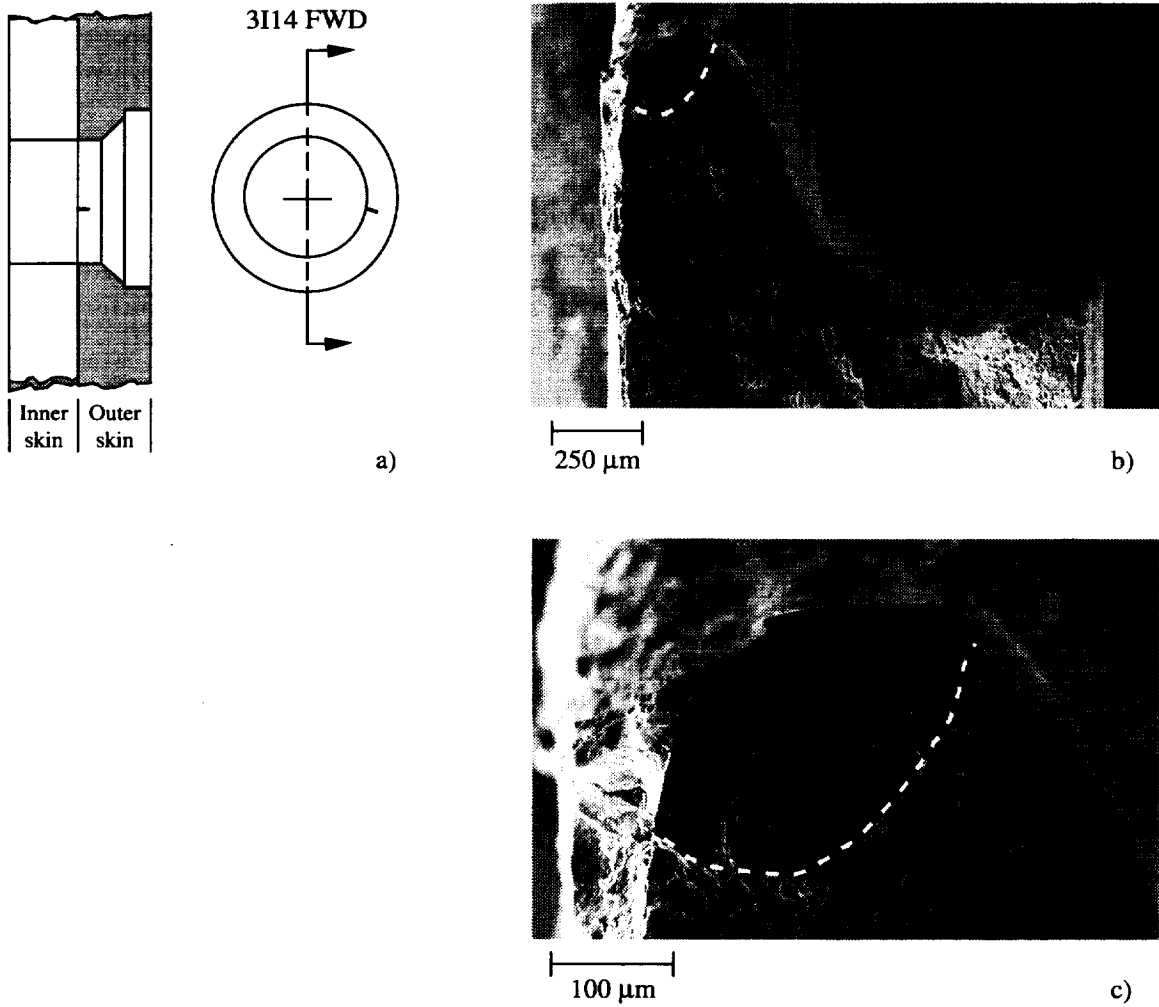
Figure 9.36 a) The schematic shows the rivet hole 3I14 configuration and the location of the outer skin fatigue crack oriented in the forward direction below the 3 o'clock position. b) The SEM micrograph the fatigue crack and the rivet hole. The dashed line marks the fatigue crack front. c) The SEM micrograph shows the region of crack initiation at the rivet hole shank.

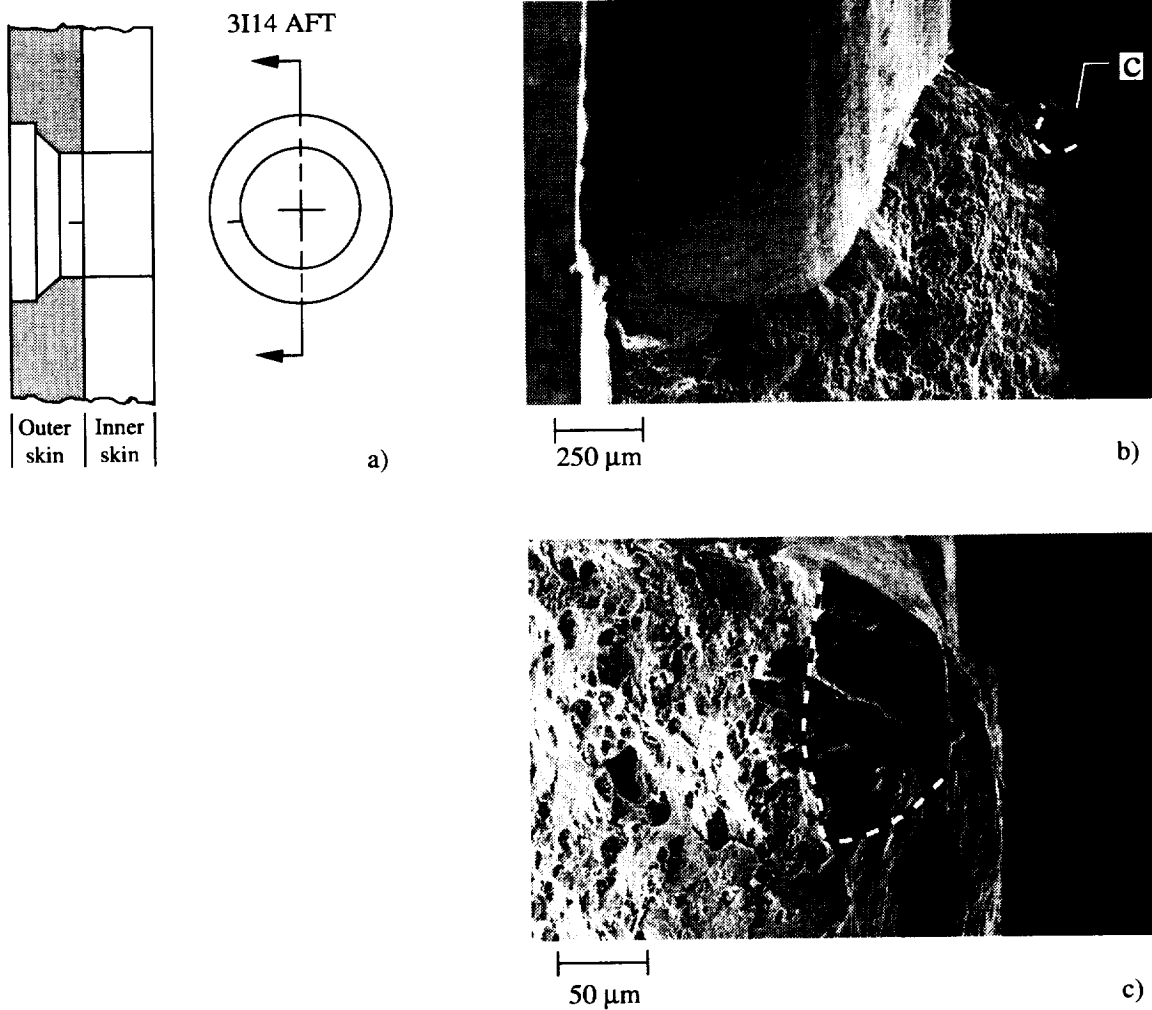
Figure 9.37 a) The schematic shows the rivet hole 3114 configuration and the location of the outer skin fatigue crack oriented in the aft direction below the 9 o'clock position. b) The SEM micrograph shows the fatigue crack at the inboard corner of the rivet hole. The dashed line marks the fatigue crack front. c) The SEM micrograph shows the region of crack initiation at the rivet hole shank region "c" in Figure 9.37.b. The dashed line marks the fatigue crack front.

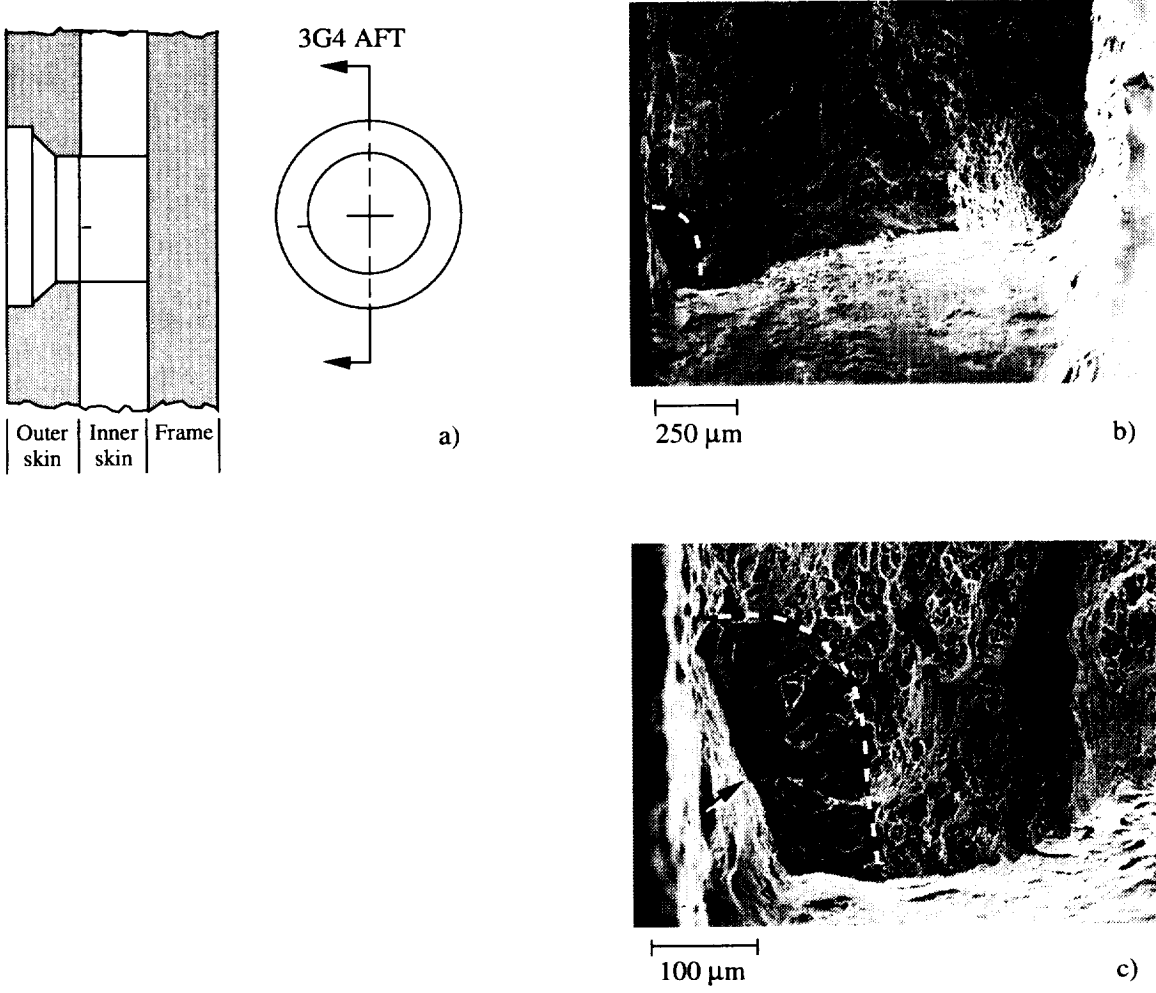
Figure 9.45 a) The schematic shows the rivet hole 3G4 configuration and the location of the inner skin fatigue crack oriented in the aft direction below the 9 o'clock position. b) The SEM micrograph shows the fatigue crack at the outboard corner of the rivet hole. The dashed line marks the fatigue crack front. c) The SEM micrograph shows the region of crack initiation (arrow) at the outboard corner of the rivet hole. The dashed line marks the fatigue crack front.

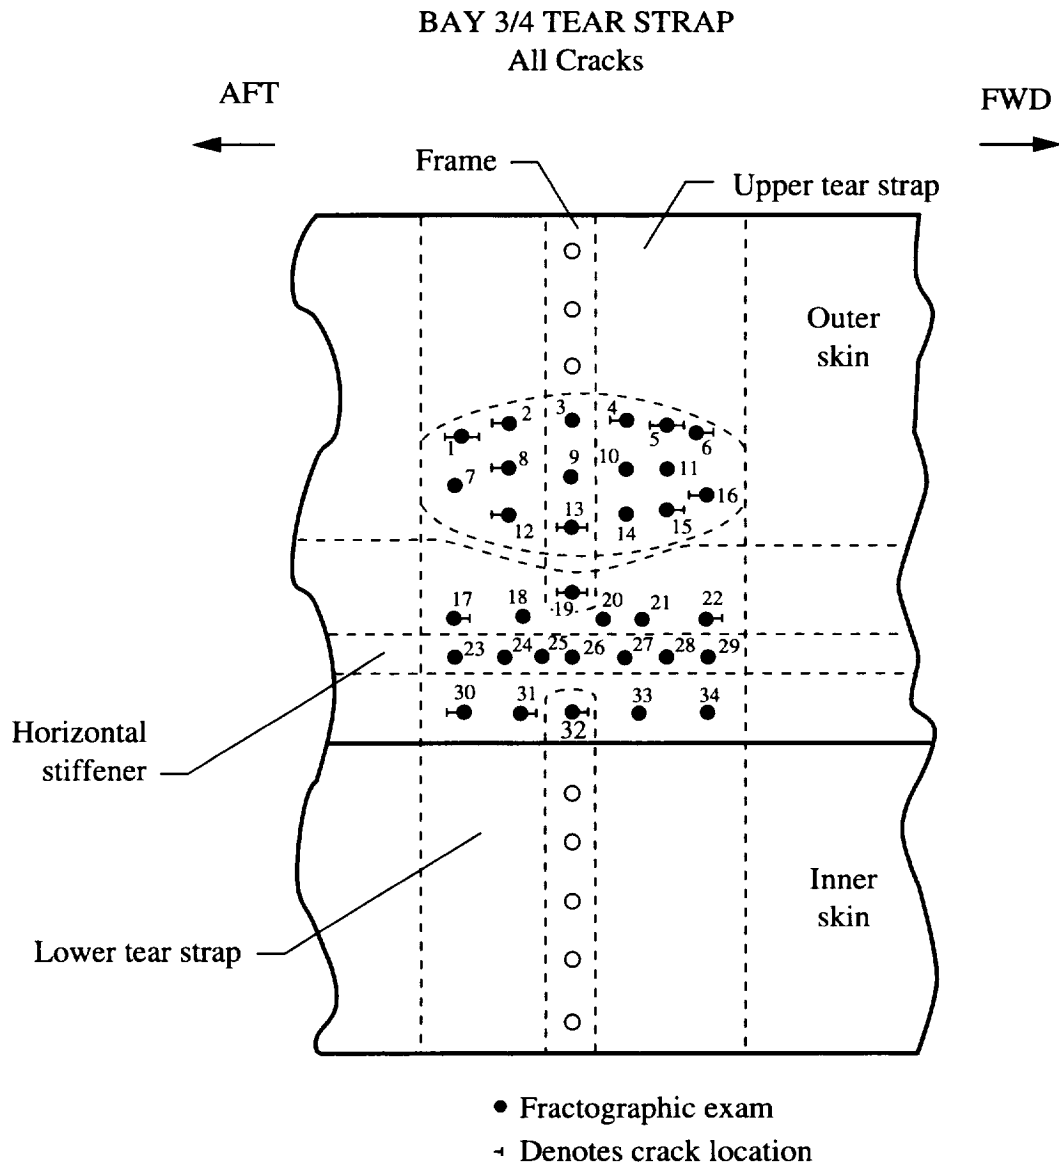
Figure 10.1 The schematic shows the location of all fatigue cracks found in the bay 3/4 tear strap by destructive examination. All filled and numbered rivet holes were destructively examined.

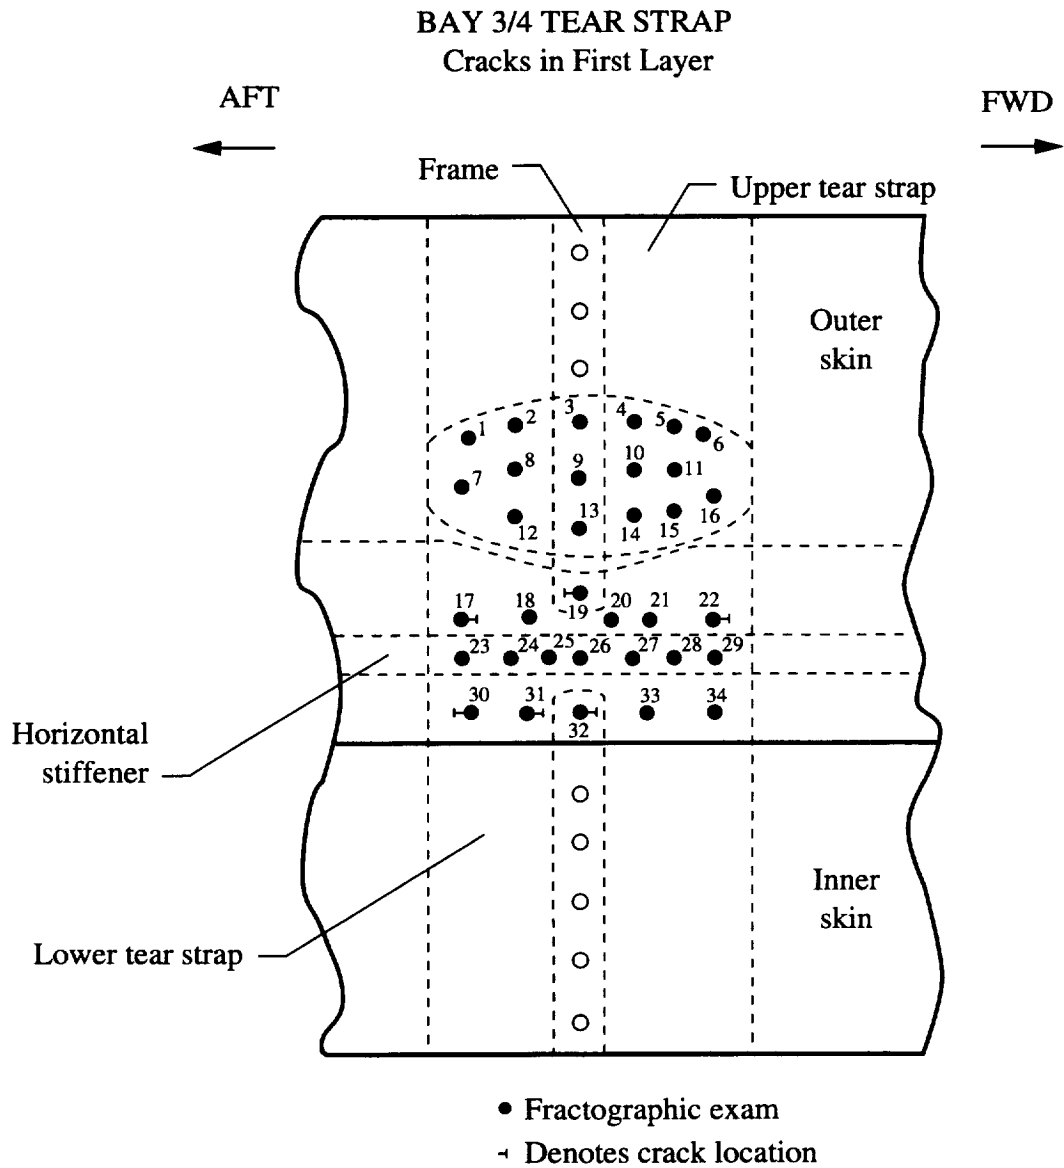
Figure 10.2 The schematic shows the location of fatigue cracks found in the first layer (outer skin) of the bay 3/4 tear strap by destructive examination.

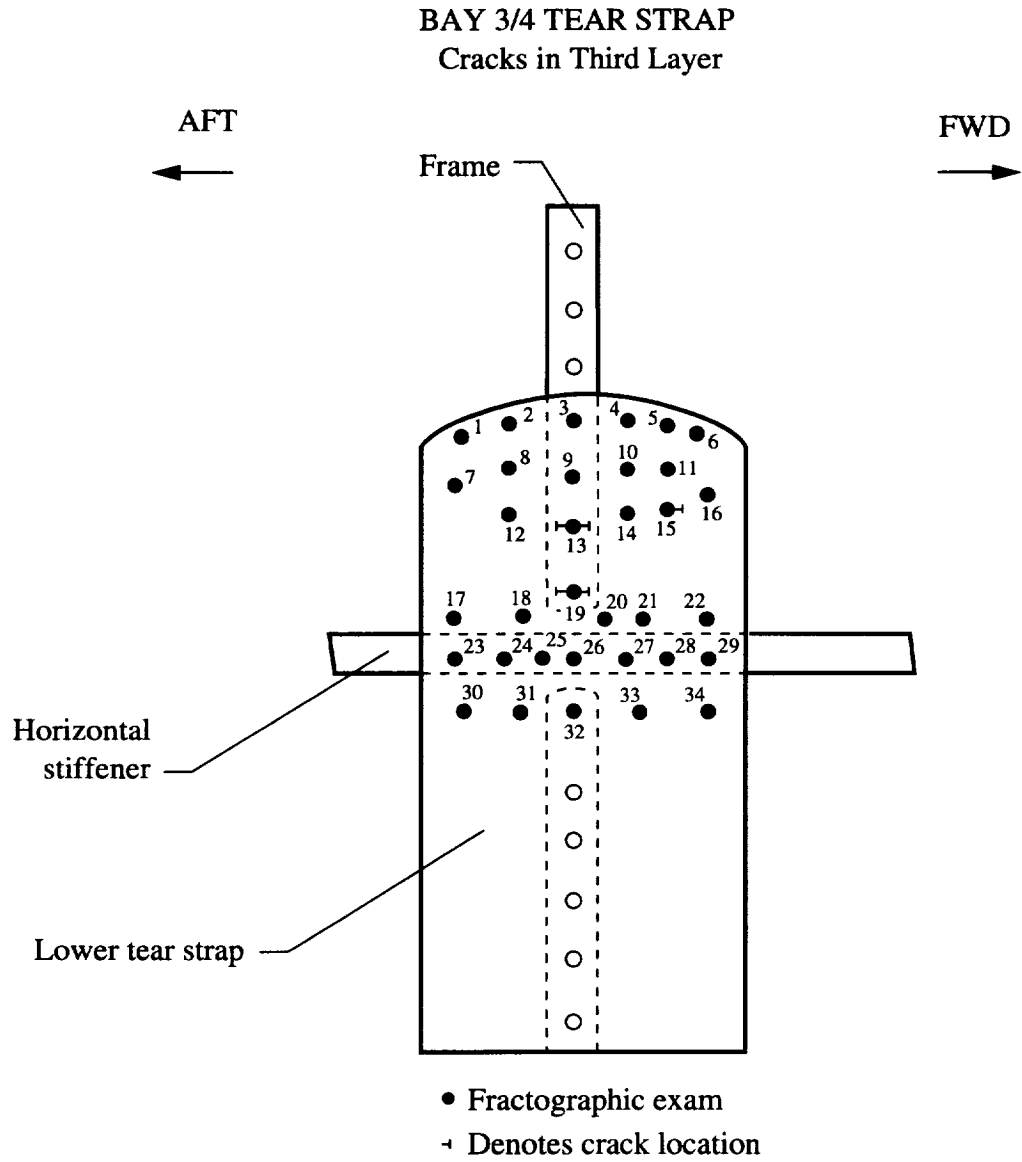
Figure 10.4 The schematic shows the location of one fatigue crack found in the third layer (lower tear strap) of the bay 3/4 tear strap by destructive examination.

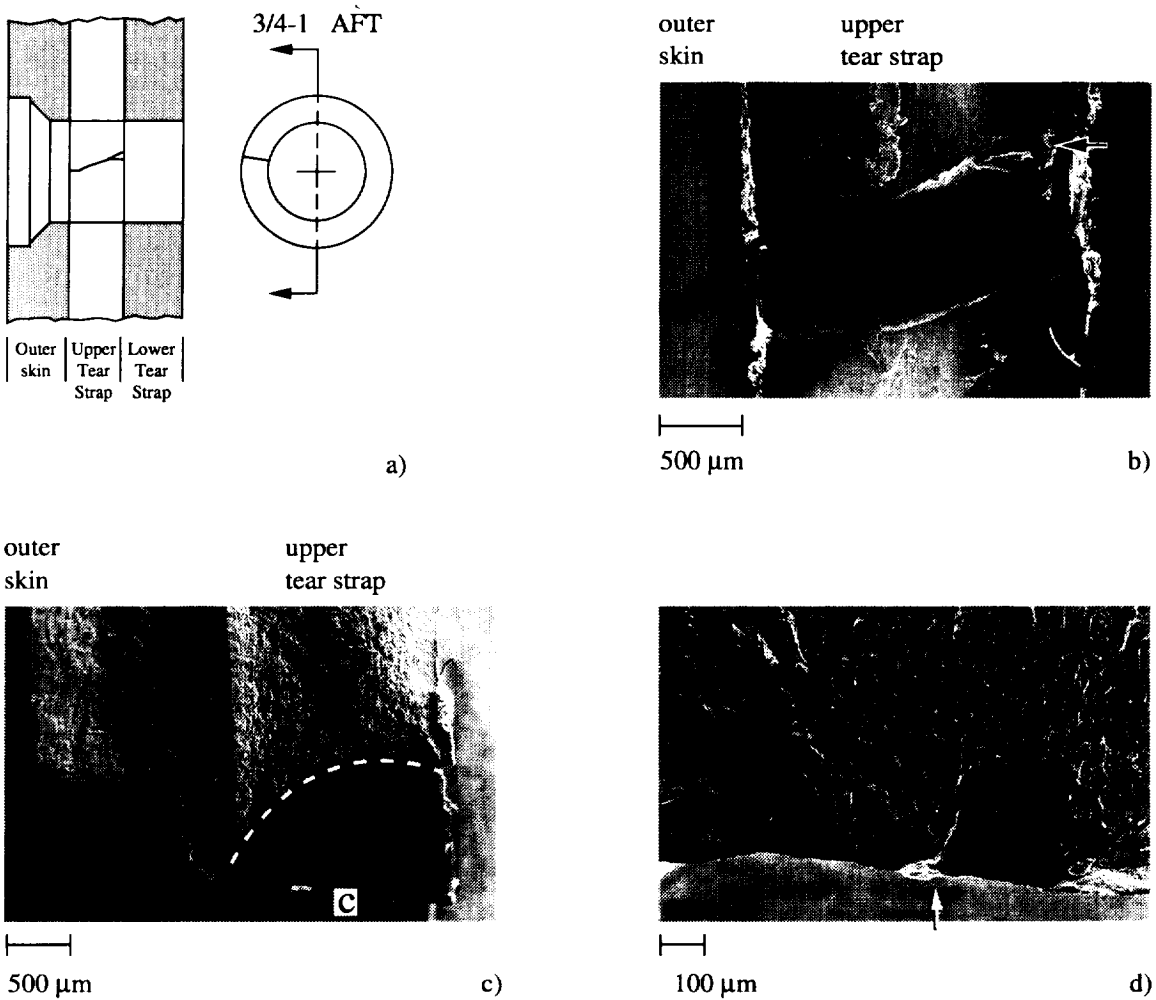
Figure 10.11 a) The schematic shows the rivet hole 3/4-1 configuration and the location of an upper T.S. fatigue crack oriented in the aft direction above the 9 o'clock position. b) The SEM micrograph shows the partially opened upper T.S. crack at the rivet hole surface. To the left is the fractured outer skin. A small partially opened fatigue crack is visible above the main fracture surface (arrow). c) The SEM micrograph shows the location of the fatigue crack contained in the upper T.S. The dashed line marks the fatigue crack front. Here the rivet hole is located at the bottom of the micrograph and the outer skin is located to the left of the fatigue crack region. d) The SEM micrograph shows the region of crack initiation at high magnification, region "c" in Figure 10.10.d. The arrow marks the likely crack initiation site.

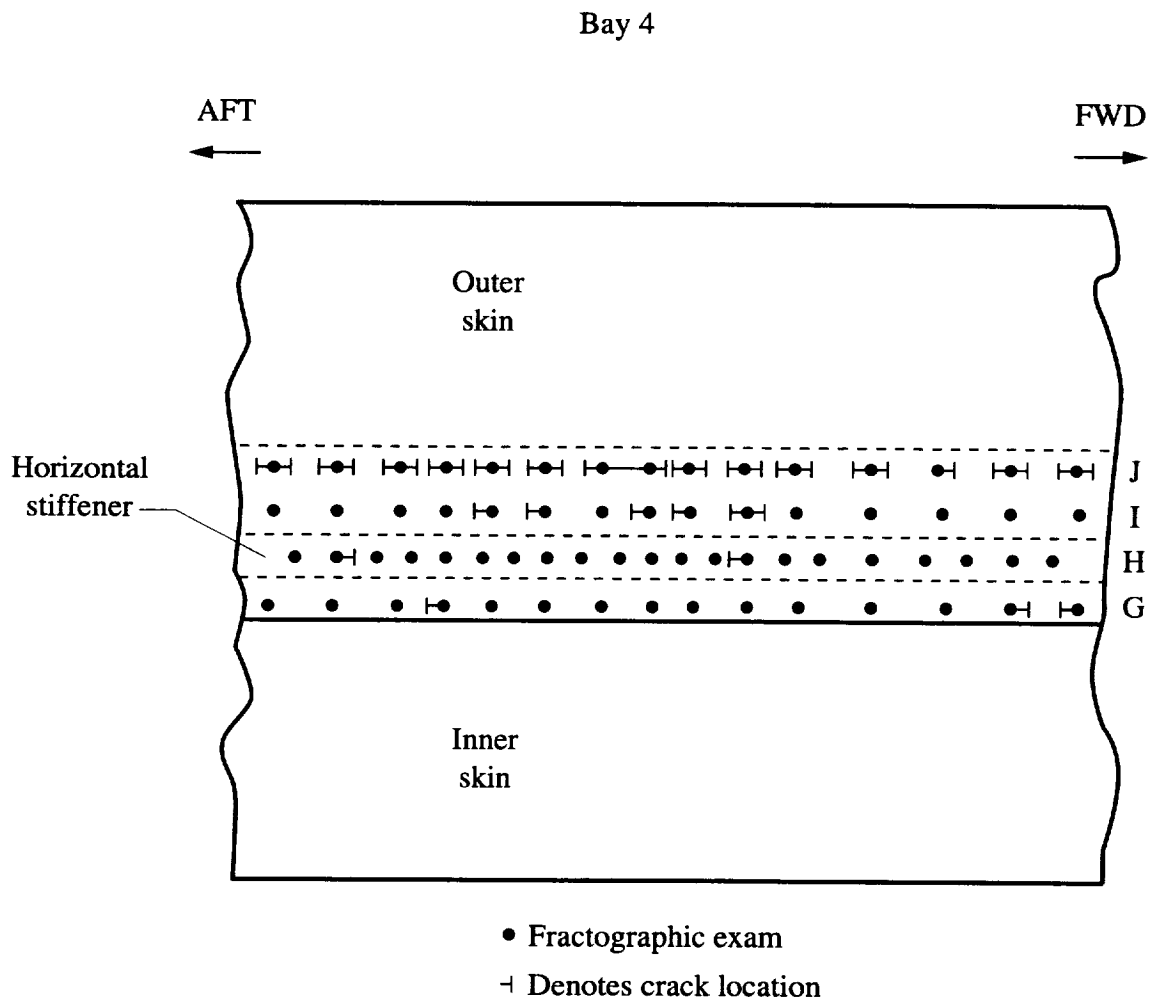
Figure 11.1 The schematic shows the location of all fatigue cracks found in the bay 4 lap splice joint by destructive examination. All bay 4 rivet holes were examined.

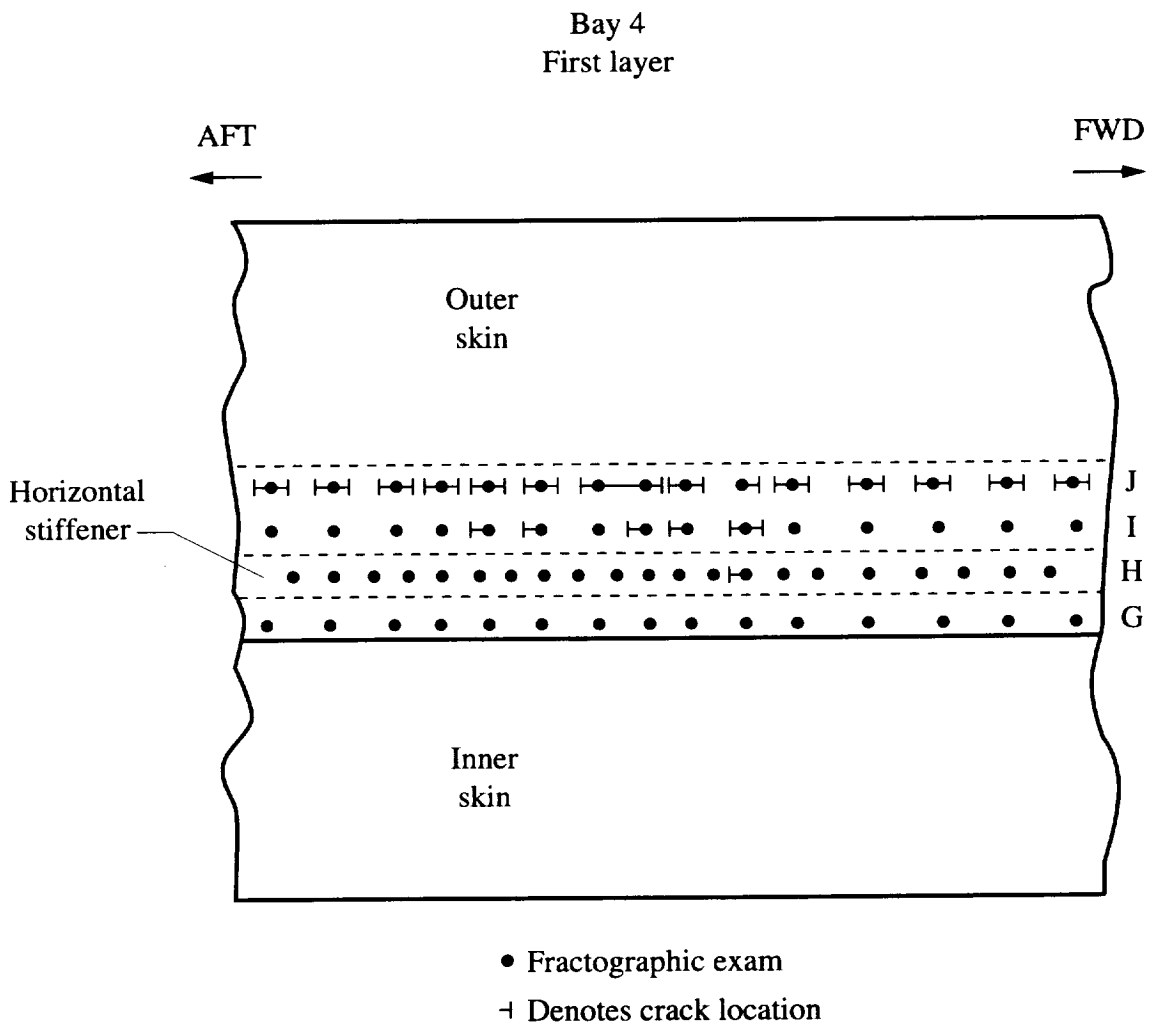
Figure 11.2 The schematic shows the location of fatigue cracks found in the first layer (outer skin) of the bay 4 lap splice joint by destructive examination.

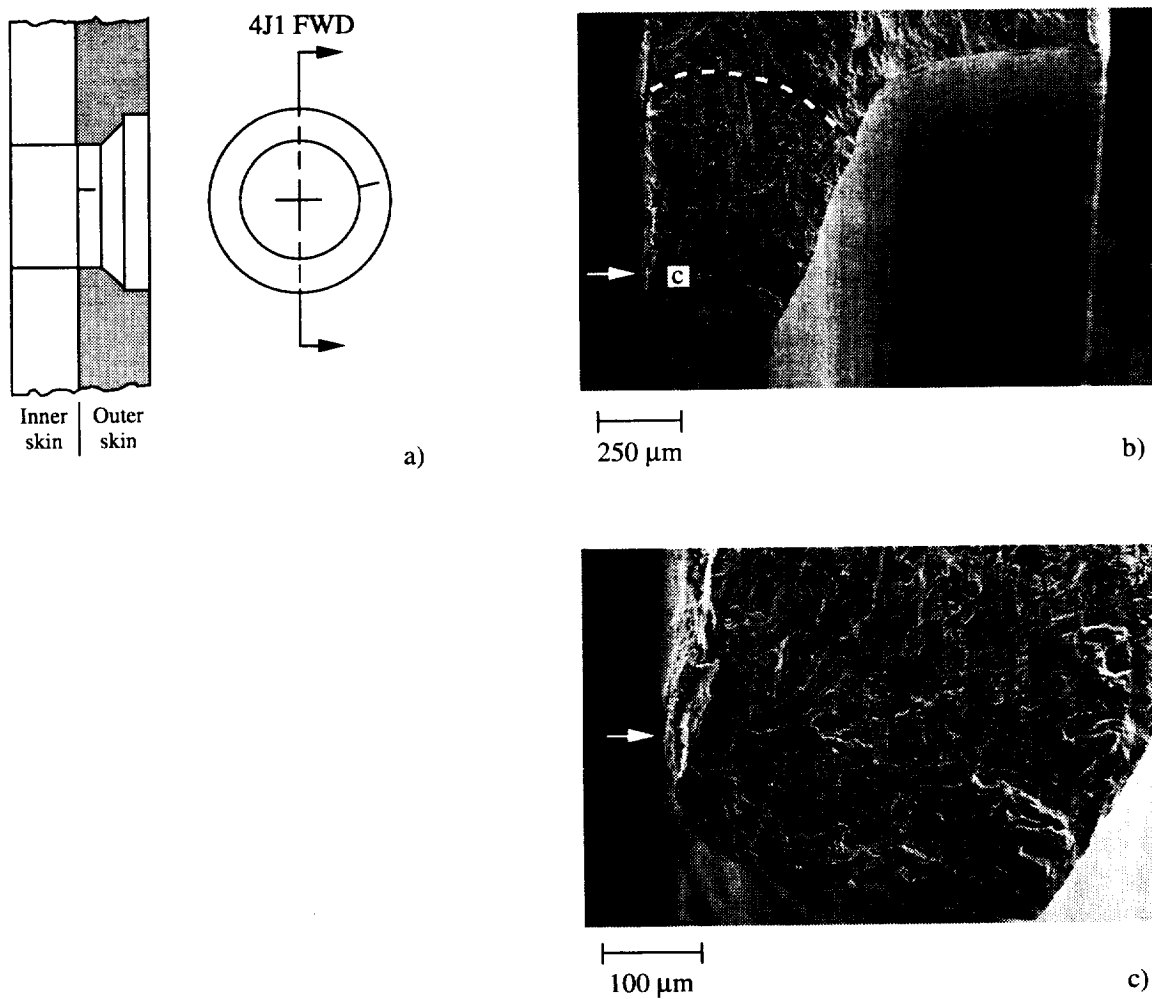
Figure 11.9 a) The schematic shows the rivet hole 4J1 configuration and the location of the outer skin fatigue crack oriented in the forward direction and above the 3 o'clock position. b) The SEM micrograph shows the fatigue crack fracture surface located at the rivet hole shank region. The arrow marks the likely crack initiation region along the faying surface and the dashed line marks the fatigue crack front. c) The SEM micrograph shows the fatigue crack fracture surface at region "c" in Figure 11.9.b. The arrow marks the likely crack initiation region along the faying surface.

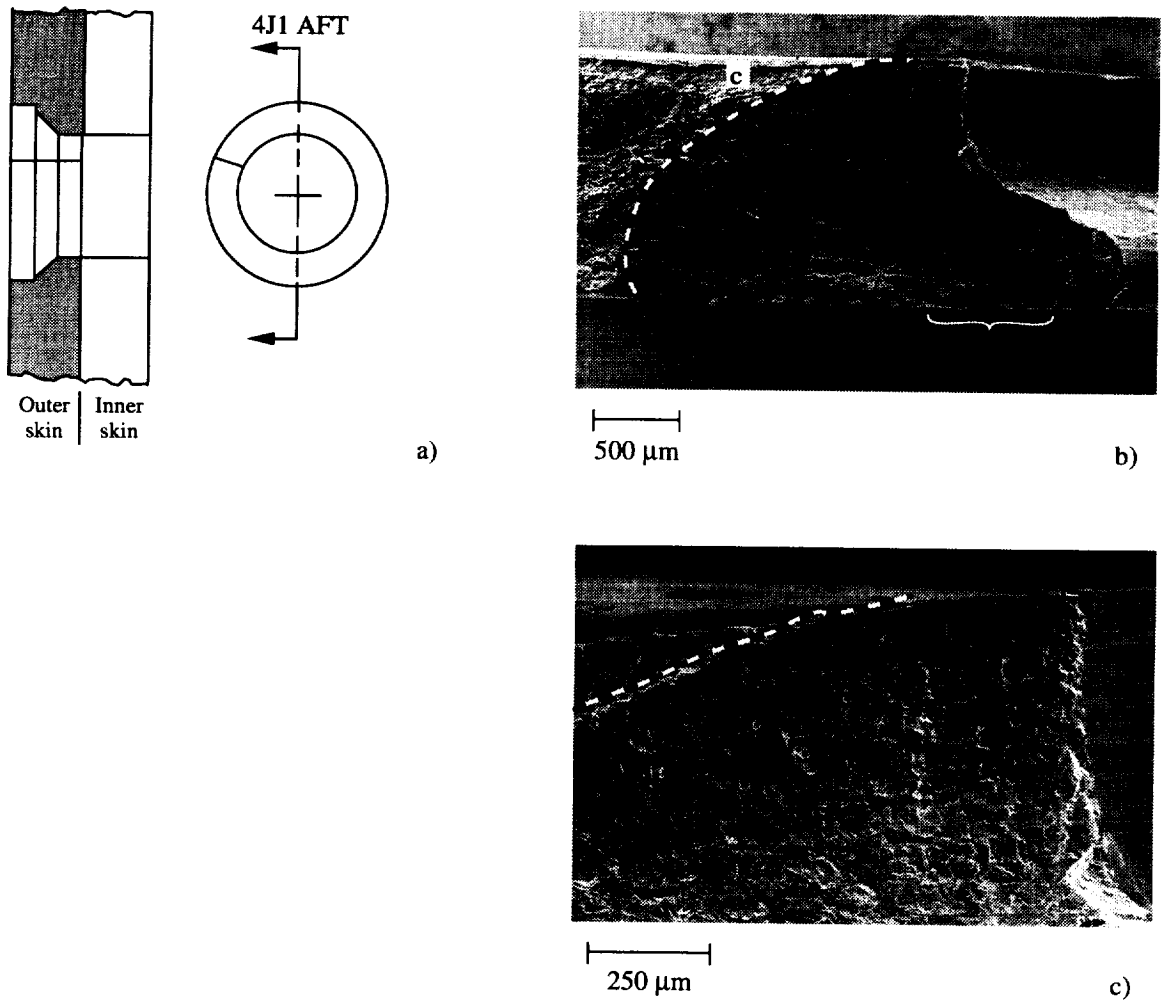
Figure 11.10 a) The schematic shows the rivet hole 4J1 configuration and the location of the outer skin fatigue crack oriented in the aft direction and about the 10 o'clock position. b) The SEM micrograph shows the fatigue crack fracture surface located at the outer skin rivet hole (right). The dashed line marks the fatigue crack front. The bracket marks the region of crack initiation. c) The SEM micrograph shows the fatigue crack front, region "c" in Figure 11.10.b. The dashed line marks the fatigue crack front as it intersects the outboard surface of the outer skin.

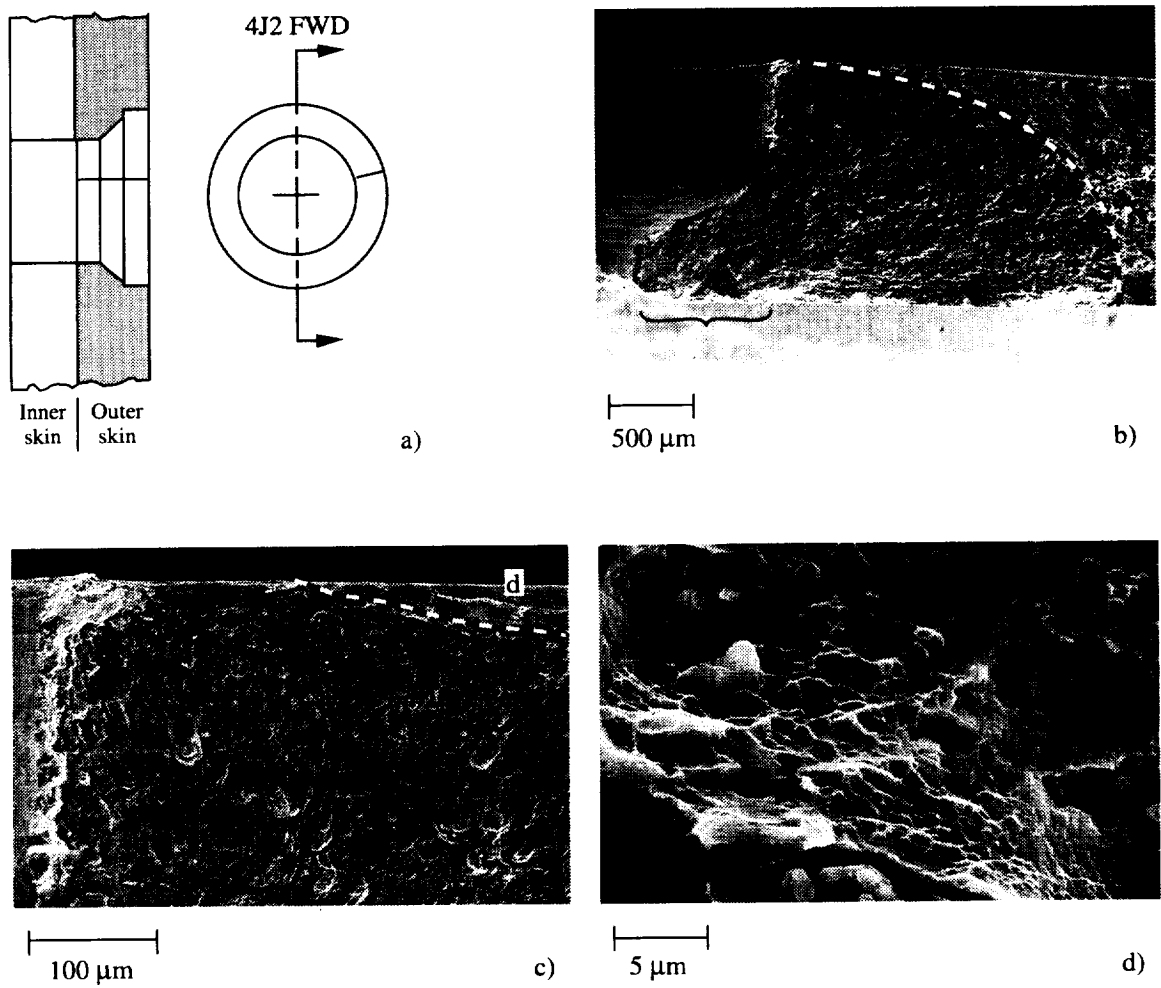
Figure 11.11 a) The schematic shows the rivet hole 4J2 configuration and the location of the outer skin fatigue crack oriented in the forward direction and above the 3 o'clock position. b) The SEM micrograph shows the fatigue crack fracture surface located at the outer skin rivet hole (left). The bracket marks the likely region of crack initiation and the dashed line marks the fatigue crack front. c) The SEM micrograph shows the fatigue crack front region (dashed line) as it intersects the outboard surface of the outer skin. The rivet hole is located to the left. d) The SEM micrograph shows the ductile morphology of the over load fracture surface at region "d" in Figure 11.11c at high magnification.

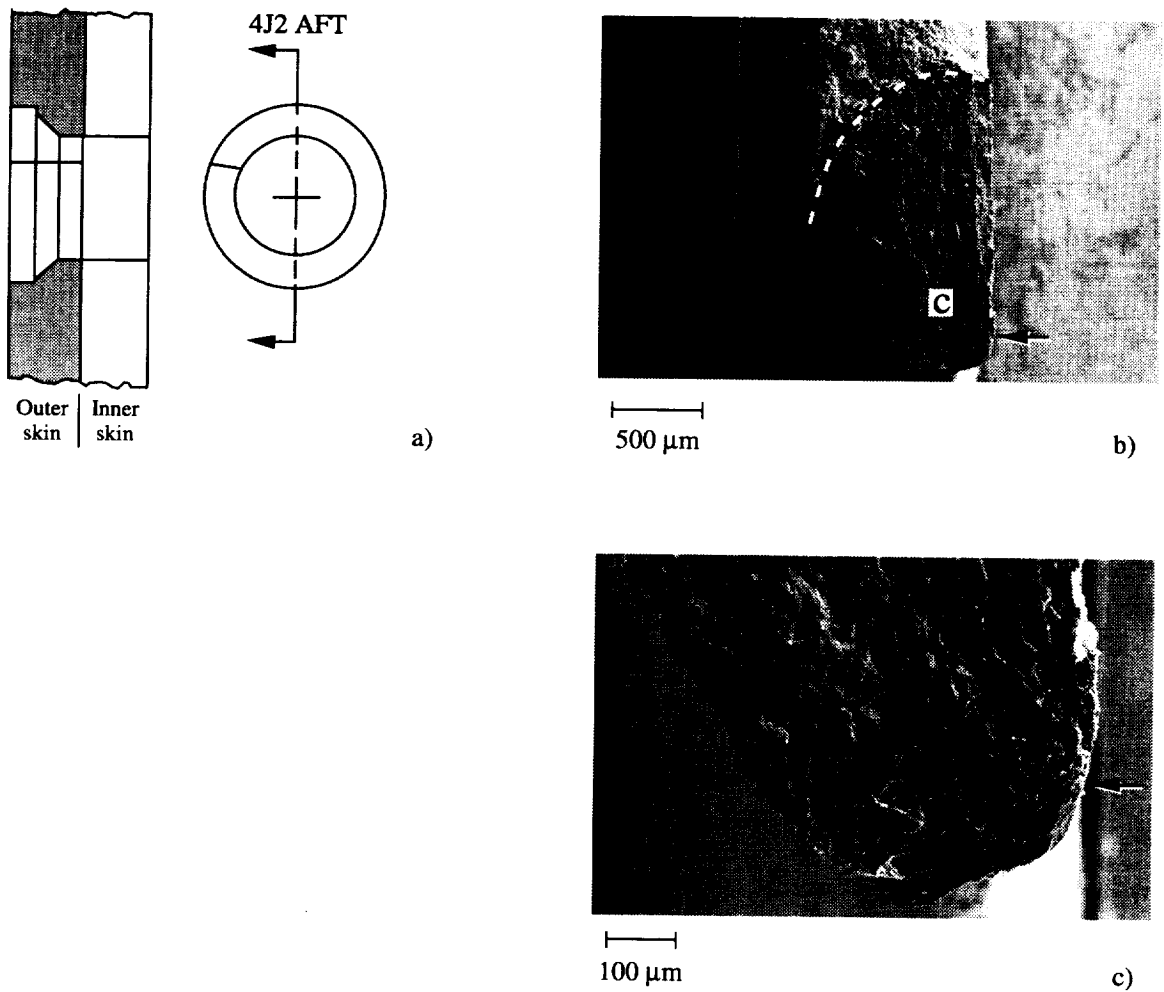
Figure 11.12 a) The schematic shows the rivet hole 4J2 configuration and the location of the outer skin fatigue crack oriented in the aft direction and about the 10 o'clock position. b) The SEM micrograph shows the fatigue crack fracture surface located at the outer skin rivet hole (bottom). The arrow marks the likely crack initiation site and the dashed line marks the fatigue crack front. c) The SEM micrograph shows the fatigue crack front region "c" in Figure 11.12.b. The arrow marks the region of crack initiation.
