NASA/TP-97-206257

The Characteristics of Fatigue Damage in the Fuselage Riveted Lap Splice Joint

Robert S. Piascik
Langley Research Center, Hampton, Virginia

November 1997

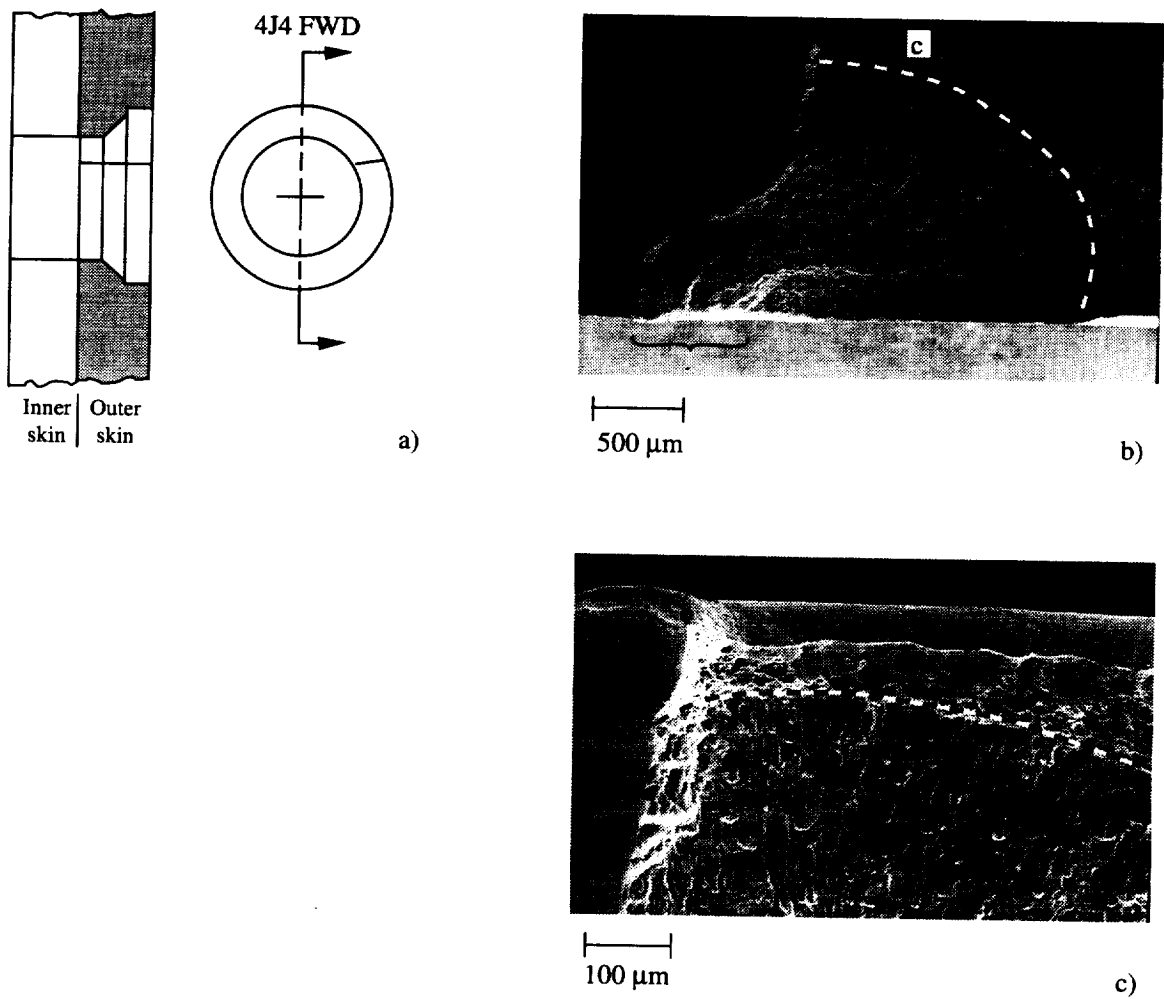
Figure 11.14 a) The schematic shows the rivet hole 4J4 configuration and the location of the outer skin fatigue crack oriented in the forward direction and about the 2 o'clock position. b) The SEM micrograph shows the fatigue crack fracture surface located at the outer skin rivet hole (left). The bracket shows the region of crack initiation and the dashed line marks the fatigue crack front. c) The SEM micrograph shows the fatigue crack front region "c" in Figure 11.14.b. The dashed line marks the fatigue crack front where it intersects the rivet hole (left). The outboard surface of the outer skin is located at the top of the micrograph.
