Comparison of Spacecraft Contamination Models with Well-Defined Flight Experiment

NAS8-40581

Progress Report for May 15, 1997 to August 15, 1997

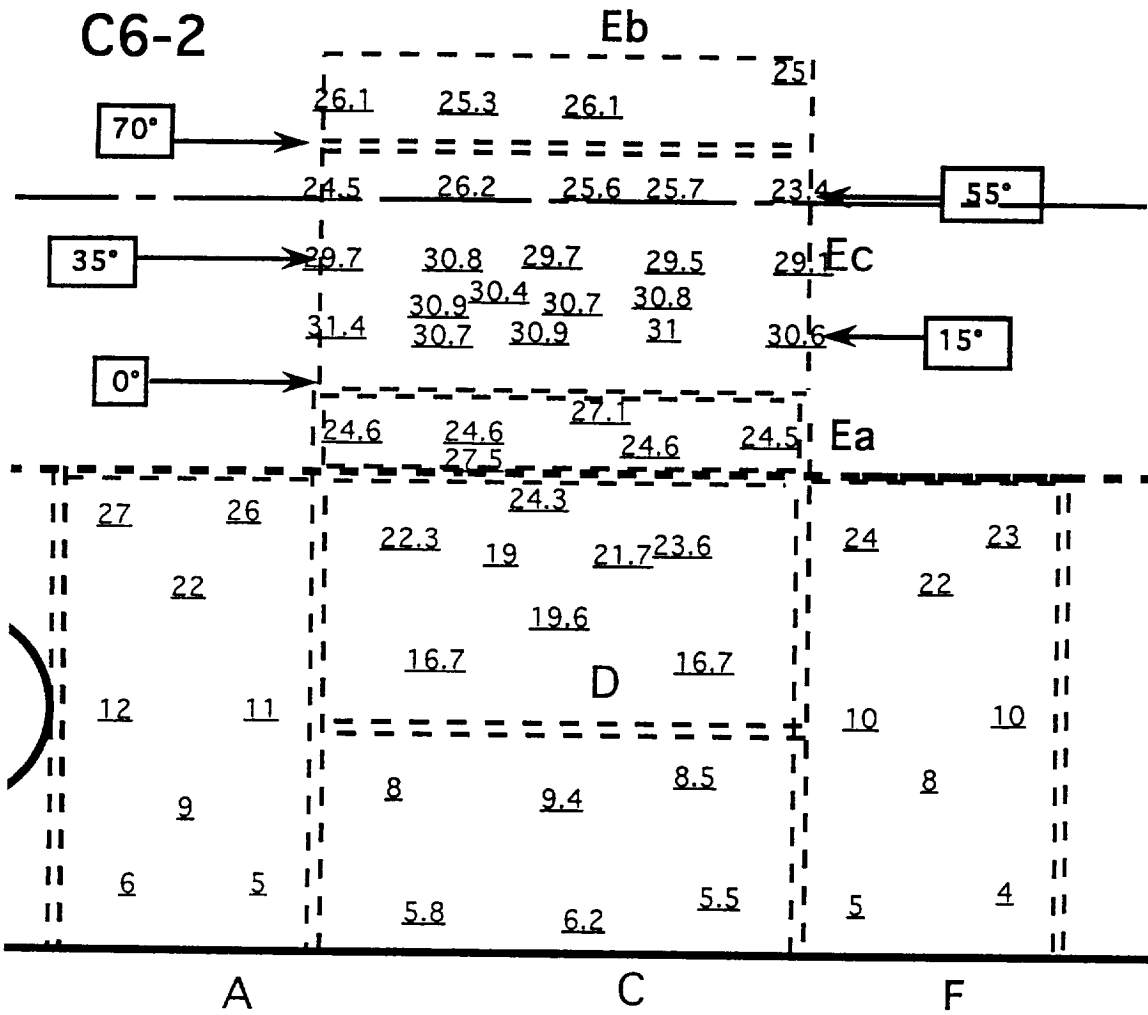
Figure 1.

Diagram showing Percent Silicon on the tray surface C6-2 at the measured locations for all individual ESCA measurements.

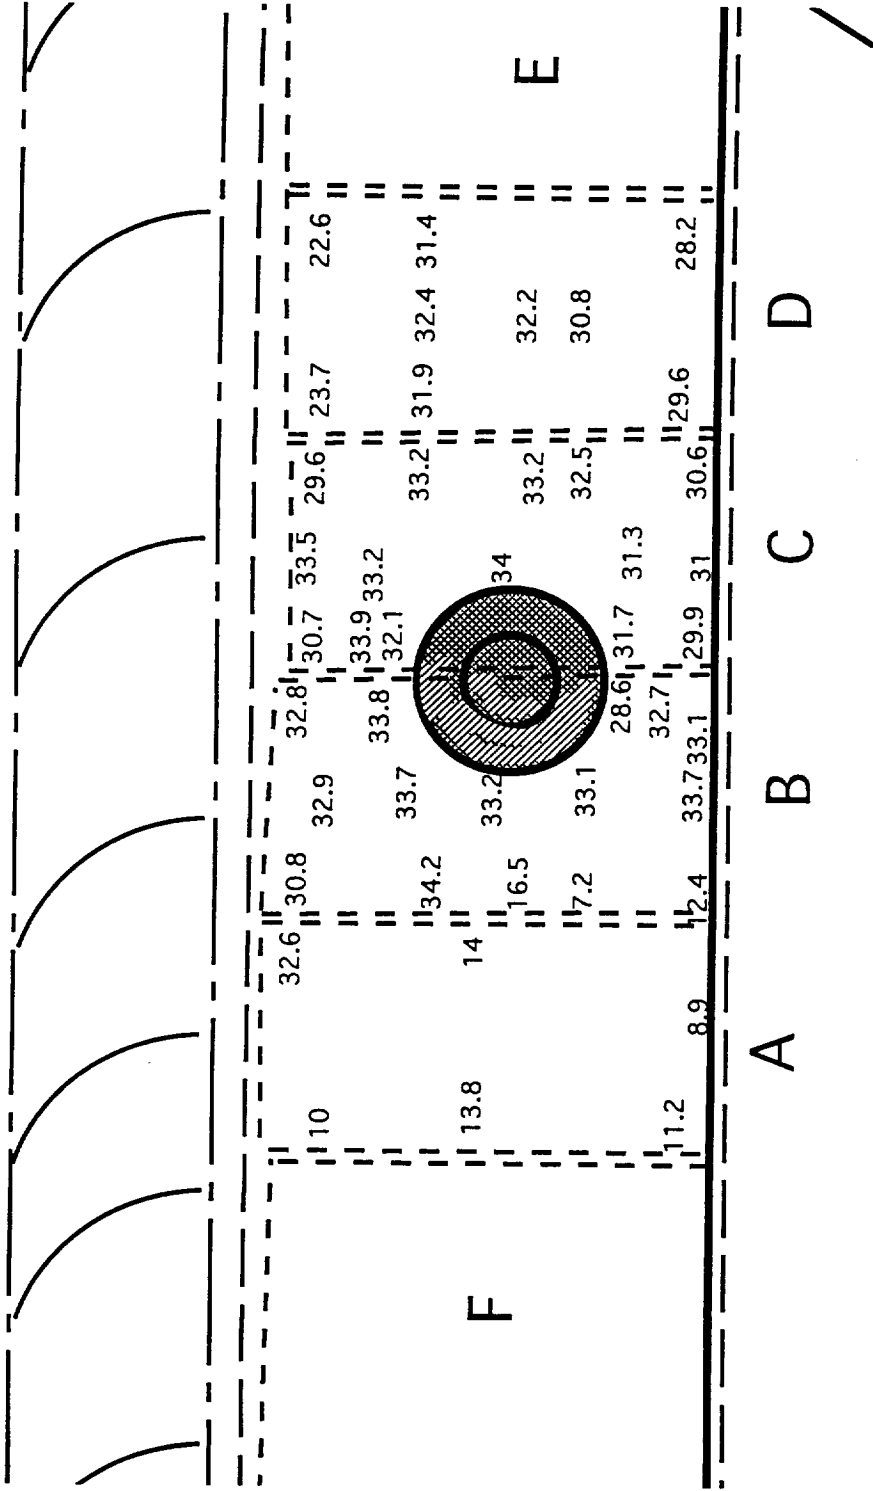
Figure 2. Diagram showing Percent Silicon on the tray surface E10-8 at the measured locations for all individual ESCA measurements.

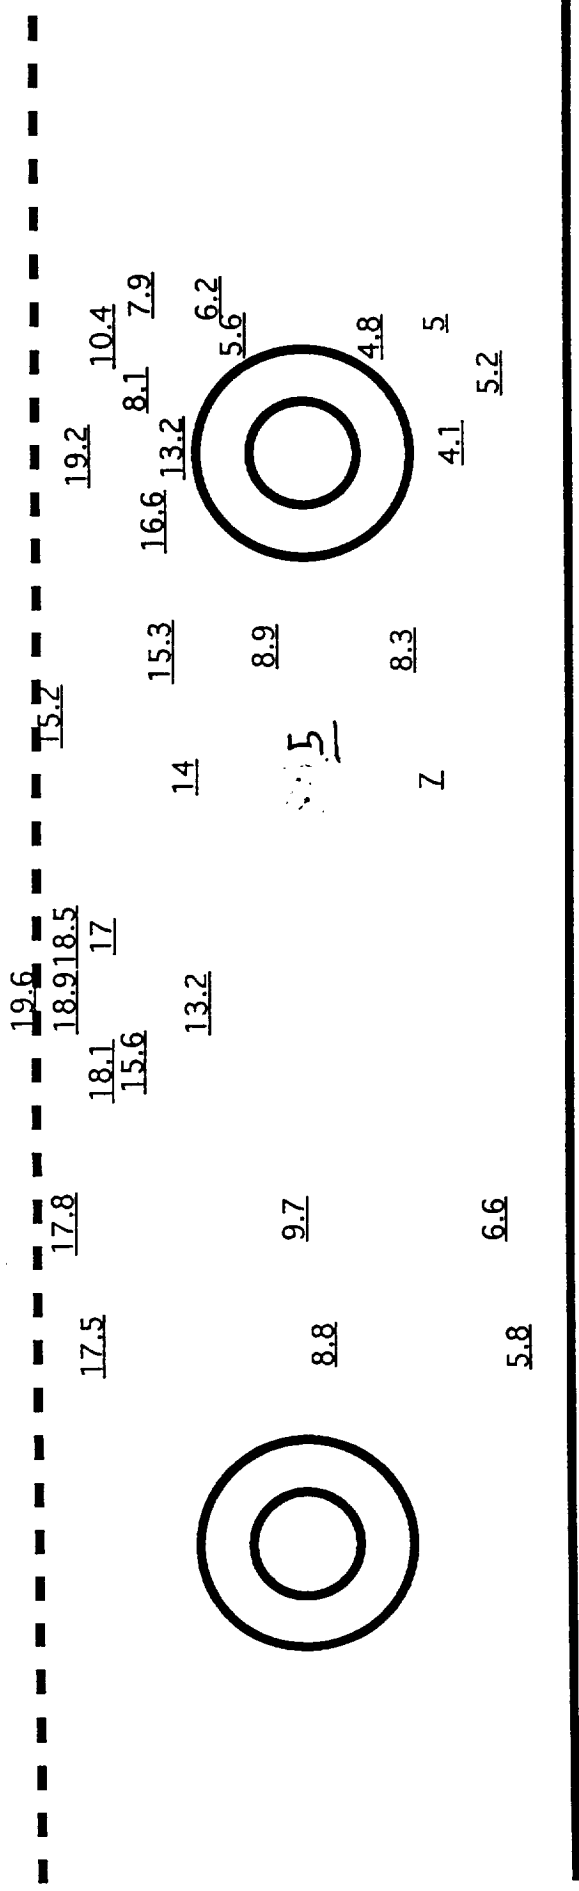
Figure 3. Diagram showing Percent Silicon on the tray surface A4-9 at the measured locations for all individual ESCA measurements.

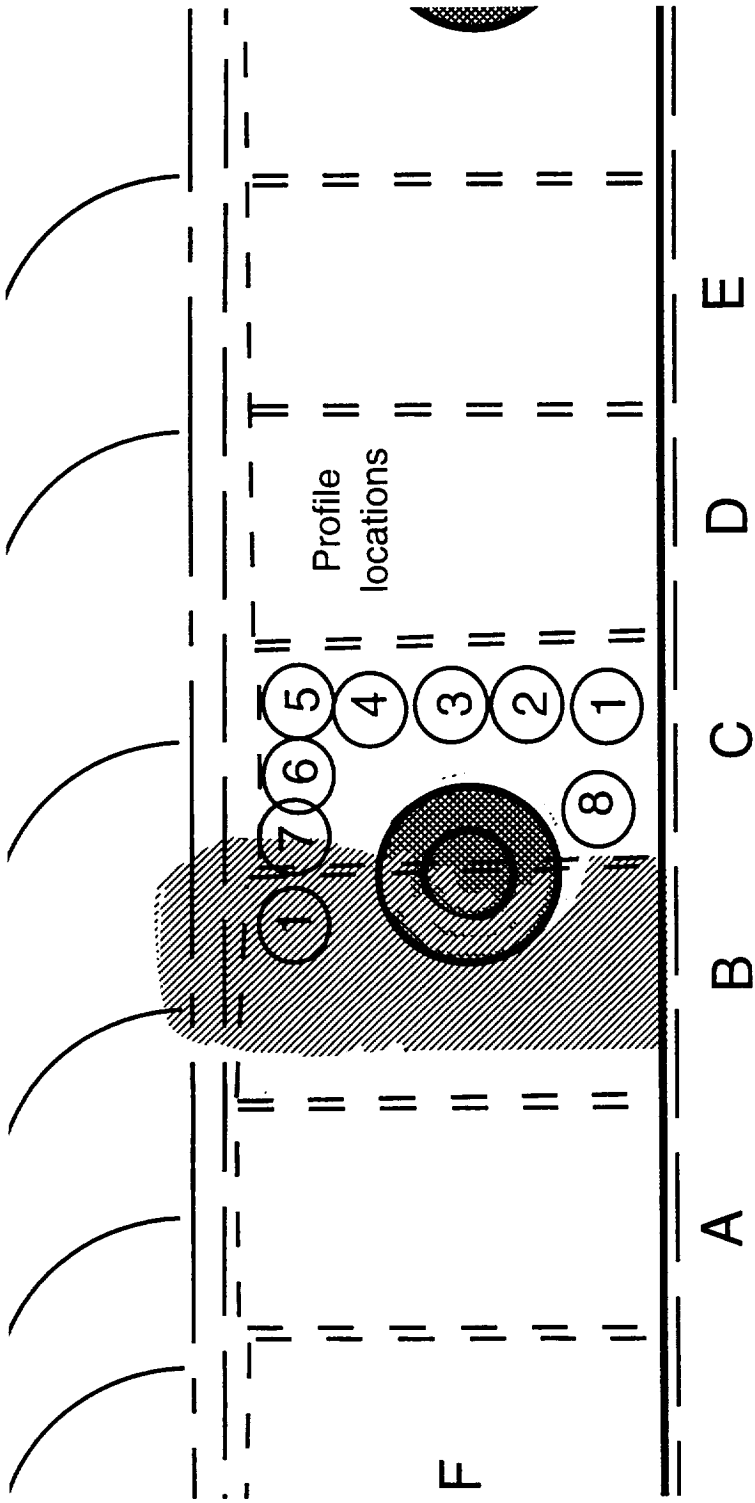
Figure 4. Locations of auger depth profiles obtained to-date from tray location E10-8.

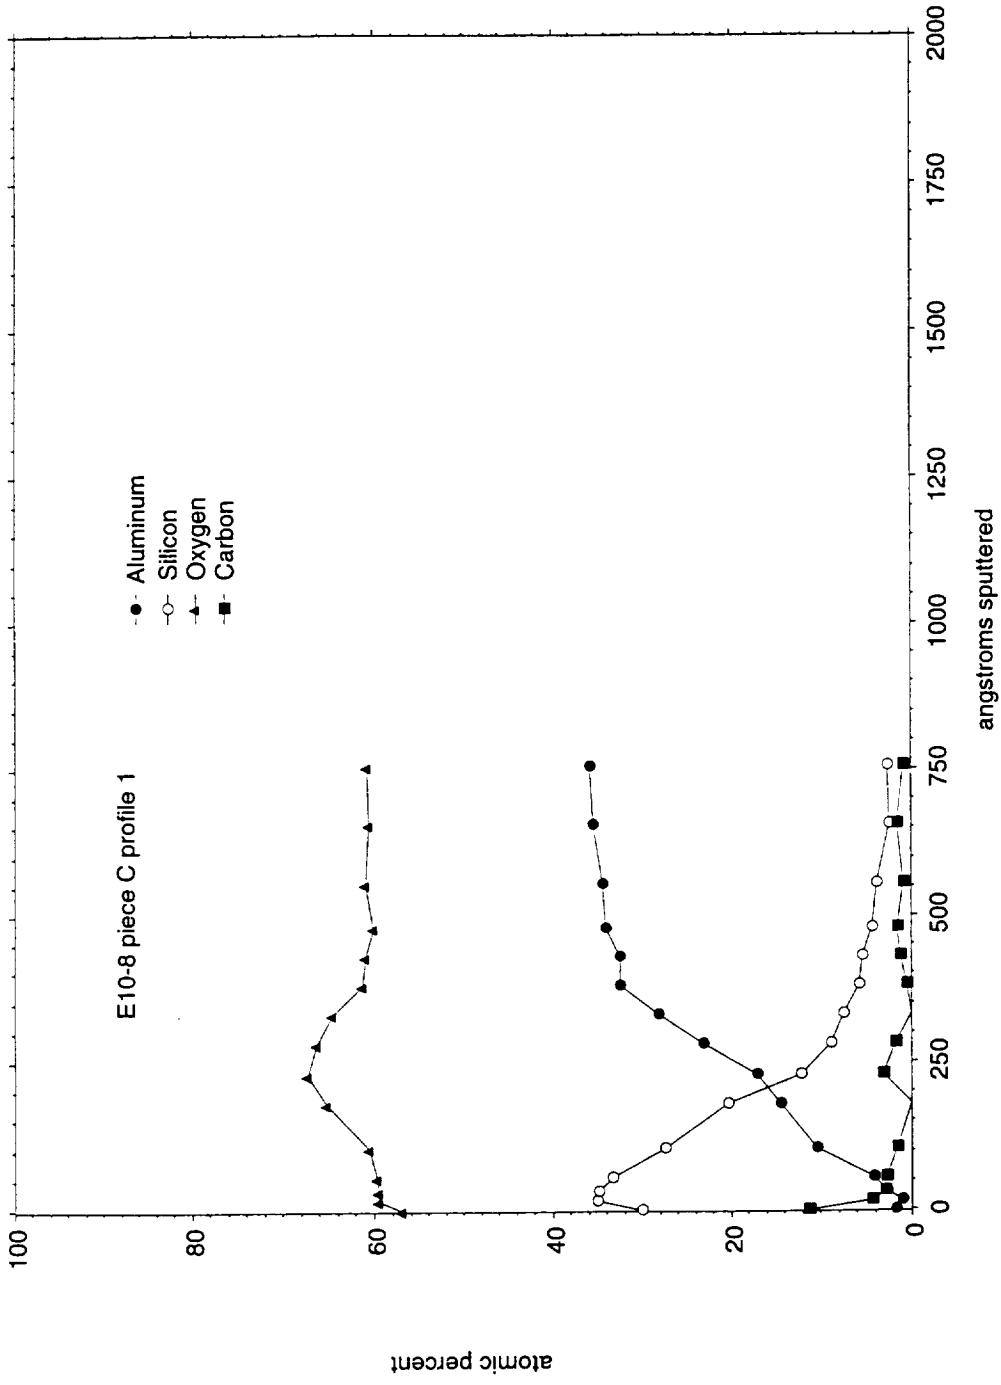
To begin to interpret these profiles it should be kept in mind that the mission time essentially goes from right to left. The first material deposited is the material with the very high carbon content. The periodicity in the intensity levels may be a function of seasonal variation of the sun orientation with respect to the surface, but this is just a guess at present. The oxygen flux rate was much greater toward the end of the LDEF flight relative to the first 3-4 years, so much of the surface oxidation could have occurred over the last few months of the flight. In summary, the contamination deposits directly across from the vents are complex mixtures of materials and the mechanisms by which they may have been changed, once deposited on the surface, are not yet clear. The next surface to be depth profiled will be from tray C6, which saw less than 1% of the atomic oxygen exposure received by tray E10. Tray C6 did see about 60% of the solar exposure level received by tray E10.

Figure 5. Depth Profile showing Silicon, Carbon, Aluminum, and Oxygen elemental %'s at location "C-1" from tray surface E10-8.

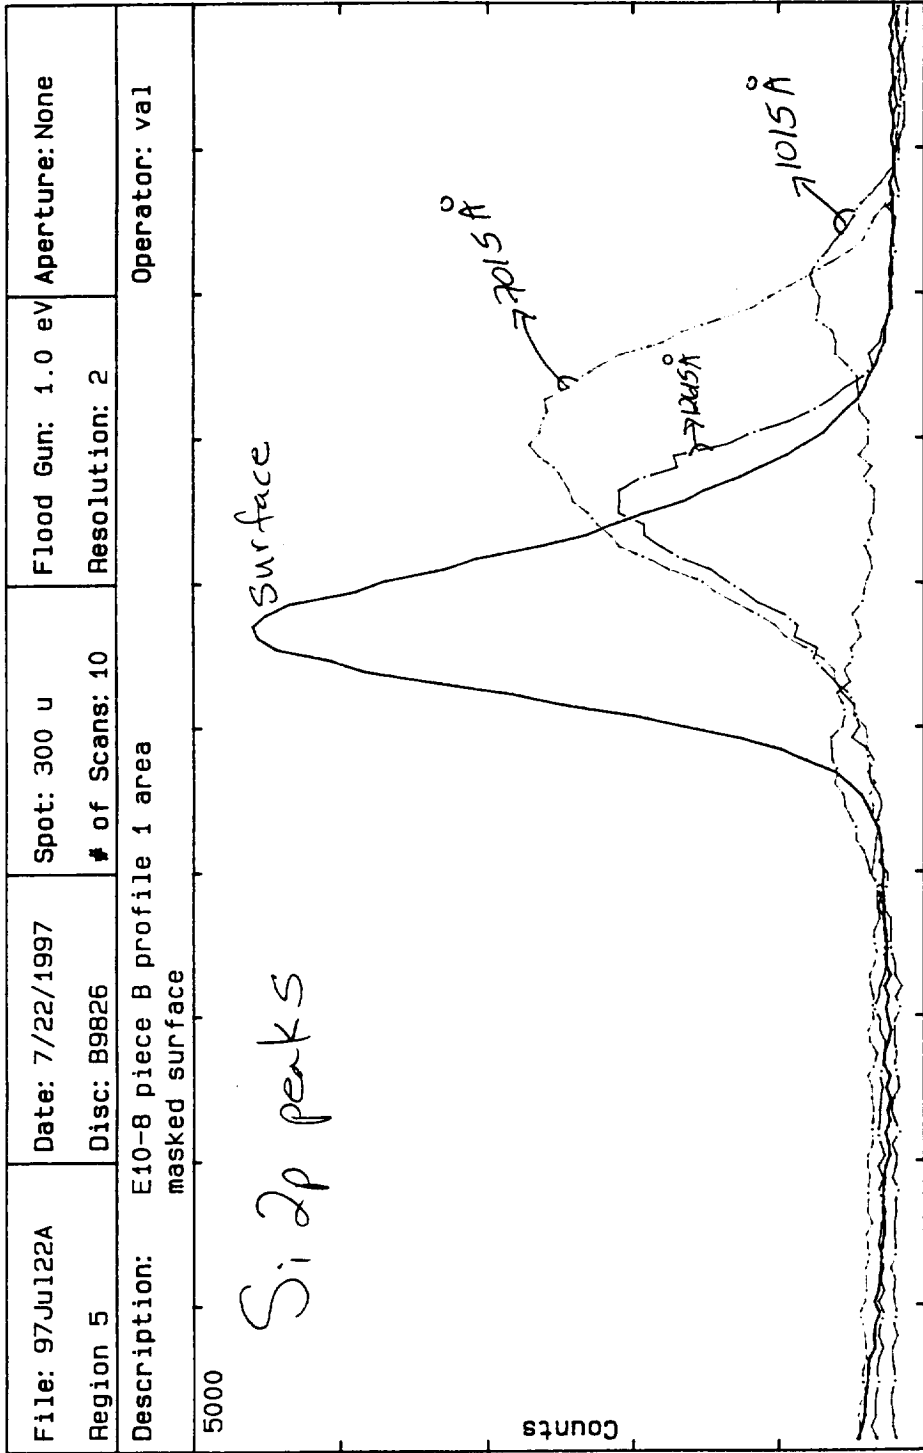
Figures 14 and 15 show peak energies and peak shapes for silicon ESCA peaks at different sputtering depths. The peak positions have not yet been corrected for possible charging effects. The position of the Carbon peak has also been measured at each of the nominal depths, but this data is not yet available. The areas under the peaks reflect the relative amounts of silicon at the different depths. Figure 15 shows the peaks normalized to identical areas in order to show the relative shapes of the peaks. The peaks at a nominal depth of 101.5 nm suggest at least two very different materials mixed at this level.

Figure 14. Silicon 2p peaks at selected sputtering depths, showing relative peak areas.

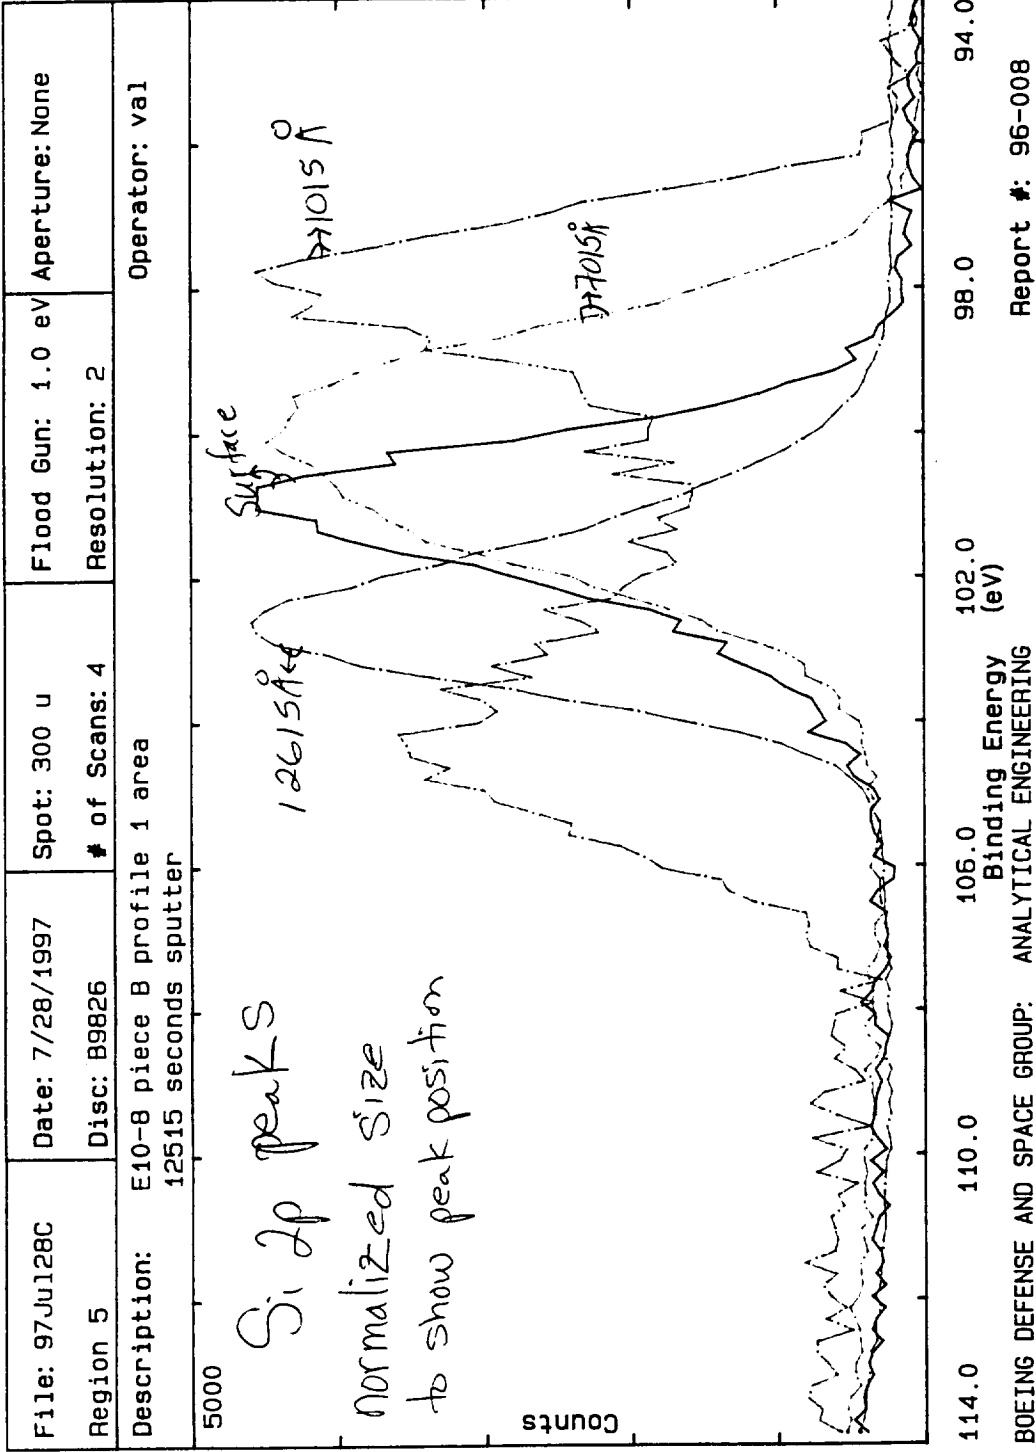
Figure 15. Silicon 2p peaks from figure 14, with areas normalized, to show peak shapes more clearly.
