Debris/Ice/TPS Assessment and Integrated Photographic Analysis of Shuttle Mission STS-94

*Process Engineering/Mechanical System Division/ET-SRB Branch,
Kennedy Space Center, Florida*

**DEBRIS/ICE/TPS ASSESSMENT
AND
INTEGRATED PHOTOGRAPHIC ANALYSIS
OF
SHUTTLE MISSION STS-94**

1 July 1997

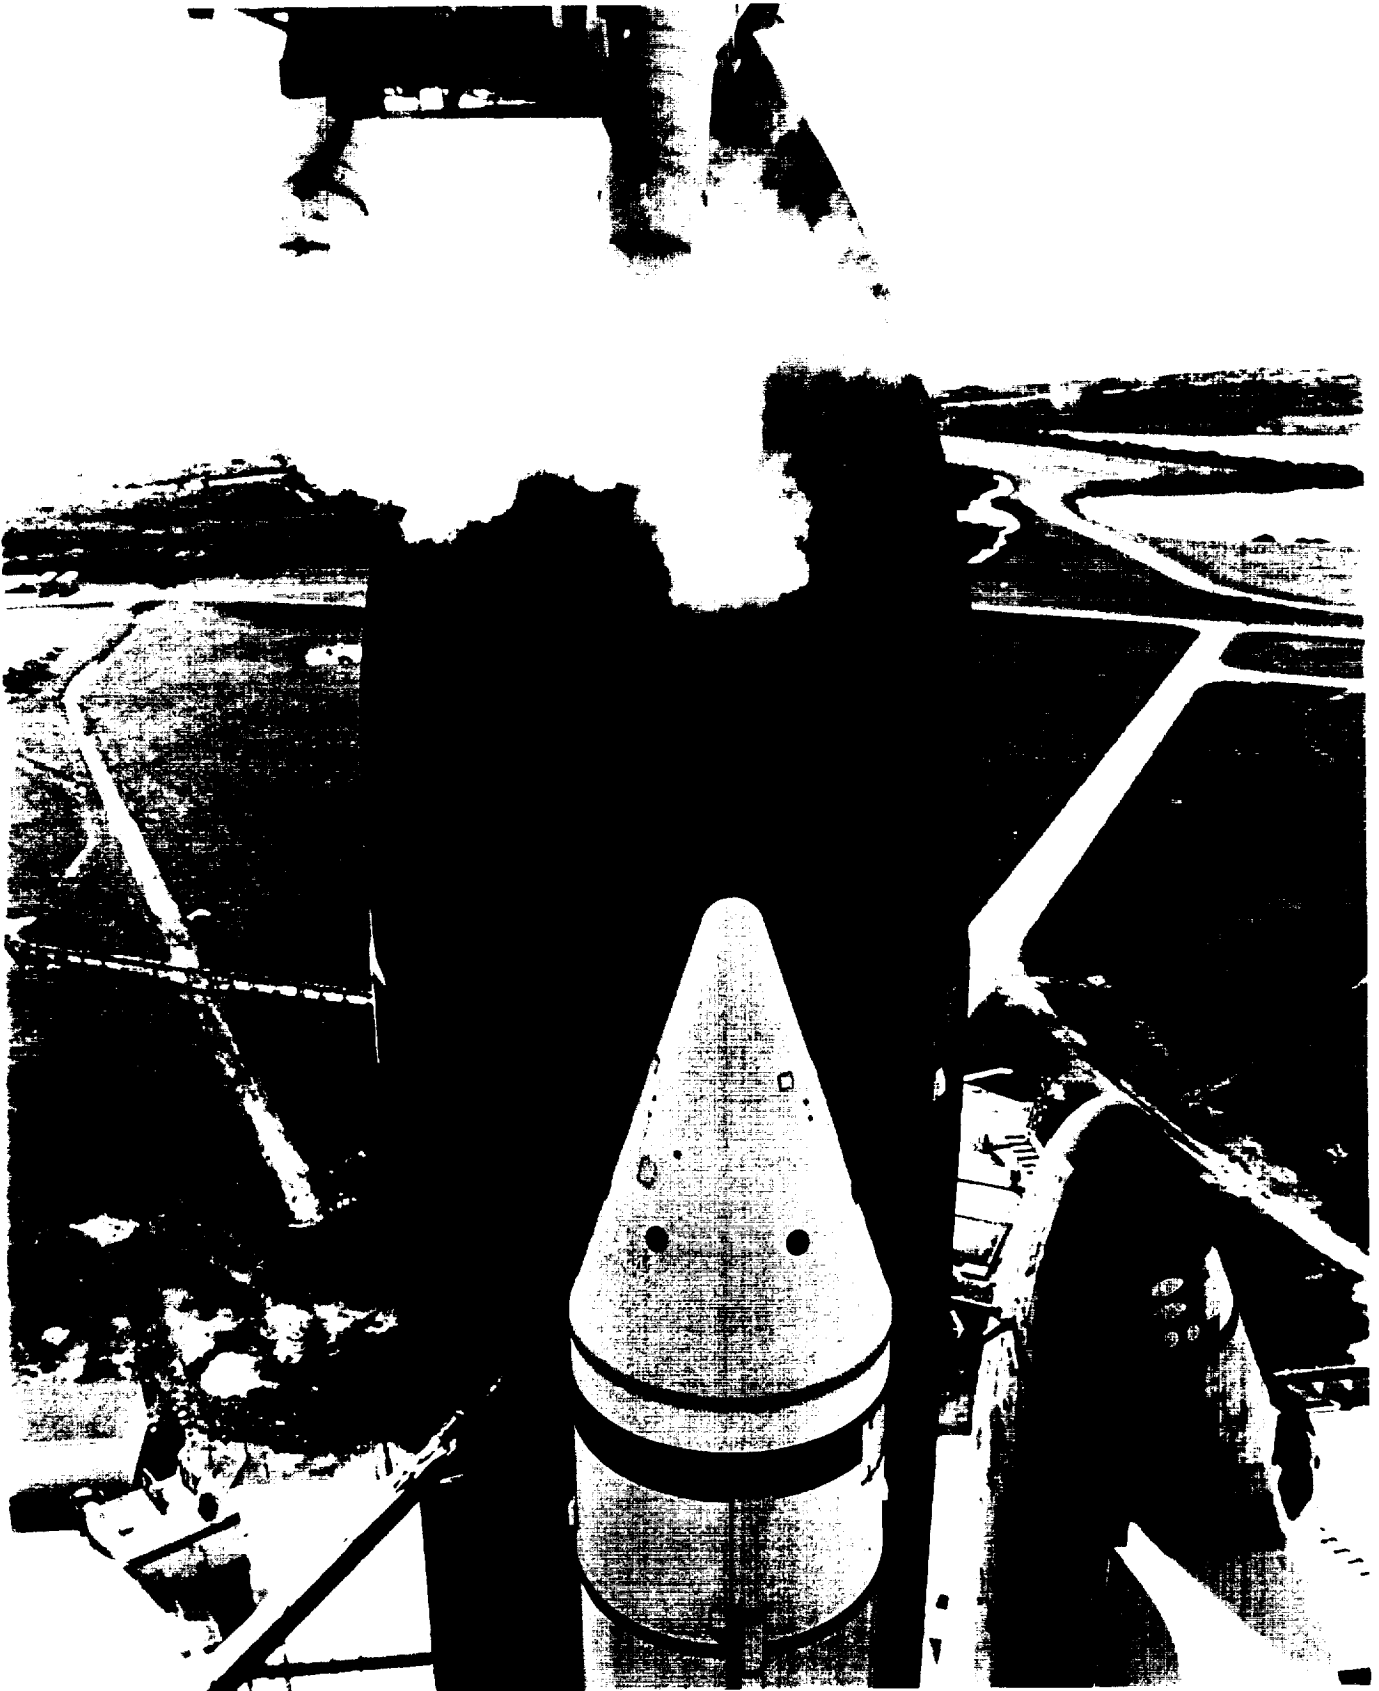
Photo 3: LO2 Tank and Intertank After Cryoload

The Final Inspection Team observed light condensate, but no ice or frost accumulations, on the LO2 tank acreage. TPS surface temperatures averaged 70 degrees F.

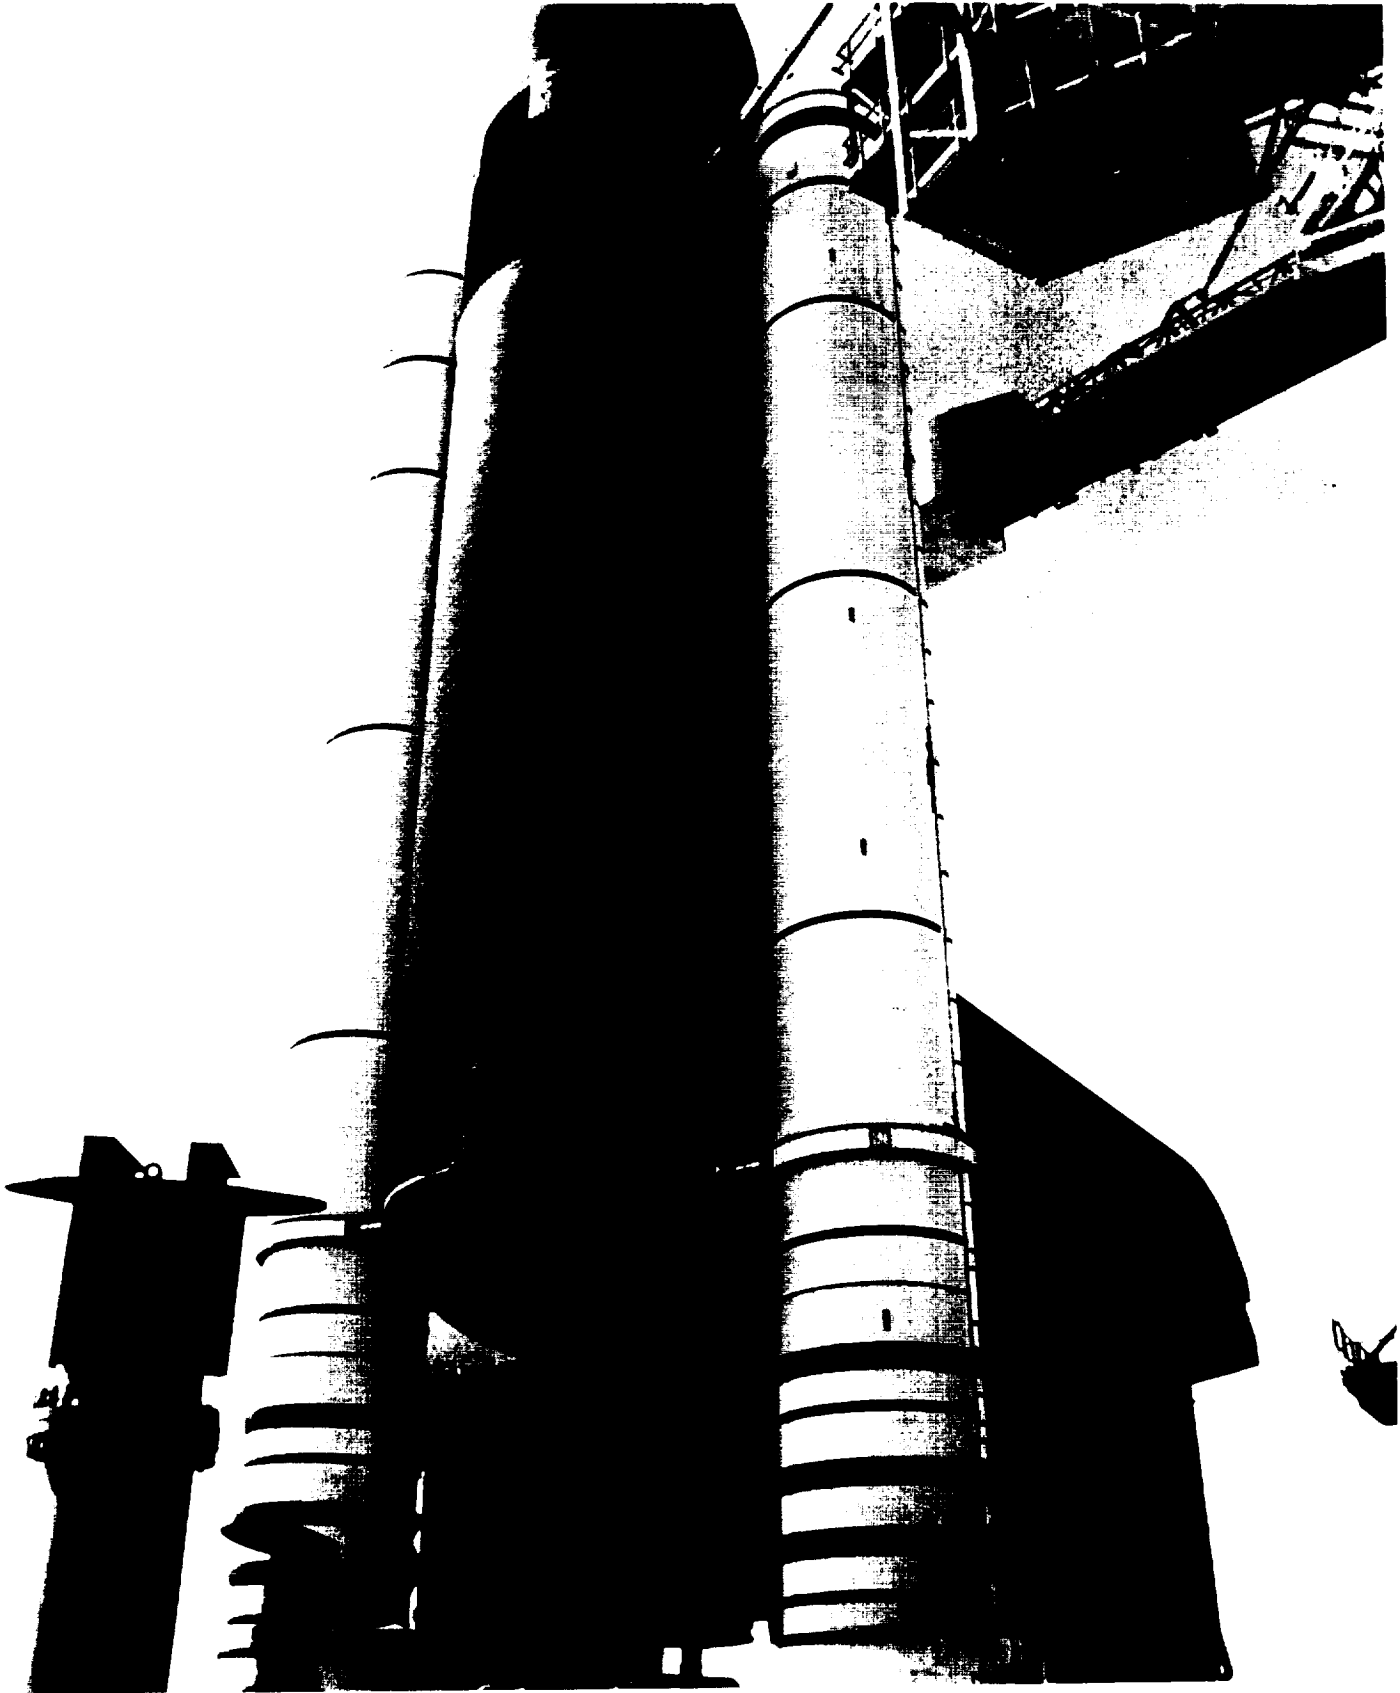
Photo 5: ET LH2 Tank Acreege

The Final Inspection Team observed light condensate, but no ice or frost accumulations, on the LH2 tank acreege. TPS surface temperatures averaged 68 degrees F.

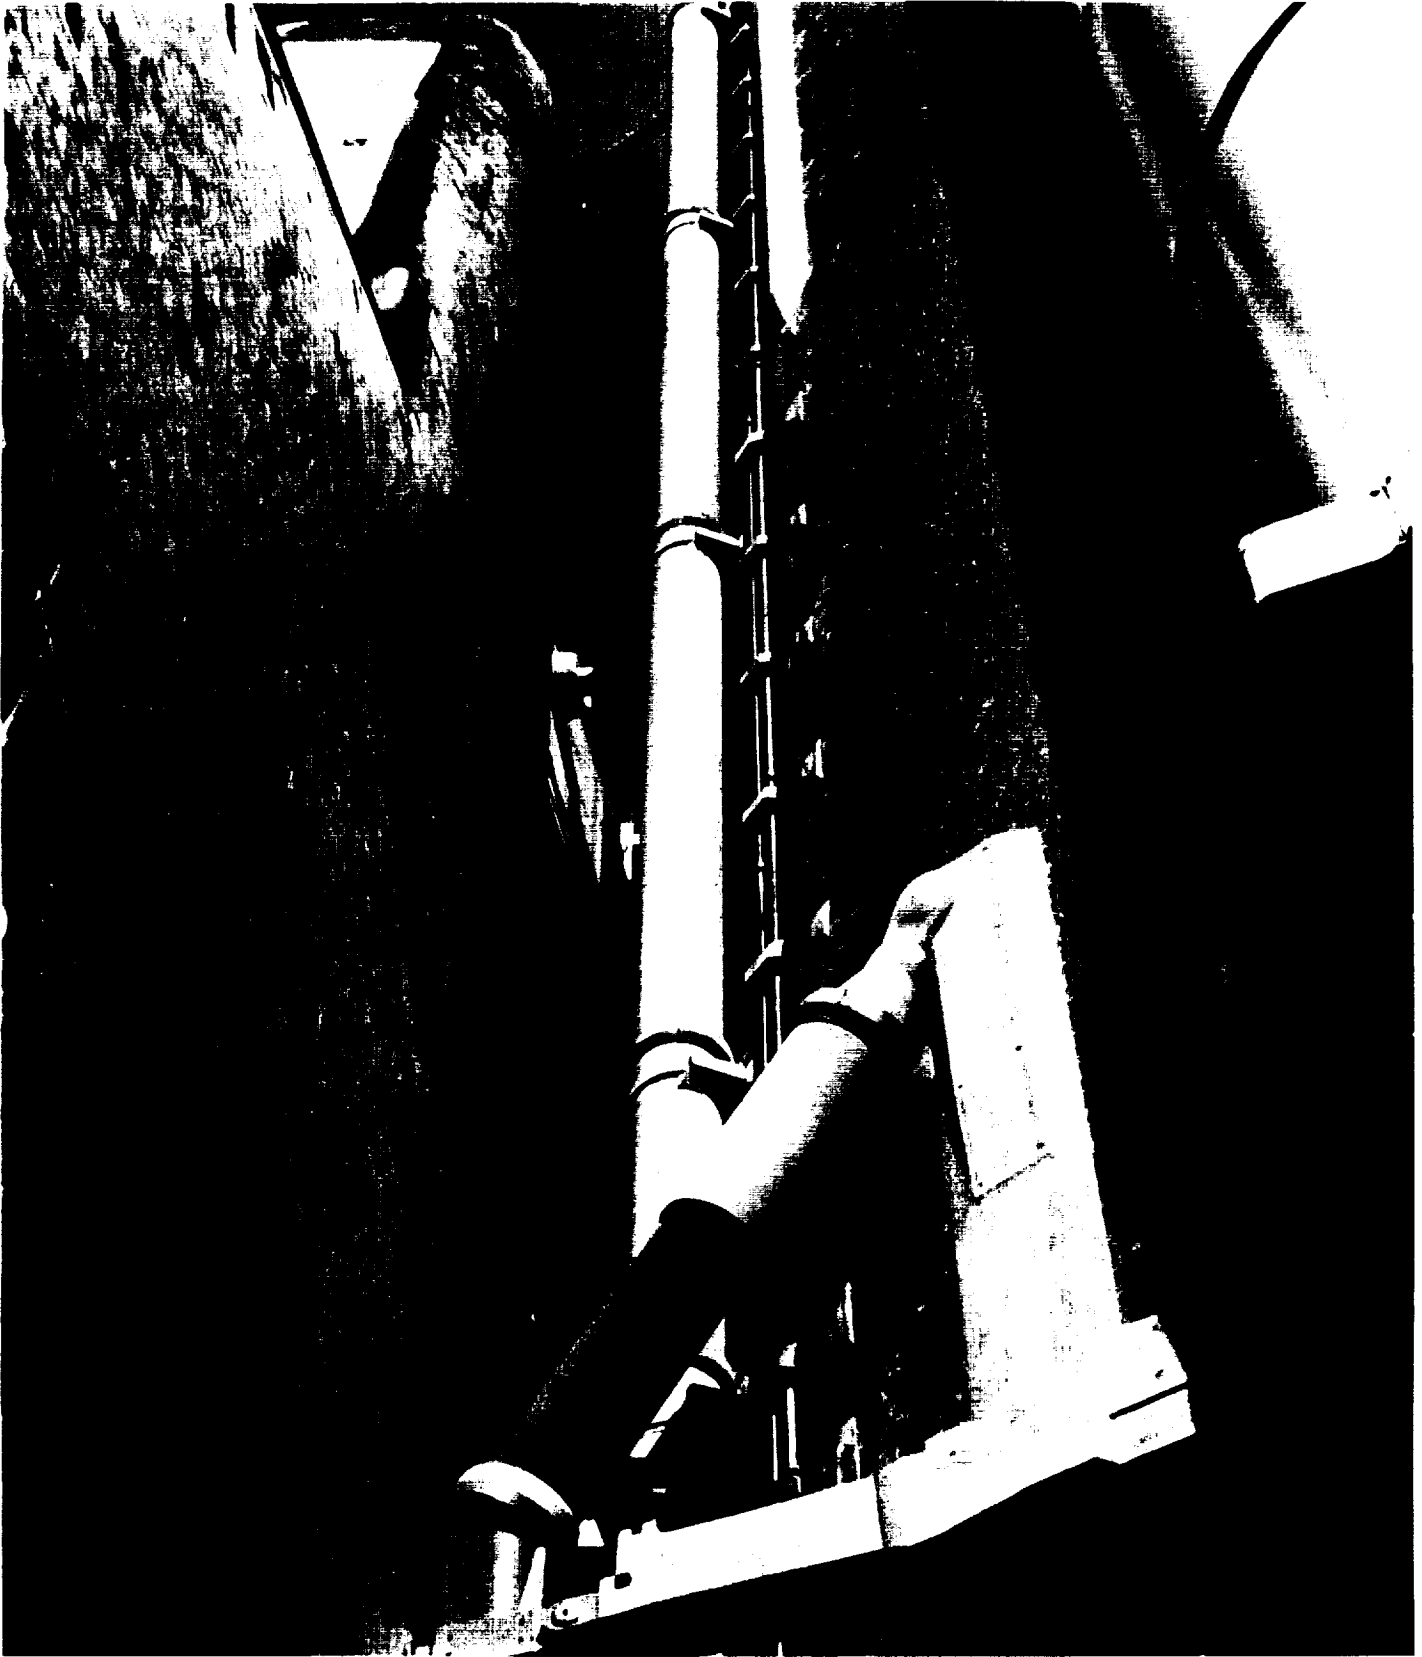
Photo 7: LH2 Feedline and +Z Side Repairs

The LH2 feedline bellows were wet with condensate. All TPS repairs on the +Z side of the LH2 tank were intact and in nominal condition.

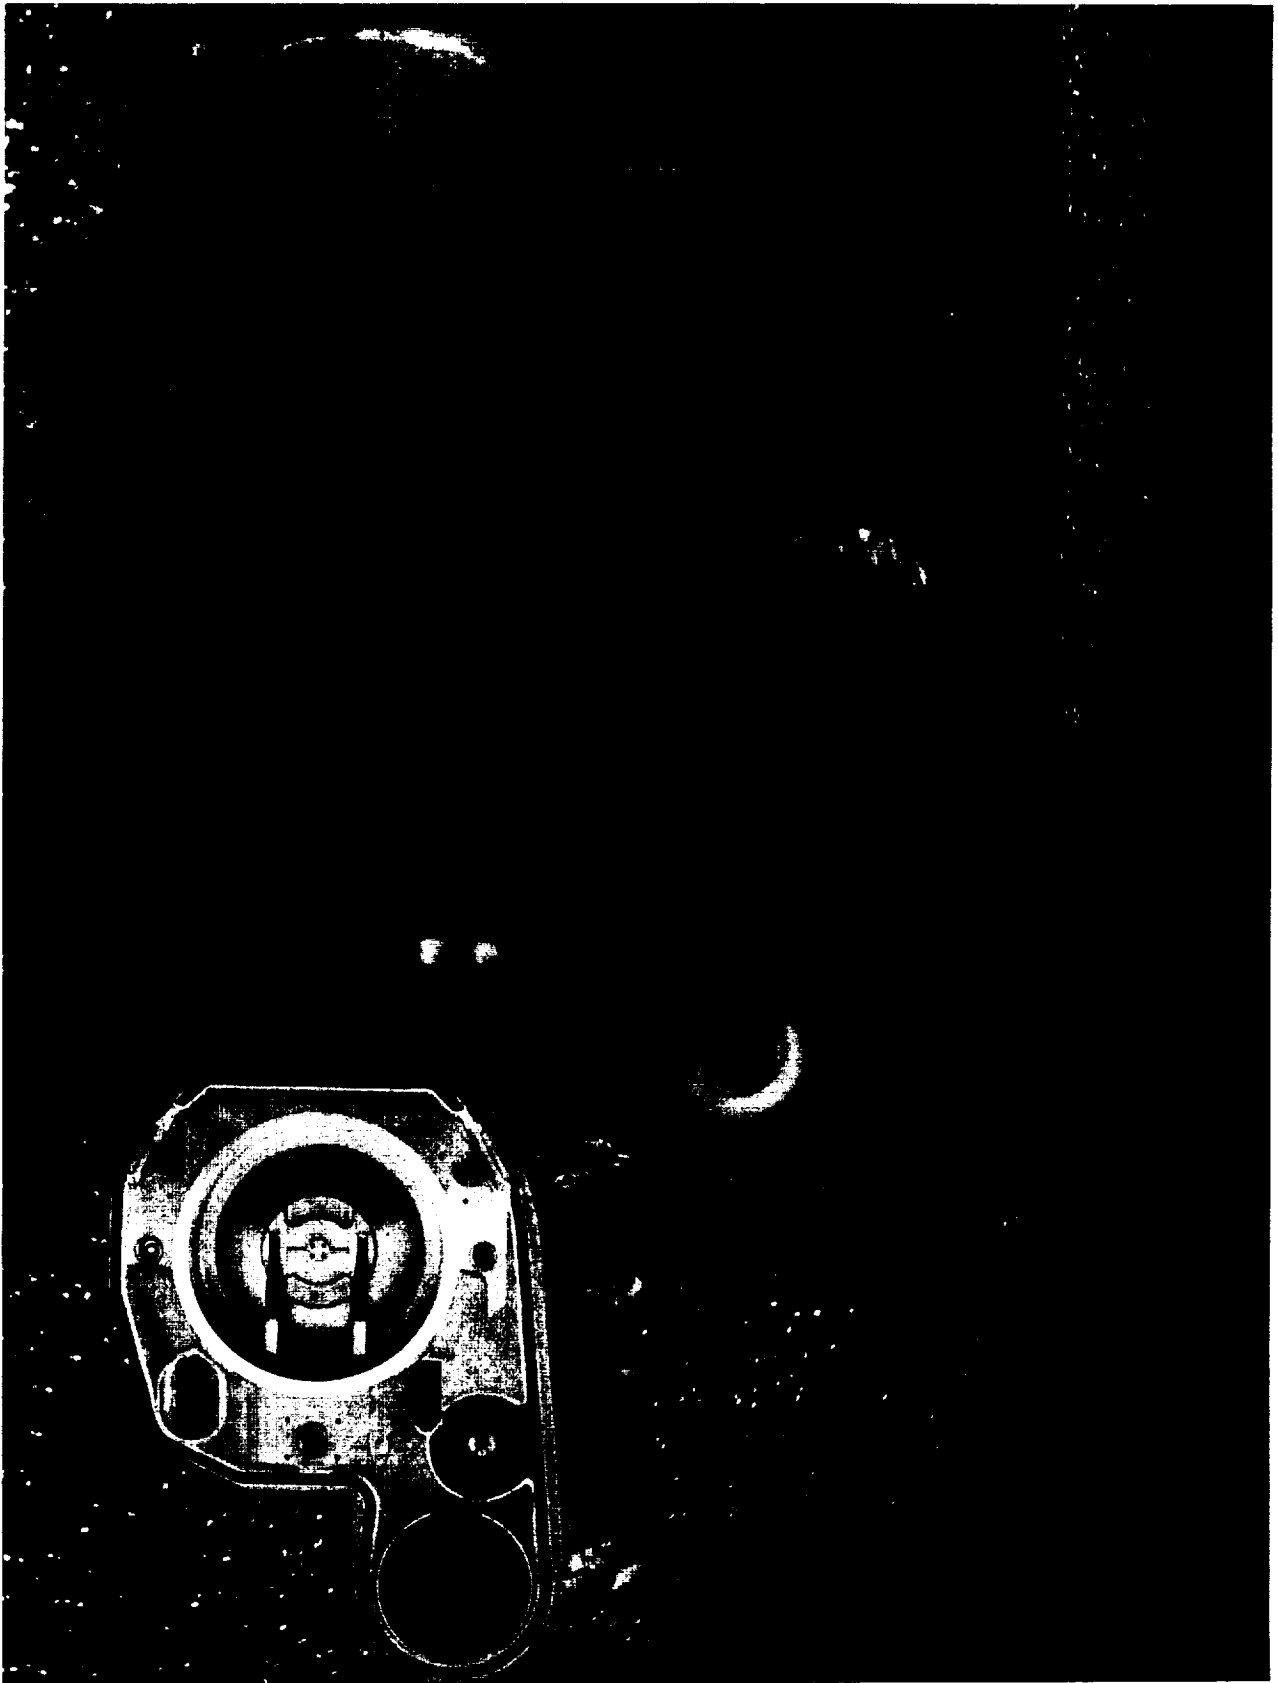
Photo 14 : ET/ORB LO2 Umbilical

The LO2 ET/ORB umbilical sustained no visible TPS damage during separation. Numerous divots and eroded areas were visible on the horizontal and vertical sections of the cable tray. The red barrier around the EO-3 fitting was dislodged.

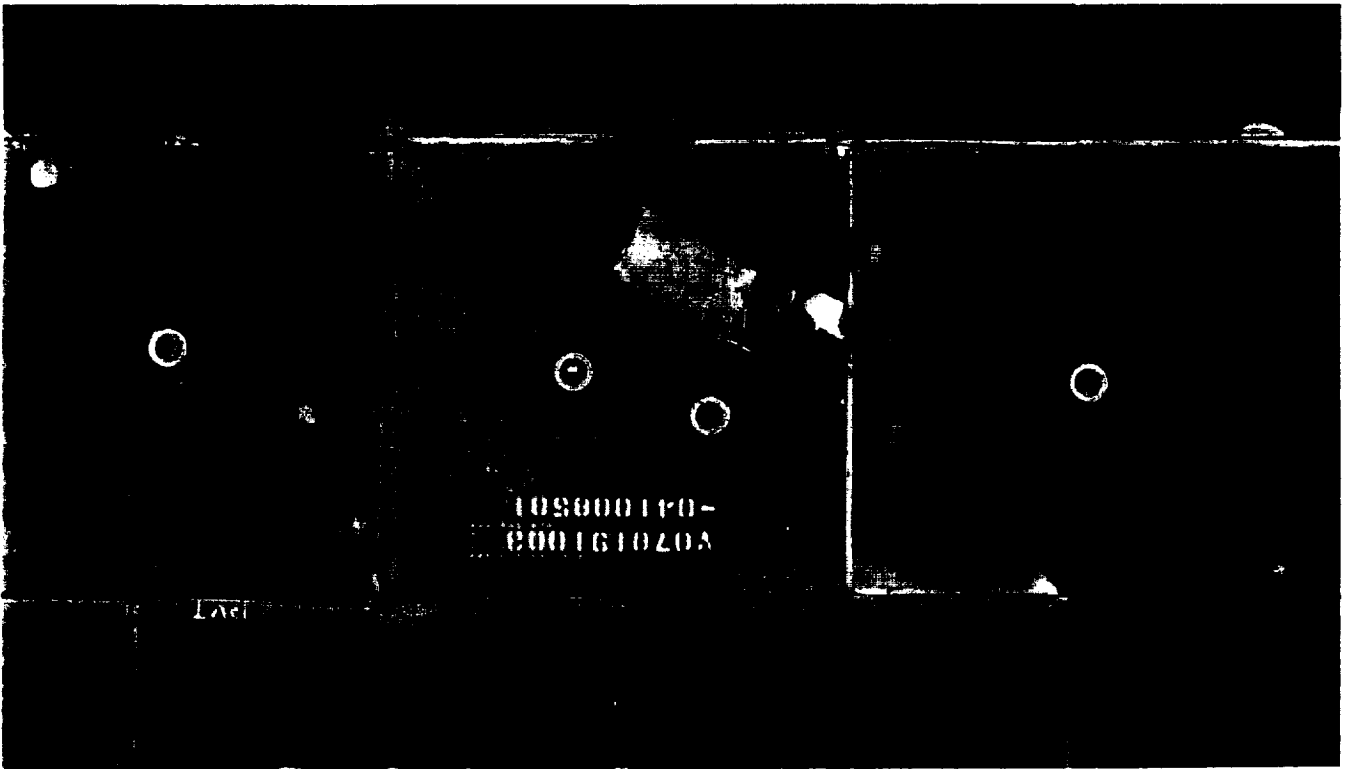
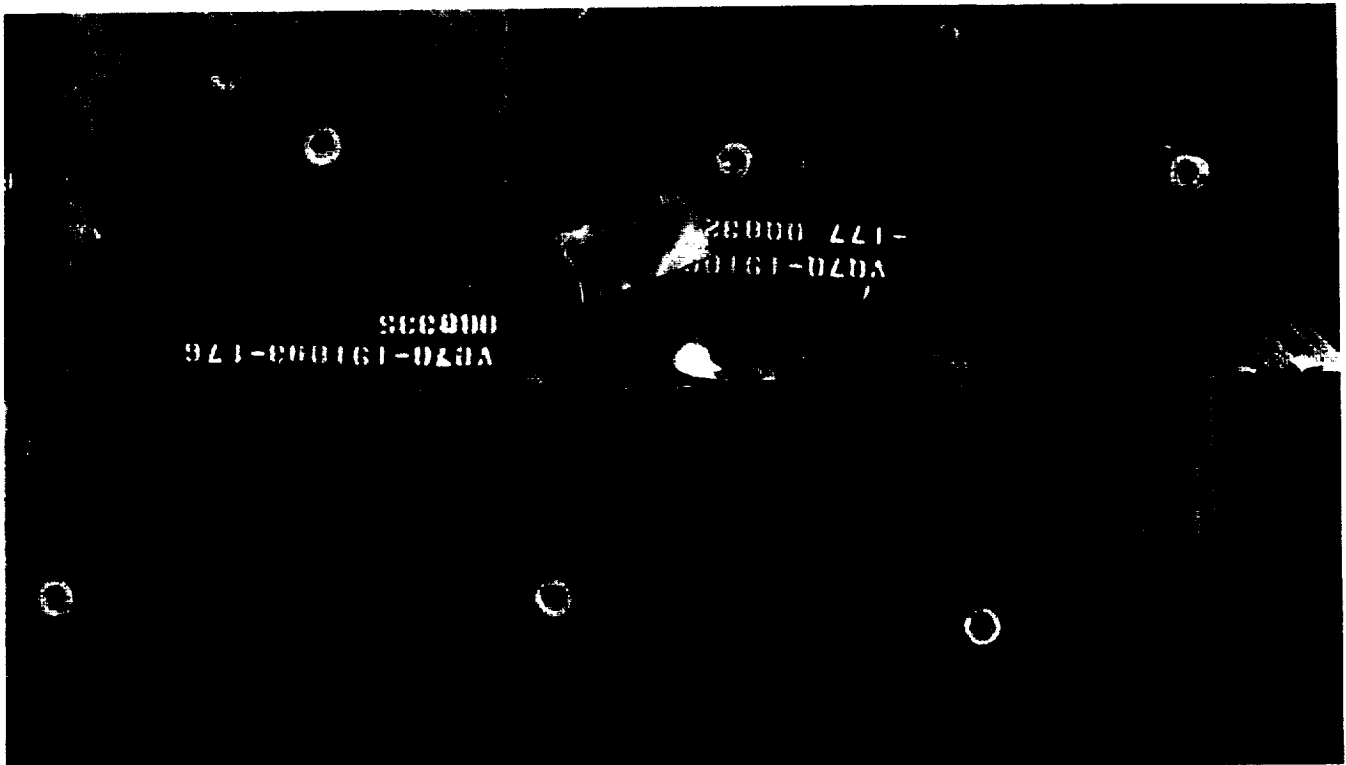
Photo 27: Tile Damage Sites Forward of Right MLG Door

Two tile damage sites forward of the right MLG wheel well (tiles 191003-041 and 191003-177) were originally thought to be candidates for micrometeorite impacts due to the 0.75-inch diameter surface openings with larger, deep internal cavities. However, closer inspection in the OPF revealed glazing and erosion, which suggested the impacts occurred during ascent.

Two tile damage sites forward of the right MLG wheel well (tiles 191003-041 and 191003-177) were originally thought to be candidates for micrometeorite impacts due to the $\frac{3}{4}$ -inch diameter surface openings with larger, deep internal cavities. However, closer inspection in the OPF revealed glazing and erosion, which suggested the impacts occurred during ascent.

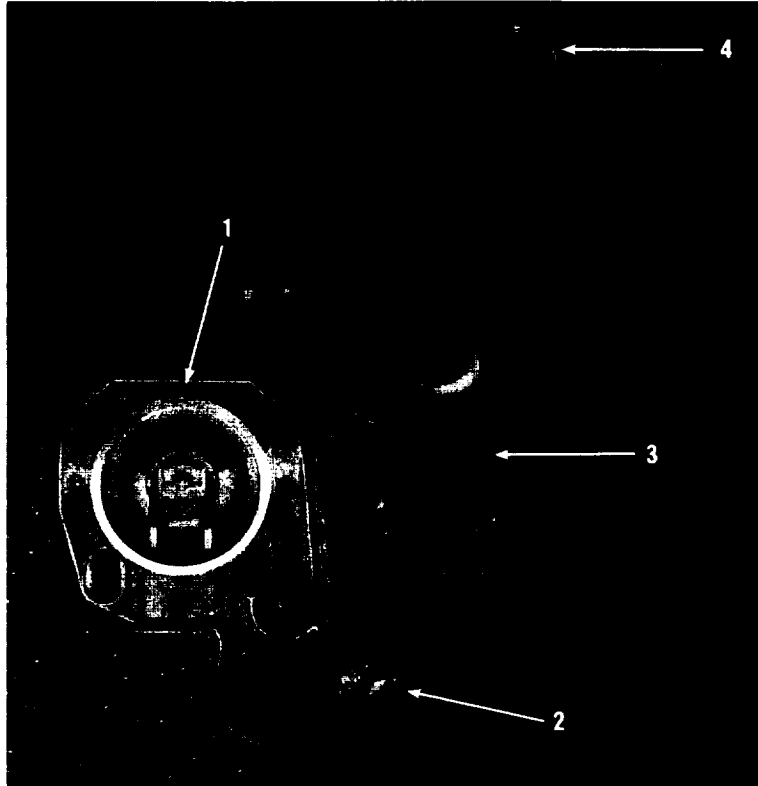
Figure 2.5.1 (A) ET/Orbiter LO2 Umbilical

One of the five lightning contact strips (12 o'clock position) appeared to be missing from the ET/Orbiter LO2 umbilical interface plate (1). KSC reported that STS-94 (ET-86) was the first vehicle to use the new "wire-mesh" electrical contact plates (lightning contact strips) on the LO2 ET/Orbiter umbilical. This new material is similar in form to umbilical foam and can give the appearance that a contact plate is missing. KSC confirmed that all five of the LO2 umbilical contact plates were intact and properly attached.

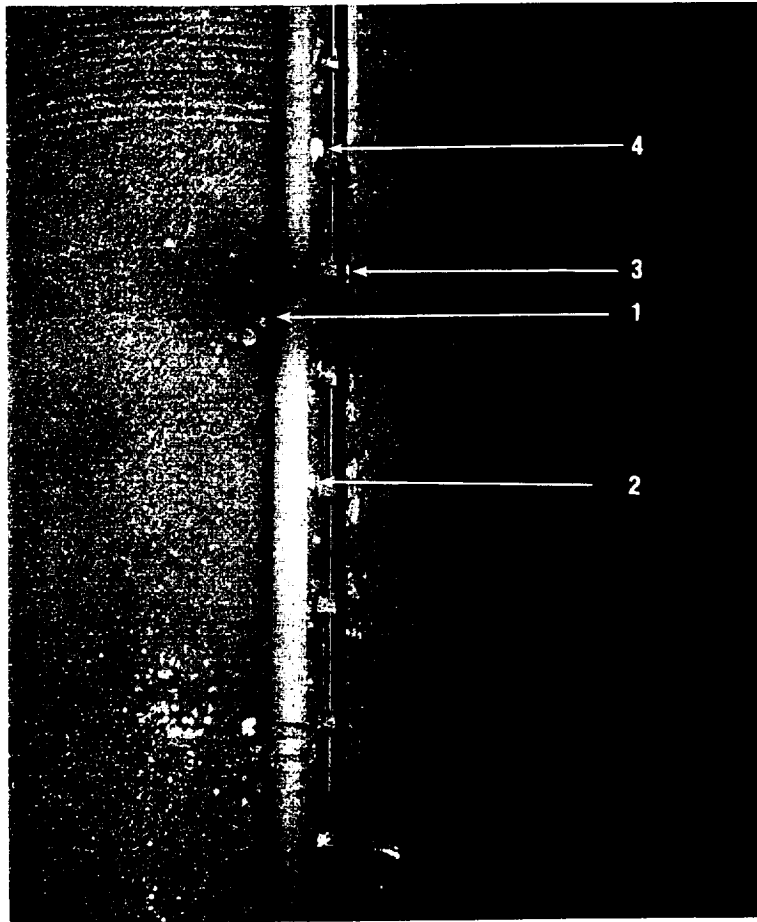
Figure 2.5.1 (B) LH2 Tank Divots

A shallow white mark (divot) approximately four inches in diameter was seen to the left of the LO2 feedline on the LH2 tank TPS at approximately station XT-1623 (1). Several divots were seen near the LH2 tank pressurization line and the LO2 feedline support brackets: a white mark (divot), approximately six inches in size, is visible between the LO2 feedline and the electric cable tray forward of the +Y thrust strut at approximate station XT 1722 (2), a 14-inch long divot was noted outboard (+Y) of the electric cable tray ramp at approximate station 1593 (3), and a 16-inch long divot was visible between the LO2 feedline and the pressurization line at approximate station XT 1528 (4).
