NASA Technical Memorandum 110204

Structural Test Documentation and Results for the McDonnell Douglas All-Composite Wing Stub Box

Dawn C. Jegley and Harold G. Bush
Langley Research Center, Hampton, Virginia

April 1997

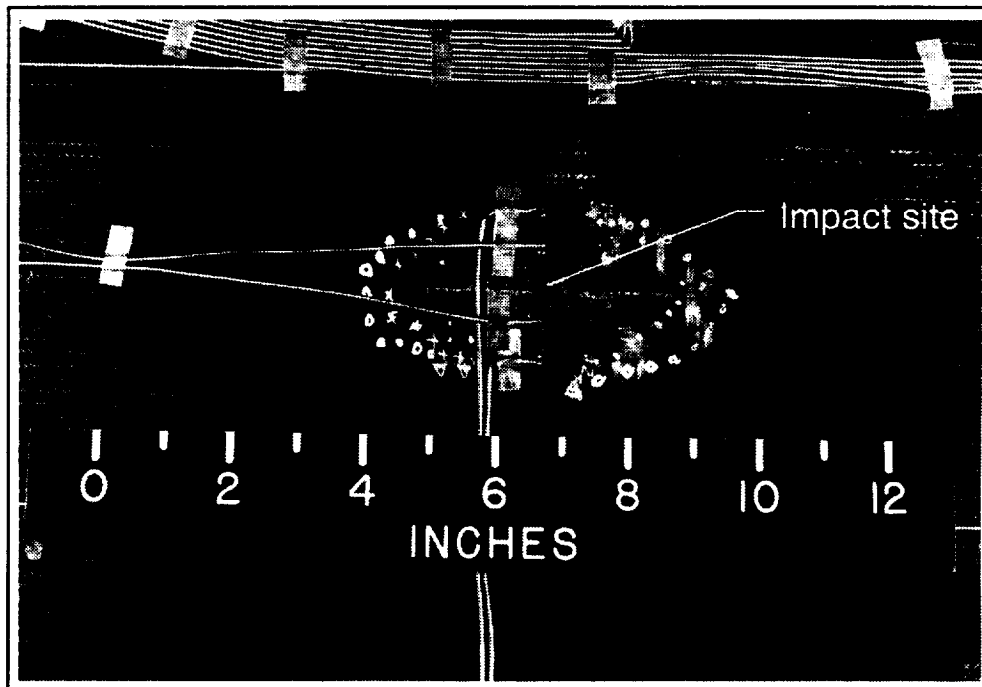
Figure 20. Visible impact damage region DET1.

In order to limit the dent depth to 0.1 inches, the damage was inflicted by a series of impacts at the same location. Four impacts were required to inflict the required dent depth. After each impact, the dent depth was measured and the region of skin around the impact site was nondestructively evaluated by ultrasonic scanning to determine the area of the structure which had been damaged. The impact energies of the four impacts and their effects are shown in table 1. After the fourth impact, the dent was 0.093 inches deep and the damage area was defined by an oval with an axial dimension of 5.75 inches and a width dimension of 2.75 inches. No further impacts were made since further growth in the size of the damage area was not desired. The stringer flanges and blades of the upper cover panel were not damaged in the impact process. A photograph of the damaged region, with the region of damage outlined by white marks, is shown in figure 20. Damage was easily visible by eye.

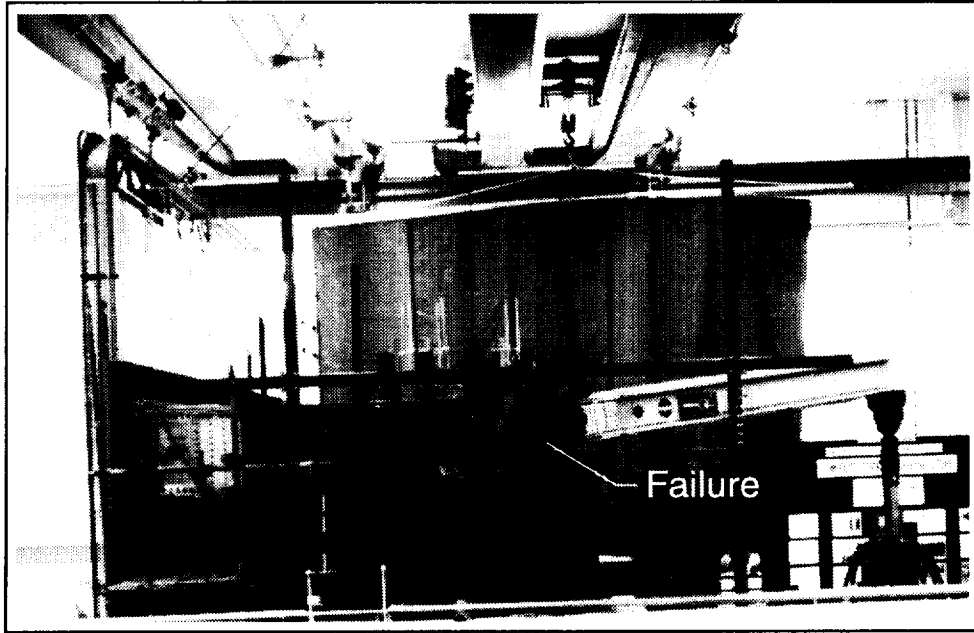
Figure 63. Side view of test specimen after failure.

The maximum load supported by the structure at failure was 154 kips. A view of the entire structure after failure is shown in figure 63. Failure occurred across the entire width of the upper cover panel and into both spars. The lower cover panel skin remained intact. Photographs of the failures in the upper cover panel, and in the stringers between ribs 7 and 8 are shown in figures 64 and 65, respectively. Two independent failures occurred in the wing stub box. The first failure was in the unsupported region at the runout of stringer 6 where it terminates at rib 7 at a load of approximately 140 kips. During the test, the flanges and web of the stringer failed and the skin remained intact. This stringer has extensive damage in the form of delaminations between the skin and flange, broken stitches, bolts pulled through the flange, and cracking of the blade, as shown in figure 65b. The second failure was catastrophic and initiated at the nondetectable impact damage site at the runout of stringer 7. This failure began at a load of approximately 145 kips. This failure resulted in a crack that runs across the upper cover panel through impact damage site NDT2, as shown in figure 66, and across the upper cover panel into the spars. Failed stringers aft of the impact site are shown in figure 65a.

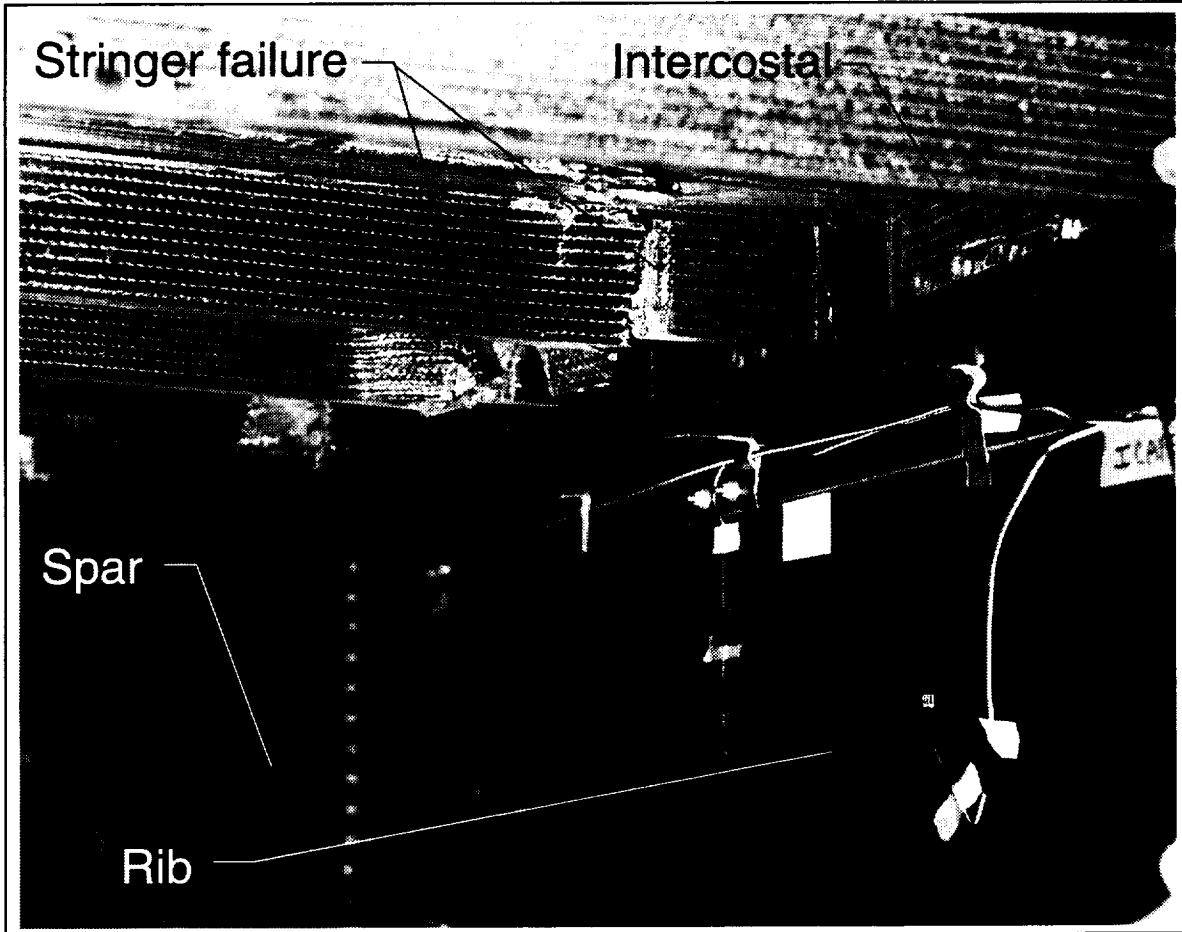
a) Failed stiffeners in upper cover panel

Delamination between the flange of stringer 5 and the upper cover panel skin inboard and outboard of rib 7 were also found, although the stitches between the flange and skin remained largely intact. Stringer 5 is on one edge of the unsupported skin region. This type of damage was not found in stringer 7, which is on the other edge of the unsupported skin region.
