NASA Technical Memorandum 110302

Compression Response of a Sandwich Fuselage Keel Panel With and Without Damage

David M. McGowan and Damodar R. Ambur
Langley Research Center, Hampton, Virginia

February 1997

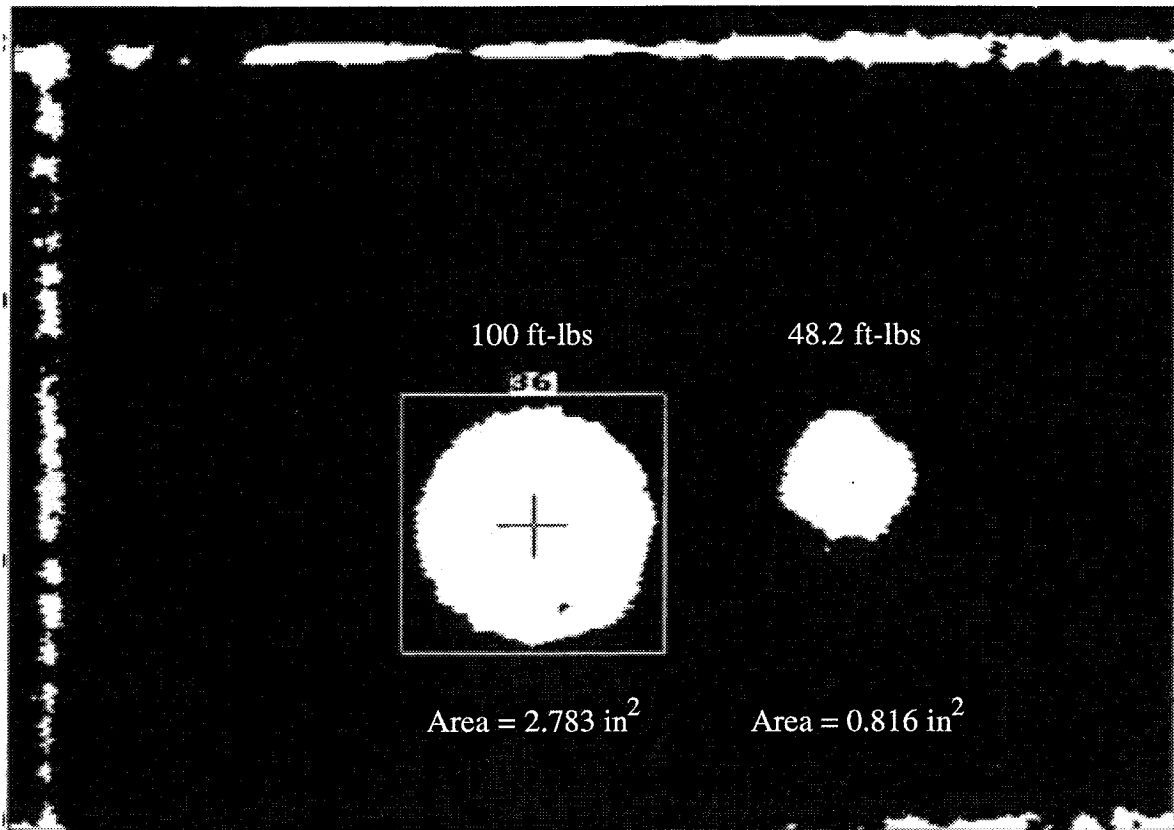
Figure 11. Ultrasonic C-scan images of impact damage at the thick end of the FK1 remnant.

of 100 ft-lbs. Although this is a very small dent, the damaged area resulting from this impact is significant. Ultrasonic C-scan images of this impact site and the 48.2 ft-lb impact site are shown in Fig. 11. As indicated in Fig. 11, the projected damage area for the 100 ft-lb impact energy is 2.789 in². Measured values of the damage area at the impact sites are plotted as a function of the impact-energy level in Fig. 12 for the thick and thin ends of the remnant. This figure is similar to Fig. 10 in that the measured values are represented by the open symbols, and cubic splines fit through these data points are represented by curves. As shown in Fig. 12, a considerable amount of damage occurs for impact energies well below 100 ft-lbs. The damage area increases as the impact-energy level is increased from 30 ft-lbs up to 100 ft-lbs. At the thin end, significant damage first occurs at 20 ft-lbs of impact energy. However, the damage area increases as the impact-energy level is increased from 20 ft-lbs to 80 ft-lbs, and it approaches a constant value for impact-energy levels greater than 80 ft-lbs. The impact-energy levels at which damage initiation is indicated in Fig. 9 is higher than the impact-energy levels for the formation of damage in the specimen. Visual inspection of the thin-end impact sites impacted at these higher impact energies showed a significant increase in surface damage. Typical shear failures across the outer $\pm 45^\circ$ plies were evident at impact energies of 90 and 100 ft-lbs. These results indicate that penetration into the laminate at the thin end was beginning to occur at impact-energy levels greater than 90 ft-lbs.

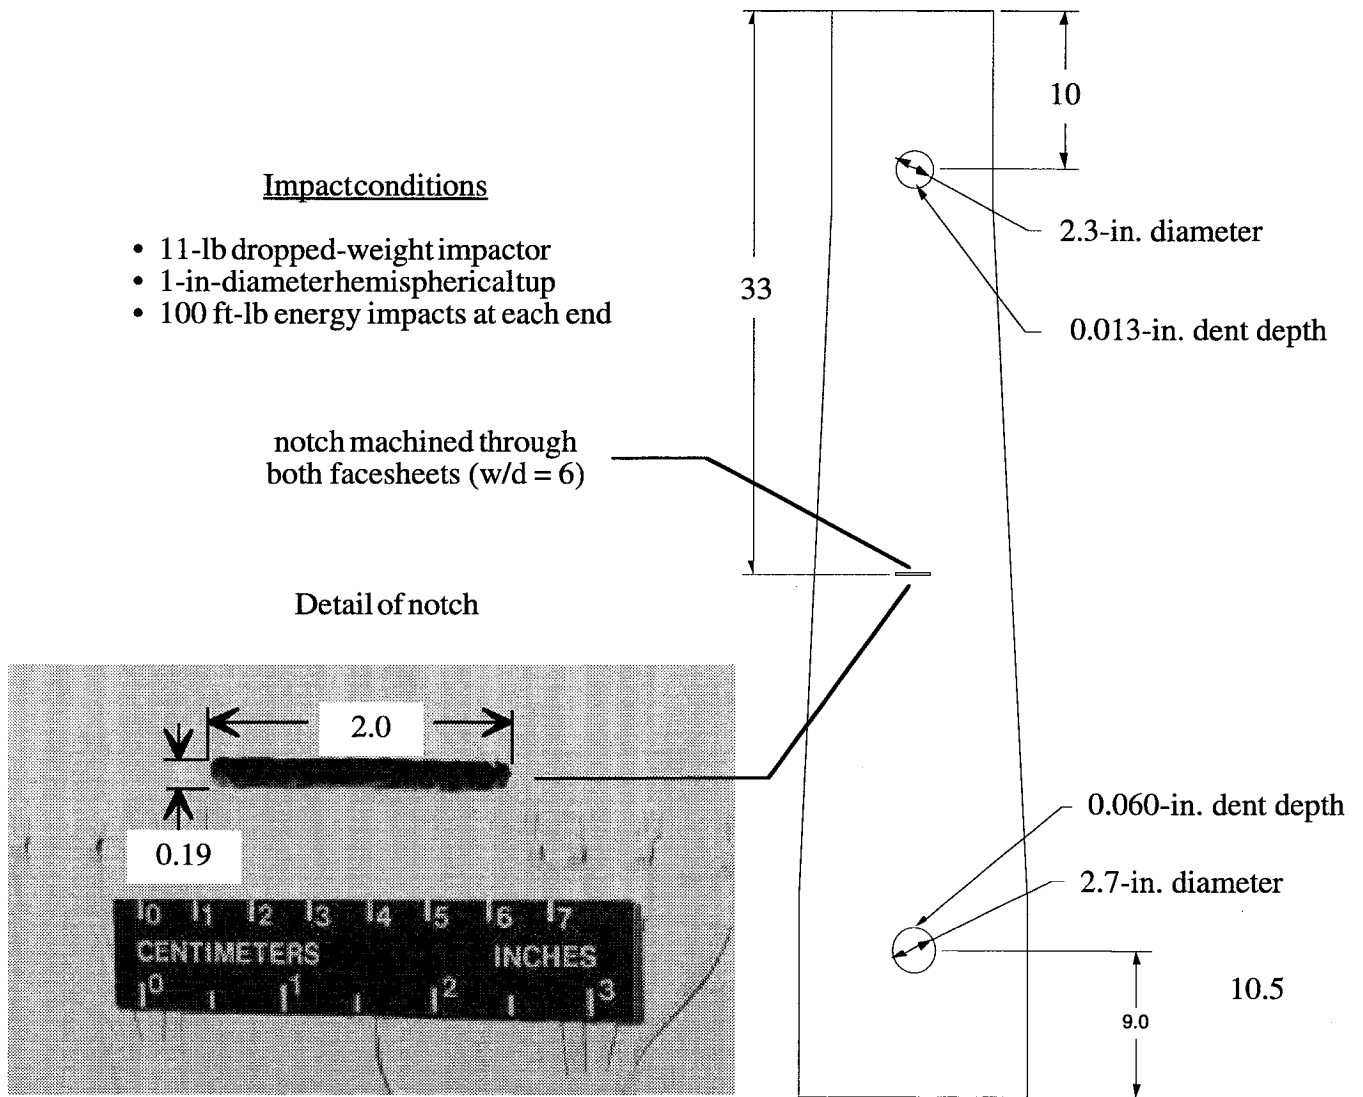
Figure 17. Details of impact-damage sites and machined notch.

Following the test of the undamaged panel, the test panel was impacted at two locations and the panel was loaded to 130 percent of its design limit load (175 kips). This load level was sufficient to provide well-defined strain distributions around the impact sites, and was low enough to prevent premature failure of the panel. As previously discussed, an impact-energy level of 100 ft-lbs was used at each impact site in an effort to inflict barely visible impact damage to the panel. The locations of the impact sites and the resulting dent depth and diameters of the damage areas are shown in Fig. 17. The impact at the thick end was 10.0 inches from the narrow end of the panel, and the impact at the thin end was 10.5 inches from the wide end of the panel. The support conditions used for these impact events matched those used for the impact-damage screening tests. Although the dent depth at the thick end is 0.013 inches, which is smaller than that obtained in the impact-damage screening tests, the dent depth at the thin end of the test panel is identical to the 0.060 inches obtained in the screening tests. The extent of the damage was mapped using a pulse-echo ultrasonic testing device. This device identifies the approximate boundaries of the damage site, and the damage-site diameters are presented in Fig. 17. As shown in the figure, the diameter of the damage site at the thick end is 2.3 inches, and the diameter at the thin end is 2.7 inches.

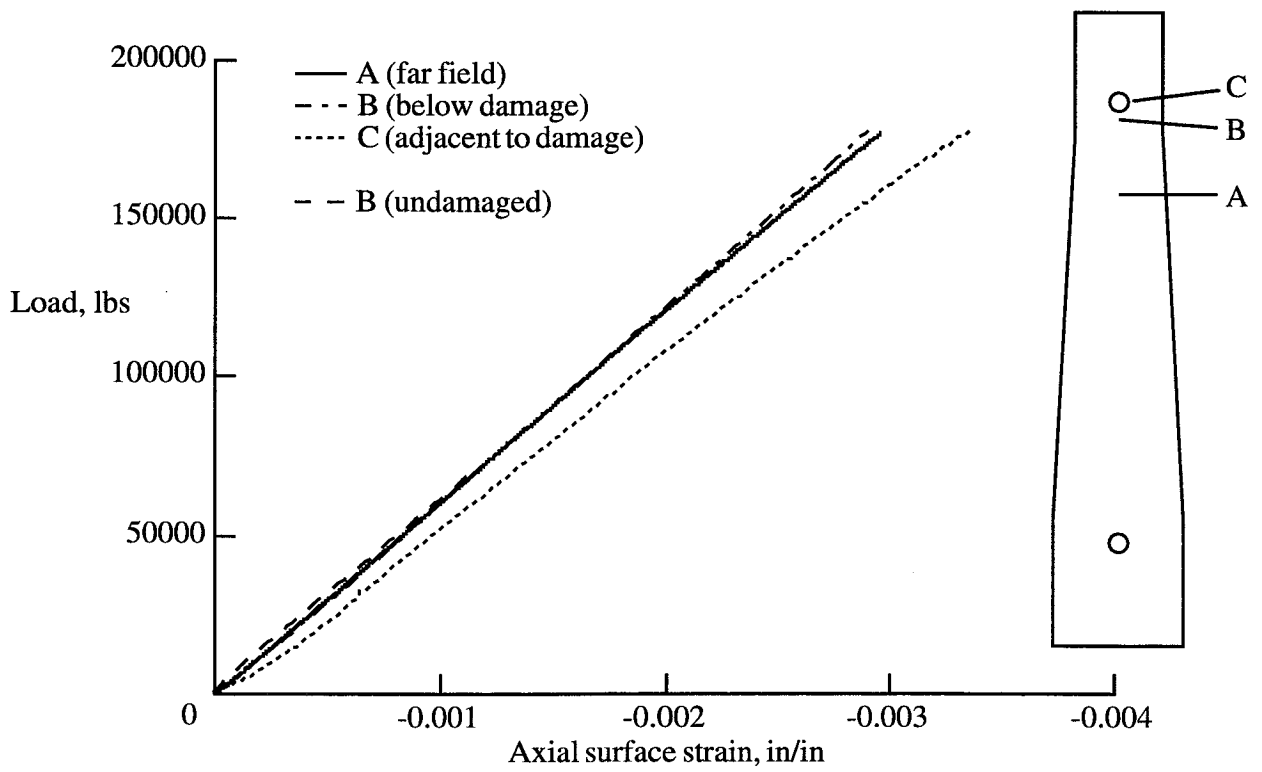
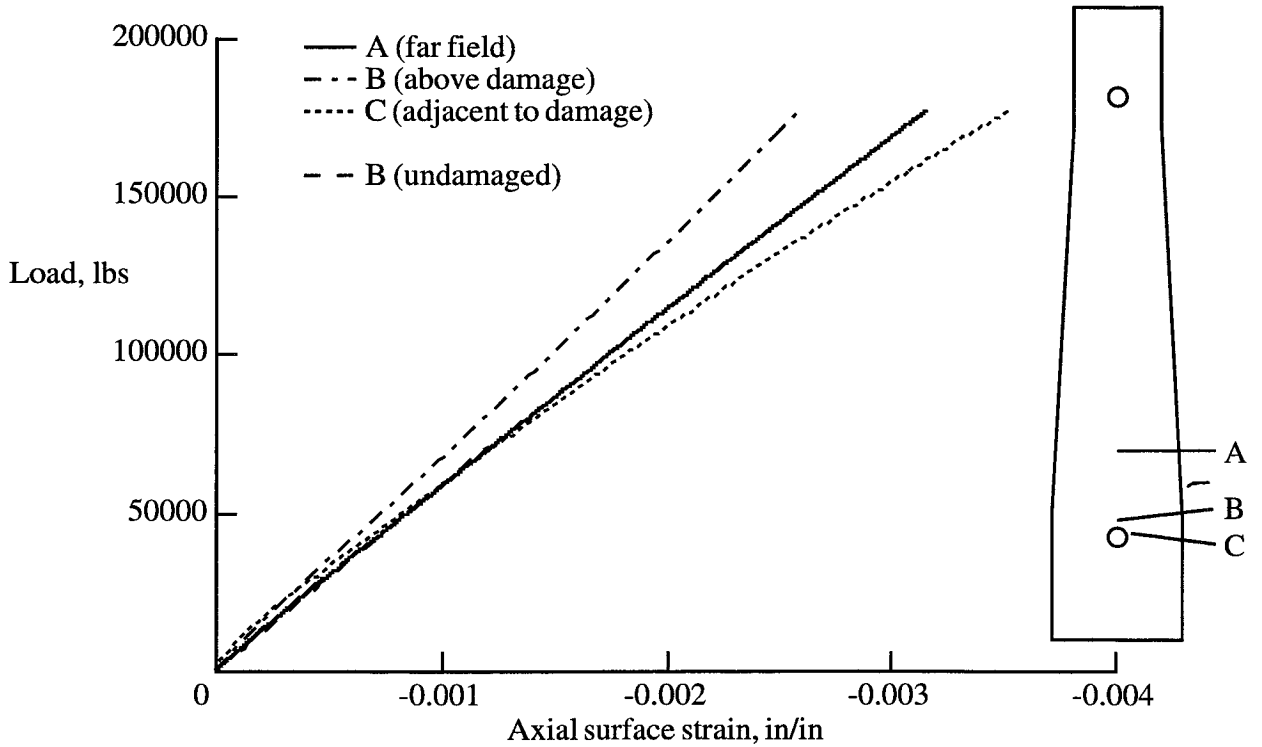
Figure 18. Experimental surface strain results for the impact-damaged panel.

Experimental surface strain results for the impact-damaged panel that show strain distributions around the impact sites at the thick and thin ends of the panel are given in Fig. 18(a) and 18(b), respectively. These figures present load as a function of strain at three locations around each of the impact sites. Location A is far away from the damage and is considered to be a far field location. Location B is very near to the damage and is located on the axial centerline of the panel. Locations A and B are towards the middle of the panel in

each case to avoid any influence from the potted ends. Location C is adjacent to the damage sites and is located on the horizontal centerline of each site. The strain data recorded for location B during the test of the undamaged panel are also presented in each figure. The data in Fig. 18(a) indicate that the thick-end impact damage does not significantly affect the response of the panel in that region since the data for locations A and B are very similar. Furthermore, the data at location B for the undamaged-panel test are nearly identical to the data for the impacted-panel test at that location. At location C, the strain is approximately 17 percent greater than the strain at location A. These results suggest that damage at this site introduces a mild local stress concentration, but does not affect the stress state slightly removed from the damage site. The data in Fig. 18(b) indicate that the thin-end impact damage does have an appreciable effect on the response of the panel in that region. The strains at location A are approximately 19 percent greater than the strains at location B. This difference in strains directly represents the effect of the impact damage on the response of the panel since the data from location B for the undamaged-panel test is very nearly the same as those for location A for the impact-damaged panel test. The strains at location A are approximately 16 percent lower than those at location C. The results presented in these figures confirm the intuitive notion that the larger damage site at the thin end of the panel affects the response more than the damage at the thick end.

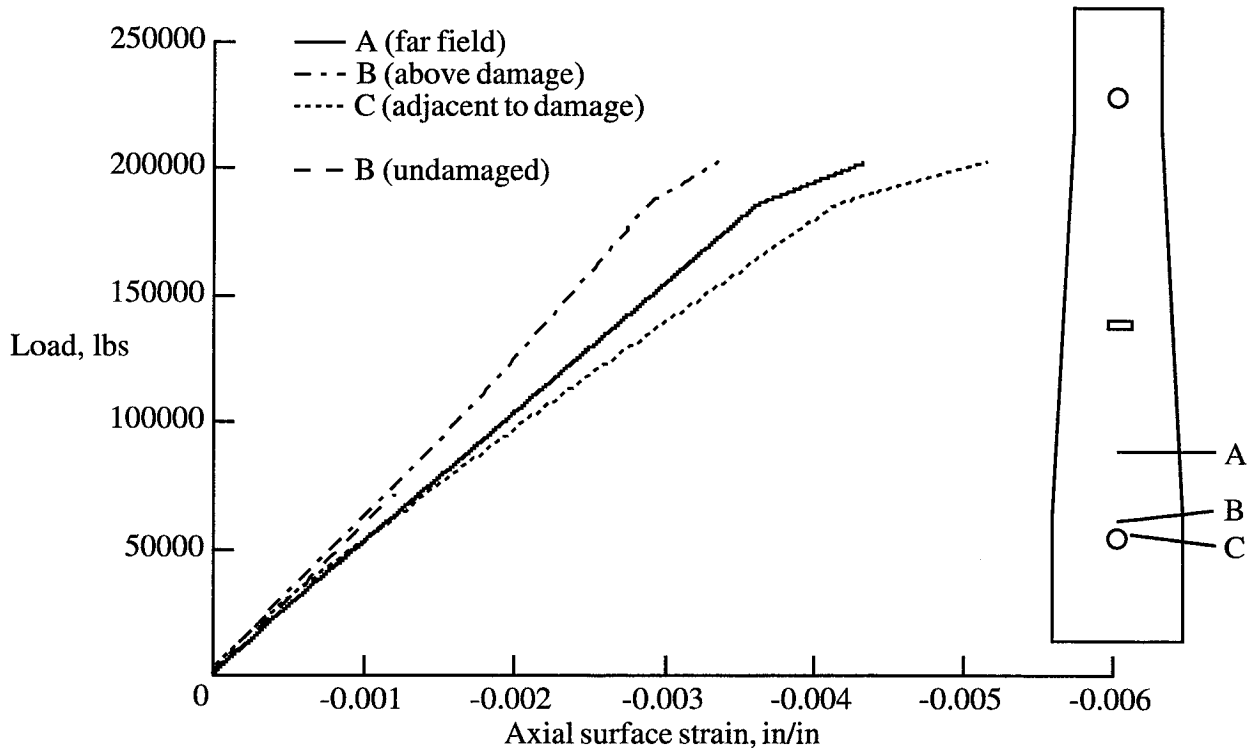
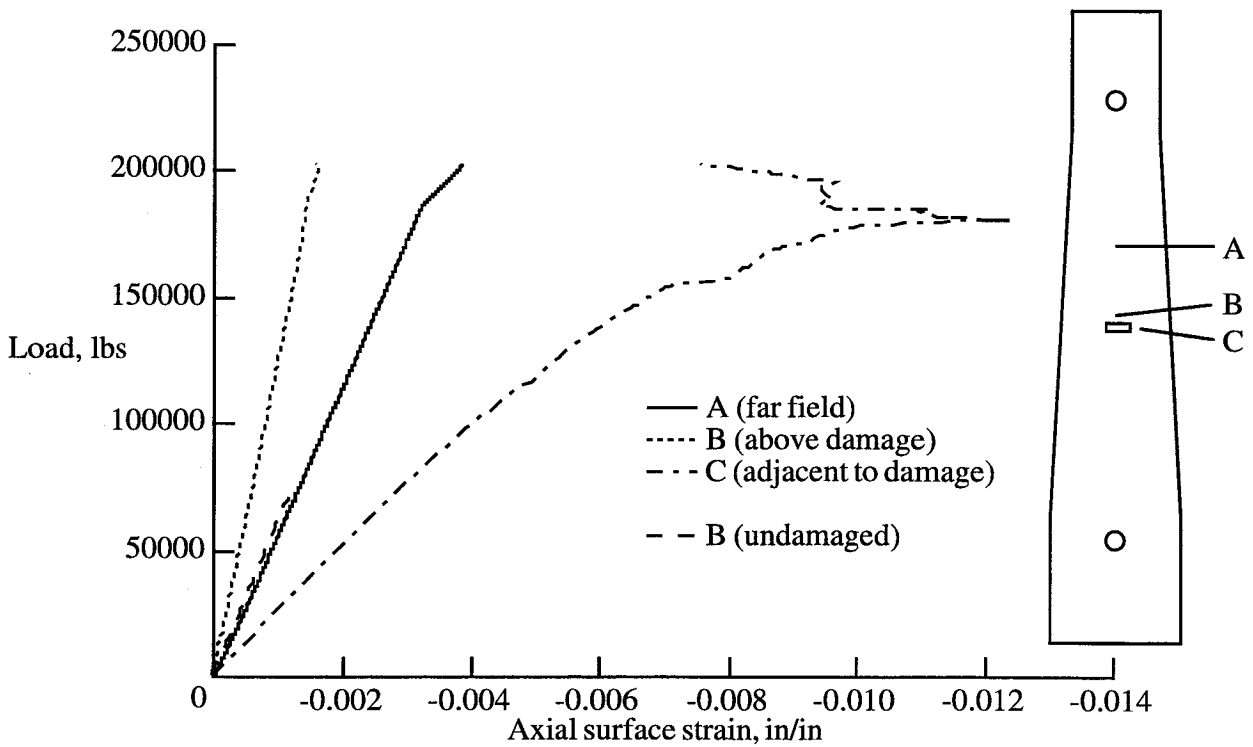
Figure 19. Experimental surface strain results for the notched panel.

Experimental surface strain results for the notched panel that show the strain distributions around the impact site at the thin end of the panel are given in Fig. 19(a). The trends in the data are very similar to those shown in Fig. 18(b). The strain level decreases as the damage site is approached from the far field location (from location A to B) and it increases adjacent to the damage (from location A to C). This result suggests that the notch has no influence on the load distribution at this impact site. The change in slope of the three curves in Fig. 19(a) correspond to a local failure that occurred near the notch tip. Experimental surface strain results for the notched panel showing the strain distributions around the notch are given in Fig. 19(b). The results in this figure indicate that the notch site is the most critical of the three damage sites. The compressive strain level increases by more than a factor of two when the damage site is approached from the far field location (from location A to B). More importantly, there is an increase in the strain level

of 350 percent over the far-field value at the notch tip (location C). The strain level at this point reaches a maximum of approximately 12,500 μ -in/in before local failures in the face sheets occurred at approximately 185 kips of applied load. Evidence of these local failures is indicated by the decrease in the strain level at location C for loads greater than 185 kips. This decrease in strain occurs as the load redistributes around the local failure sites at the notch tip. Analytical surface strain contours for the notched panel are presented in Fig. 20. The results in this figure are presented for an applied load of 70 kips. As shown in Fig. 20, the analysis predicts a relatively uniform strain distribution in the areas of the panel that are not near the notch location. There are, however, very high strain gradients predicted near the notch. An enlarged view of the notch location that shows these gradients is also given in Fig. 20. Experimental strain values at locations above and adjacent to the notch are also given in this figure. Although the predicted strain above the notch is close to the experimental value, the predicted strain at the notch tip is higher than the experimental value. This difference can be attributed to the coarseness of the finite element mesh at this high stress gradient region.

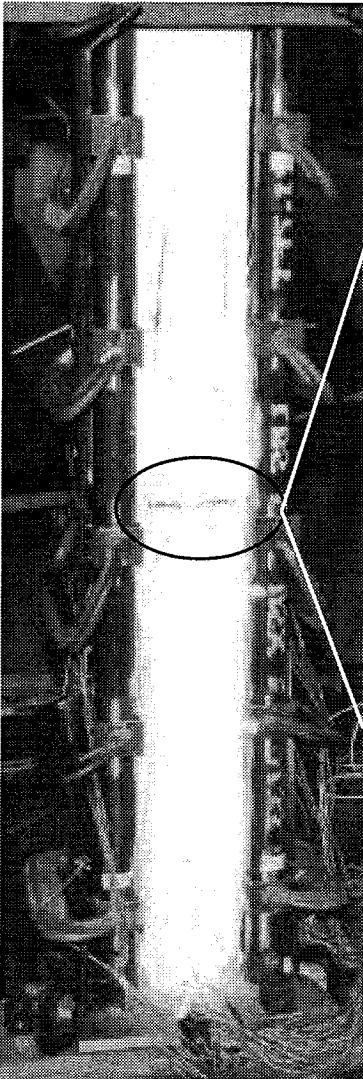
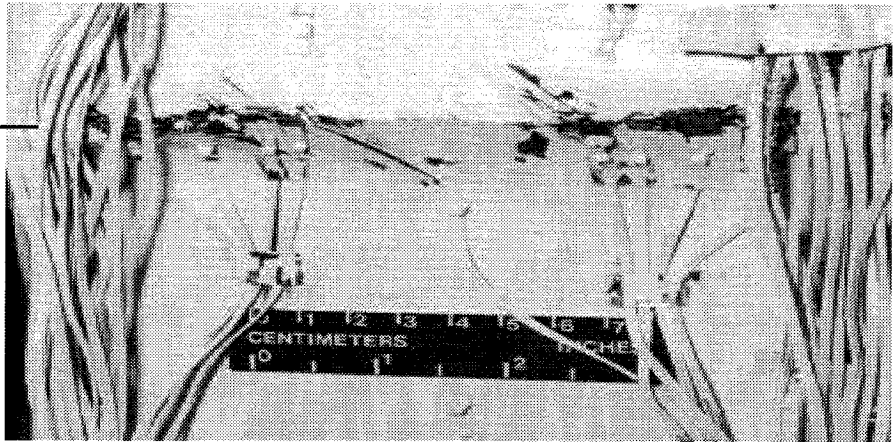
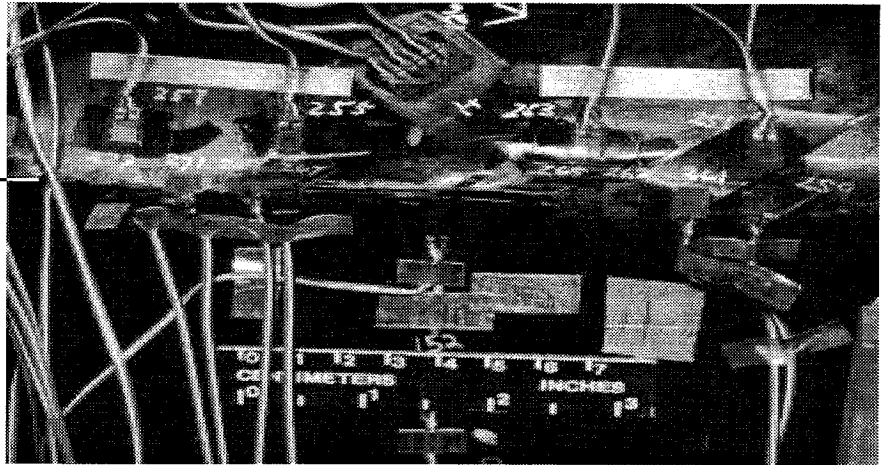
Figure 21. Failure mode for the notched panel, failure load = 202 kips.

Failure occurred across the width of the panel at 202 kips which is the design ultimate load of the panel. The failure mode of the panel is shown in Fig. 21. The failure mode is a compression failure of both face sheets at the notch location. Photographs showing front and back views of the failure are shown in Fig. 21. A post-test ultrasonic inspection of the two impact sites indicated that the area of the impact damage did not grow during the final two tests.
