TSS-1R Mission Failure Investigation Board

Final Report

National Aeronautics and Space Administration

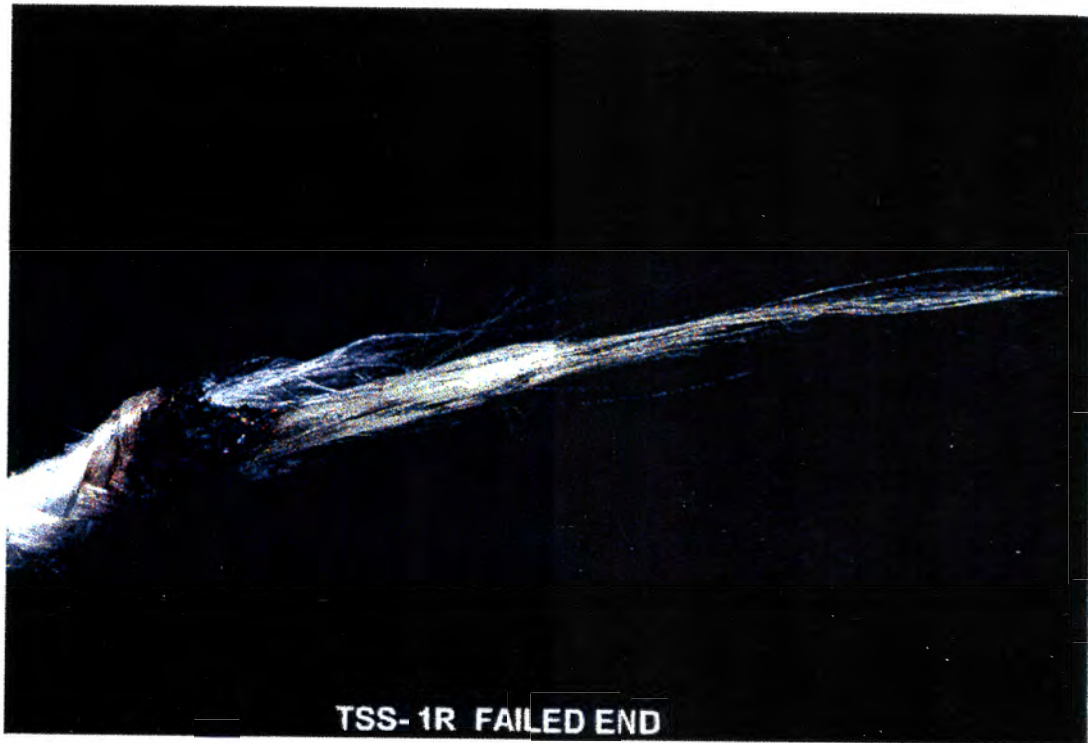
Figure 3.2-4 — Failed End of Flight Tether

shown in figure 3.2-4. Images using x-ray, microphotography, and SEM were taken. These revealed that 2 to 4 of the 10 copper conductors failed in tension and the others melted through. The FEP insulator was completely burned or melted away in the break area. Most of the Kevlar, and inner and outer Nomex were also burned or melted away. Some remaining Kevlar and Nomex fibers, which did not burn, were failed in tension (see figure 3.2-4).

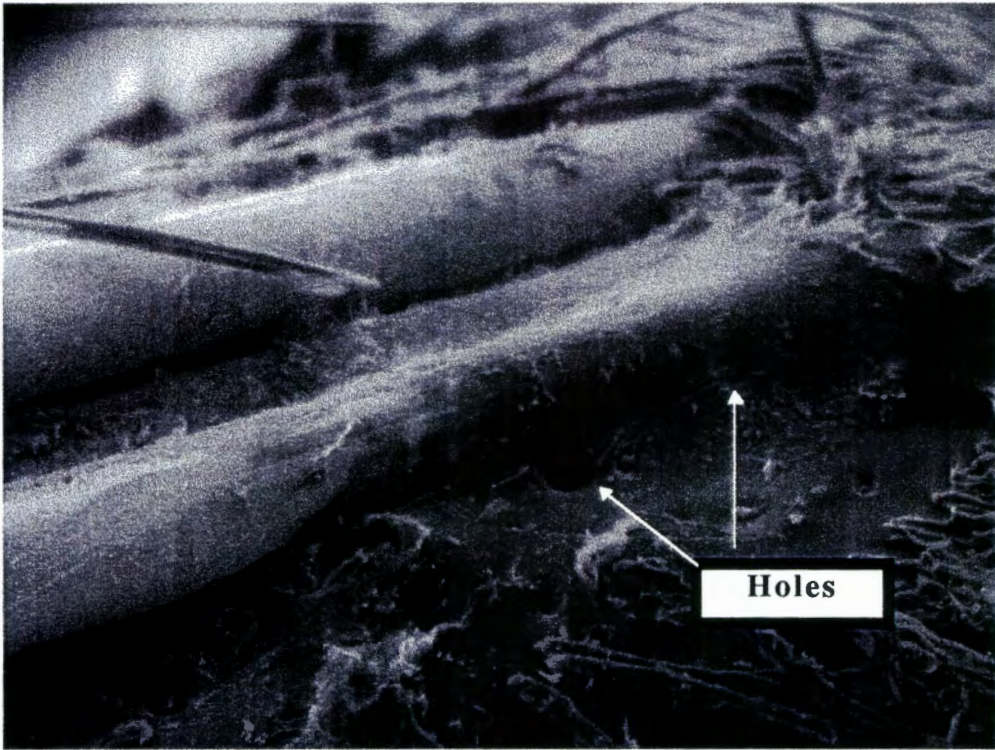
Figure 3.2-7 — FEP DAMAGE IN FAILED AREA

contributed to the arcing, or merely a result of the discharge/burning or heating which occurred in the immediate area.

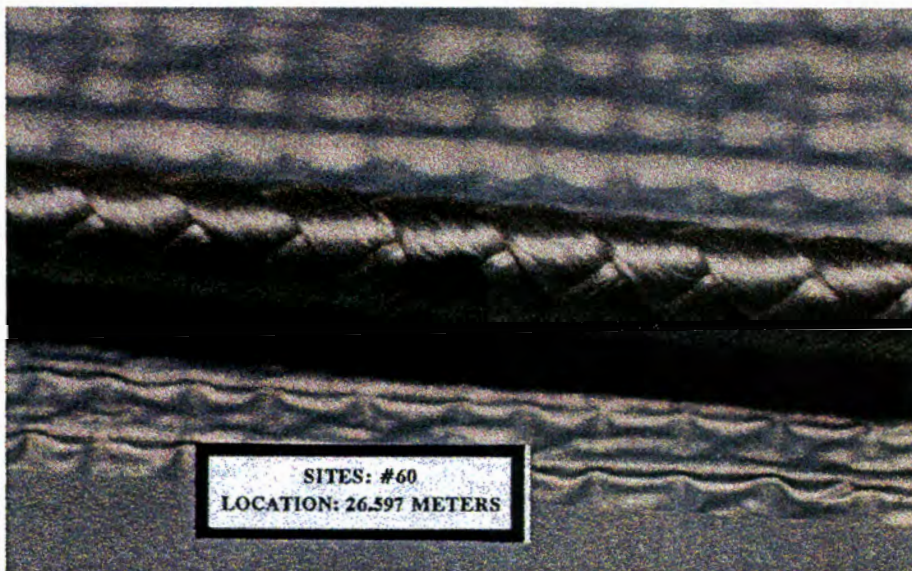
Figure 3.2-10 — Typical Spot

An analysis of the spot locations revealed that all but one of the spots were within a definite linear pattern of finite spacings. Sets of these spots matched up perfectly with the linear distance (circumference) around the 4 pulleys located in the LTCM. The 2 idler pulleys and the tensiometer pulley all have the same circumference of 0.24 m and the encoder pulley has a circumference of 0.50 m. As discussed in section 3.3 each of these pulleys have one pyrolyzed spot on its circumference; therefore the conclusion is that as the tether traveled through the pulleys, each pulley repeatedly deposited some of the carbon on the tether as it rotated. This process continued for approximately 9 m (or 9 s) from the failed/burned tether end. Figure 3.2-9 summarizes the analysis showing the set of spots for each of the 4 pulleys. Figure 3.2-10 is a picture of a typical spot.

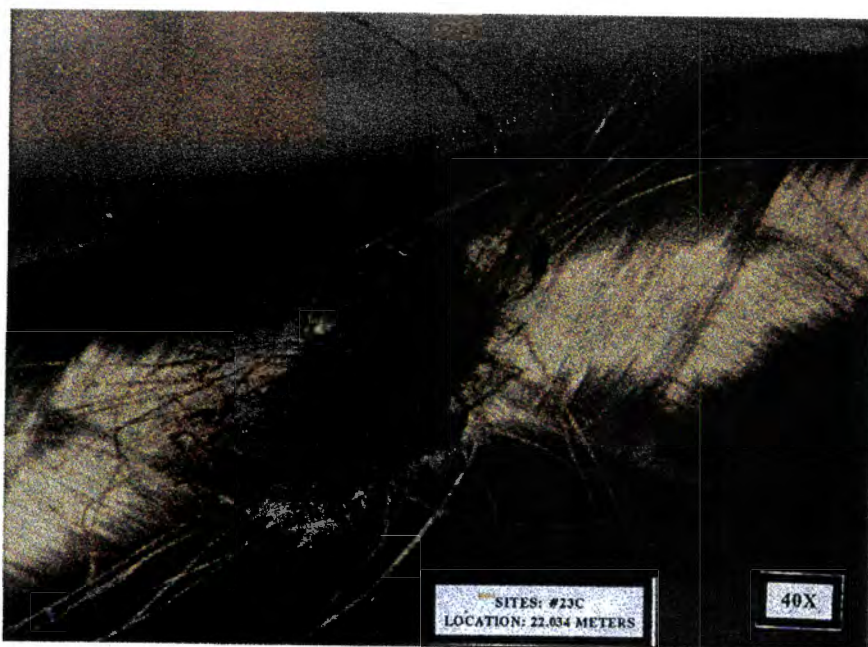
Figure 3.2-11 — Kevlar Fiber Protrusion

b) At three locations on this section of tether, Kevlar fiber was found to be protruding out from under the Nomex tows. The cause of these tufts are unknown and remain unexplained. Figure 3.2-11 shows a typical tuft of Kevlar. The Board did not attribute any part of the failure to these tufts.

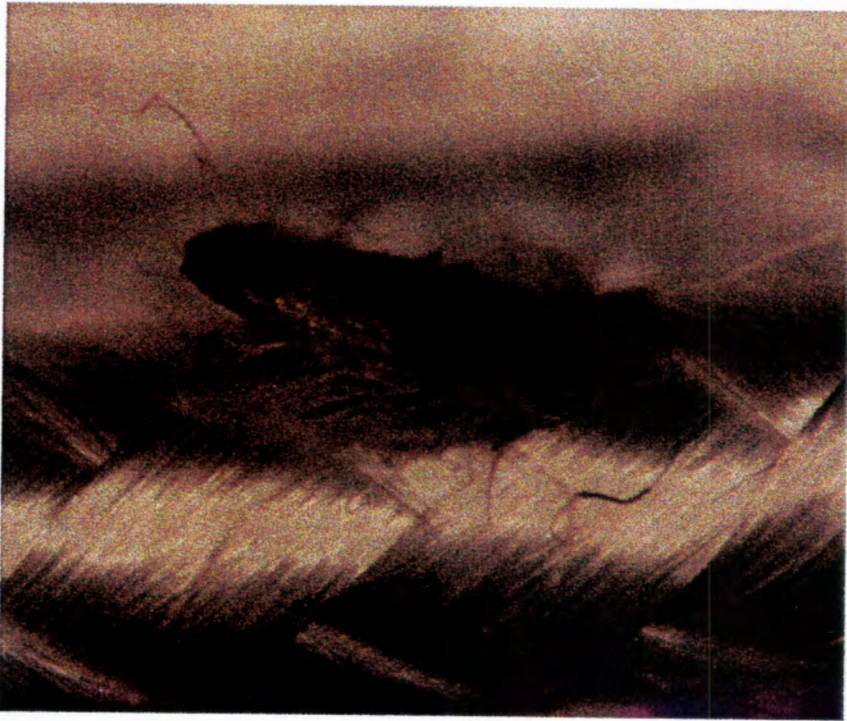
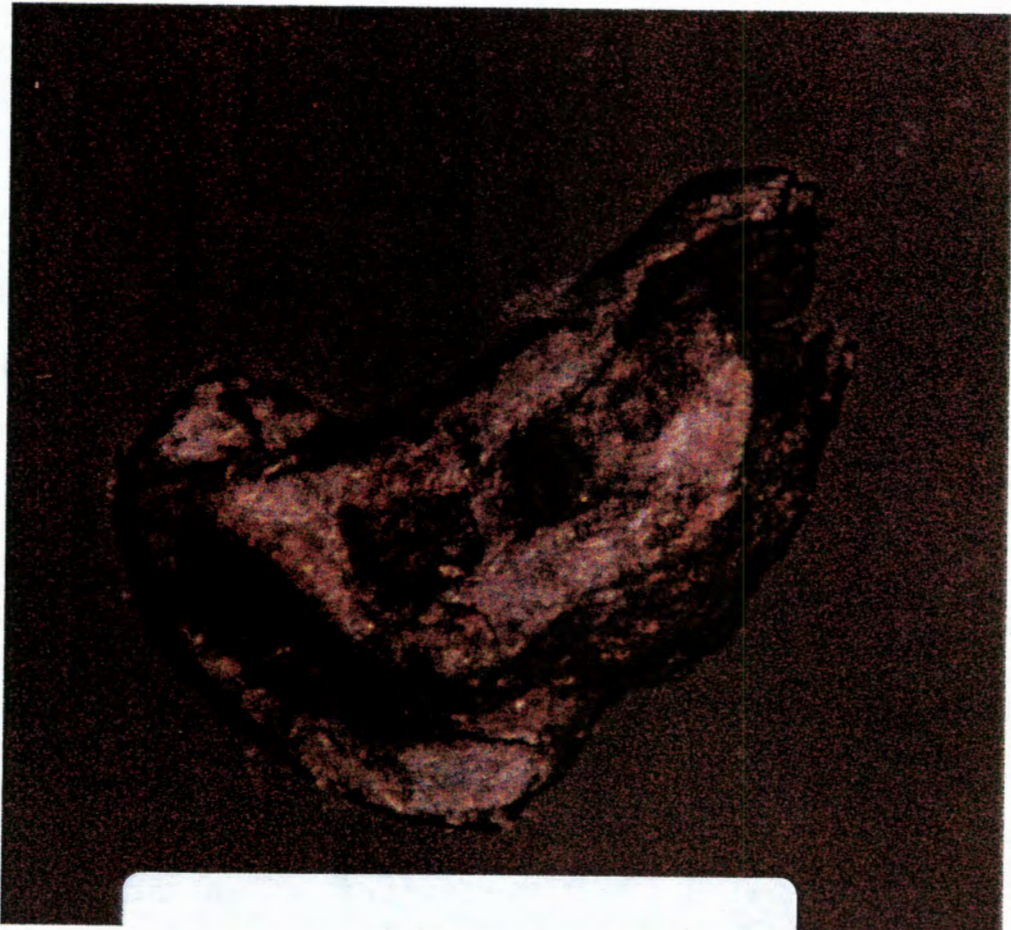
Figure 3.2-12 — Contaminant Particle in Tether

The largest particle found within the fiber weaves by inspection was a piece of polypropylene (see figures 3.2-12 and 3.2-13) which was 4.97 m from the failed end (anomaly #23A). The particle was approximately 0.8 mm in length and 0.4 mm in width.

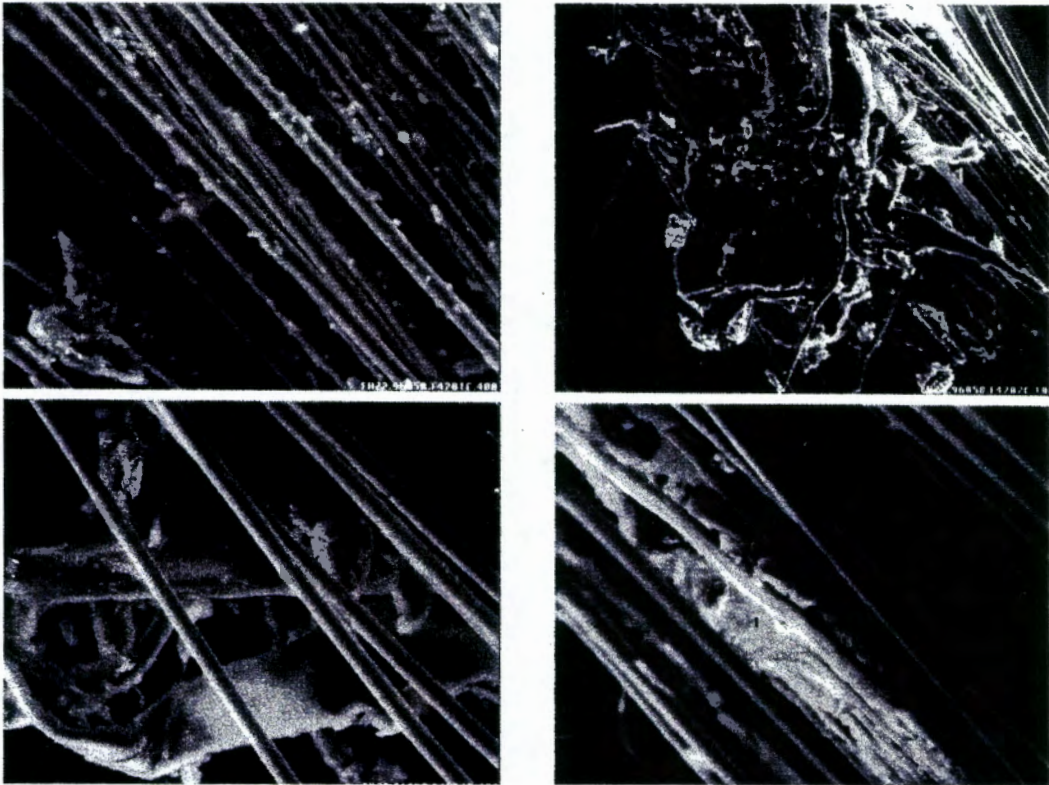
Figure 3.2-14 — R5 Kevlar 1 Analysis Areas

Other contaminants were found in the weave at several locations. As an example, at 11.73 m from the failed end (anomaly R5) a contaminated area was found (see figure 3.2-14). The contaminants included a particle approximately 0.4 mm in size (in upper right view of figure 3.2-14), as well as, a microscopic metal particle (in lower left view of figure 3.2-14). The EDS analysis on the first particle indicates that it is an accumulation of dirt (figure 3.2-15a), and the metal piece, (figure 3.2-15b) was identified as aluminum. The elemental constituency of contaminants found in different layers of the tether at other locations included: silicon, zinc, iron, calcium, chlorine, aluminum, and potassium. These were generally in low concentrations.

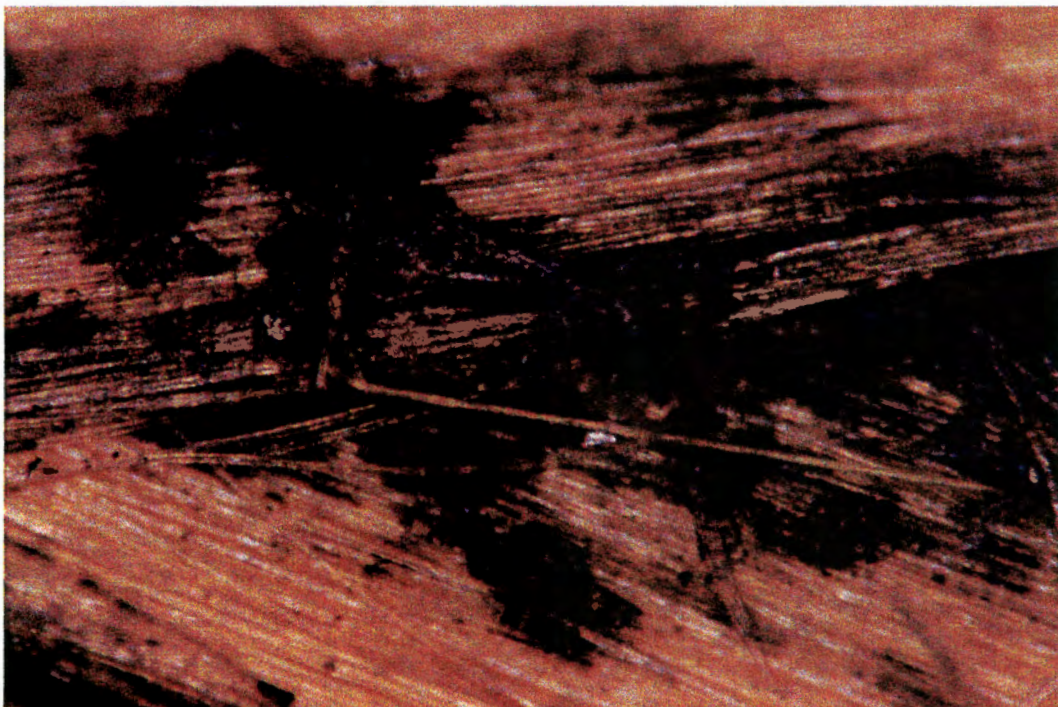
Figure 3.2-16 — Blue/Black Streaks

e) Blue/black streaks composed of some material in the Kevlar/Nomex fibers were found between the failed tether end and 13.67 m from that end (figure 3.2-16). No further streaking was found past the 13.67 m point. Heating of a length of tether or heating a local spot on the tether did not duplicate the blue/black streaks. This phenomenon is not completely understood, but is a post-failure mechanism, and did not contribute to the failure.

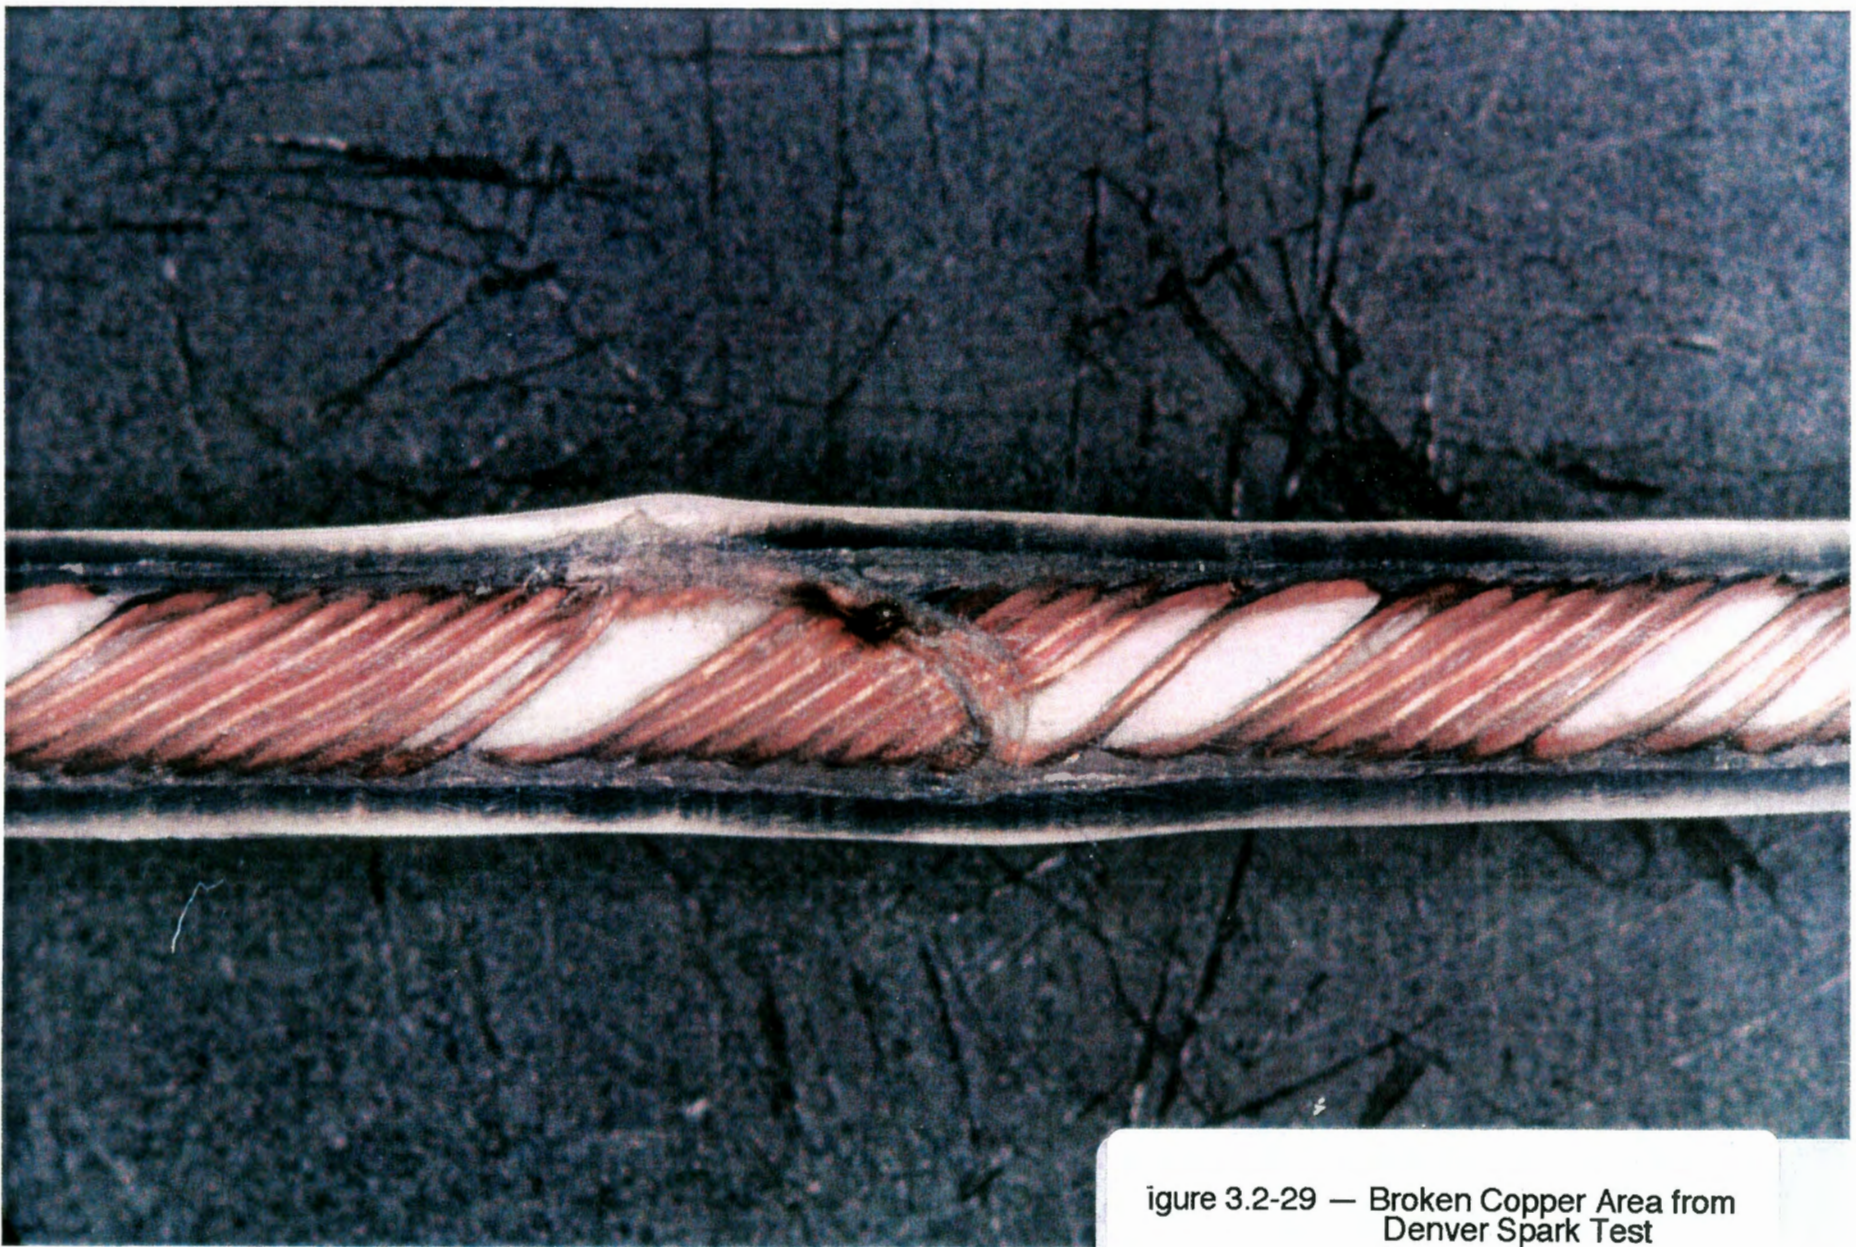
Figure 3.2-29 — Broken Copper Area from
Denver Spark Test

- Manufacturing difficulties had the potential of producing a defect in the tether that later resulted in a breach of the FEP through reel wrap forces, pulley forces, or handling.
- Failure areas on the qualification tether, along with similar copper conductor damage under undamaged FEP in the flight tether, indicate the potential of defects in the manufacturing process.

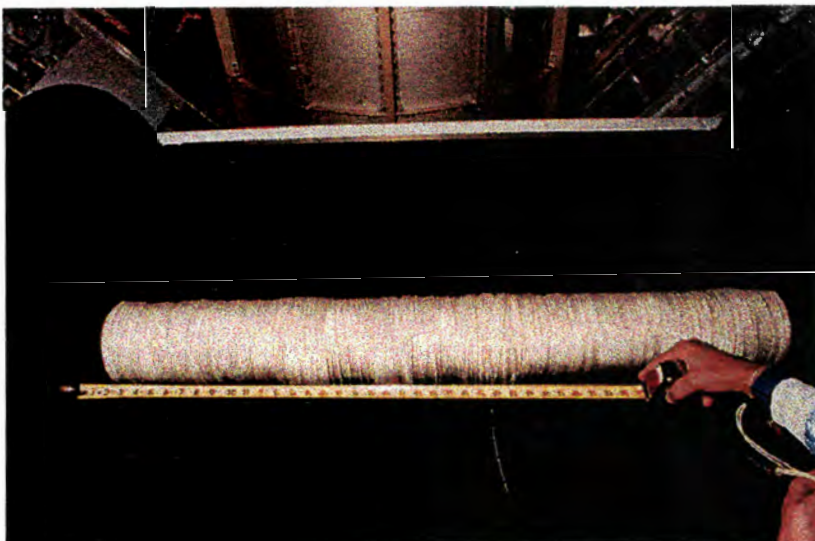
Figure 3.3-1 - Reel Assembly

The reel mechanism operated normally during the mission and did not contribute to the failure. Small metallic debris were found in the reel housing which could contribute to foreign object damage to the tether.
