Shearographic Non-Destructive Evaluation of Space Shuttle Thermal Protection Systems

Christopher K. Davis, NASA
Jeffery A. Hooker, INET
Stephen M. Simmons, INET
Kenneth E. Tenbusch, NASA

John F. Kennedy Space Center, Florida

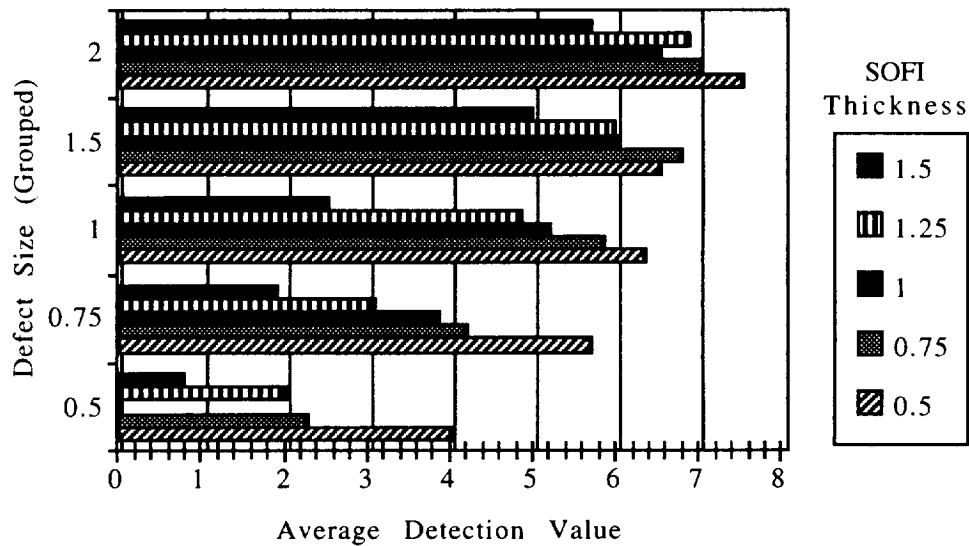
The preliminary results of the SOFI testing indicate that debonds with dimensions along the direction of the shearing on the order of the foam thickness were easily detectable and flaws with dimensions on the order of half the foam thickness were often detected and a significant number of even smaller defects were observed. The shearing optics in the camera used in testing had a 0.5 degree shearing angle, a limited number of images were taken with 1 degree shearing optics. The 1 degree camera did not provide any additional detections, but did provide better fringe visibility. Preliminary data showing defect detection as a function of defect size and SOFI thickness are shown below in CHART 1.

CHART 1: Average detection values of debonds in SOFI at a vacuum of 1 inch of water. Values of 4 or greater are detects.

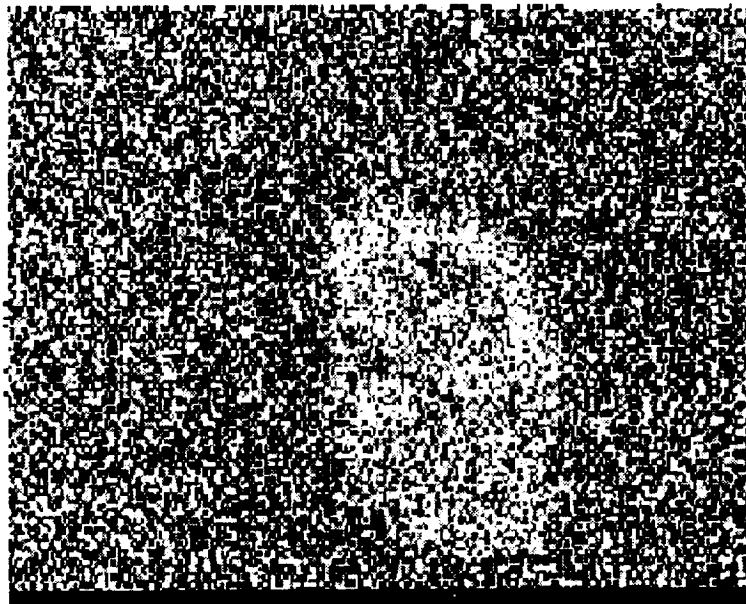
Debond 1: 0.50 to 0.75 inches in diameter, located 57 inches from elbow joint, and at 8 o'clock (facing aft); suspect kevlar to honeycomb debond

FIGURE 3: An image enhanced shearogram of Debond 1 found on the RMS.

mission threatening, nor even structurally significant, at this time. Until the Design Center develops accept/reject criteria, shearography will inspect all RMS on a ten flight interval to monitor/detect any debonds.
