Debris/Ice/TPS Assessment and Integrated Photographic Analysis of Shuttle Mission STS-72

**DEBRIS/ICE/TPS ASSESSMENT
AND
INTEGRATED PHOTOGRAPHIC ANALYSIS
OF
SHUTTLE MISSION STS-72**

11 January 1996

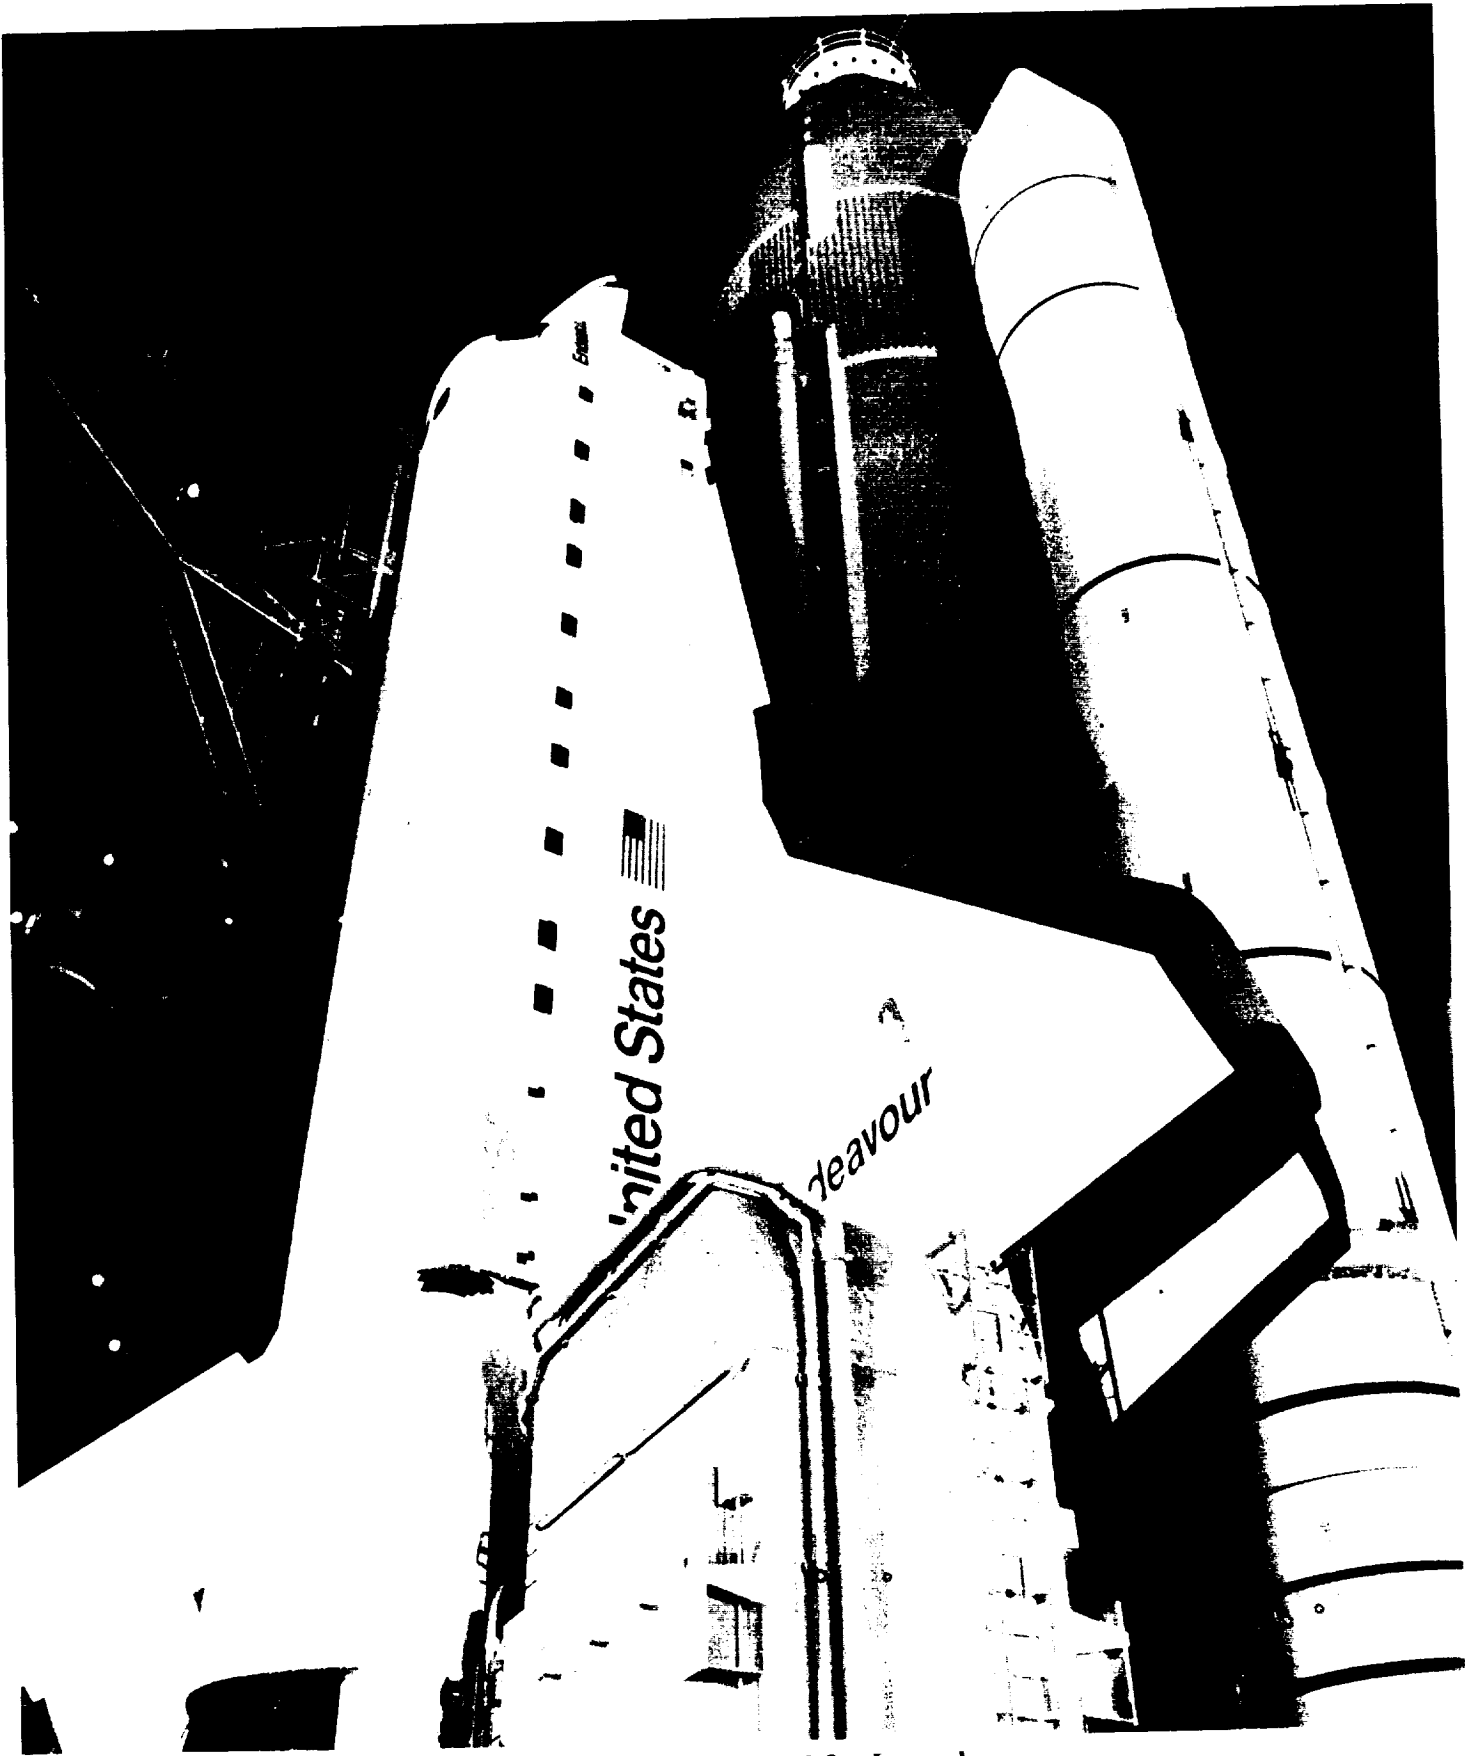
Photo 2: ET-75 Cryoloaded for Launch

The Final Inspection Team observed dry TPS on the LO2 tank ogive. Very light condensate and frost, but no detectable ice, had accumulated on the LO2 tank barrel and LH2 tank acreage +Y+Z quadrant.

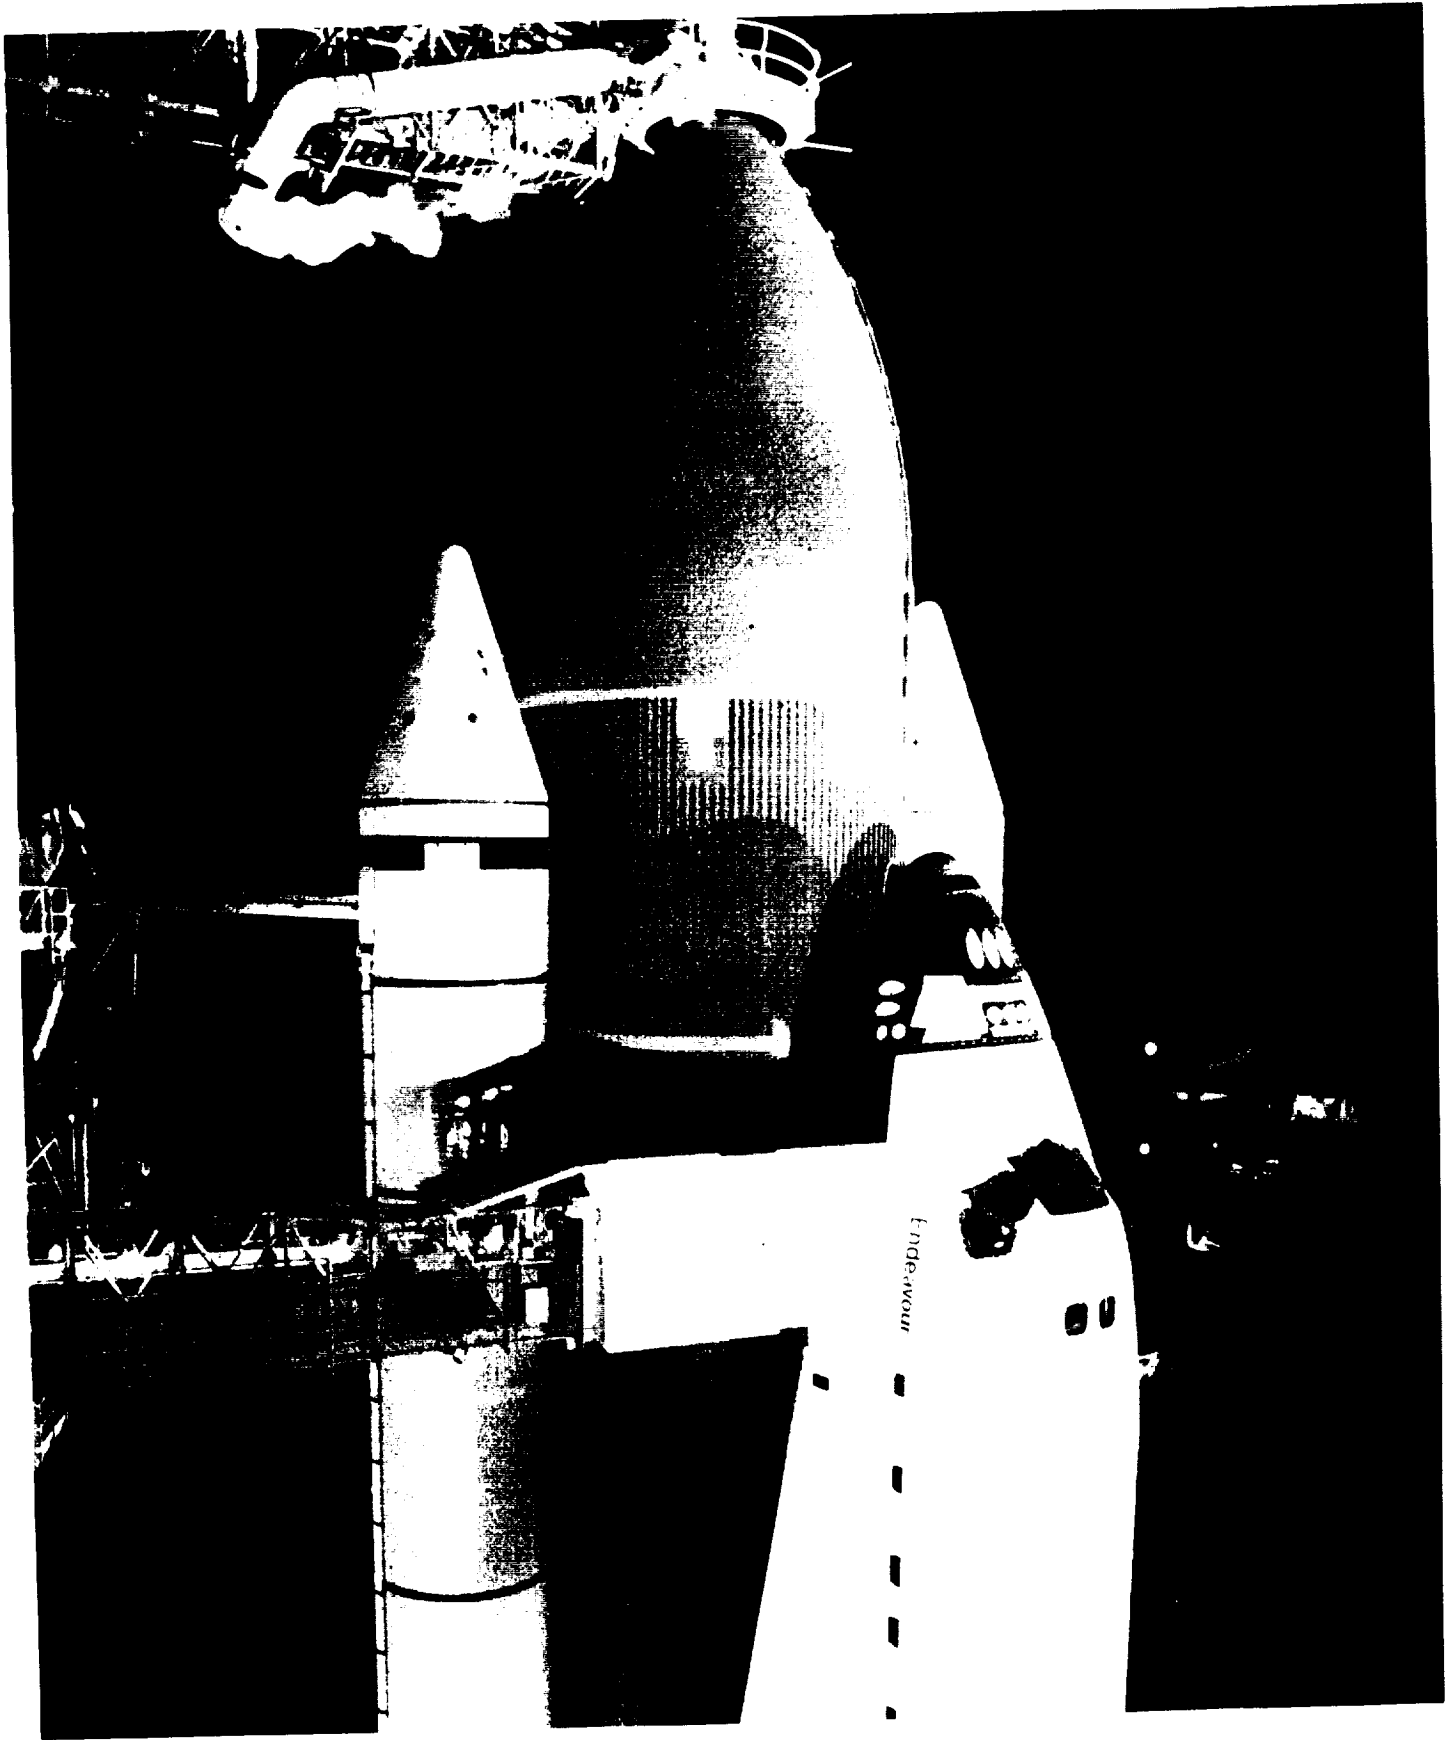
Photo 4: ET Intertank and LO2 Tank Barrel After Cryoload

The intertank acreage exhibited no TPS anomalies. The portable STI and Raytek measured an average surface temperature of 50 degrees F on the intertank. Very light condensate and frost, but no detectable ice, accumulated on the LO2 tank barrel +Y+Z quadrant.

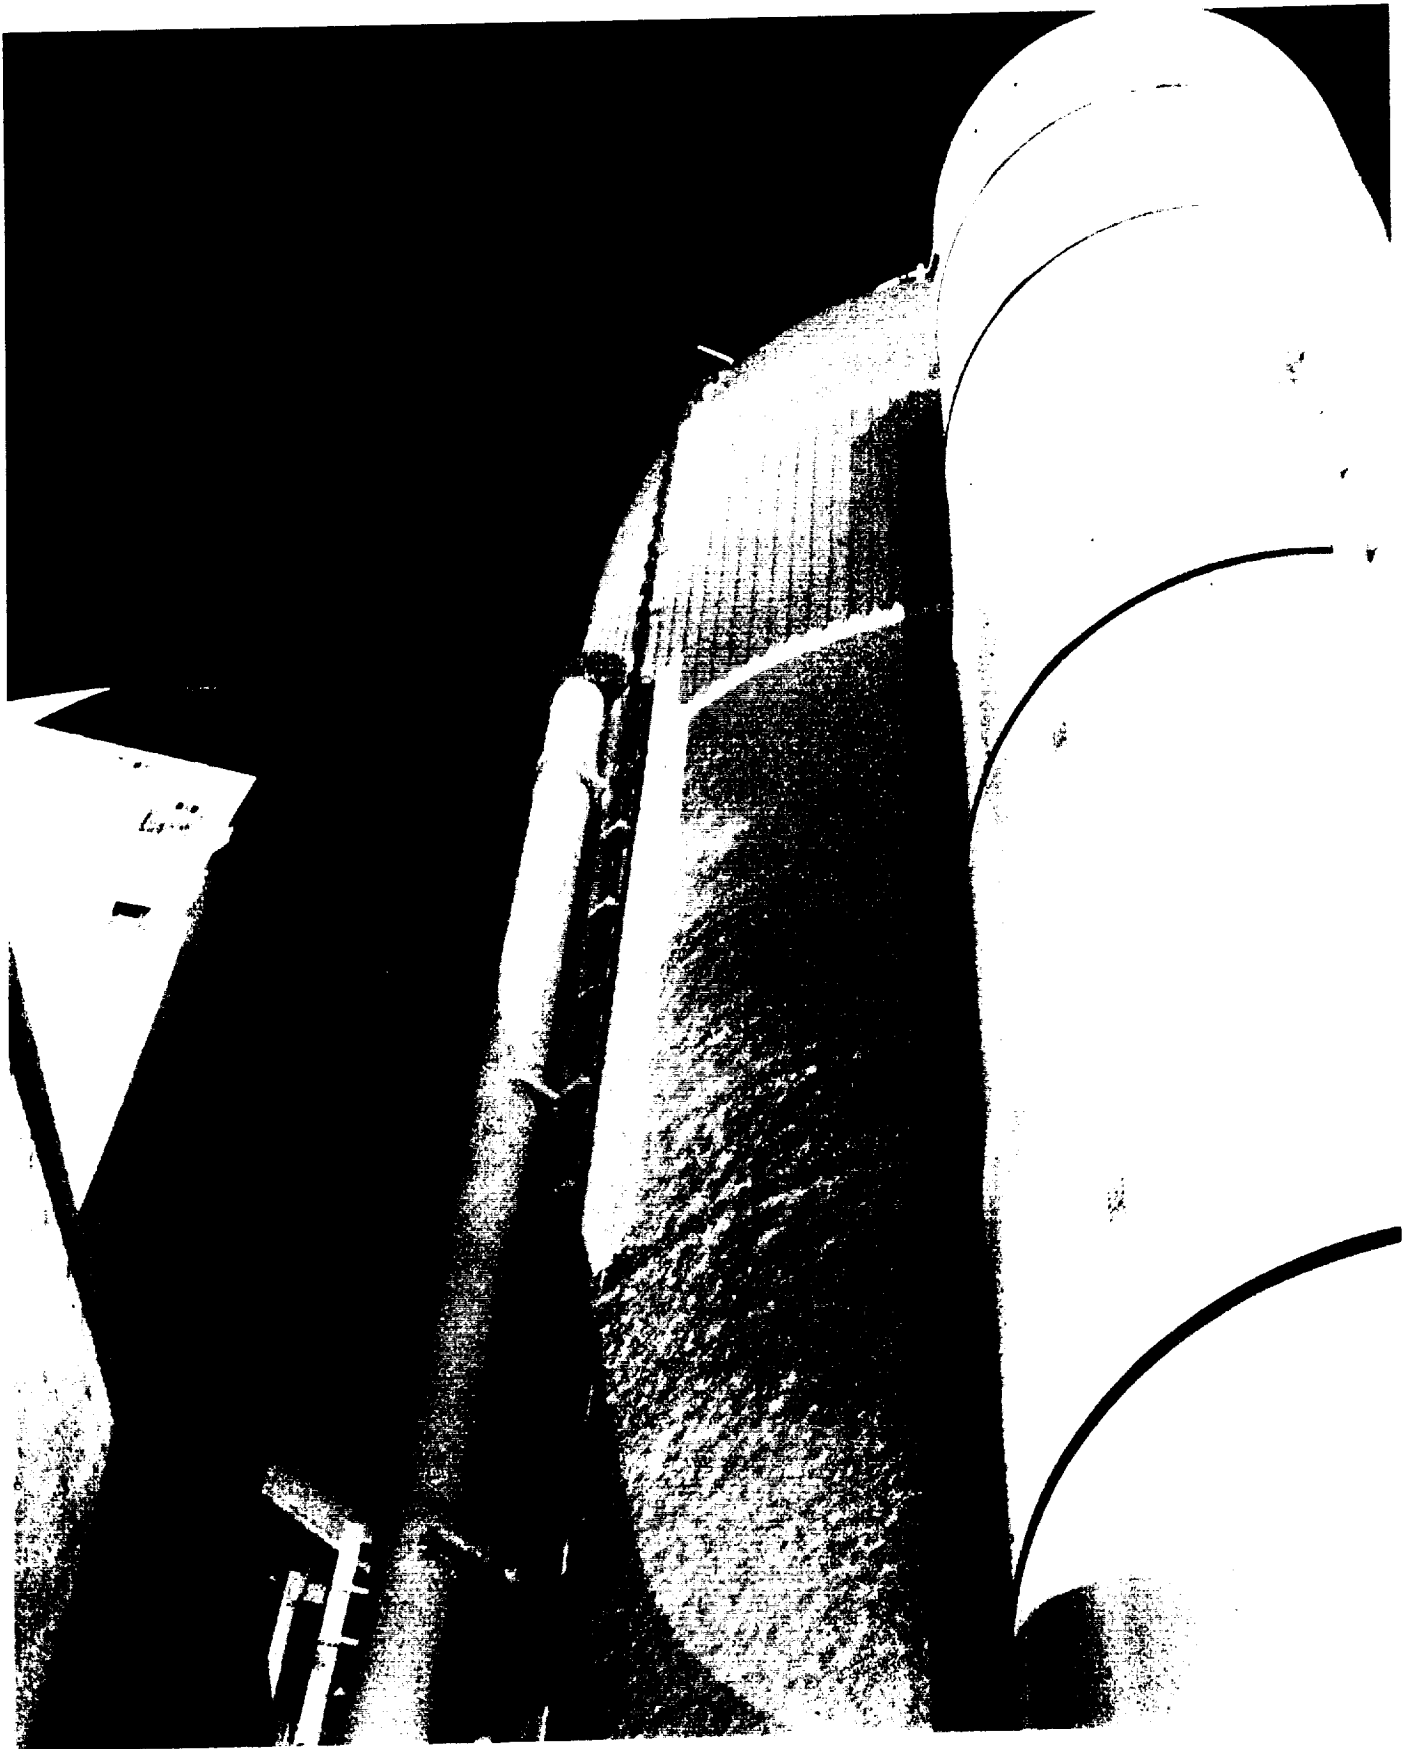
Photo 5: LH2 Tank +Y+Z Quadrant

There were no LH2 tank TPS anomalies. Very light condensate and frost, but no detectable ice accumulation, was present on the acreage. Most of the frost had formed in the +Y+Z quadrant.

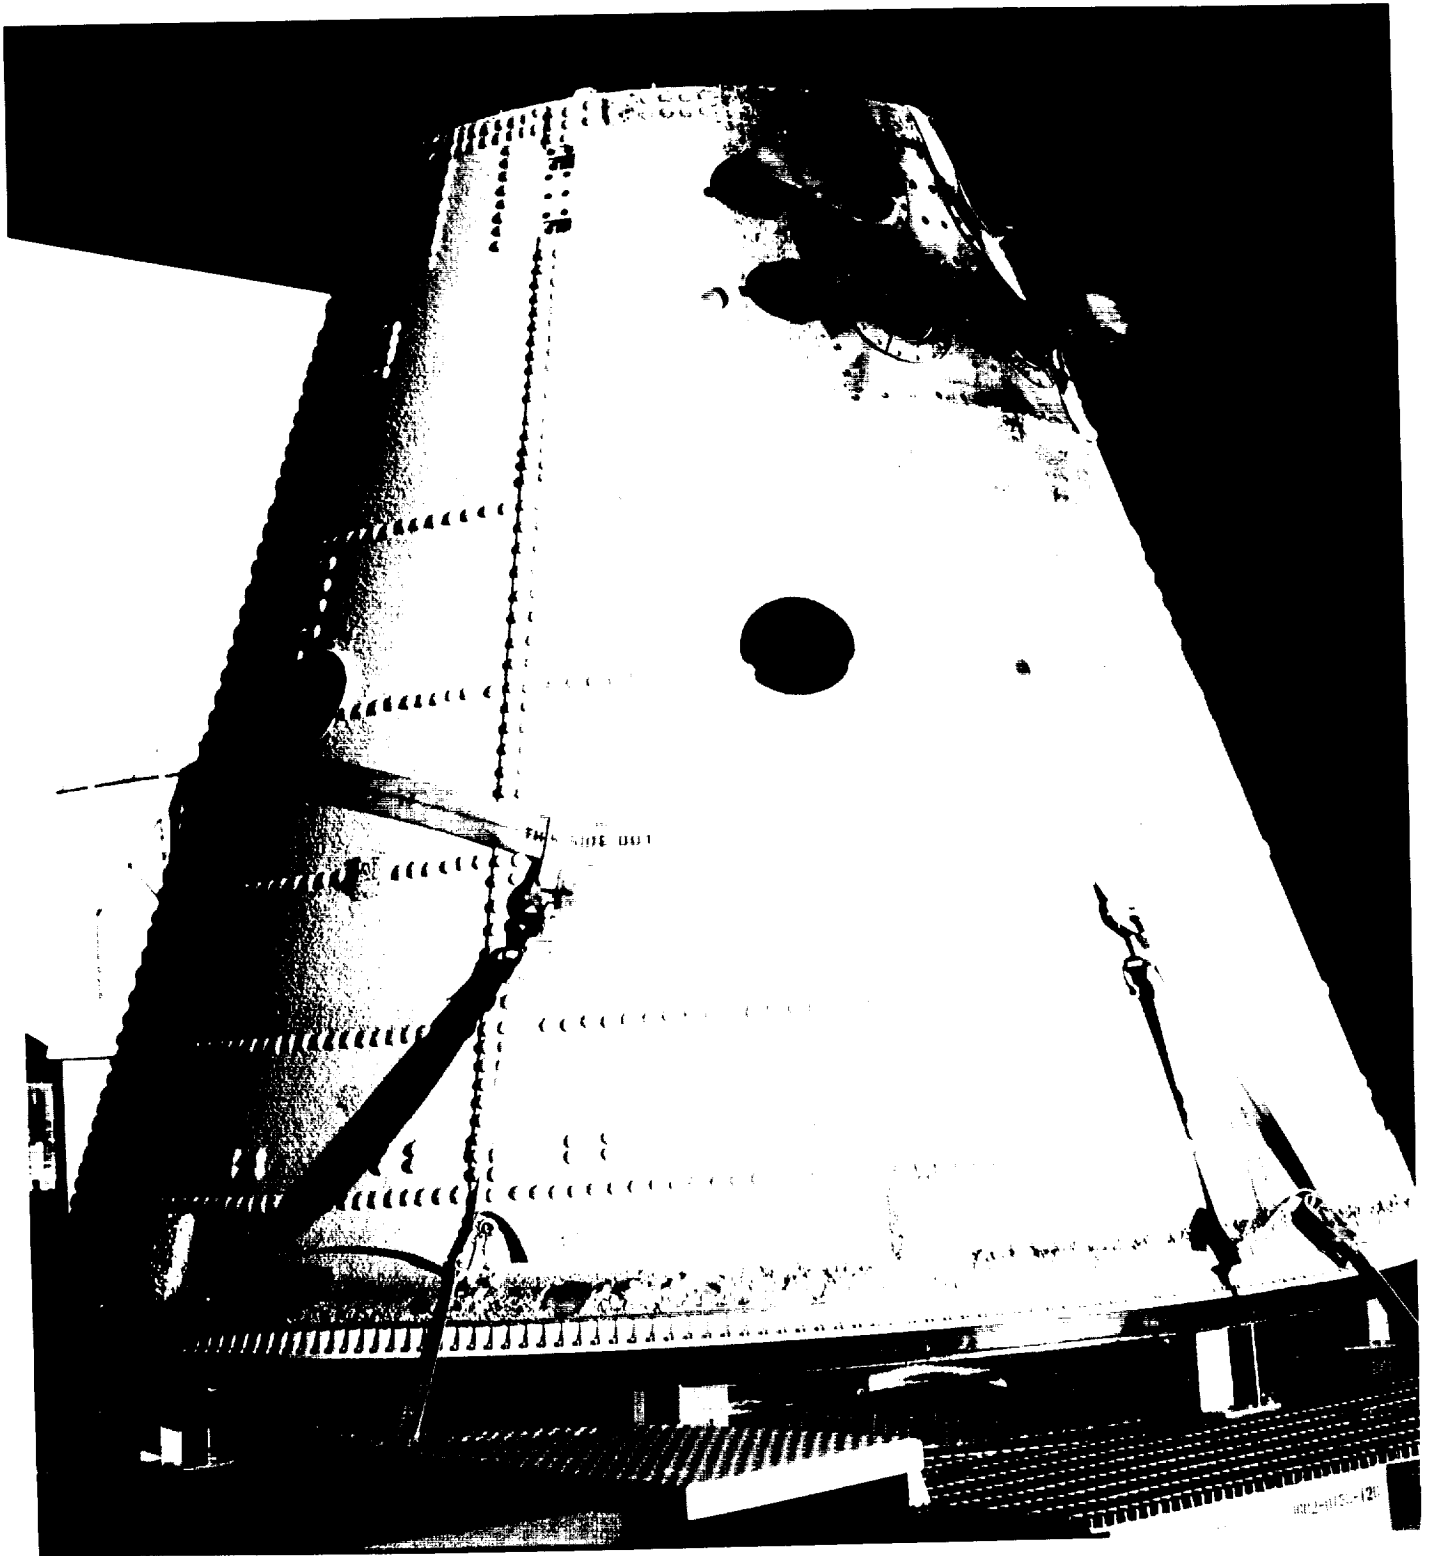
Photo 13: RH Frustum

The RH frustum was missing no TPS. The number of debonds over fasteners (27) and over acreage (1) was close to the average. Hypalon paint was blistered/missing along the XB-395 ring frame where BTA closeouts had been applied. However, most of the exposed BTA substrate was not sooted. The BSM aero heat shield covers had locked in the fully opened position though the two lower cover attach rings had been bent slightly by parachute riser entanglement.

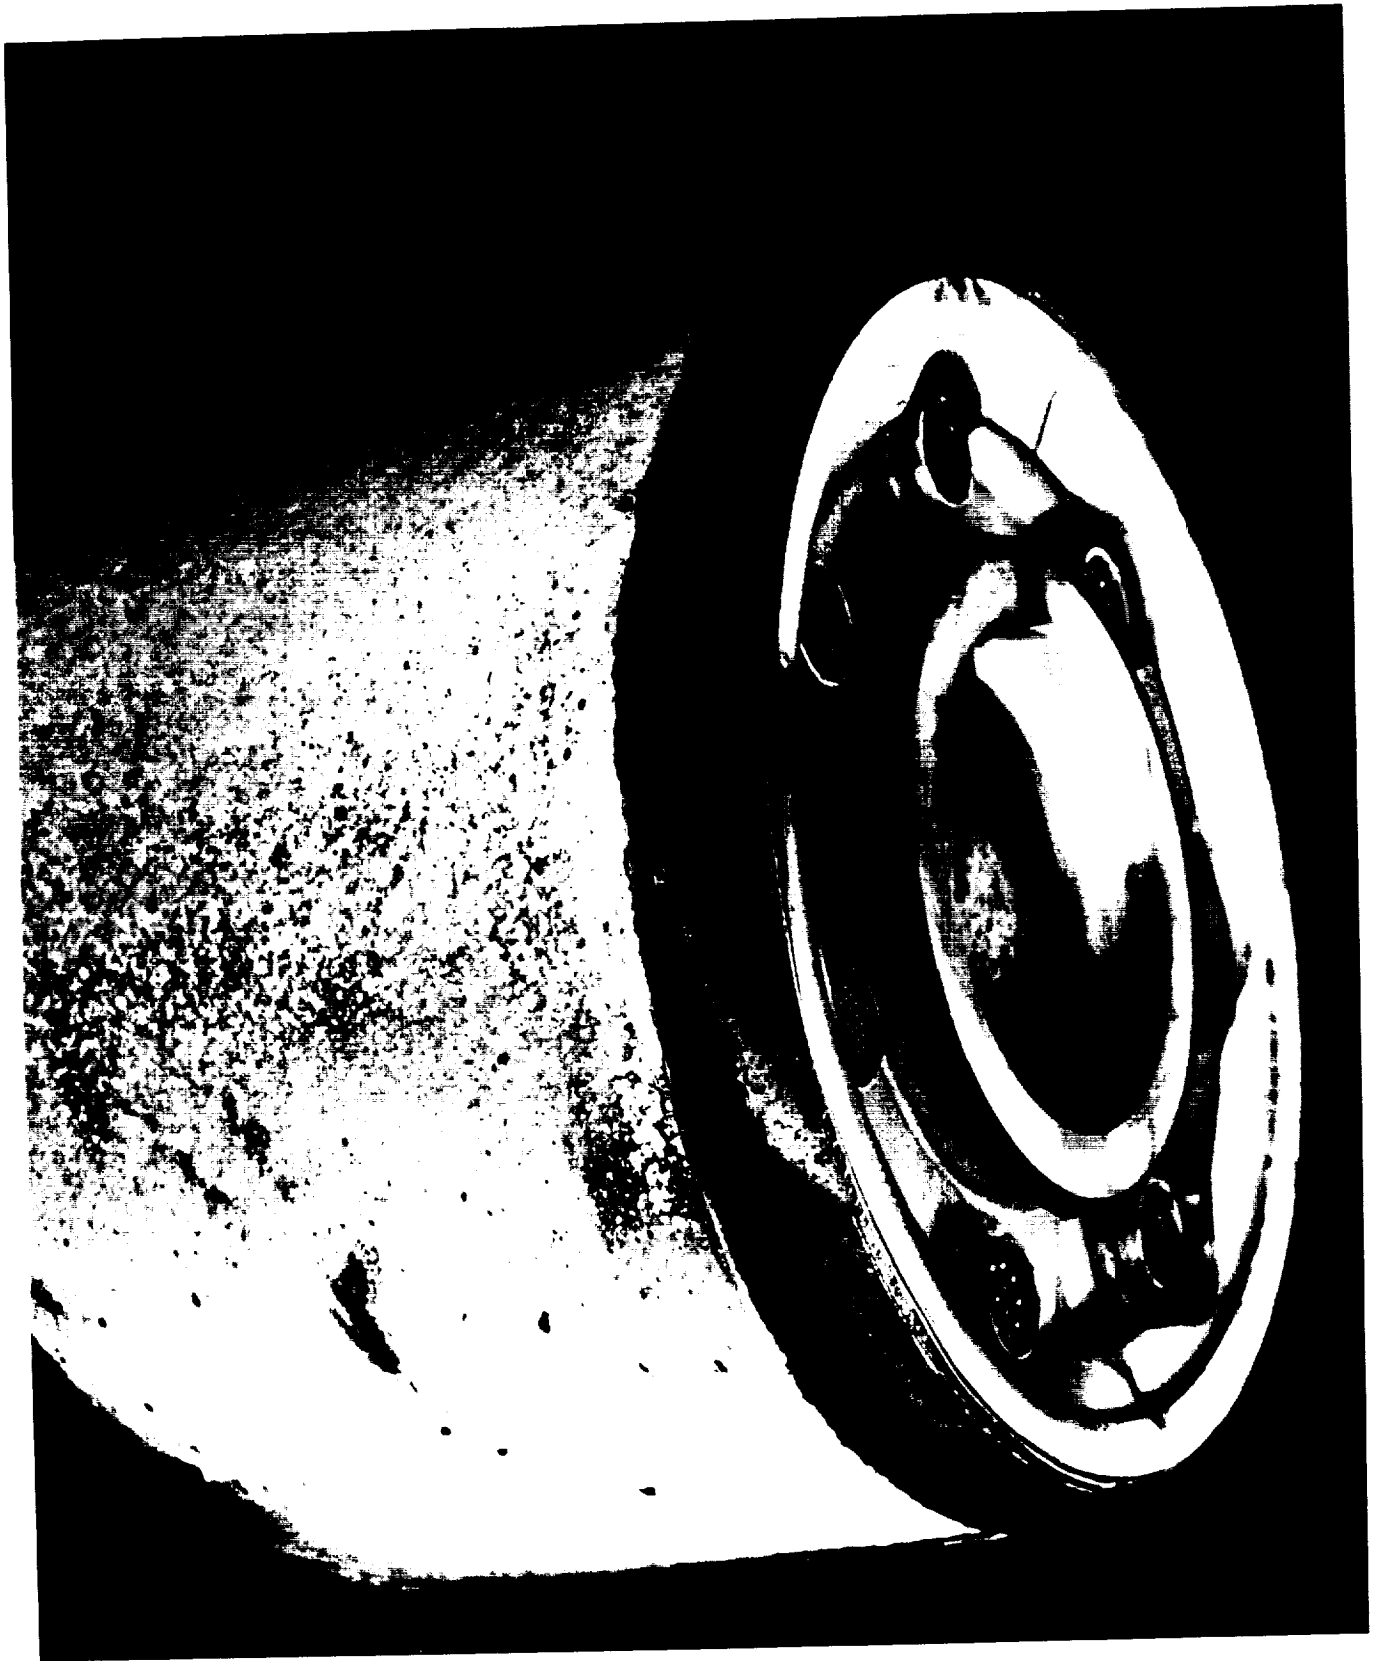
Photo 15: Upper Strut Fairing Missing K5NA

Separation of the aft ET/SRB struts appeared normal. K5NA 3-inches long by 1-inch wide was missing from the separation plane of the upper strut fairing.

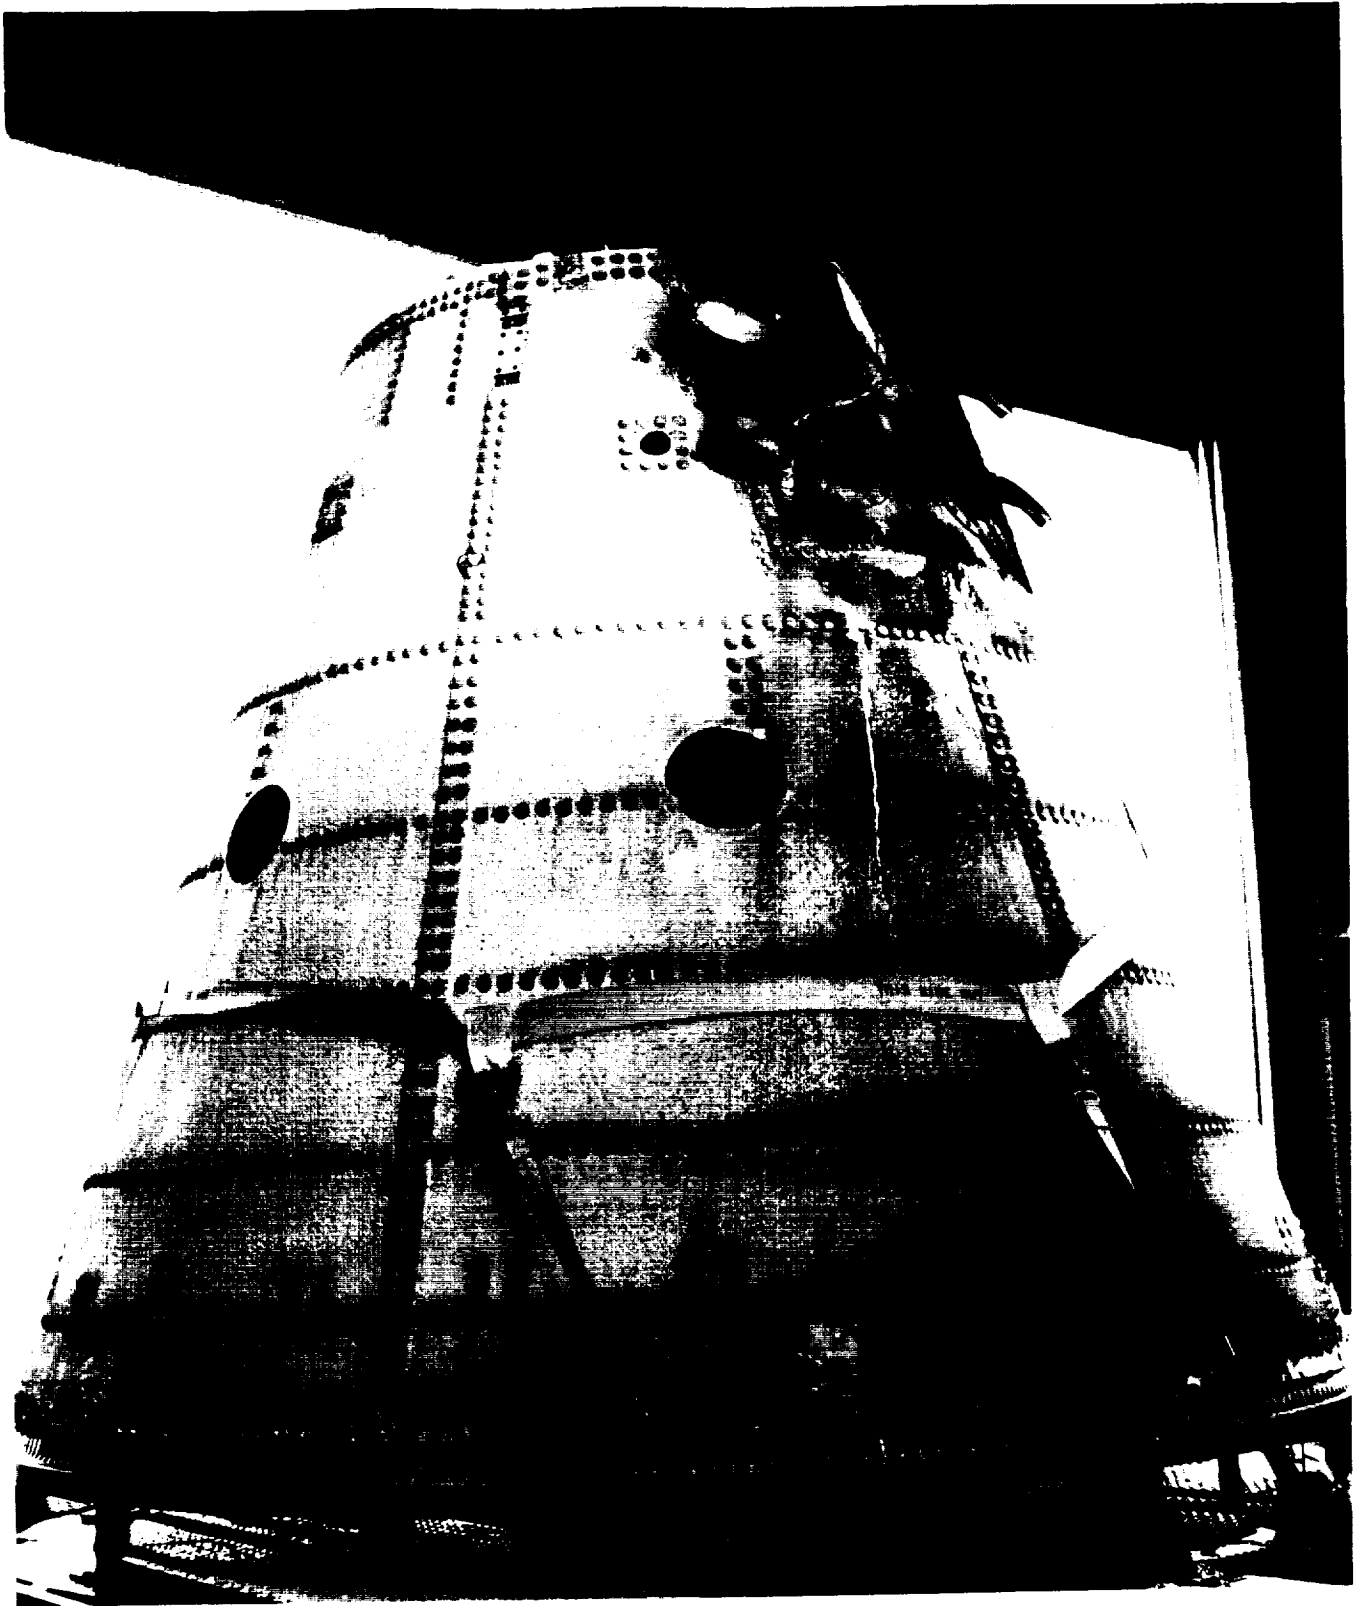
Photo 17: LH Frustum

The LH frustum was missing no TPS. The number of MSA-2 debonds over fasteners (36) was average. Hypalon paint was blistered/missing along the XB-395 ring frame where BTA closeouts had been applied. However, most of the exposed BTA substrate was not sooted. The BSM aero heat shield covers had locked in the fully opened position.

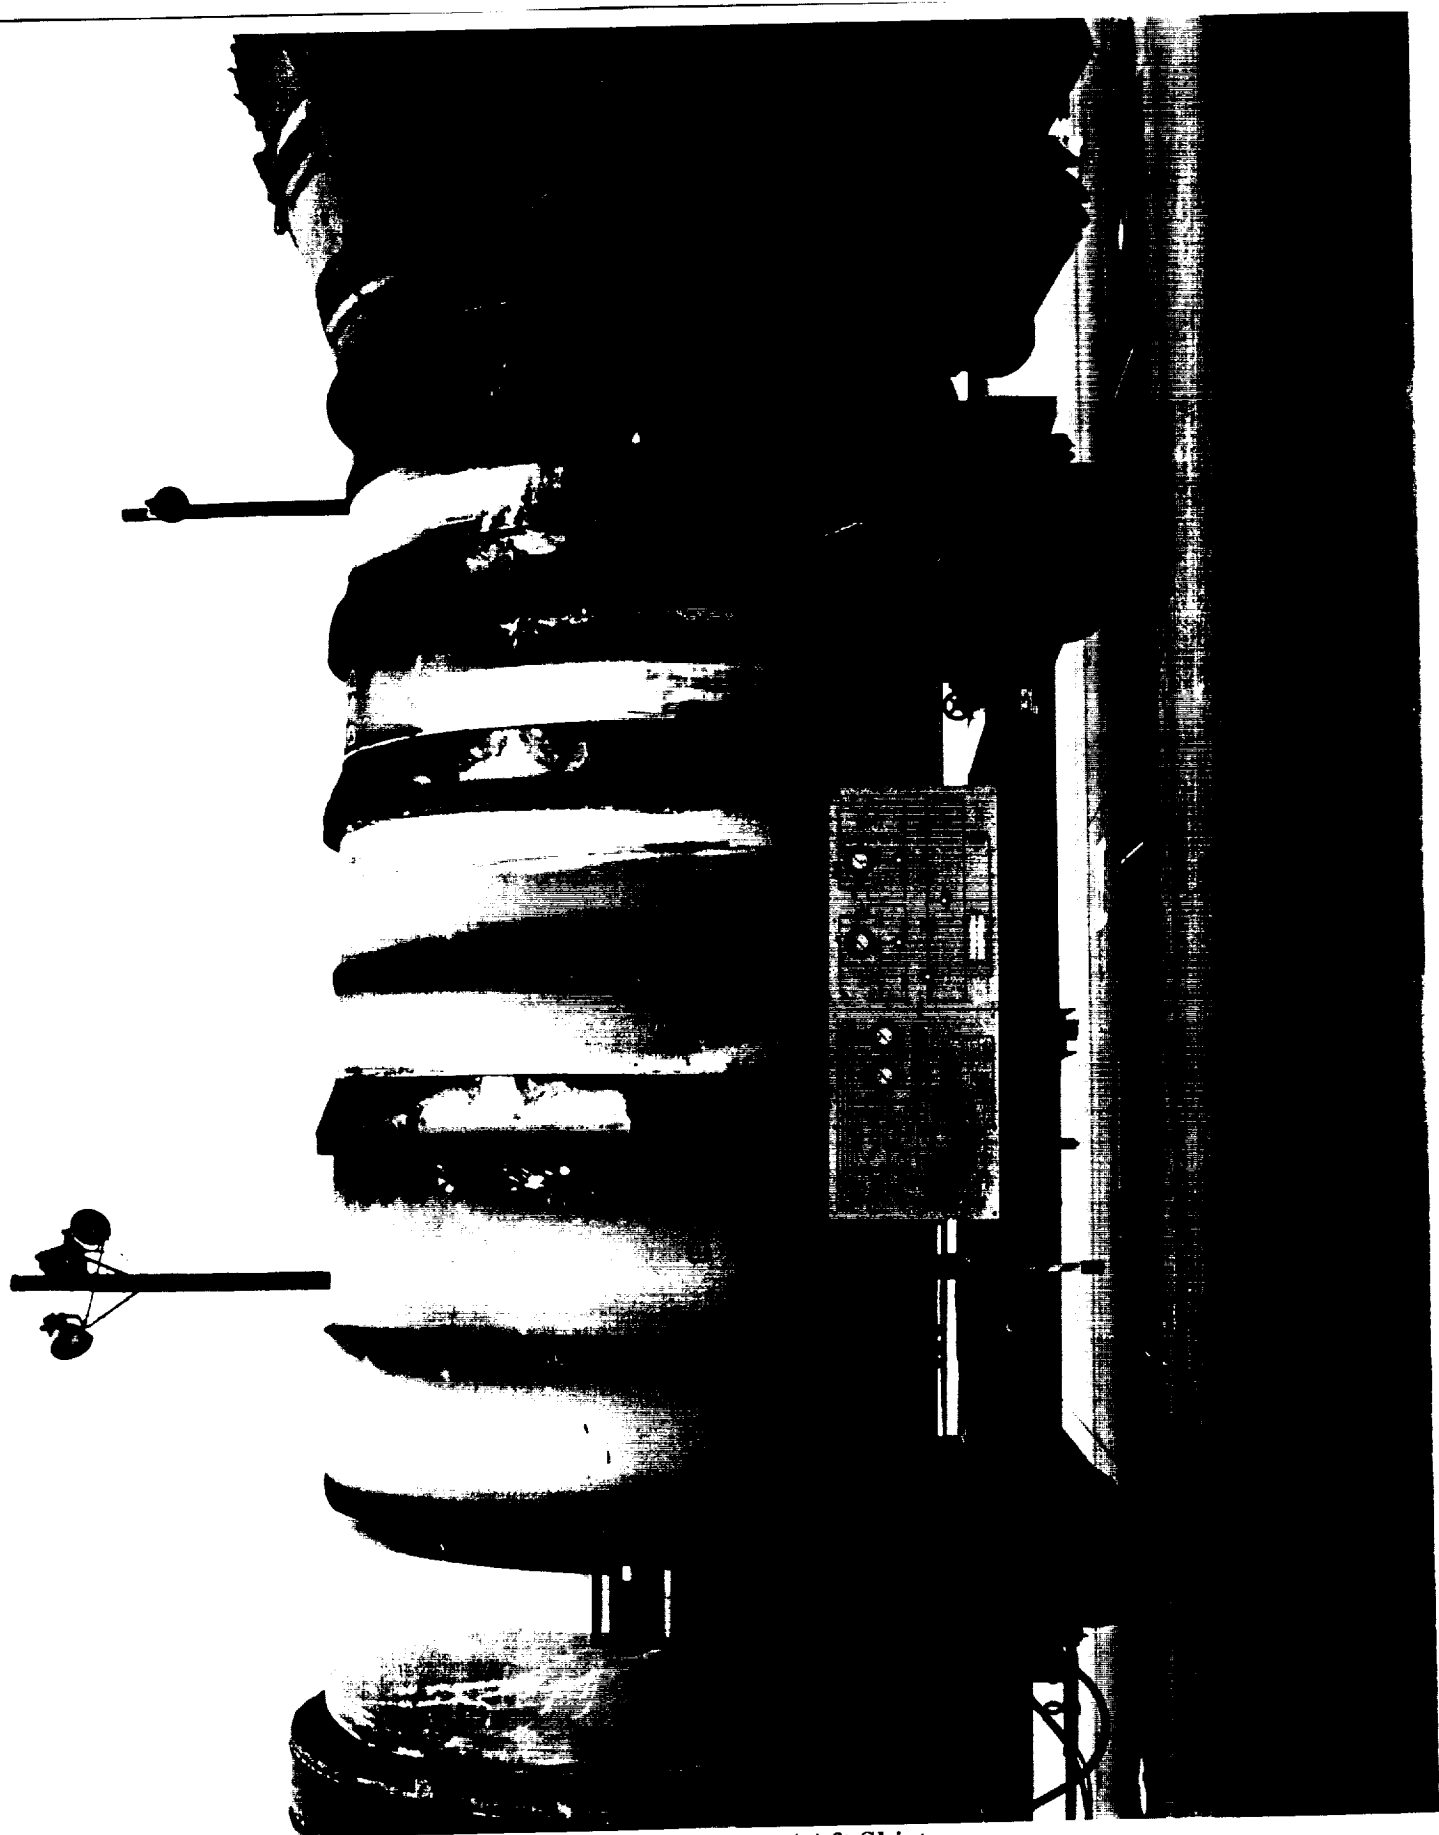
Photo 19: LH Aft Booster/ Aft Skirt

Aft skirt MSA-2 was intact. The HDP Debris Containment System (DCS) plungers were seated and appeared to have functioned properly.

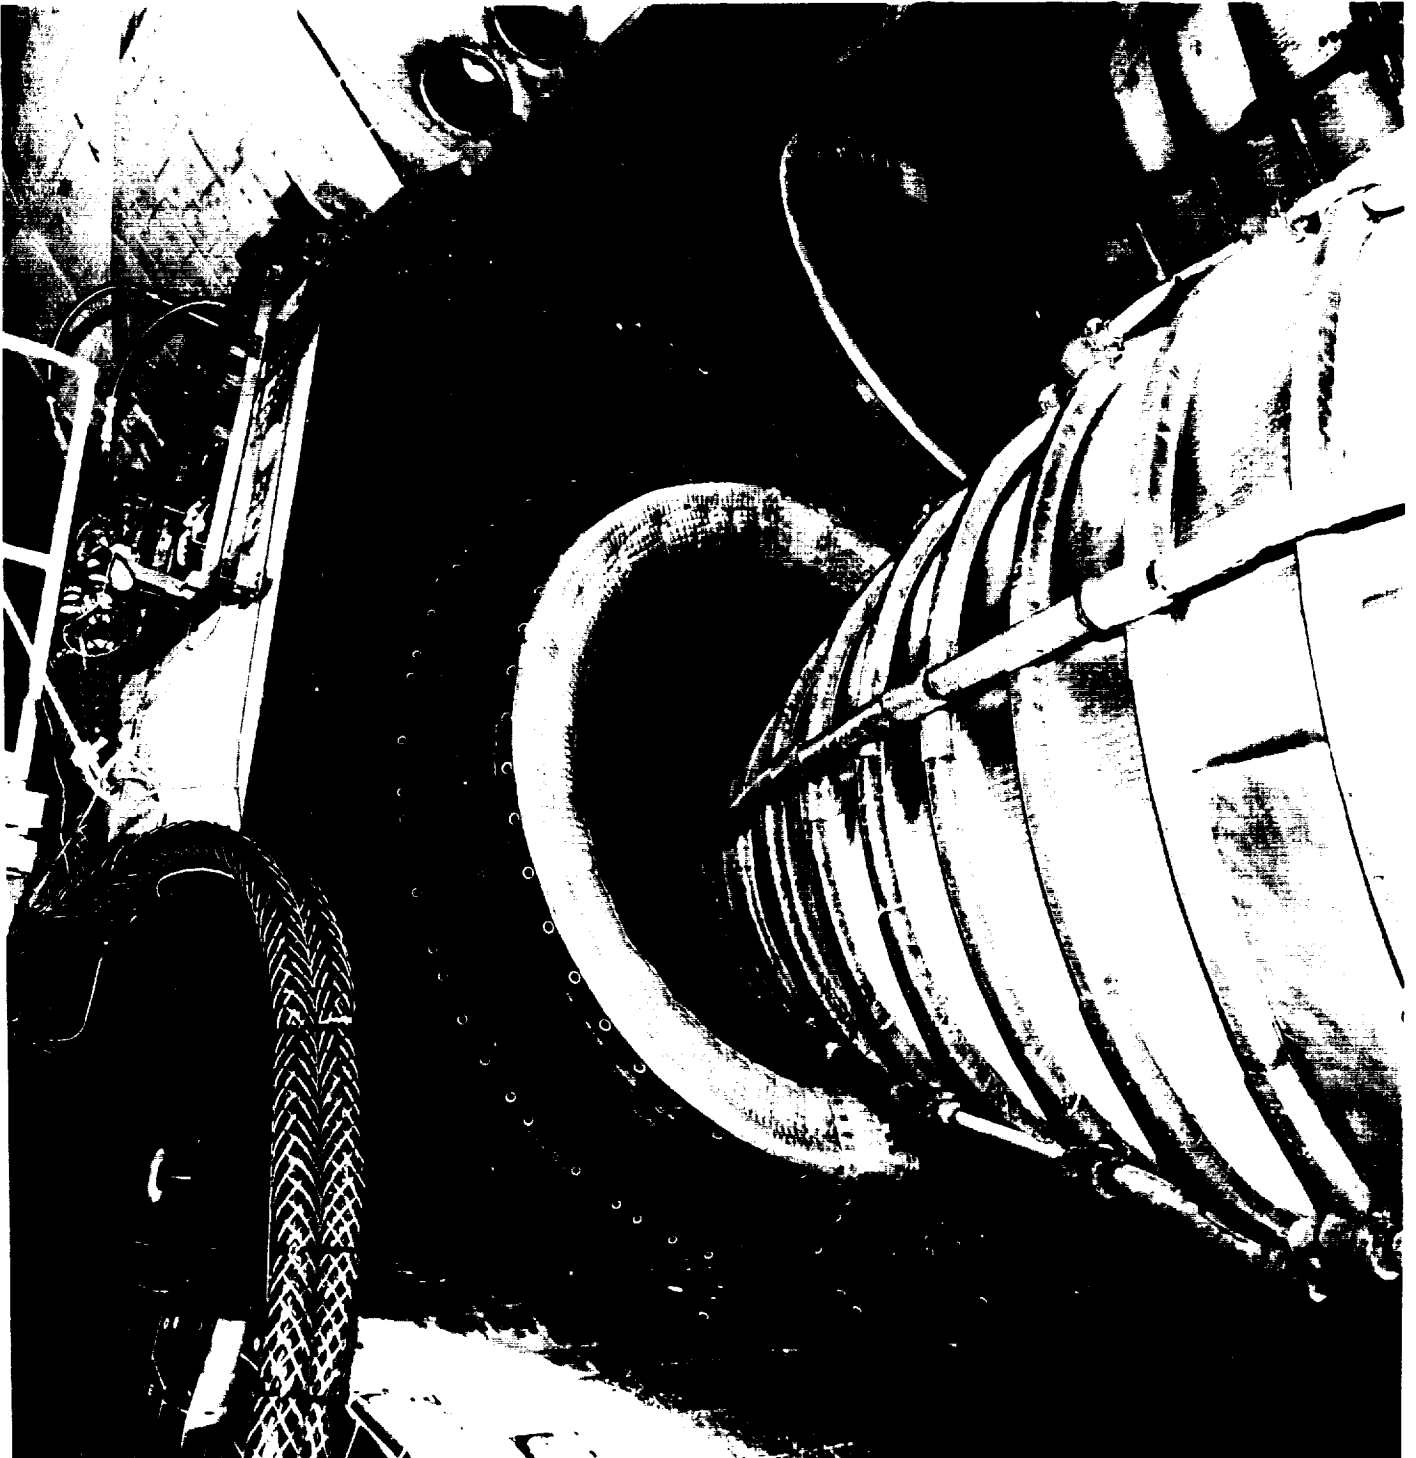
Photo 22: View of Base Heat Shield

All three Dome Mounted Heat Shield (DMHS) closeout blankets were in excellent condition with no missing material.

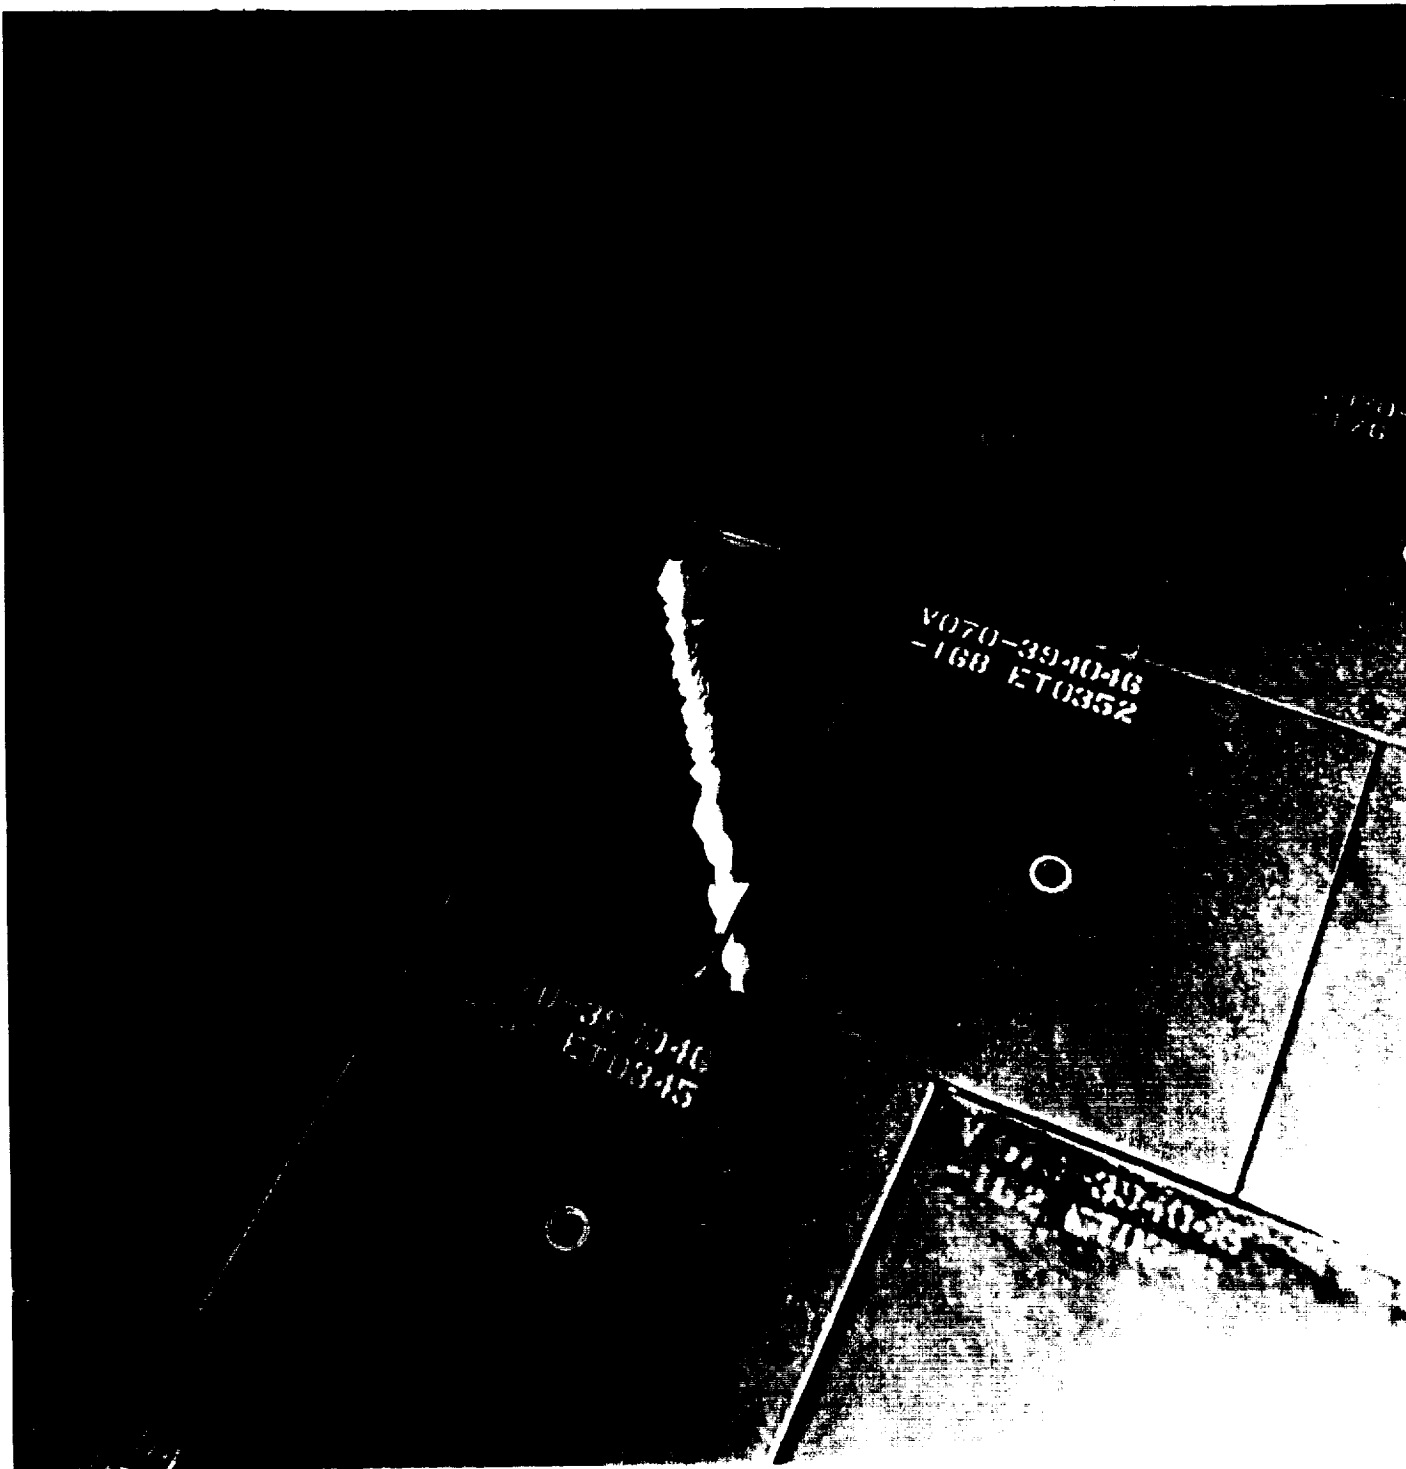
Photo 23: Lower Surface Tile Damage

The Orbiter lower surface sustained a total of 55 hits, of which 6 had a major dimension of 1-inch or larger. The largest lower surface tile damage site occurred approximately 15 feet forward of the RH MLG wheel well and measured 6.0-inches long by 0.375-inches wide by 0.25-inch maximum depth

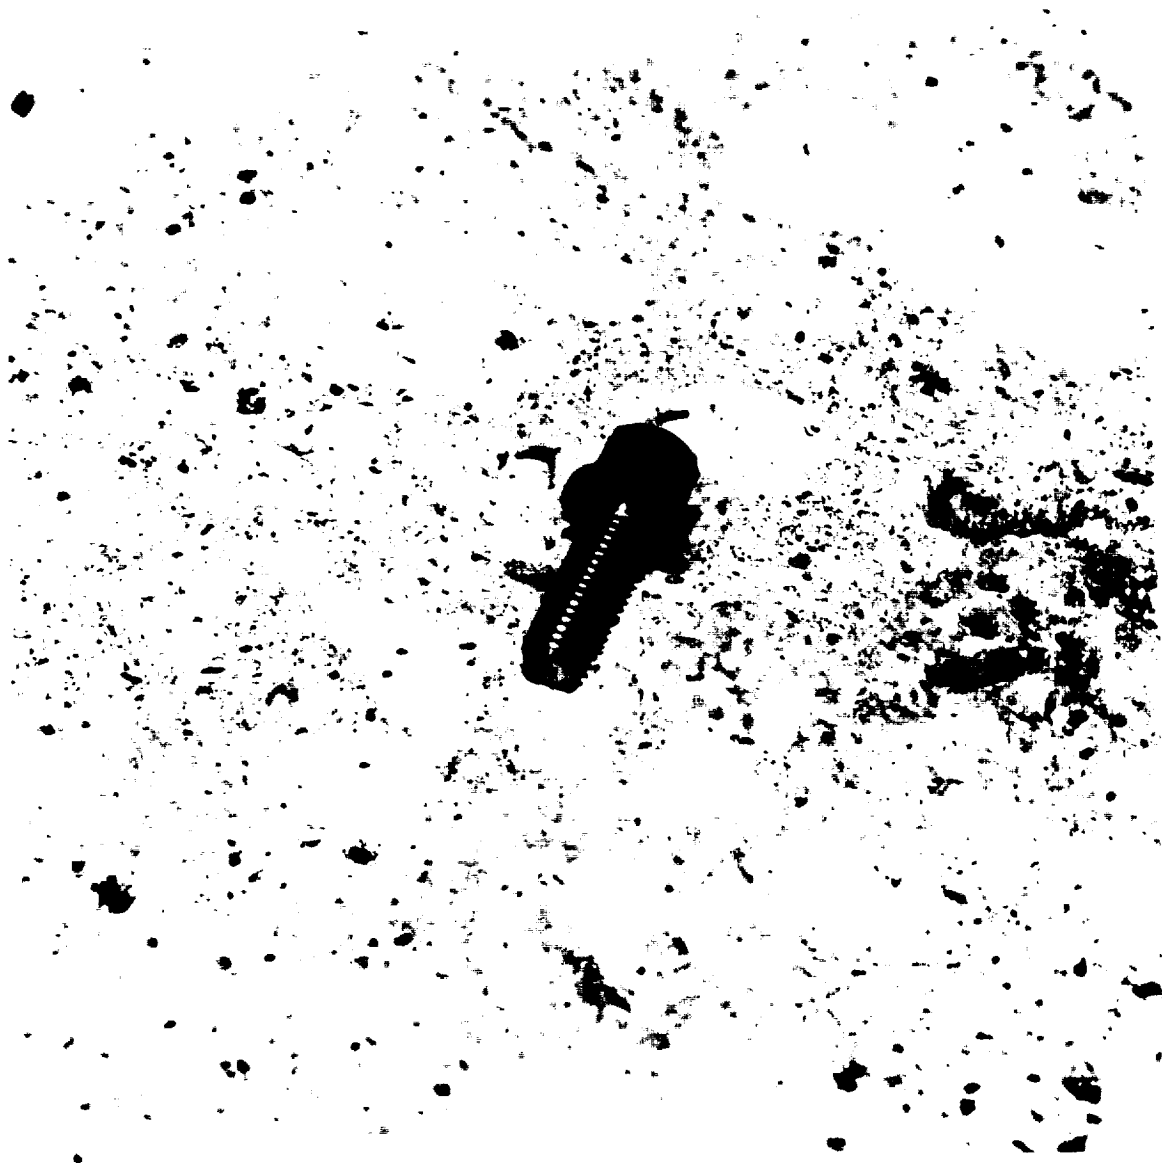
Photo 24: Debris Found on Runway Under Umbilical Cavity

The only debris found on the runway under the umbilical cavities (LH2) consisted of a bolt 0.875-inches long by 0.1875-inch diameter with a red coating on the bolt head. The bolt, which is stamped with the number MS 21279-7, is used in the Orbiter aft compartment SSME wire bundle clamps. A post flight inspection of the aft revealed no missing bolts (Ref. Lost and Found PR LAF-5-11-0199).
