Debris/Ice/TPS Assessment and Integrated Photographic Analysis of Shuttle Mission STS-72

**DEBRIS/ICE/TPS ASSESSMENT
AND
INTEGRATED PHOTOGRAPHIC ANALYSIS
OF
SHUTTLE MISSION STS-72**

11 January 1996

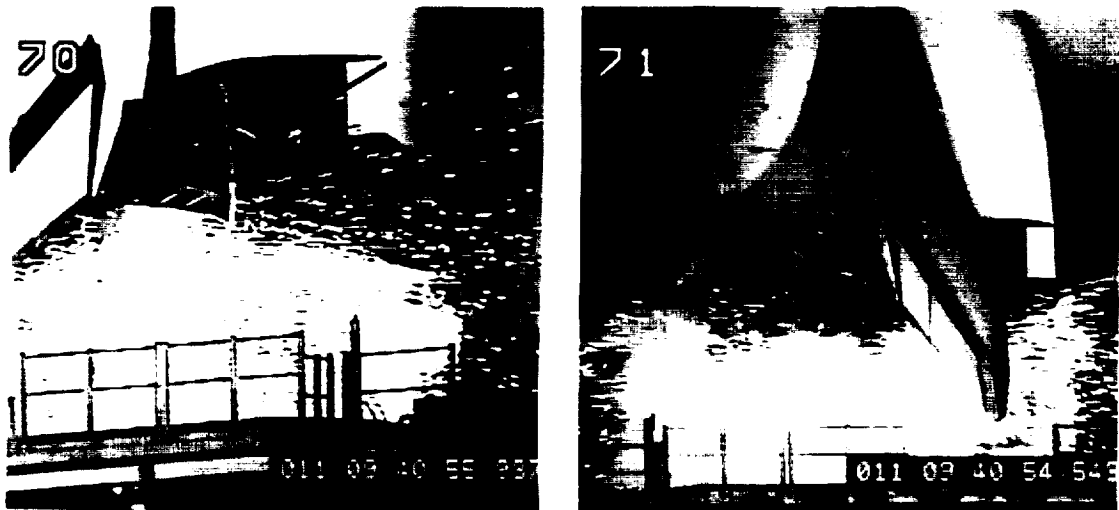
Figure 2.2.3 Orange Vapor

Orange vapor (possible free burning hydrogen) was seen above the SSME bells, by the port RCS stringer, under the bodyflap, near the vertical stabilizer and near the base heat shield during SSME ignition (09:40:54.2 UTC). Orange vapor has been seen on previous missions. No follow-up action was requested.
