NASA Reference Publication 1374

Electronic Systems Failures and Anomalies Attributed to Electromagnetic Interference

R.D. Leach and M.B. Alexander, Editor

July 1995

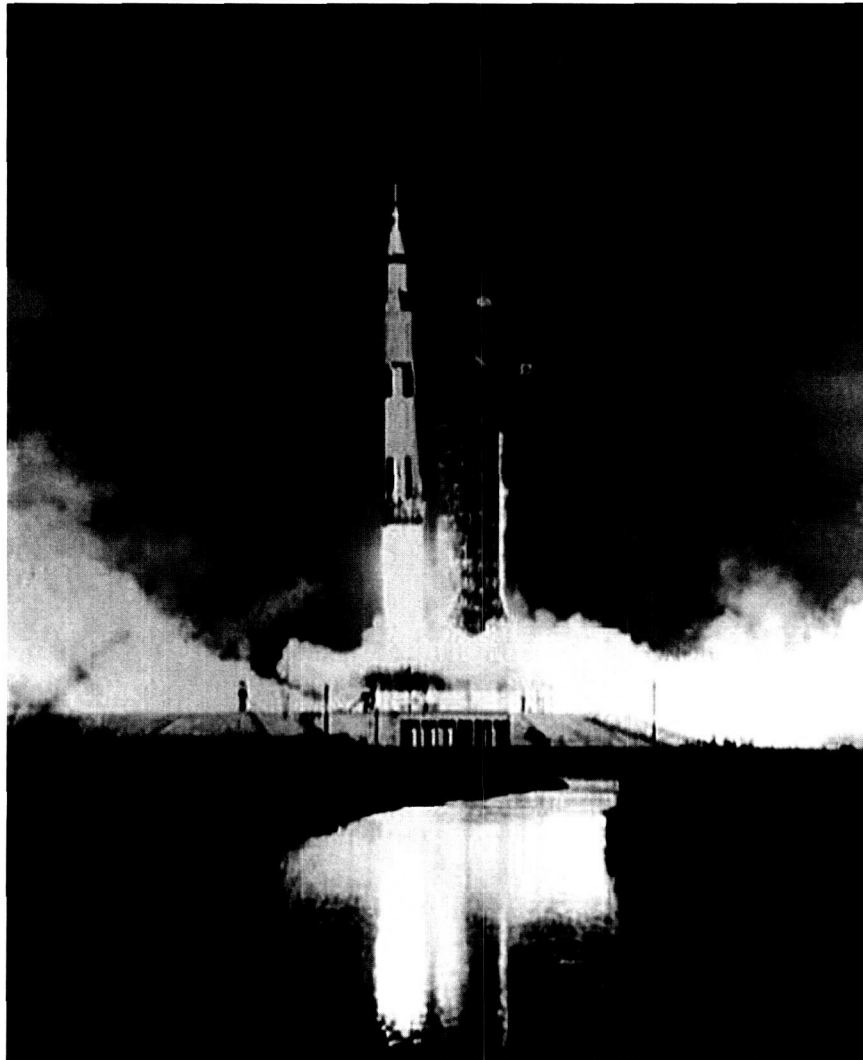
Figure 1. Saturn V launch.

During on-pad checkout at the Kennedy Space Center (KSC) prior to one of the early developmental test flights of the Saturn launch vehicle, the range safety receivers detected an extraneous signal. Because these receivers processed commands for engine cutoff, arm, and destruct, a thorough investigation was conducted to determine the cause of this unintended signal transmission. The problem appeared to be the production of spurious signals originating from the sum and difference combinations possible when signals frequencies are mixed. Although technically these spurious signals are not beat frequencies (associated with sound energy), this particular case is known within NASA as the beat frequency case and is maintained in this report by that title. The spurious signals were caused by the multitude of transmitters located on board to collect test data. Analysis determined that spurious signal frequencies very near the frequency of the range safety receivers were produced by a combination of frequencies from several telemetry transmitters in combination with one of the vehicle's tracking transponders. Further investigation determined that mixing sources for the signals were the hinged cable tray covers and chain handrails on the gantry. This insight and analysis proved to be useful later. With a Saturn vehicle on pad, the range safety receivers detected a spurious command signal for engine cutoff from a Titan launch vehicle checkout on the next pad. The Titan was using the same modulation frequencies on a different carrier frequency for its range safety receivers. A signal sent to the Titan vehicle was also received by the tracking transponder on the Saturn vehicle. The retransmitted signal of the transponder was mixed with certain telemetry signals resulting in the false engine cutoff command. After this incident, the decision was made to fly with the culprit transponder inactive (eventually it was removed from the vehicle). Later, both

telemetry and range safety transmissions were moved to a higher frequency range where the production of spurious signals did not interfere with the range safety system.⁵

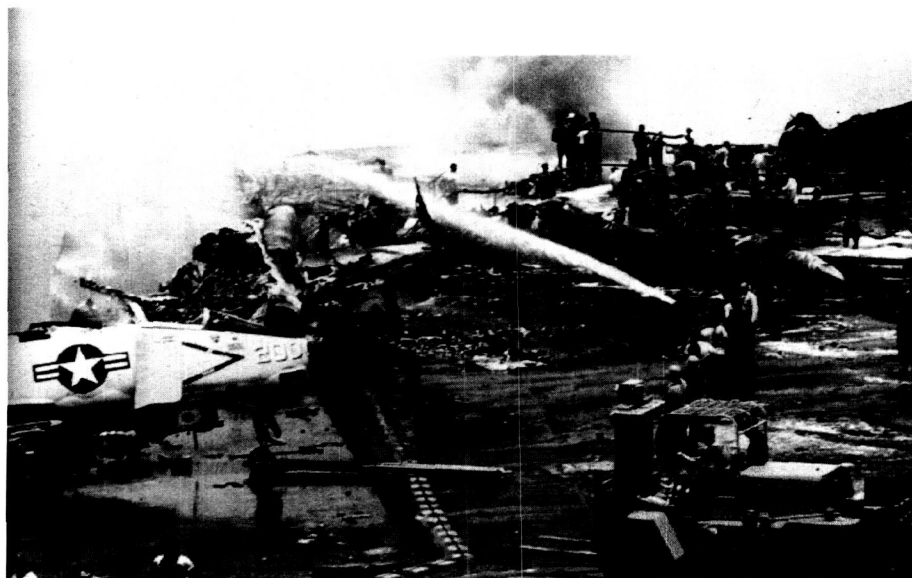
Figure 3. Aftermath of U.S.S. *Forrestal* EMI incident.

In 1967 off the coast of Vietnam, a Navy jet landing on the aircraft carrier U.S.S. *Forrestal* experienced the uncommanded release of munitions that struck a fully armed and fueled fighter on deck (fig. 3). The results were explosions, the deaths of 134 sailors, and severe damage to the carrier and aircraft. This accident was caused by the landing aircraft being illuminated by carrier-based radar, and the resulting EMI sent an unwanted signal to the weapons system. Investigations showed that degraded shield termination on the aircraft allowed the radar frequency to interfere with routine operations. As a result of this case, system level EMC requirements were revised to include special considerations for electroexplosive devices.¹²

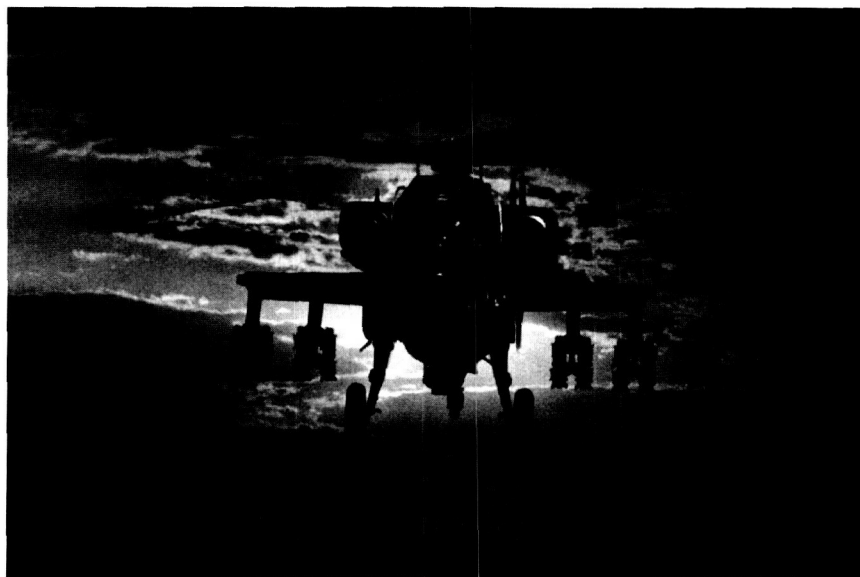
Figure 4. AH-64 *Apache* attack helicopter.

The *Apache* helicopter (fig. 4) was designed primarily as an airborne antitank weapon to provide quick-strike capability against tanks and armored vehicles. The *Apache* is essentially an electronic device with multiple electric and electronic systems that control navigating and fighting abilities. During early missions, pilots complained that HIRF signals interfered with electronics. In one case, EMI triggered an overspeed condition that could have resulted in double engine failure. Subsequent reports showed that the aircraft was susceptible to low-level emitters such as commercial microwave, television, and airport and missile radar. At one point, the Army concluded that the *Apache* should not be used on aircraft carriers. After determining that the source of unwanted signals was coupling in the I/O cables, the shielding was redesigned; but not before many costly aircraft were built with EMI deficiencies.¹²
