NASA Technical Paper 3583

# Impact Damage Resistance of Carbon/Epoxy Composite Tubes for the DC-XA Liquid Hydrogen Feedline

*A.T. Nettles*

September 1995

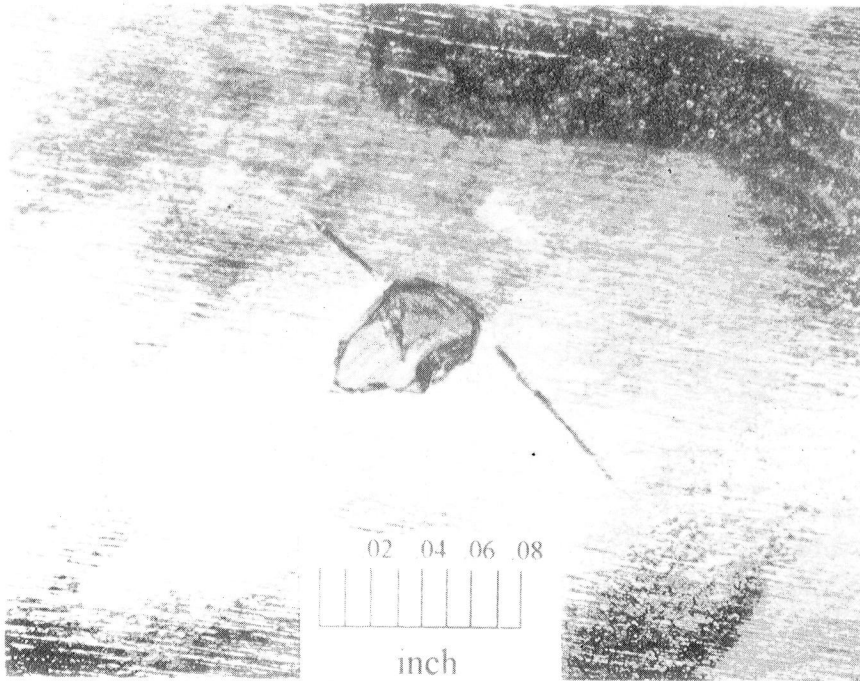
Hit No. 7

On impact No. 7, the first hit that did not produce obvious external damage, the photomicrograph shows that a small crater has formed in the outer gel coat of the tube's surface. Two small cracks in the gel coat propagate from this crater. Specimen dissection, discussed in the next section, will show if any fiber damage has occurred. However, no fiber damage needs to occur for permeability to be present, only a leak path through the matrix resin is needed.

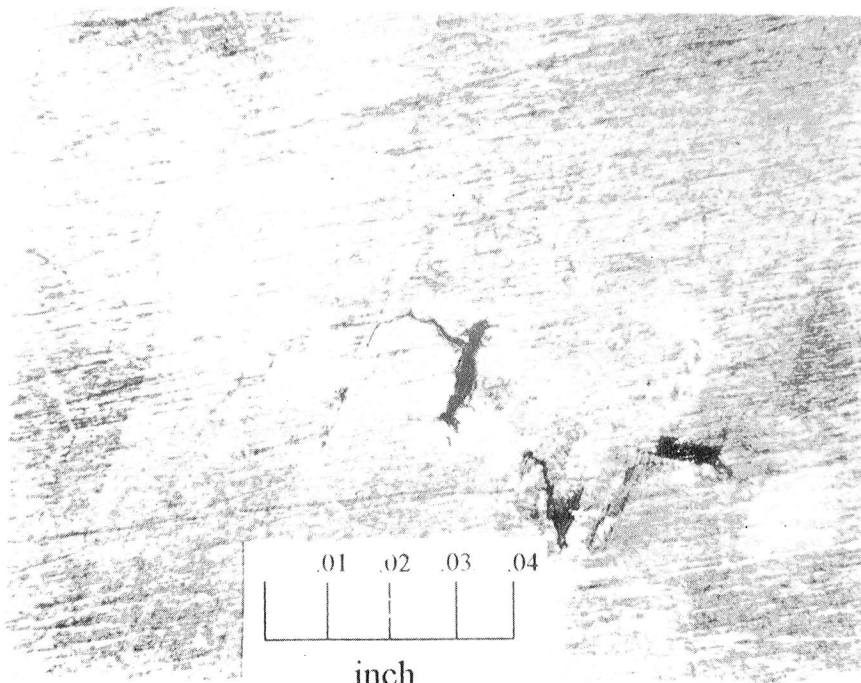
Hit No. 8 is an example of damage that did not cause detectable leakage, yet was visible under microscopic examination. While damage such as this may not cause detectable leakage of argon gas using a soap based leak detector solution, hydrogen permeation may still occur at high rates.

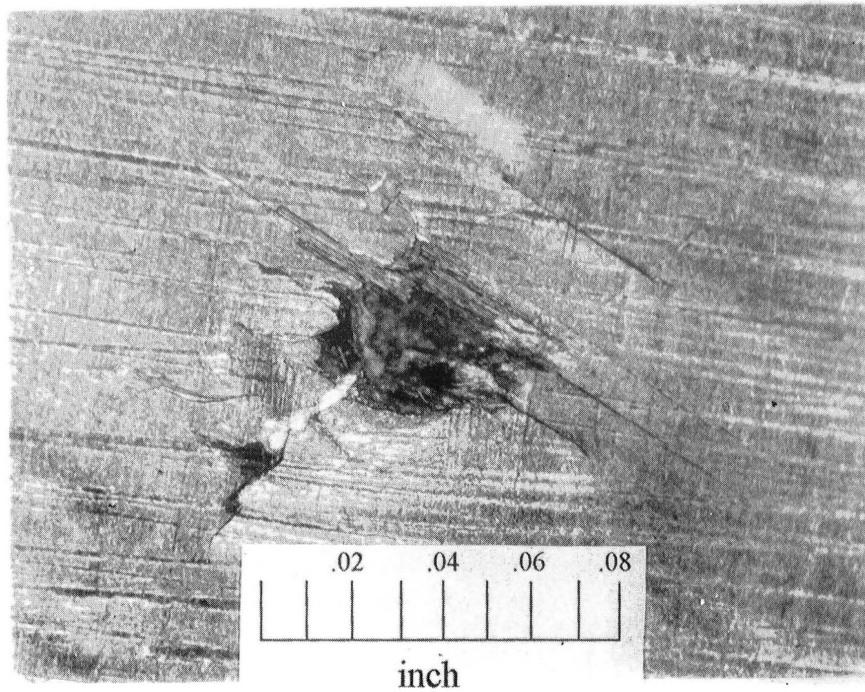
Hit No. 10

Also of interest is hit No. 10 that caused a visible nick in the surface, yet did not cause a detectable leak. The cross-sectional examination results, given in the next section, will show why this is. Hit No. 11 shows far less surface damage than hit No. 10, yet hit No. 11 leaked while hit No. 10 did not. Thus, surface damage alone is not a good indicator of whether or not an impact event will cause leakage. One explanation for this is that hit No. 11 was performed with a 2-mm diameter striker which was relatively blunt compared to the sharpened bolt strikers. The impact energy due to a blunt hit is distributed over a wider area and less contact stresses occur, thus the energy is dissipated as matrix cracking through the entire thickness of the tubes instead of the localized puncture that may not go through the thickness. This seems to be the case since all impacts with the 2-mm diameter striker caused leaks even though the impact energies were lowered to the lowest level used with the sharpened bolts (~0.8 J).

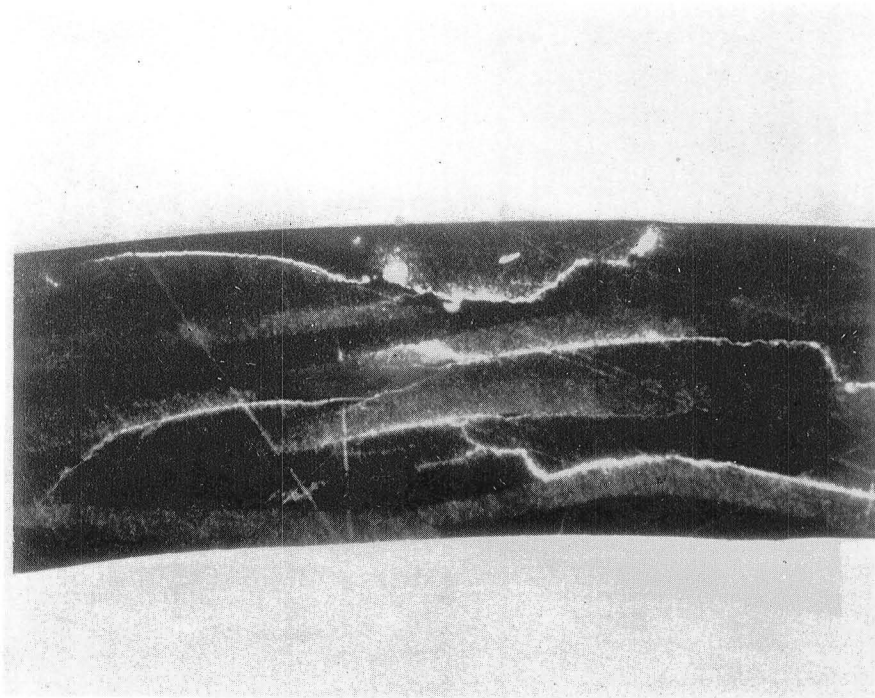
Hit No. 7

From the cross section of hit No. 7, it can be seen that no fiber breakage is present, but extensive matrix cracking exists. This was found to be typical of all of the impacts except Nos. 1, 2, and 3, which demonstrated obvious fiber breakage visible from the surface. The majority of the lengths of these cracks run between plies of carbon/epoxy as is typical of impact delamination damage. The leak paths form when these lines of delamination are joined by transverse cracks that bridge between layers. Some of these cracks can be seen on the photomicrograph of hit No. 7. Since the entire volume of impact damage cannot be represented by a cross-sectional photograph, a complete leak path may not be visible on any one plane perpendicular to the specimen. Thus, the density of cracks on the plane in the photomicrograph must be used to assess the likelihood of a leak path forming through the entire tube wall thickness. For example, the cross-sectional photograph of hit

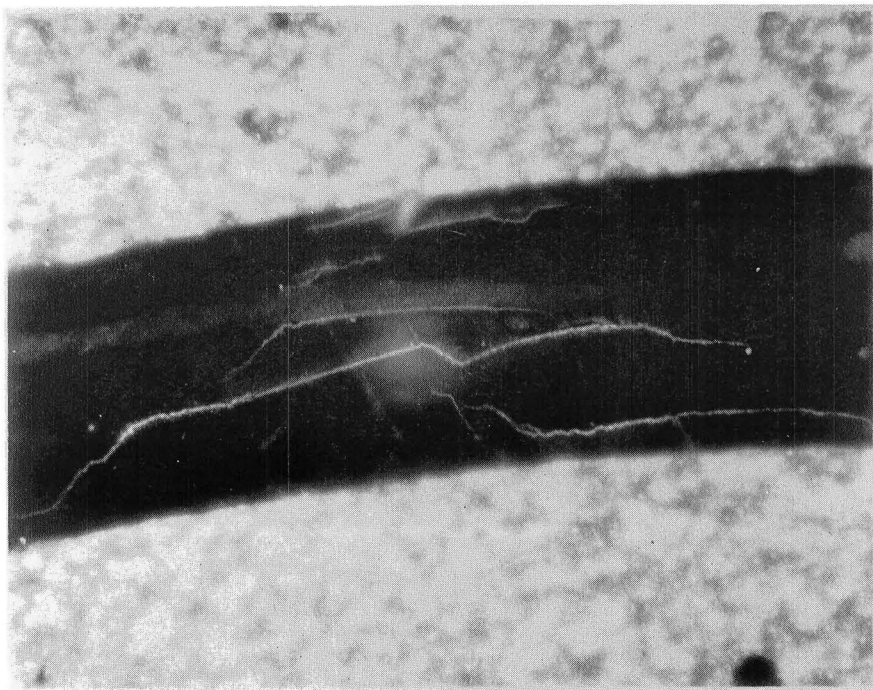
Hit No. 8

No. 8 seems quite similar to that of hit No. 7, yet No. 7 leaked while No. 8 did not. These two photographs represent the borderline impact level at which leakage begins to occur.

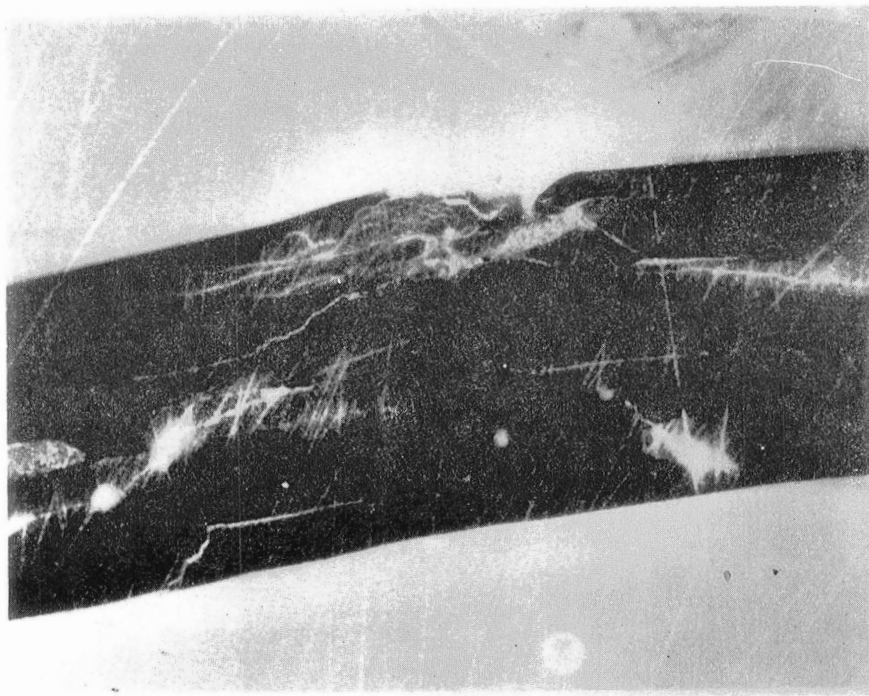
Hit No. 9

The surface damage can be seen in the cross-sectional photograph of hit No. 9. The typical conical region of damage observed in impact damaged composites can be seen in this, and most other, photomicrographs. This type of damage consists of heavy matrix damage below the impact site, with delaminations spreading out further away from this point as the specimen gets deeper.

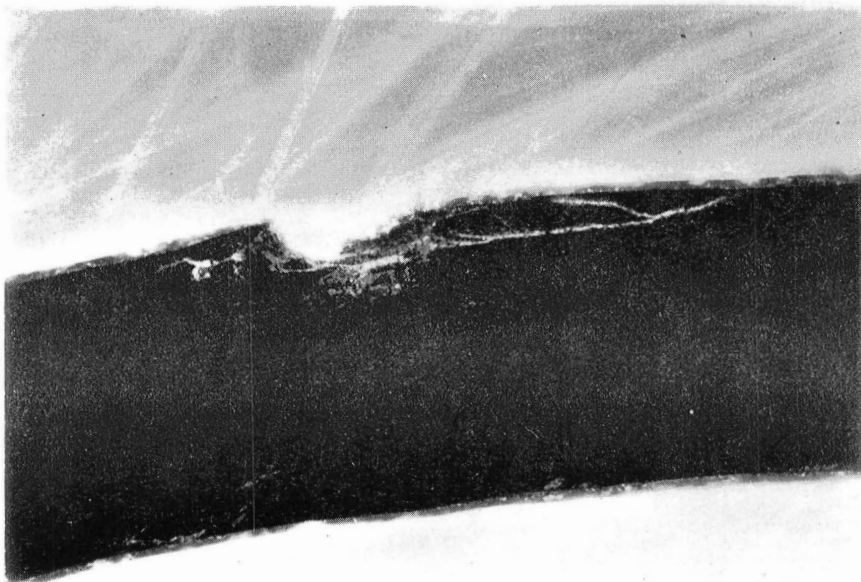
Hit No. 10

As mentioned in the previous section, hit No. 10 sustained a visible surface nick yet did not leak. The photomicrograph of this specimen helps confirm the theory that the punctured area near the surface absorbed most of the incident impact energy, leaving little energy to form delaminations and matrix cracking deeper in the specimen. The photomicrograph of hit No. 11, which was similar to hit No. 10 only with a more blunt striker, shows that not as much surface damage was inflicted upon the specimen, allowing the impact energy to be dissipated into the entire thickness of the tube wall as delaminations and matrix cracking.

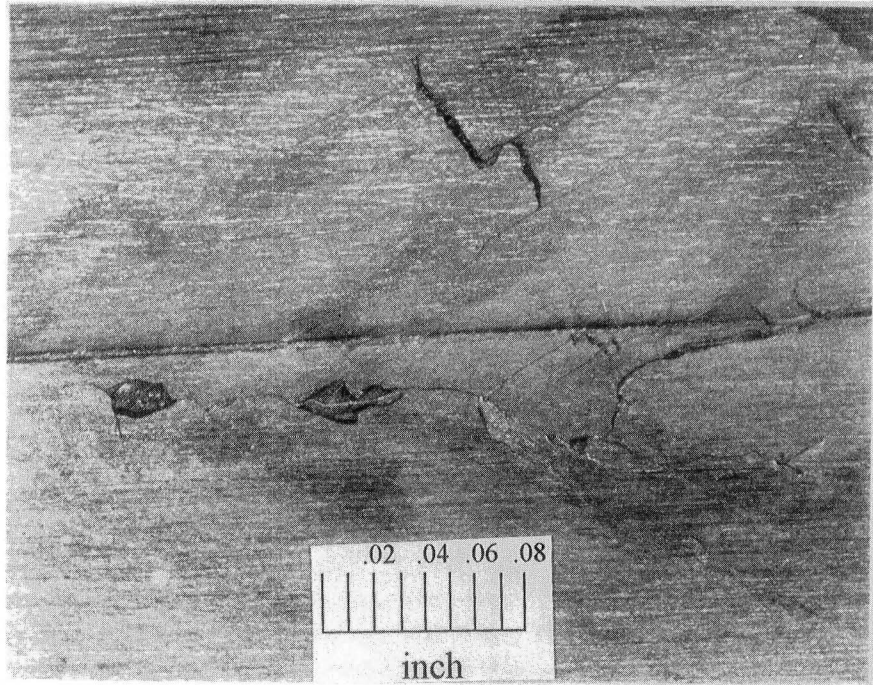
Hit No. 1

1. Surface Damage. Surface photomicrographs of the damage that caused leaks are given in appendix D. All of the photographs show matrix gel coat cracking in the region near the impact site with no localized damage present. This is due to the large diameter striker being used, which helps

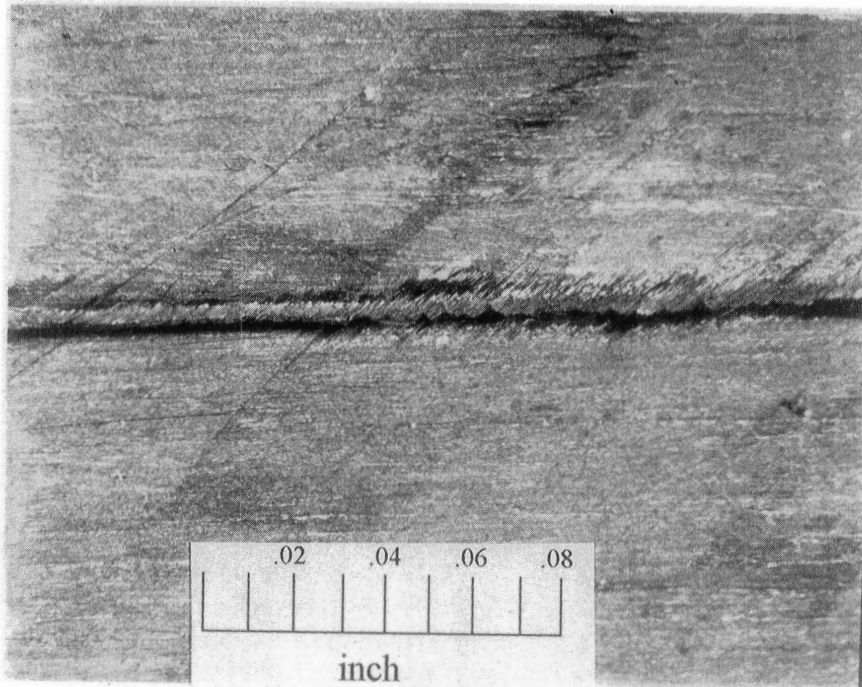
Hit No. 4

to spread the impact energy over a larger area, reducing localized damage. Note that on hits No. 4 and 6, the cracking was contained within the seam of the gel coat caused by the outer clamshell mold used in the processing of the part. These areas are resin rich, and the cracks can propagate much more easily in these areas than in those outside the seam which contain fibers closer to the surface. This indicates that impacts that occur on the "seam" of the tube may be much more difficult to visually inspect, thus care must be taken for these impacts.

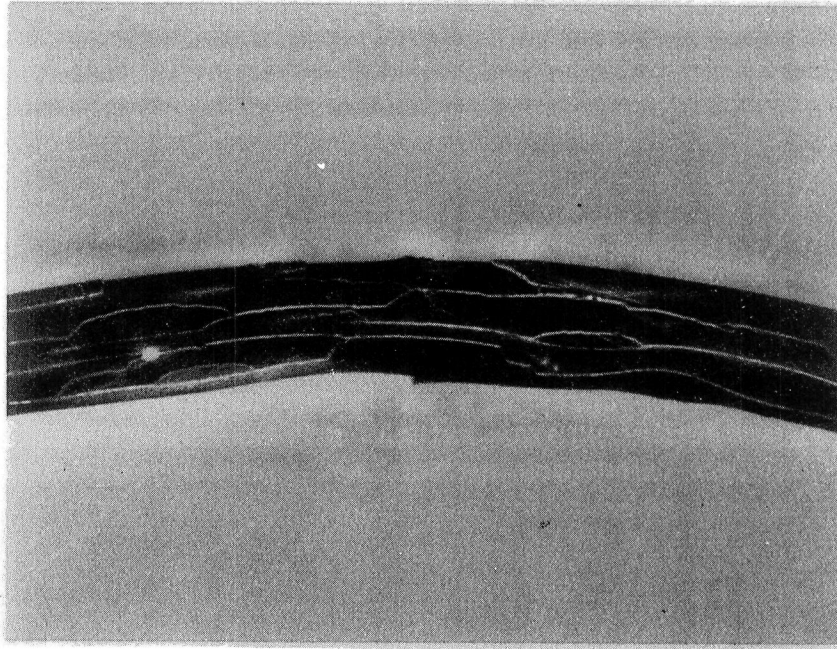
Hit No. 1

2. Cross-Sectional Examination. Cross-sectional photomicrographs of the impacted areas that caused leaks are given in appendix E. Extensive delaminations and matrix cracking are evident on specimens No. 1 and 2 as might have been expected due to the high leak rates observed. Specimens No. 4 and 6, which had surface damage confined to the "seam" area of the tube, show typical delaminations and matrix cracking, indicating that subsurface damage is not effected by the visible damage being restricted to the "seam" area. Specimen No. 15 shows the typical conical type damage mentioned in the previous section on sharp impacts.
