# STRUCTURAL TESTING OF THE TECHNOLOGY INTEGRATION BOX BEAM

C. F. GRIFFIN

LOCKHEED AERONAUTICAL SYSTEMS COMPANY  
MARIETTA, GEORGIA

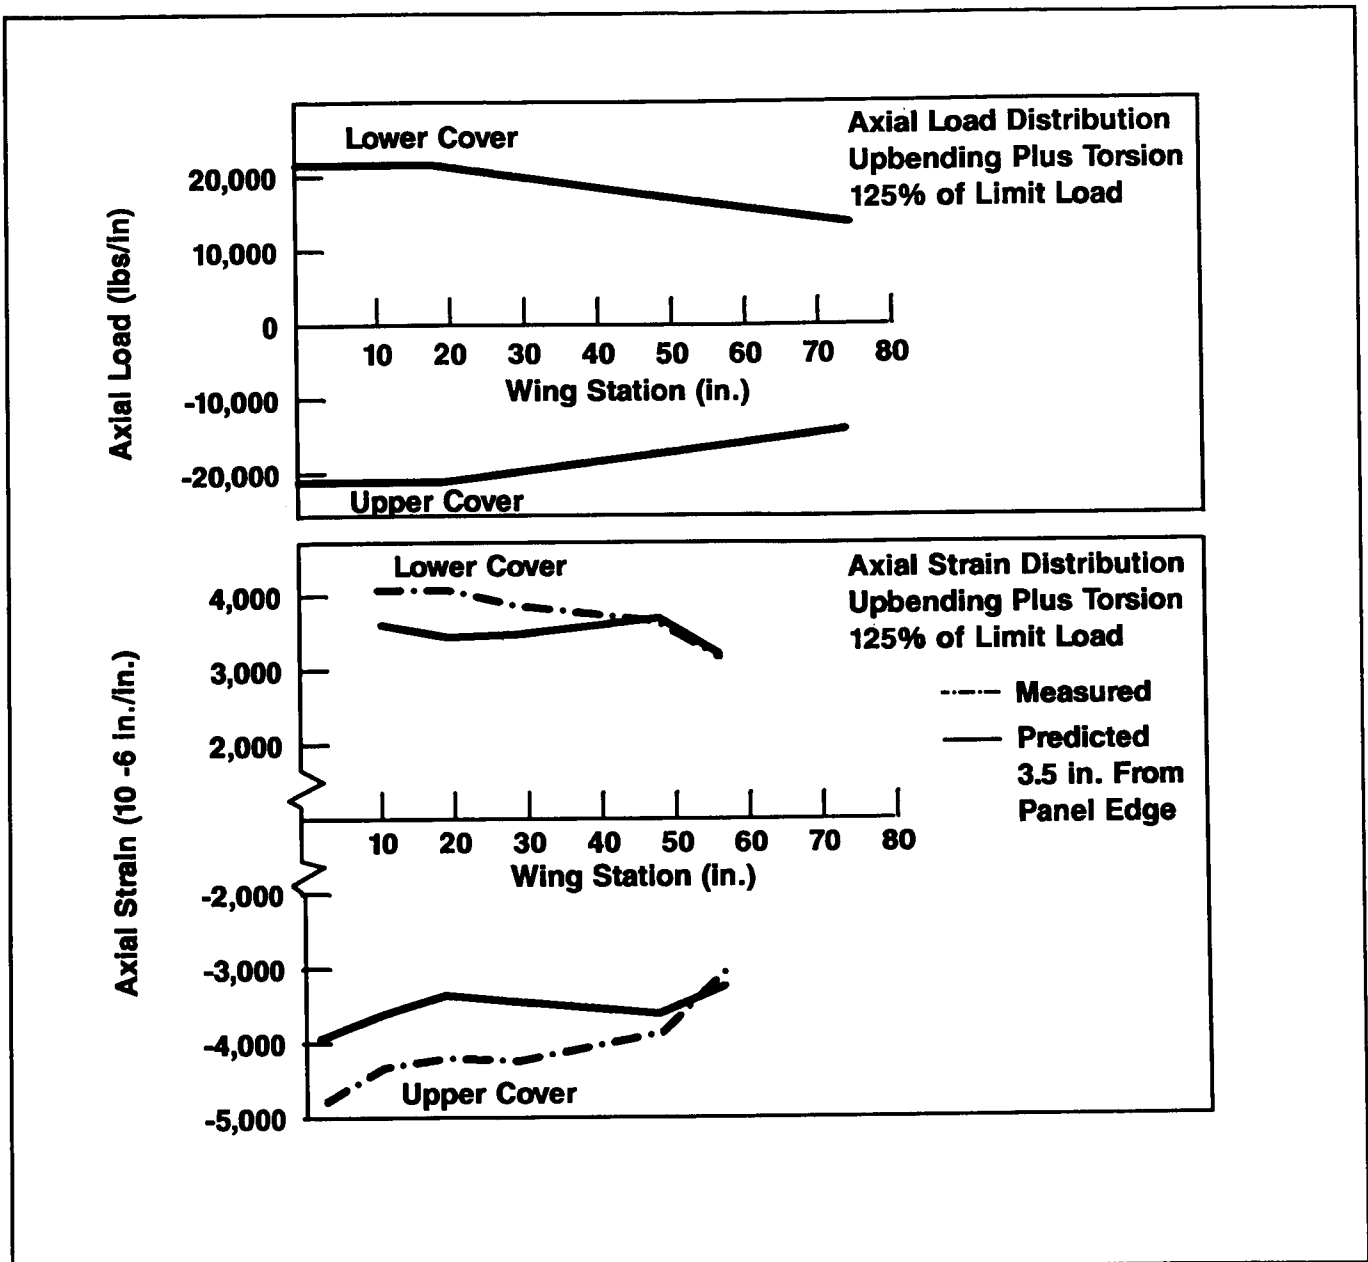
Figure 9. Cover Loads and Strains at Box Failure Load

An upbending combined with torsion loading condition was conducted to limit load followed by the ultimate load test for the same combined load condition. During the ultimate load test the box failed at 125% of design limit load. The failure location was in the upper cover and spars at wing station 45. Figure 9 presents the average axial loads for the upper and lower covers and the axial strains in the covers at the failure load. The measured strains are the averages for the gages mounted back-to-back on the cover skin located approximately 4 inches from the spar web. Compared to strains predicted by finite element analysis, the measured strains are considerably greater in the mid-span locations of the box. From W.S. 30 inboard, the measured strains on the lower cover were 16 percent greater than predicted and 22 percent greater than predicted on the upper cover.

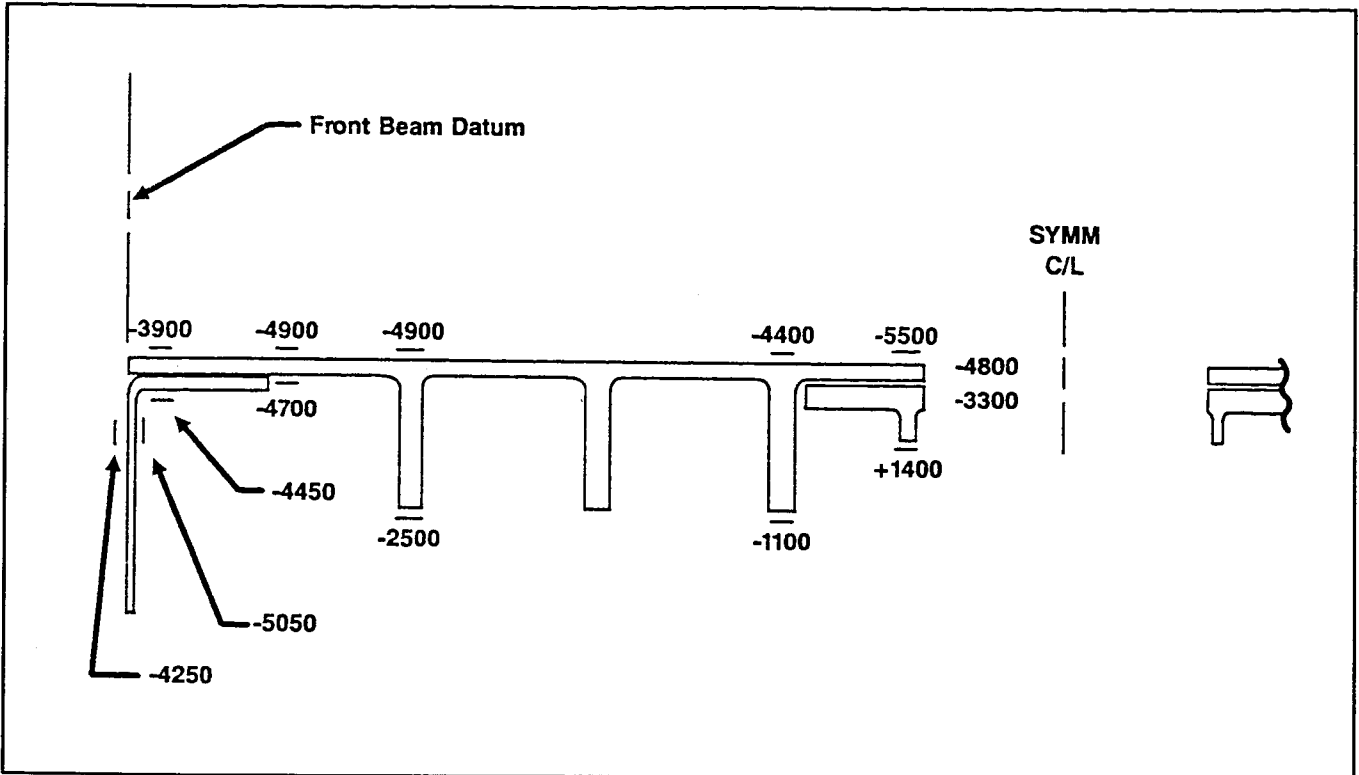
Figure 10 Measured Axial Strains of Upper Cover at W.S. 0 at Failure Load (All Strains  $10^{-6}$  In./In.)

A review of the load-strain information for the upbending condition indicated that no local buckling occurred in the covers or spars prior to failure. However, as shown in Figure 10, a significant amount of local bending was measured in the central section of the upper cover in the area surrounding the cutout. The 5500 microinch/inch compressive strain recorded near the edge of the cutout was also the largest strain measured on either upper or lower covers. Most of the local bending which occurred in this region is due to the axial load path eccentricity caused by the access hole and its reinforcement.

In addition to the suspected design detail problem at the hat runout in the upper cover, data from the test program also indicated a local bending around the access hole in the upper cover. The access hole reinforcement design concept should be revised to minimize the load path eccentricities in that area. Another design change recommended is to use an intermediate modulus fiber such as IM7 in place of the AS4 for the spanwise plies in the covers and spar caps. Trade studies have indicated that this change would result in a substantial weight savings compared to the current design and more than offset the weight added to modify the design details associated with the hat stiffener runout and access hole reinforcement.

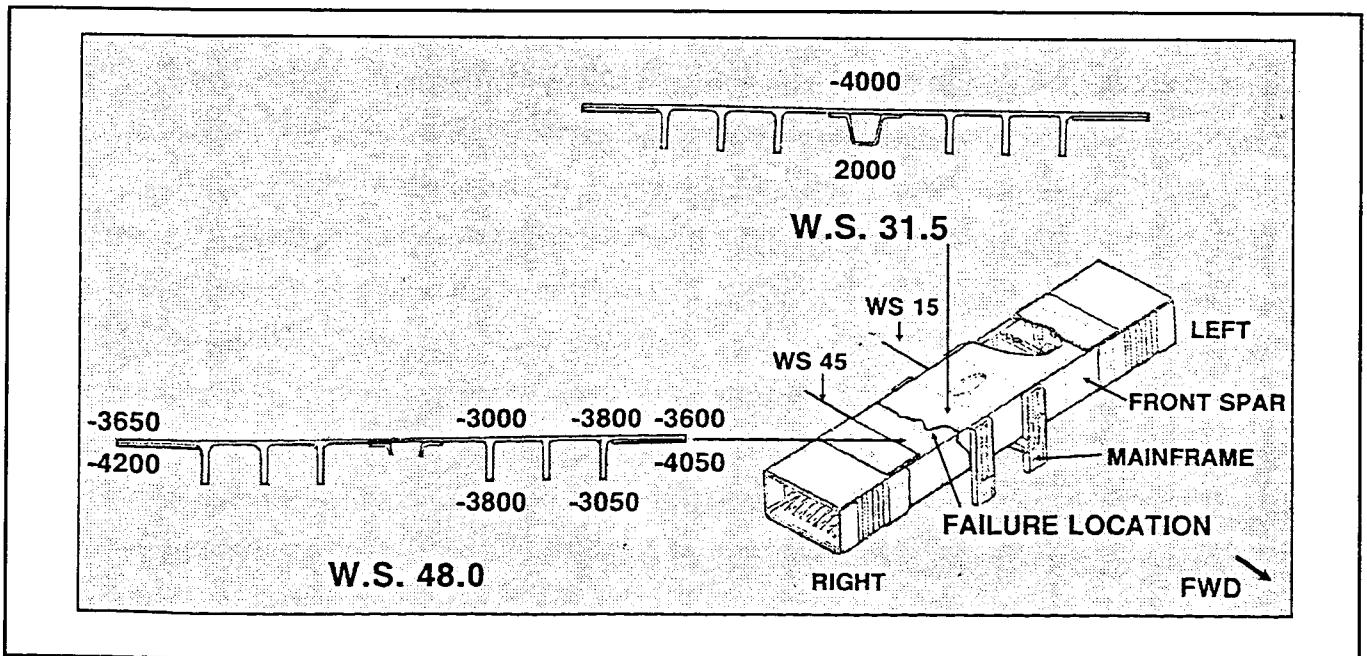
Figure 11. Axial Strains Near Failure Location (All Strains are  $10^{-6}$  In./In.)

Failure of the upper cover occurred at W.S. 45. The failure location and axial strains measured in the location just prior to failure are shown in Figure 11. Note that all of these strains are much less than the compression design allowable for the cover material, and as shown previously in Figure 9 are close to predicted values. However, the hat runout at the rib cap does cause a load path eccentricity in the central section of the cover which causes a local bending moment as indicated by the strains measured on the skin and hat crown gages at W.S. 31.5. It is hypothesized that local bending on the skin laminate at the hat runout precipitated failure of the upper cover through the last row of fasteners attaching the hat flanges to the skin. Figure 12 shows the upper cover failure as viewed from outside of the box. The photograph in Figure 13 presents the upper cover failure viewed from inside the box. Note that the modes of failure seen in the cover skin and blade stiffeners were similar to those seen in stiffened panel tests previously conducted to evaluate compression load carrying performance of this type of construction.

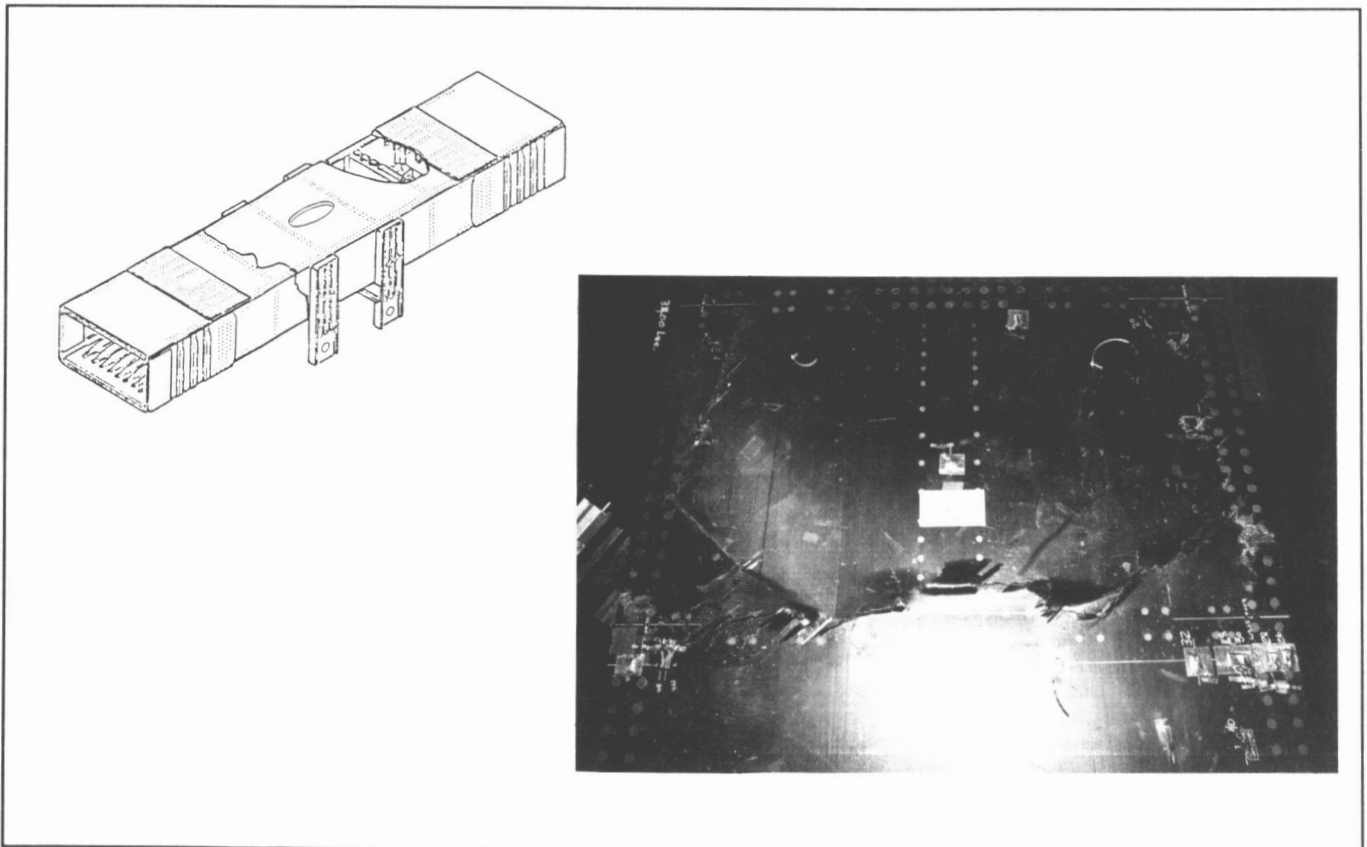
Figure 12. Upper Cover Failure at W.S. 45

Upon completion of the test program, a review was made of the load-strain data, and the box failure locations were visually inspected from the exterior and interior of the box. For the no-impact damage condition, structural analysis had predicted that the minimum margin of safety for the upper cover was at W.S. 45 for a bearing/bypass failure mode at the cover to spar cap joint (see Figure 7). However, all of the axial strains measured near the failure location, previously presented in Figure 11, were considerably less than the average open hole compression strength for this material and laminate orientation. A review of the inspection records indicated there were no anomalies in the covers or spars at the failure location. The spar cap and spar web had higher margins of safety than the cover at this location.

Additional structural analysis, quality assurance tests and panel tests are being conducted on the box to determine the cause of the premature failure. Analysis completed to date points to the hat runout as the most likely detail which initiated the failure.

stiffener runout in the central section of the cover. It is hypothesized that the load path eccentricity at the stiffener runout caused higher than predicted local bending stresses which resulted in a premature failure in the upper cover. Additional structural analysis and tests are continuing to substantiate this hypothesis.

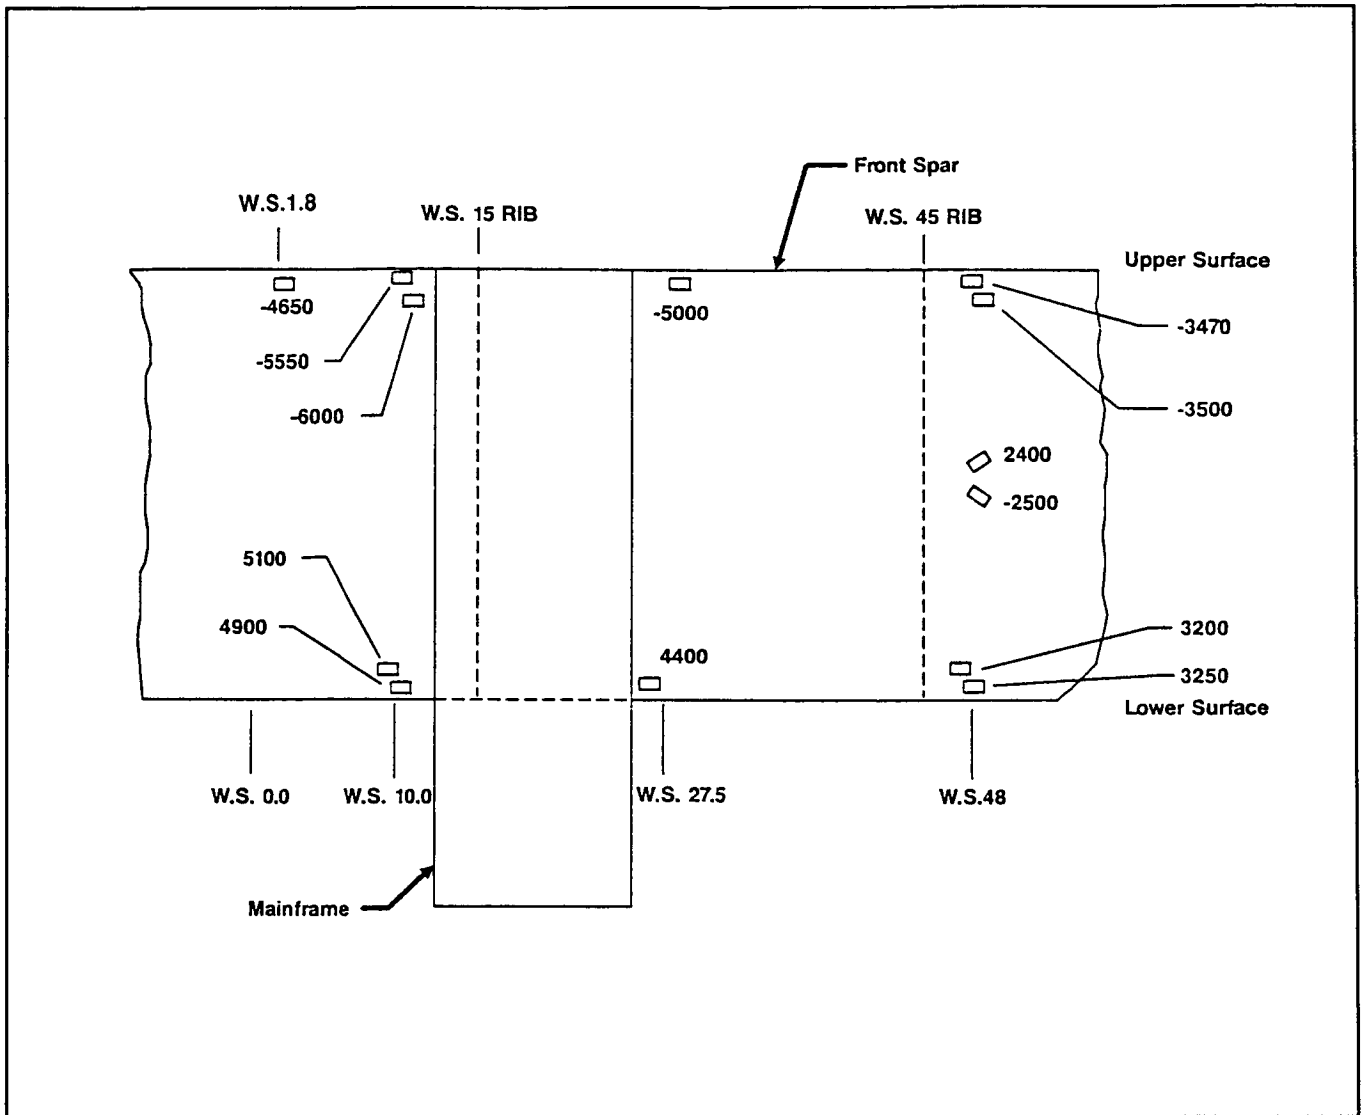
Figure 14 Front Spar Measured Strains at Failure Load

A review of the load-strain plots for the front and rear spars indicated no local buckling had occurred prior to failure. Measured strains on the front spar web at the failure load, shown in Figure 14, averaged 18 percent greater than the predicted values at W.S. 10 and W.S. 27.5. At W.S. 48 the measured strains were equal to the predicted strains. Note that the maximum strain at plus/minus 45 degrees on

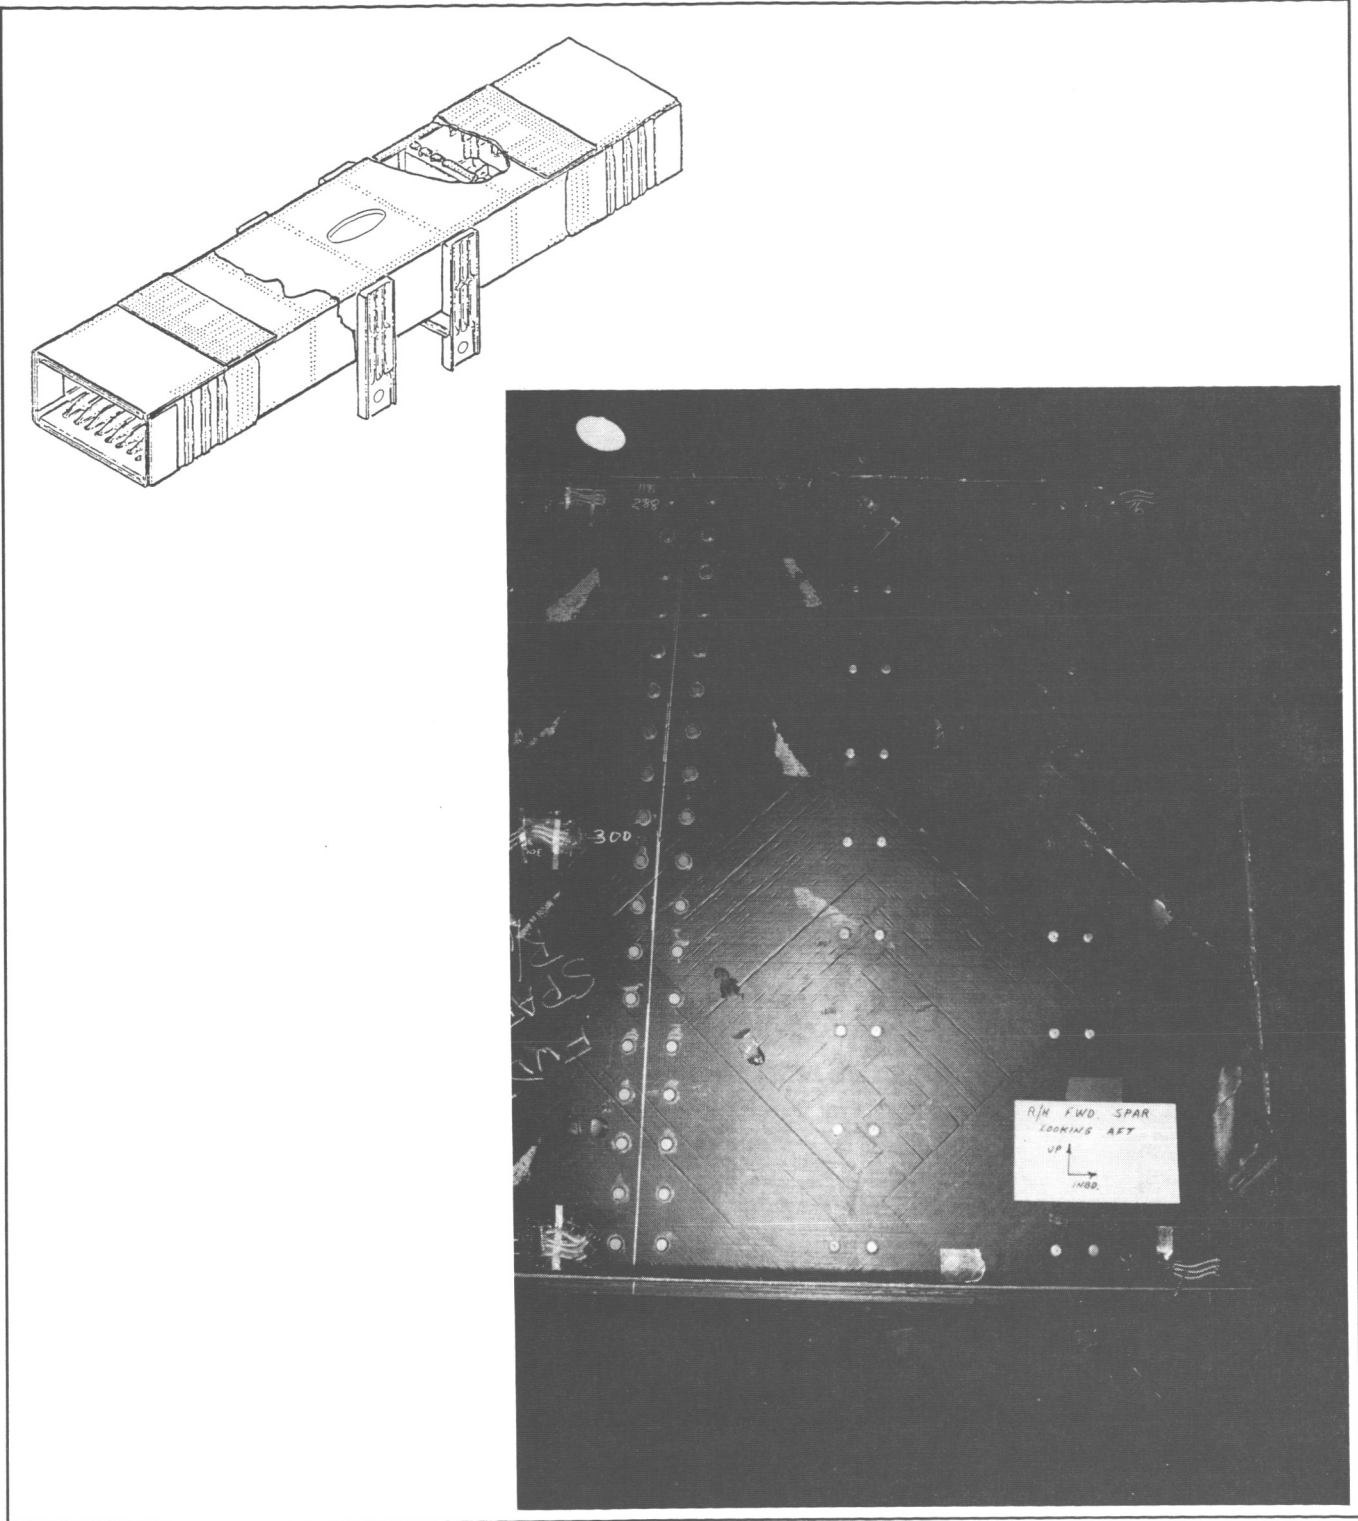
Figure 15. Exterior View of Front Spar Failure

the web is -2500 microinch/inch. Figure 15 shows the failure of the front spar web which starts at the upper cap at about W.S. 42 and runs to the edge of the mainframe at W.S. 25. The failure of the rear spar was similar to that shown for the front spar.
