# Debris/Ice/TPS Assessment and Integrated Photographic Analysis of Shuttle Mission STS-64

**DEBRIS/ICE/TPS ASSESSMENT  
AND  
INTEGRATED PHOTOGRAPHIC ANALYSIS  
OF  
SHUTTLE MISSION STS-64**

**9 August 1994**

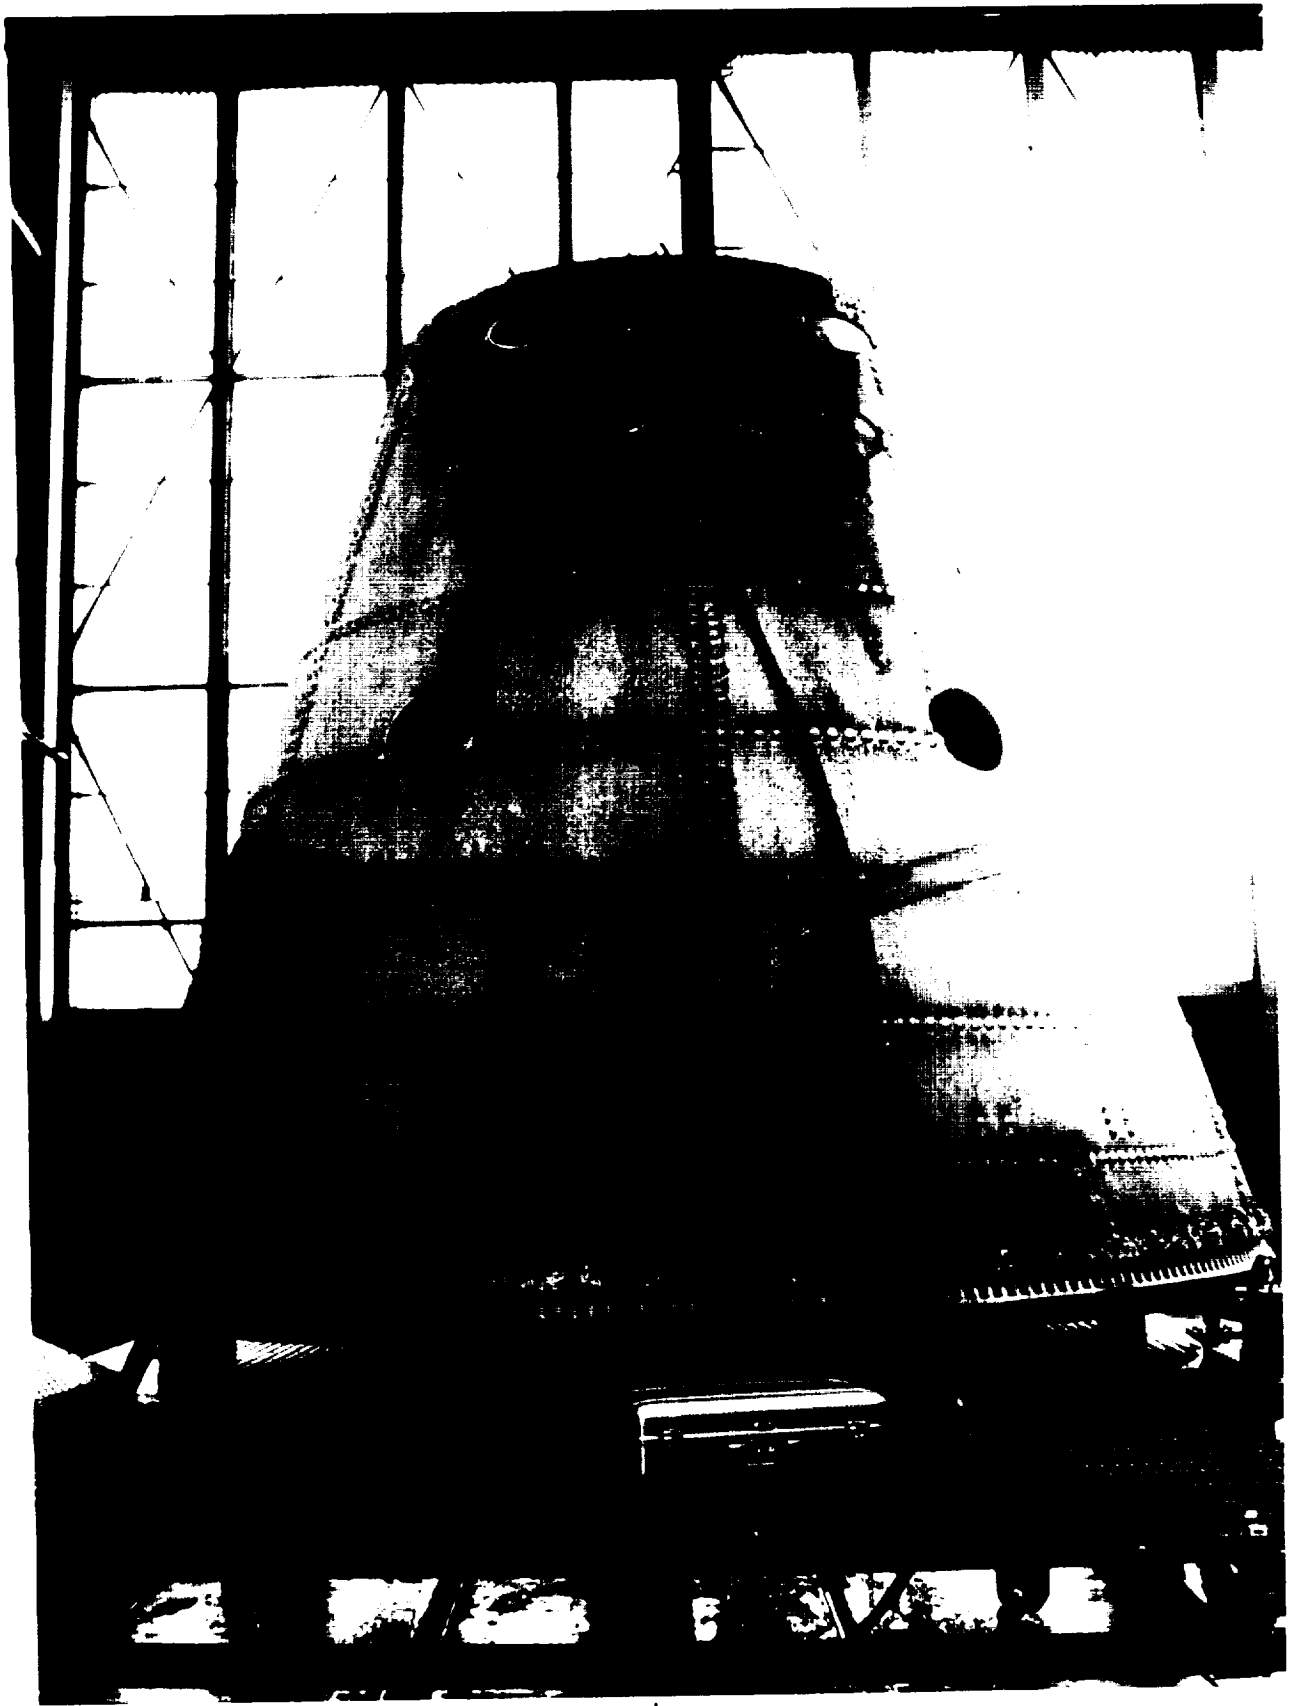
**Photo 11 : RH SRB Frustum**

The RH frustum was missing no TPS but had 18 MSA-2 debonds over fasteners and 2 debonds over acreage (Figure 1). Hypalon paint was blistered/missing where BTA closeouts had been applied. Some of the underlying BTA was lightly sooted. All BSM aero heat shield covers had locked properly in the fully opened position.

The RH frustum was missing no TPS but had 18 MSA-2 debonds over fasteners and 2 debonds over acreage. The BSM aero heat shield covers had locked in the fully opened position.

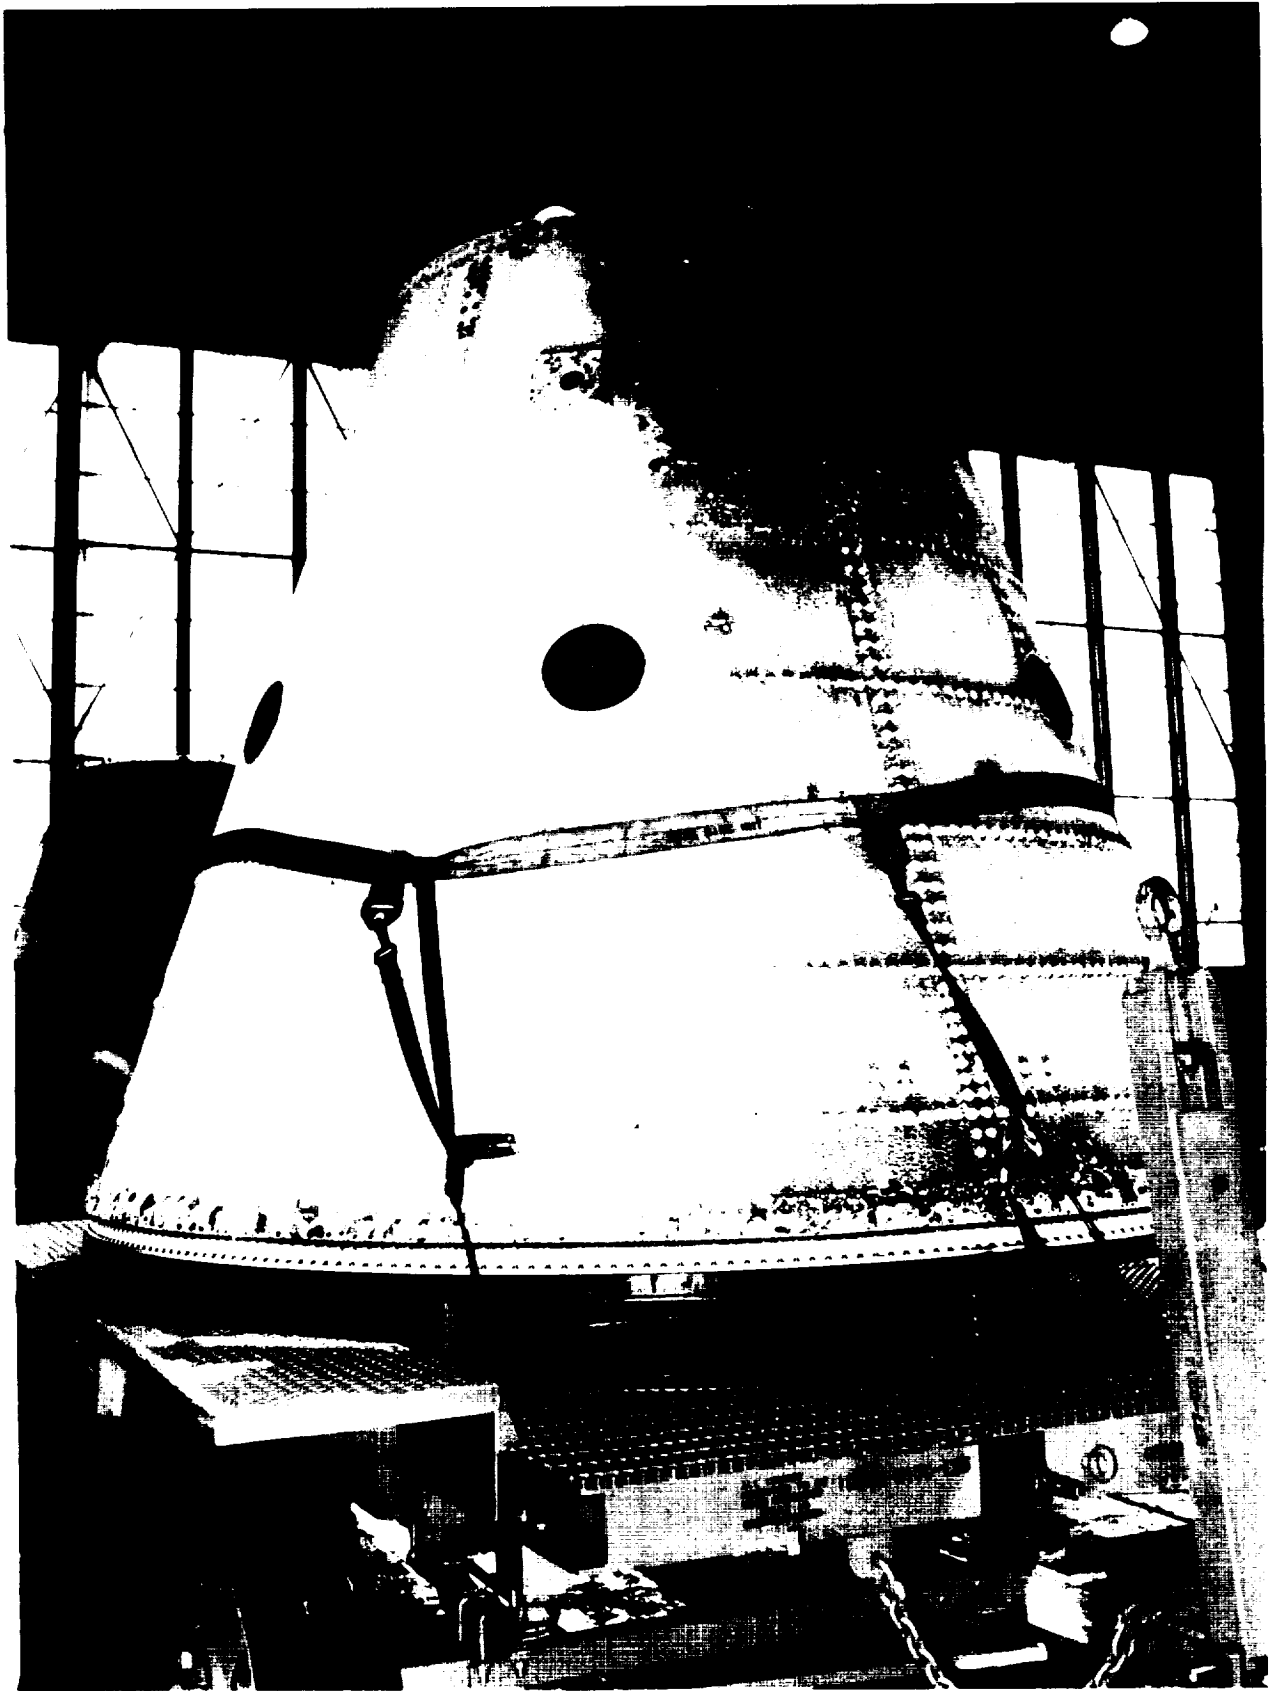
**Photo 14 : LH SRB Frustum**

The LH frustum was missing no TPS but had 18 MSA-2 debonds over fasteners (Figure 2). Hypalon paint was blistered/missing where BTA closeouts had been applied. Some of the underlying BTA was lightly sooted. All BSM aero heat shield covers had locked properly in the fully opened position.

The LH frustum was missing no TPS but had 18 MSA-2 debonds over fasteners. Hypalon paint was blistered/missing where BTA closeouts had been applied. All BSM aero heat shield covers had locked in the fully opened position.

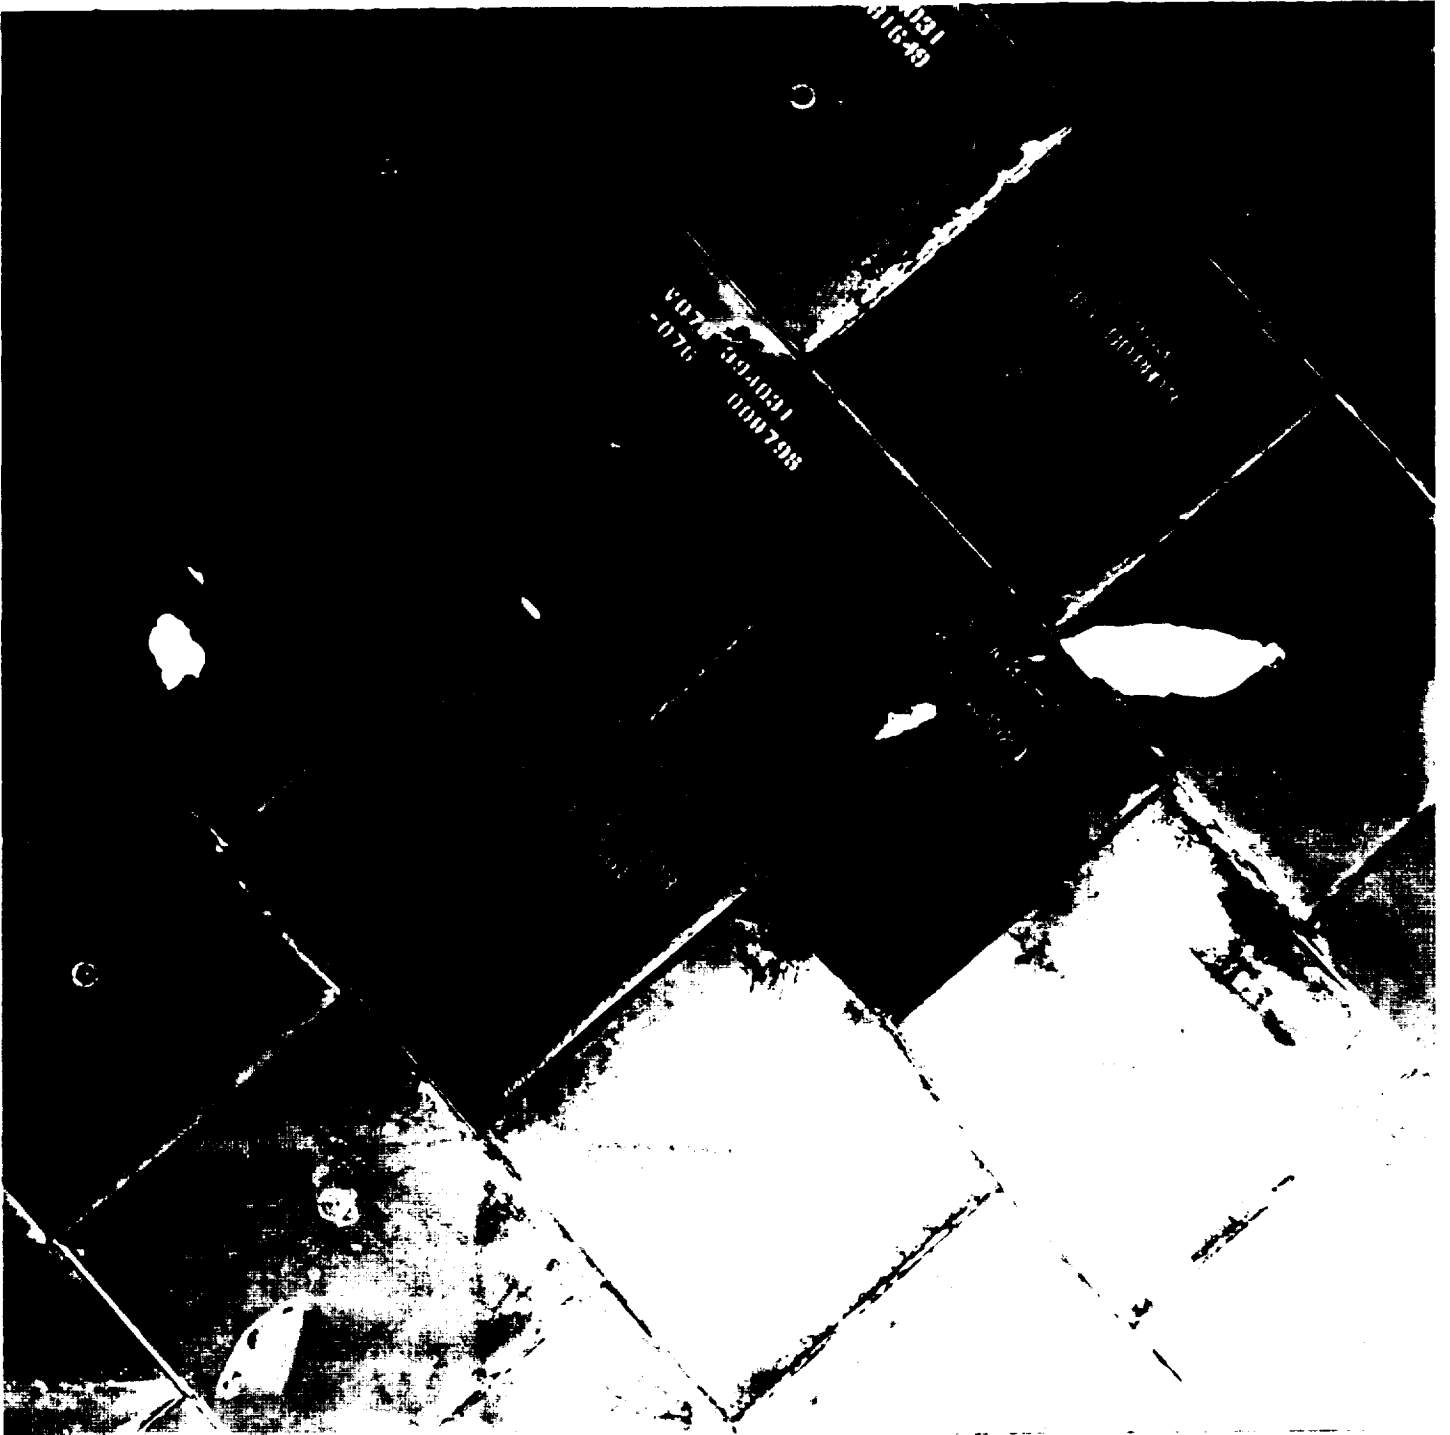
**Photo 18 : Damage to Lower Surface Tiles**

The Orbiter lower surface sustained a total of 116 hits, of which 18 had a major dimension of 1-inch or greater. A total of 53 hits occurred just aft of the LH2 ET/ORB umbilical. Two of these damage sites had a major dimension greater than 1-inch. Cluster of hits aft of the LH2 and LO2 ET/ORB umbilicals are believed to be impacts from umbilical ice and purge barrier (baggie) material.

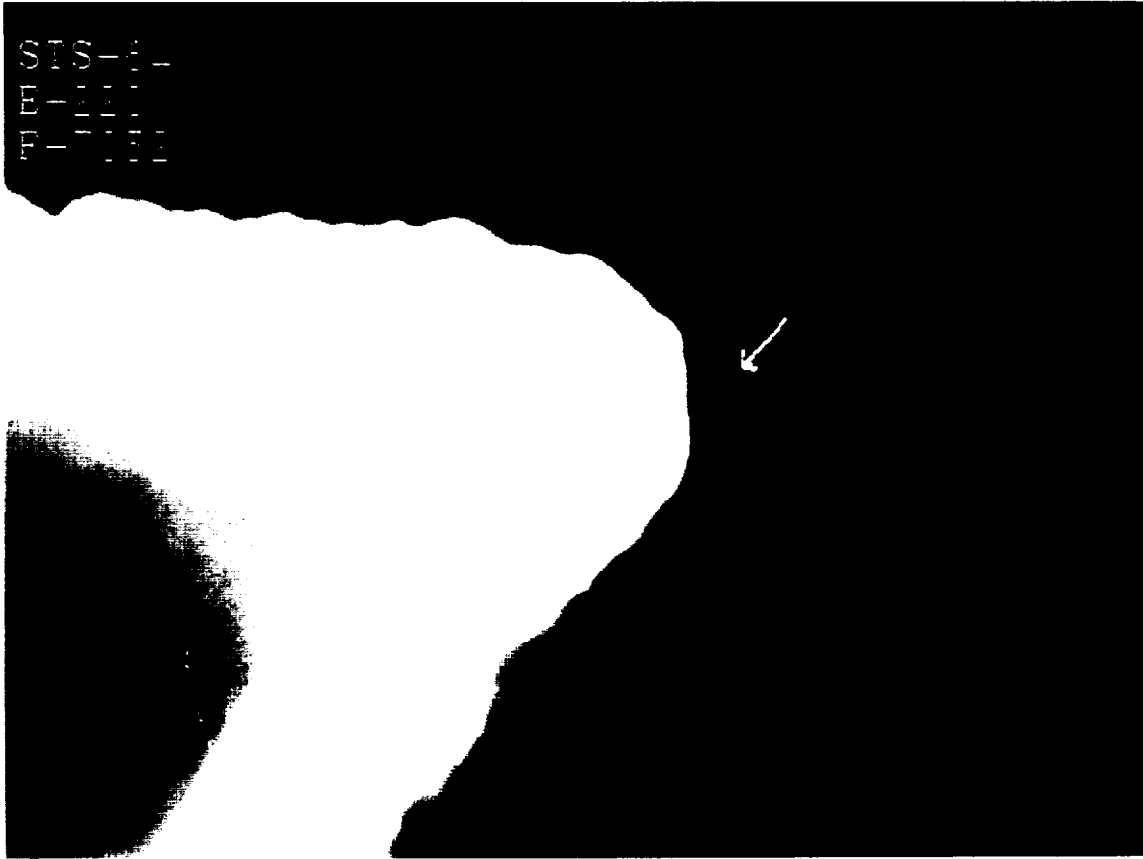
**Figure 2.1.3.2** Debris near SRB Exhaust Plume  
(Camera E-220)

Two light colored pieces of debris were seen falling aft of the SLV and along the SRB plume at approximately 75 seconds MET. A large light colored piece of debris was seen falling aft of the SLV and into the SLV exhaust plume at approximately 76 seconds MET.
