NASA Technical Memorandum 109142

# The Characterization of WideSpread Fatigue Damage in Fuselage Structure

September 1994

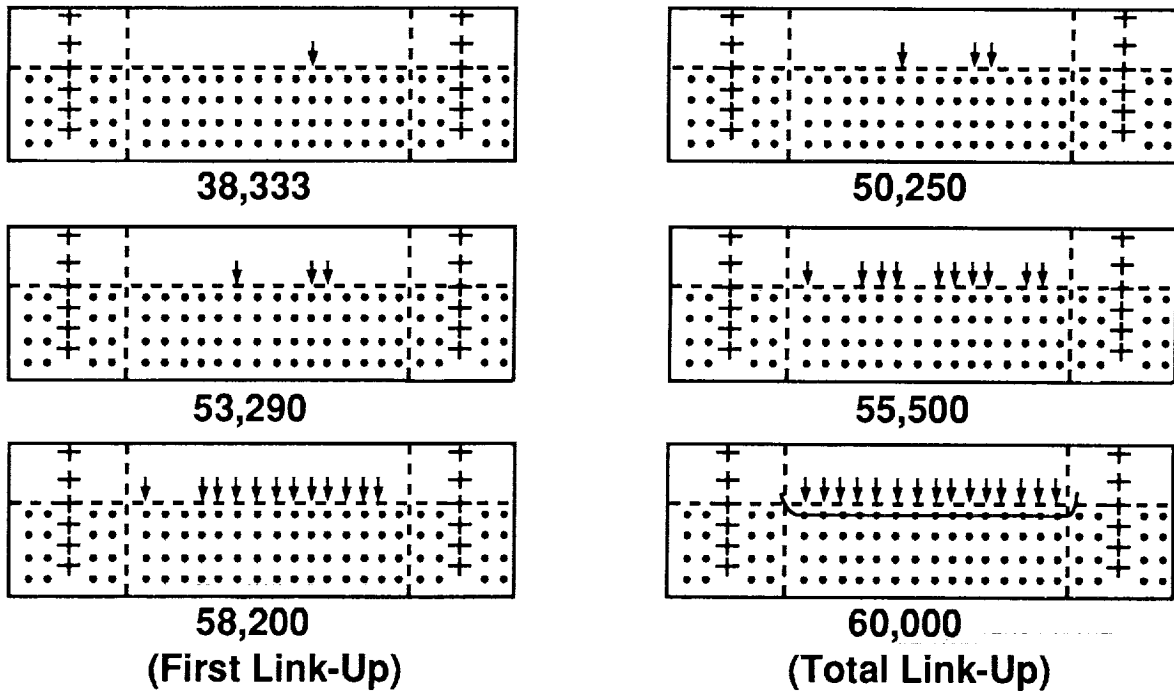
Figure 1 is a schematic of bay #1 summarizing the results of in situ visual examinations conducted during fuselage pressure testing. After 20,000 pressure cycles, inspections were conducted at intervals of approximately 1700 cycles. The small arrows in Figure 1 mark the upper row rivet locations that contained visible cracks. The first evidence of cracking was observed near the mid-bay after 38,333 cycles. No further cracking was observed in bay #1 until 50,250 pressurizations, when three mid-bay cracks were noted. At 55,500 cycles, ten rivet locations contained cracks. The first evidence of crack link-up was observed after 58,200 cycles. An additional 1800 pressurizations were performed, totaling 60,000 cycles, before cracks at all upper row rivet locations had linked-up. A single long crack, 47.9 cm (18.85 inch) in length, had formed along the upper row of rivets, terminating at the adjacent tear straps. After completing the three lifetime test, the four bay region containing wide spread fatigue damage was removed for detailed teardown inspection at LaRC. Upon completion of pressure testing and in situ

Figure 1. A schematic of bay #1 summarizing the location of outer skin fatigue cracks identified during visual in situ examinations.

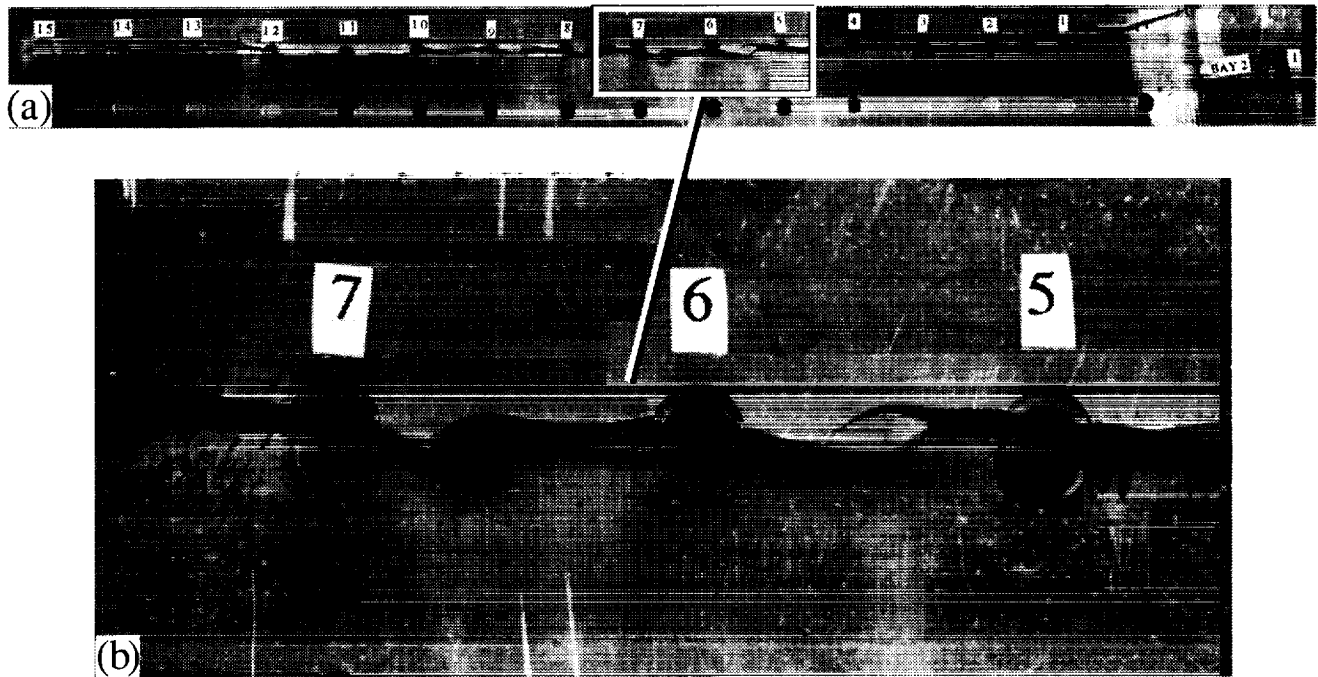
Prior to destructive examination, bay #1 was examined visually (10X) and by eddy current techniques. These laboratory inspections yielded results similar to that obtained by in situ examination. With one exception, all outer skin fatigue cracks were observed in the upper row rivet locations shown in Figure 1. The single exception was observed in the most forward rivet of the second row. The location and description of this outer skin crack was confirmed later by the destructive examination. Subsurface or inner skin fatigue cracking was not detected by NDE. Figure 2 is a photograph showing the long outer skin crack located along the upper row of rivets in bay #1. Figure 2b details the link-up crack path for fatigue cracks propagating from rivets 5, 6, and 7. Interacting "curved" cracks shown in Figure 2b have been observed in the laboratory and modeled by Ingrassia et al. [5].

Figure 2. Photographs showing the fatigue cracking after link-up in bay #1 lap splice joint.

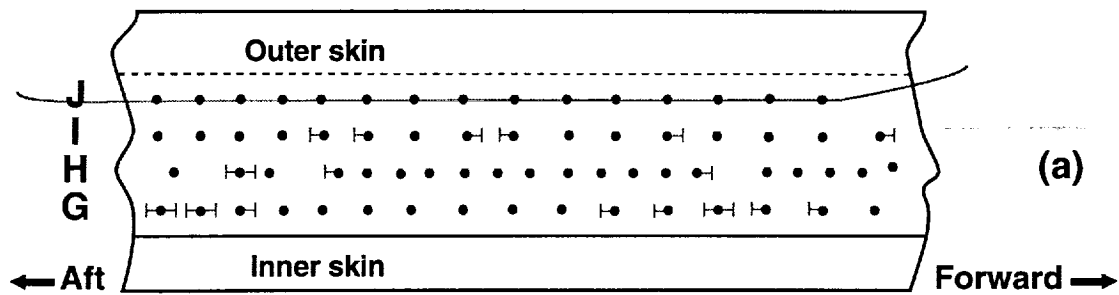
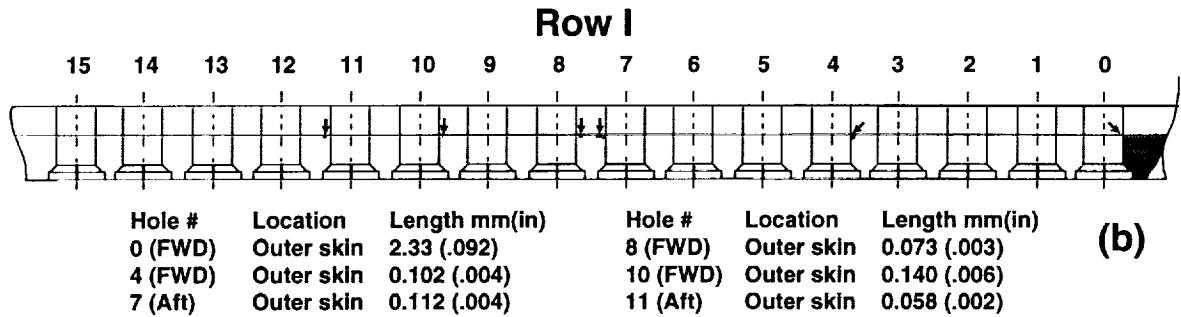
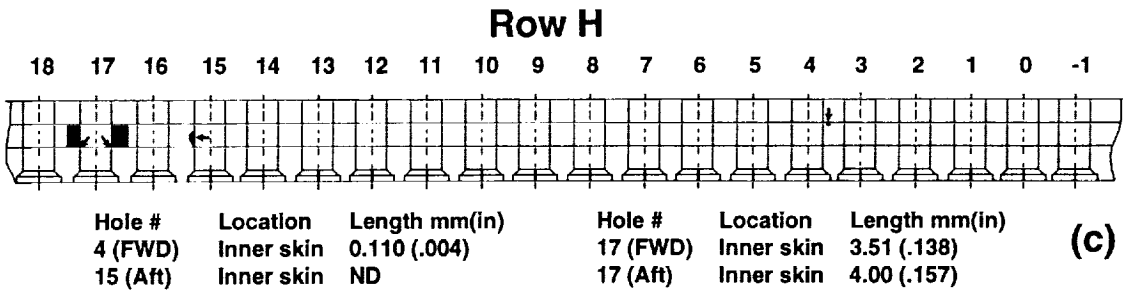
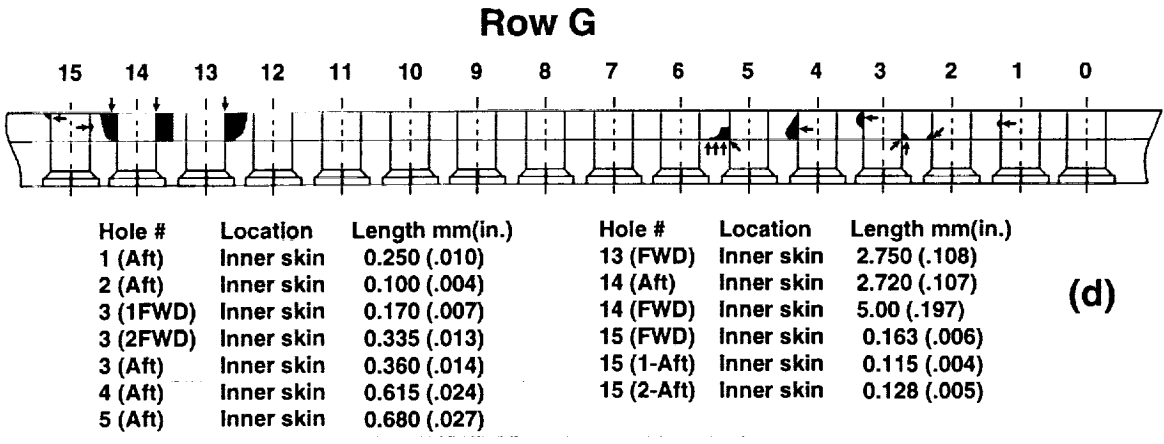
Figure 4 summarizes the results of the destructive examination. Figure 4a is a schematic of bay #1 identifying the four rows of rivets (rows G, H, I and J), the location of the long crack along row J and the location of smaller cracks found in rows G, H and I during the destructive examination. Figures 4b, 4c and 4d are schematics (not drawn to scale) of each rivet row detailing the location, initiation site (arrow) and length of each fatigue crack. Crack depth was computed from the point of initiation to the point of greatest crack depth (length) or, for through-thickness cracks, from the rivet hole surface to the point of greatest crack depth. In rows G, H and I, 17 holes of the 52 examined were found to contain fatigue cracks. A total of 23 fatigue cracks were found in rows G, H and I. Row I contained six outer skin cracks; the crack located at hole position "0" was detected by eddy current inspection. All other fatigue cracks in row I were small and located under the rivet head. Row H contained four inner skin fatigue cracks, two through-thickness cracks located at positions 17 and 18 and small cracks at positions 4 and 15. Row G exhibited cracking in eight rivet holes. Hole locations 13 and 14 contained through-thickness fatigue cracks. The remaining six holes contained smaller surface and corner cracks. The site of crack initiation varied; Row I contained outer skin cracking that primarily initiated along the mating surface between the outer and inner skin, Row H contained inner skin cracks that initiated at rivet hole corners, rivet hole surface and outer/inner skin surface, and Row G contained cracks that initiated at rivet hole corners, rivet hole surfaces and outer/inner skin surface.

Detailed examination of the fracture surface from the long crack contained in upper row J (Figure 4a) revealed that outer-skin fatigue cracks initiated along the lap splice joint interface, identical to that shown in Figure 5c. Further examination of the fatigue fracture surfaces from each rivet hole revealed a thin region (ligament) exhibiting evidence of ductile tearing located along the outboard surface of the outer skin. Figure 6 shows the fracture morphology of upper row fatigue cracks at different stages of propagation from rivet holes located in adjacent bay #2. From Figures 6b, 6c and 6d, a pattern of fatigue crack propagation has been derived for the upper row locations and illustrated in Figure 6a. Figure 6d shows a third outer skin crack of approximately 3.8 mm (0.150 in) in length. Here, the subsurface crack had formed an outboard surface ligament similar to that observed in the upper row on bay #1. These results show that outer skin cracks initiate at the inner/outer skin interface (arrows in Figures 6b, 6c and 6d) and propagate in a subsurface manner depicted in Figure 6a.

Figure 4. Illustrations showing the location of fatigue cracks in bay #1.

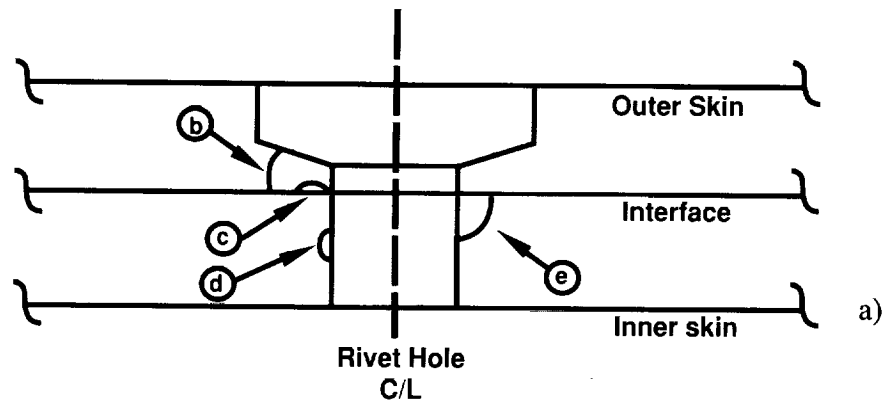
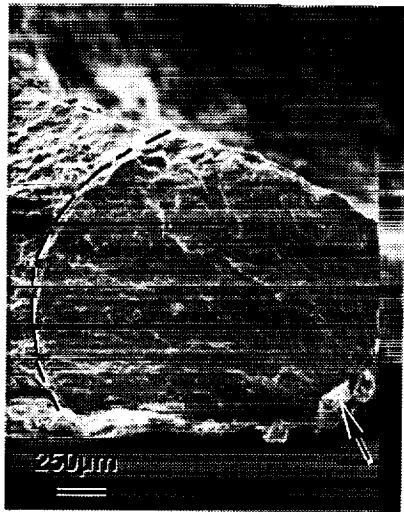
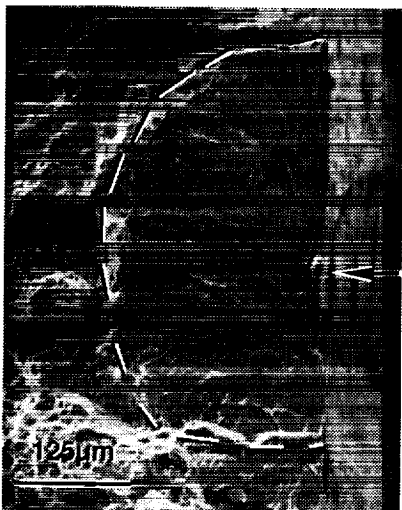
The SEM micrographs shown in Figure 5 illustrate the typical transgranular morphology and location of fatigue cracks observed in the outer and inner skin of bay #1. Outer skin countersink cracking, located in region b in Figure 5a, is shown in Figure 5b. Typically, countersink cracks initiate at the inboard corner of the rivet hole marked by the arrow in Figure 5b. Here, the inboard corner of the countersink exhibits disturbed metal and possible evidence of local clad thinning. The outer skin surface cracks, shown in Figure 5c, initiate at surface clad discontinuities marked by the arrow. These surface cracks are located at the outer/inner skin interface near the rivet hole countersink identified by region c in Figure 5a. Evidence of surface clad abrasion (fretting) was observed at the point of crack initiation, i.e., clad surface disturbed metal, black oxide debris at the outer/inner skin interface and secondary microcracks at the clad metal interface in some cases. Rivet hole surface cracks, region d in Figure 5a, typically initiate at surface discontinuities identified by the arrow. Inner skin corner cracks, located at region e in Figure 5a, initiate at corner discontinuities identified by the arrow in Figure 5e.

Figure 5. Schematic and SEM micrographs showing the location of fatigue cracking, crack initiation site (arrows) and fracture morphology of fatigue cracks in bay #1.

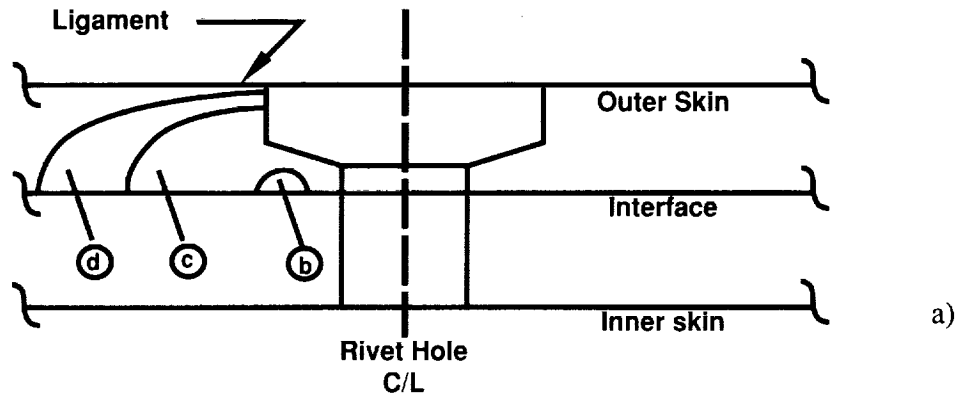
Laboratory fatigue tests conducted at LaRC has confirmed that the fatigue crack morphology shown in Figure 6 is indicative of out-of-plane bending loads. Tension-bending (T/B) constant amplitude fatigue tests were conducted using 2.1 mm thick center-cracked alloy 2024T3 sheet specimens. The fatigue crack fracture morphology from a specimen tested at a T/B ratio of 1.5 is shown in Figure 7. Figure 7a is a SEM micrograph showing the fatigue crack front (dashed line) at region A in Figure 7b. The remaining ligament, shown in Figure 7a, exhibits a ductile tearing morphology produced when breaking the specimen by overload after fatigue testing. The fatigue crack/ligament morphology was formed on the compressively-loaded surface while substantial fatigue crack growth continued on the tension surface, thus forming a crack geometry similar to that observed along the lap splice upper row rivet holes.

Upper rivet row fatigue cracking at the inner/outer skin interface shown in Figures 5c and 6 suggests that crack initiation is associated with localized damage due to fretting [8]. Evidence of fretting fatigue was noted by a black oxide deposit on the mating surface between the inner/outer skin around each rivet hole. Depicted in Figure 8 is the extent (area drawn to scale) of fretting debris (black oxide) observed on the inboard surface of bay #1 lap splice joint outer skin by estimating the area of fretting debris at each hole location. The amount of fretting was estimated by determining an arithmetic average of fretted surface area per the procedure shown in Figure 9. Here, a scaling factor was assigned to estimate the amount of fretting in each quadrant shown in Figure 9. The value 0 was assigned when no fretting was observed and 5 represented the highest degree of fretting. A "fretting Average" (FA) was calculated for each rivet position. A direct correlation of "fretting average" with rivet hole cracking was not conclusive, i.e., all fretting initiated cracks were observed in holes that exhibited a relatively high FA > 3.00, but, all holes that exhibited a FA > 3.00 did not contain fretting initiated cracks. Figure 10 is a plot of FA versus rivet hole location for the rows G, H, I and J. Here, a distinct correlation is observed for FA and rivet row, i.e., upper row J which contains the greatest number of fretting fatigue cracks, also exhibits the greatest evidence of fretting damage (highest FA level).

Figure 6. Schematic and SEM micrographs illustrating the location of fatigue crack initiation (arrows) and sequence of crack propagation in the lap splice upper rivet row.

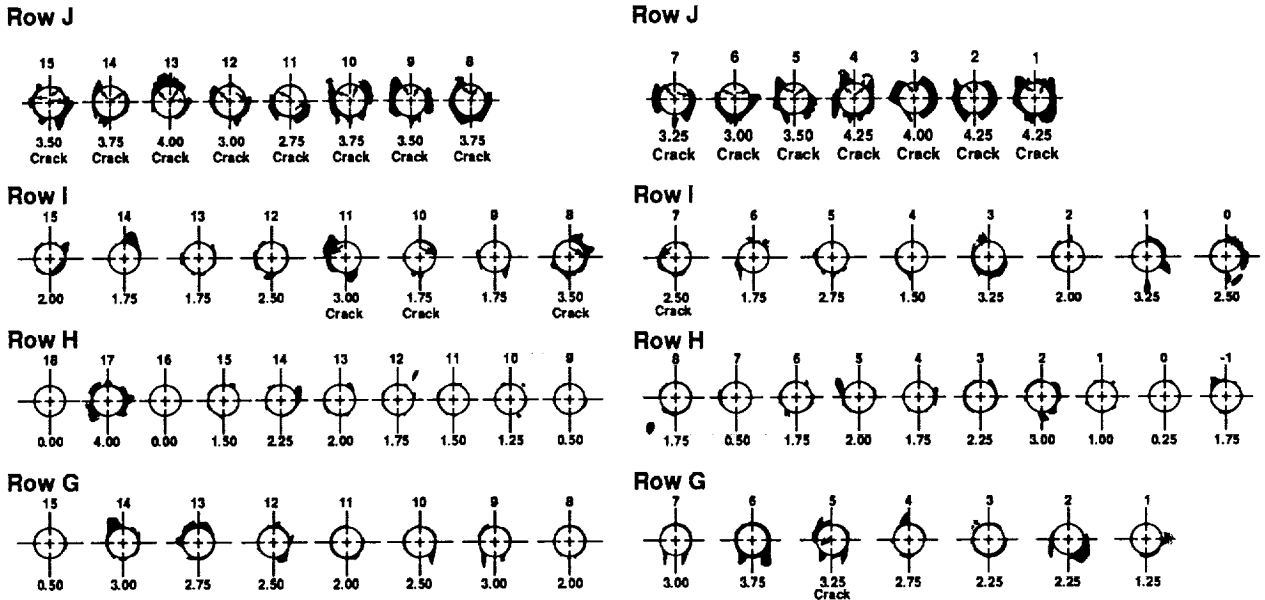
Figure 8. A schematic showing the interior surface of bay #1 lap splice outer skin. Illustrated is the location of black oxide film, the location of fretting initiated fatigue cracks and noted is the fretting average value determined by the procedure shown in Figure 9.
