THE EFFECTS OF PITTING ON FATIGUE CRACK NUCLEATION  
IN 7075-T6 ALUMINUM ALLOY

Li Ma and David W. Hoepfner \*  
University of Utah  
Salt Lake City, UT

SUMMARY

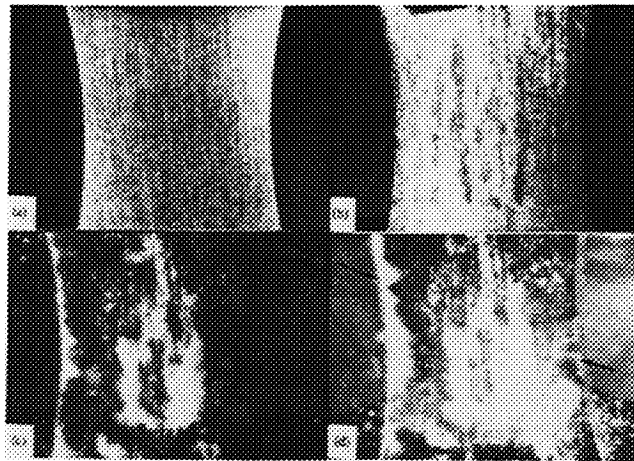
One characteristic feature observed during the testing was the formation of blisters. These blisters occurred on the surface and burst after remaining on the surface for a while. This observation supports the view regarding pit nucleation in aluminum offered by Barger and Givens.[4] They found that blistering occurred along the oxide/metal interface and resulted in breaking of the film because of high hydrogen gas pressure created in blisters, which therefore acted as precursors of pits.

Fig. 4. Video images of changes in surface states of the specimen in 3.5% NaCl, magnification 10.5X, (a) cycle, N=0, (b) cycles, N=68,900, (c) cycles, N=828,000, (d) cycles, N=3,082,000. Arrows indicate pits.

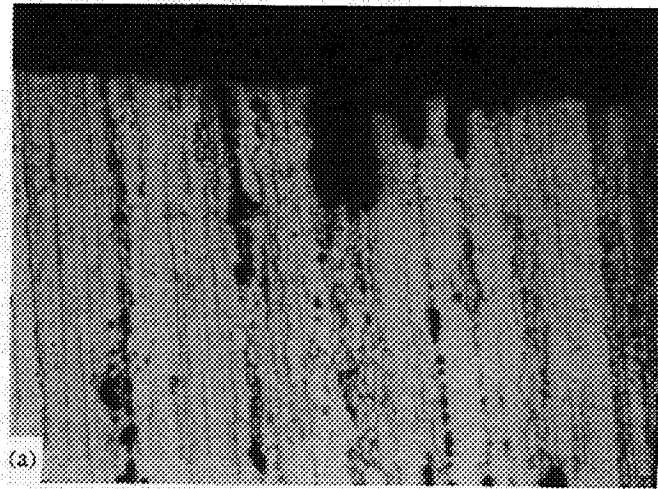
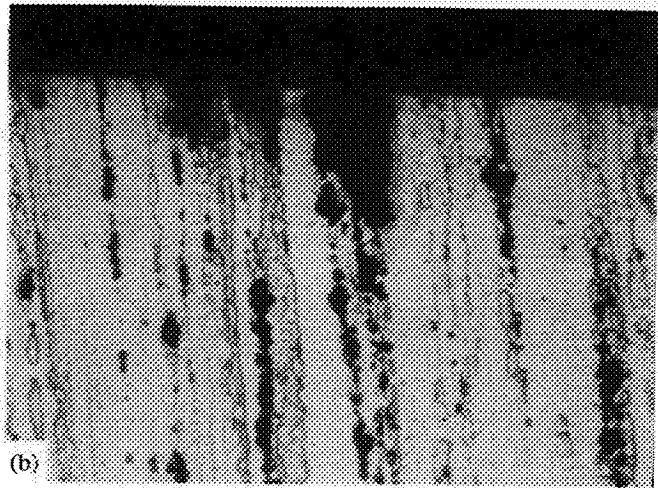
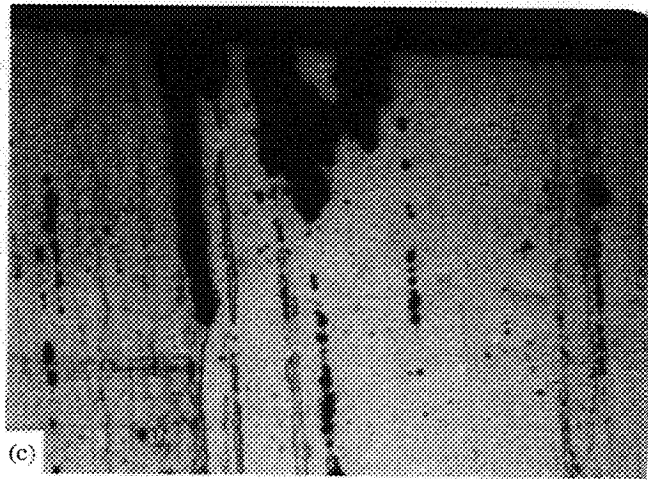
Profiles of adjacent cross sections of a tested specimen are shown in Fig. 6. To produce these adjacent cross sections, a vertical section was made through preselected pits and they were photographed. Then more material was removed from the specimen and the corrosion pits again were photographed. This process was repeated a third time. It is evident that the three pits shown in Fig. 6 (a) have coalesced. After removing a layer of metal from the pit cross section, it can be seen that the same pits were separate and had varied shapes and sizes, Fig. 6 (b). It is obvious that discrete pits nucleated at first, but that with increasing exposure time, pit coalescence took place to cause more extensive local attack. The same phenomenon was observed by Baker [6] when he studied the corrosion resistance of aluminum-magnesium-silicon alloy under a salt-spray condition.

According to ASTM standard G 46-76 (Standard practice for Examination and Evaluation of Pitting Corrosion), the pits shown in Fig. 6 (a) and (b) appear in the elliptical shape except for the smaller one in Fig. 6 which shows the narrow and deep shape. To evaluate the cross-sectional shapes of the same pits in more detail, another layer of the pit cross section was removed and the resulting pit shapes are shown in Fig. 6 (c). It is interesting to note that two pits joined together under the surface showing the undercutting shape with different depths, and other pits exhibited intergranular attack which originated from the base of the pit. Therefore, it can be concluded that a pit shape may vary irregularly when growing and it is difficult to determine the true maximum pit depth by the method of cross-sectioning the pit because the deepest pit may not have been selected and the pit may not be sectioned at the deepest point of the penetration. This observation provides evidence that modeling the pits will be an extremely complex process. Perchance on equivalent initial flaw size approach will be the best we can do. Modeling studies have been underway [1,2] by the first author and they are continuing under this program.

It also is noted that pit growth was strongly dependent on the orientation with respect to the rolling direction of the material as shown in Fig. 6. The same phenomenon was found in the other specimens. Fig. 8 presents the pits on the exposed surface of a different specimen. The picture shows that severe attack occurred along the fibrous grain orientation in the rolling direction.

Fig. 6. Cross section of pits in the specimen tested in 3.5% NaCl solution, magnification 400X (reproduced by 320 magnification), (a) after cross-sectioning, (b) after removing a layer of metal, (c) after removing the second layer of metal.

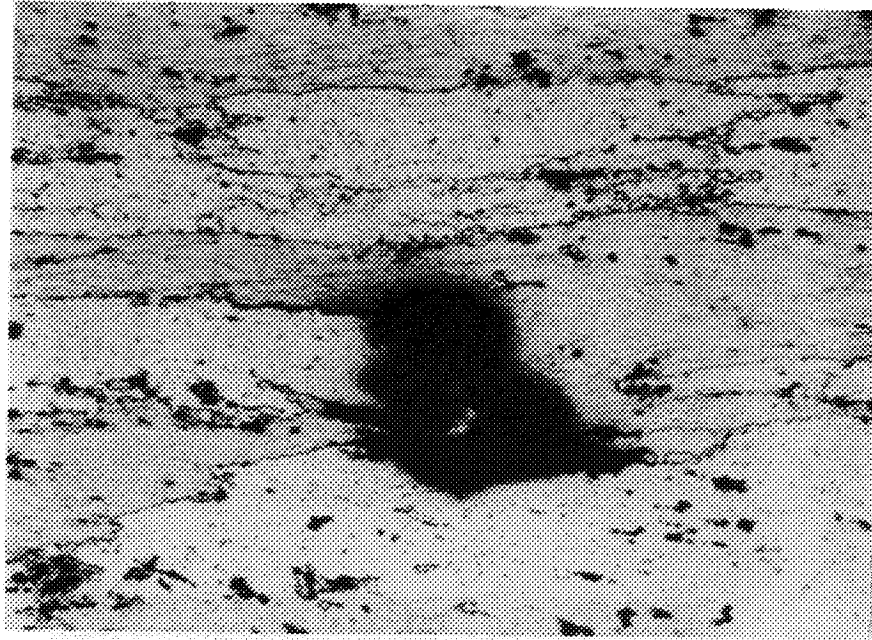
Further evidence of intergranular corrosion occurring along with the pit, in which case intergranular fissures advance into the metal laterally from the pit cavity, was identified on the exposed surface of another specimen after polishing and etching. Fig. 7 shows that the cracks which nucleated from the pit on the exposed surface of the specimen were caused by intergranular corrosion attack. In both cases (Figs. 6 (c) and 7) intergranular cracking originated from the pit. The reason for this might be that the electrochemical conditions in the pit readily lead to the occurrence of intergranular attack. According to Lifka,[7] in high-strength aluminum alloys the susceptibility to intergranular attack results from a localized decomposition of a solid solution at the grain boundaries and the formation of a precipitation in the vicinity of the grain boundaries. In the case of 7075-T6 aluminum, intergranular corrosion is probably related to the precipitation of the grain boundary phases, such as  $MgZn_2$ , which may themselves behave anodically with respect to the adjacent alloy. Hence, it is reasonable to believe that intergranular corrosion is another corrosion mechanism involved in crack nucleation in this research. Additionally, since the intergranular corrosion was found to penetrate deeply into the metal leaving behind little visible evidence of damage ( Fig. 8), it is possible that intergranular corrosion may cause failure with extreme suddenness, especially when the materials are subjected to a lower fatigue stress level and a longer exposure time than in the present testing.

This observation provides evidence for the great concern that pit formation and growth, accompanied by intergranular attack may lead to degradation of integrity. In this case, based on the metallographic examination and the observation during testing, pitting seems the predominant corrosion attack mechanism. This observation has potential significance in relation to modeling the corrosion pitting fatigue process.

Fig. 7. Corrosion pit along with the intergranular corrosion cracks on the exposed surface of the specimen tested in 3.5% NaCl solution, magnification 200X. Arrows indicate the loading directions.

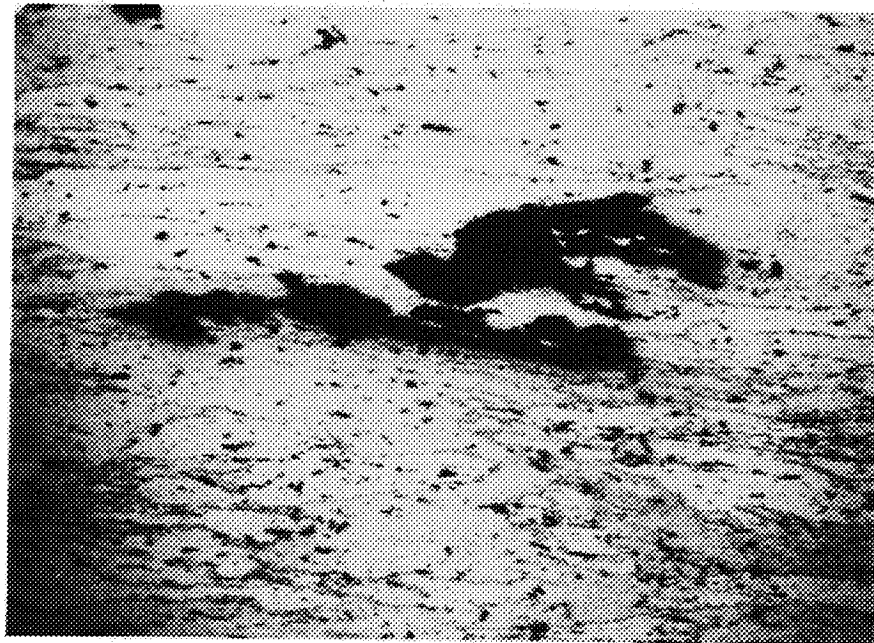
Fig. 8. Corrosion pits on the exposed surface of the specimen showing pit growth in the rolling direction, magnification 100X.

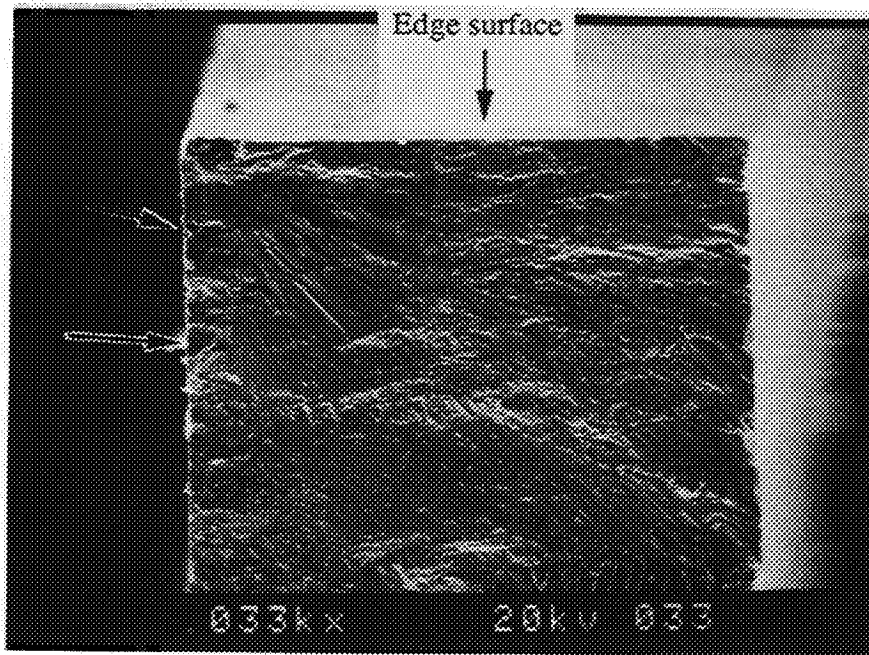
By tracing the radial track surface features shown in Fig. 9 it is evident that the fatigue cracks originated at the sites of corner corrosion pits. This observation confirms the assumption that the corrosion pits acted as stress concentration sites which resulted in nucleation of fatigue cracks. Careful examination around the crack nucleation areas showed that corner pits at the origin sites nucleated in the areas close to the corner of the edge surfaces which were covered with coating broken by solution penetrating during testing. The observations for the other specimens also indicated that the corner pits and pits close to the corners were preferential sites for fatigue crack nucleation. The reason for the evident preference for the crack to start at the corner pits or the pits close to the corners could be explained by the fact that the curved edges of the specimens were the most highly stressed areas compared to the other areas in the specimens. Finite element analysis confirmed this and is to be reported elsewhere. Some small pits also were found on the fracture surface, Fig. 9. However, it is obvious that crack nucleation was dominated by the large corner corrosion pit. It is recognized that in other cases the multiple damage sites (pits) away from the corners nucleate cracks that link up. This has been reported in other work by Hoepfner.[2]

One interesting phenomenon noticed was that the fatigue cracks seem to nucleate from the bottoms of the pits, Fig. 9. Some research [8] showed that a growing pit is a local electrochemical cell. The bottom of the pit is the anode and the surrounding walls of the pit and surface of the metal are the cathode. The fatigue crack nucleation occurred at the bottom of the corrosion pit, probably because this place is electrochemically active and the stress concentration is large enough to lead to the crack. Therefore, it is natural to conclude that corrosion fatigue nucleation is controlled by the rate at which pits nucleate and grow to a critical depth and shape. This interpretation must be tempered by the observation of intergranular cracking as discussed above.

Fig. 9. The crack nucleation area of the specimen tested in 3.5% NaCl solution showing the fracture origin at a corrosion pit. Arrows indicate the exposed surface and a small pit.

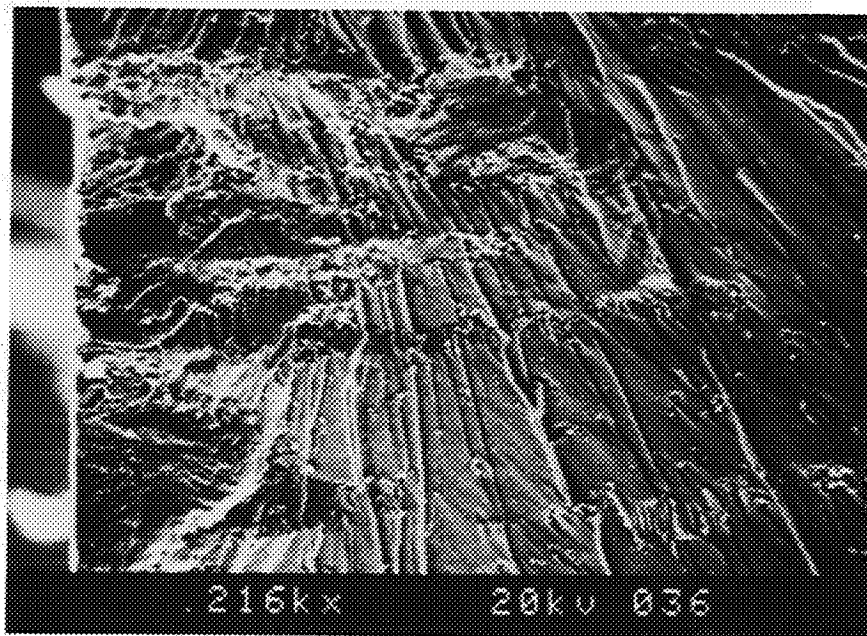
Most of the fracture surface was the fatigue crack propagation region where transgranular fracture was found to be the primary fracture path. Fig. 10 shows cleavage-like fracture, with river patterns emanating from the origin in the area adjacent to the fracture origin (see also Fig. 11). A small corrosion pit appeared on the surface, but no indication of the intergranular decohesion which would be the result of the intergranular corrosion was observed during the metallographic examination. Similar features were seen in

Fig. 10. Cleavage-like fracture near the crack origin of the same specimen showing in Fig. 9.

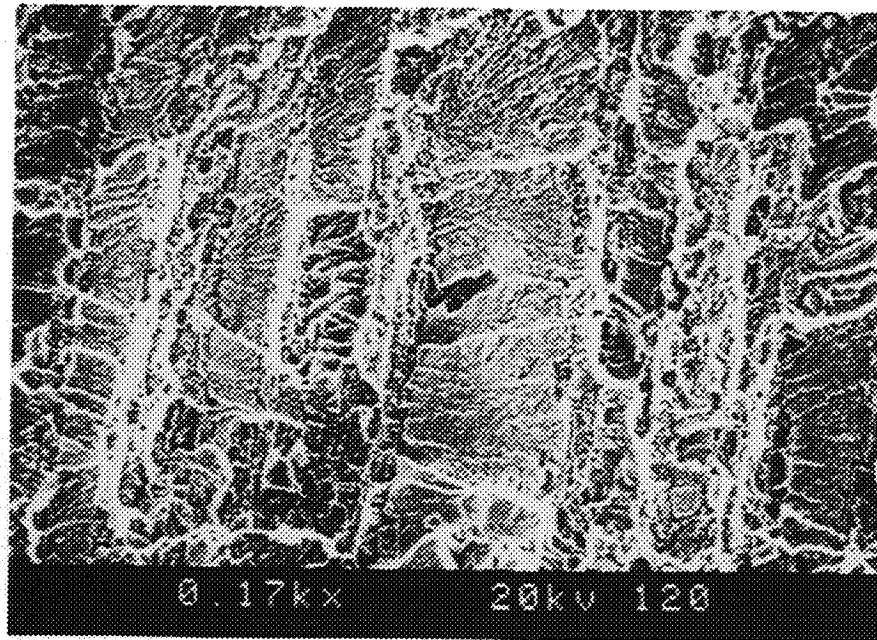
specimens tested in air from the literature.[9] Observation of the fracture surface also shows little ductility in that the cleavage facets with a few dimples appeared in the crack propagation region, Fig. 11. This phenomenon was observed repeatedly. Although crack propagation did involve other mechanisms, "quasi-cleavage" was found to be the primary mechanism for 7075-T6 aluminum tested in 3.5% solution under cyclic loading.

Fig. 11. Cleavage facets with a few dimples in the crack propagation area of the specimen tested in 3.5% NaCl solution.

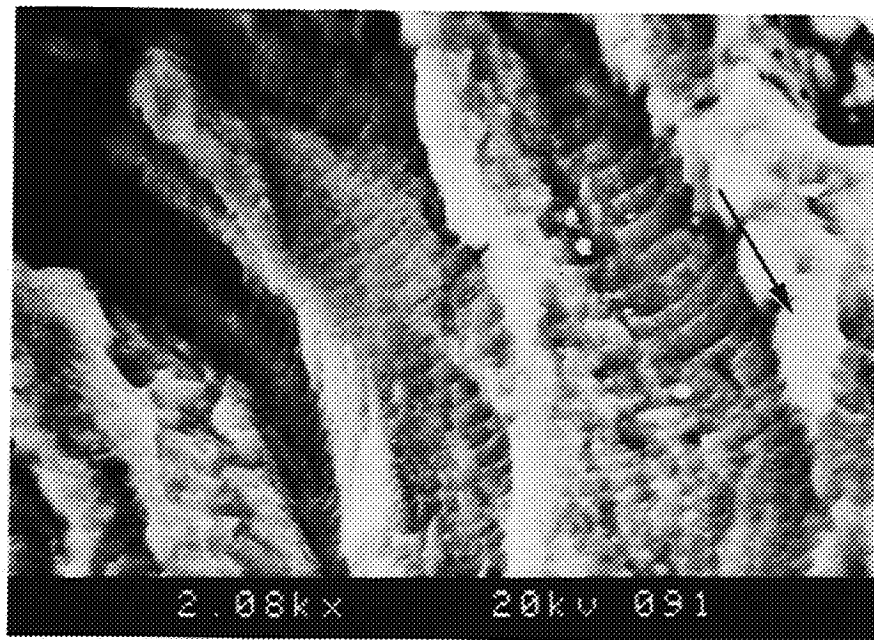
Away from the fatigue crack nucleation sites, well-defined fatigue striations were found in the crack propagation region, Fig. 12. This feature was observed in most specimens examined. No evidence of environmental influence was identified after the crack became long enough. This corresponds to the observation from the experimental work, in which crack propagation was too fast (only several thousand cycles taken in the crack propagation stage) to allow the chemical reaction to occur. Also, this is consistent with many observations in this field. Separate studies of the role of environments on fatigue crack propagation have been done by the second author and others and also are currently underway as part of this overall program.

Fig. 12. Fatigue striations in the crack propagation area of the specimen tested in 3.5% NaCl solution. Arrow indicates the crack propagation direction.

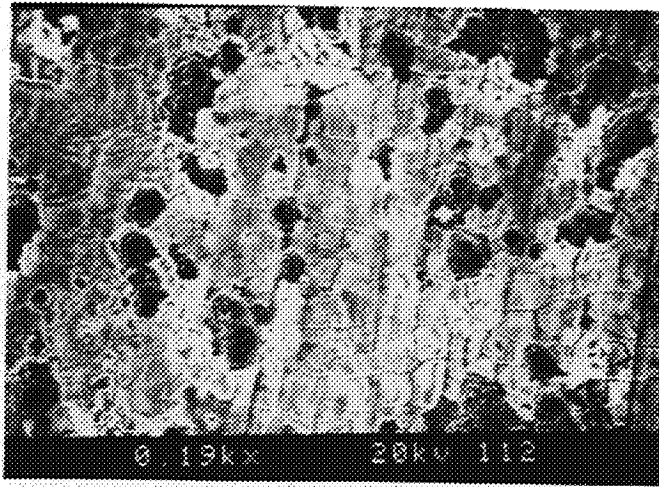
Numerous small and shallow cavities were observed on the exposed surface as shown in Fig. 13. These cavities were the result of the local breakdown of protective films and presumably attack at constituent particles and act as precursors of pits. Relatively large and deep corrosion pits also were found on the exposed surfaces of the specimens. These pits were distributed randomly on the exposed surfaces and appeared in different shapes and sizes. Figs. 14 and 15 show the appearance of pits observed in one specimen. It was interesting to notice that these pits had different shapes on the same exposed surface. Fig. 14 shows a typical hemispherical pit located at near center of the exposed surface. A group of pits was found on the same exposed surface as shown in Fig. 15, which exhibits multi-site damage (MSD) related to corrosion pitting. This group of the pits showed coalescence of pits giving rise to more local attack, and these pits appeared in irregular shapes. Numerous pits in a group also were observed in the other specimen as shown in Fig. 16. Pits in this group grew along the orientation with respect to the rolling direction of the material. All the pits were three dimensional in nature. The shapes of the corrosion pits might influence the fatigue life in different degrees, since the magnitude of the stress concentrations depends on the pit shape and geometry dimensions.

Fig. 13. Small cavities on the exposed surface of the specimen tested in 3.5% NaCl solution (cycles to failure are 4,822,200).

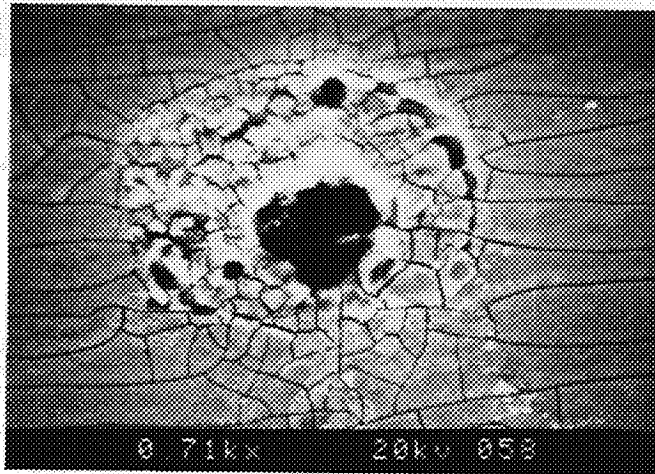
Fig. 14. Hemispherical shape of pit on the exposed surface of the specimen tested in 3.5% NaCl solution (cycles to failure are 3,279,300).

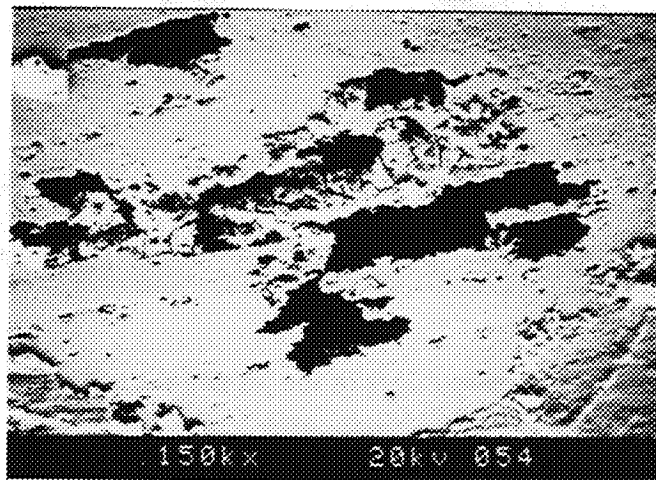
Fig. 15. Group of pits on the same specimen showing in Fig. 14.

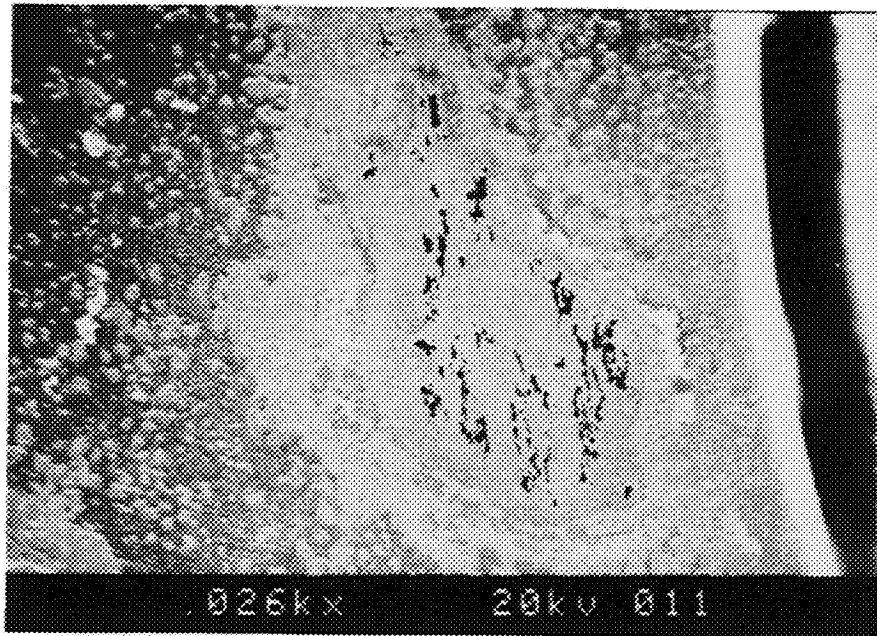
Fig. 16. Pits appear in a group in the specimen tested in 3.5% NaCl solution.
