## FIXED-HEAD STAR TRACKER ATTITUDE UPDATES ON THE HUBBLE SPACE TELESCOPE\*

Matthew S. Nadelman and Jeffrey B. Karl  
Computer Sciences Corporation  
1100 West Street, Laurel, MD 20707

### ABSTRACT

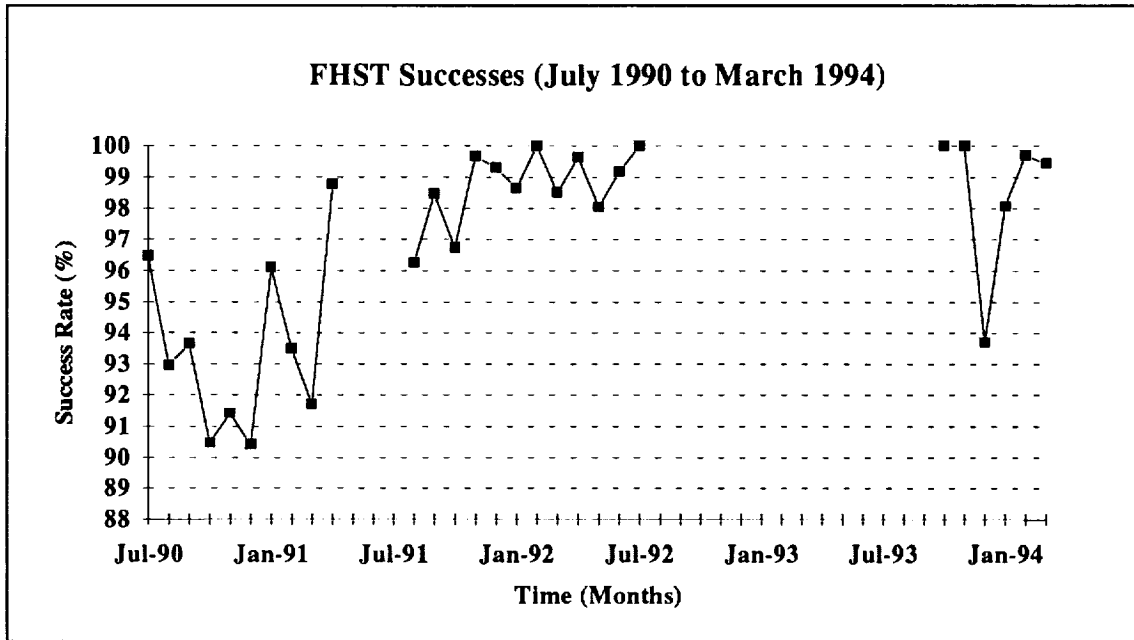
**Figure 2. FHST Successes (July 1990 to March 1994)**

Of all of these failures, only the potential AES acquisitions cannot be solved with simple data base changes. Figure 2 shows a plot of FHST update successes versus time. Each point on the plot represents the success rate for a 1-month period. Note that no data were collected for May and June 1991 and September 1992 through September 1993. The anomalous point in December 1994 contains the seven category 2 failures of the same star. Data base changes are being made to prevent this failure from occurring again.
