NASA Technical Memorandum TM 109203

# Debris/Ice/TPS Assessment and Integrated Photographic Analysis for Shuttle Mission STS-59

June 1994

Shuttle Mission STS-59 was launched at 7:05 a.m. local 4/9/94

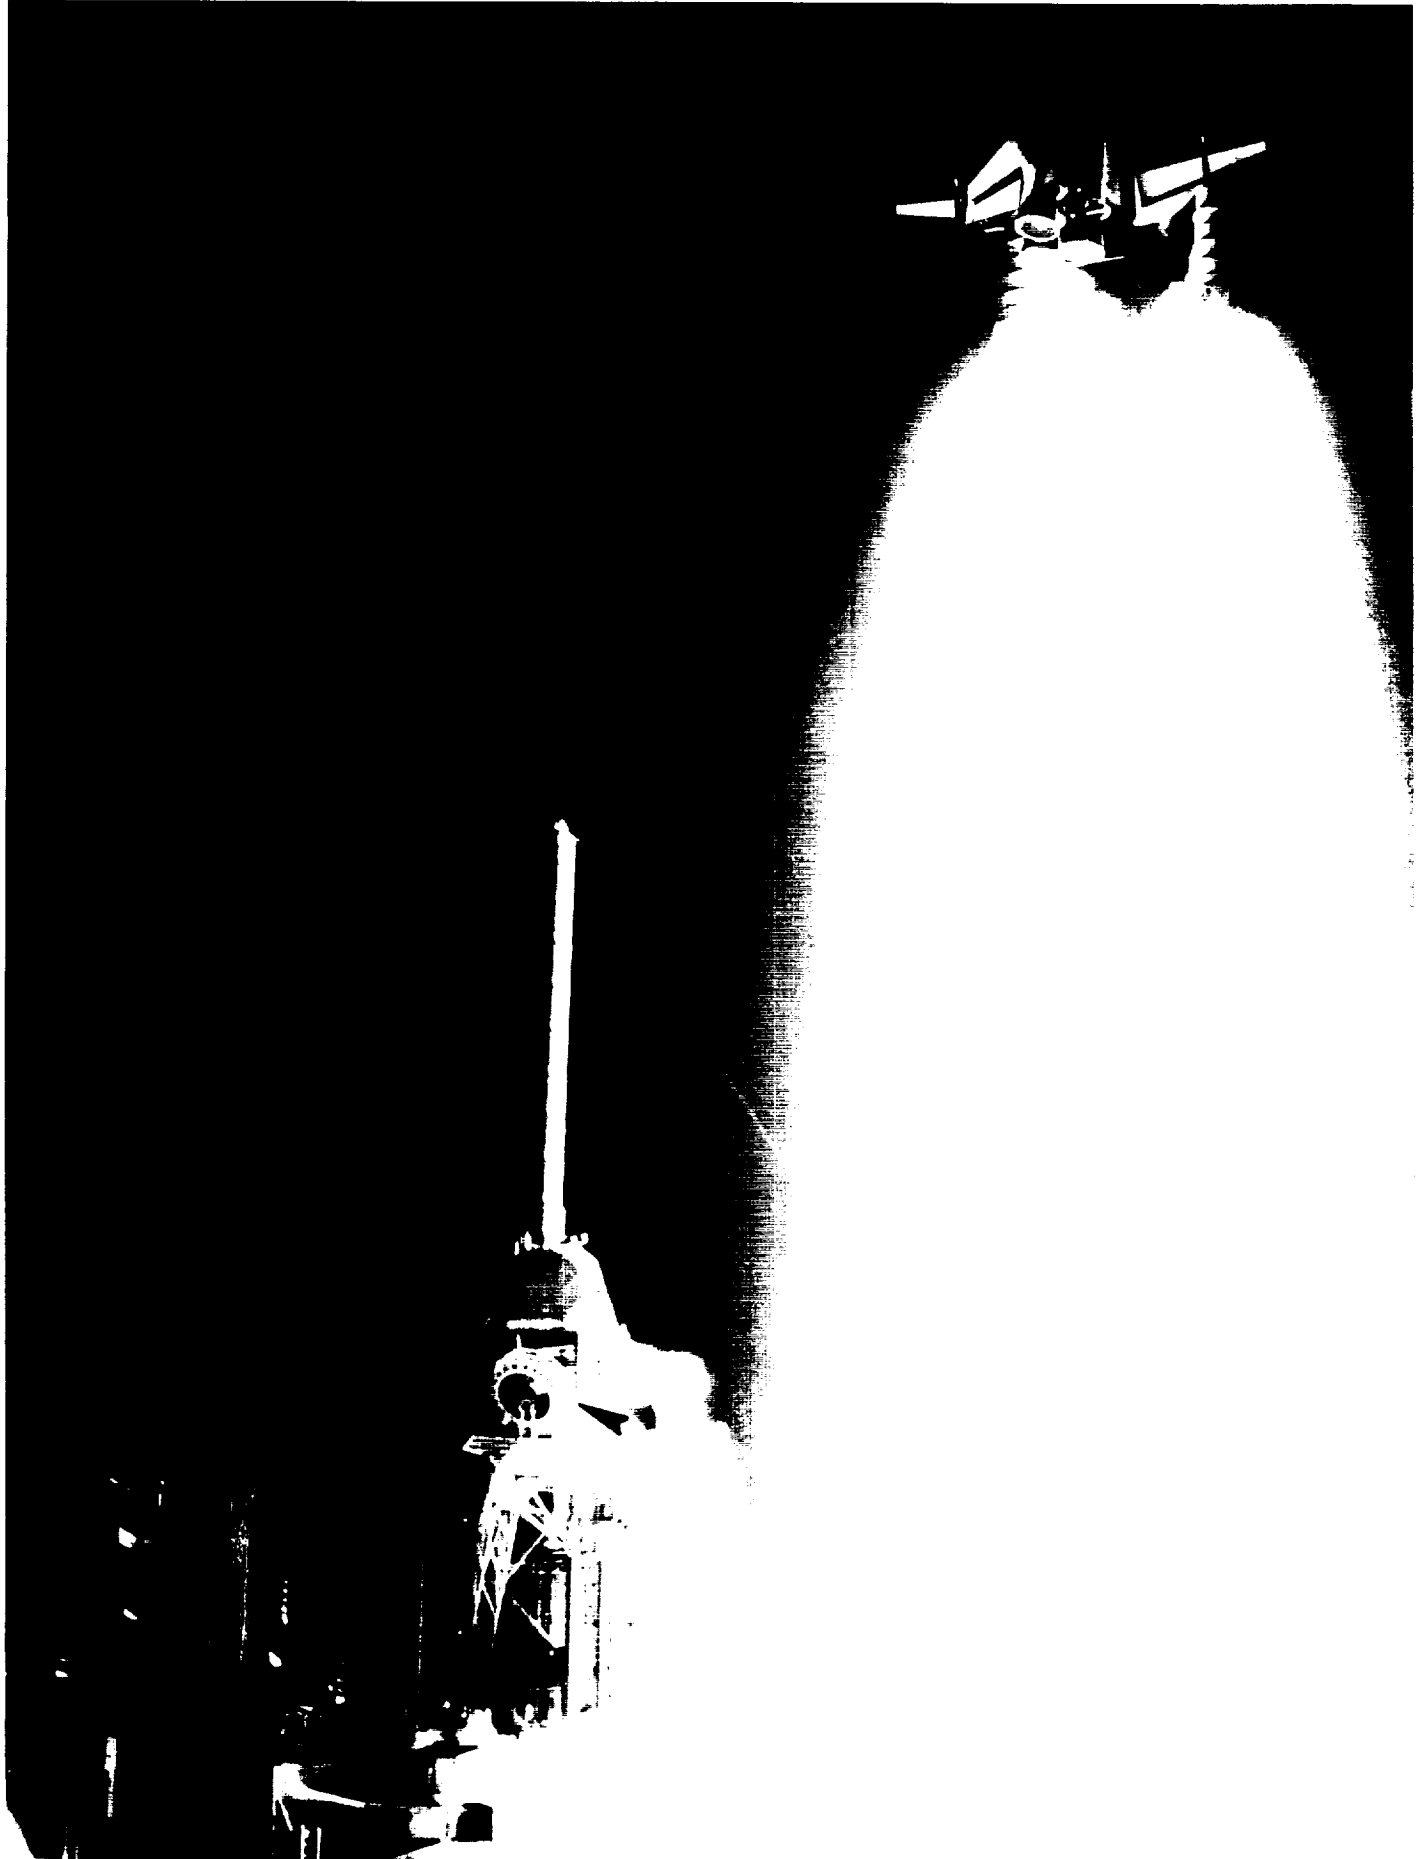
Post launch inspections revealed significant damage to the GOX Vent Arm at the axial adjustment attach point. Several welds were broken and the piston housing had collapsed. This damaged caused the hood to be skewed or twisted 1-2 inches from the centerline. Vibration/acoustic shock waves from the SRB plume and 16 knot winds from the east (105 degrees) at the time of launch are believed to be related to the failure. Some of the damage was attributed to improper welds (IFA STS-59-K-01).

A strong easterly wind and vibration/acoustics from the SRB exhaust plume caused damage to the ET Gaseous Oxygen Vent Hood and a box of emergency breathing units in the White Room.

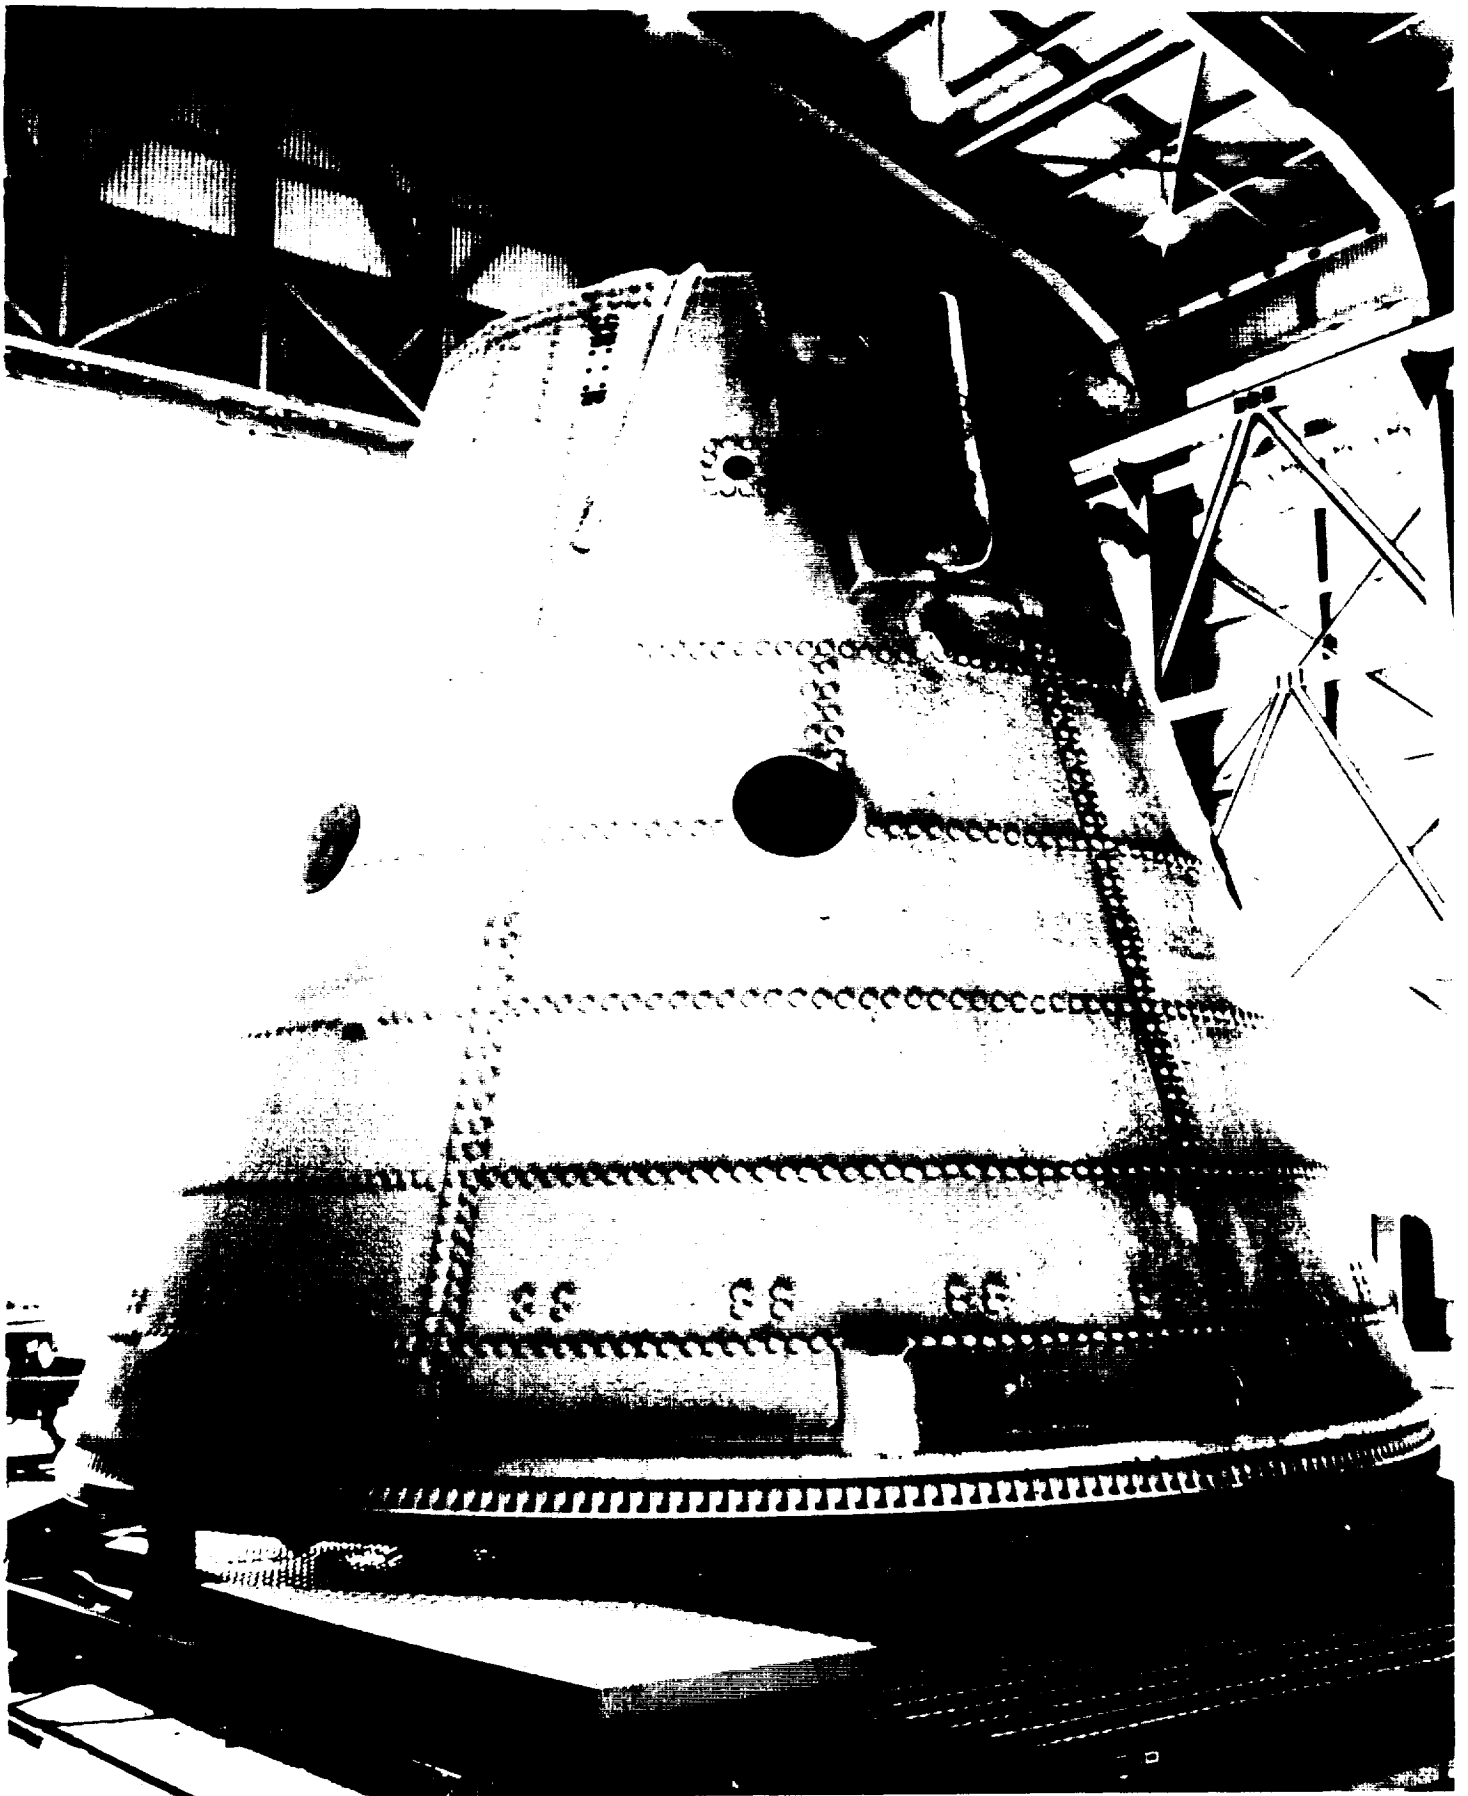
The RH frustum was missing no TPS but had 23 MSA-2 debonds over fasteners. Blistering of the Hypalon paint was minimal. The BSM aero heat shield covers had locked in the fully opened position

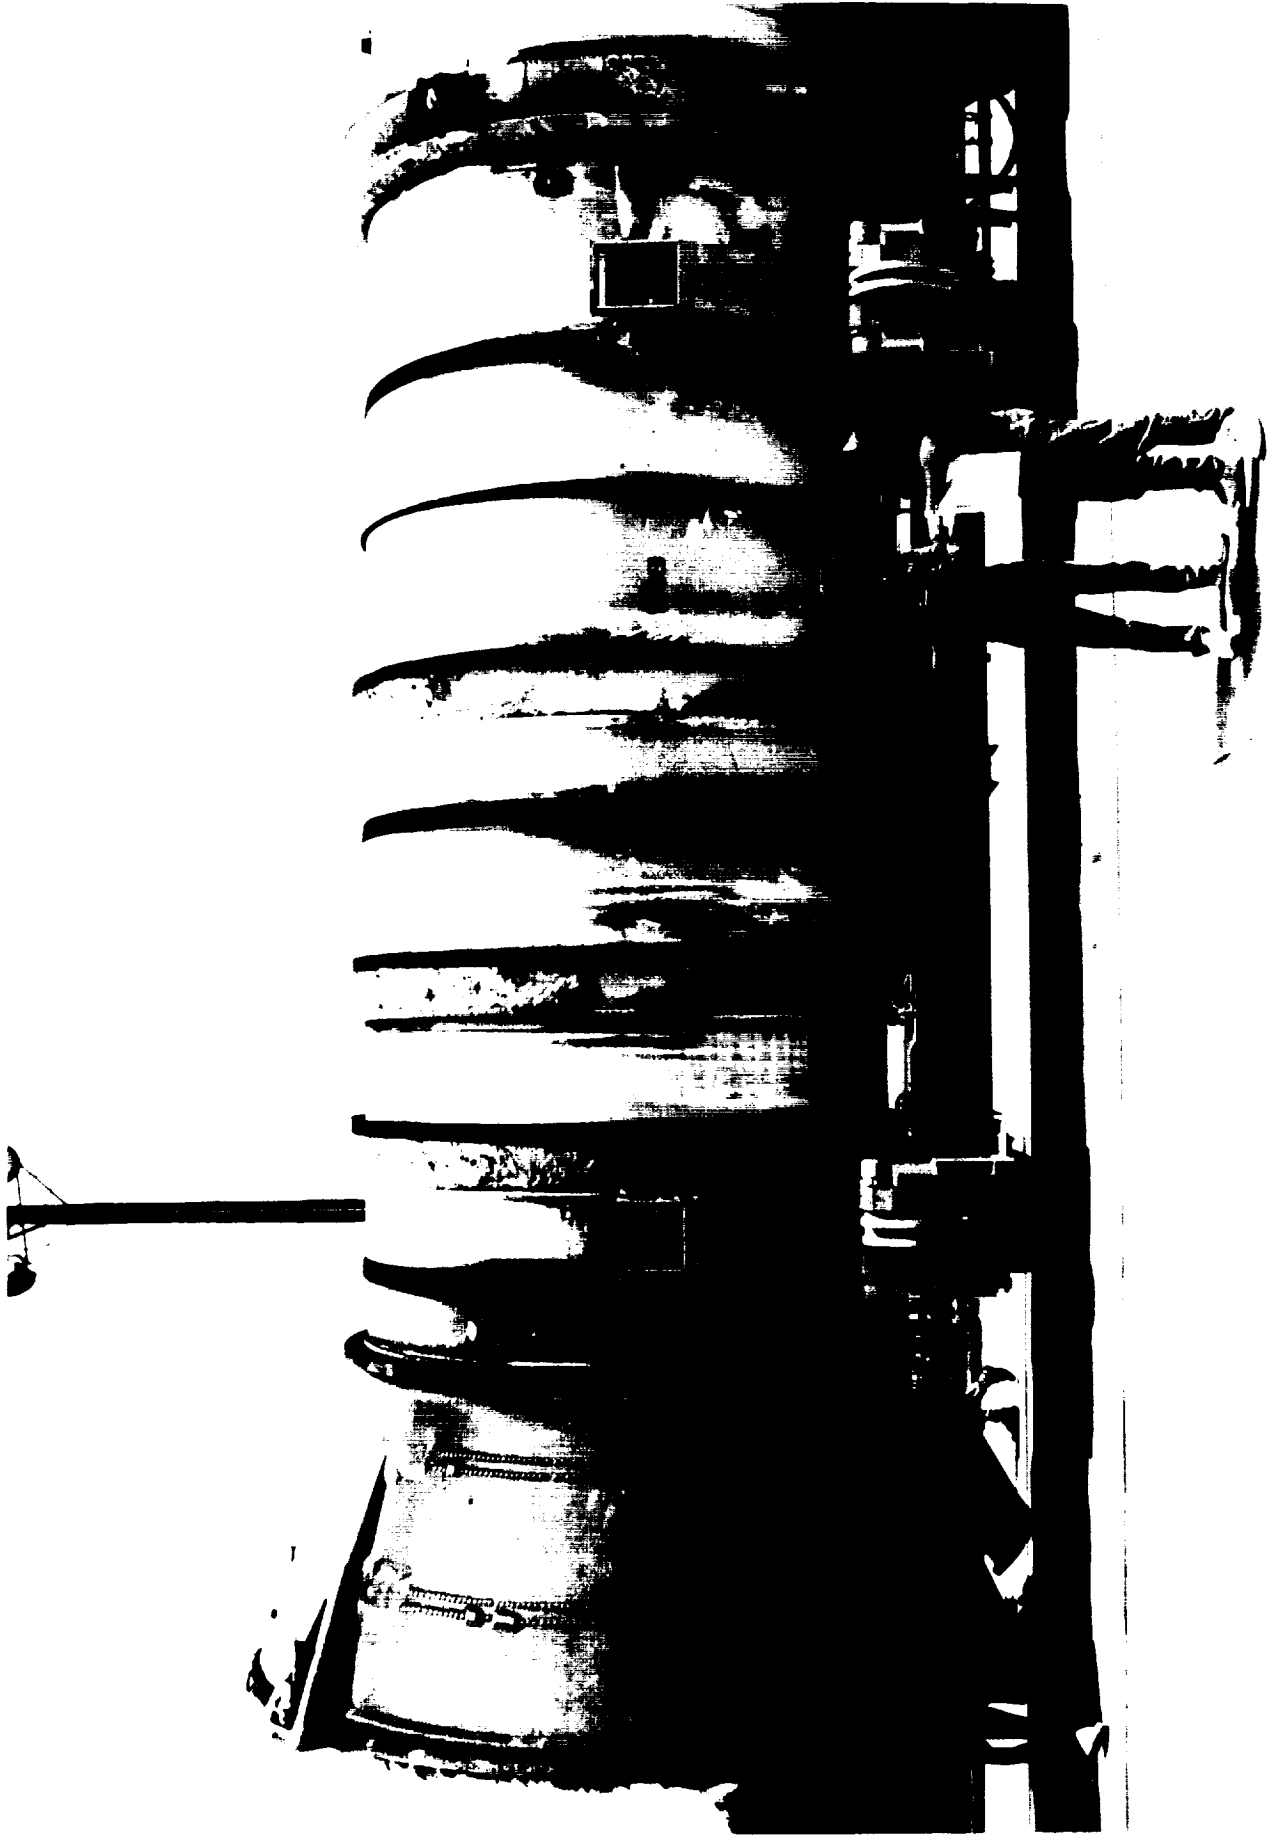
Post flight condition of the RH aft booster and aft skirt. The ET/SRB aft struts, ETA ring, IEA, and IEA covers appeared undamaged. The stiffener ring splice plate closeouts were intact and no K5NA material was missing.

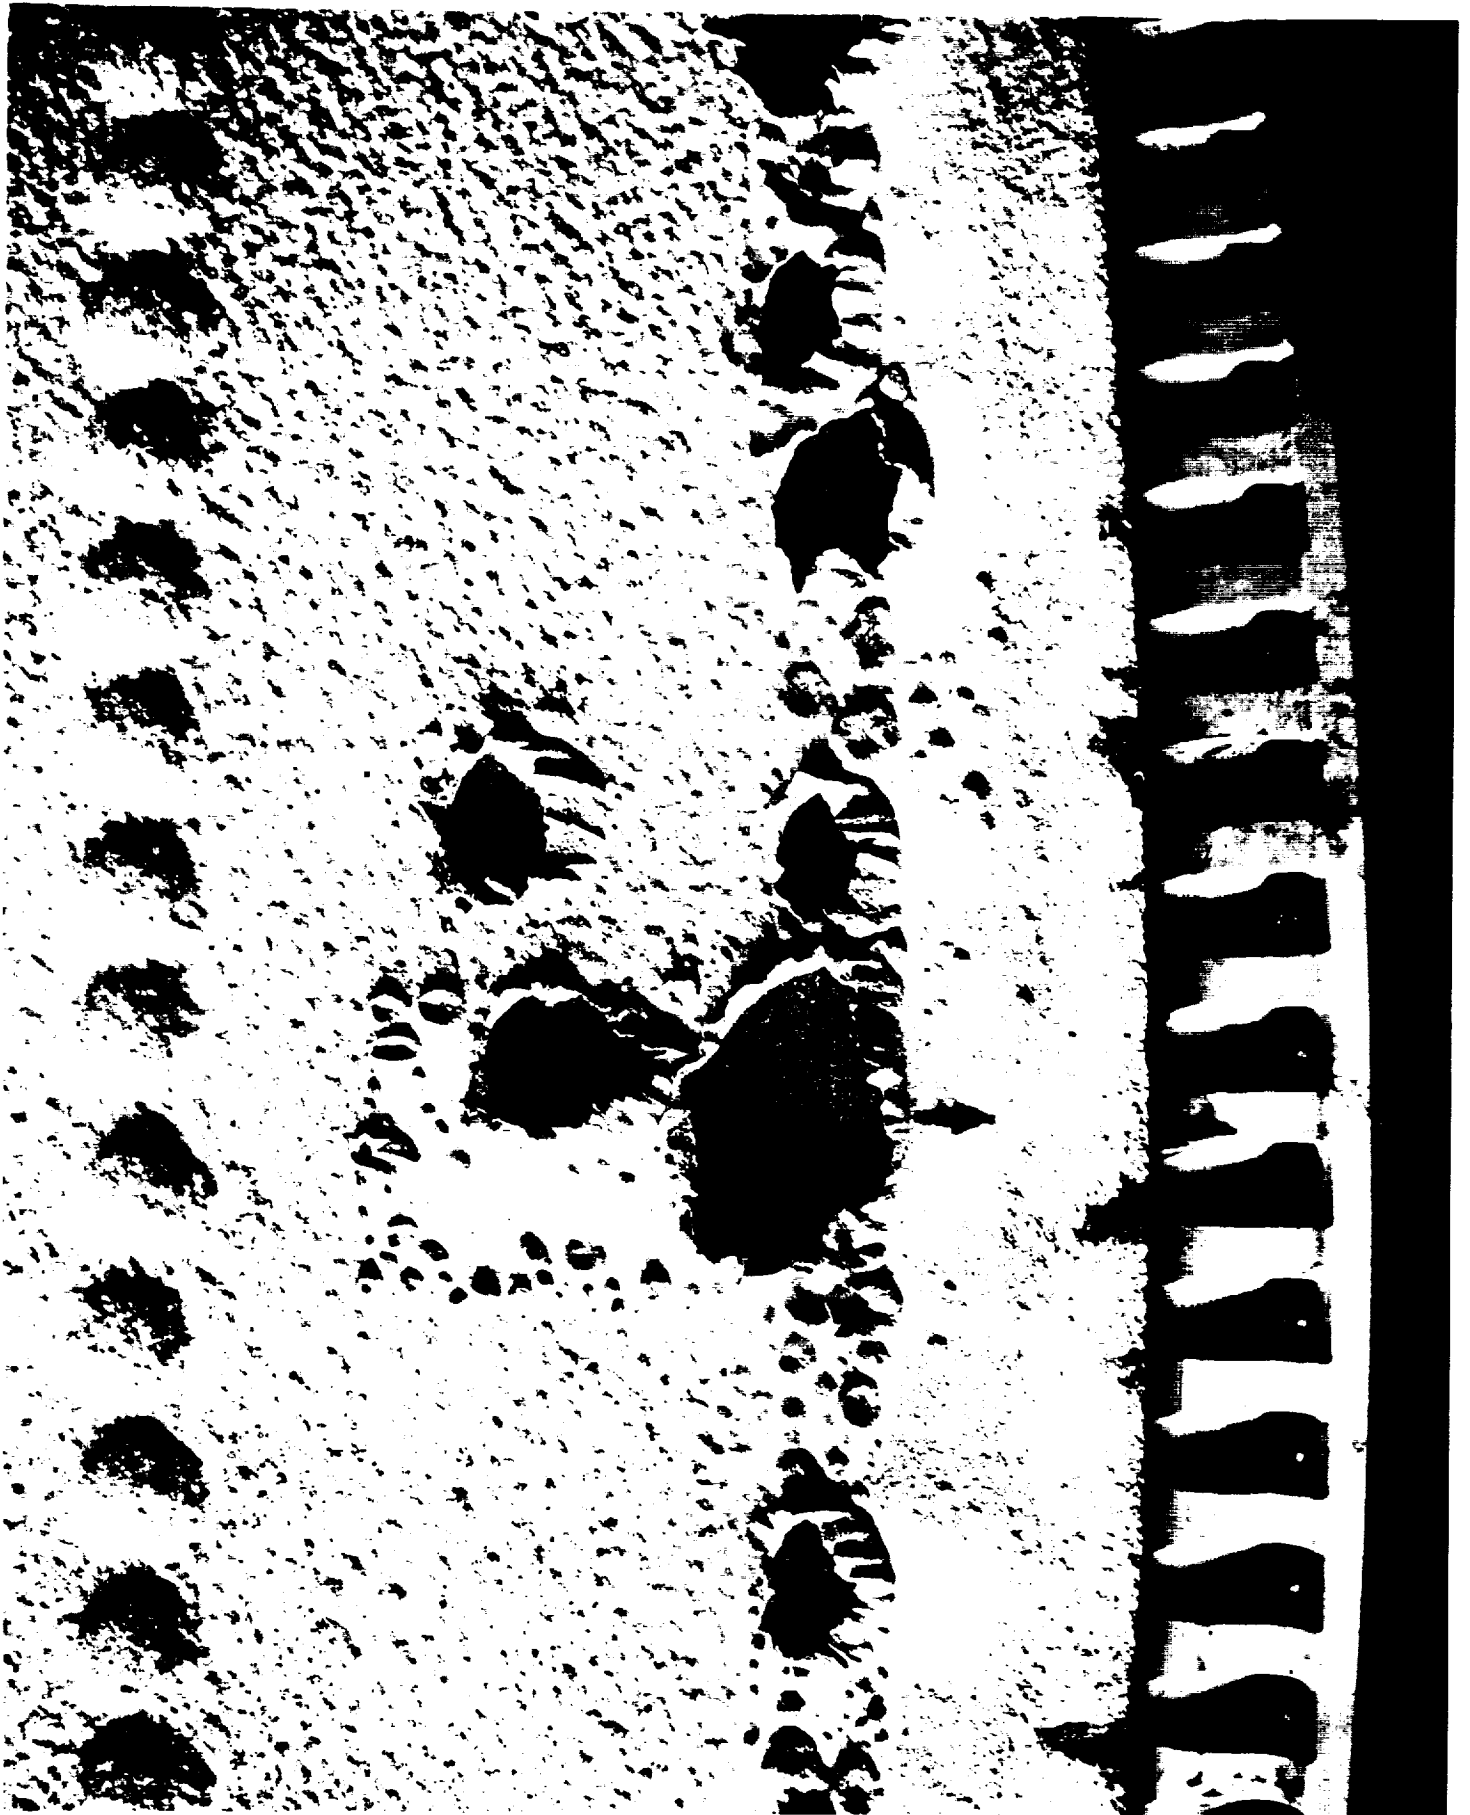
Hypalon paint was blistered and/or missing from areas where BTA had been applied. The underlying BTA was not sooted.

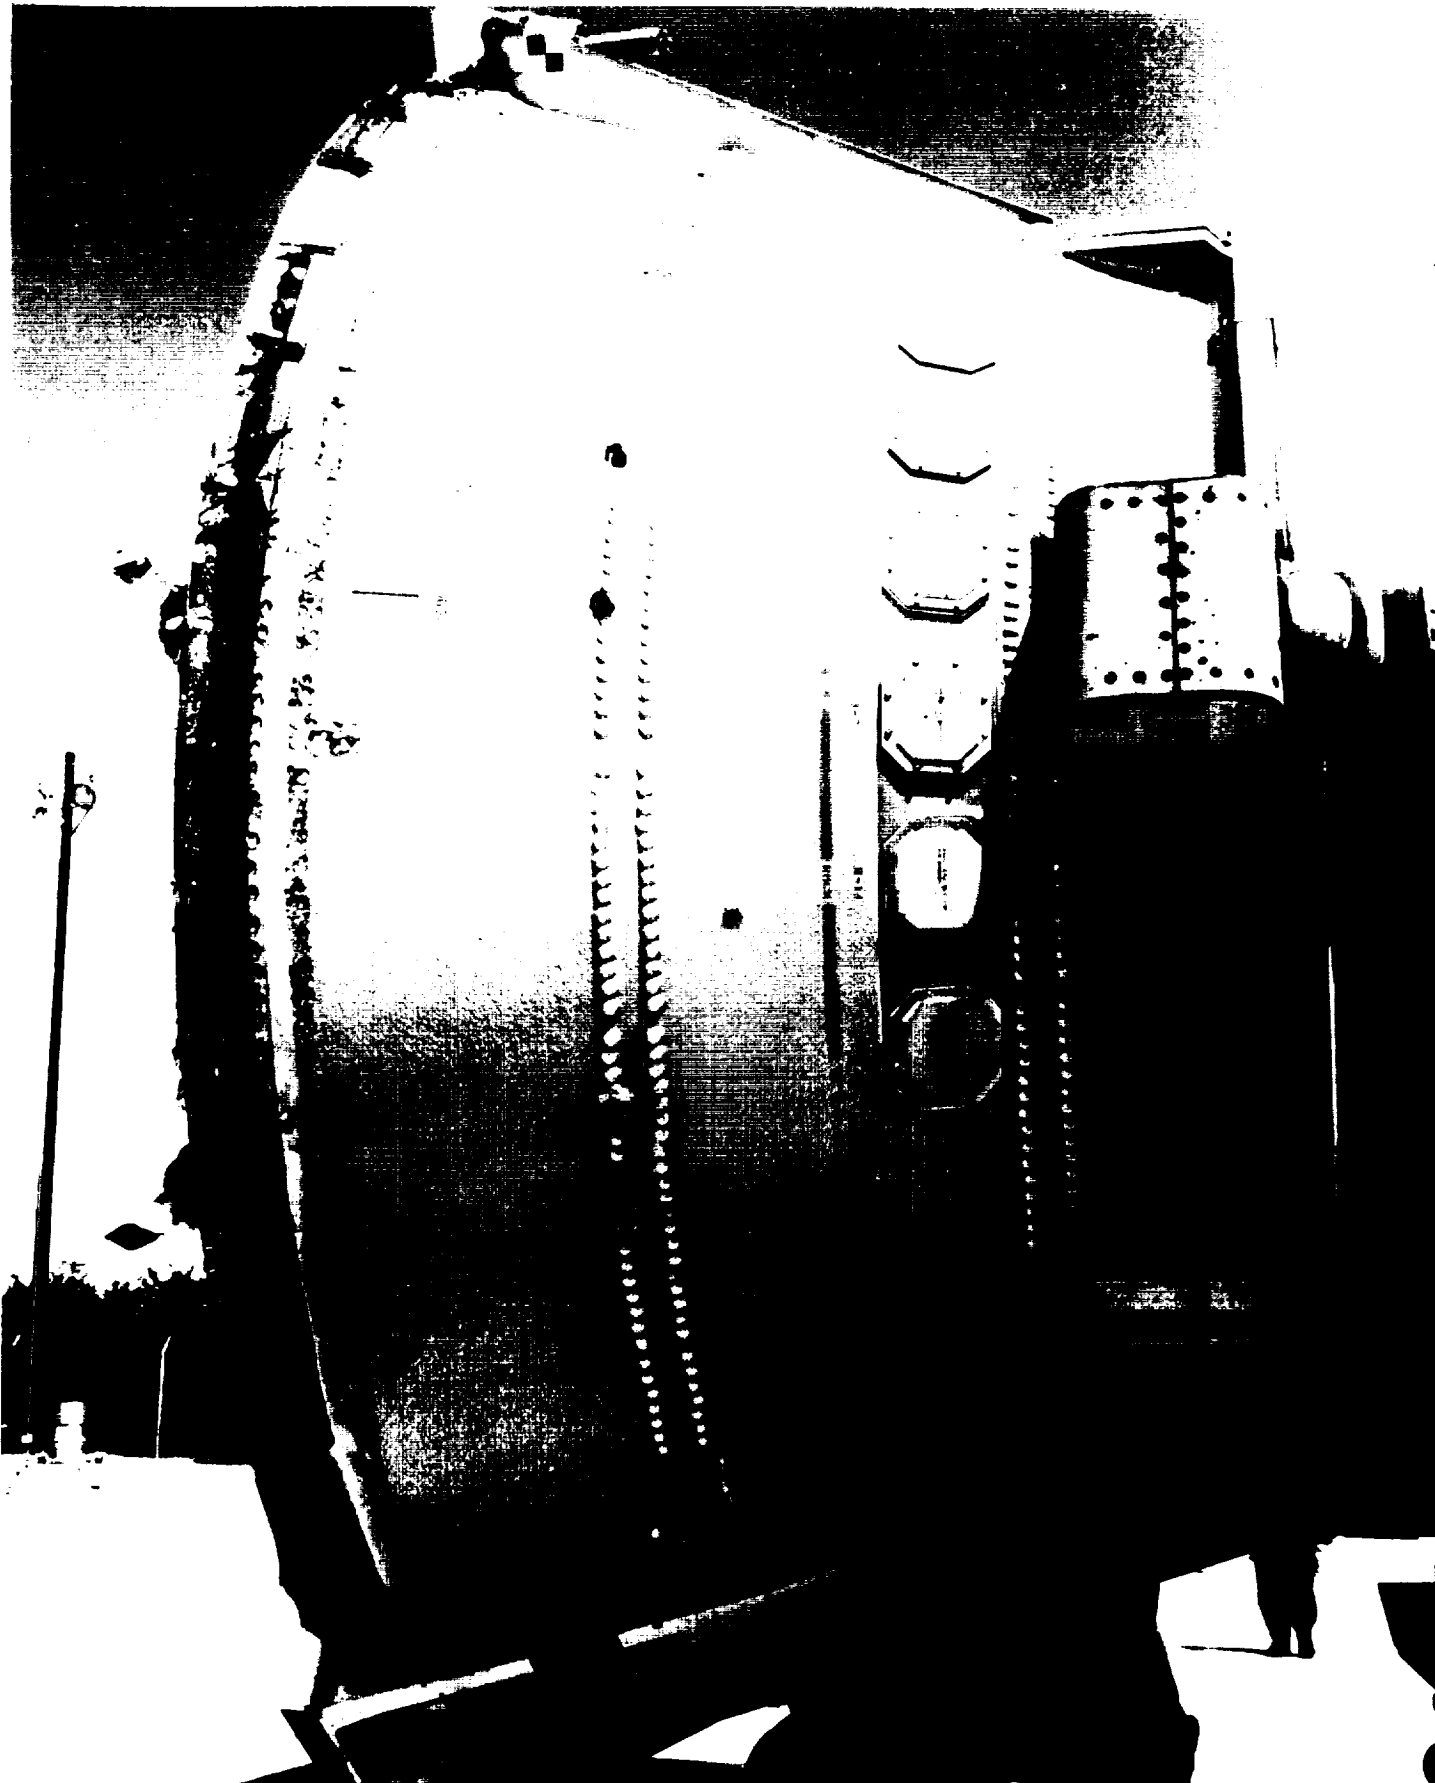
Two by two inch pieces of MSA-2 were missing from fasteners near the hydrazine service ports. Hypalon paint was blistered/missing from BTA closeout areas.

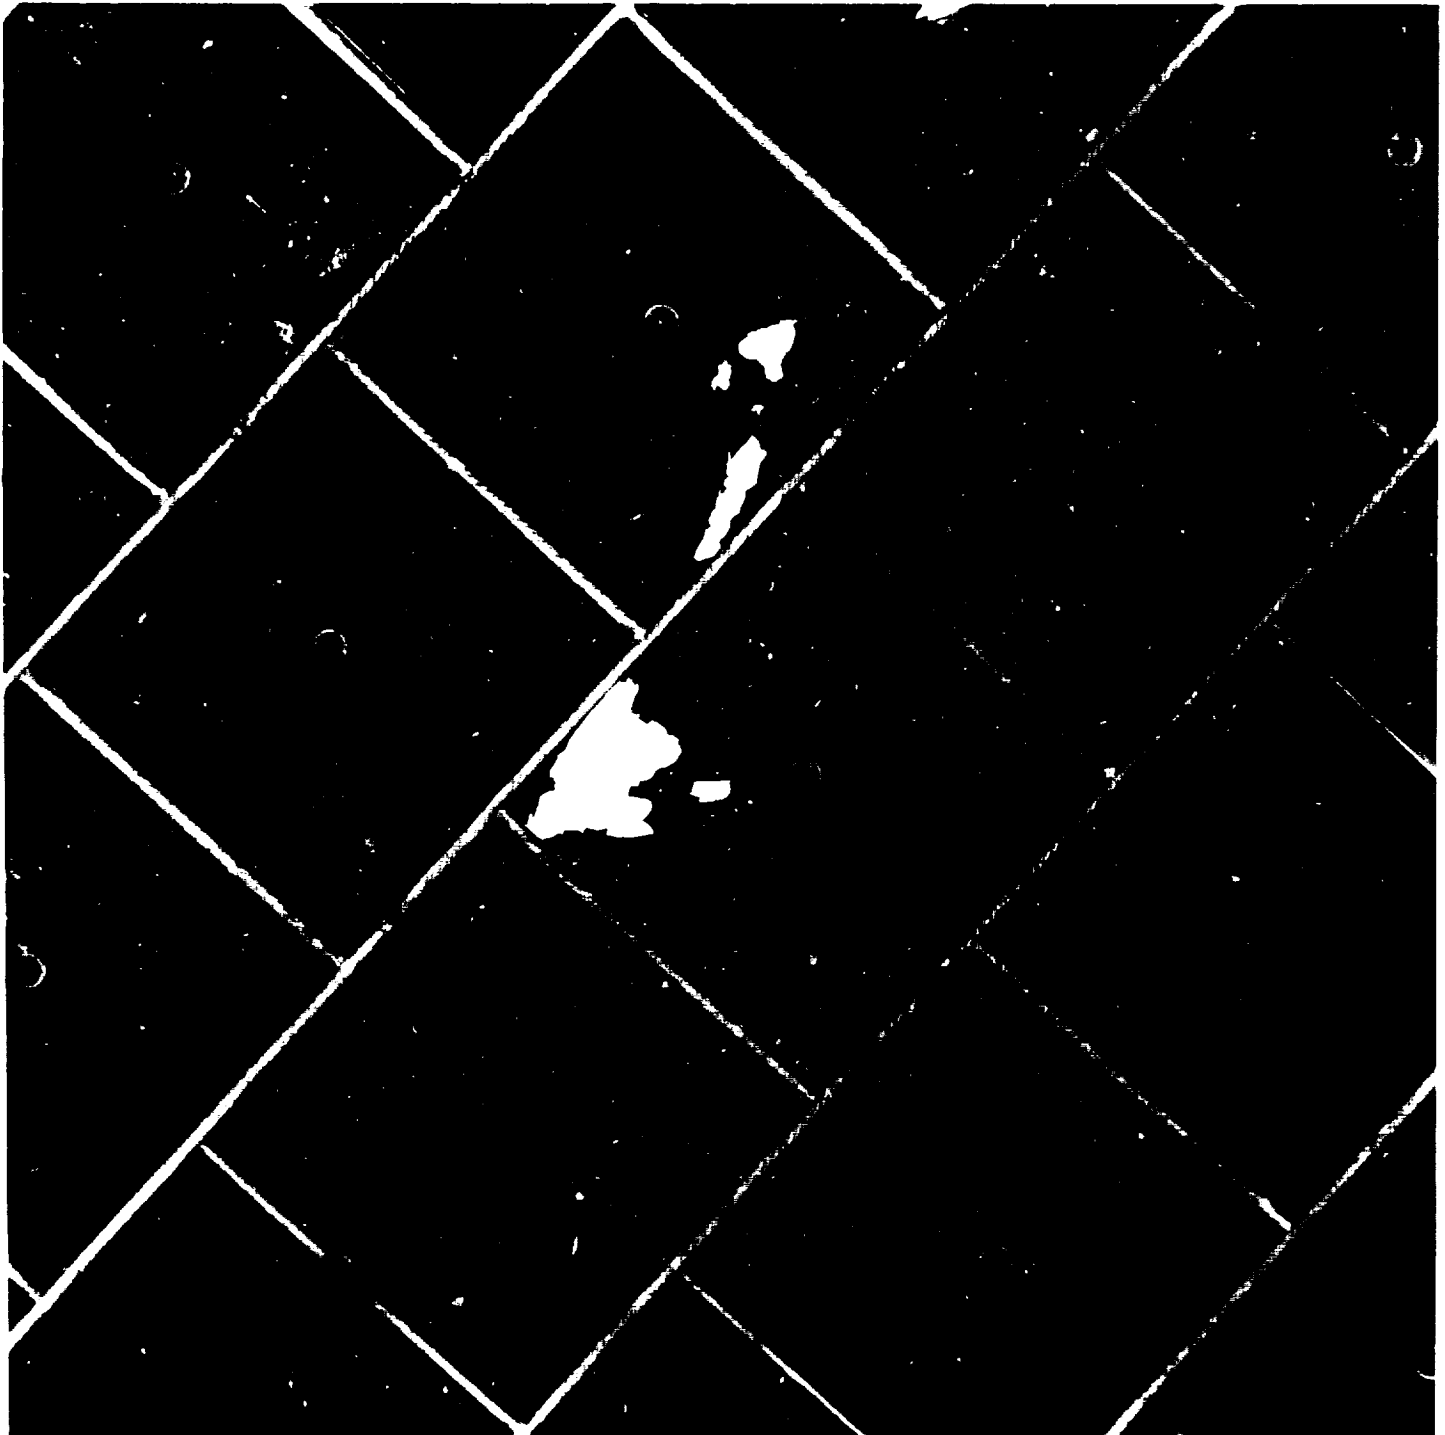
The Orbiter lower surface tiles sustained a total of 47 hits, of which 10 had a major dimension of 1-inch or greater. The largest tile damage sites were located on the lower surface of the body flap and aft of the ET/ORB umbilicals.

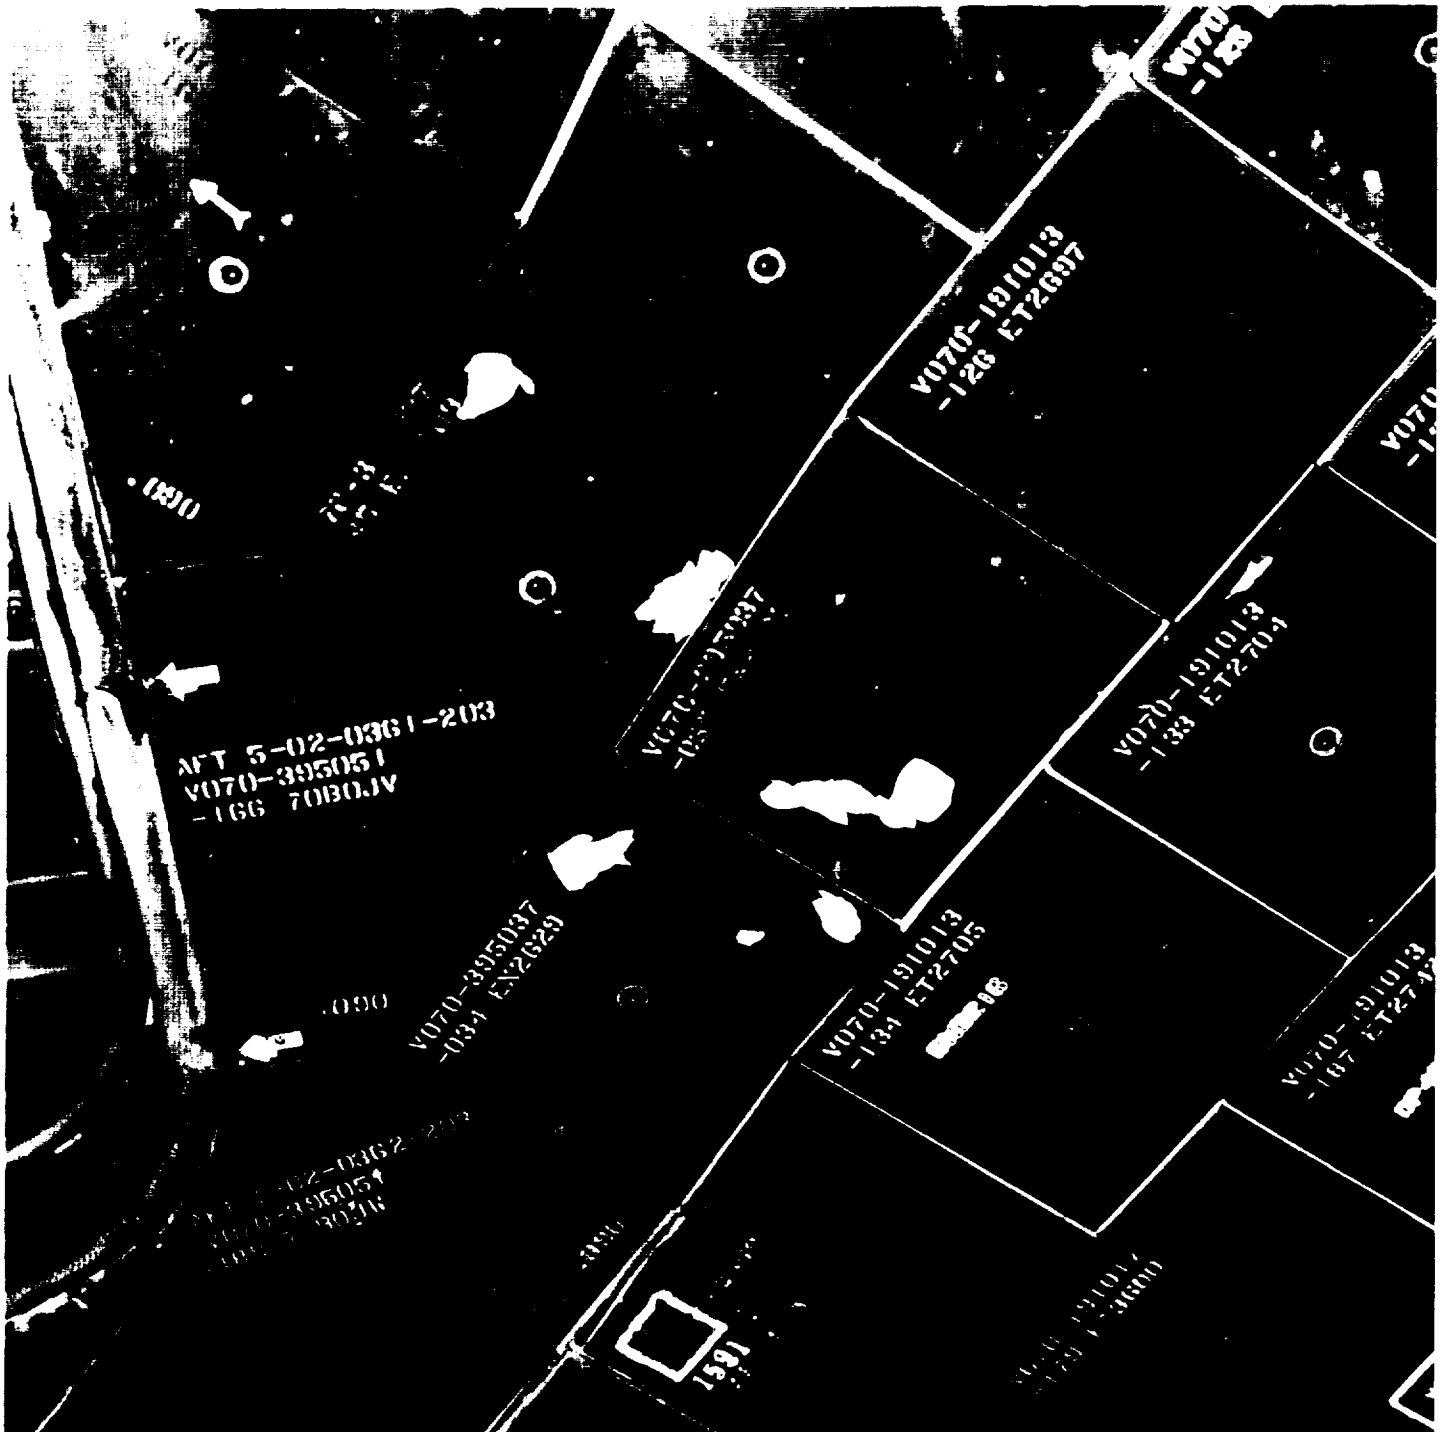
A total of 16 hits, in two clusters of 8 hits, occurred near the LH2 ET/ORB umbilical. Hits around the ET/ORB umbilicals are believed to be impacts from umbilical ice.

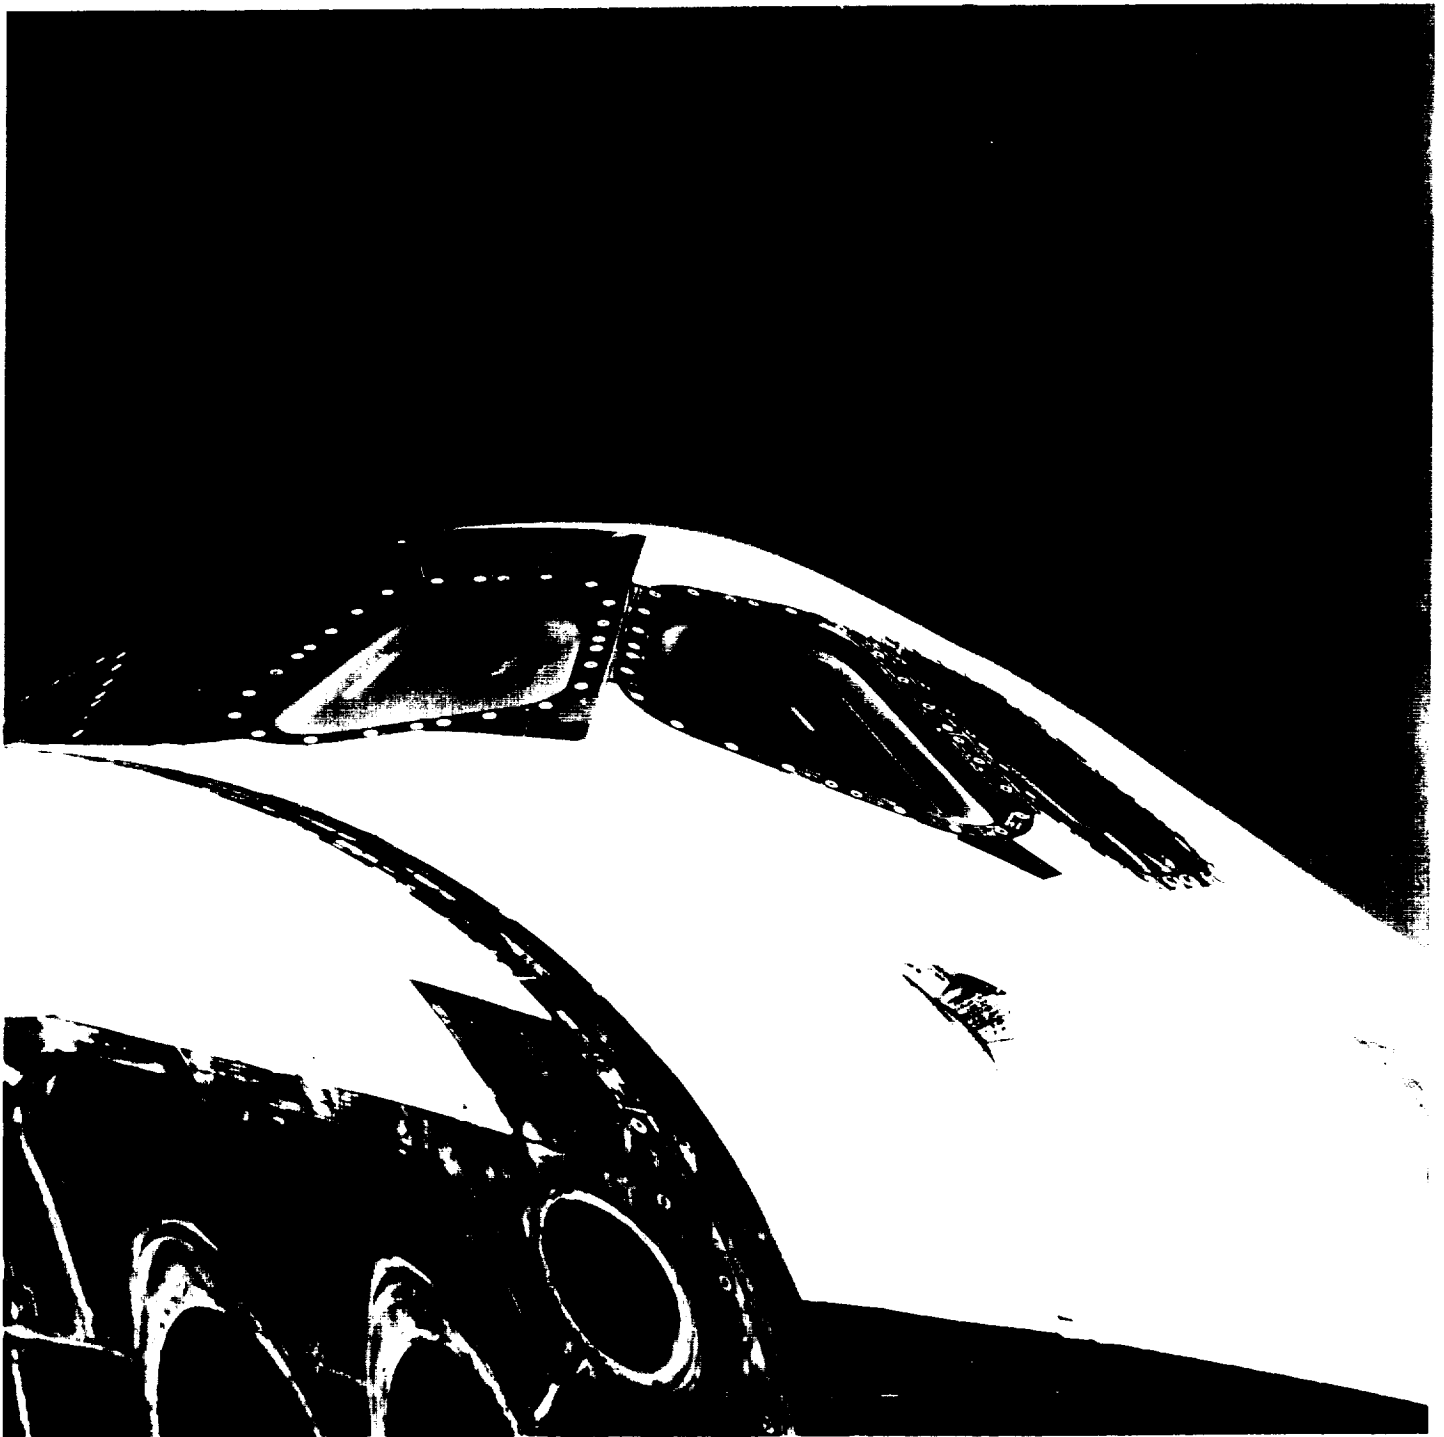
Forward-facing Orbiter windows #3 and #4 exhibited typical hazing. A very light haze was present on the other windows. Twelve hits with 8 larger than 1-inch in size were noted on the perimeter tiles around windows #3 and #5.

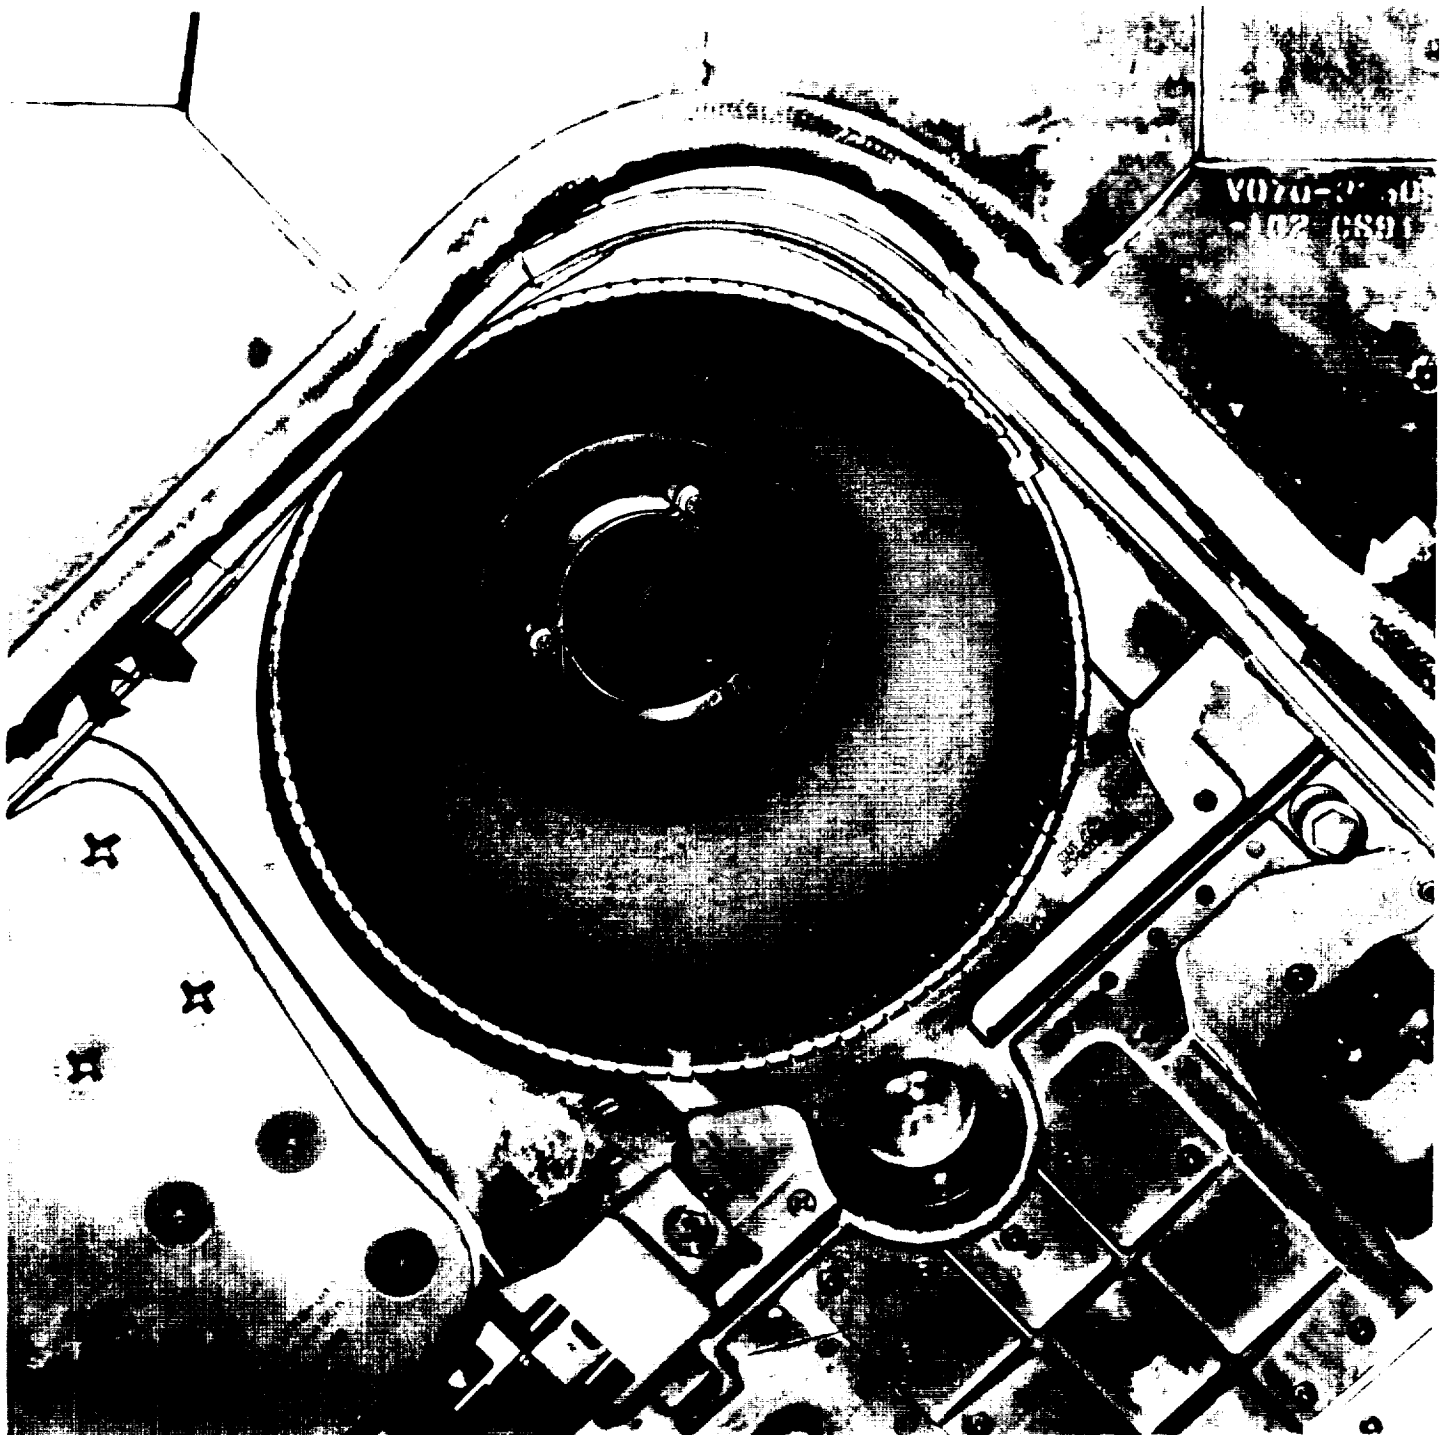
The EO-2 plunger was not seated. No flight hardware was found on the runway below the umbilical when the ET door was opened, but a loose wave spring from the pyro separation device was found resting against a fastener on the ET door

2. The EO-2 debris plunger had not seated. No debris was found on the runway beneath the ET/ORB umbilical cavities when the ET doors were opened, but a loose wave spring was found resting against a Hi-Lock fastener on the LH2 umbilical door. The wave spring is part of the pyro separation device.
