NASA Technical Memorandum TM 109203

# Debris/Ice/TPS Assessment and Integrated Photographic Analysis for Shuttle Mission STS-59

June 1994

Shuttle Mission STS-59 was launched at 7:05 a.m. local 4/9/94

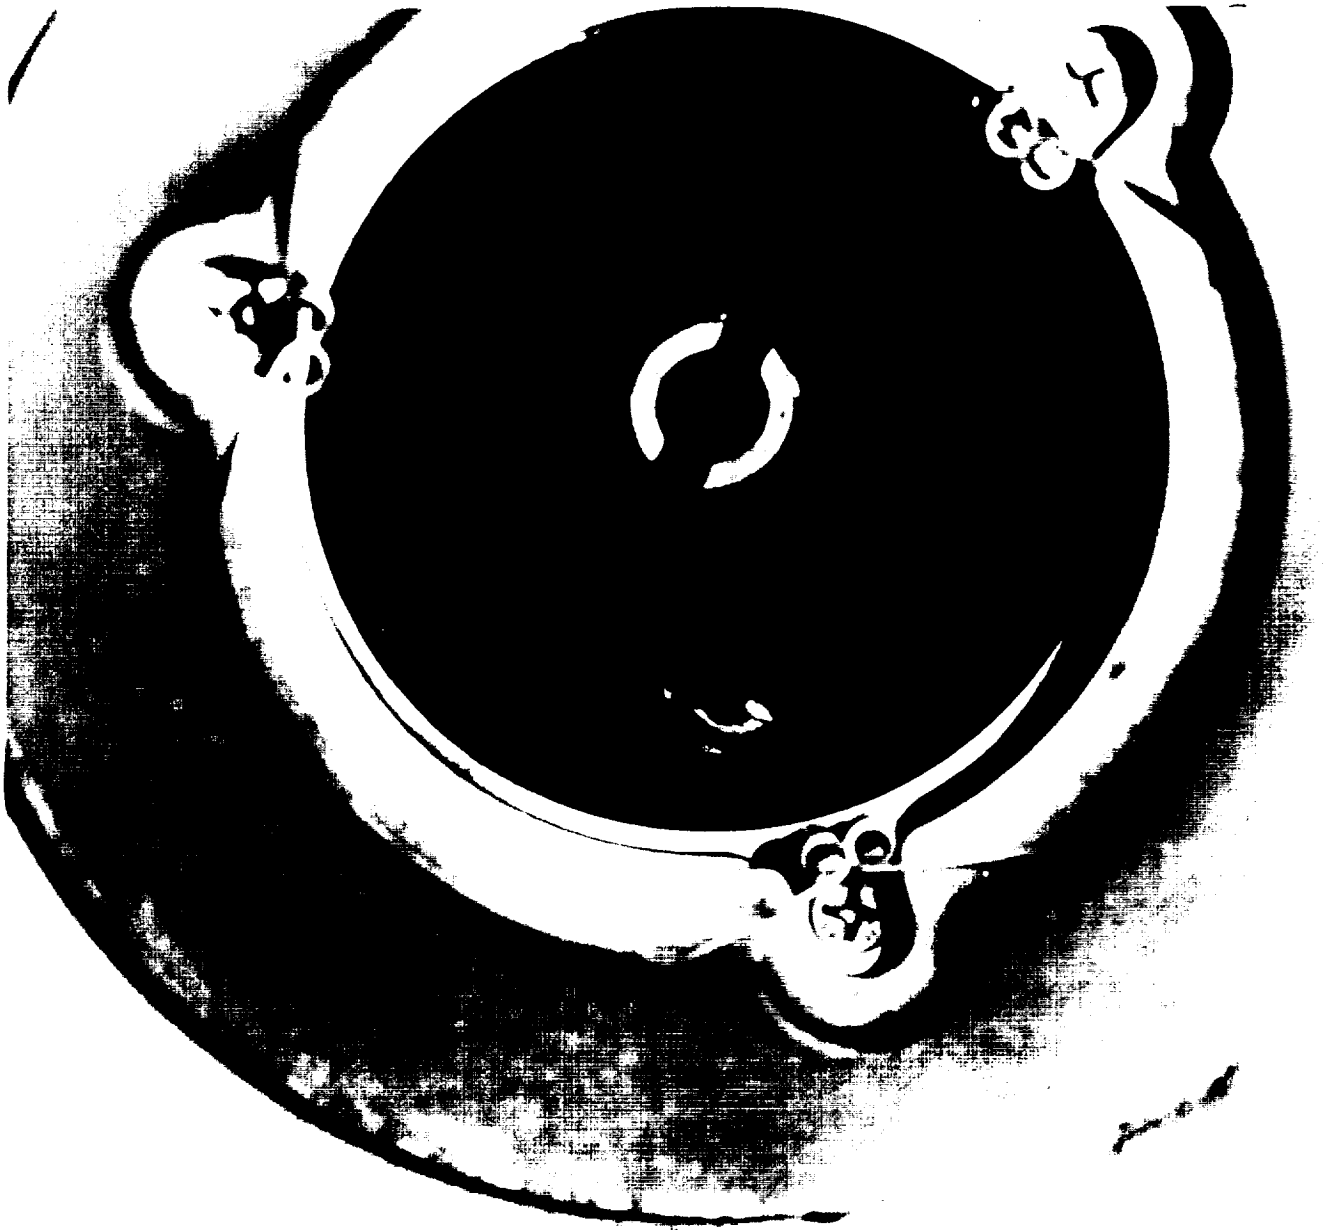
The EO-2 debris plunger was obstructed by ordnance debris
