# Debris/Ice/TPS Assessment and Integrated Photographic Analysis for Shuttle Mission STS-62

May 1994

DEBRIS/ICE/TPS ASSESSMENT  
AND  
INTEGRATED PHOTOGRAPHIC ANALYSIS  
OF  
SHUTTLE MISSION STS-62

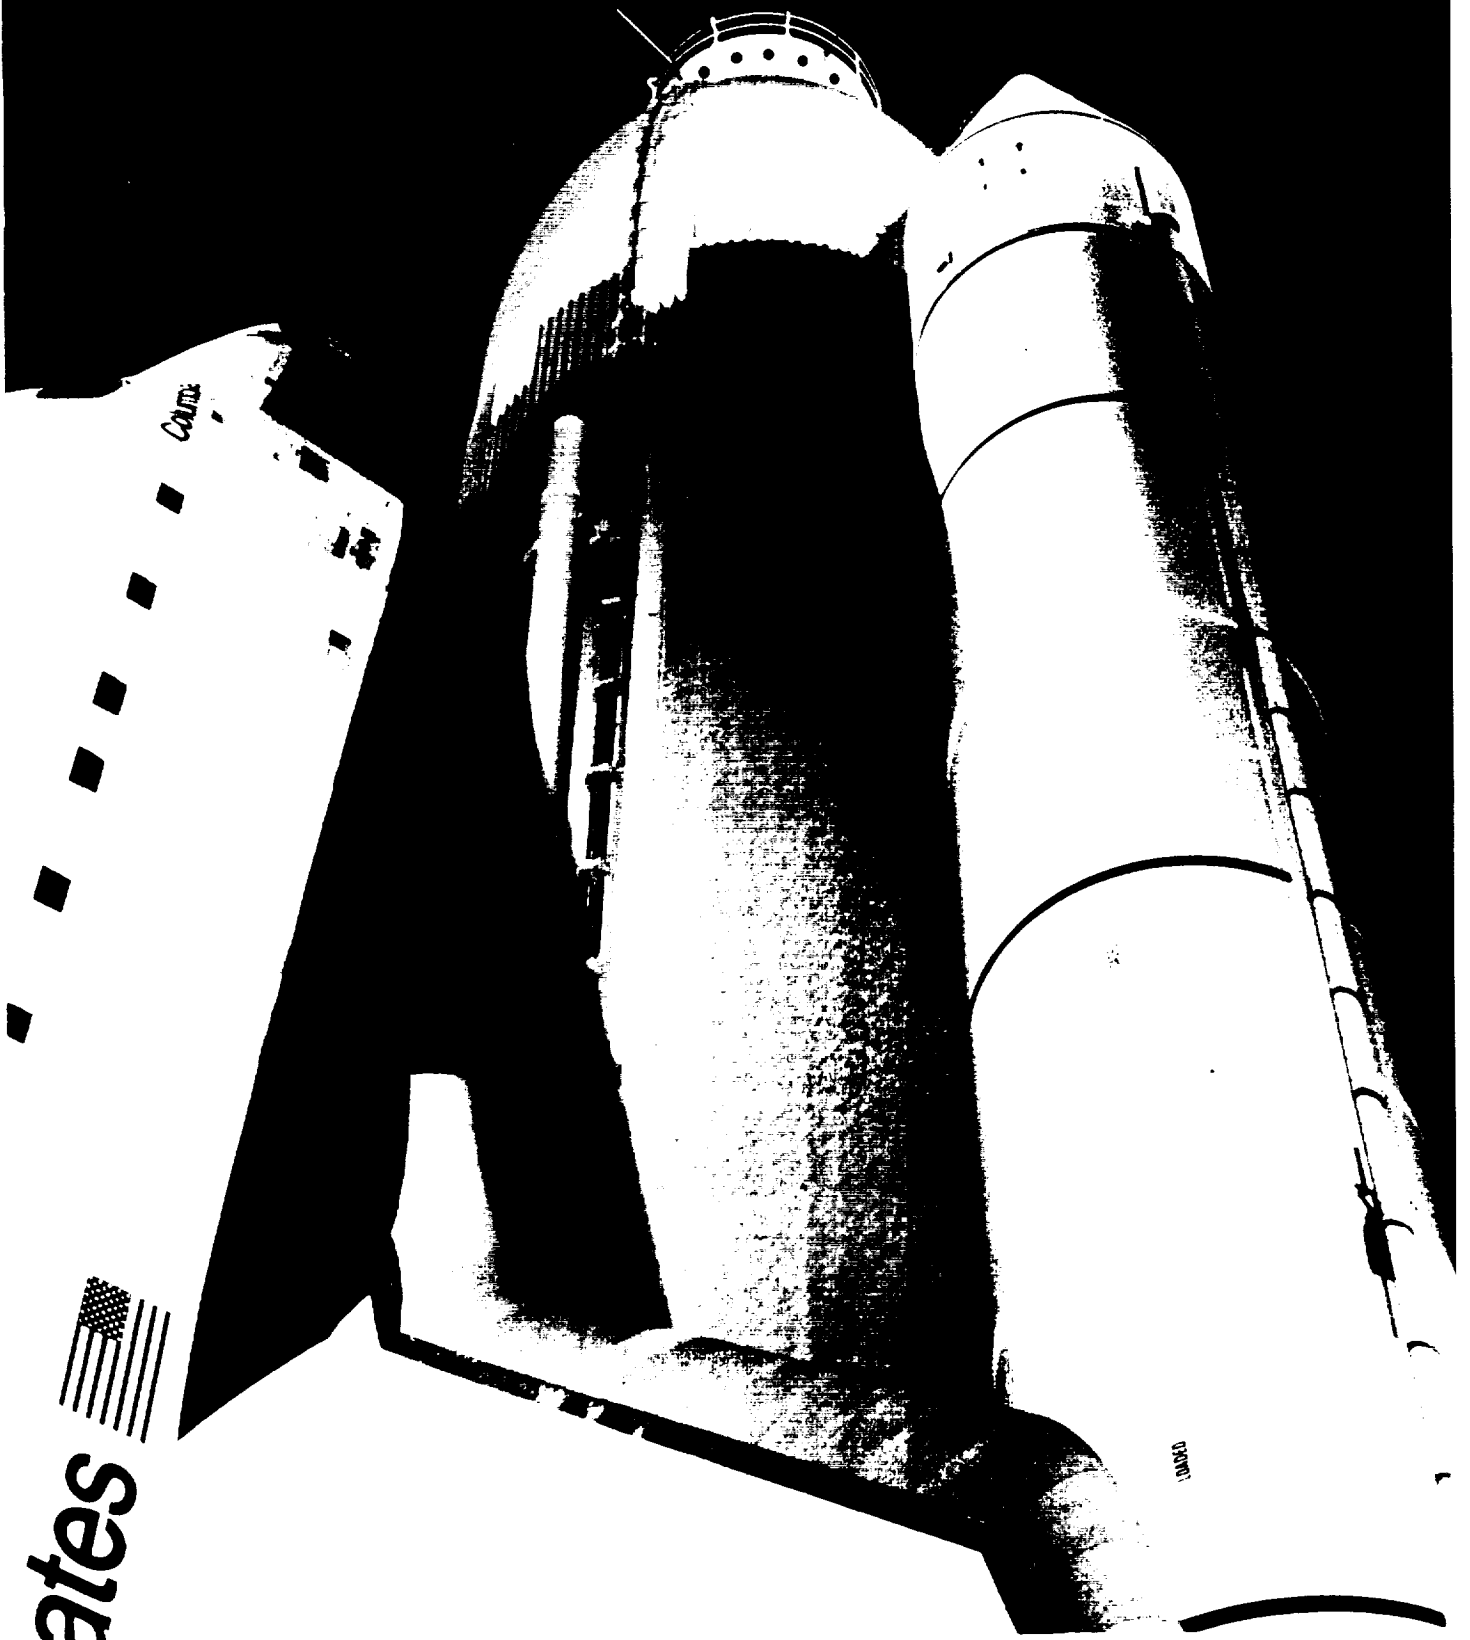
Light frost, but no ice or significant amounts of condensate, were present on the External Tank acreage after cryogenic loading. The frost melted shortly after sunrise.

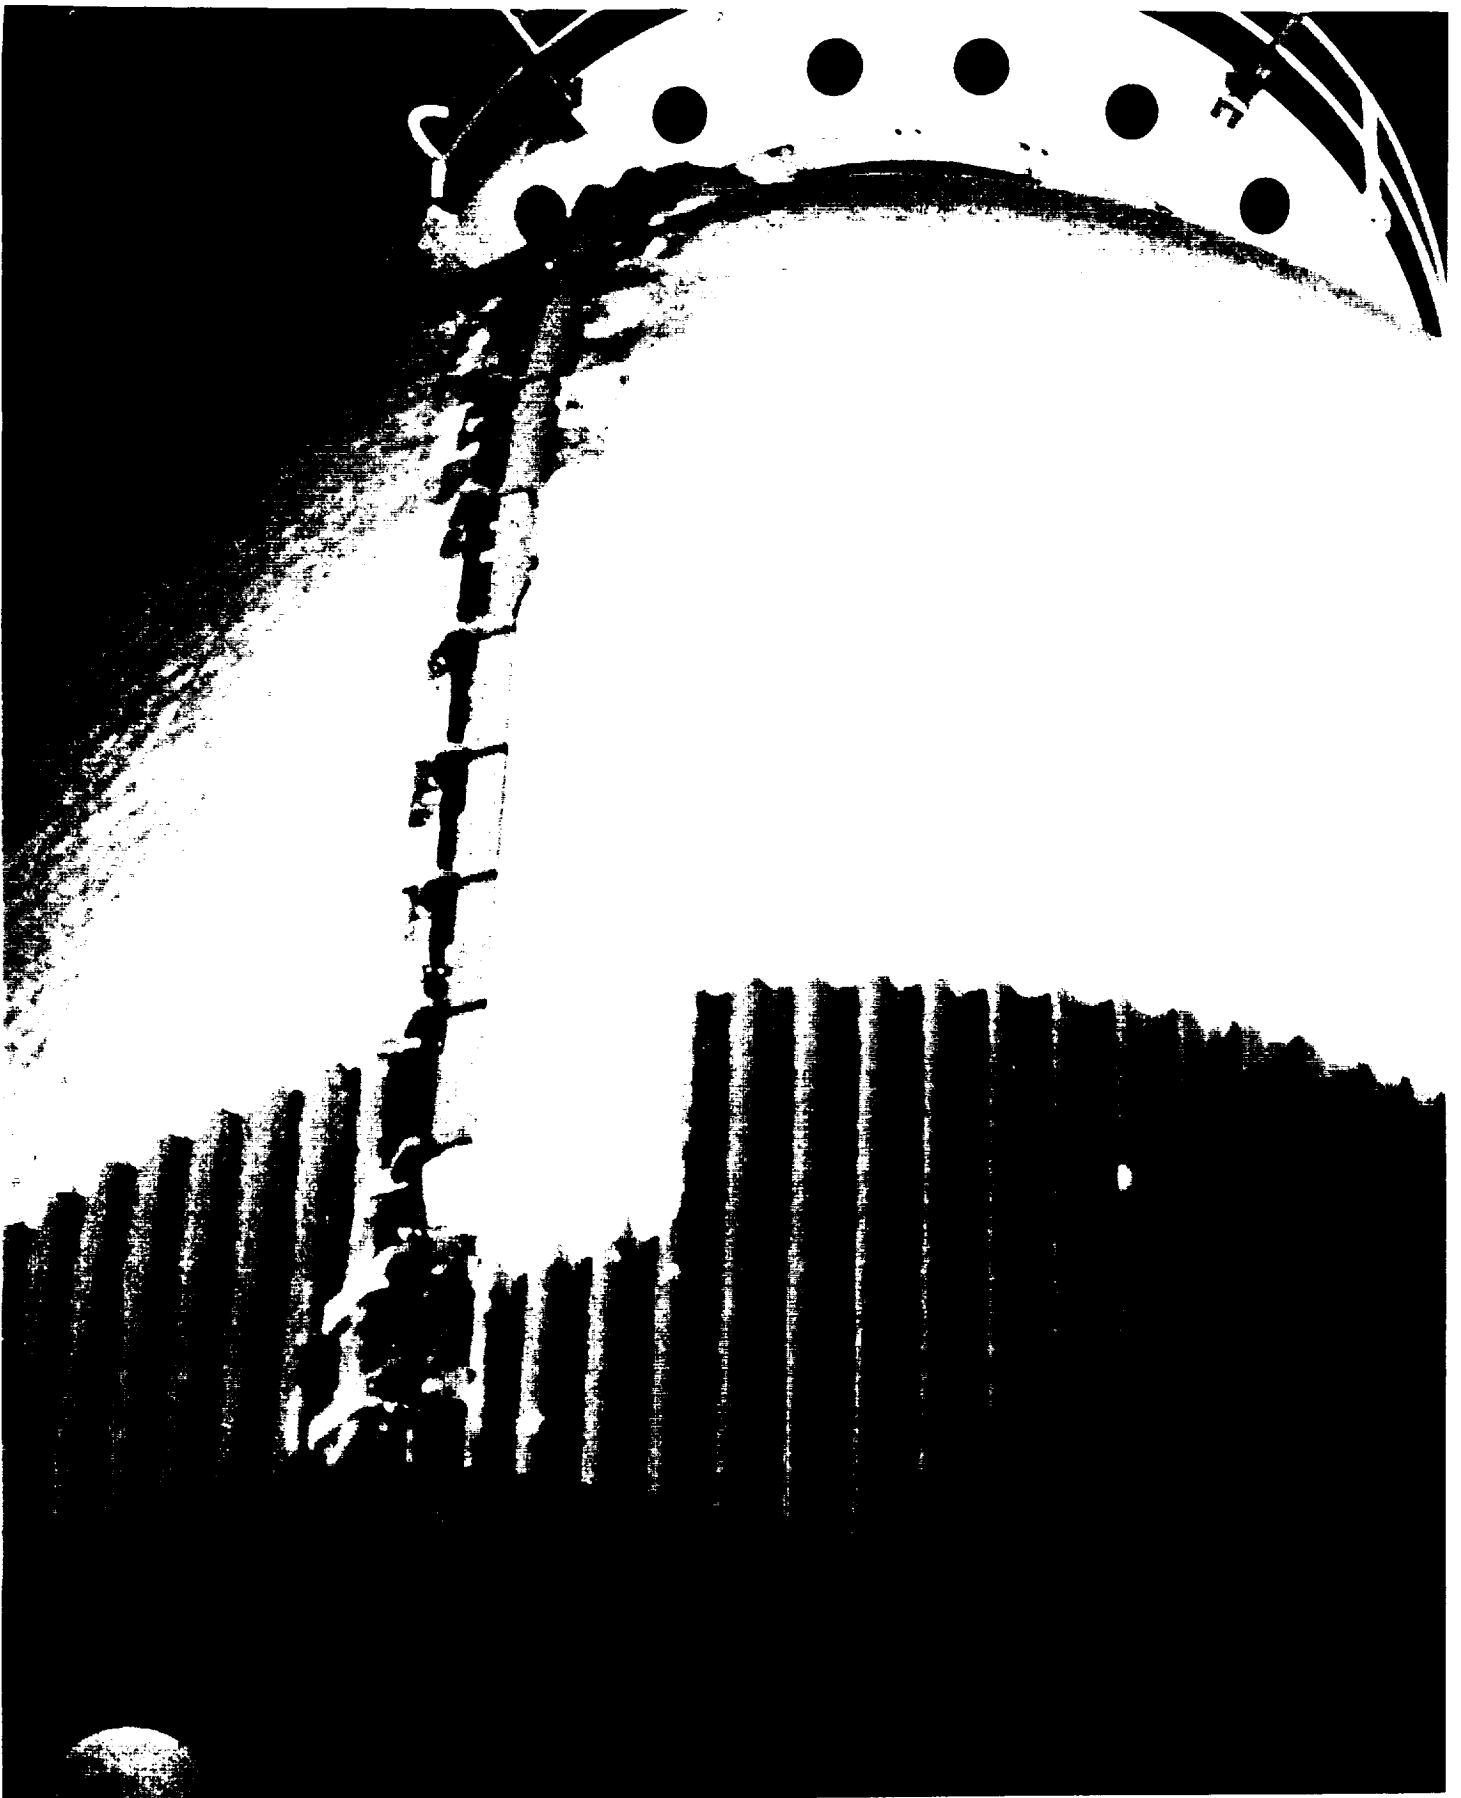
Frost, but no ice, had generally formed on the LO2 tank barrel +Y+Z quadrant. There was no ice or frost in the "No Ice" region on the nosecone and ogive.

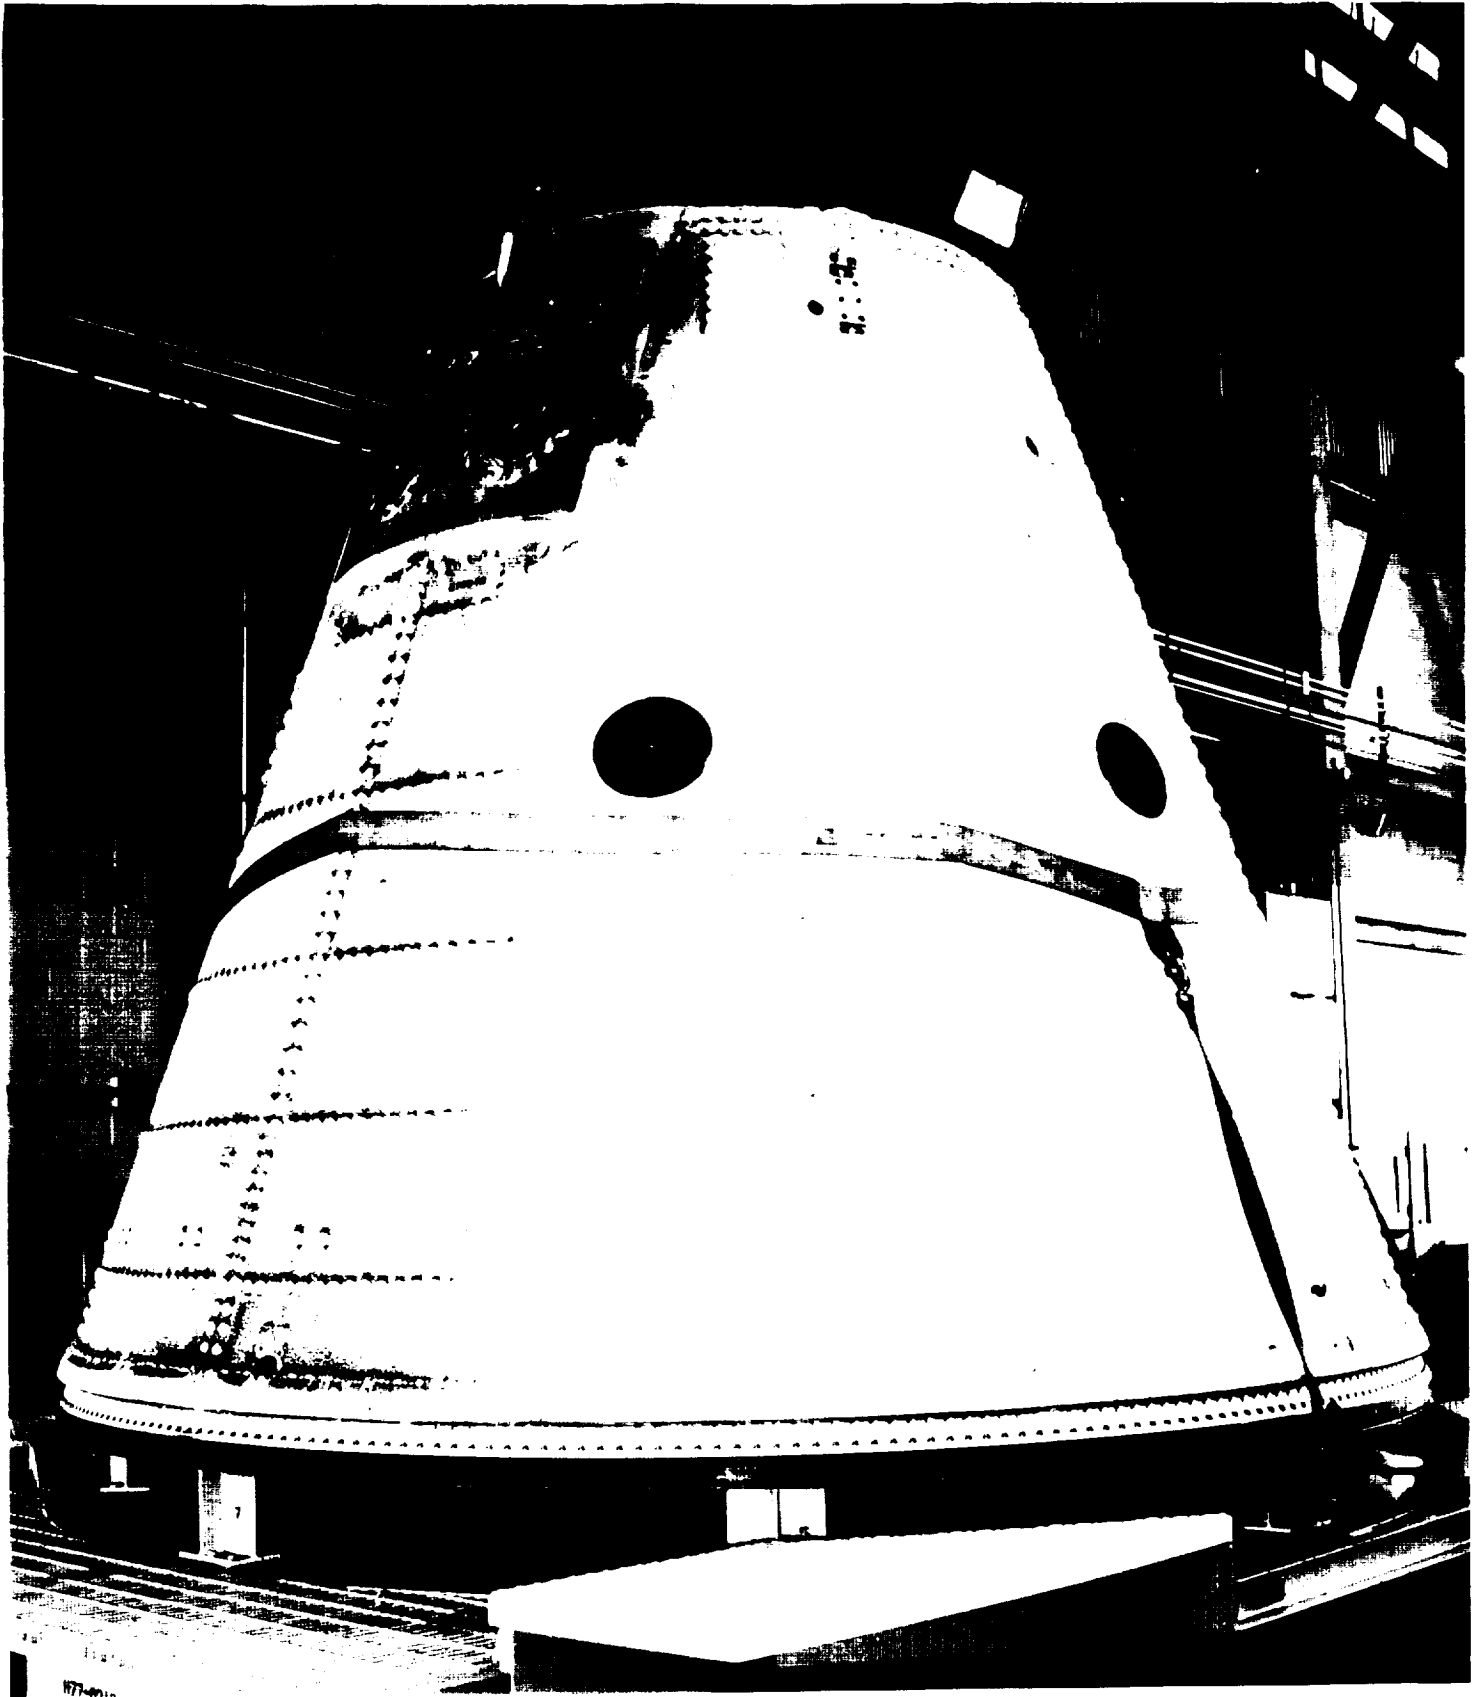
The RH frustum had 23 MSA-2 debonds over fasteners. Hypalon paint was blistered/missing from the areas where BTA had been applied. The BSM aero heat shield covers had locked in the fully opened position.

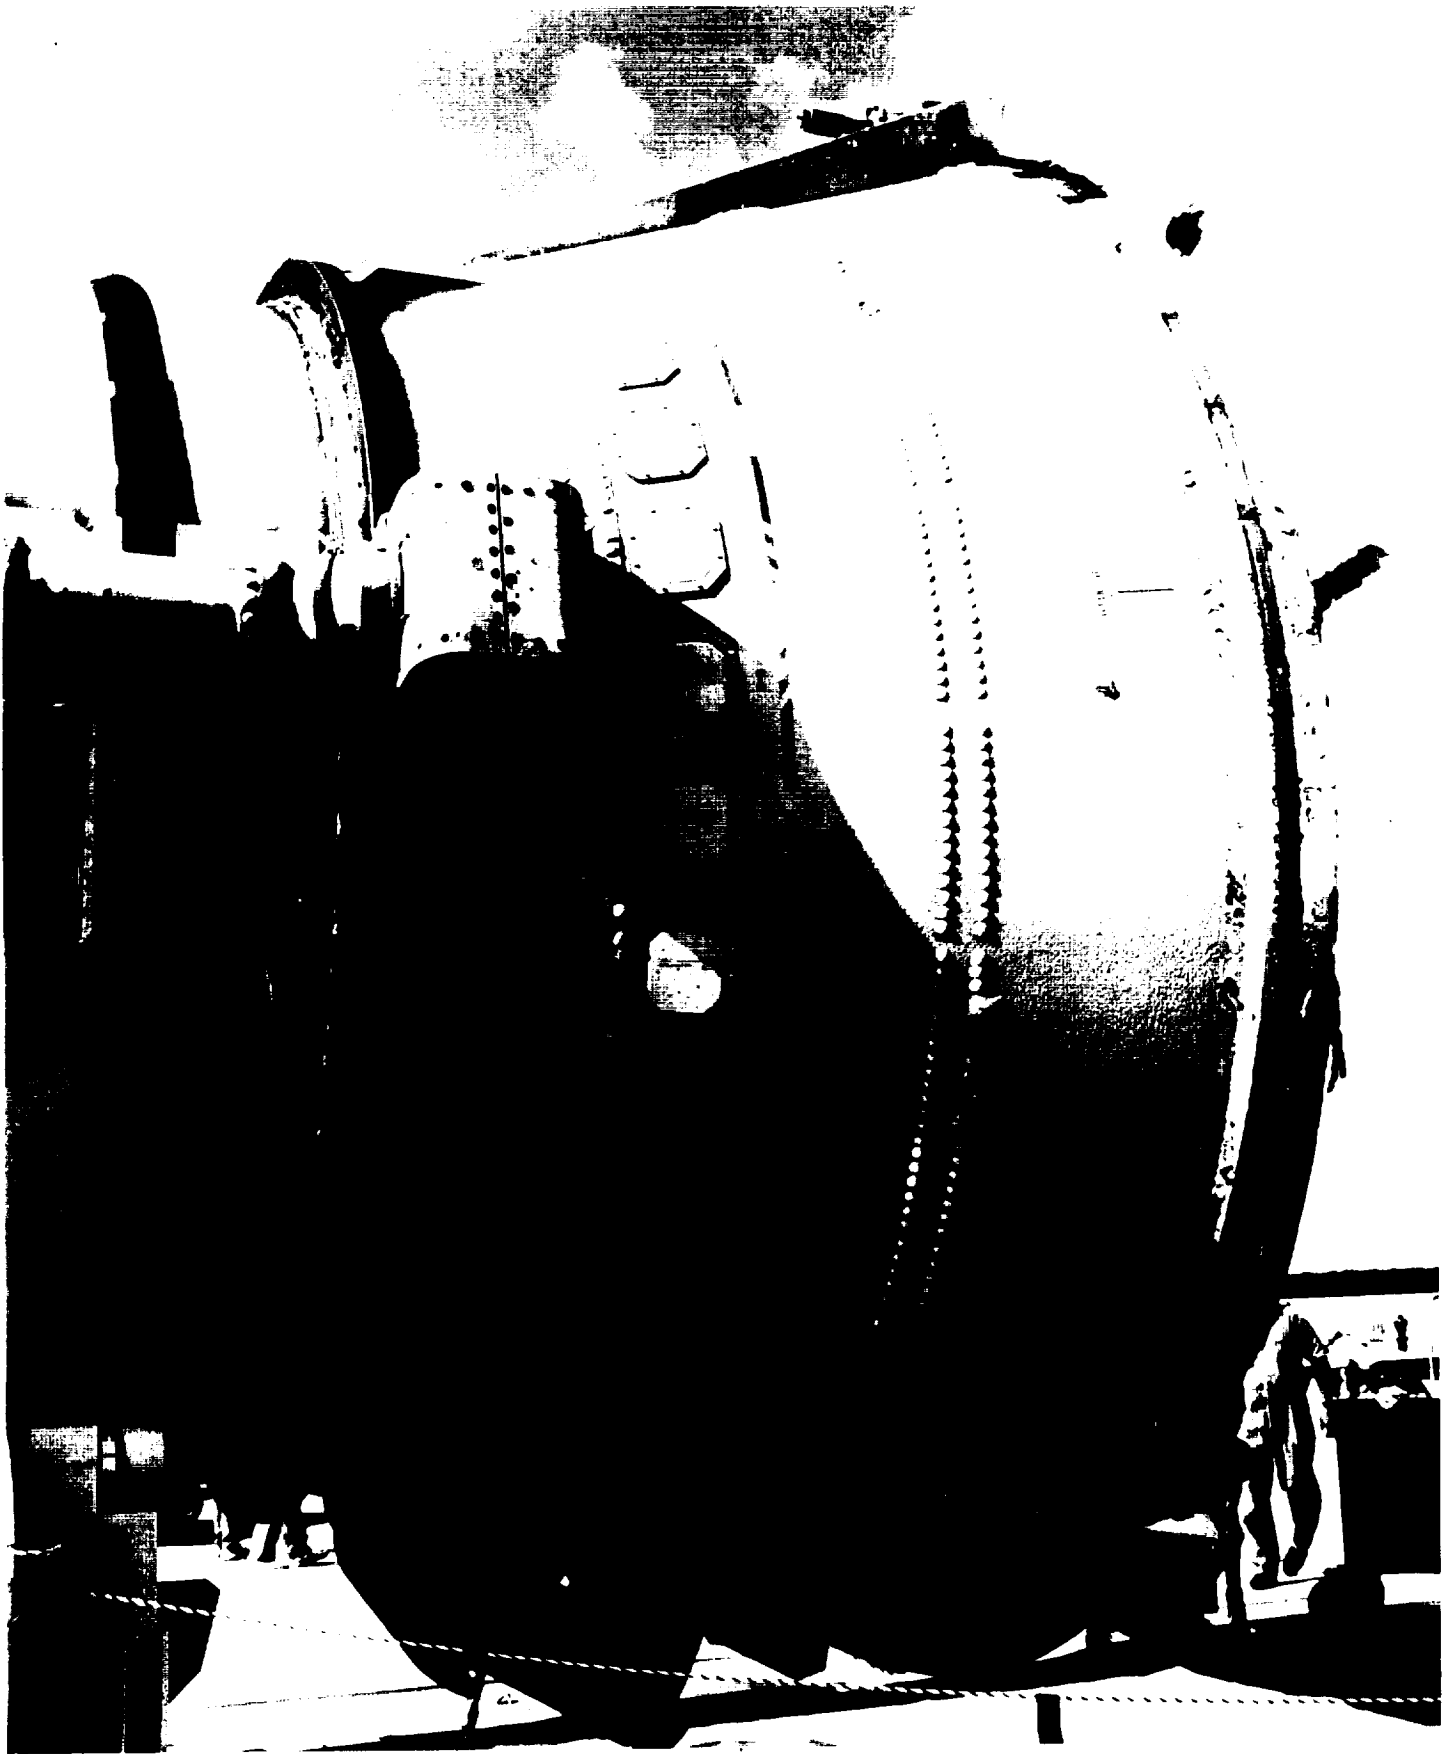
Aft skirt acreage TPS was generally in good condition. Hypalon paint was blistered and/or missing from the areas where BTA had been used as a closeout material but the BTA was not sooted or charred.

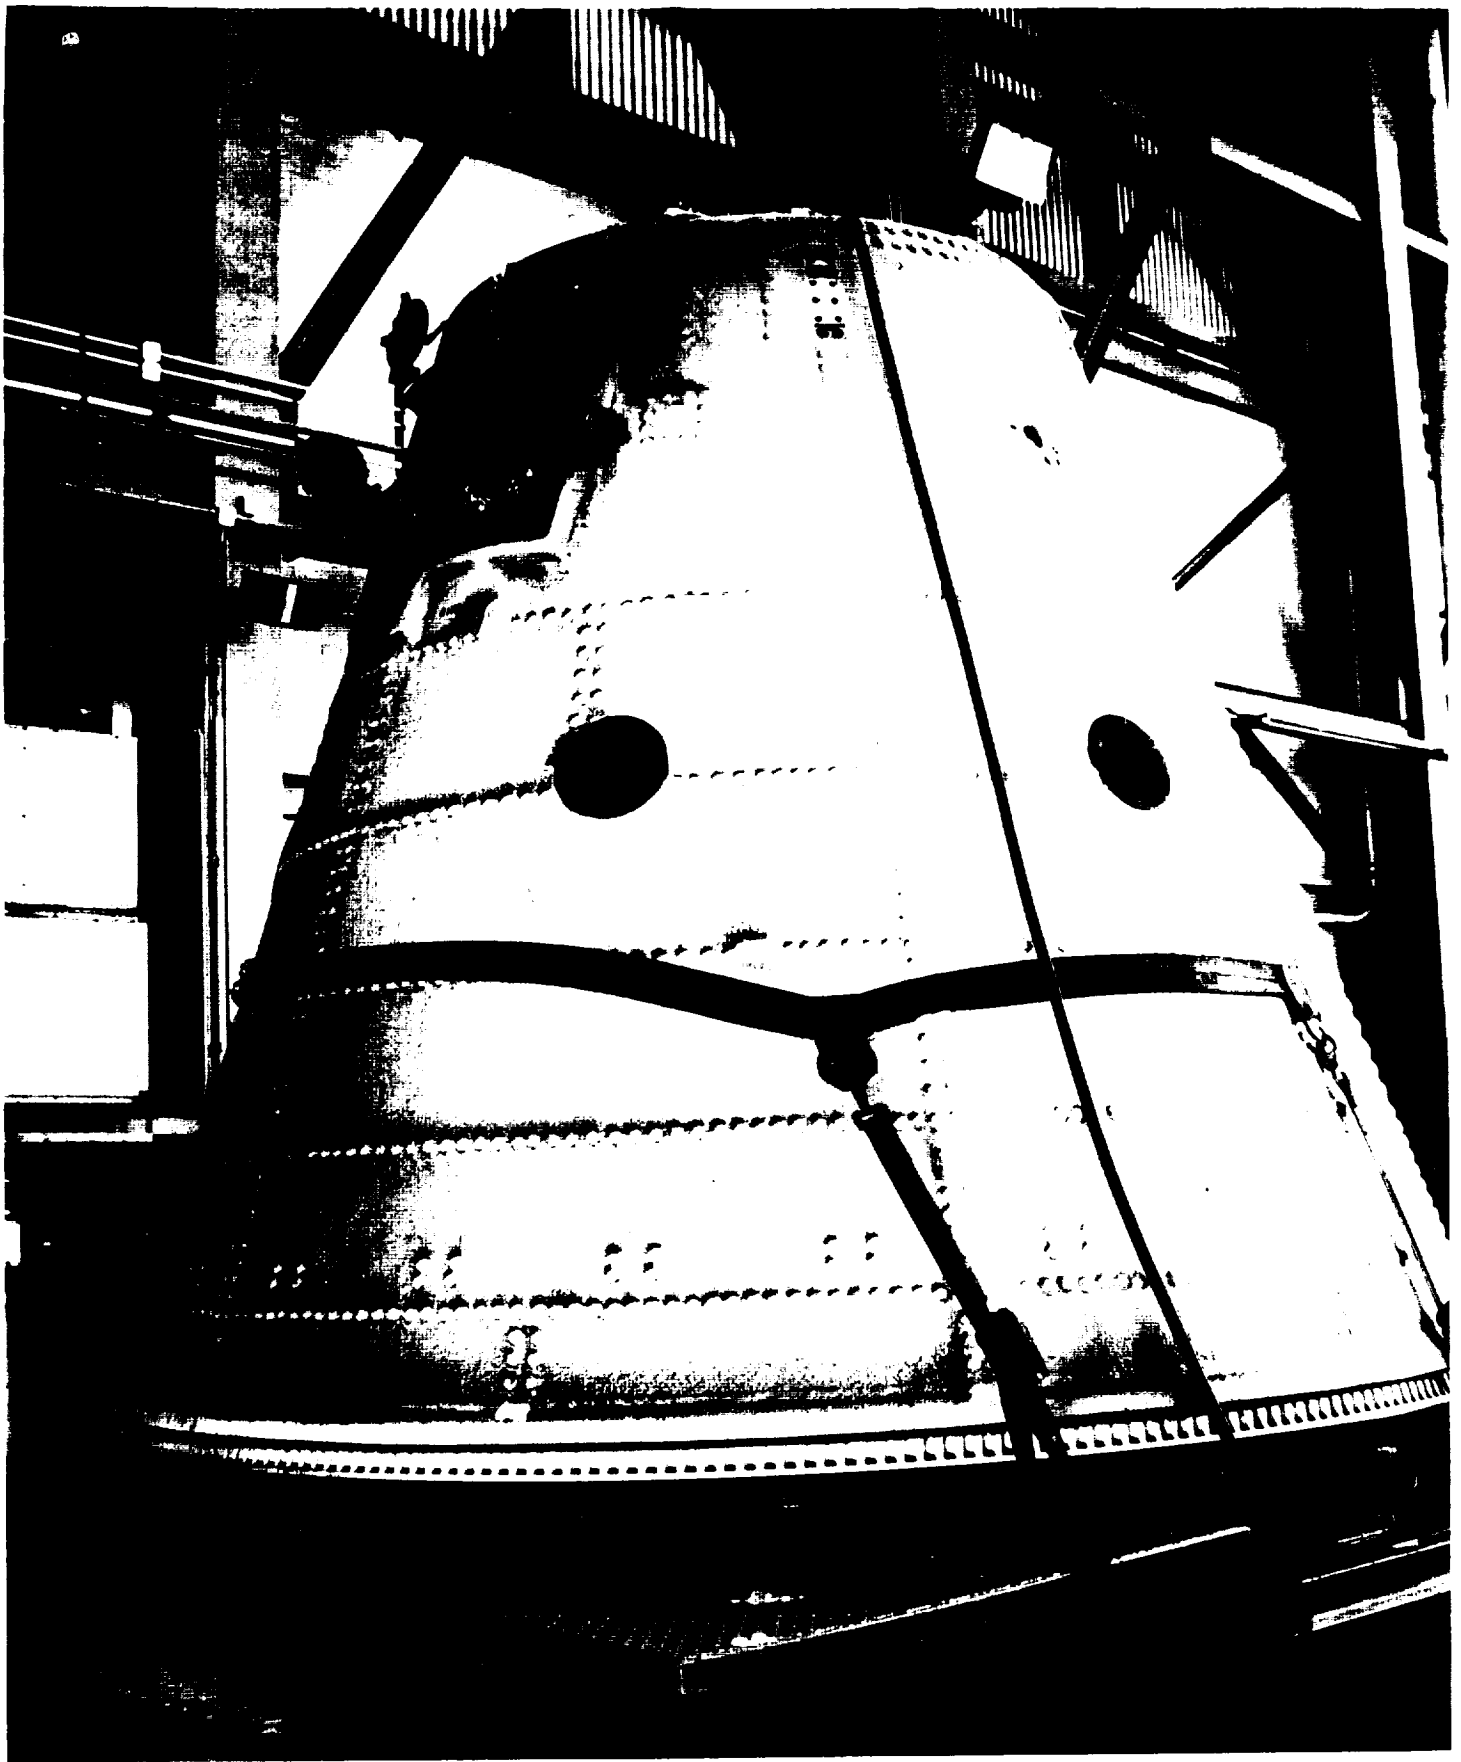
The LH frustum had a total of 21 MSA-2 debonds over fasteners. All BSM aero heatshield covers had locked in the fully opened position, though both left cover attach rings had been bent by parachute riser entanglement.
