BRUSH SEAL BRISTLE FLEXURE AND HARD-RUB CHARACTERISTICS

Robert C. Hendricks, Julie A. Carlile, and Anita D. Liang
National Aeronautics and Space Administration
Lewis Research Center
Cleveland, OH 44135

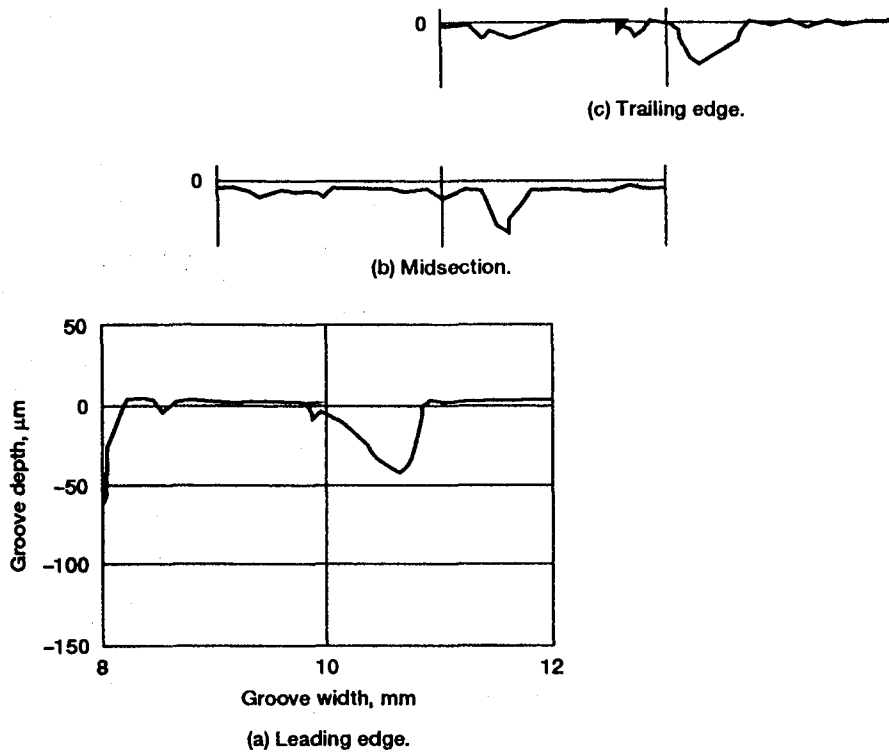
The first profile, labeled "leading edge," was taken within 0.10 mm (0.004 in.) of the leading edge and shows a broad damage region with deep grooving for test 2 (fig. 8(a)) and test 3 (fig. 9(a)) but a minor amount of material damage for test 1 (fig. 7(a)). The material buildup adjacent to the groove of test 3 probably occurred during rotor-fence rub. The second profile, labeled "mid section," was taken midway between the tooth leading and trailing edges. The damage of test 2 (fig. 8(b)) and test 3 (fig. 9(b)) was severe, and a twofold cut has developed in the rotor during test 2. Again moderate damaged was noted for test 1 (fig. 7(b)). The third profile, labeled "trailing edge," was taken within 5 percent of the trailing edge. The grooving seen in the midsection profile carried through with perhaps some sharpness of the features near the trailing edge (figs. 7(c), 8(c), and 9(c) for tests 1, 2, and 3, respectively).

Figure 7.—Profilometer traces for 40-tooth rotor (test 1).

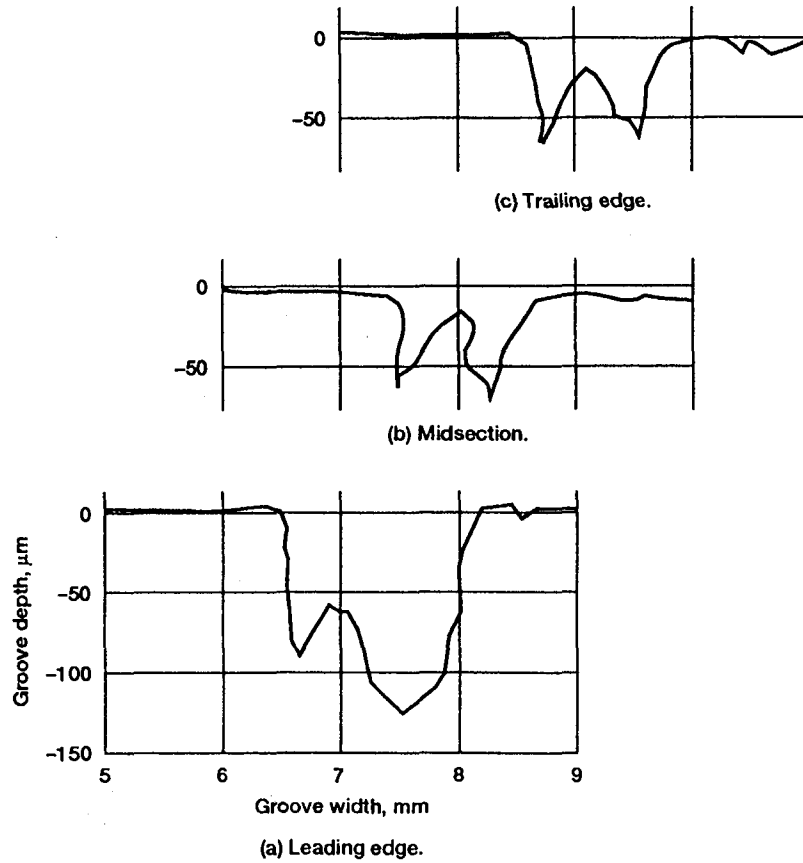
Figure 8.—Profilometer traces for 40-tooth rotor (test 2).

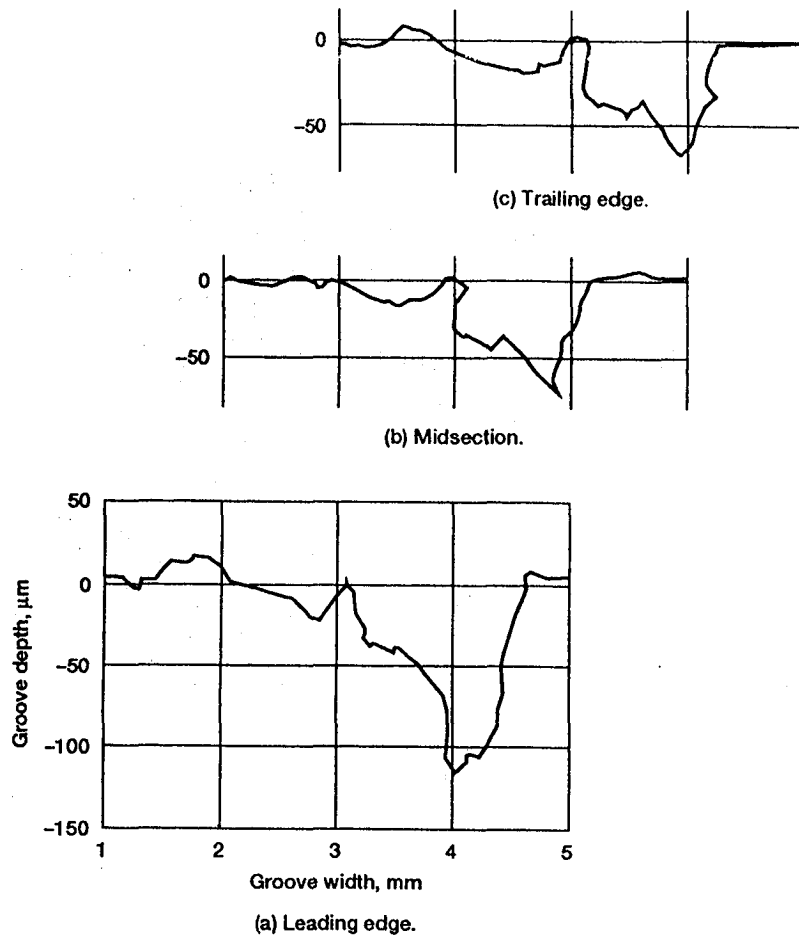
Figure 9.—Profilometer traces for 40-tooth rotor (test 3).

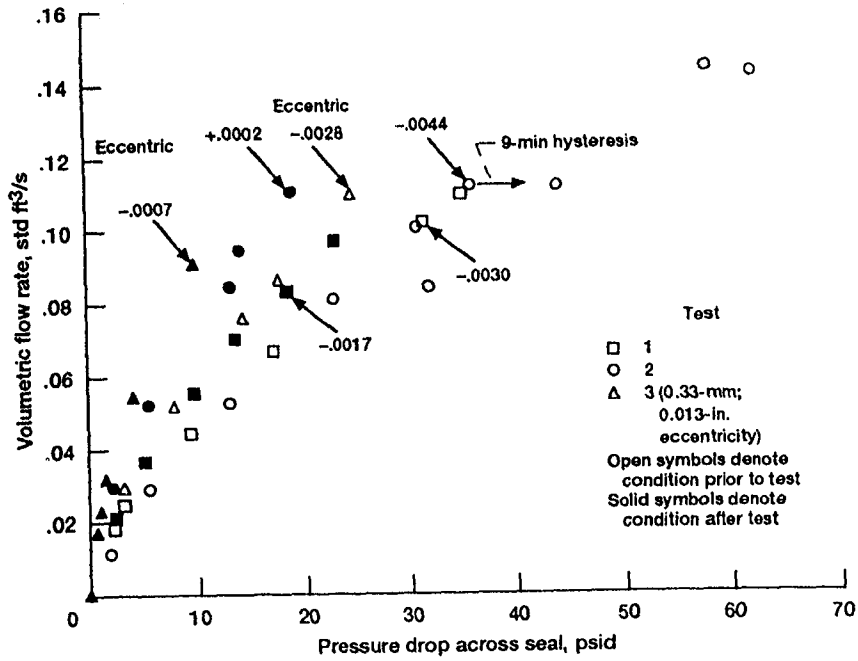
Leakage is characterized in figure 21 in terms of volumetric flow rate as a function of pressure drop across the brush seal before and after each of the three tests. Both pretest and post-test results are provided in the same figure. Because this brush seal was damaged (see APPARATUS section), absolute leakage measurements would require weighing, but the relative leakage should be accurate. The interference fits for the brush seal leakage data for pretests 1 and 2 were nearly the same, resulting in corresponding leakages. While taking data it was found that the brush would stiffen and the pressure drops would increase. Data points illustrating hysteresis (typical in brush seals) are shown. After correcting the post-test 2 data for clearance, these test results agreed with those of post-test 1.

For test 3 the repositioning of the stator and the differential spindle loading introduced an unaccountable bias that was difficult to estimate in correlating the leakage results. From the data of reference 19 a relation was found for the change in pressure as a function of eccentricity at a fixed volumetric flow rate. Using this relation and corrections for clearance and assuming a pretest static eccentricity of 0.15 mm (0.006 in.) and a post-test static eccentricity of 0.25 mm (0.010 in.) show that the results of test 3 were overcorrected by 20 percent with respect to the results of tests 1 and 2. Future testing requires instrumentation to overcome these positioning errors. Nevertheless, these leakage data indicate that under conditions of severe brush and rotor wear the brush seal leakage increased 30 percent. And, although brush seal performance degraded, the brush seal did not fail.

Figure 21.—Pre- and posttest leakage results for smooth rotor.
