NASA
Technical
Paper
3413

Results of an Electrical Power System Fault Study (CDDF Final Report No. N06)

N.R. Dugal-Whitehead
and Y.B. Johnson

N.R. Dugal-Whitehead and Y.B. Johnson
*George C. Marshall Space Flight Center
Marshall Space Flight Center, Alabama*

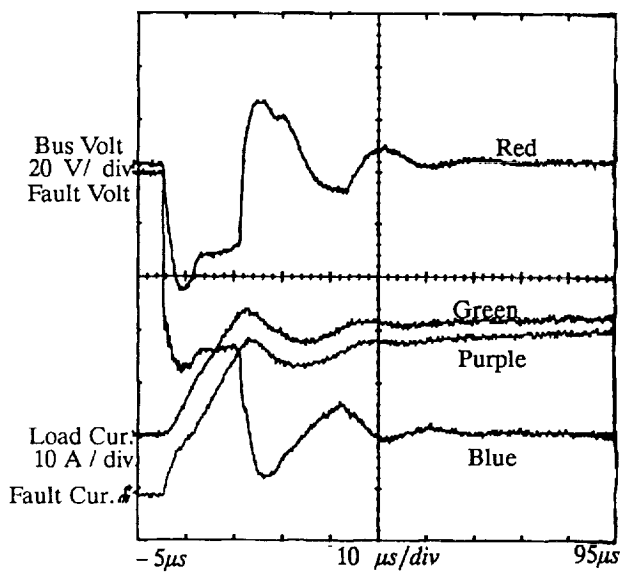
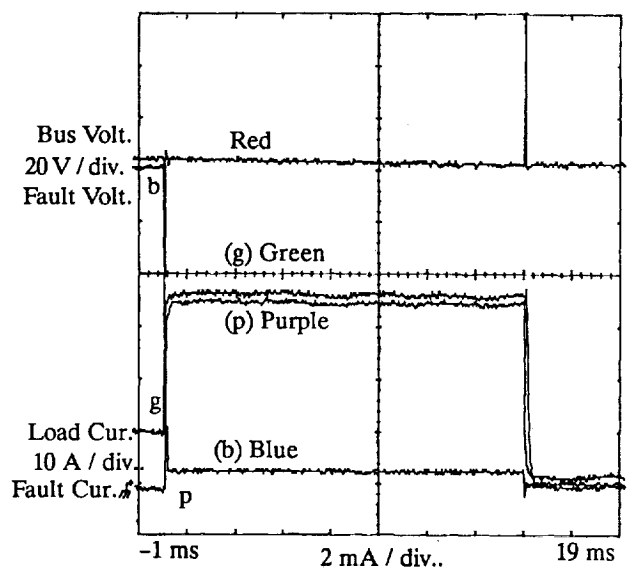
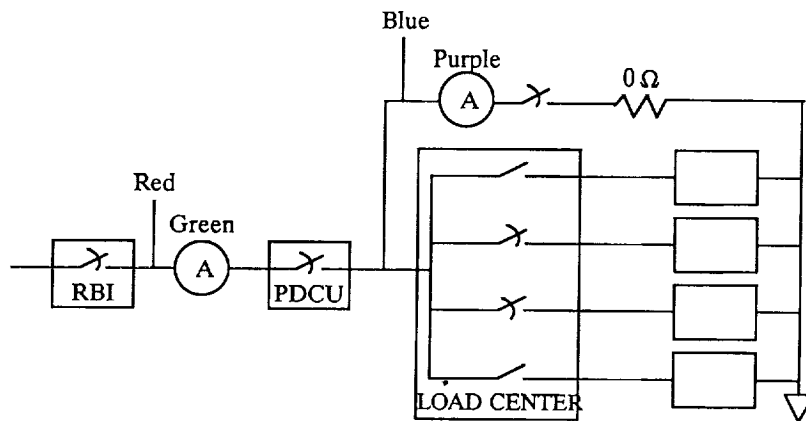
Figure 9. 3 kW RPC direct short to ground.

To see how the system would react, a direct short to ground was placed below the shorted 1 kW switch. When the fault was placed below the 1 kW RPC, the 3 kW PDCU switch was placed into current limit and the PDCU tripped. The diagnosis was the same as for the direct short to ground in the release of software this was tested with.

(A) Initial transient.

(B) Direct short to ground trip.

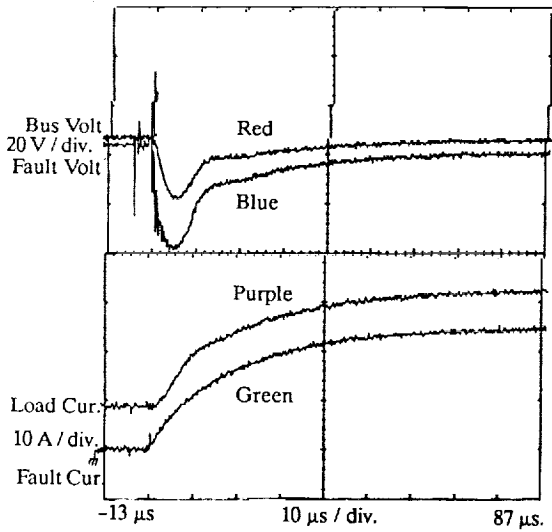
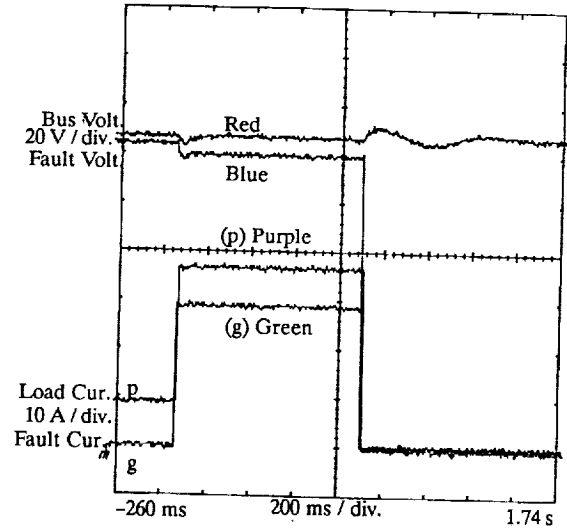
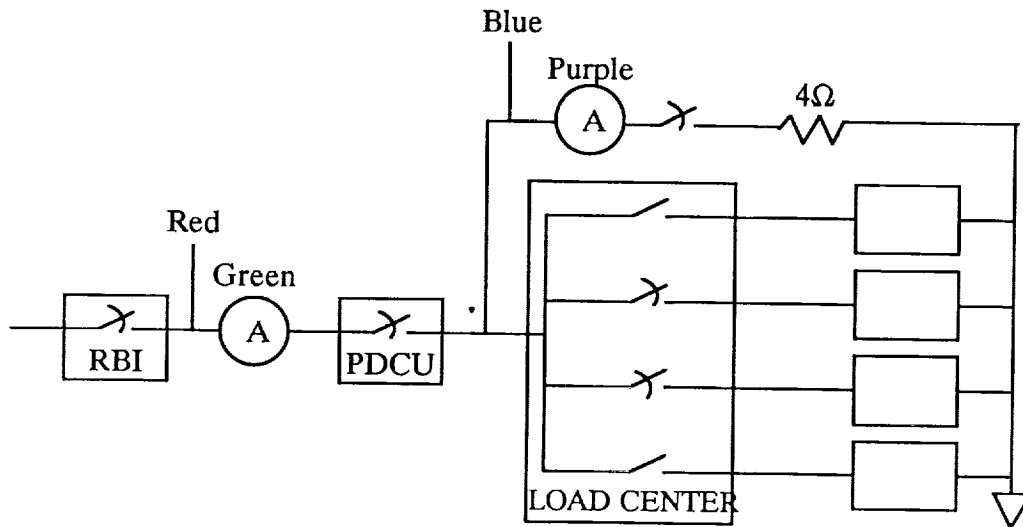
Figure 10. 3 kW RPC 4 ohm short to ground.

(1) Power Distribution Control Unit. When the PDCU's were tested for the I^2t function of the RPC, they were tested using a 4 ohm short to ground and under various loading conditions. These load conditions included 10 A of load on the PDCU (fig. 10), the lightest load the load center could provide on the PDCU, and no load below the PDCU switch from the load center. The tests were run in manual or maintenance mode, then while the system was in autonomous mode. When in autonomous mode, the load on the load center depends on what part of the schedule is being run and which load center the PDCU switch is controlling.

The fault resistance to be used in forming the I^2t faults below the PDCU's was to be 4 ohms. The actual value of the 4 ohm resistor turned out to be about 4.14 ohms. The 4 ohm resistor was just on the edge of triggering the I^2t timer with a value of exactly 4 ohms. As a result of this slightly too high resistance value, two things happened. First, if none of the loads are on in the load center, the switch

(A) Initial transient.

(B) 4 ohm short to ground trip.

does not trip and the system does not shed (turn off switches which are pulling too much power) a switch at the PDCU level. This is a problem since the system will allow a fault of this type to remain on the switch forever or until some load is turned on below it to reach the I^2t trigger point. The other thing which came out of applying this fault shows up in autonomous mode. With a schedule running in autonomous mode, when the 4.14 ohm fault is placed in the system the switch trips, in what is called in the software an "over current" trip, and all the switches below the PDCU switch are tripped on "under voltage." The first thing the software does is turn off all the switches which tripped, then it goes in and turns on the PDCU switch to see if it trips again. Because the switch is now unloaded, it does not trip again. The software then comes back with the following diagnosis:

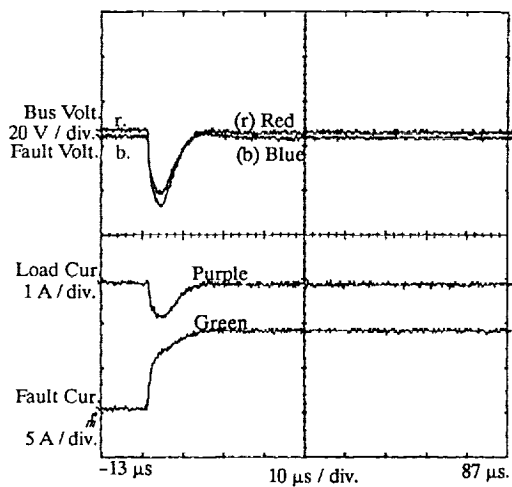
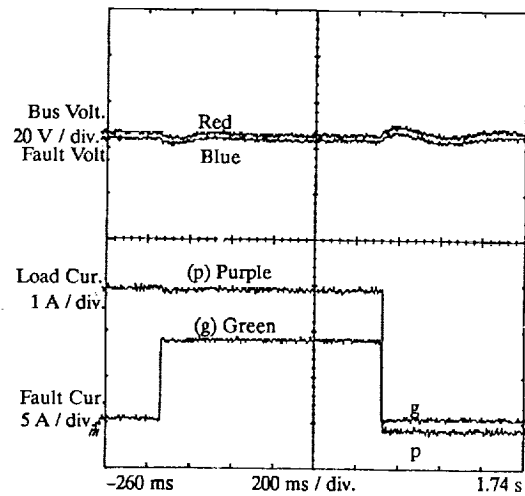
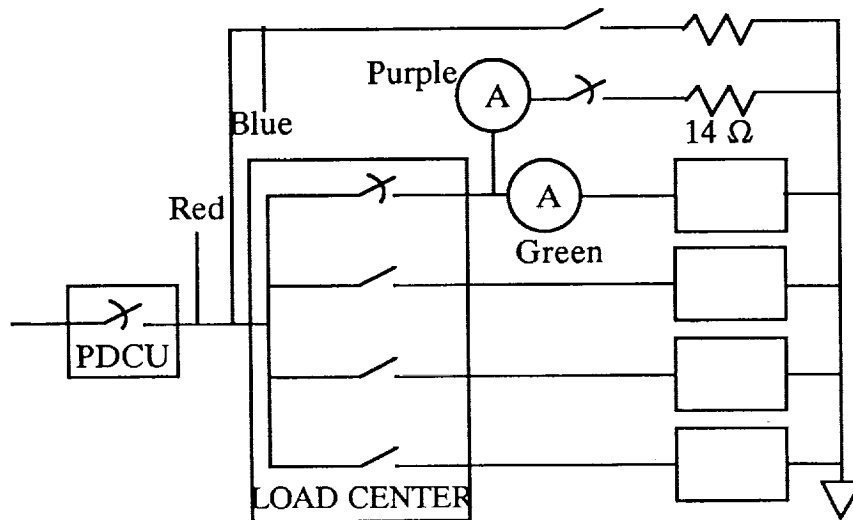
Figure 11. 1 kW RPC 14 ohm short to ground.

(2) Load Center. The I²t fault which was put into the 1 kW RPC's in the load centers was approximately 14 ohms (fig. 11). This fault, unlike the one injected on the PDCU's, always tripped the load center RPC's on "over current." The main thing which was learned from applying these faults was that there is a race between the hardware and software as to which catches these faults.

(A) Initial transient.

(B) 14 ohm short to ground trip.

The 386 machines monitor the status of the RPC's in the load center fast enough that the slow I^2t fault applied would sometimes be caught by the LLP before the I^2t timer would time out. The old LLP's were so slow that it was assumed that the RPC would always trip first. These races were a result of not taking into account the extra speed of the new LLP's or failing to rewrite this portion of the code when the change was made.
