Debris/Ice/TPS Assessment and Integrated Photographic Analysis for Shuttle Mission STS-57

July 1993

Gregory N. Katnik
NASA/Kennedy Space Center

DEBRIS/ICE/TPS ASSESSMENT
AND
PHOTOGRAPHIC ANALYSIS
OF
SHUTTLE MISSION STS-57

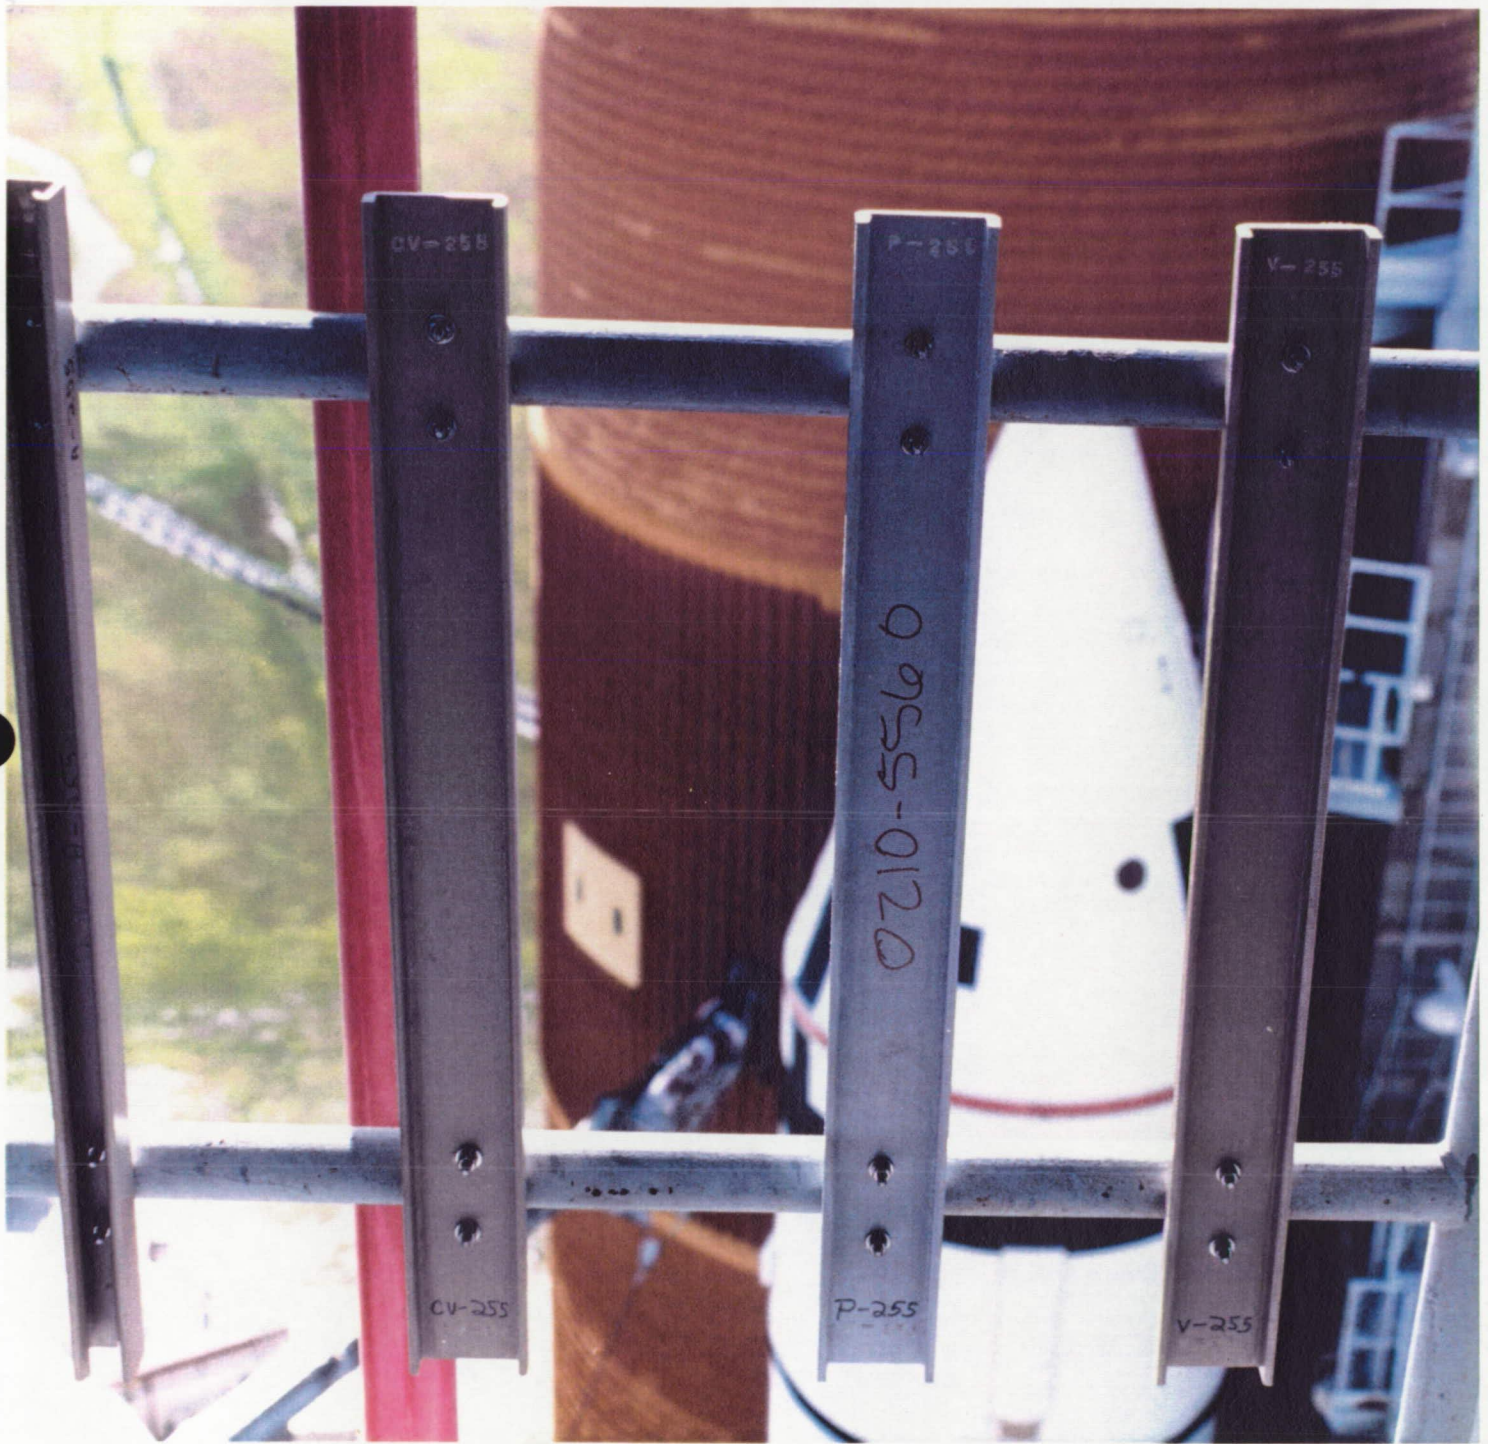
Four each composite material samples were U-bolted to the hand rails on four levels of the FSS east side

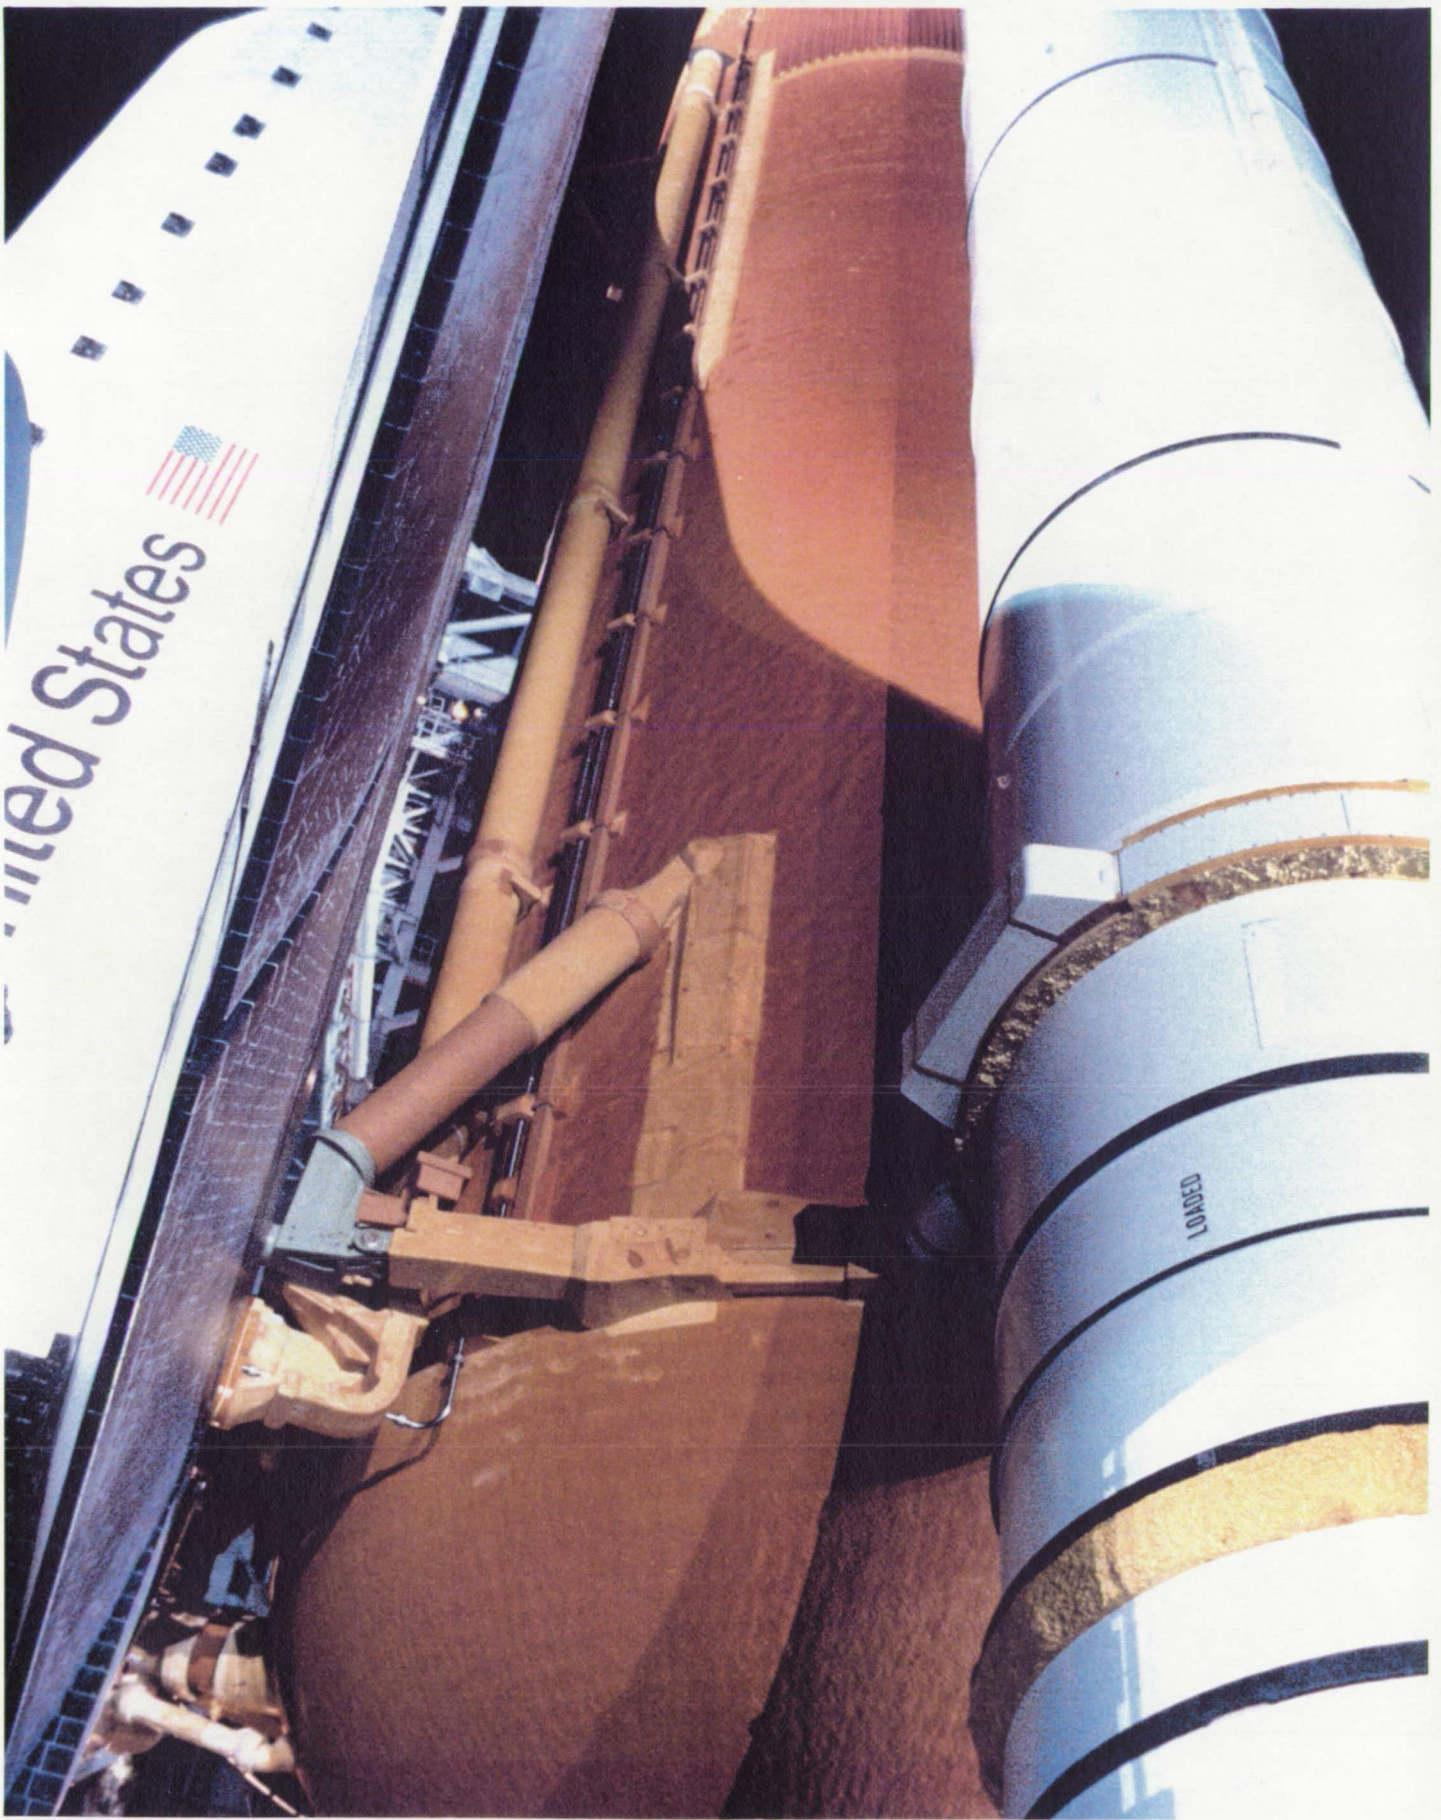
Condensate, but no ice or frost, was present on the LH2 tank acreege. There were no acreege TPS anomalies.

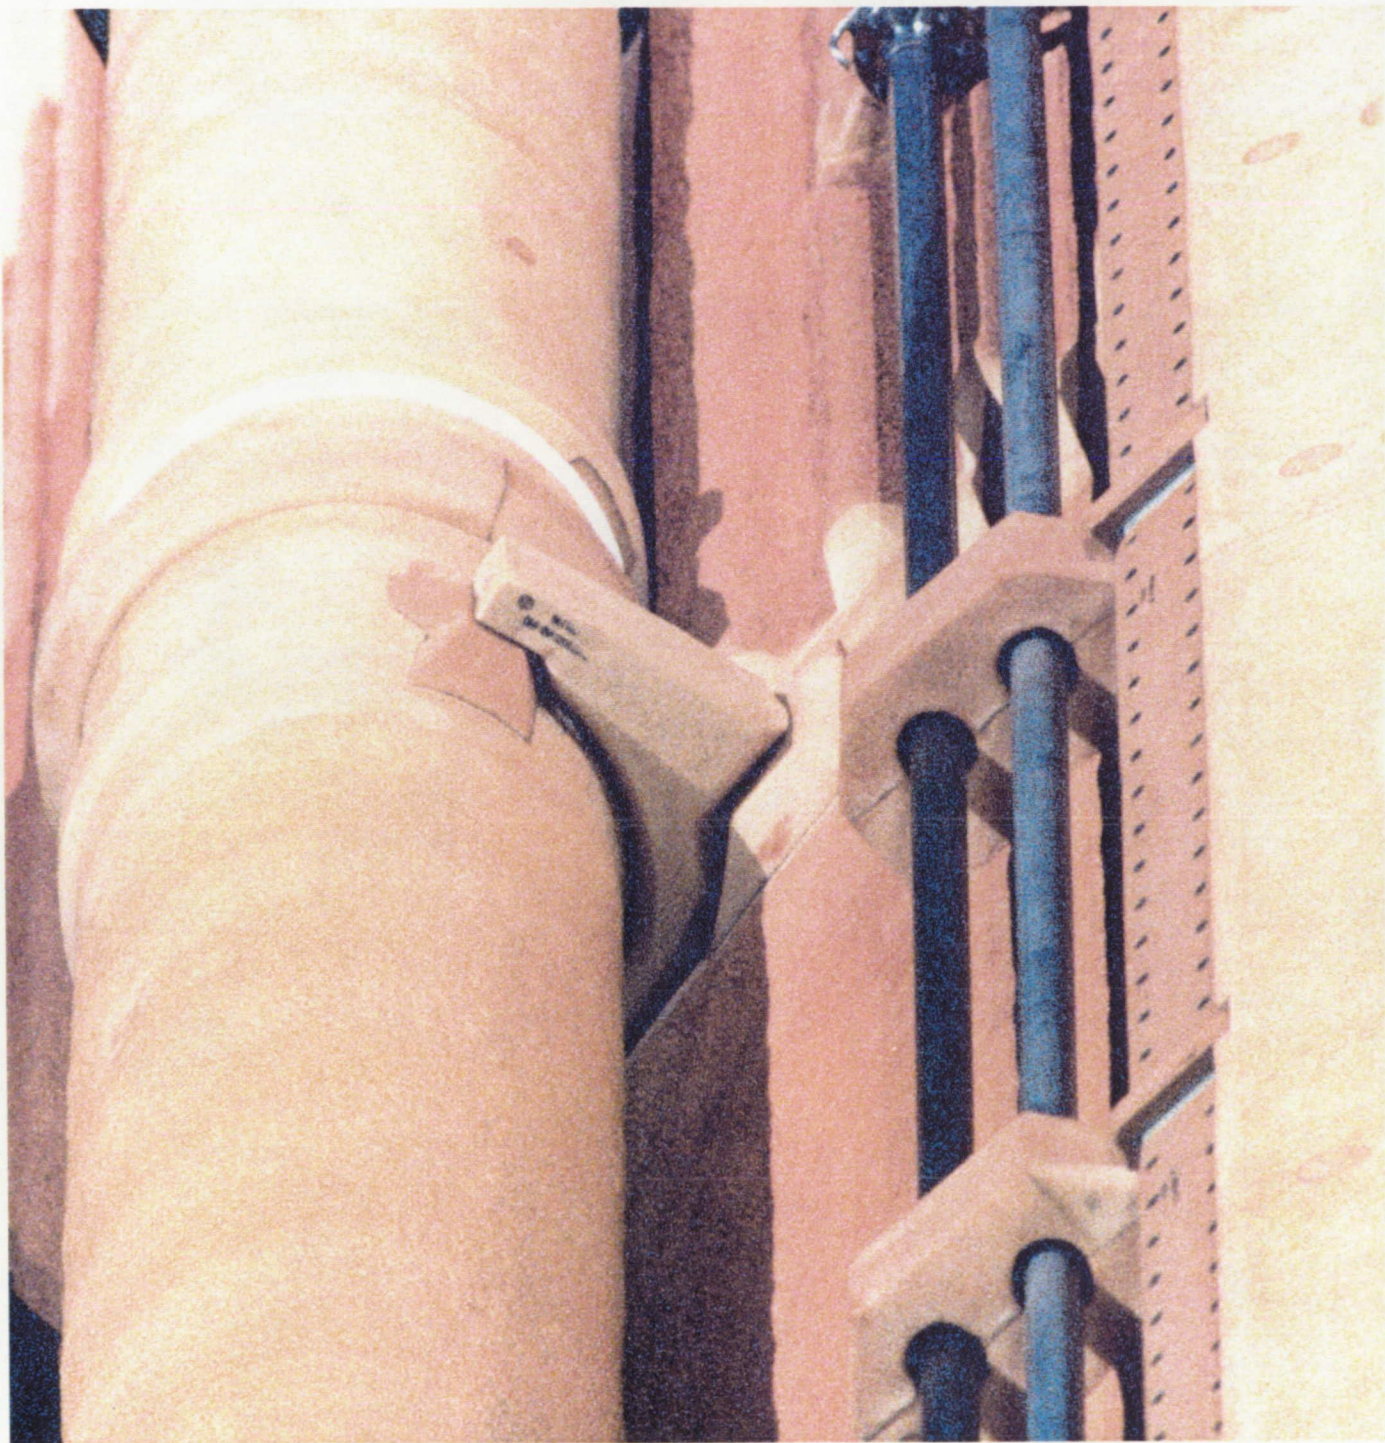
Ice/frost accumulations in the L02 feedline bellows
and support brackets was typical

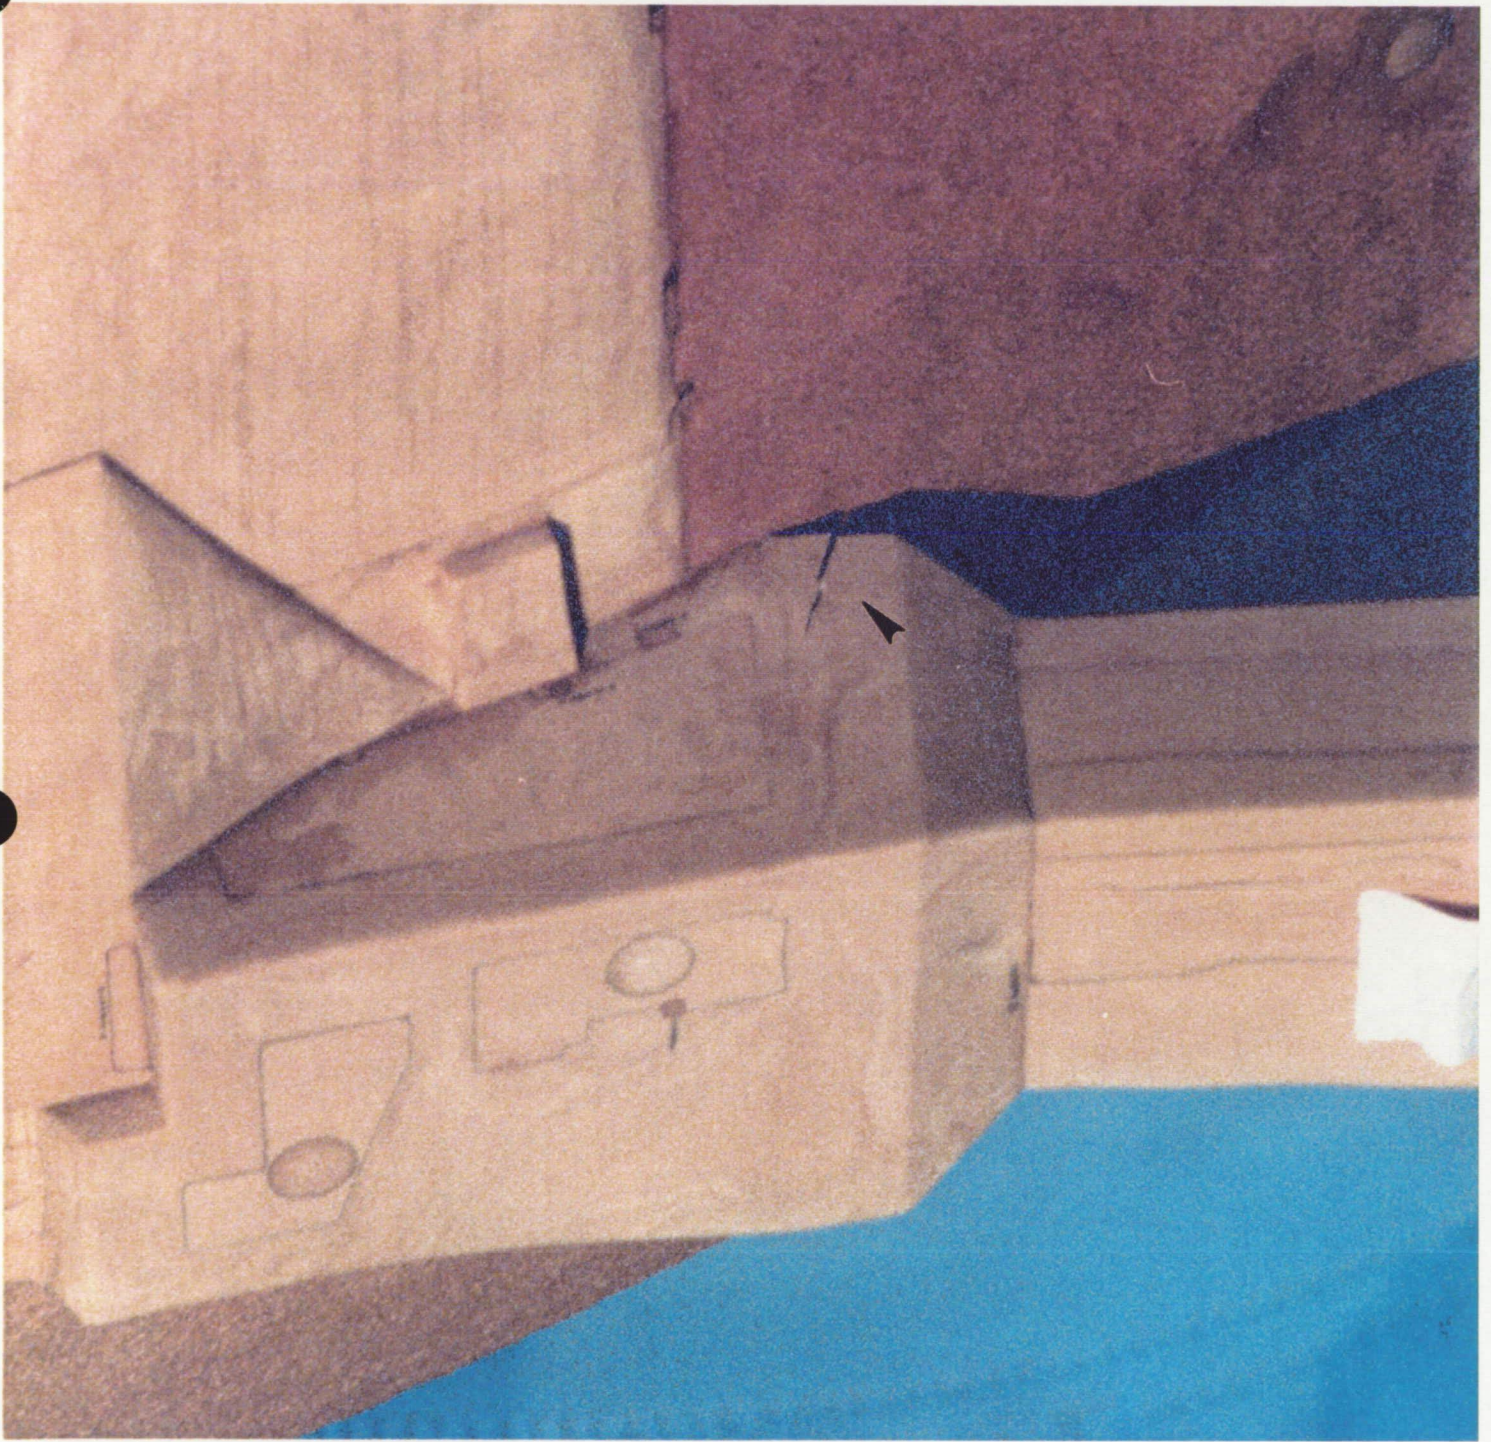
Anomaly 001 documented a 6-8 inch long by 3/8-inch wide crack in the -Y vertical strut cable tray forward surface near the longeron closeout interface. The crack exhibited no offset and was not filled with ice or frost.

An 8-inch long by 3/8-inch wide crack occurred in the -Y vertical strut cable tray forward surface TPS near the longeron closeout interface. The crack exhibited no offset and was not filled with ice or frost. The presence of the crack was acceptable for flight per the NSTS-08303 criteria.

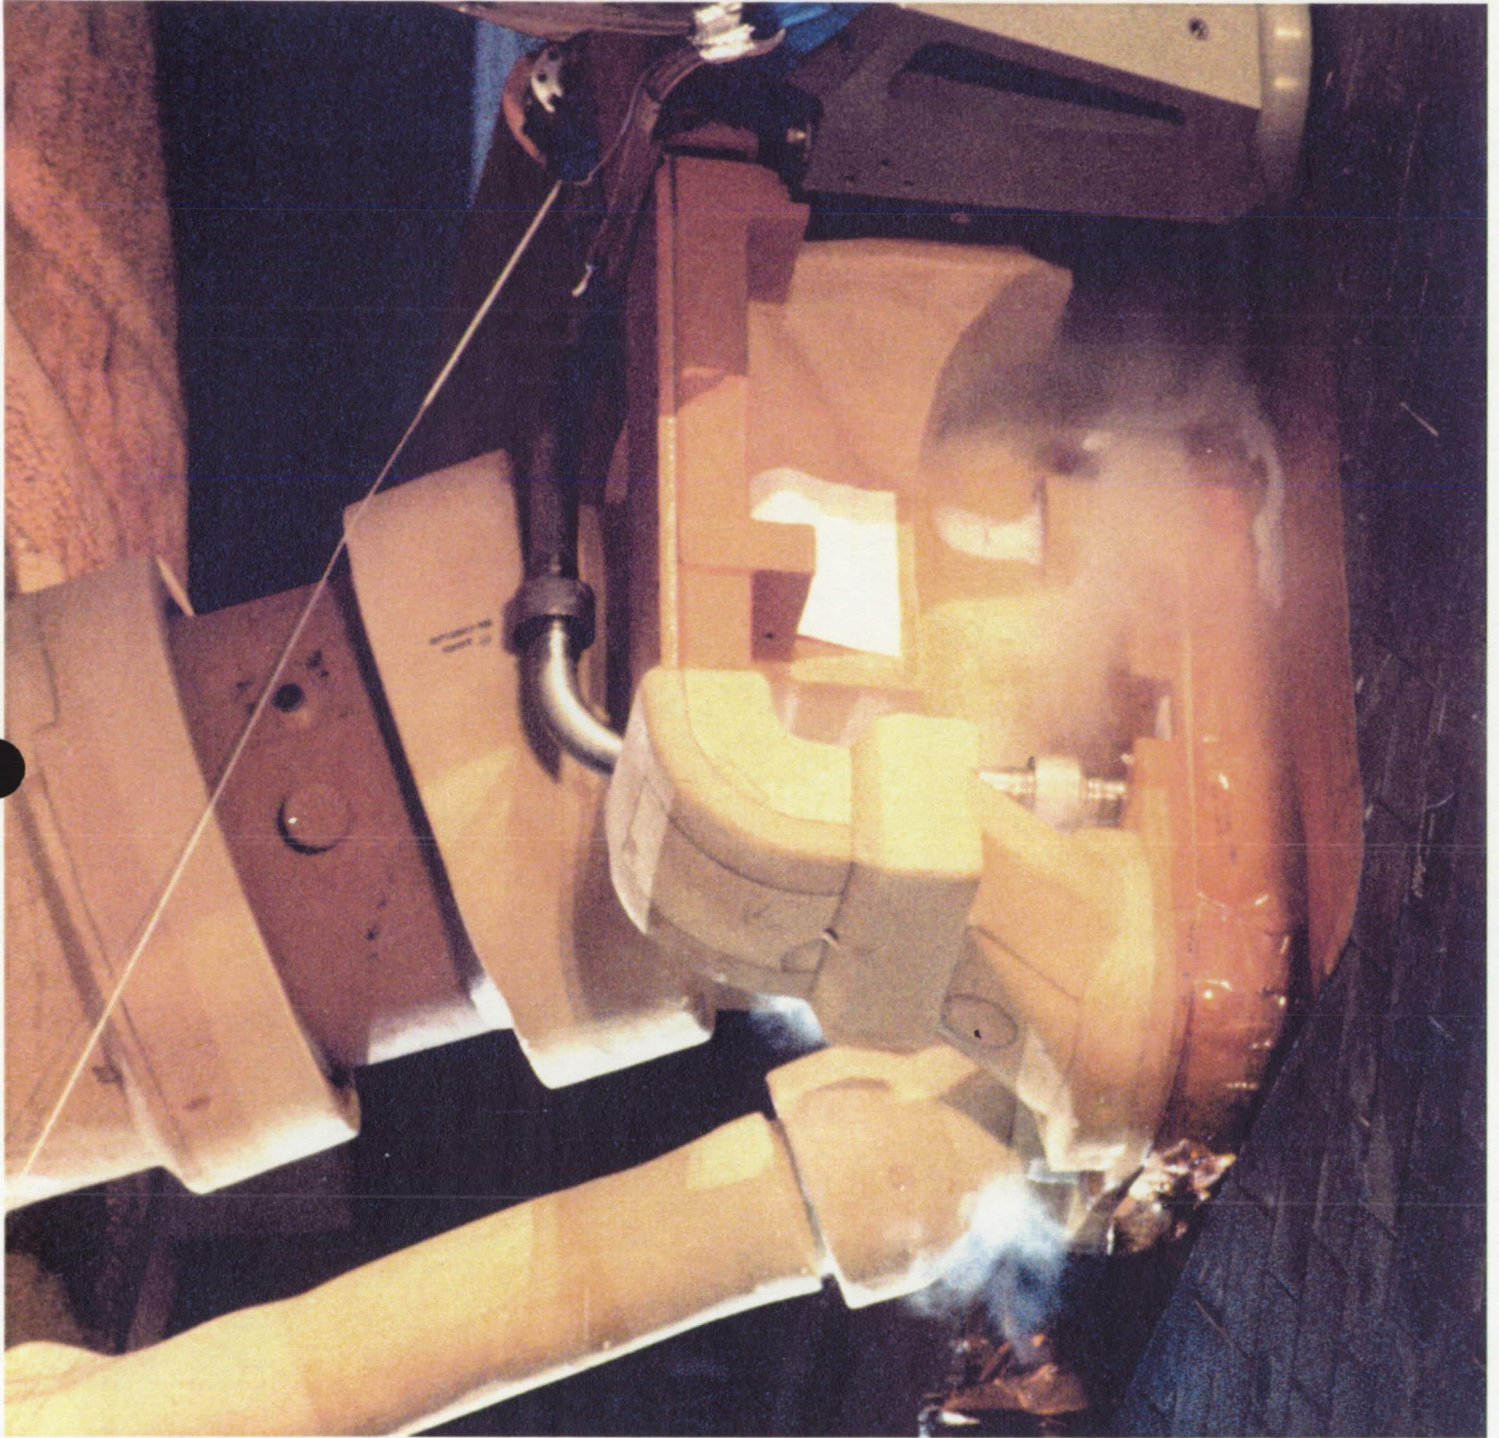
Less than usual amounts of ice/frost had formed on the ET/ORB LH2 umbilical. No cryogenic drips or unusual vapors appeared during tanking, stable replenish, and launch.

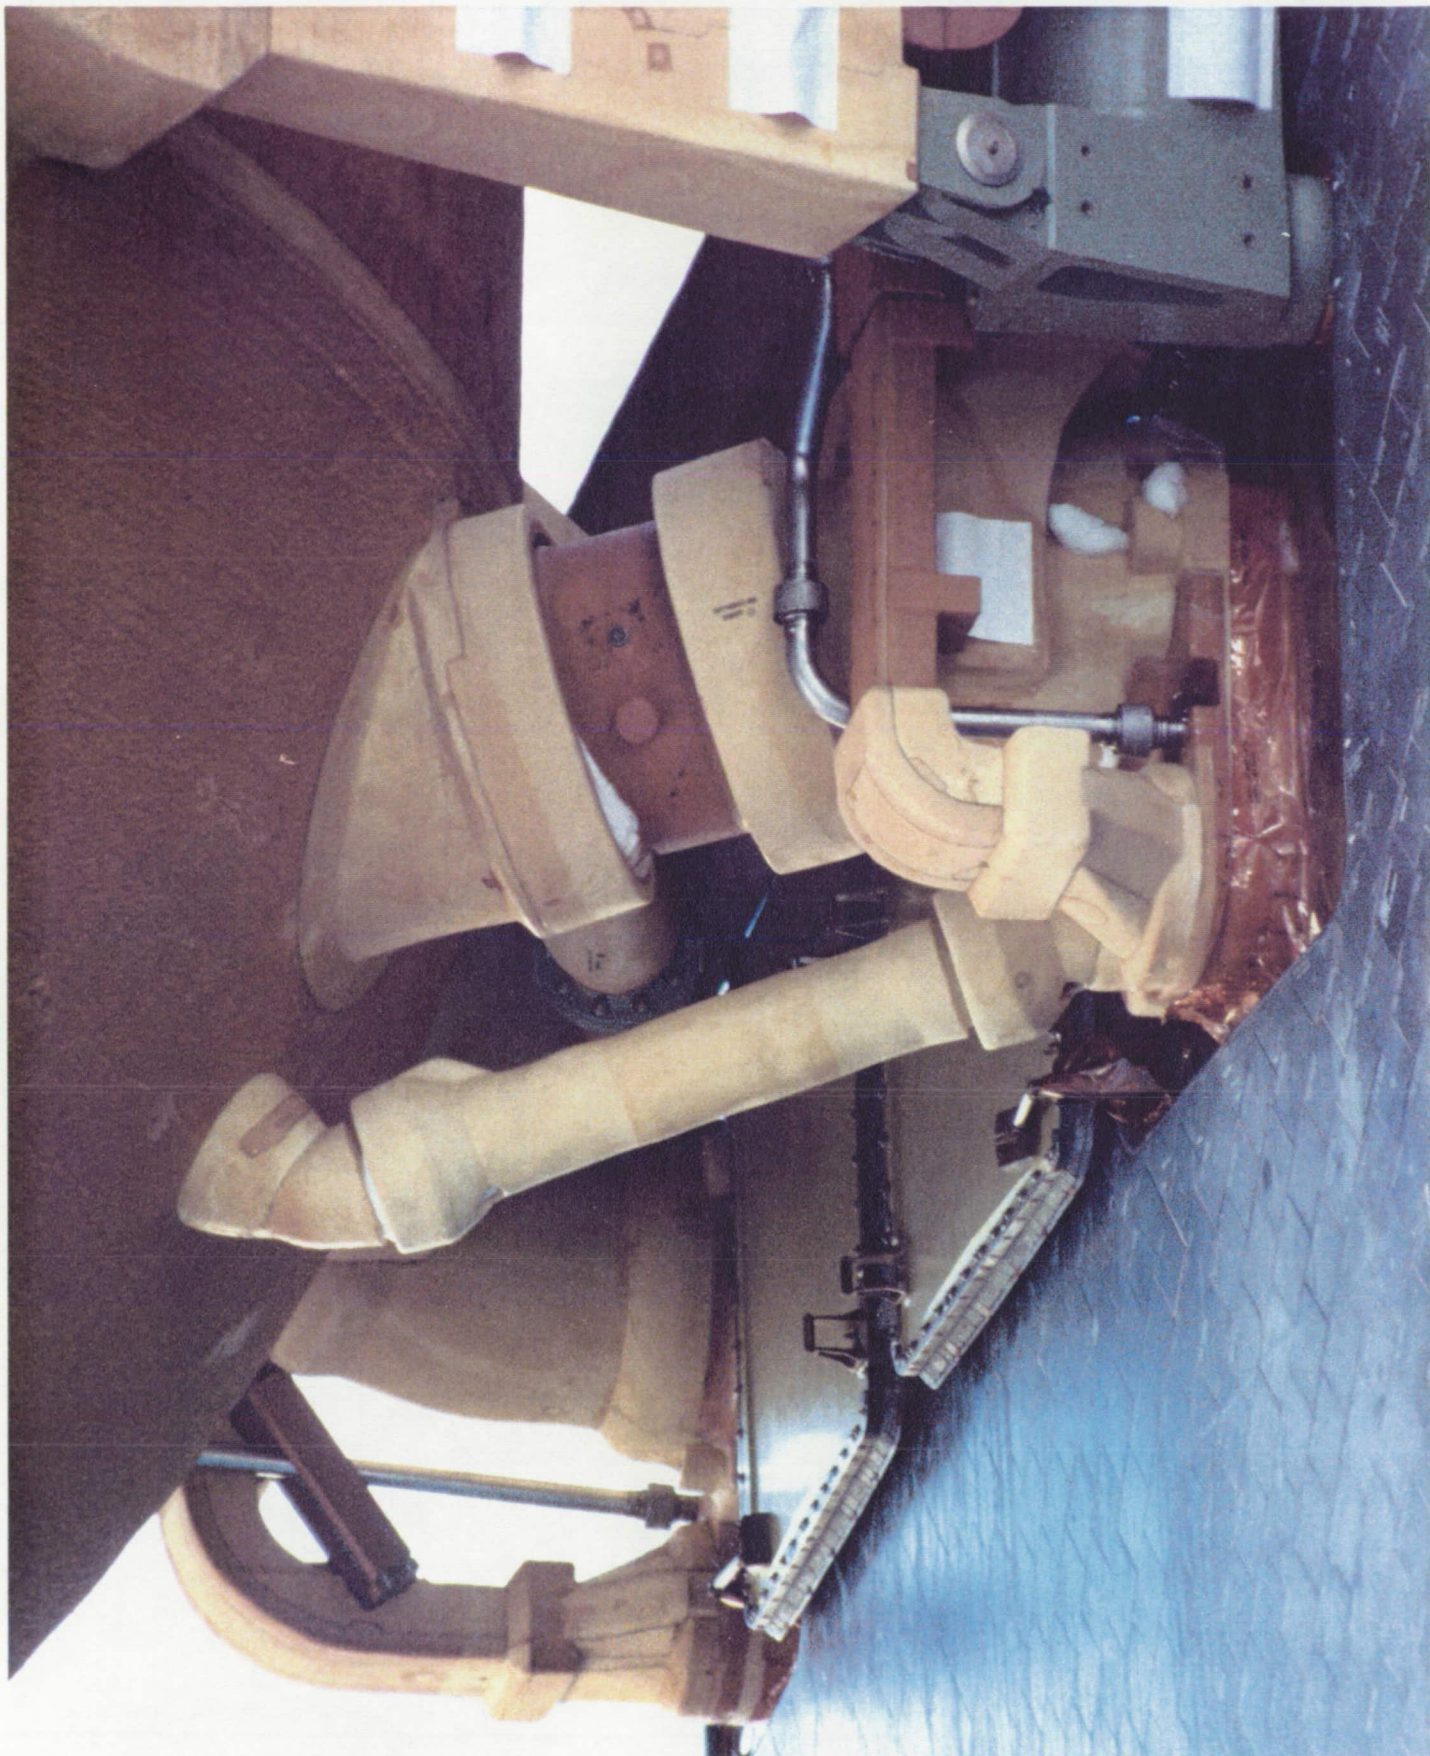
Post drain inspection revealed ice on the pyro canister purge vents, plate gap purge vents, LH2 recirculation line bellows, and LH2 feedline bellows - an expected condition. There were no TPS anomalies.

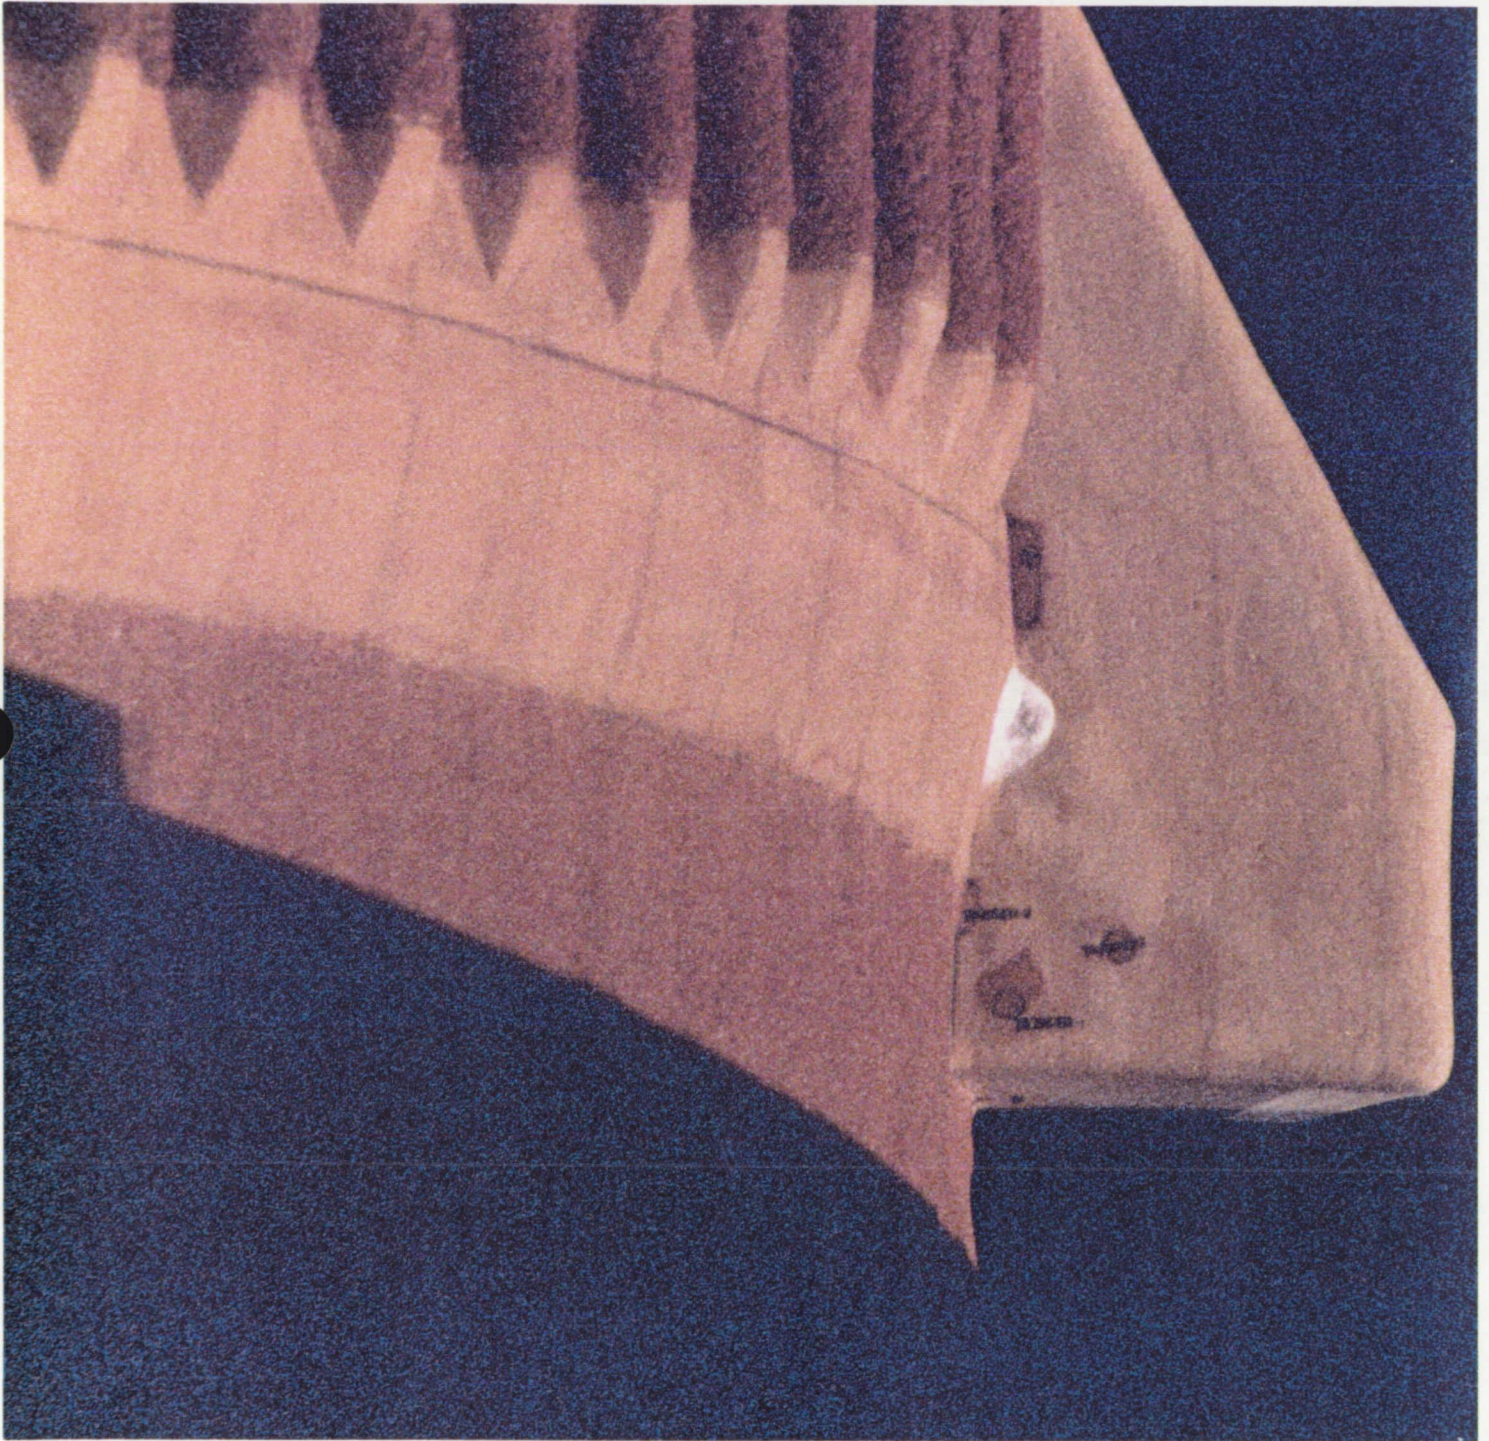
A 2-inch diameter ice/frost accumulation, which first appeared during drain, had formed on the -Y bipod spindle housing-to-ET interface bondline.

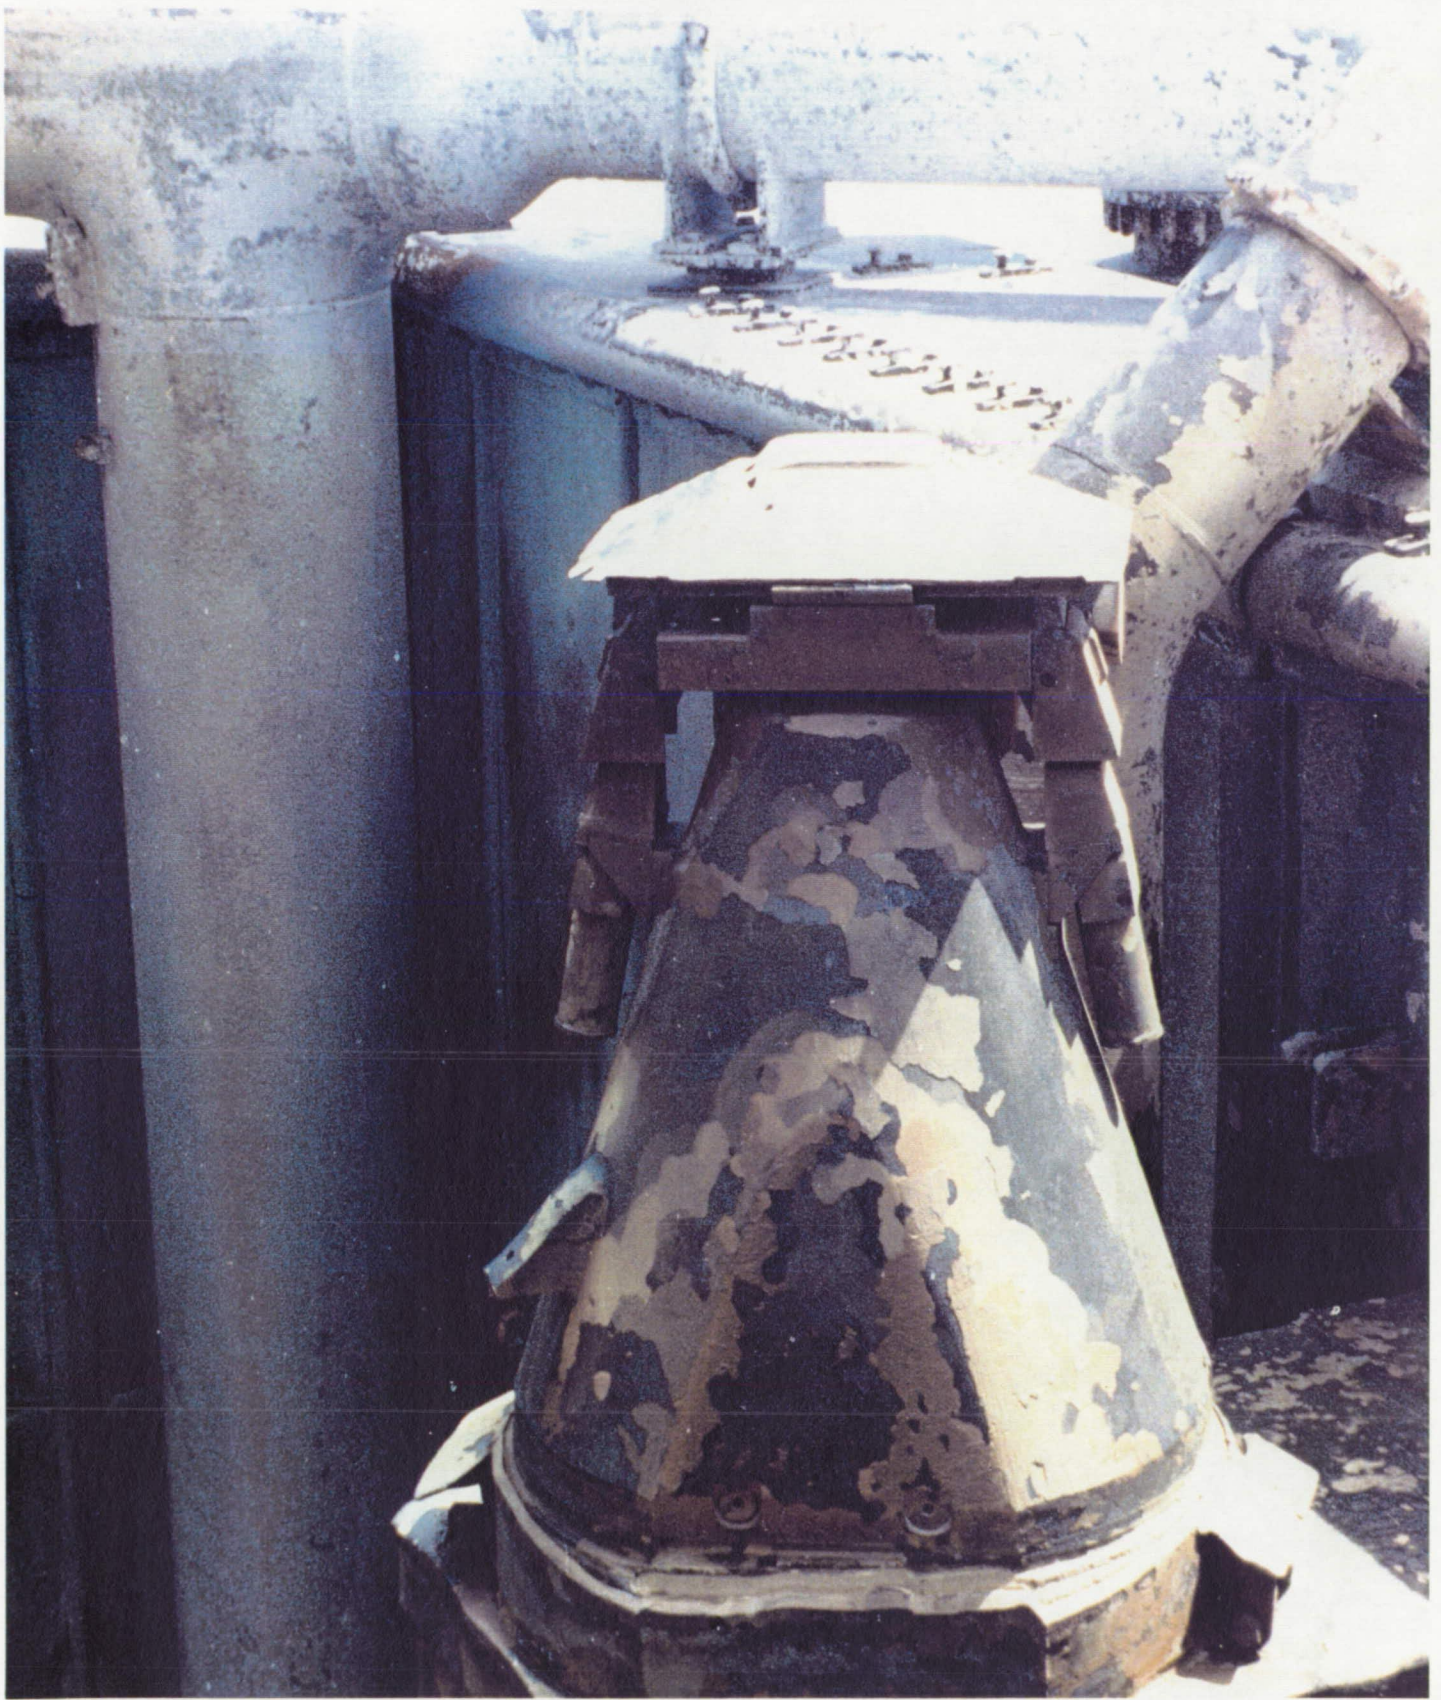
SRB plume erosion of the north HDP blast covers was typical with the exception of the HDP #4 cover, which had several burn-through holes.

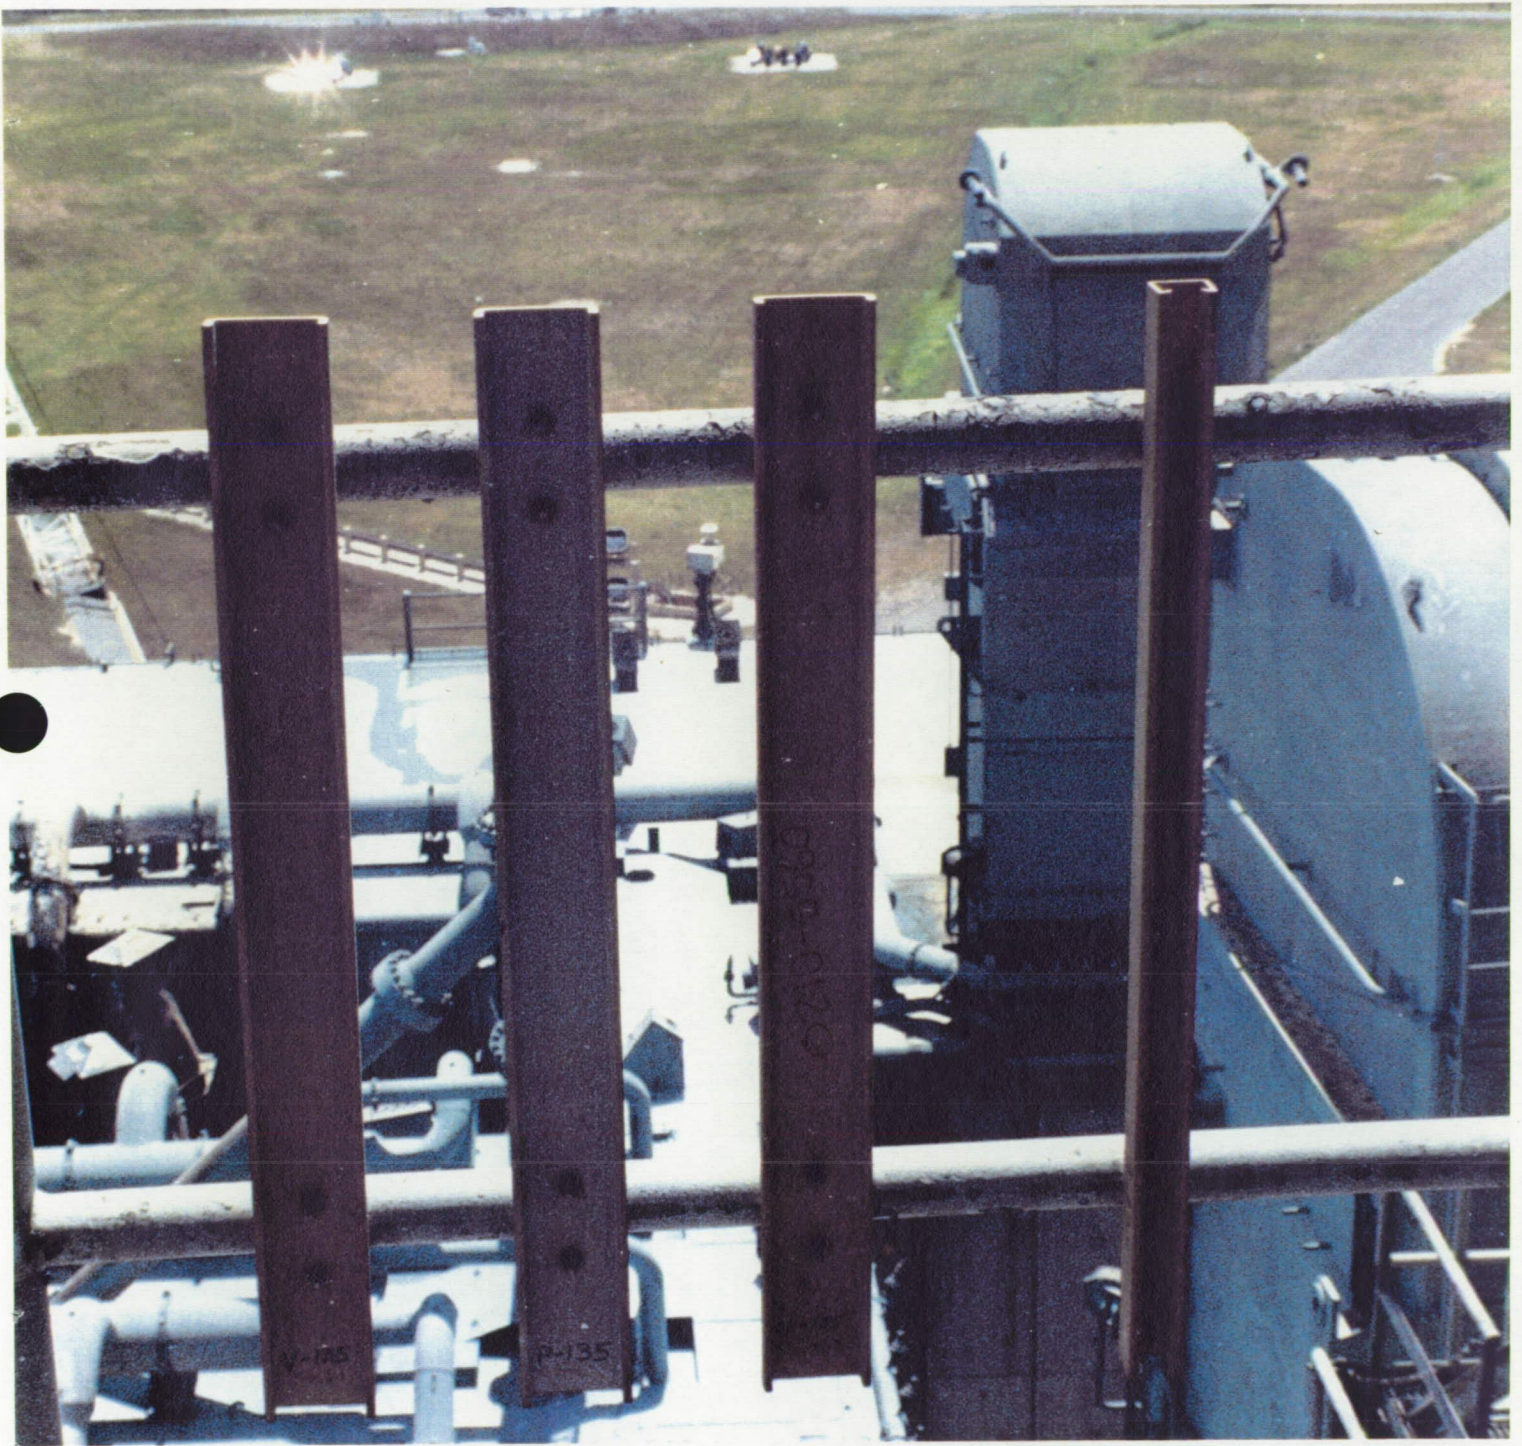
All composite material samples attached to the FSS east side handrails were intact and undamaged

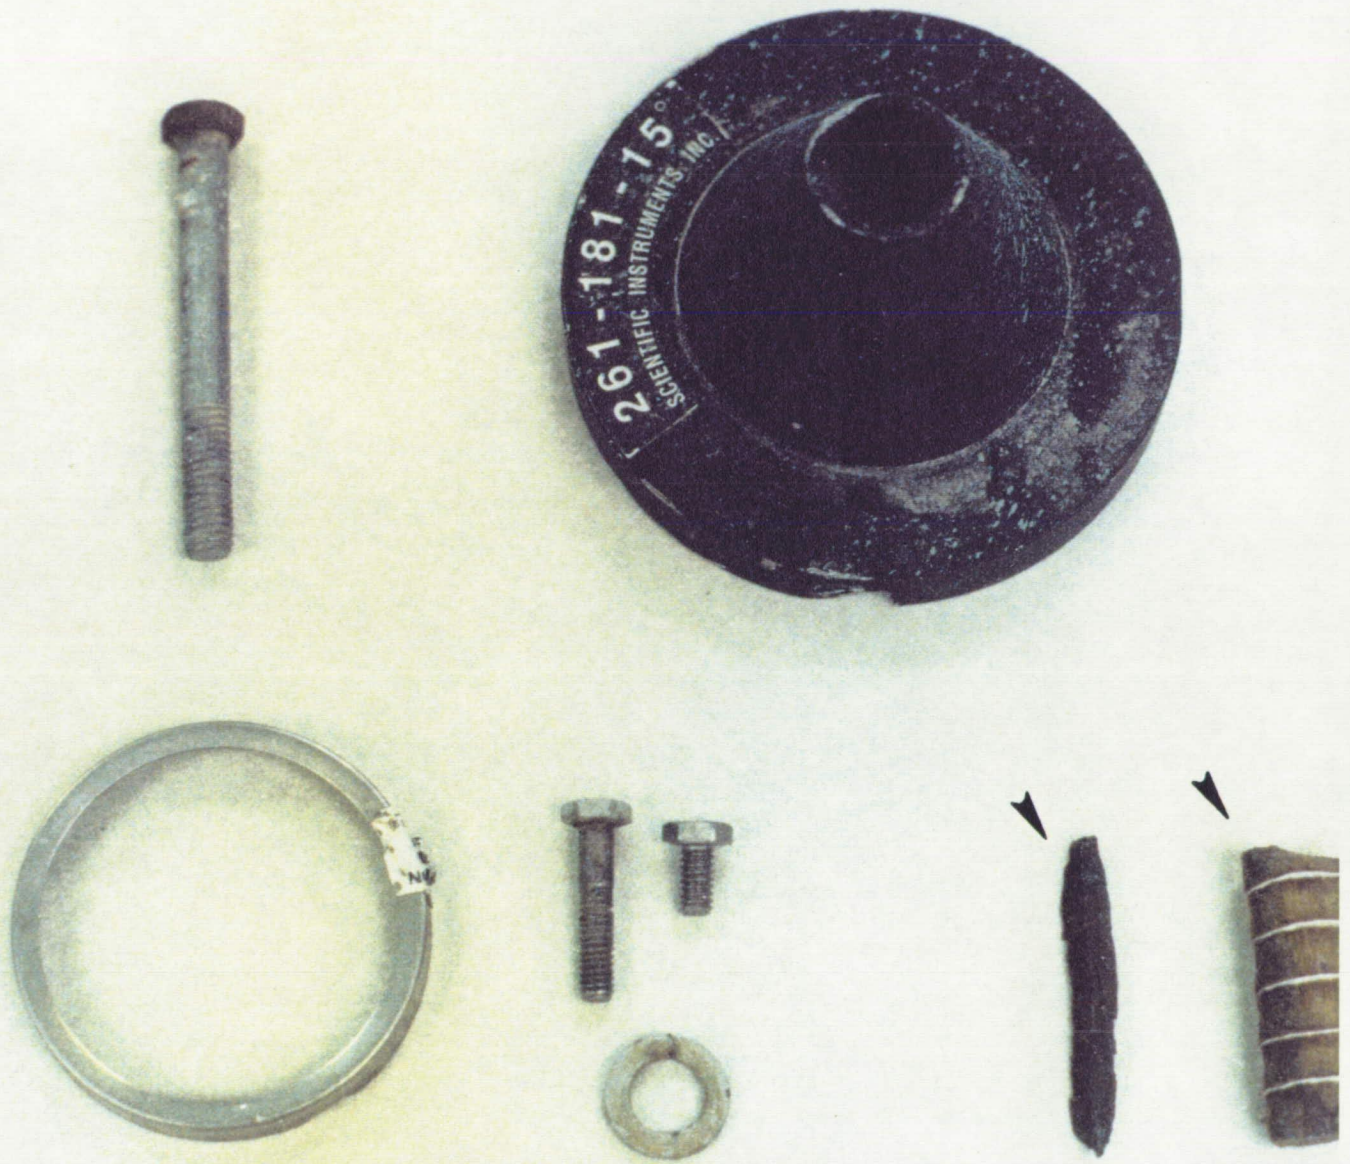
A frangible nut web, 2-1/4" by 5/16", was found on the stud in holddown post #2. A Q-felt plug from the Orbiter base heat shield was found on the southwest pad apron.
