Debris/Ice/TPS Assessment and Integrated Photographic Analysis for Shuttle Mission STS-57

July 1993

Gregory N. Katnik
NASA/Kennedy Space Center

DEBRIS/ICE/TPS ASSESSMENT
AND
PHOTOGRAPHIC ANALYSIS
OF
SHUTTLE MISSION STS-57

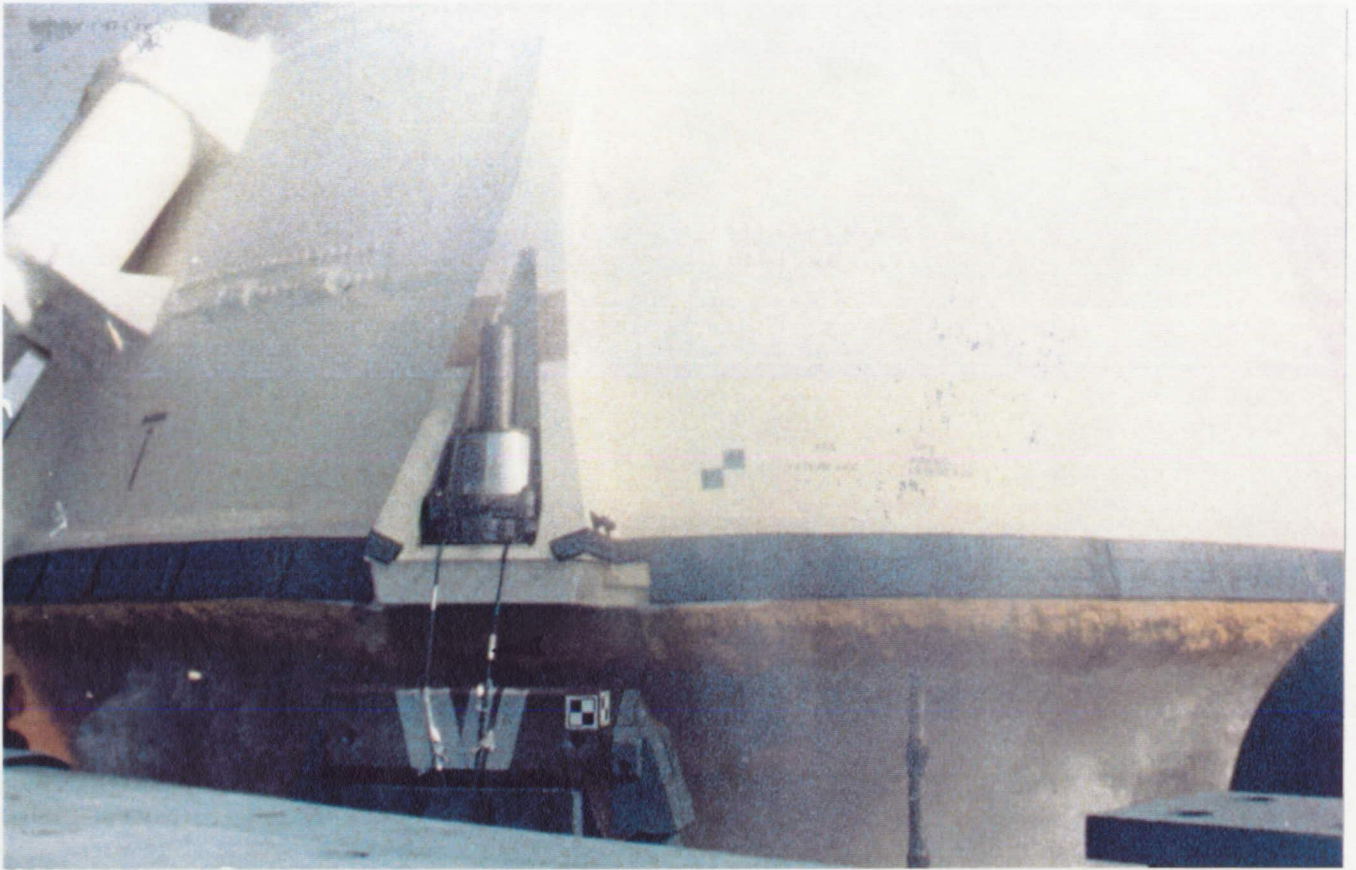
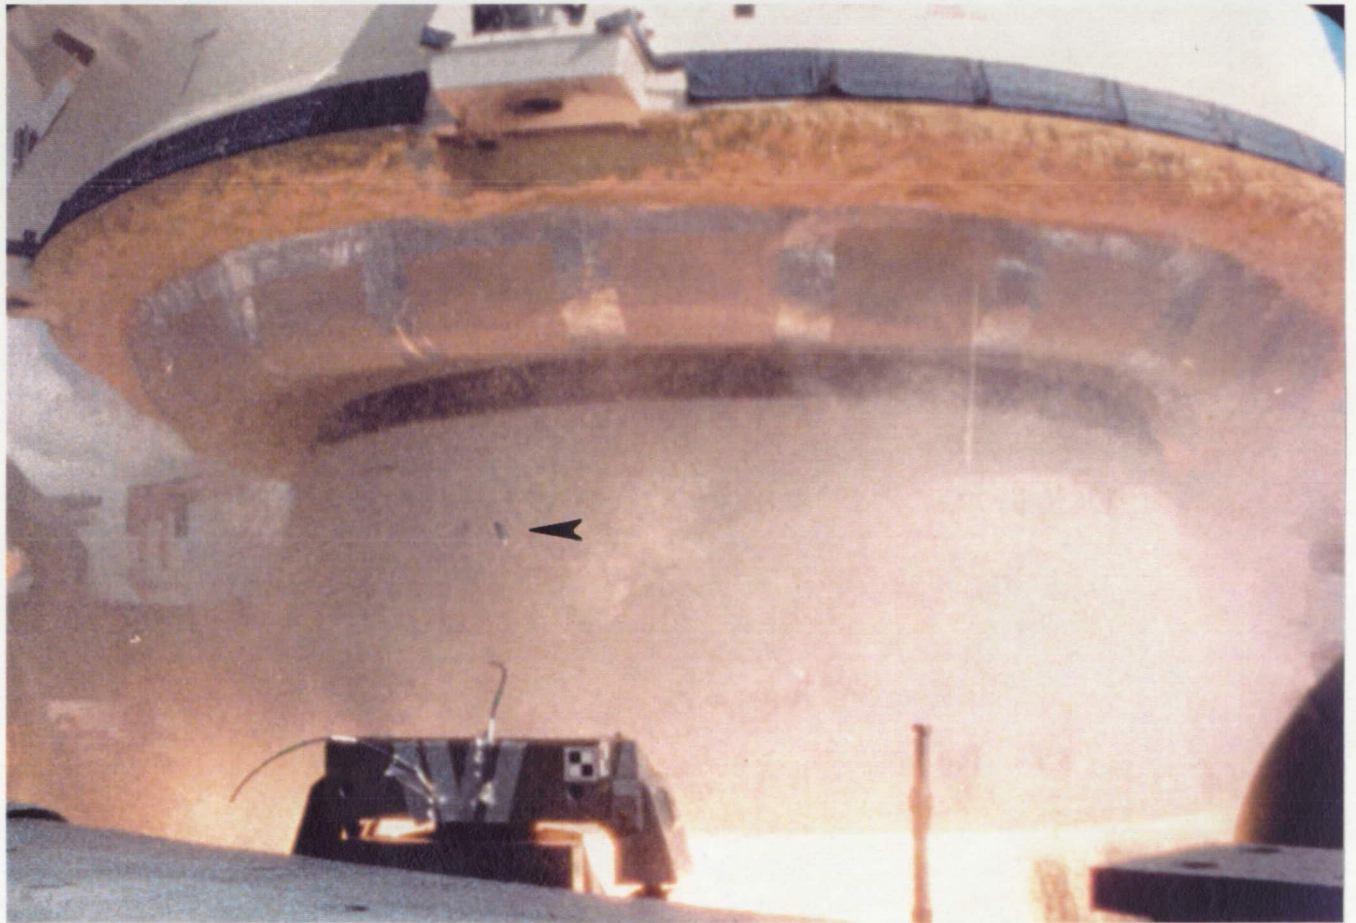
Two frangible nut pieces fell from the HDP #2 DCS/stud hole after liftoff.

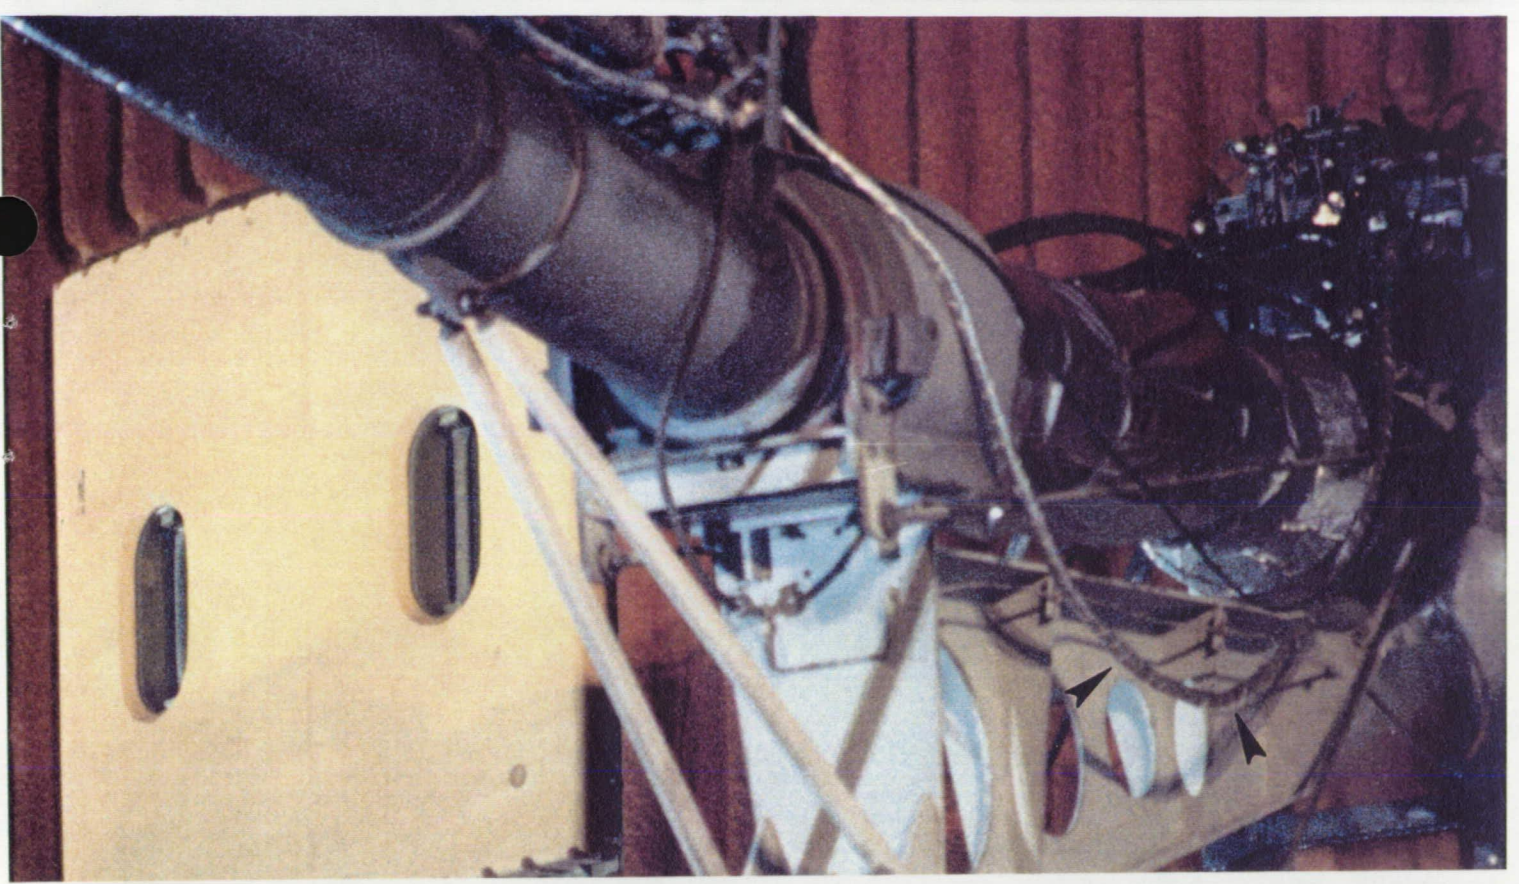
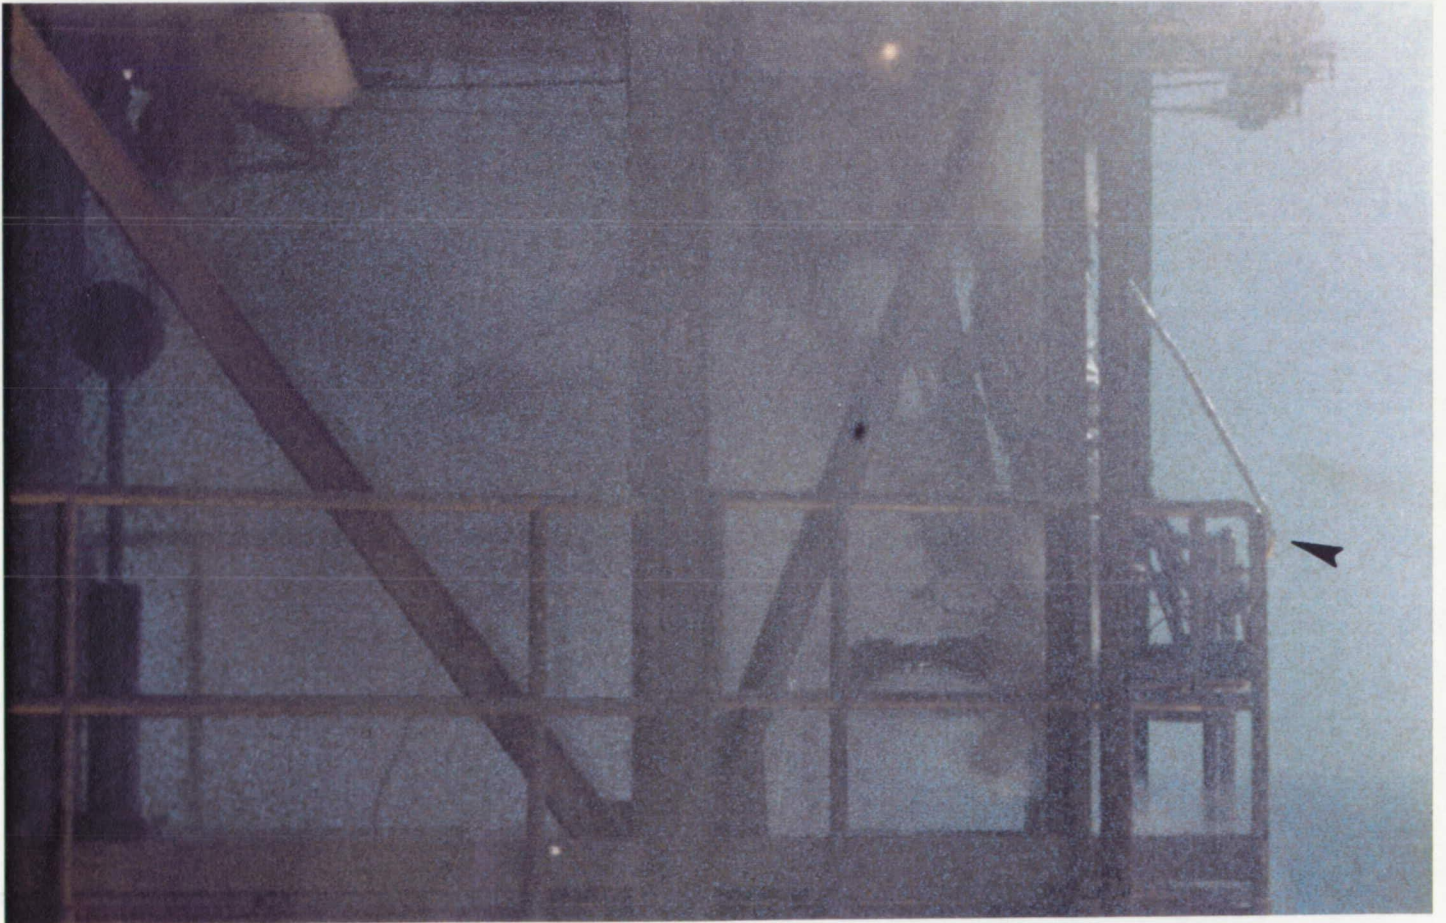
Excessive slack on the cable attached to the GUCP J2 electrical connector caused the cable to momentarily catch on an intertank access platform hand rail during retraction.

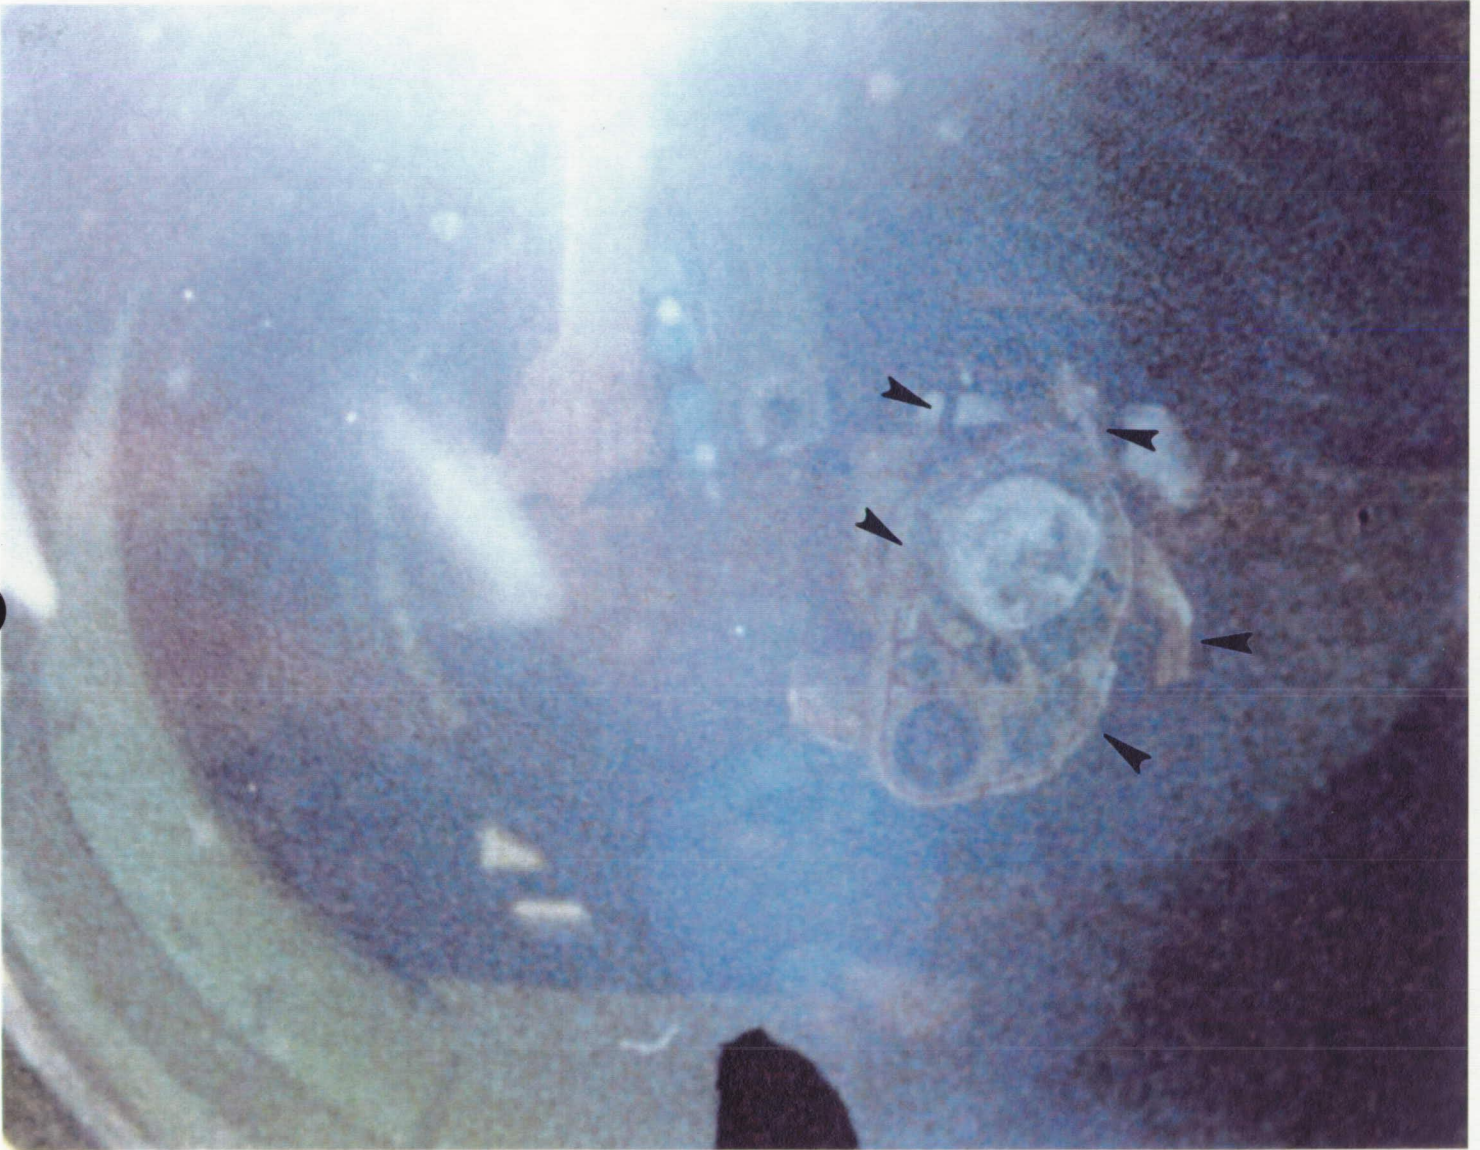
The red purge seal was missing from the ET/ORB LH2 umbilical near the 4-inch disconnect and at the top outboard section. TPS was damaged on the inboard side of the umbilical and a large piece of foam, which measured approximately 2 feet long by 4 inches wide by as much as 1 inch thick, had partially separated from the umbilical. TPS on top of the umbilical had peeled back in two places.

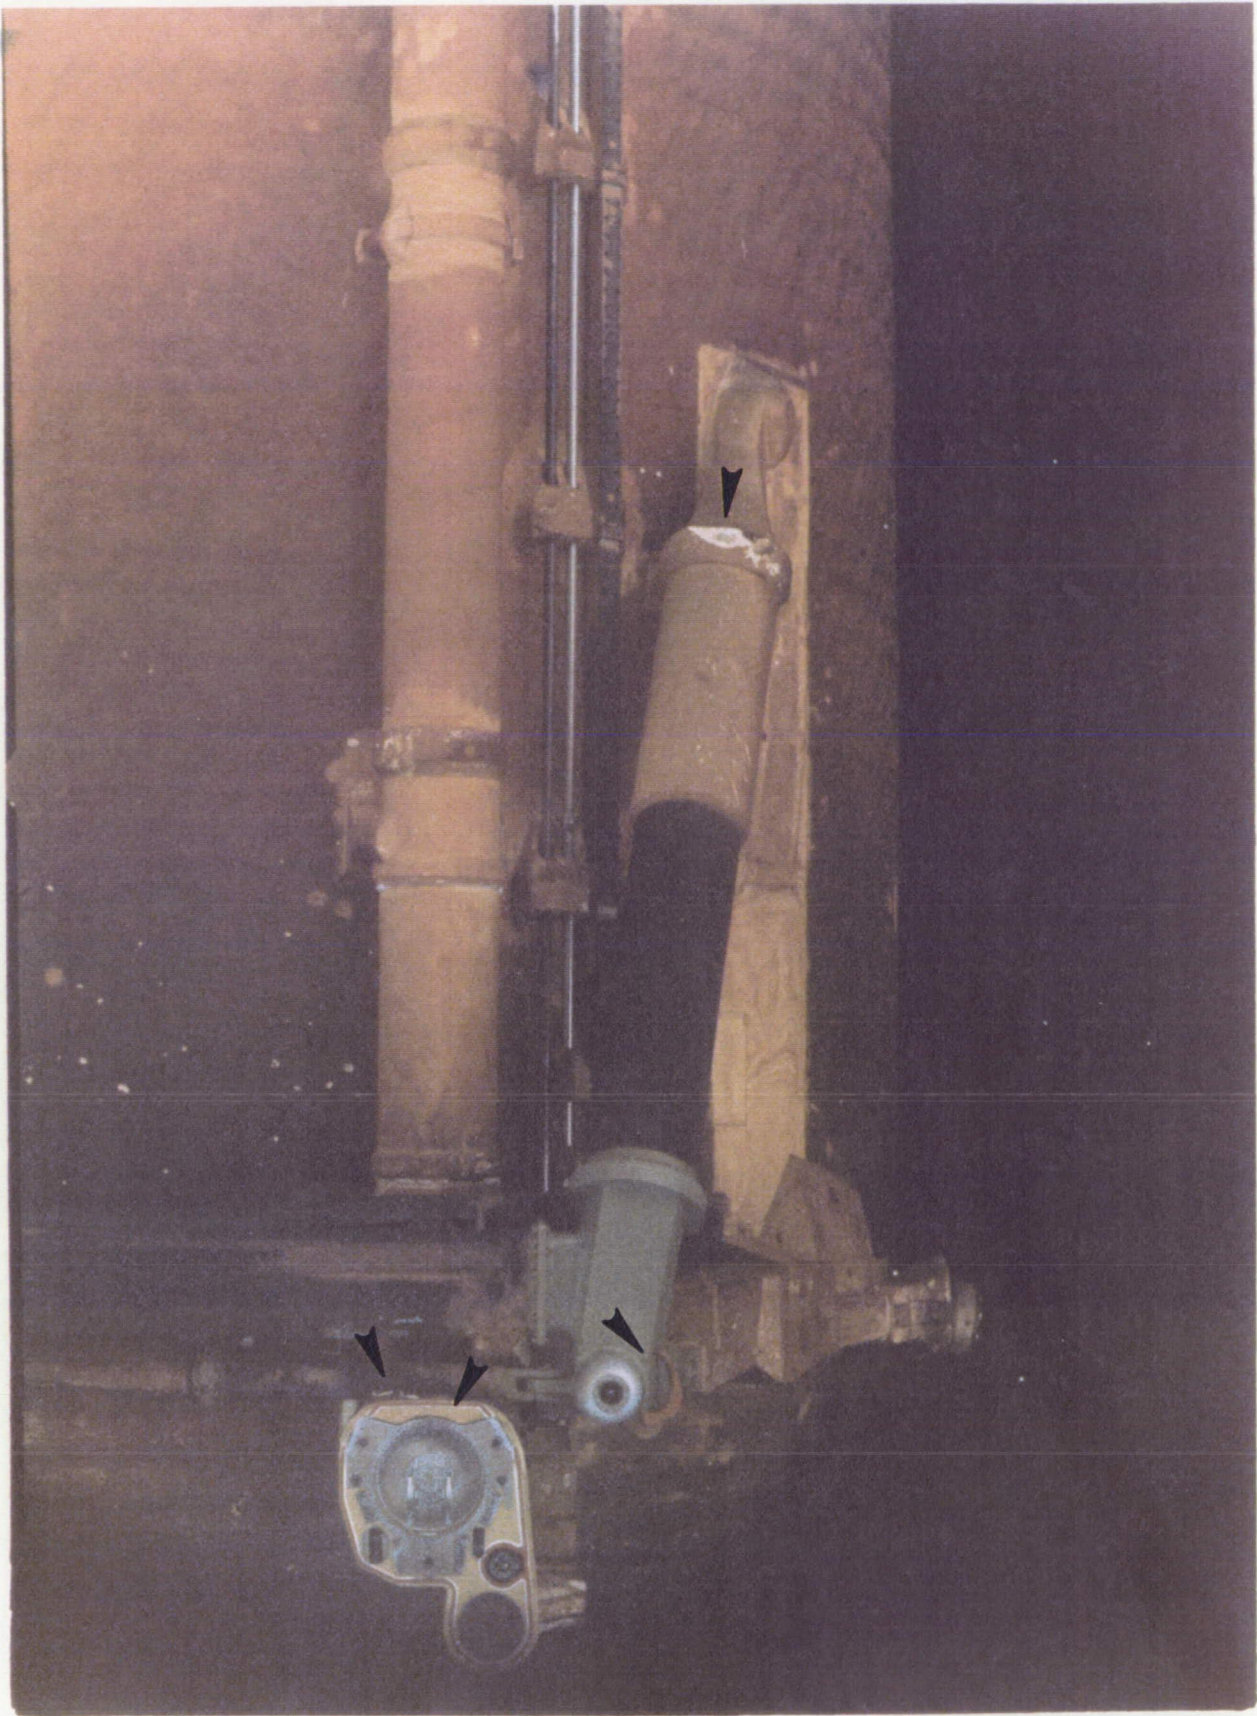
The lightning contact strip was missing from the top of the L02 ET/ORB umbilical (the others were intact). TPS was damaged on the top inboard side of the umbilical. The red seal at the EO fitting was loose and dangling by the retaining cord. Foam was missing from the +Y thrust strut flange and primer/metal substrate was exposed.

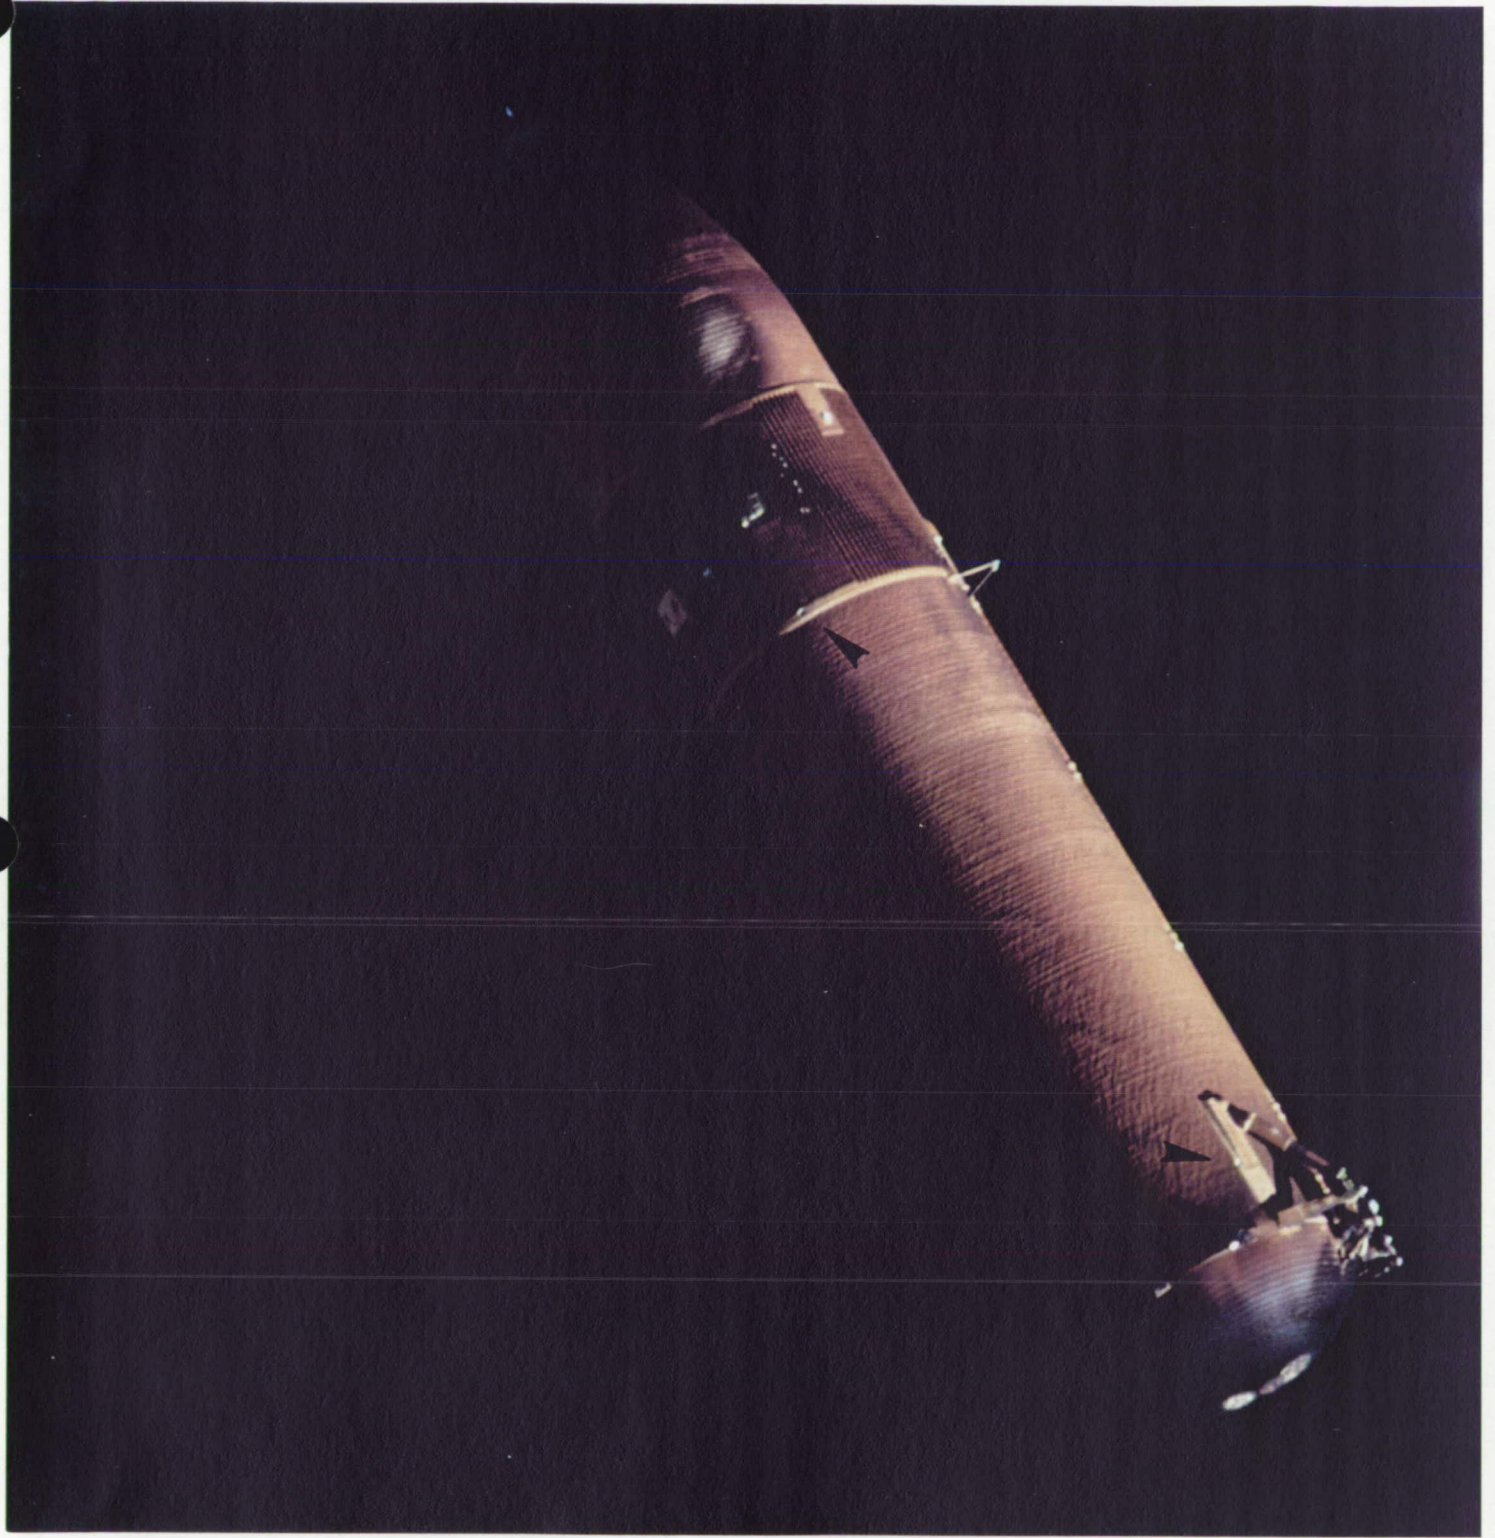
Nine divots occurred in a rough line along the edge of the -Y thrust panel. A divot is visible in the LH2 tank-to-intertank flange closeout and the -Y longeron closeout. There were no TPS anomalies on the LH2 and LO2 tank acreage.

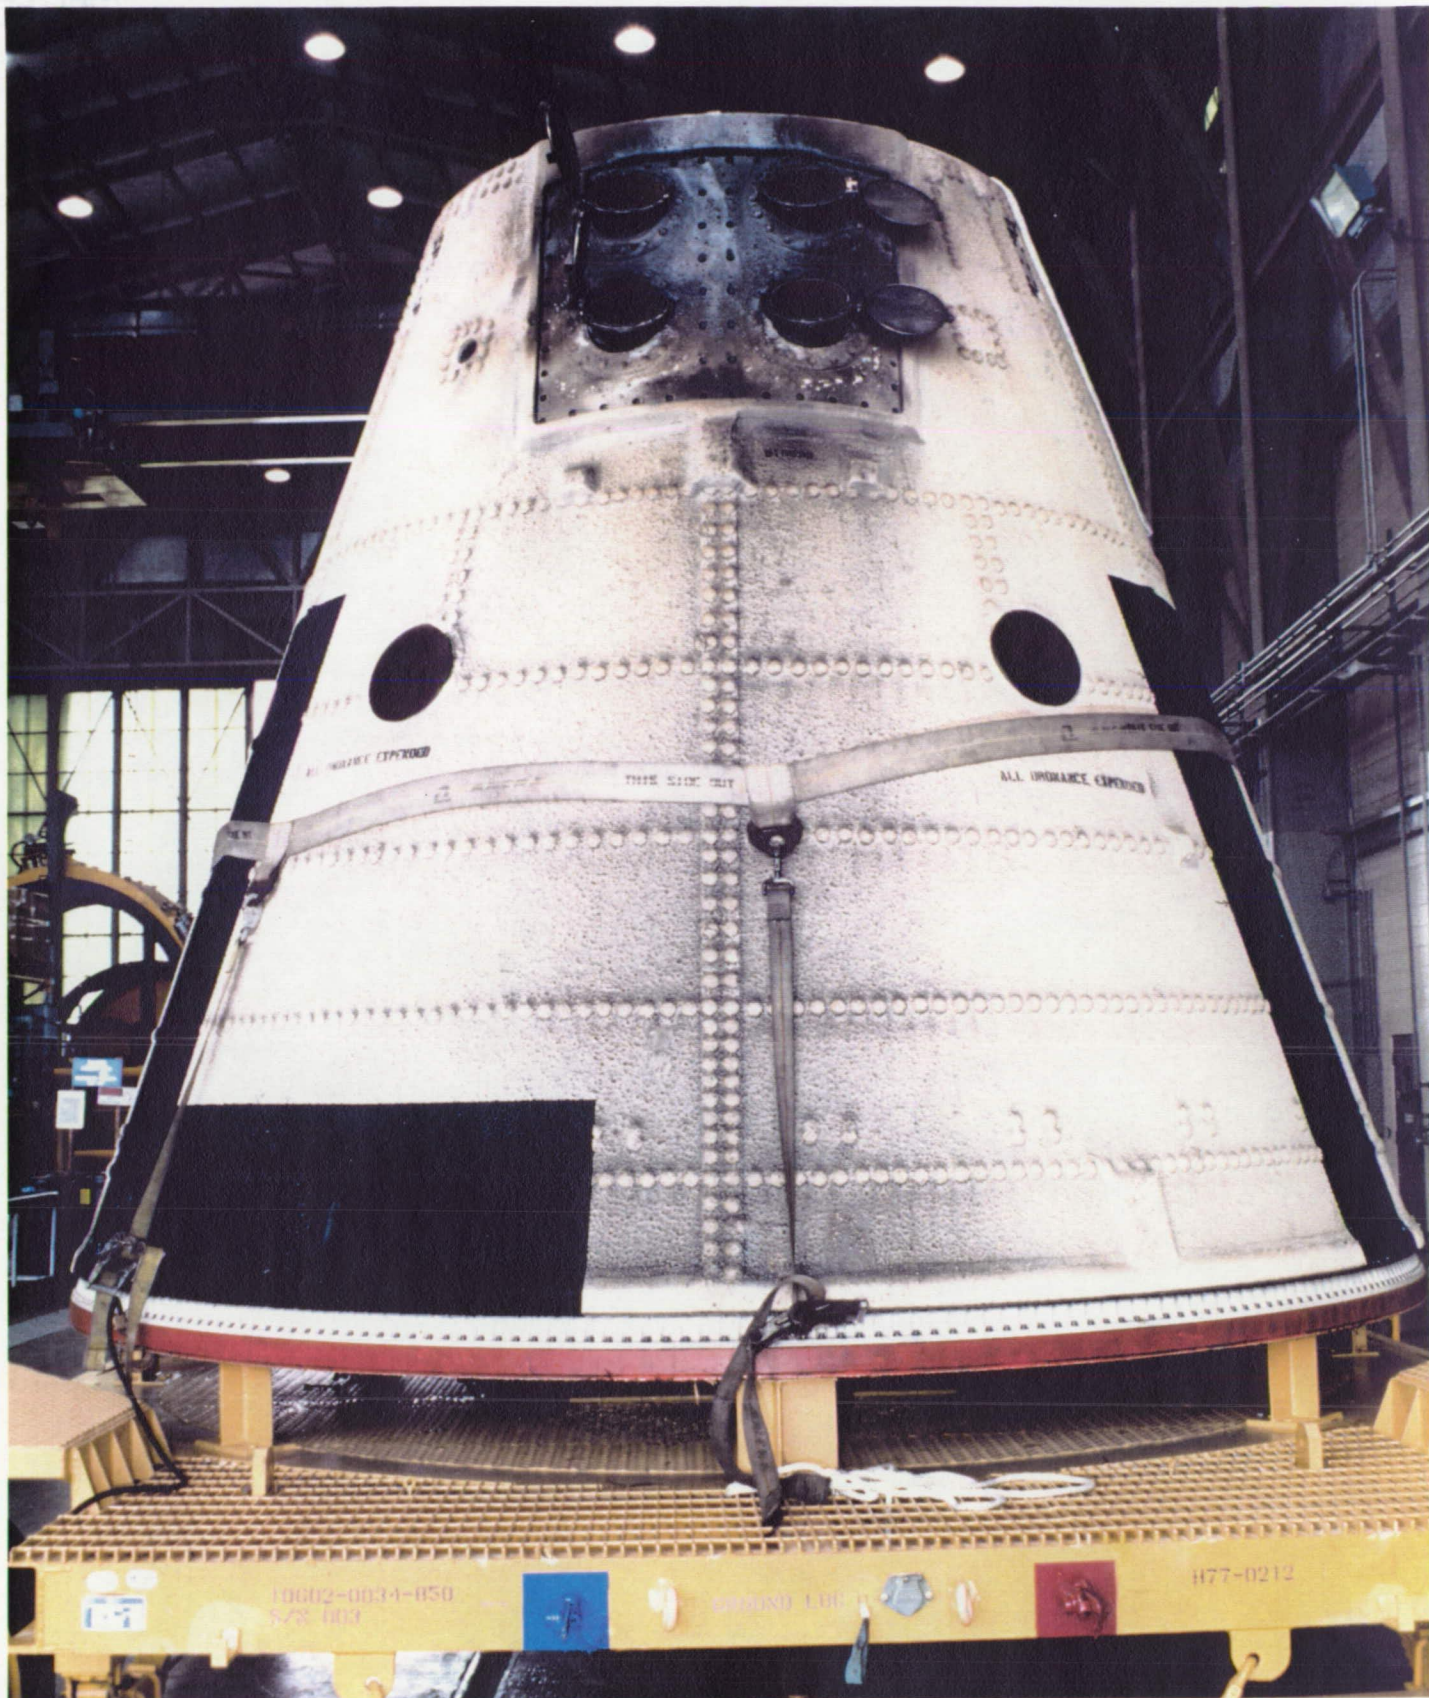
The RH frustum had 46 MSA-2 debonds over fasteners and two areas of missing MSA-2. All BSM aero heatshield covers were locked in the fully opened position, though the two left cover attach rings had been bent by parachute riser entanglement.

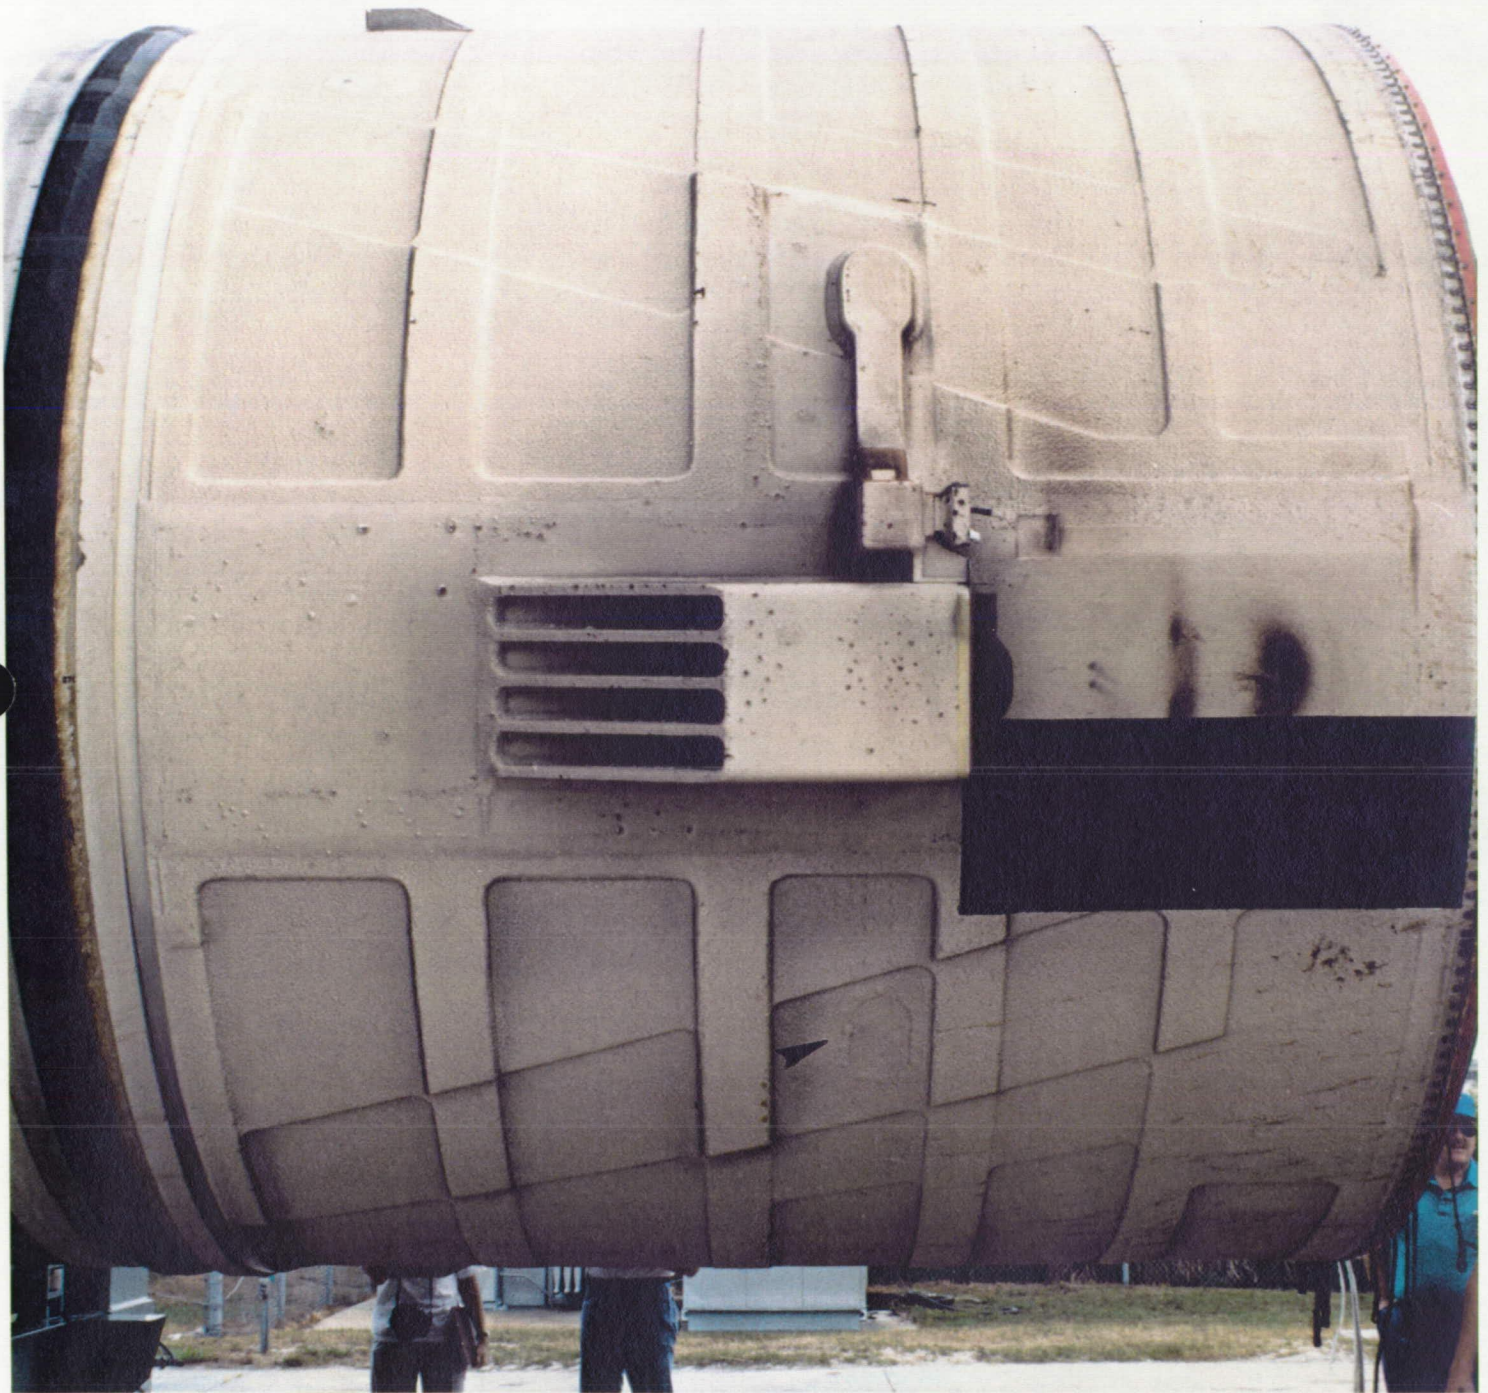
The RH forward skirt acreage MSA-2 was missing no TPS, but had one MSA-2 debond near the forward attach fitting. Both RSS antenna covers/phenolic base plates were intact.

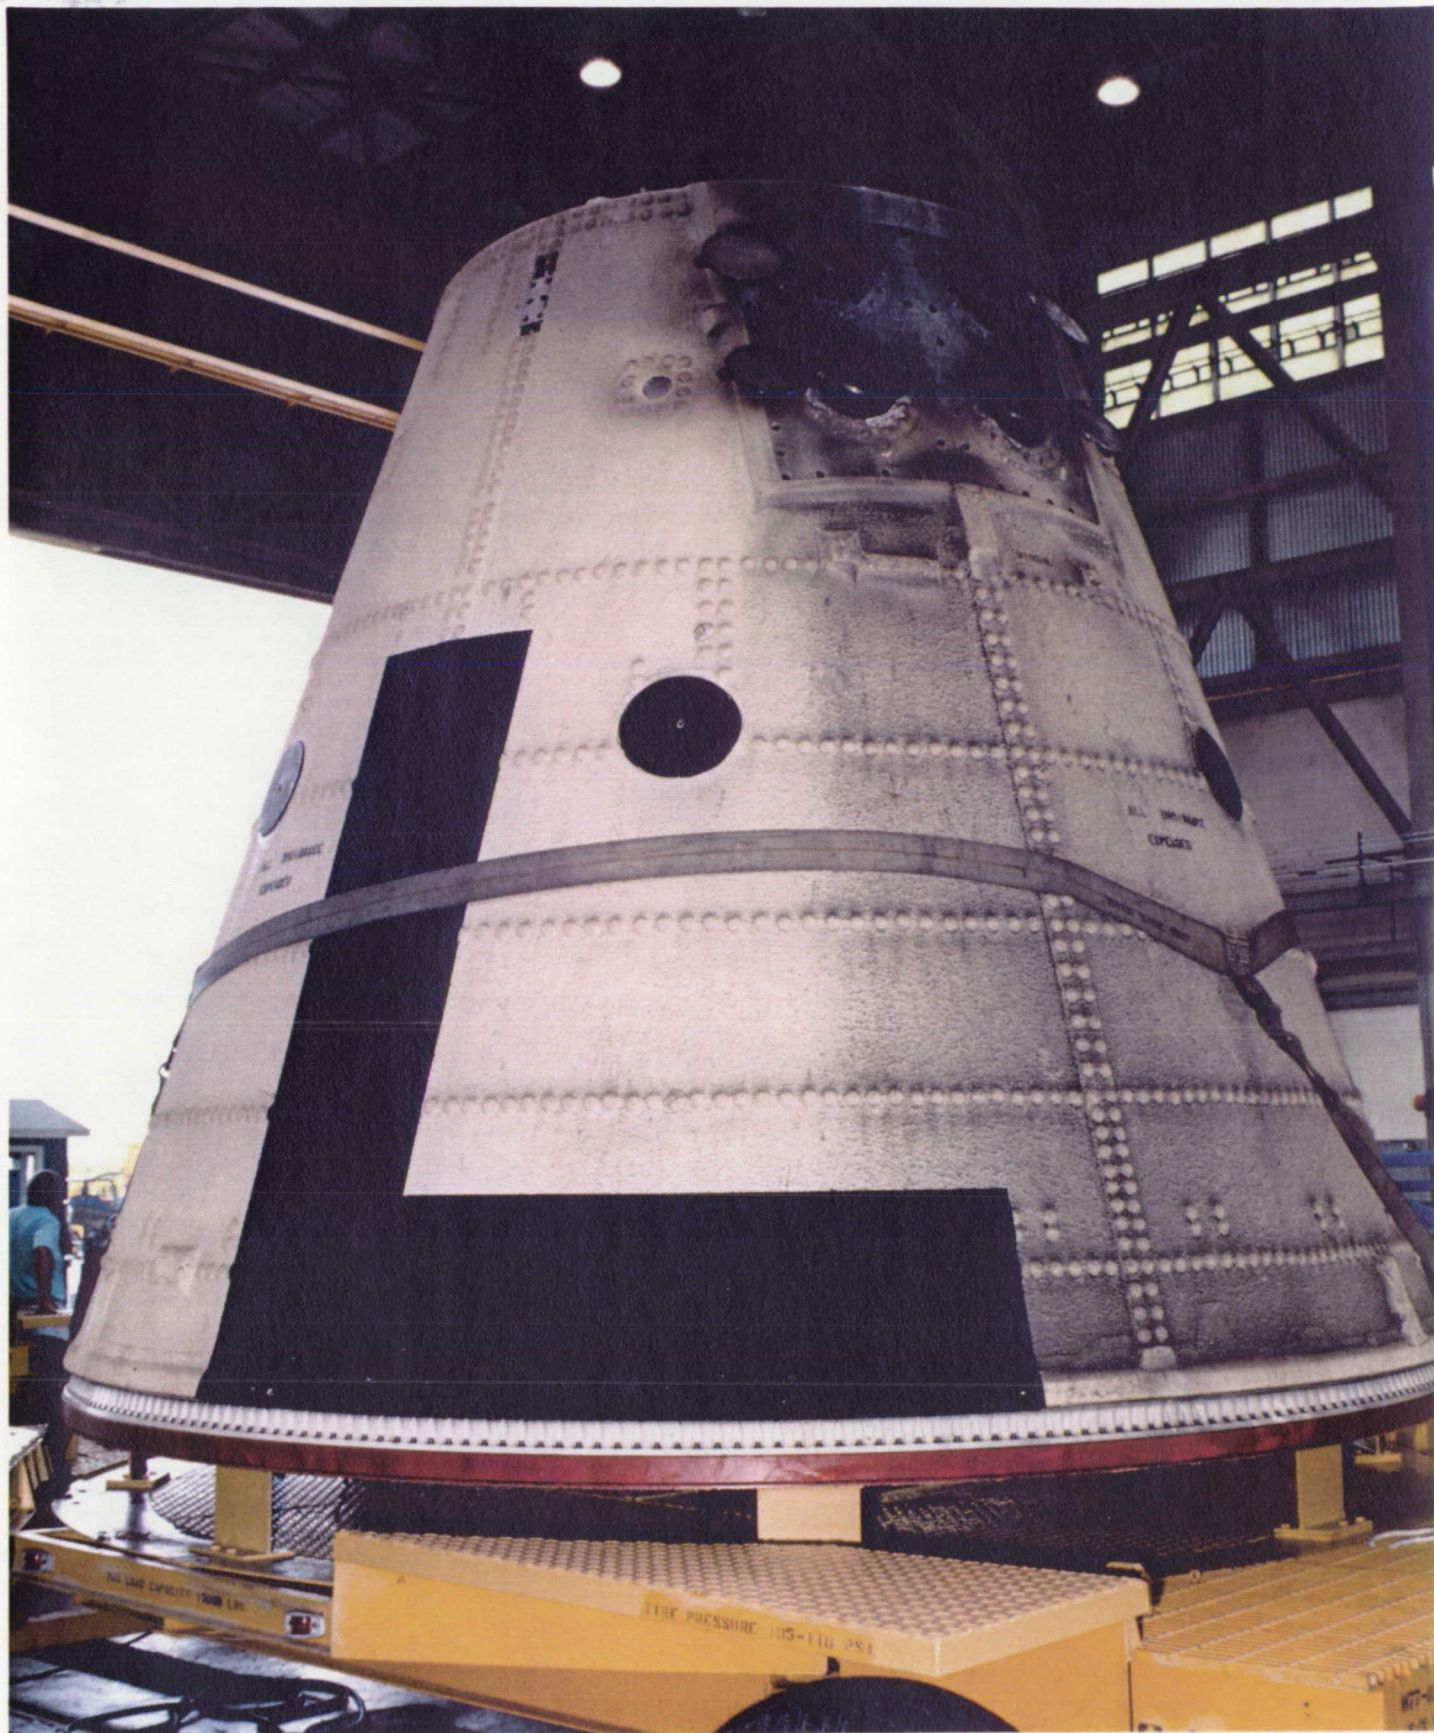
The LH frustum had a total of 27 MSA-2 debonds over fasteners. The BSM aero heat shield covers were locked in the fully opened position.

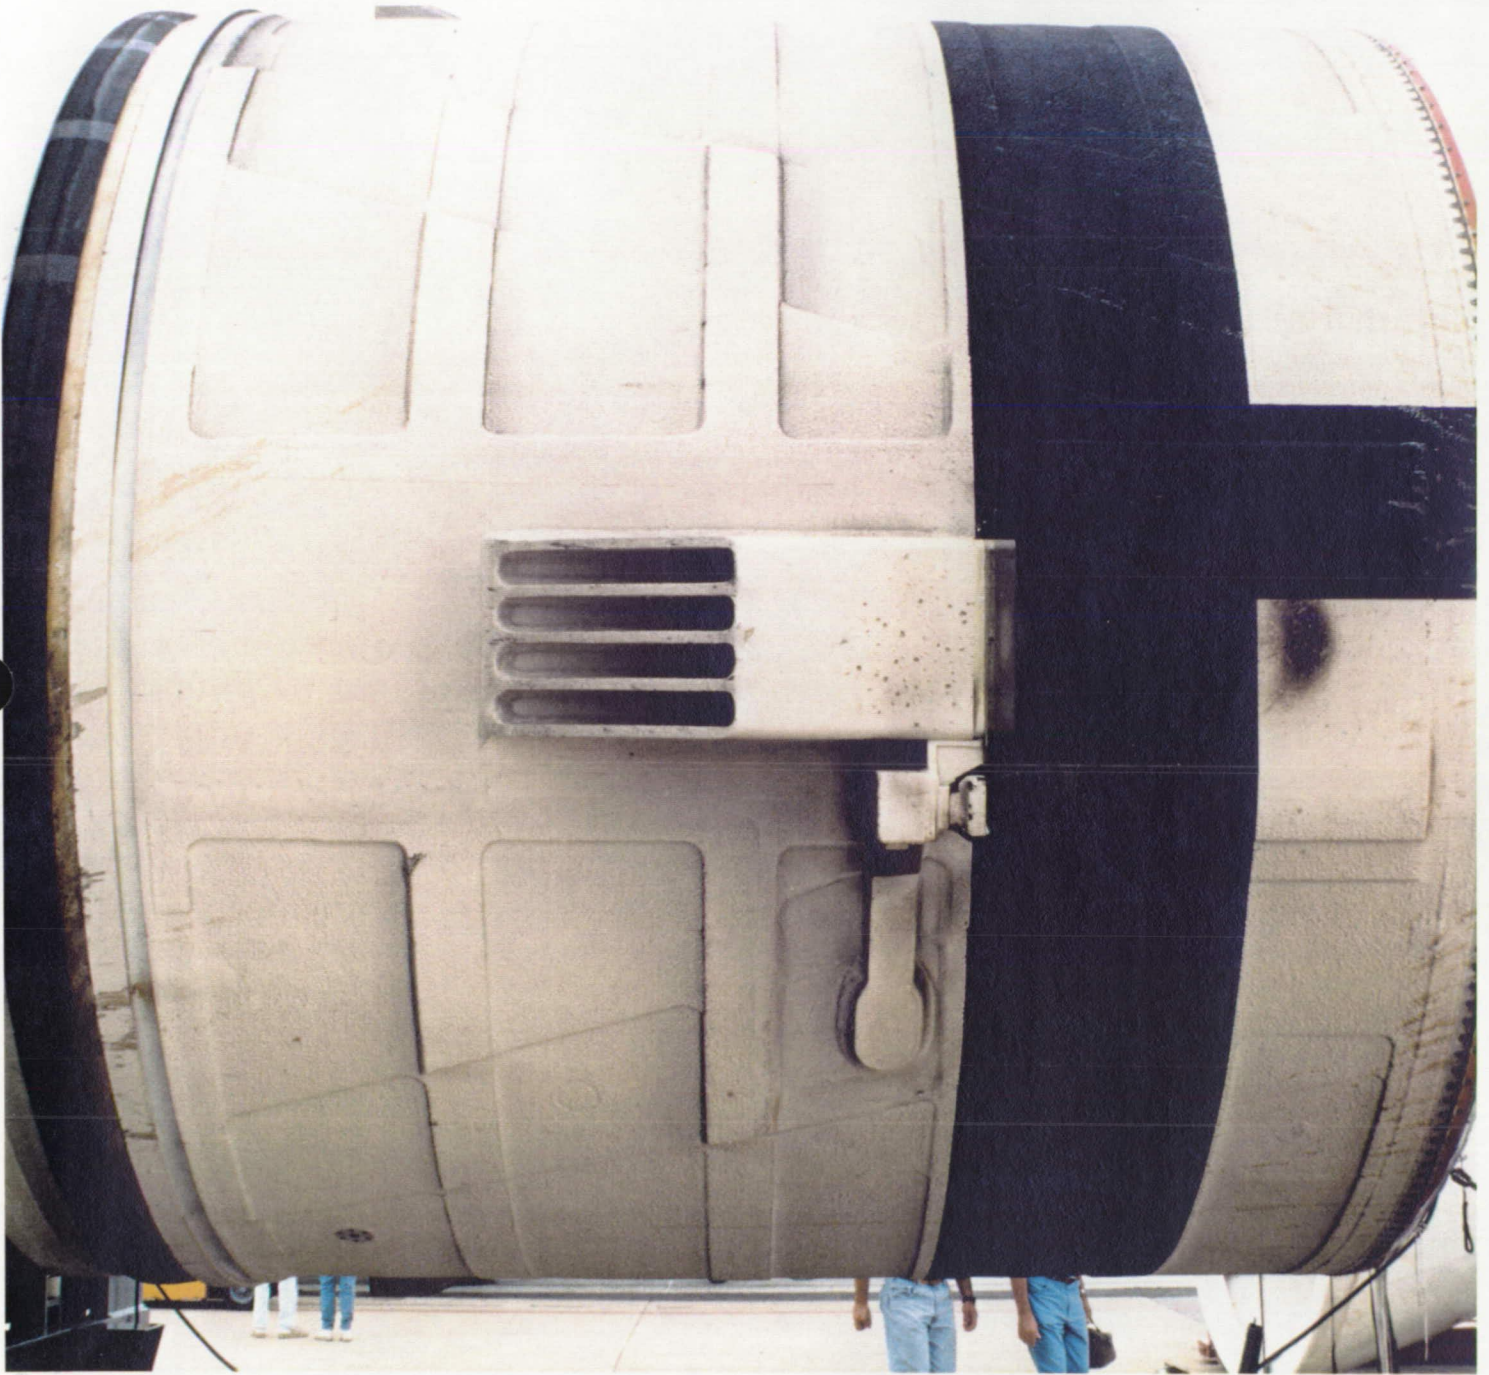
The LH forward skirt acreeage MSA-2 exhibited no debonds or missing TPS. Both RSS antenna covers/phenolic base plates were intact.

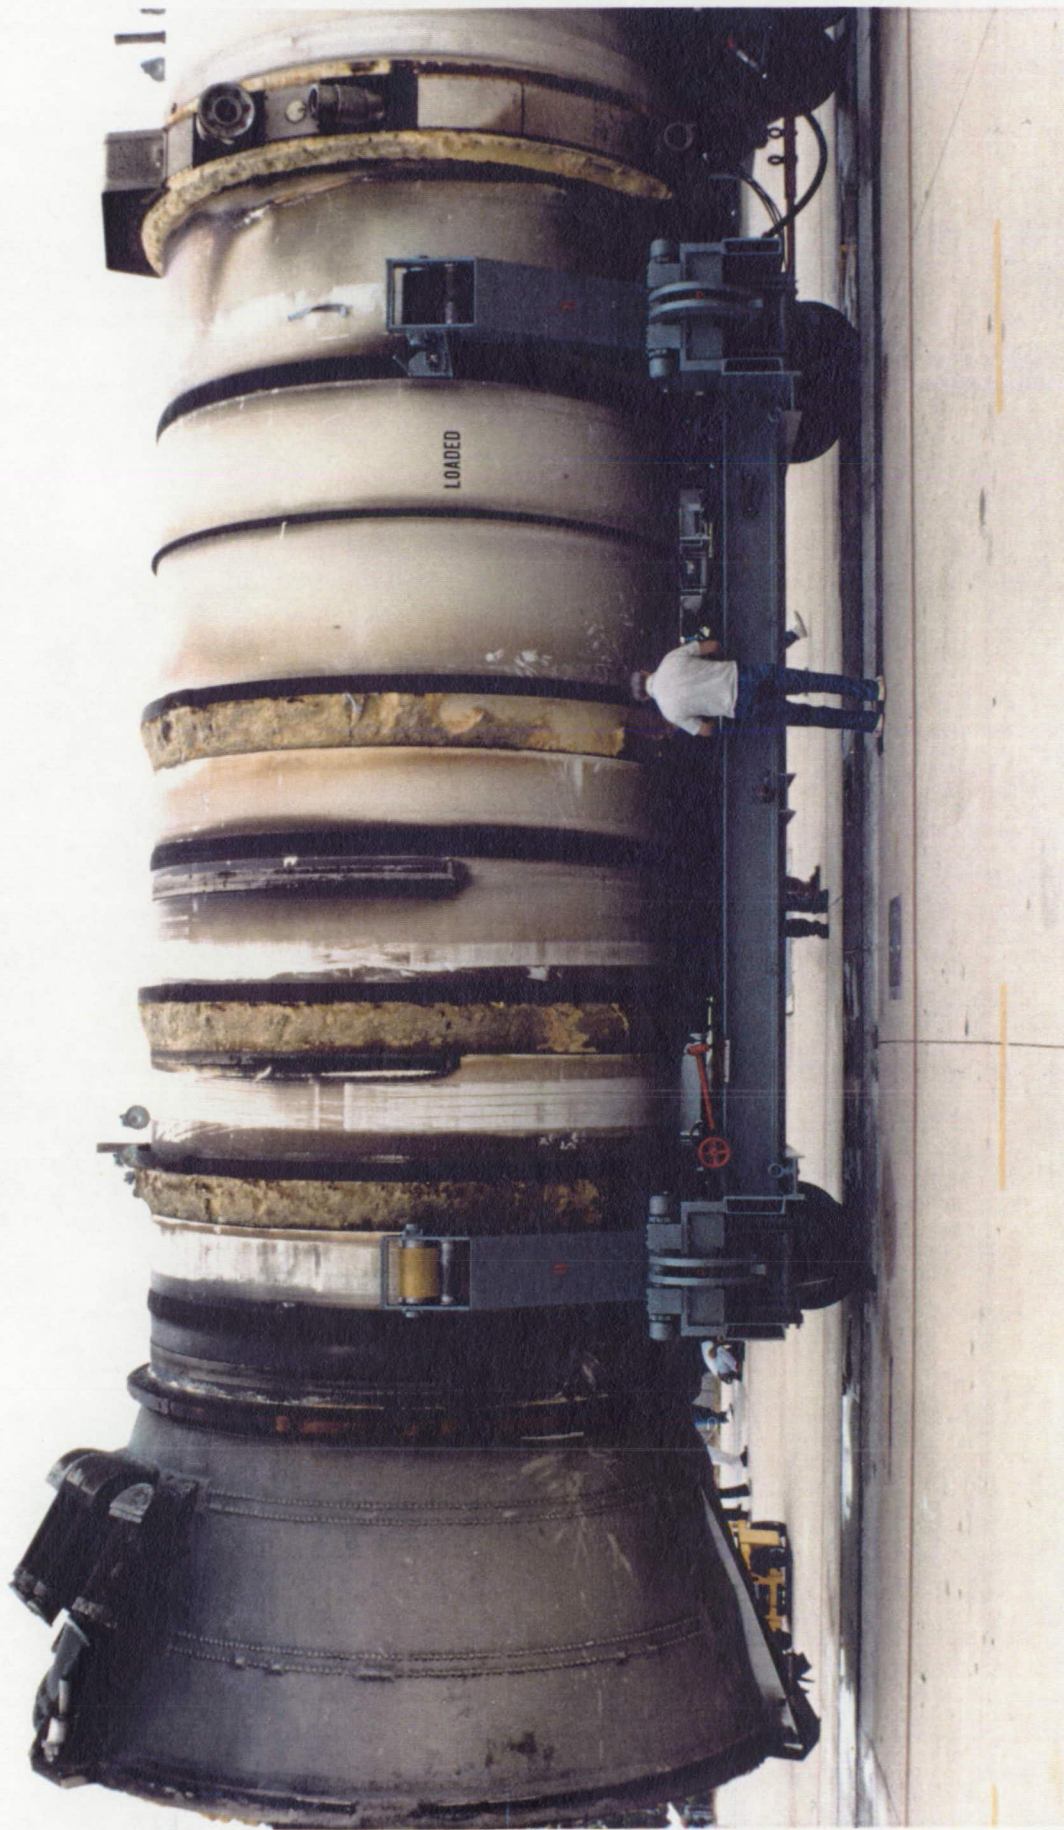
Post flight condition of the LH aft booster and aft skirt. The ET/SPB aft struts, ETA ring, IEA, and IEA covers appeared undamaged. All three aft booster stiffener rings were damaged by water impact.
