Debris/Ice/TPS Assessment and Integrated Photographic Analysis for Shuttle Mission STS-57

July 1993

Gregory N. Katnik
NASA/Kennedy Space Center

DEBRIS/ICE/TPS ASSESSMENT
AND
PHOTOGRAPHIC ANALYSIS
OF
SHUTTLE MISSION STS-57

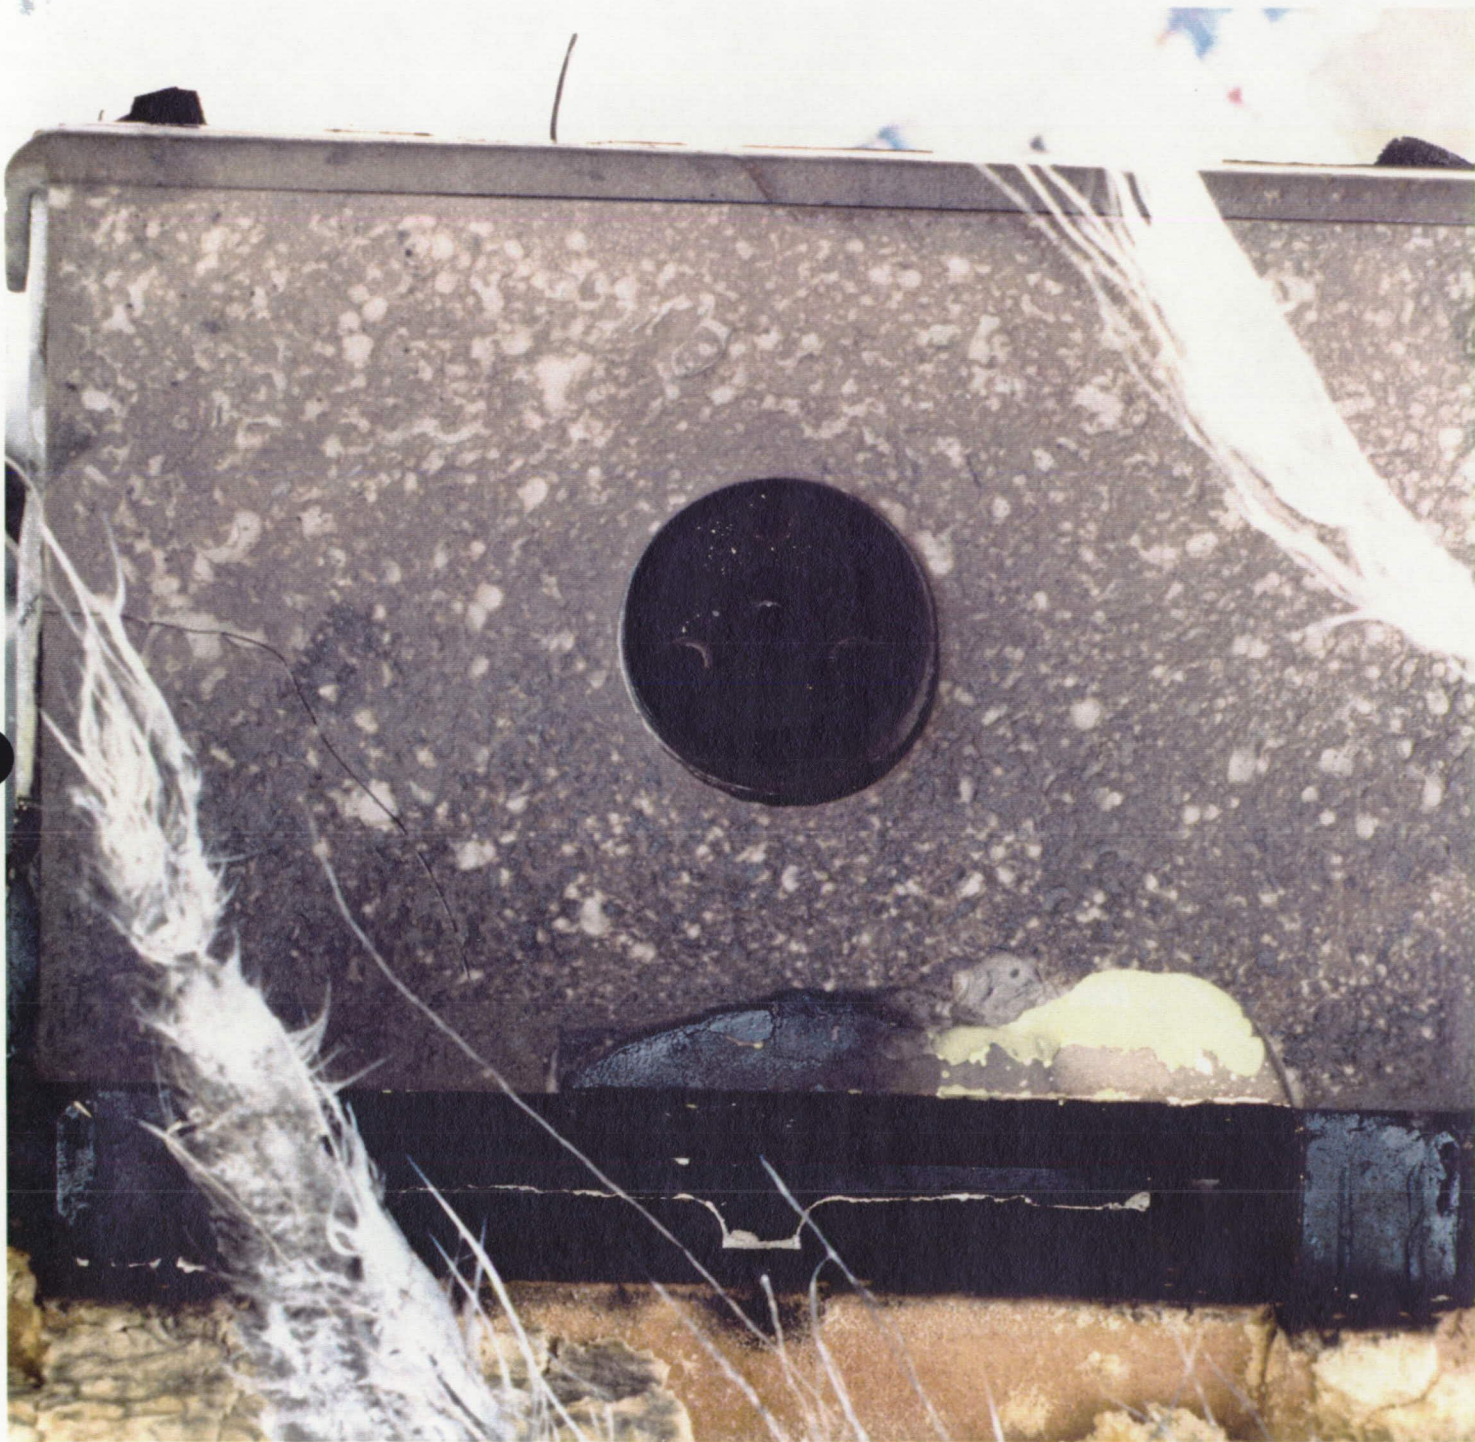
Approximately ten percent of the EPON shim material was missing prior to splashdown. The substrate was sooted.

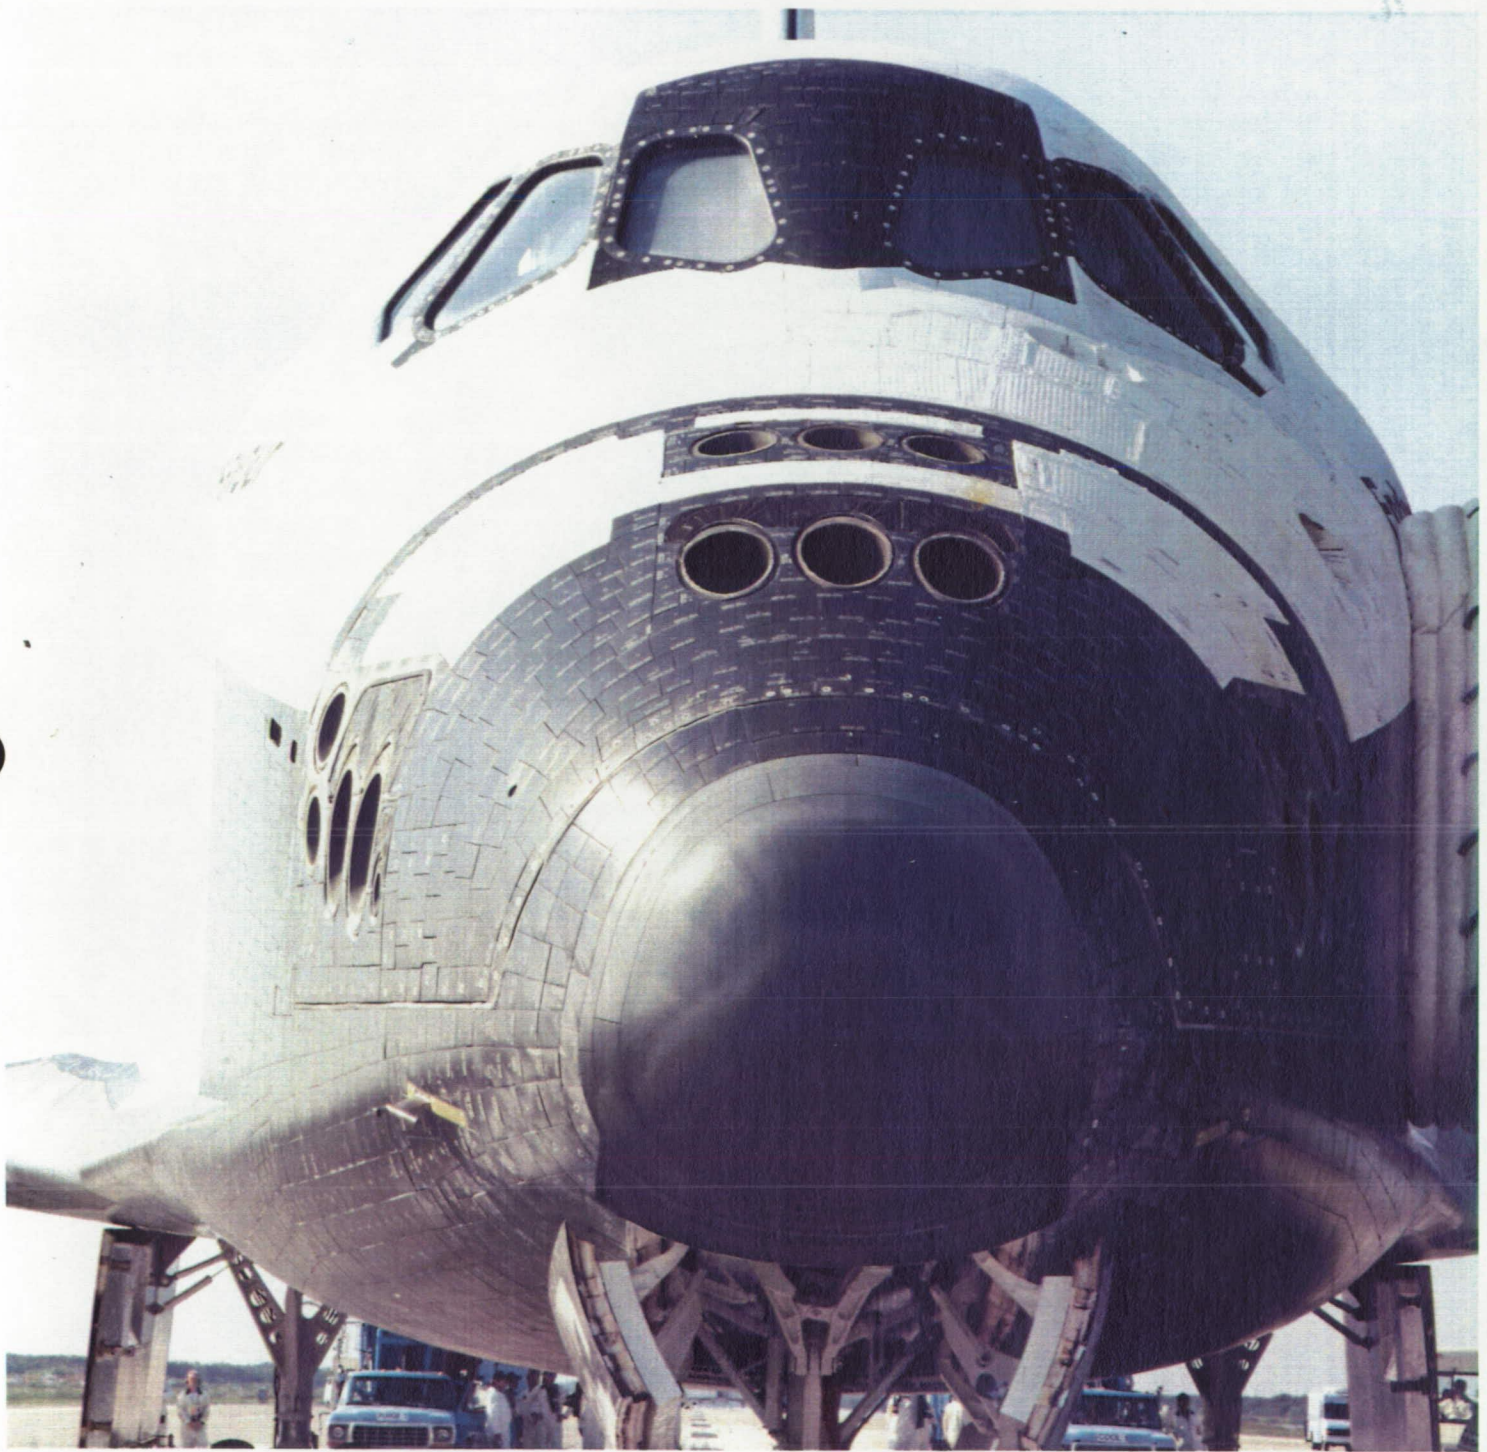
Overall view of the Orbiter nose. Forward facing windows were moderately hazed. Note discoloration of the AFRSI near the F3D and F1F thrusters.

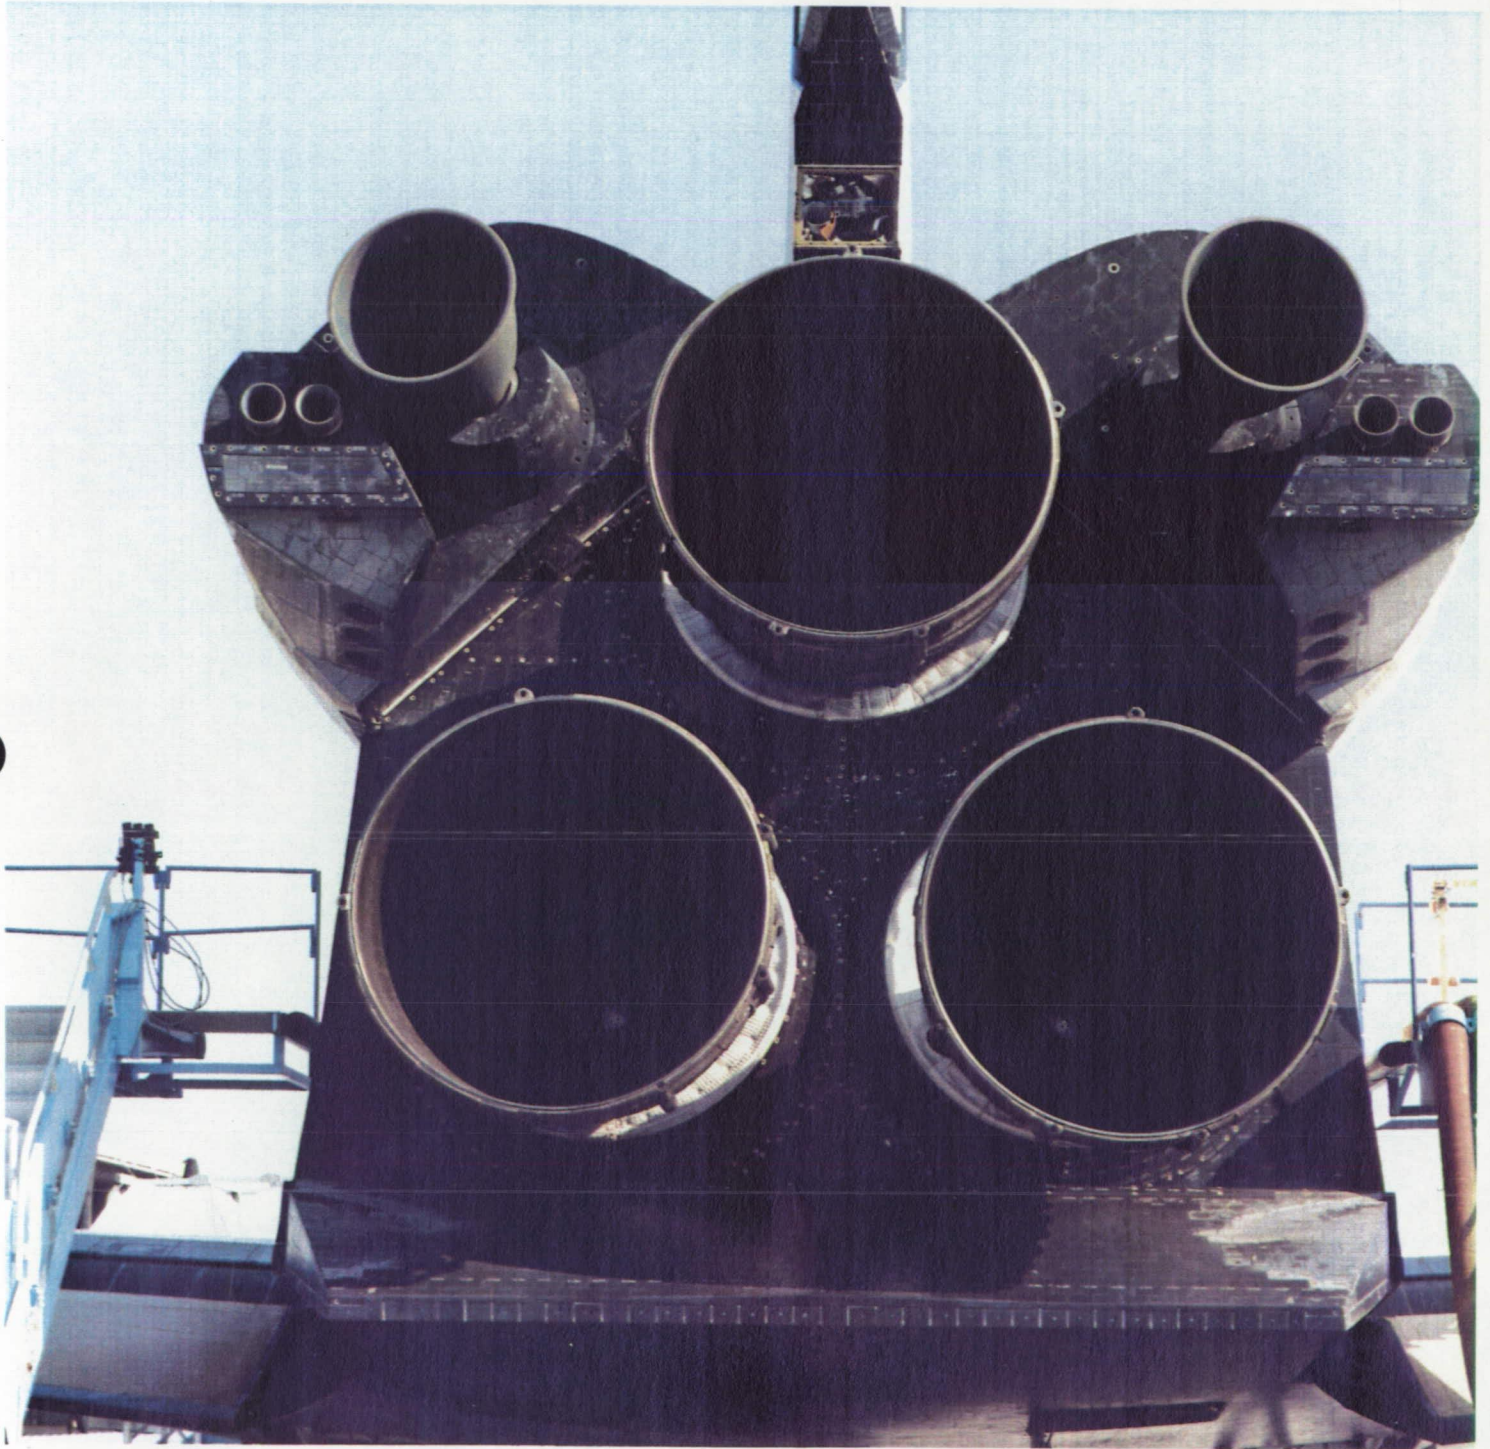
Tile damage on the base heat shield was average. The SSME Dome Mounted Heat Shield (DMHS) closeout blanket sacrificial panels were intact and missing no material.

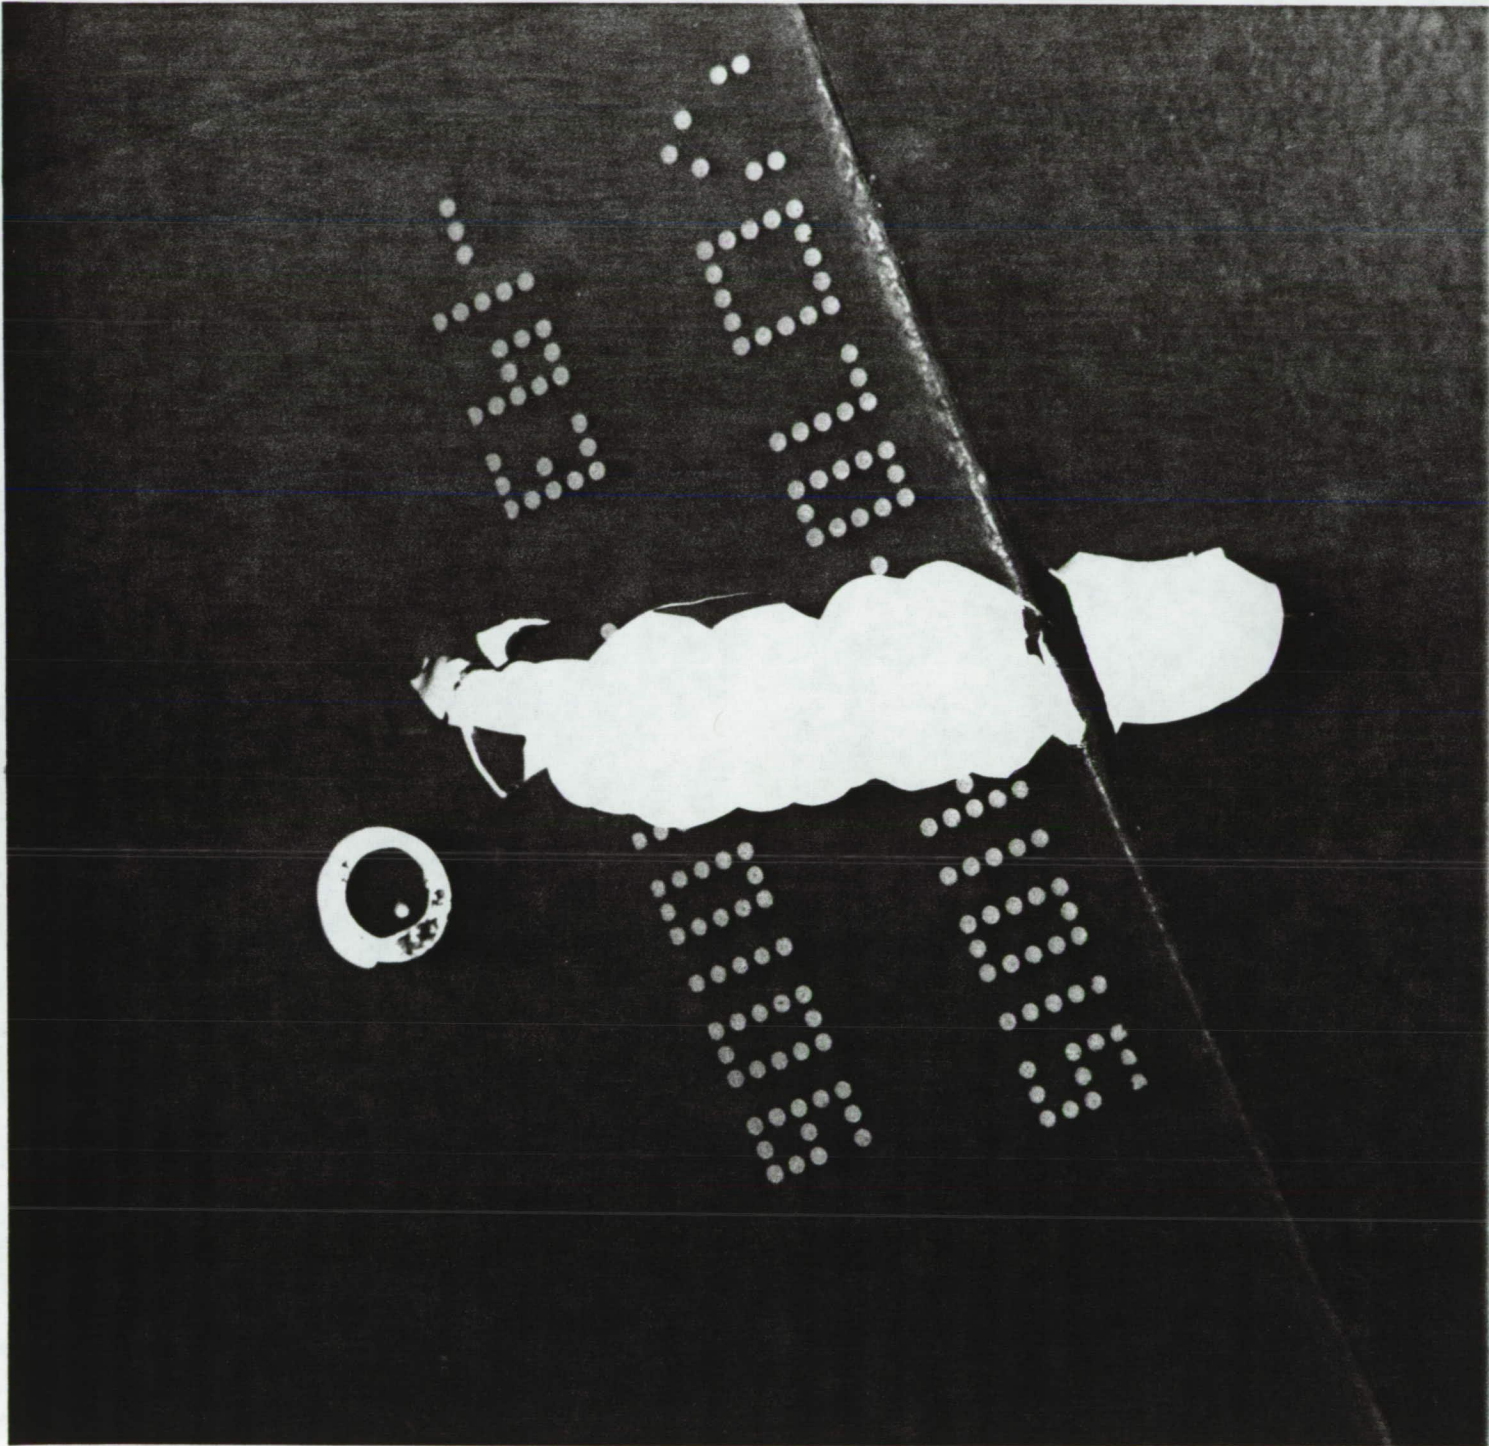
The Orbiter lower surface sustained a total of 75 hits. The largest tile damage site measured 3.5" x 0.75" x 0.375" and was located on the RH lower surface outboard of the nose landing gear door.

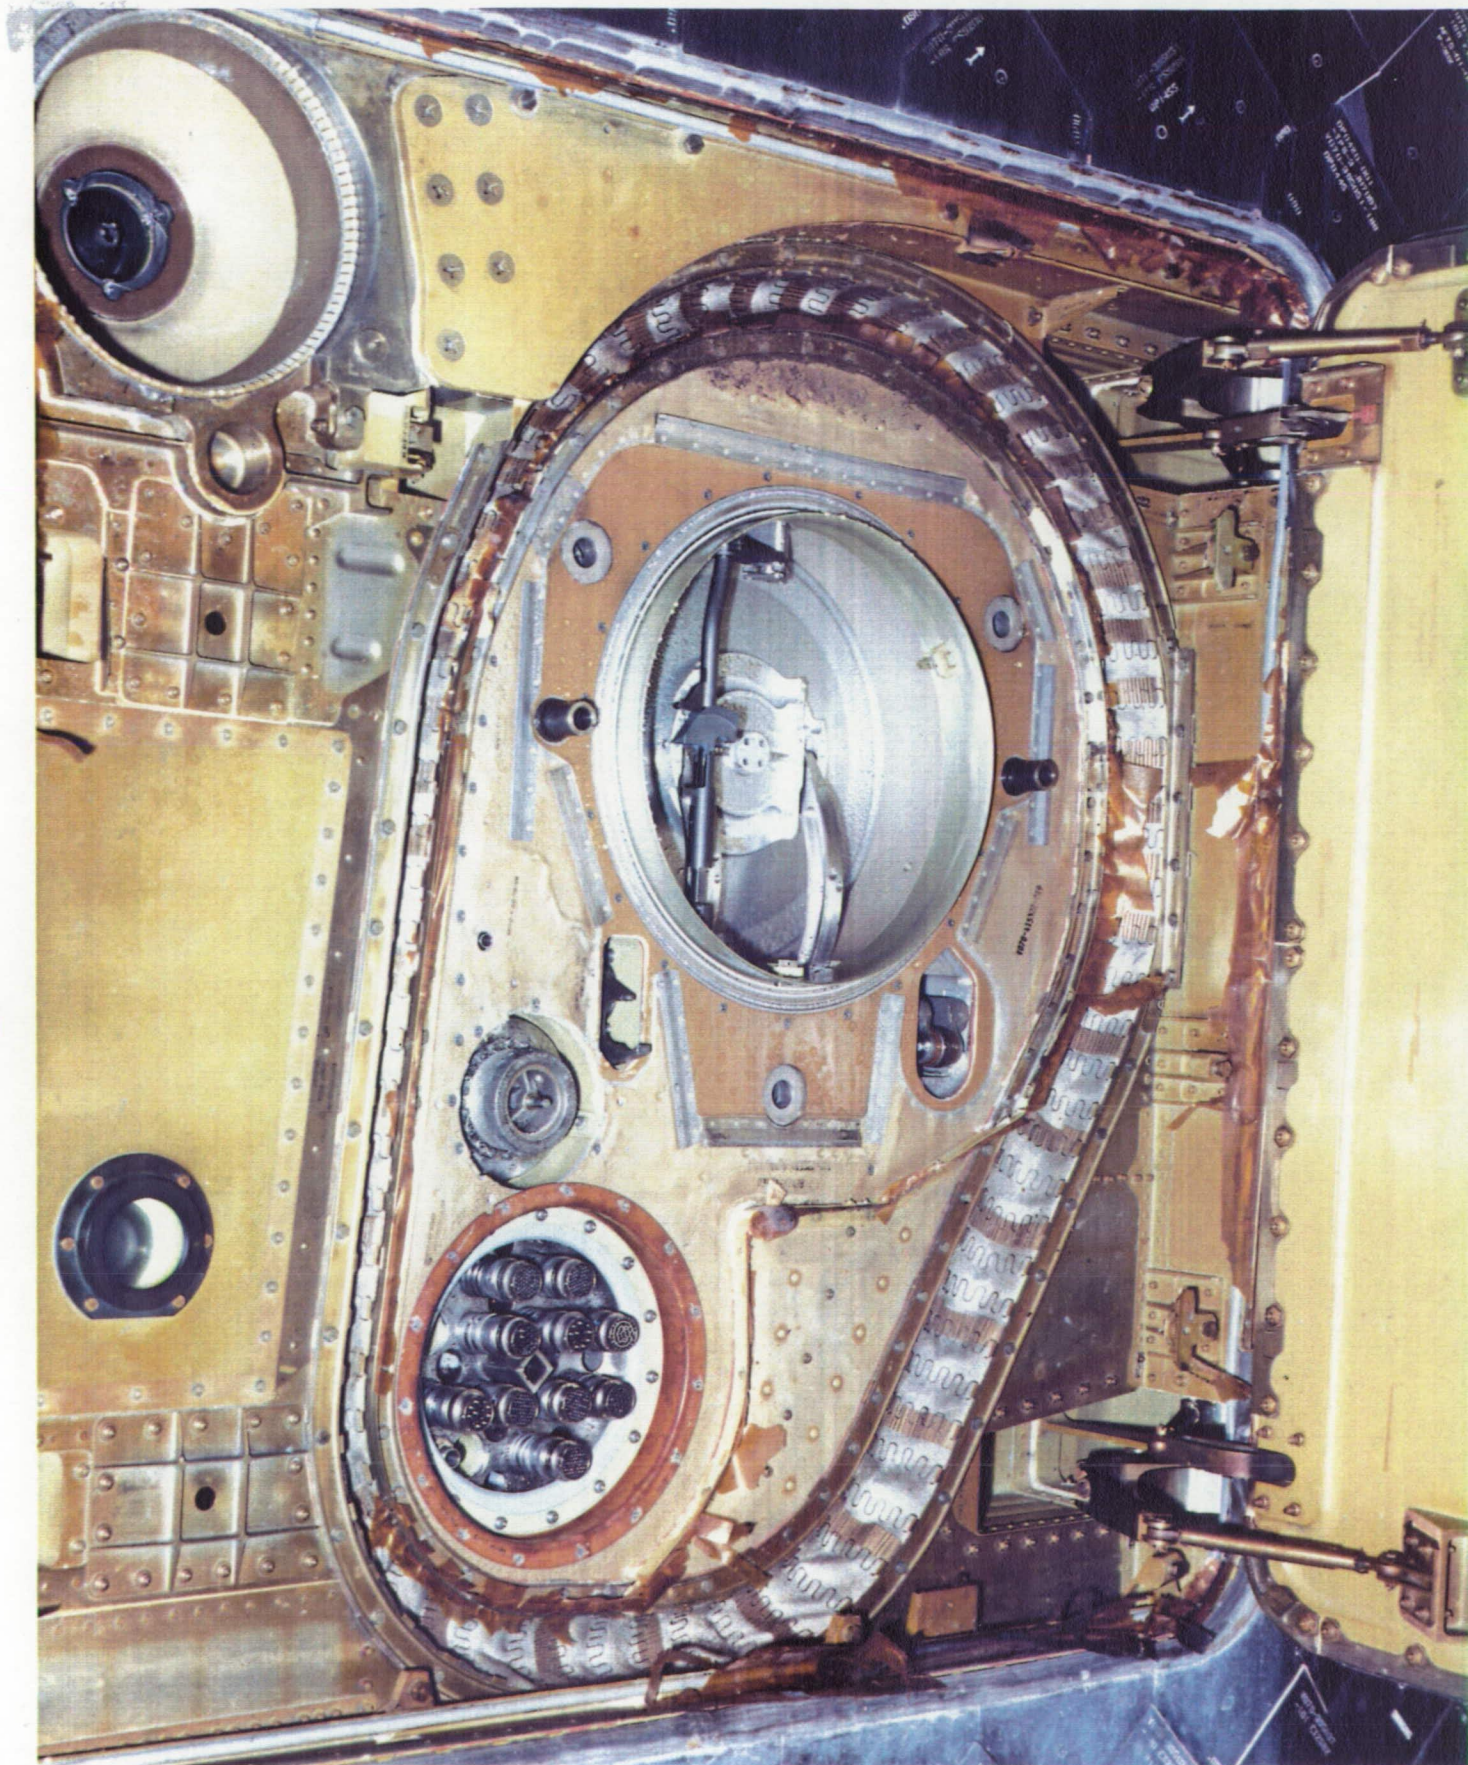
Overall view of the L02 ET/ORB umbilical. All separation ordnance devices functioned properly. No flight hardware was found on the runway below the umbilical when the ET door was opened.

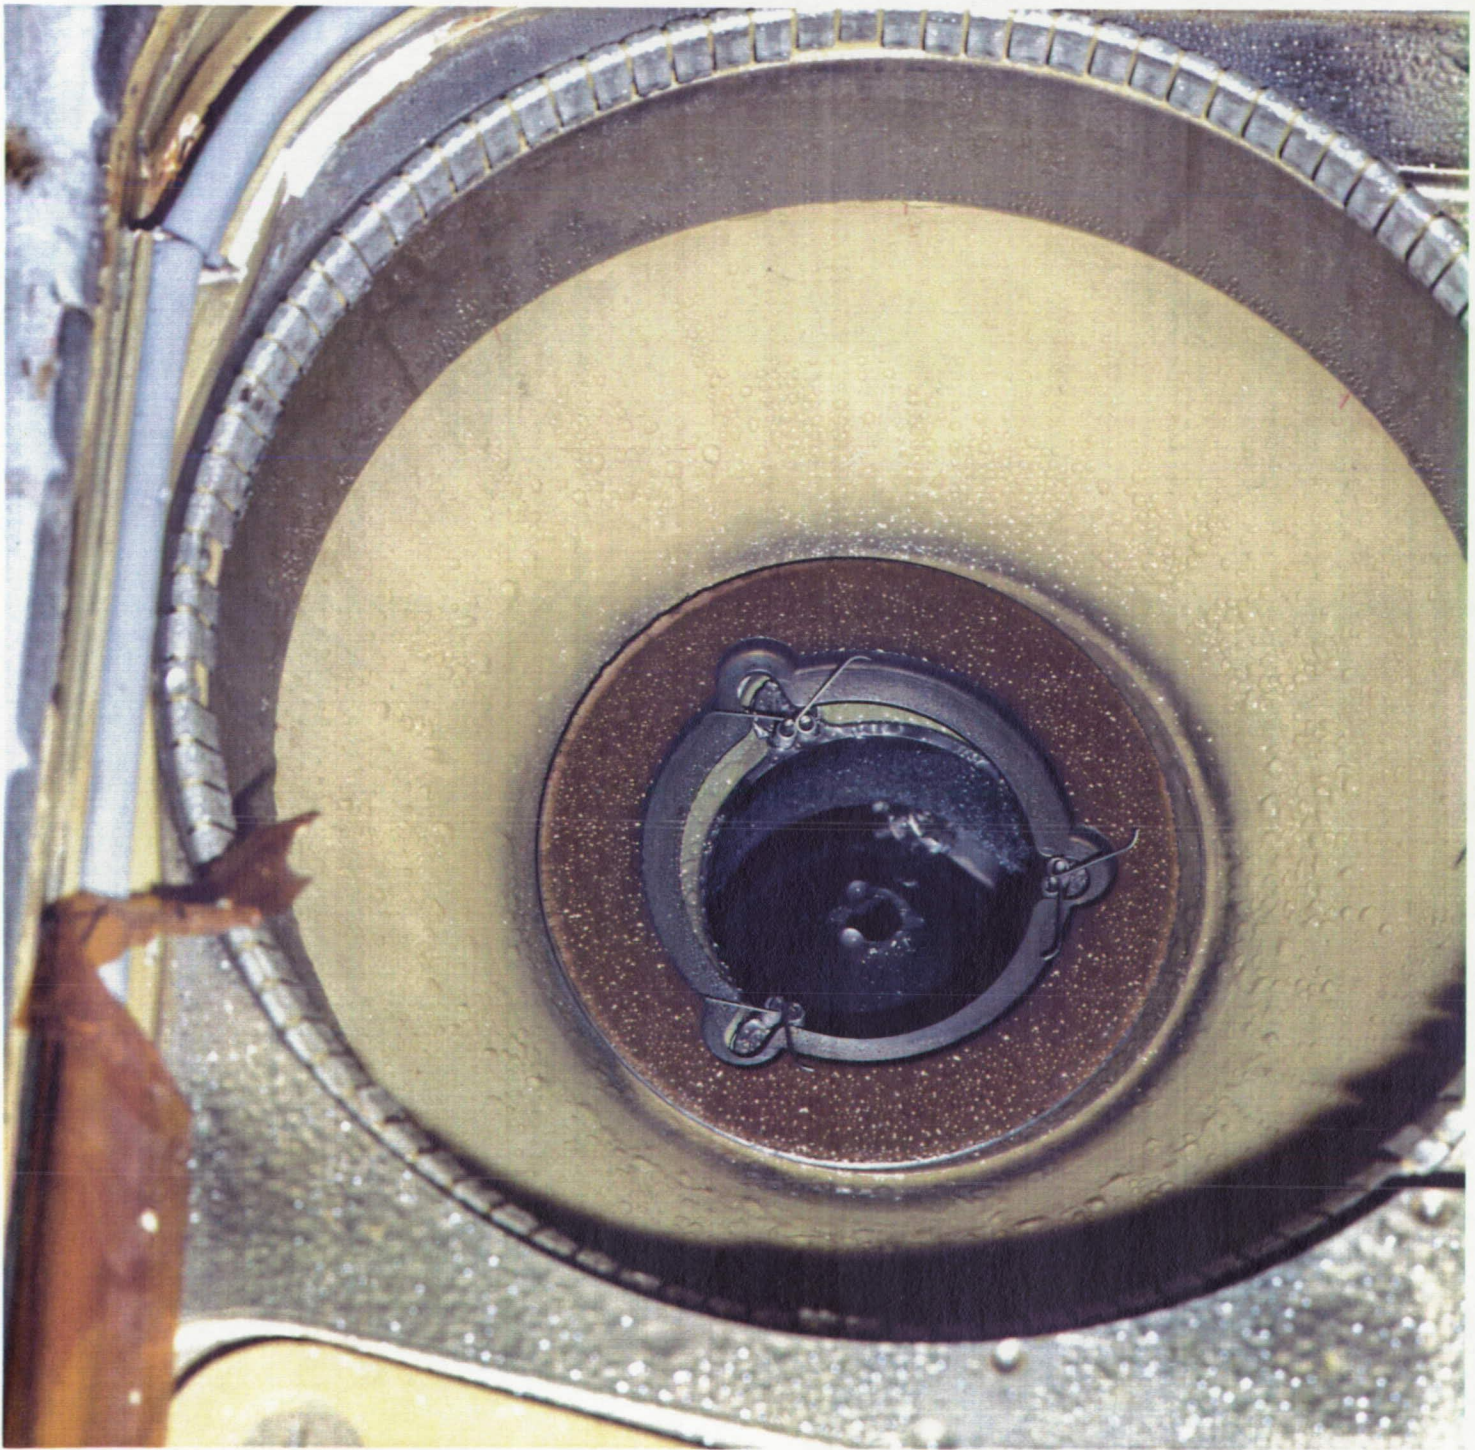
The left ET/ORB attach point (EO-2) hole plugger had not seated and was obstructed by ordnance fragments

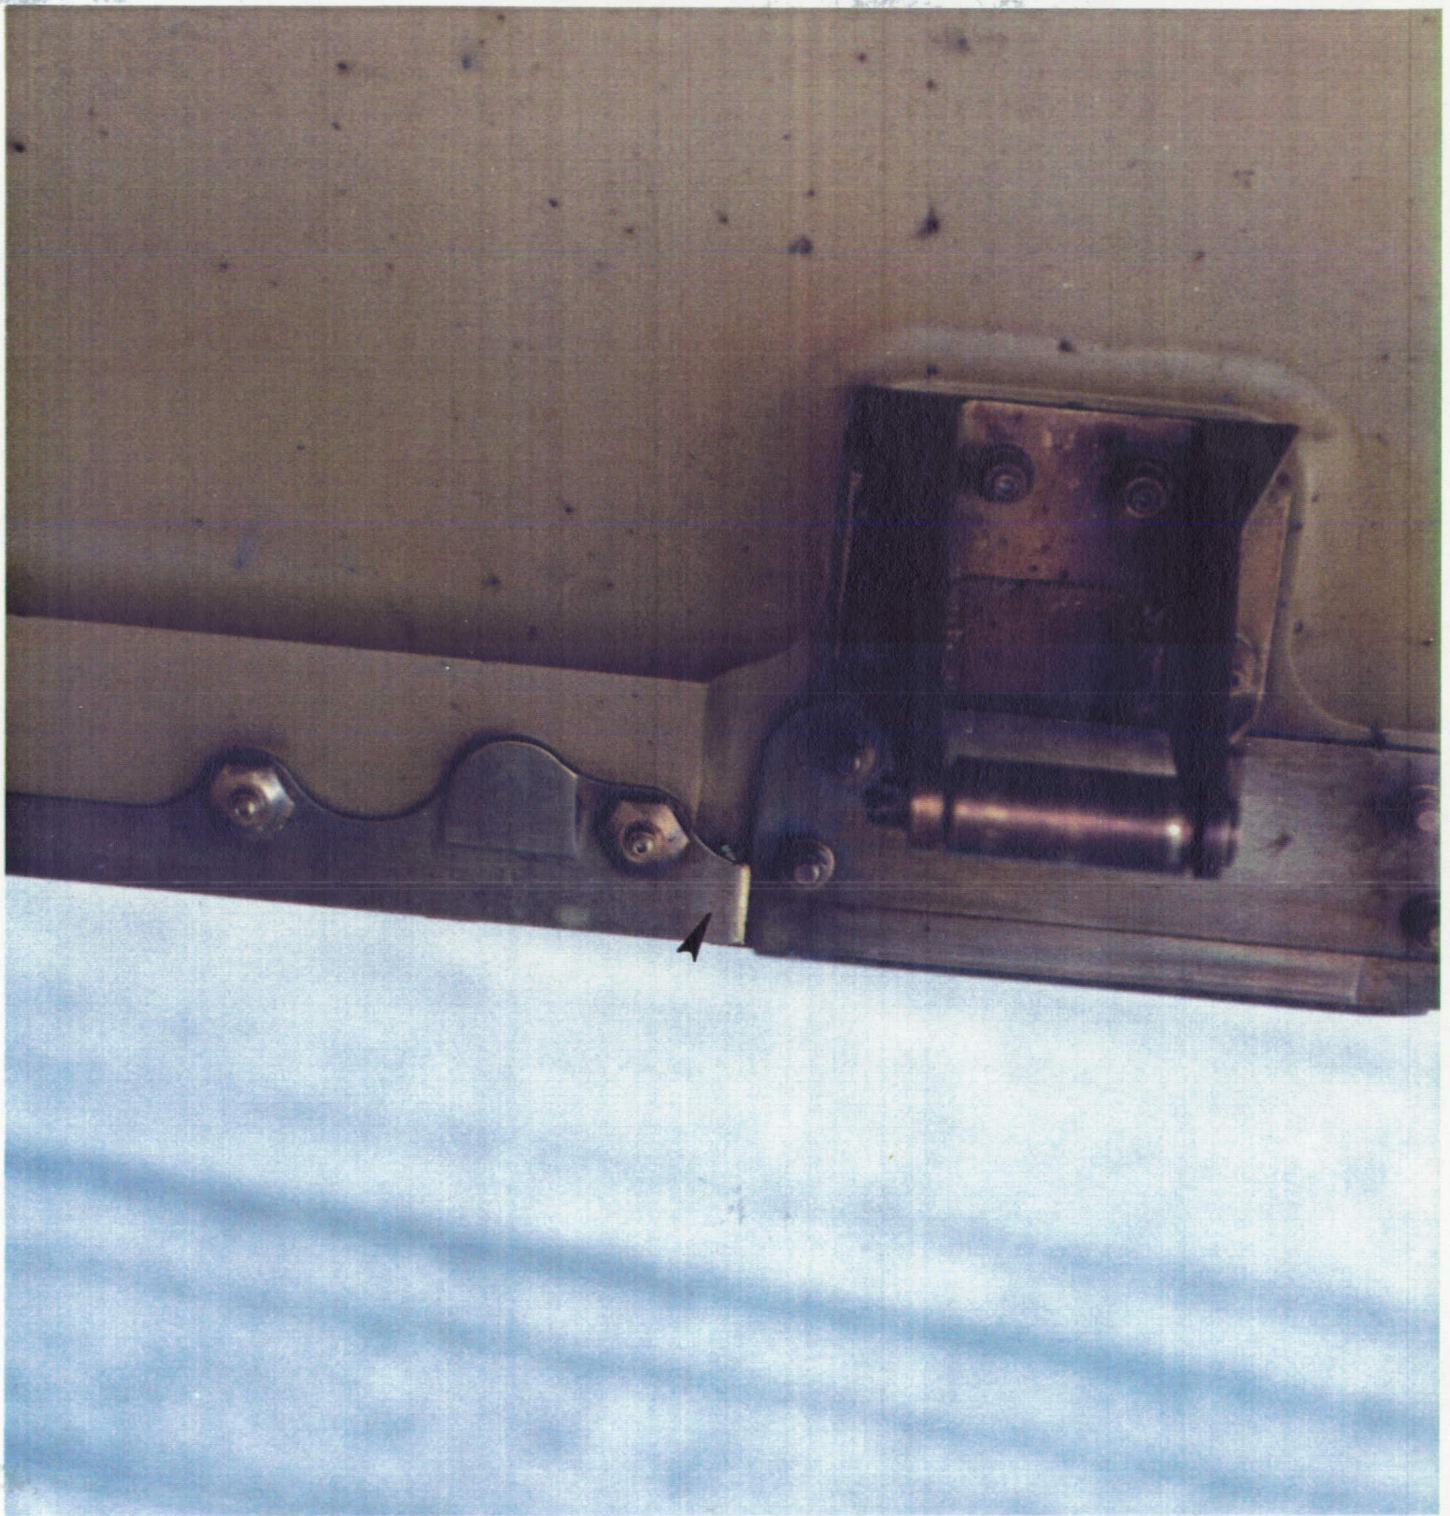
A 7/16" x 3/32" screw from the purge barrier retainer lay on the runway below the LH2 ET/ORB umbilical cavity. A nutplate with threads matching the screw was found wedged in a cavity on the ET door.

A small screw from the purge barrier retainer was found on the runway below the LH2 ET/ORB umbilical cavity. A nutplate with threads matching the screw, shown here, was wedged in a cavity on the left ET door.

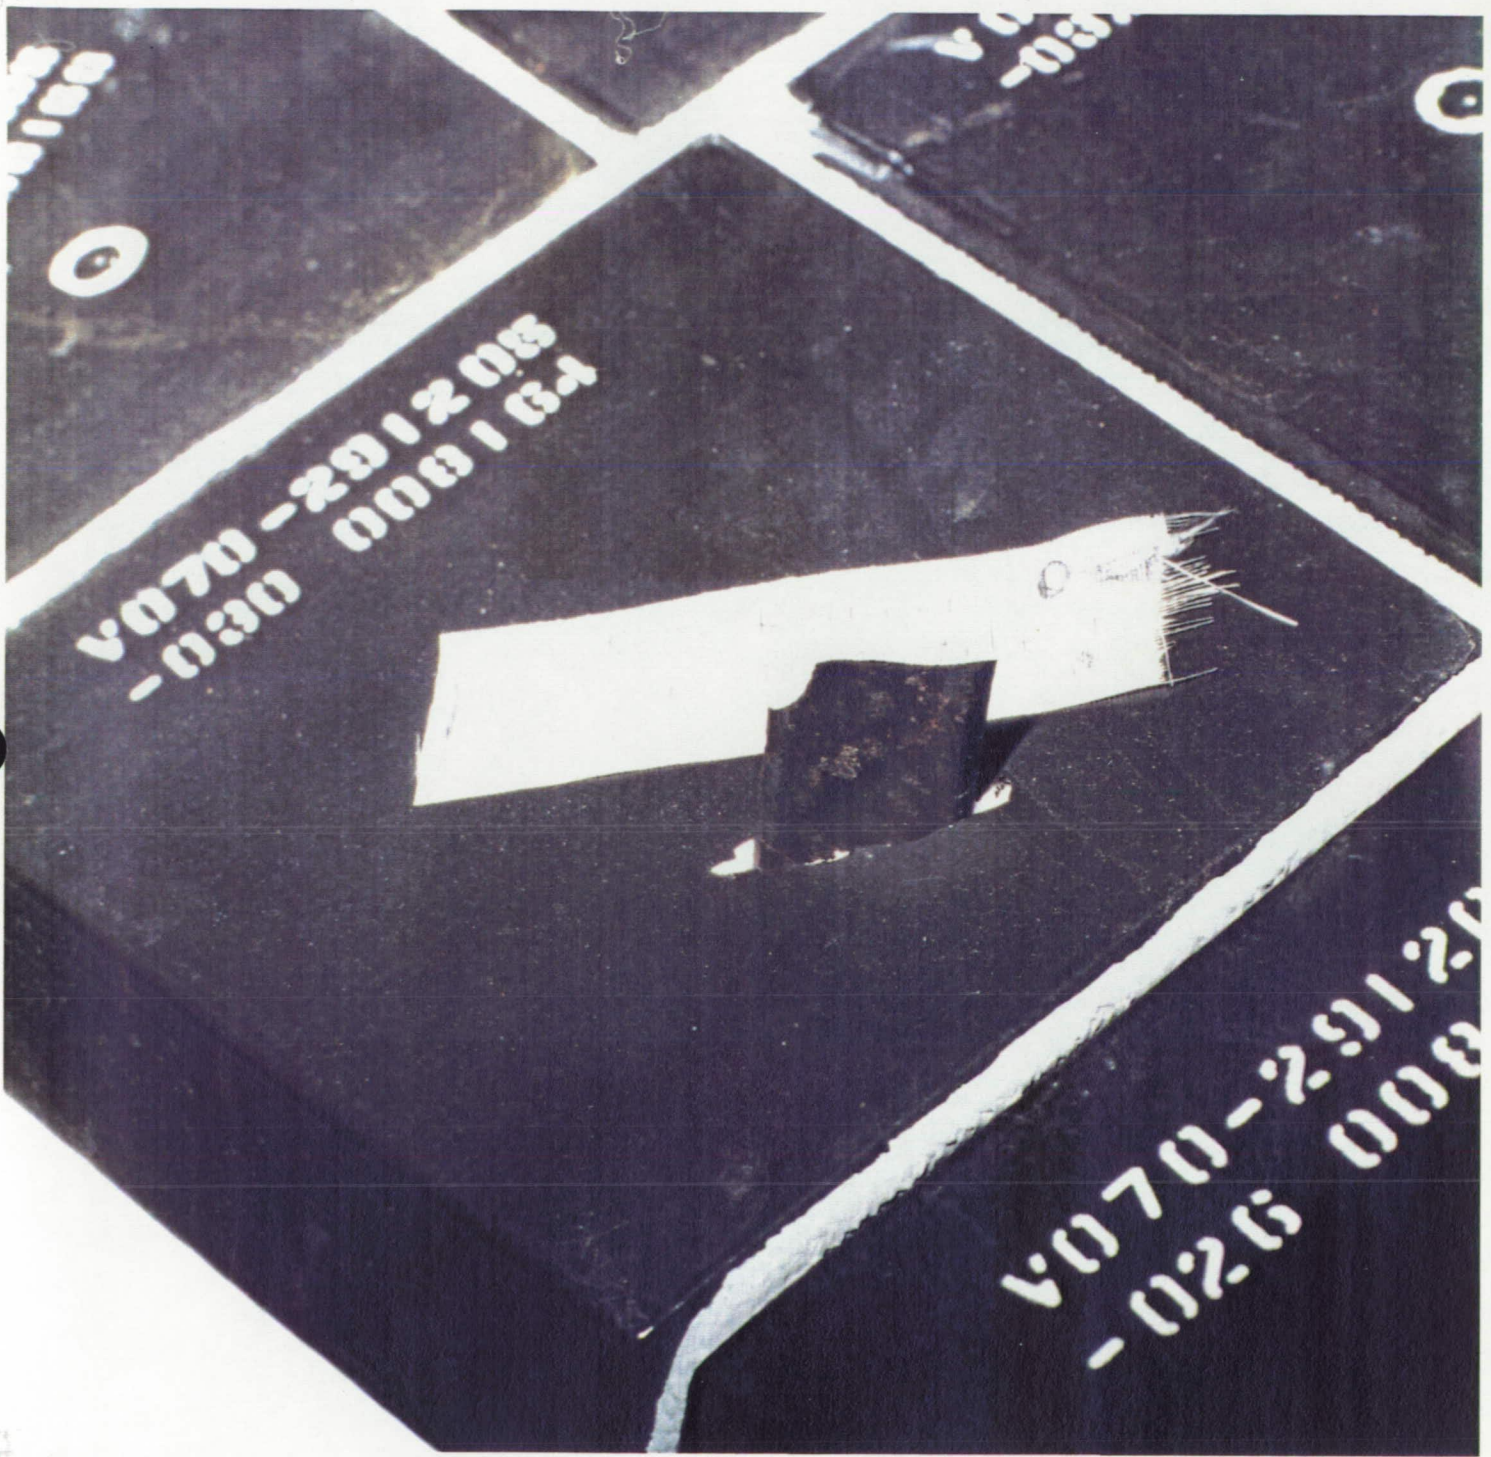
A 2" x 1" piece of metal spring was embedded in a tile on the vertical stabilizer stinger near the hinge

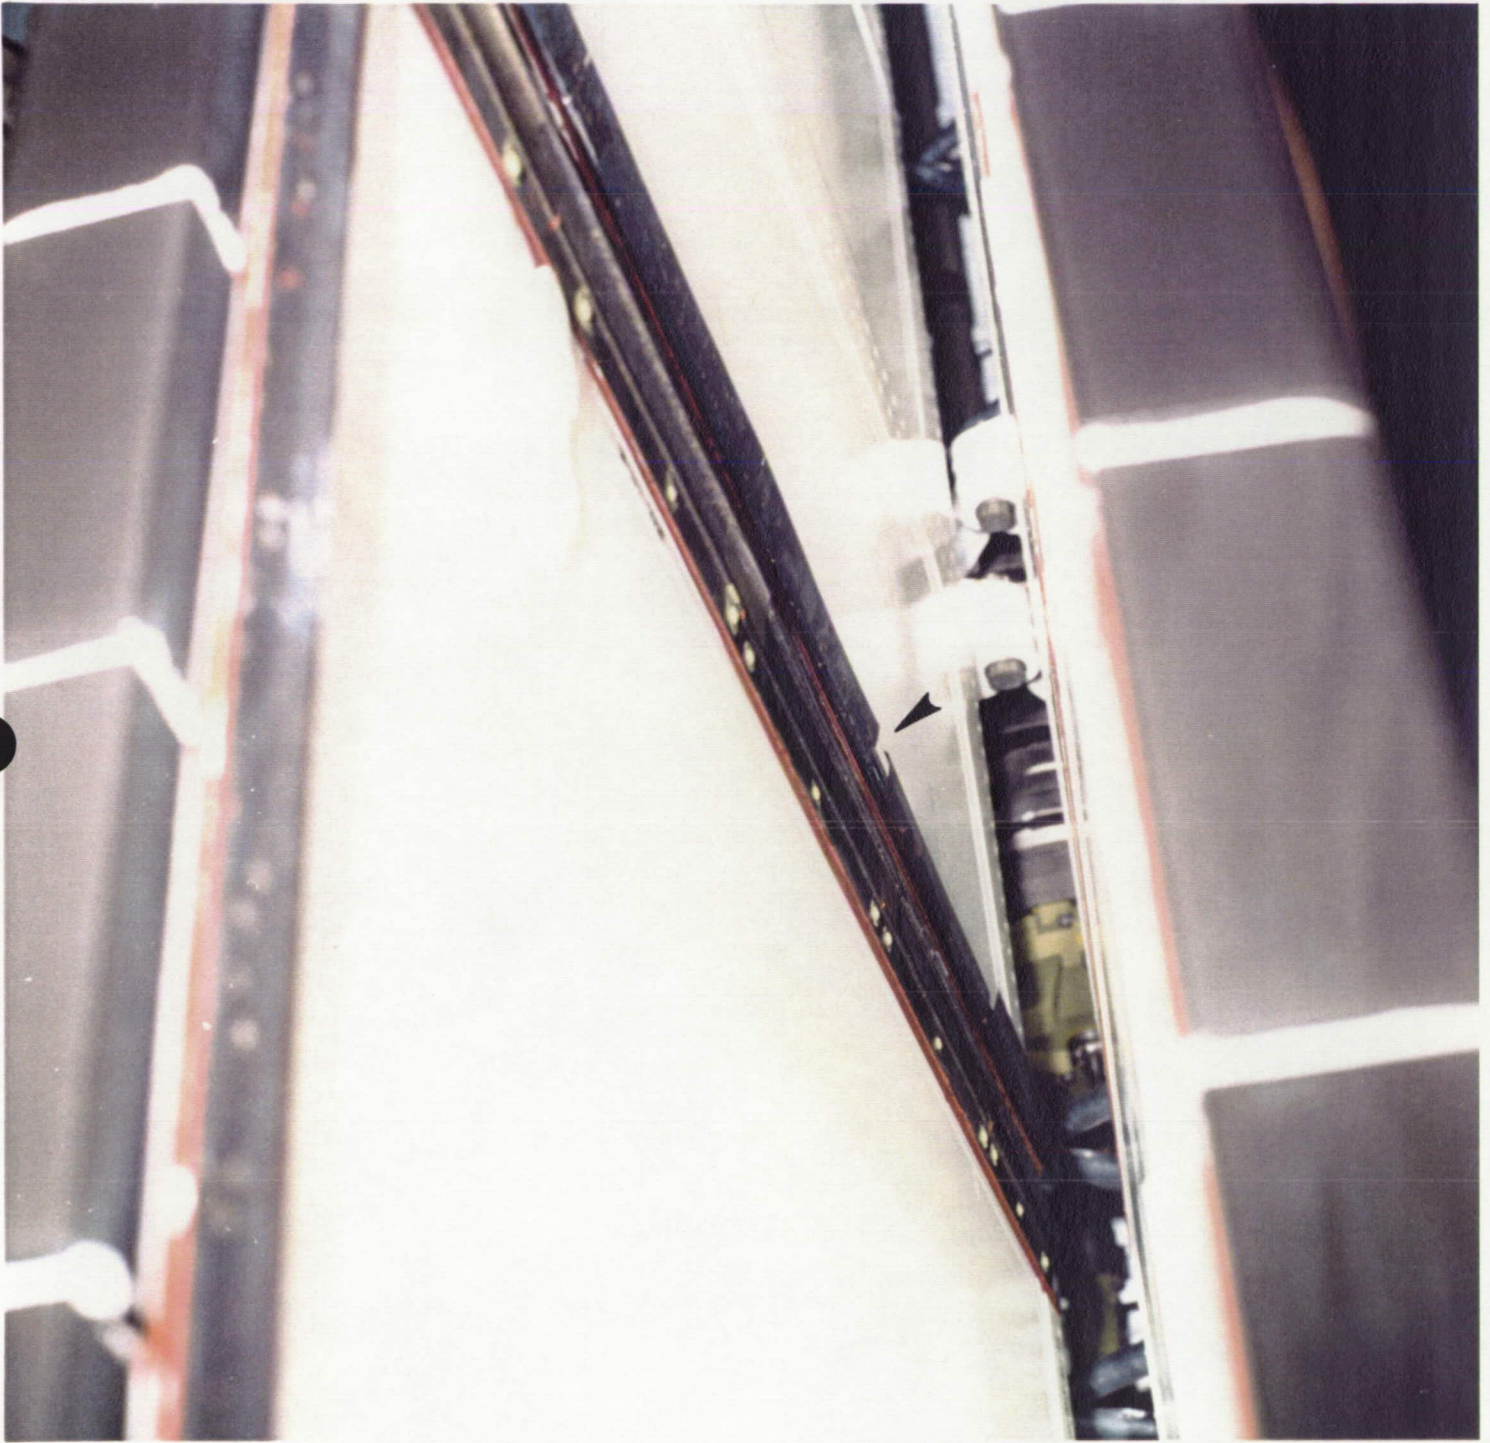
The piece of metal spring originated from the inside surface
of the rudder/speed brake left panel

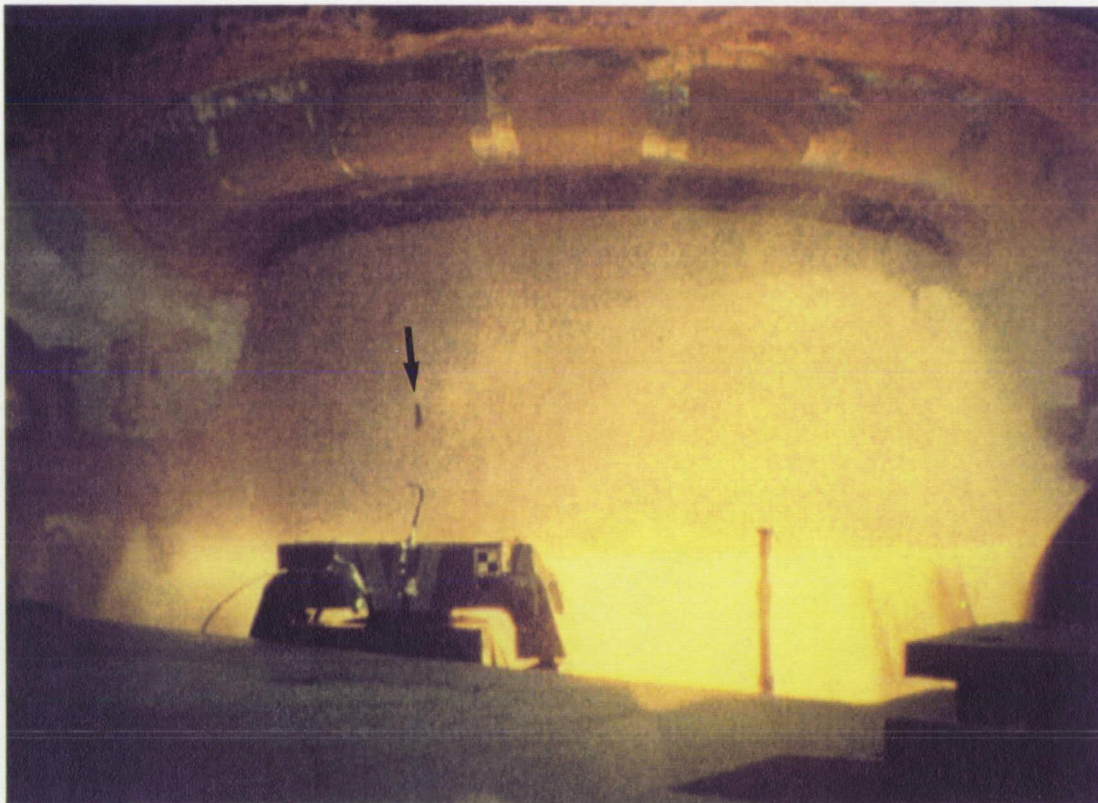
Figure 2.1.2.1 Metallic Debris from DCS Stud Hole of the RSRB HDP M-2

A metallic appearing piece of debris (see Figure 2.1.2.1) was noted to fall from the DCS stud hole of the RSRB holddown post M-2 at liftoff (13:07:23.048 UTC).

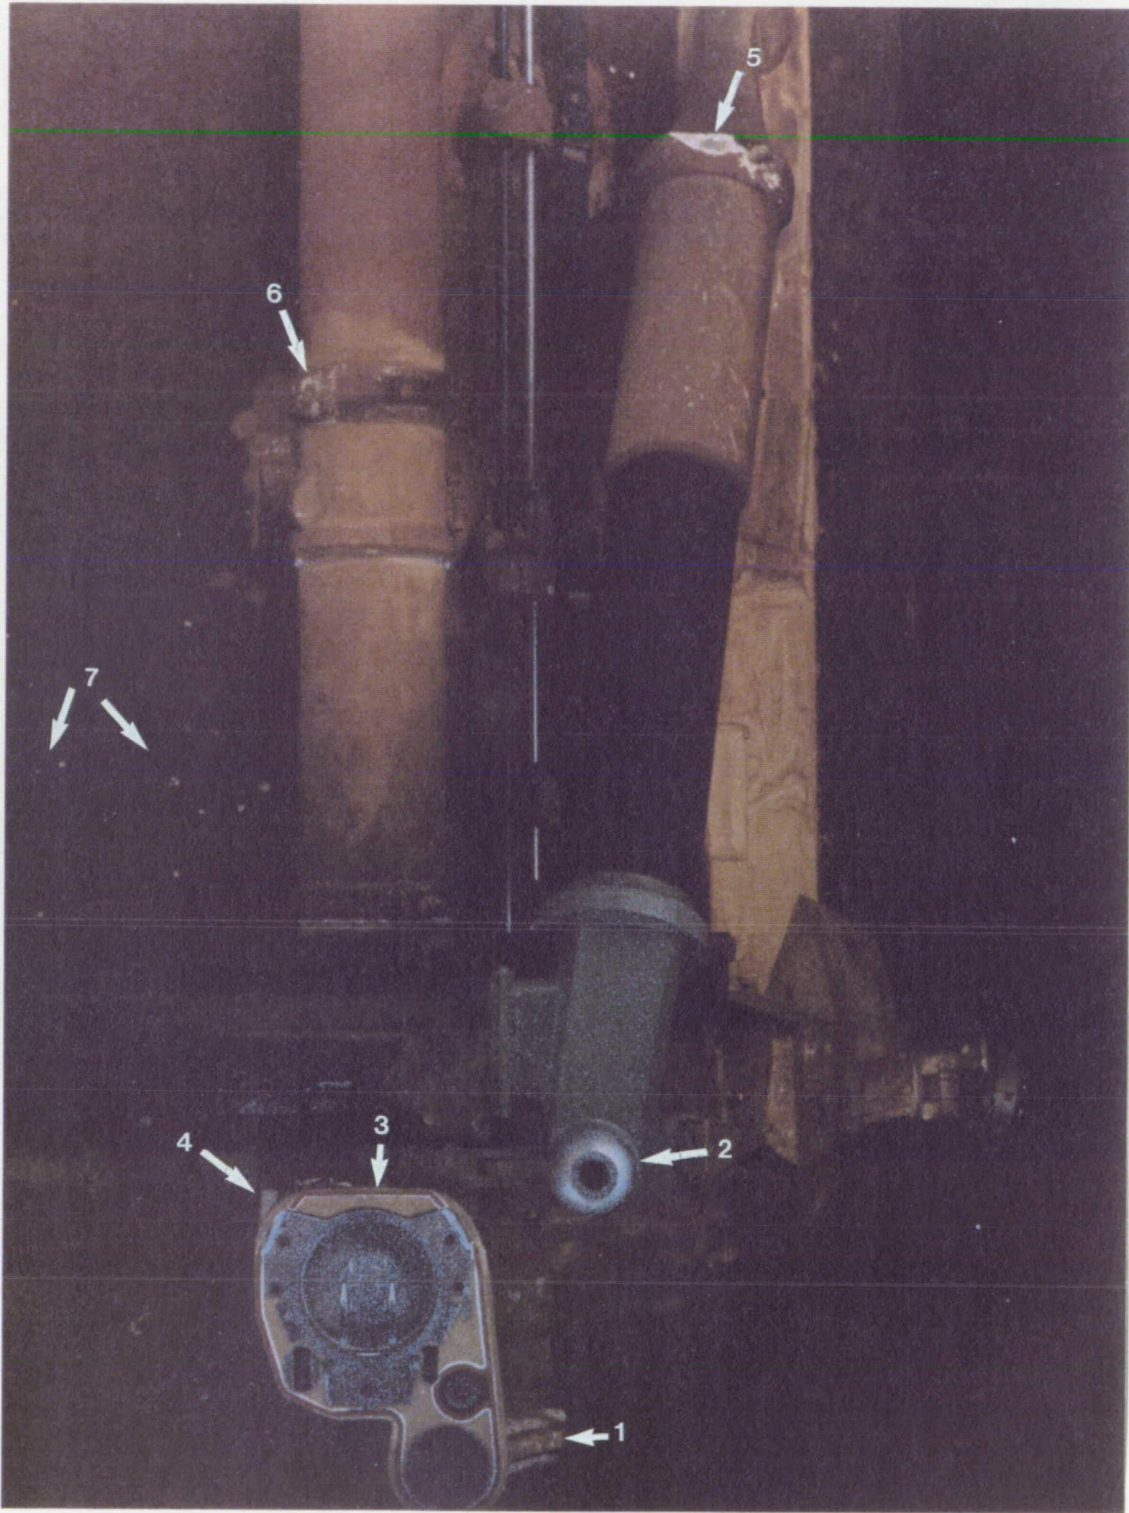
Figure 2.4.4a 35 mm Camera View of the ET LO2 Umbilical

TPS erosion was visible on the right side of the LO2 umbilical (1). A red seal around the EO-3 fitting above the LO2 umbilical was detached (2). The lightning contact strip at the

forward end of the LO2 umbilical appeared to be missing (3). JSC engineers were consulted and according to their information the electric contact strip was present prior to launch. Possible TPS damage or a piece of loose insulation was visible near the upper left corner of the LO2 umbilical (4). This possible loose insulation may be related to a three inch piece of ET foam that was found during the post landing inspection of the Orbiter LO2 umbilical by the debris inspection team. This three inch piece of foam adhered to a tile on the LO2 door near the hinge line according to the post landing inspection team report. A section of TPS was missing from the forward end of the ET aft +Y LO2 vertical thrust strut (5). The missing TPS appeared to have left a deep divot. A primed or bare metal surface was visible at the center of the missing TPS area. An engineer at MSFC stated that the missing TPS is being worked as part of the divot problem reported on the STS-56 external tank (inflight anomaly number STS-56-T-001). TPS erosion was visible on a aft bracket over the LO2 feedline at approximately station 1958 (6). Small, white marks were visible on the TPS to the left of the LO2 feedline at the base of the LH2 tank (7).
