Debris/Ice/TPS Assessment and Integrated Photographic Analysis for Shuttle Mission STS-57

July 1993

Gregory N. Katnik
NASA/Kennedy Space Center

DEBRIS/ICE/TPS ASSESSMENT
AND
PHOTOGRAPHIC ANALYSIS
OF
SHUTTLE MISSION STS-57

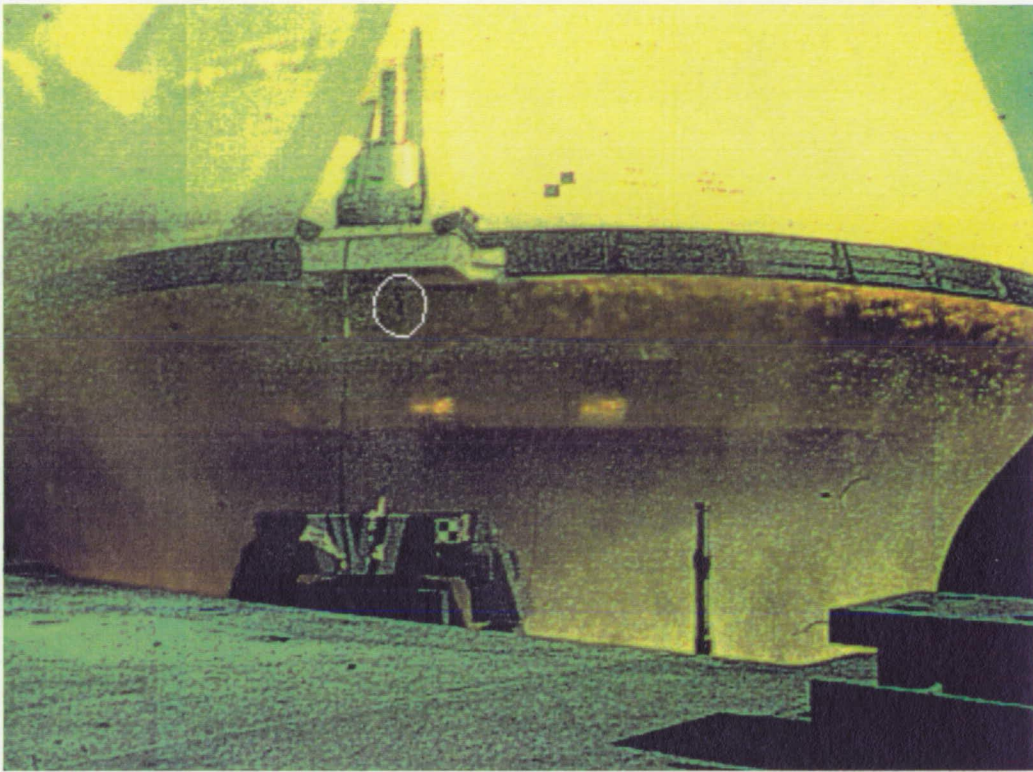
Figure 1.

Frangible nut material from holddown post M-2.

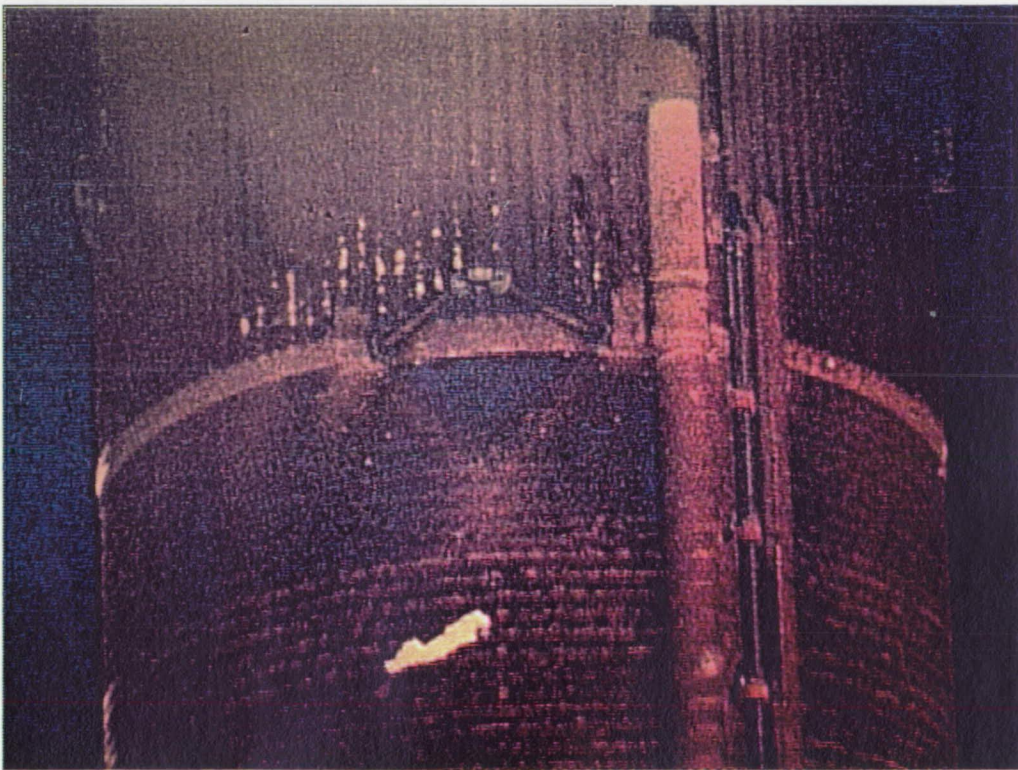
Figure 2.

Popcorning of TPS near bipod strut and large divot on LH2 tank.

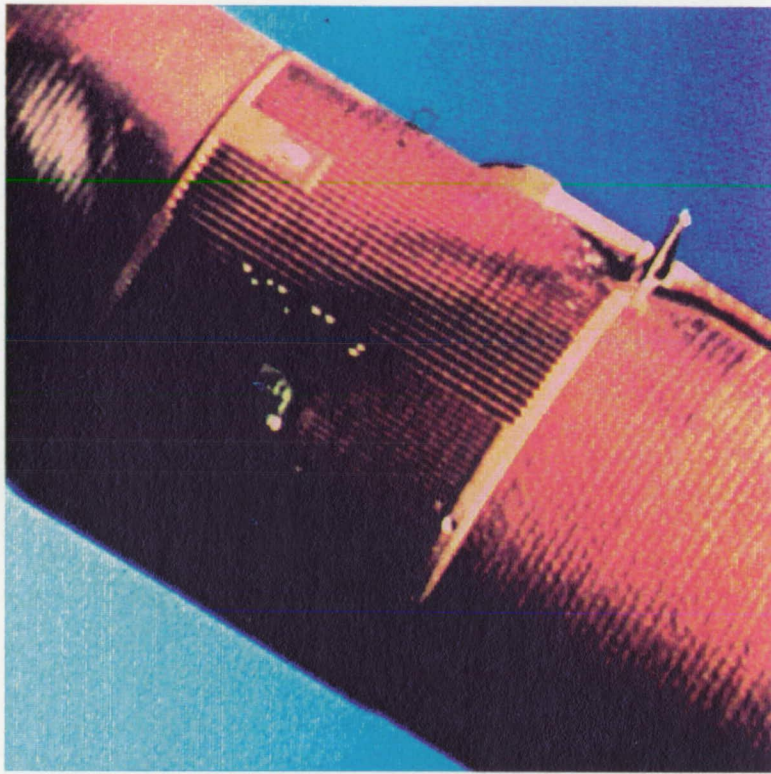
Figure 3.

Divots on intertank near left SRB attach point.

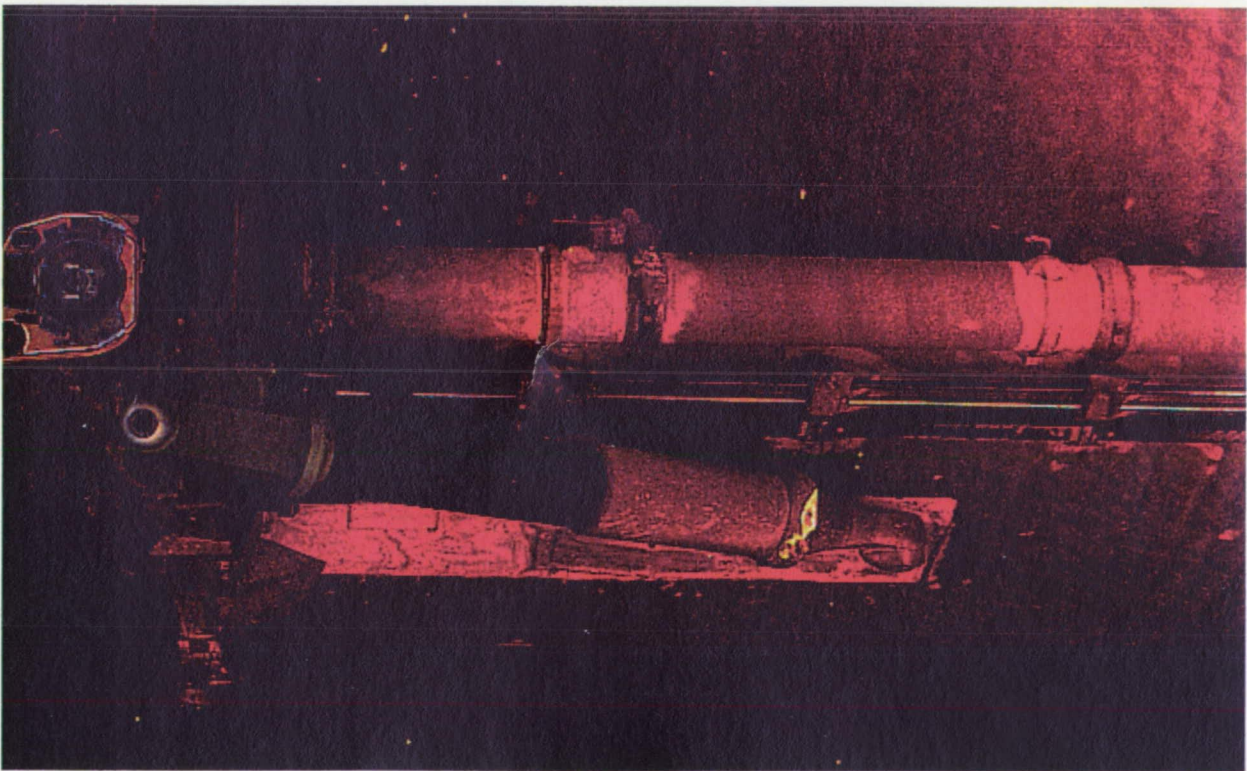
Figure 4.

Divots on thrust strut.
