# WARTIME REPORT

FLIGHT TESTS OF THE THERMAL ICE-PREVENTION  
EQUIPMENT ON THE B-17F AIRPLANE

By Bonne C. Look

Ames Aeronautical Laboratory  
Moffett Field, California

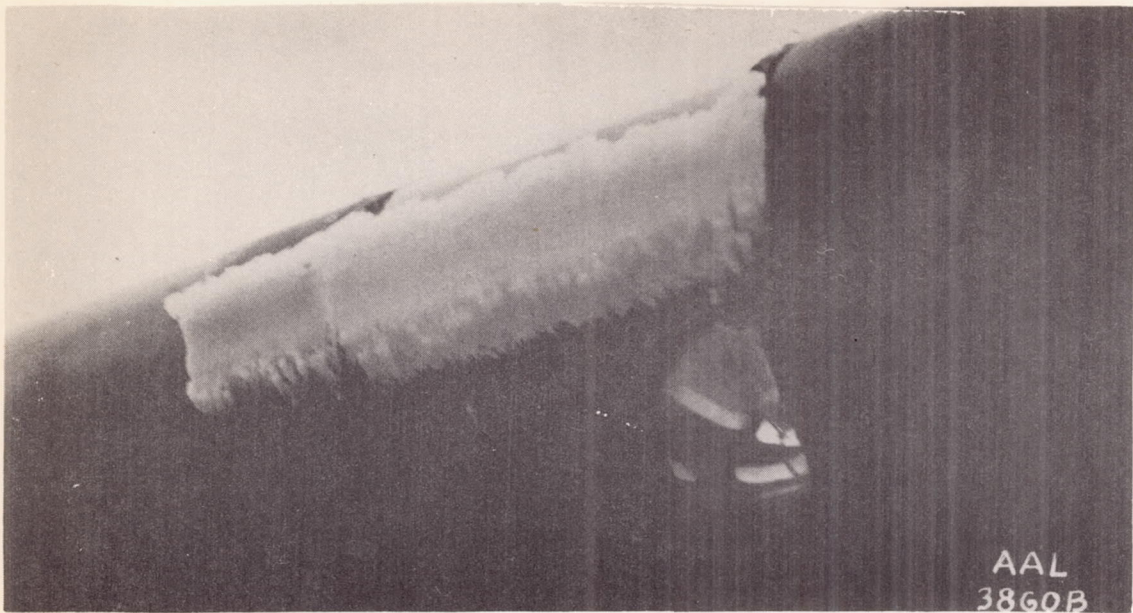
The wing outer panels from stations 19A to 33 were free from ice formations during all the icing conditions encountered. Ice formed on the wing-tip leading edges during all the icing flights. The unheated landing-light cover and the leading edge at the wing splice accumulated ice as shown in figure 16. Figures 17 and 18 are photographs of the right and left wing inner panels and illustrate the partial protection afforded the right wing inner panel, between nacelles 3 and 4, by the ice-prevention system.

Figure 16.- Rime-ice formation on the right-hand landing-light cover and on the unheated leading edge at the wing splice. The photograph was taken after landing from test 7.

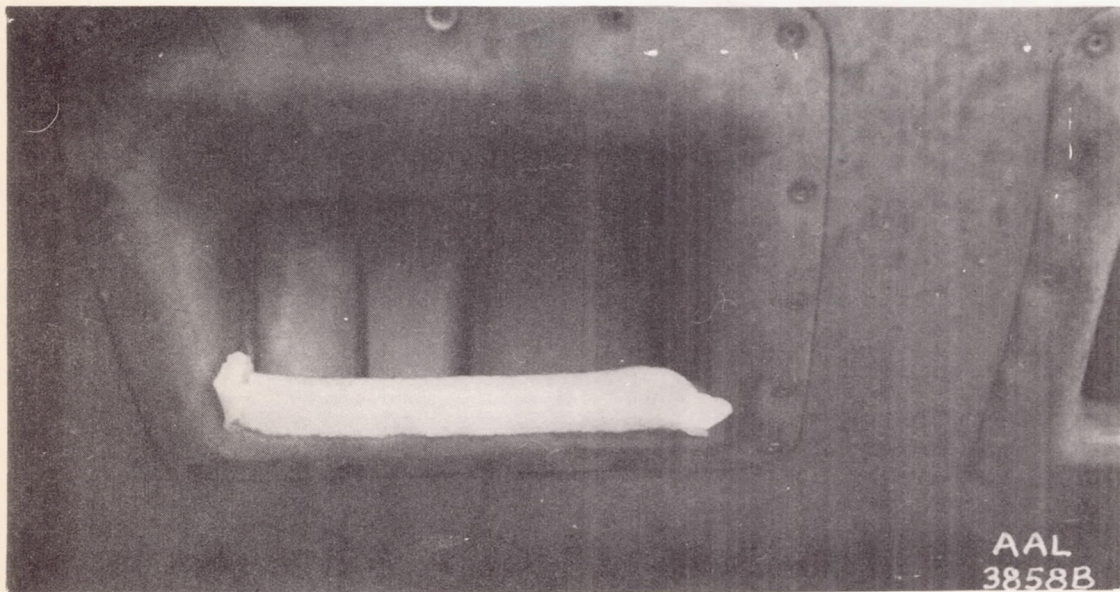
The heated inlets were not visible to the flight personnel during flight, but ice accumulations were observed on these inlets after landing, similar to the formations shown in figure 19, which is a photograph of the intercooler air inlet for engine 1. Figures 20 and 21 show further examples of ice accretions on the air inlets. An accumulation of ice in the elbow of the ducts leading from the air inlets in the wing leading edge to the engines was observed after most of the icing flights. The most severe accumulations were observed after landing

from test 7, at which time figure 19 was obtained and shows ice on the turning vanes in the duct elbow, aft of the inlet. During flights ice was observed to accumulate on the inlets of the oil coolers to the extent that the inlet area was decreased to approximately one-half the normal area. The ice accumulated on the inlets did not appear to affect the operation of the engines during the reported limited flights in icing conditions. However, during extended operation in inclement weather, it is probable that the inlets may become sufficiently obstructed with ice to prevent desired oil cooling and eliminate the carburetor and intercooler inlets as a source of air.

Figure 19.- Rime-ice formation on the lower lip and on the turning vanes in the duct of the intercooler air inlet located in the left wing leading edge outboard of nacelle 1, accumulated during test 7. (Photographed after landing.)

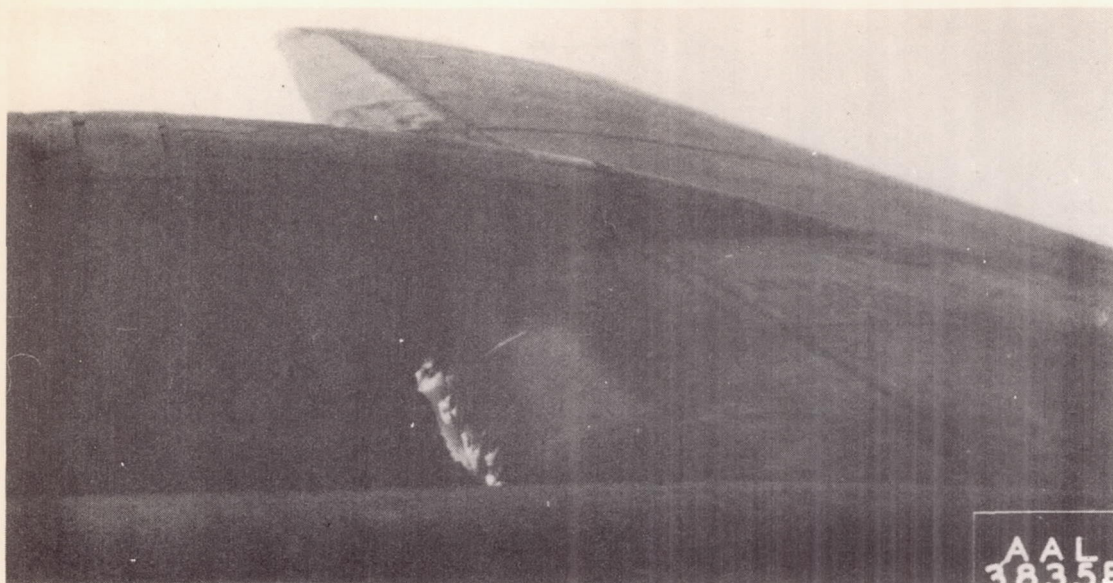
The upper surface of the wing inner panel was visible during flight, and light accumulations of ice were observed in this region during tests 4, 5, and 7. Figure 17 is a photograph of the heated region of the wing inner panel visible during test 7. Most of the ice accumulation shown has formed on the oil-cooler inlet for engine 4 and not on the heated region of the wing leading edge. The oil-cooler inlet was observed to accumulate ice during every flight in icing conditions. Figure 18 shows the unheated wing inner panel between nacelles 1 and 2

Figure 17.- Ice accumulation on the heated leading edge of the right-hand wing between nacelles 3 and 4 during test 7.

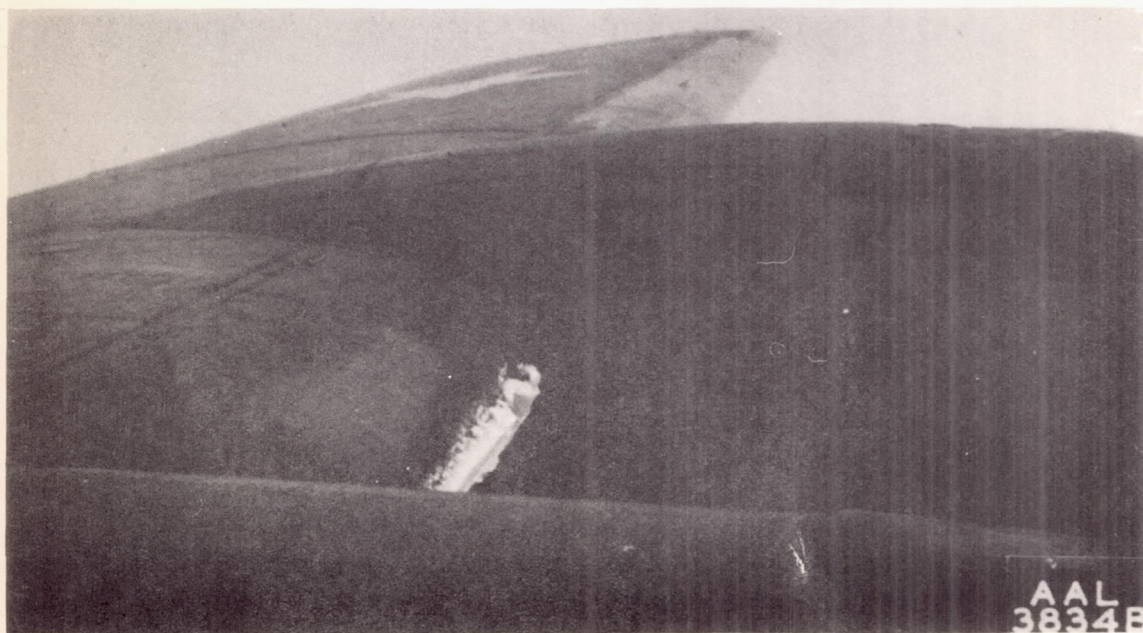
Figure 18.- Ice formation on the unheated leading edge of the left wing between nacelles 1 and 2, test 7.

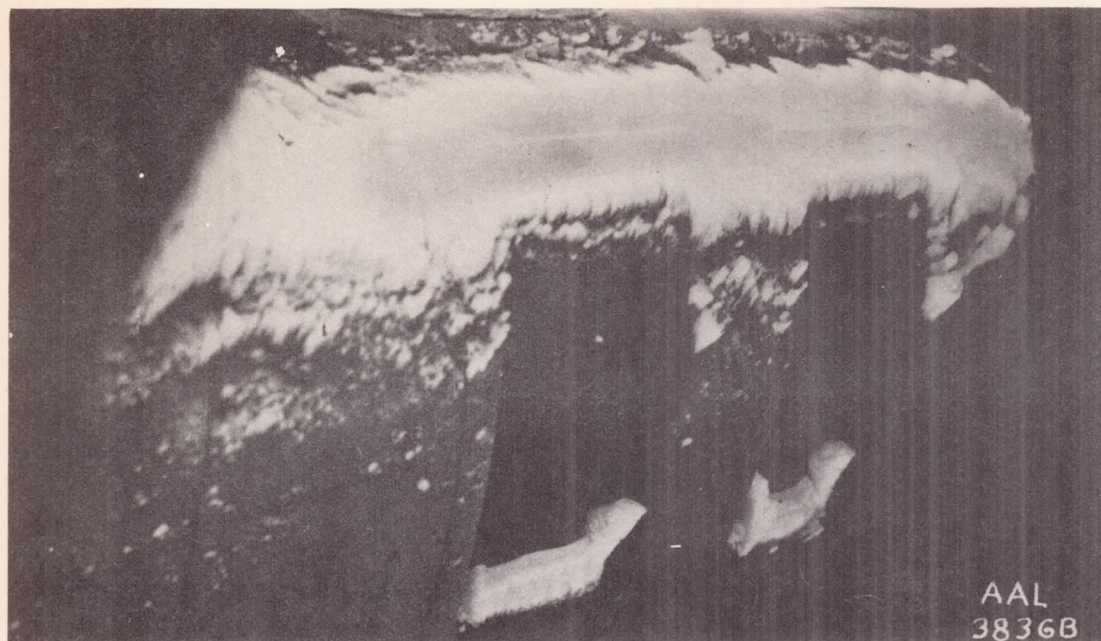
The susceptibility of unprotected surfaces of the airplane to icing is illustrated in figures 20, 27, 33, 42, and 43. The ice accumulations shown resulted from limited flight in icing conditions and indicate the necessity of providing protection for airplanes to be flown in inclement weather.

Figure 20.- Rime-ice formation on the unheated wing leading edge and carburetor and intercooler air inlets between the fuselage and the left inboard nacelle, accumulated during test 7. (Photograph taken after landing.)

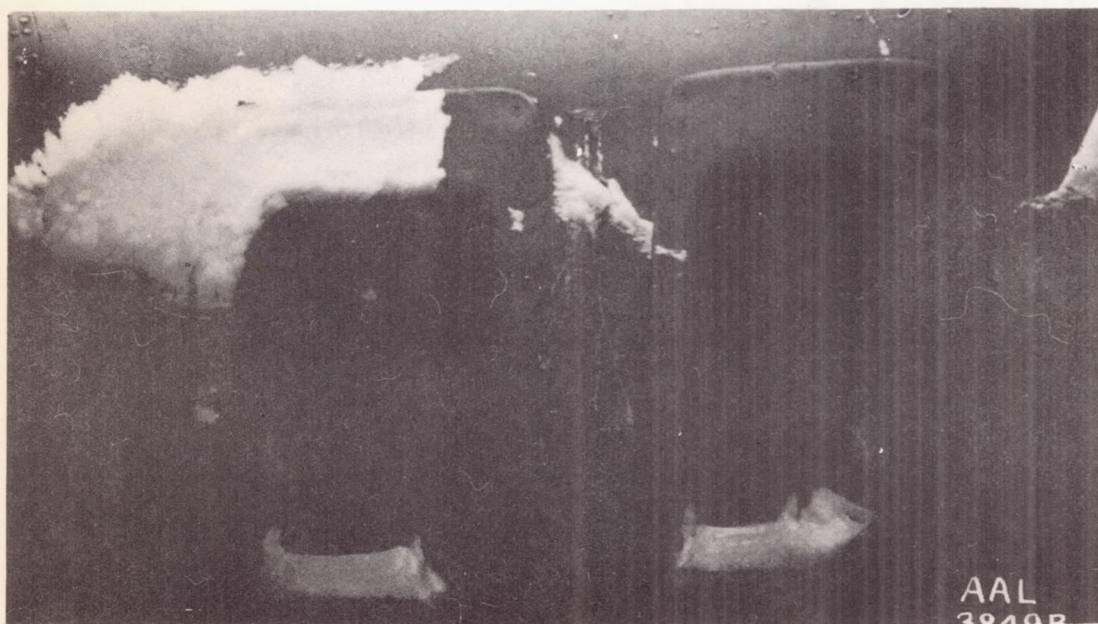
Figure 21.- Rime-ice accumulations around the carburetor and intercooler air inlets in the unheated wing leading edge between the fuselage and the right inboard nacelle during test 7. (Photograph taken after landing.)

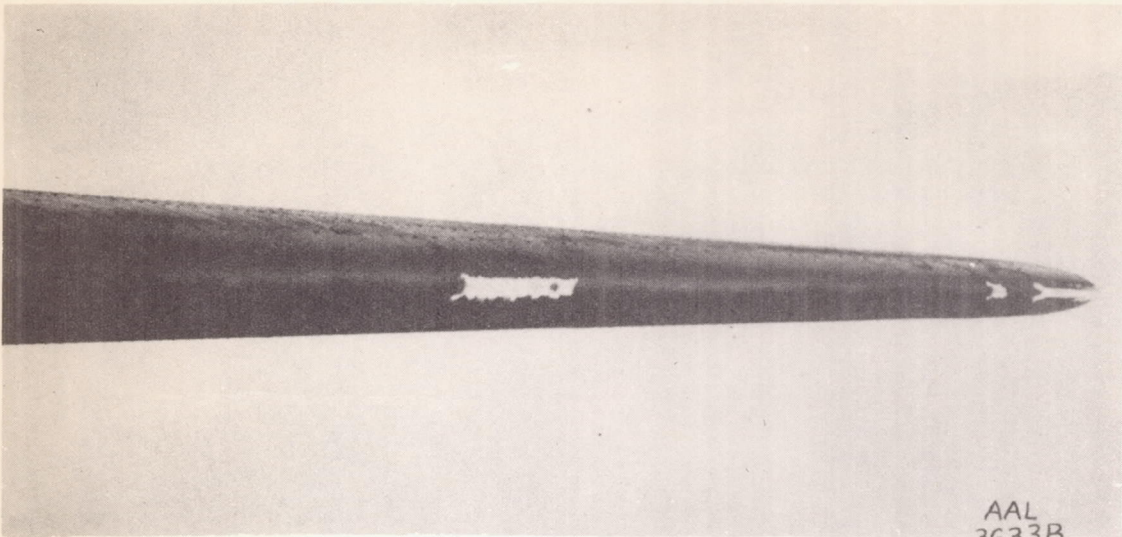
Figure 22.- Ice accumulations on the leading edge of the left horizontal stabilizer during flight of February 23, 1943.

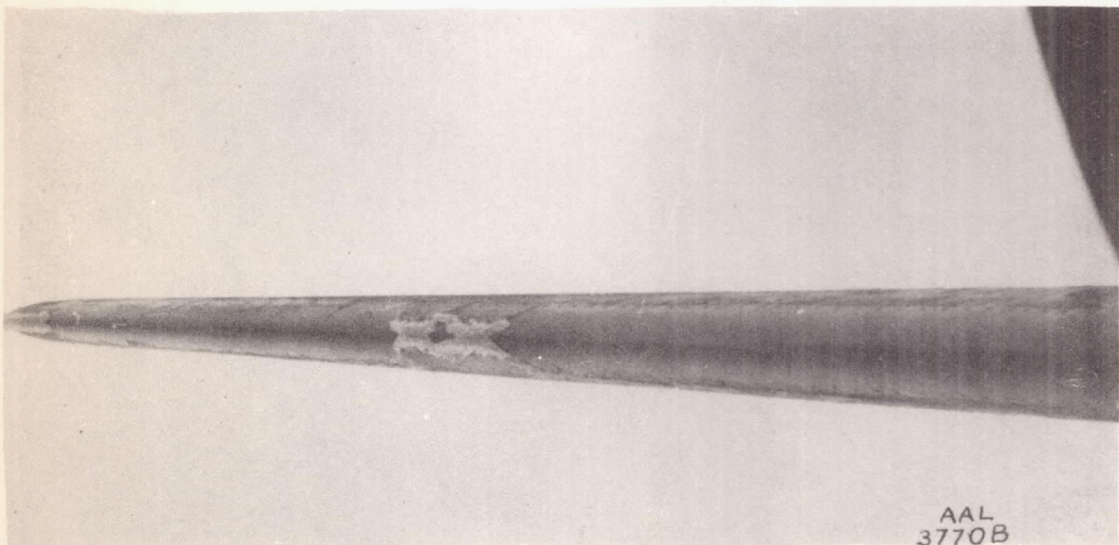
During all the icing flights the heating system prevented the accumulation of ice on the major portion of the heated region. The areas of the leading edge which were not adequately protected to prevent the accumulation of ice during all conditions were at the tip, at midspan, and about 10 inches of the leading edge at the junction of the horizontal stabilizer and fuselage. The extent to which the horizontal stabilizer accumulated ice is shown in figures 22, 23, and 24. In the most severe icing conditions (tests 4 and 5) ice was observed to form on the aft region of the heated double-skin and on the upper and lower surfaces of the horizontal stabilizer aft of the heated leading edge (figs. 23, 24, and 25).

The ice formations which accumulated on the leading edge of the horizontal stabilizer were found to be at the inboard, midspan, and tip regions where the distribution duct had been discontinued and the heated air discharged into a chamber through a 1-inch-diameter hole in the end of the duct (fig. 6). The thermocouples which indicated the leading-edge skin temperatures were located in or near the regions where ice accumulated and, therefore, may not give a true indication of the temperature rise of the protected portion of the leading edge. The thermal data, given in table IV for the horizontal stabilizer, show an average skin temperature rise for the leading edge of approximately  $30^{\circ}$  F for tests 1, 3, 4, and 5, and  $65^{\circ}$  F for test 7. During the dry-air flights (tests 2 and 6) the average skin temperature rise was approximately  $40^{\circ}$  F. The increase in engine power conditions (test 5) did not materially affect the skin temperature rise or the degree of protection afforded by the ice-prevention system. The heated-air flow rate to the horizontal stabilizer was not obtained, but the total weight of air supplied to the empennage group was determined and the distribution of the air to the horizontal and vertical stabilizers was based upon the skin temperature rises.

Figure 23.- Glaze-ice accumulation on leading edge of the right horizontal stabilizer at the tip, at mid-span, and in scattered areas on the aft portion of the double skin during tests 4 and 5.

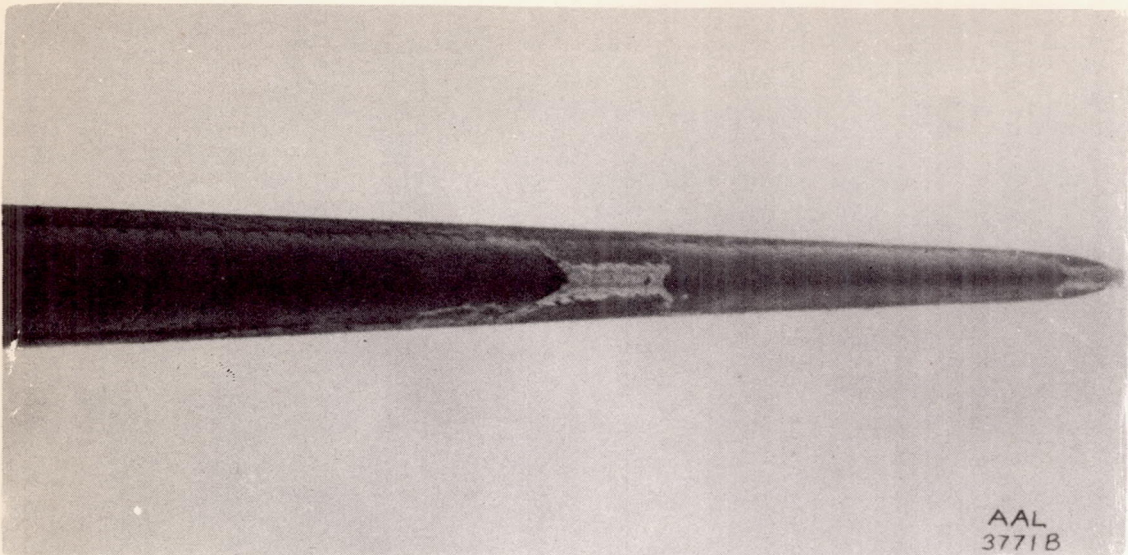
Figure 24.- Ice formation on the left horizontal stabilizer accumulated during tests 4 and 5.

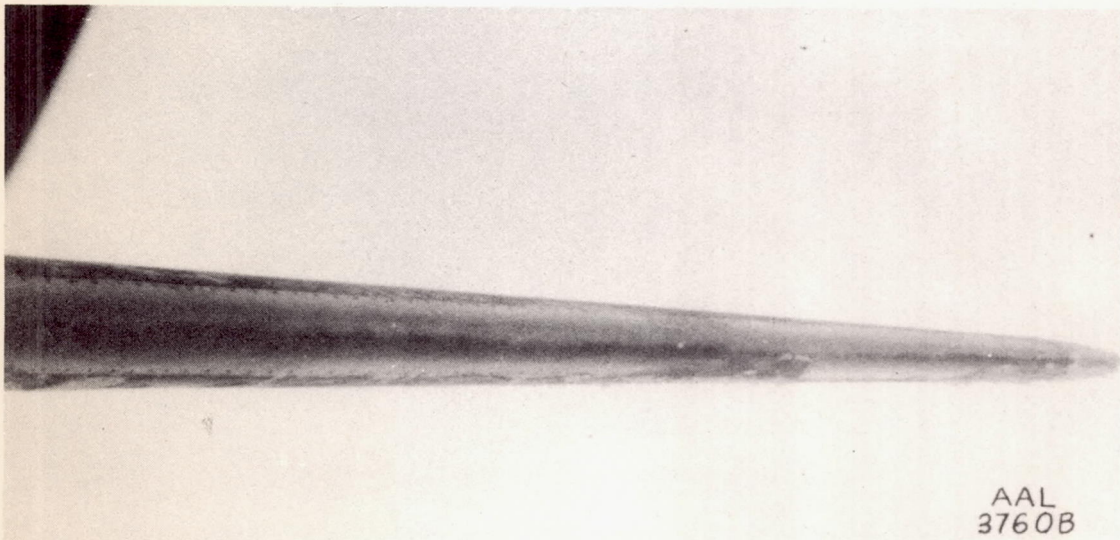
Figure 25.- Ice formation on the leading edge of the left horizontal stabilizer tip, on the aft portion of the double skin, and aft of the double skin on the upper and lower surfaces, accumulated during tests 4 and 5.

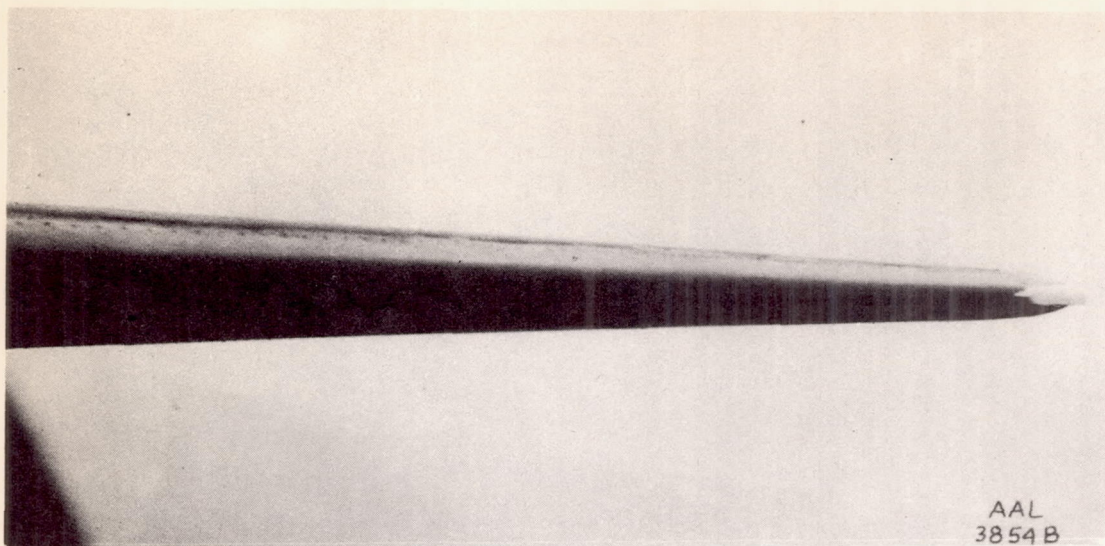
Figure 26.- Rime-ice accumulation on the left horizontal stabilizer during test 7.

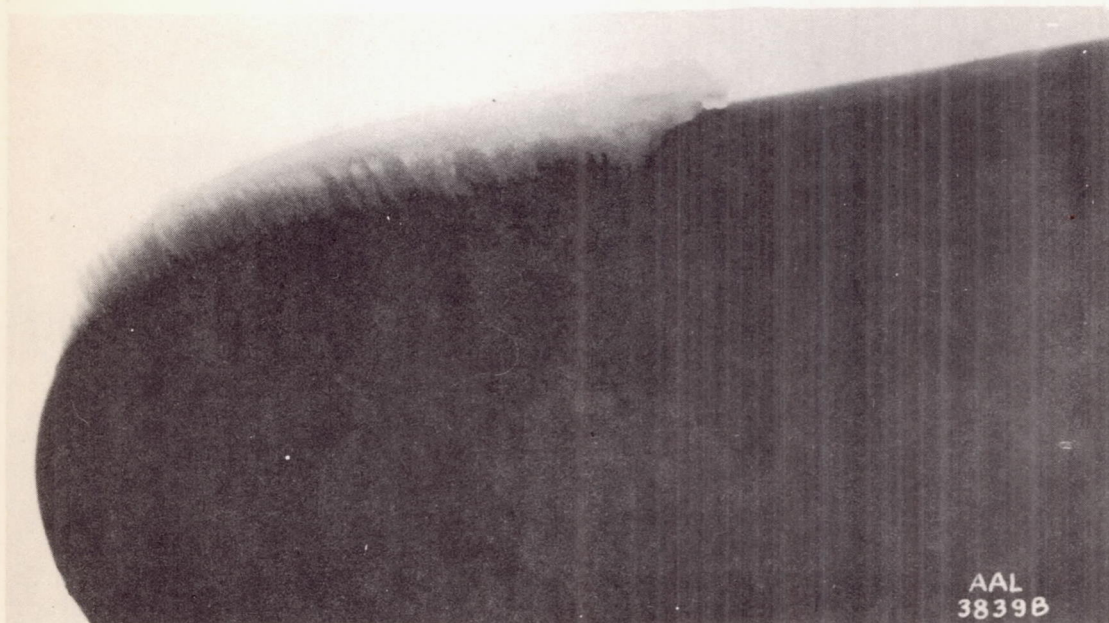
Figure 27.- Rime-ice accumulation on the right horizontal stabilizer tip during test 7. (Photograph taken after landing.)

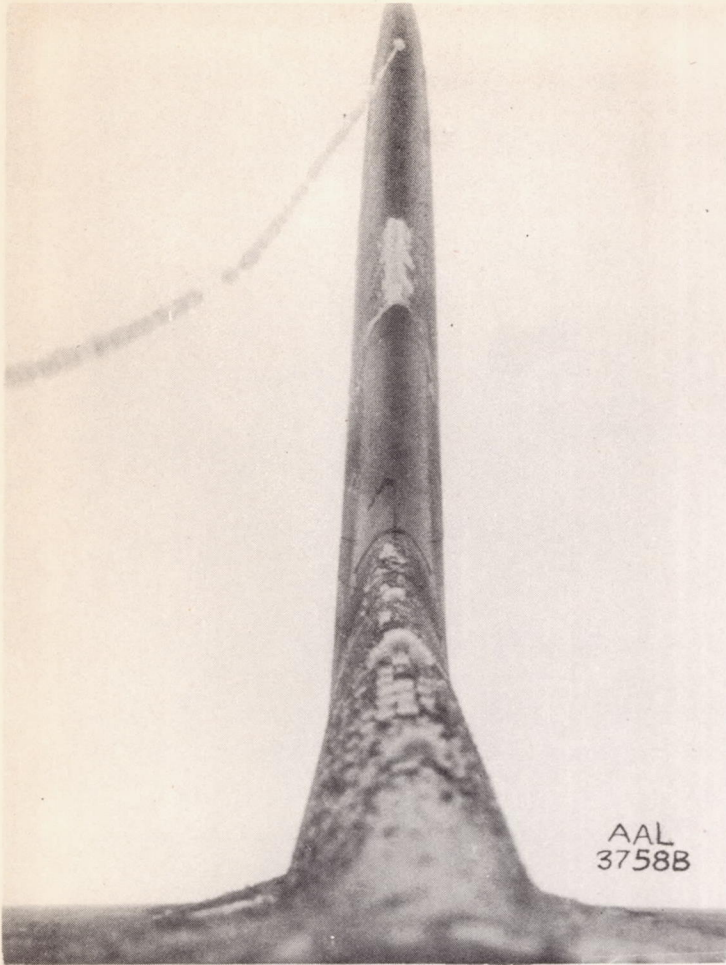
In addition to the wing, empennage, fuselage, and engine cowls, unprotected objects, such as the airspeed-head support masts, the housings for the loop antenna and the fuel booster pumps, and the drift sight were observed to be subject to icing. Figure 43 is a photograph of ice formations accumulated during test 7 on the drift sight, the loop-antenna housing, and the left airspeed-head support mast. The ice accumulations observed on these unprotected protrusions and on the rivets and running lights (figs. 28, 29, and 30) illustrate the extreme importance of aerodynamic cleanness.

Figure 28.- The vertical stabilizer showing ice accumulation on the heated leading edge in the region of the dorsal and fin joint, and on the unheated forward portion of the dorsal during tests 4 and 5.

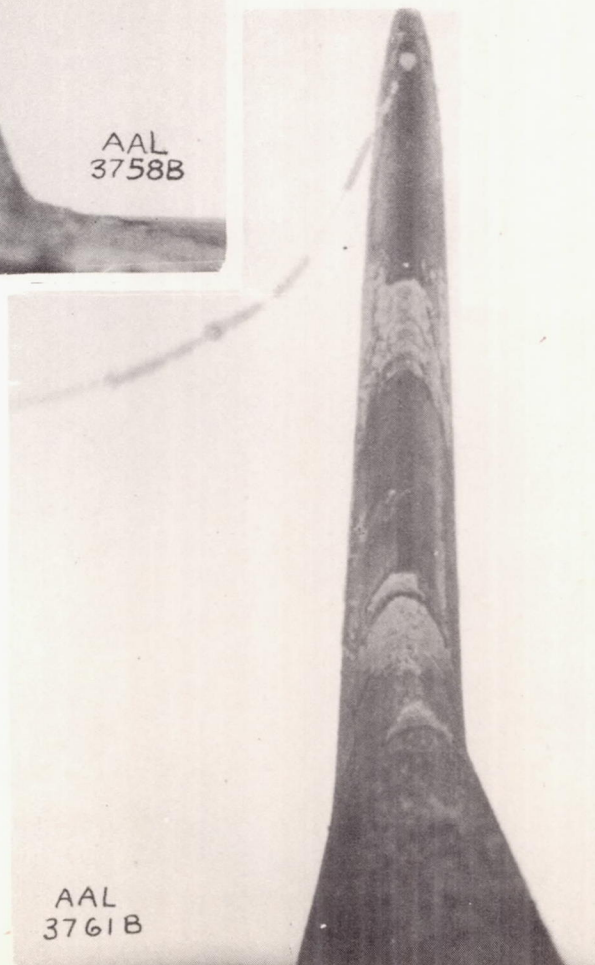
Figure 29.- The vertical stabilizer showing the accumulation of ice on the leading edge of the dorsal forward of the heated double skin, on the leading edge at the junction of the dorsal and fin, at the fin tip, and aft of the leading edge during tests 4 and 5.

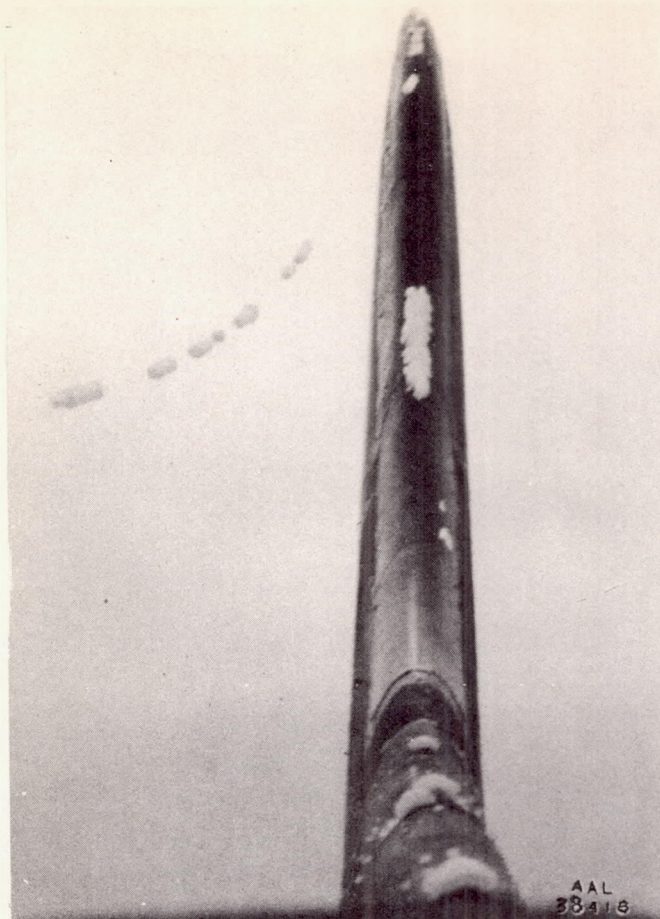
Figure 30.- Rime-ice formation on the heated leading edge of the vertical stabilizer at the junction of the dorsal and fin, at the tip of the fin, and on the running lights on the forward portion of the dorsal during test 7.

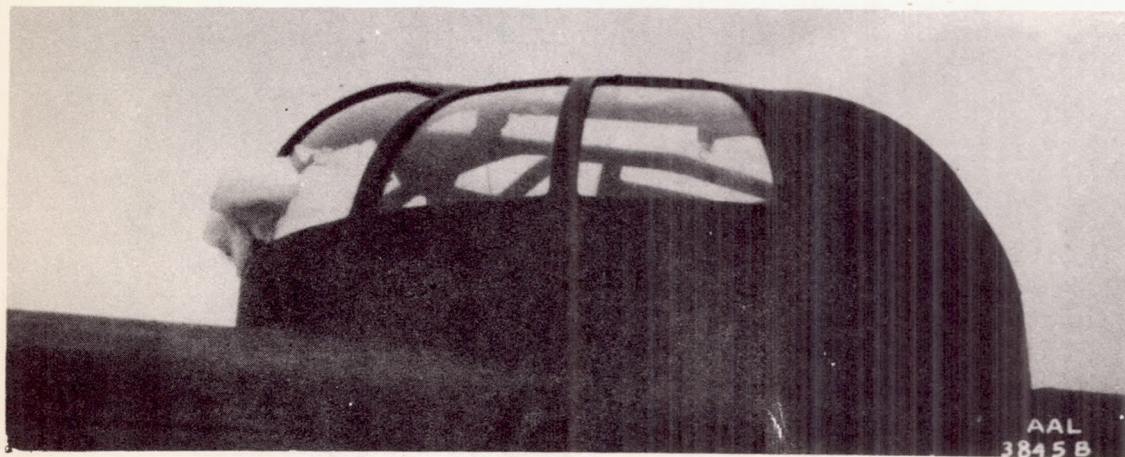
Photographs of the ice remaining on the upper gun turret, on the ball turret, and on the front of the fuselage, after landing from flight test 7, are presented in figures 35, 36, and 37, respectively. During flight, the ice extended over a greater area of the regions than is shown in the figures, but some of the ice was lost after leaving the icing condition. The results of these observations indicated that protection should be provided for the windows used by the gunners, the bombardier, and the pilot if the airplane is to be successfully flown in inclement weather.

Figure 35.- Rime-ice formation on the forward side of the upper gun turret accumulated during test 7. (Photograph taken after landing.)

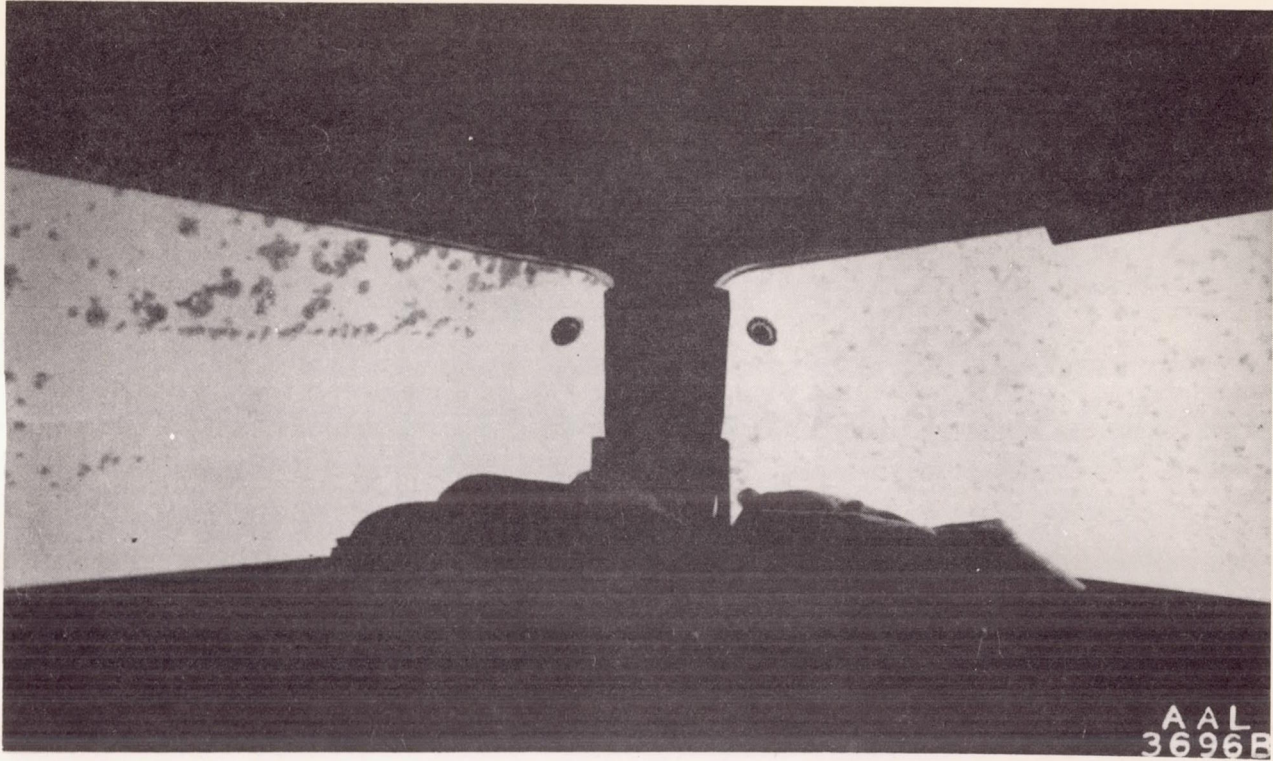
The pilot's heated windshield, adapted from the service windshield and defrosting system, was protected from ice accumulations on the lower portion, as shown in figures 31 and 32. Figure 33 is a view of the windshield exterior, obtained from the aft top window of the bombardier's compartment during test 3, and illustrates the susceptibility of the windshield to icing. Although the pilot's windshield was not completely protected during flight in icing conditions, it was observed to clear more rapidly than did the unheated copilot's windshield when the airplane was flown out of the icing conditions, as shown in figure 34.

Figure 31.- Icing of pilot's (left) and copilot's (right) windshields during flight of February 23, 1943. The photograph shows the partial protection afforded the heated pilot's windshield.

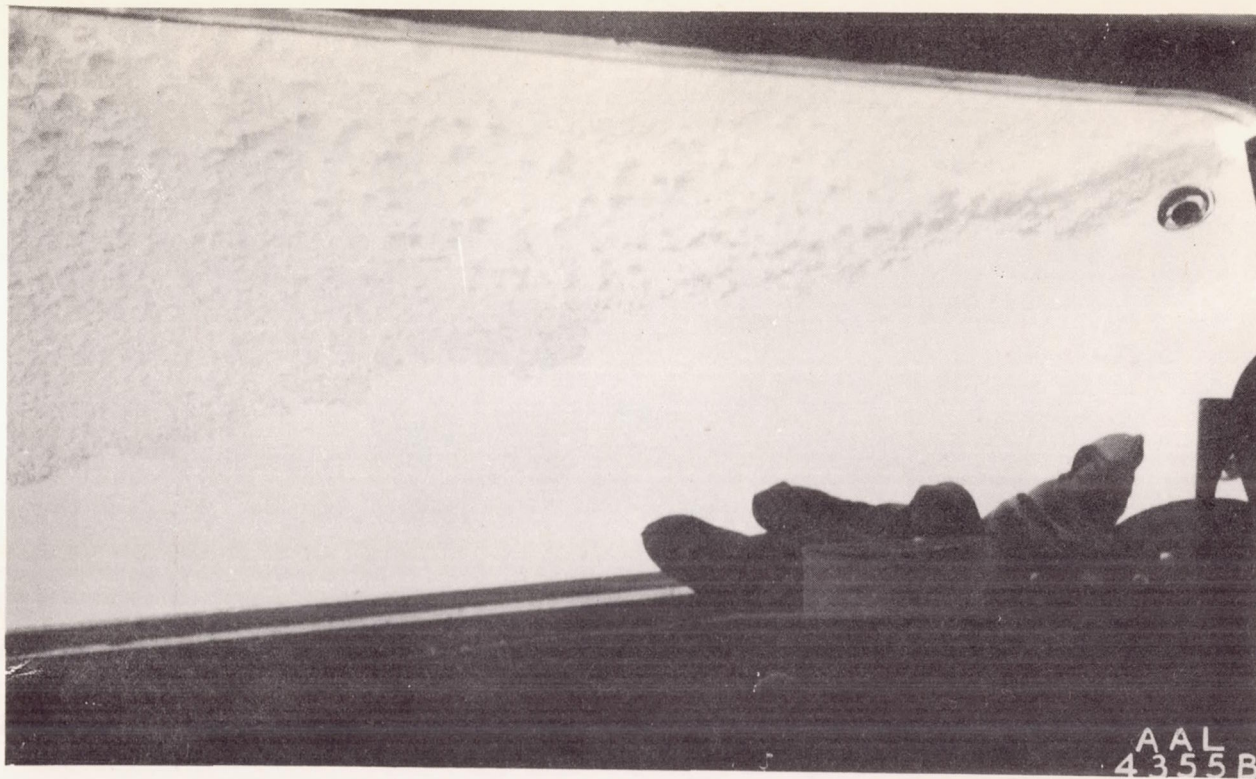
Figure 32.- Ice accumulation on the pilot's heated windshield during flight in icing, test 3.

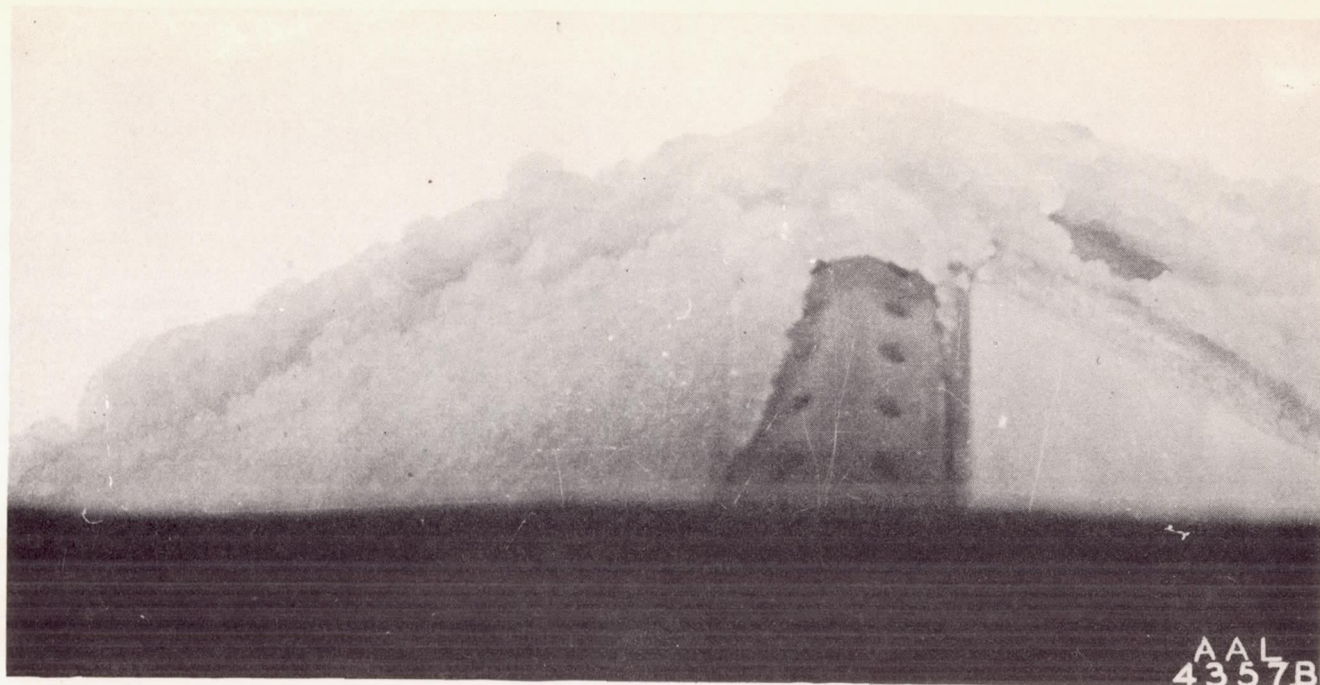
Figure 33.- Ice formation on the pilot's and copilot's windshield during test 3. The lower portion of the heated pilot's windshield (on the right) is clear of ice.

more complete protection, the results of the test indicate that the adaption of the service windshield and defrosting system would not produce an installation which would be satisfactory for all icing conditions. It is probable that, by decreasing the gap between the two panes of glass, a satisfactory heated windshield might be developed which utilizes the same source of heated air as did the reported temporary installation.

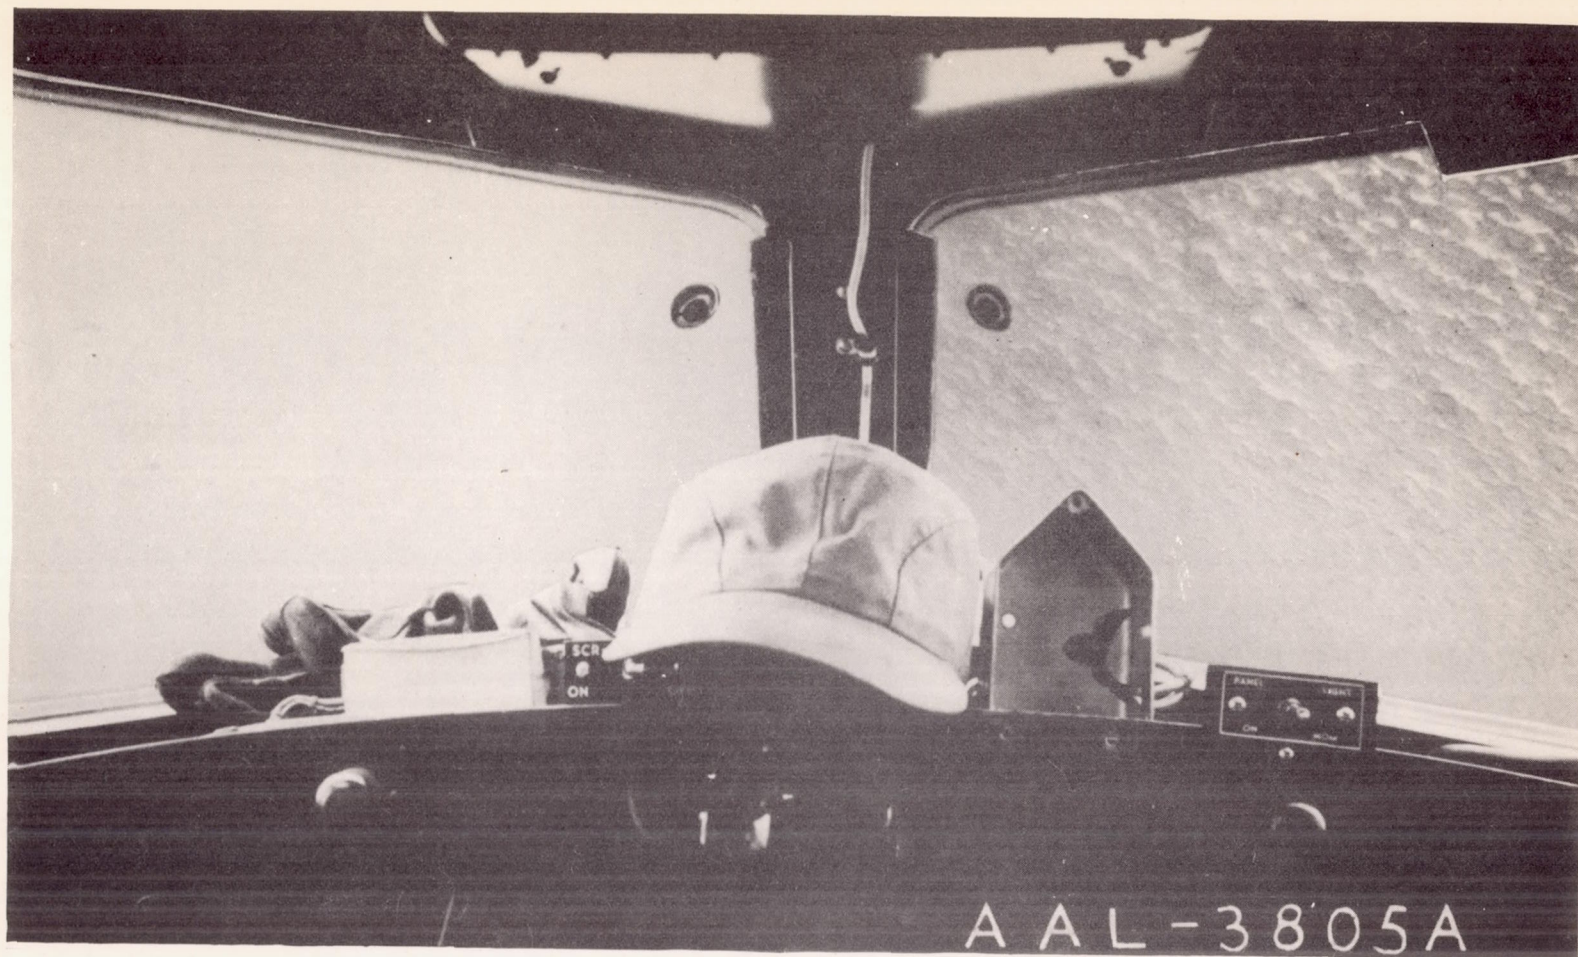
Figure 34.- The pilot's (left) and copilot's (right) windshields during tests 4 and 5, after leaving the icing region. The heated pilot's windshield is clear of ice.

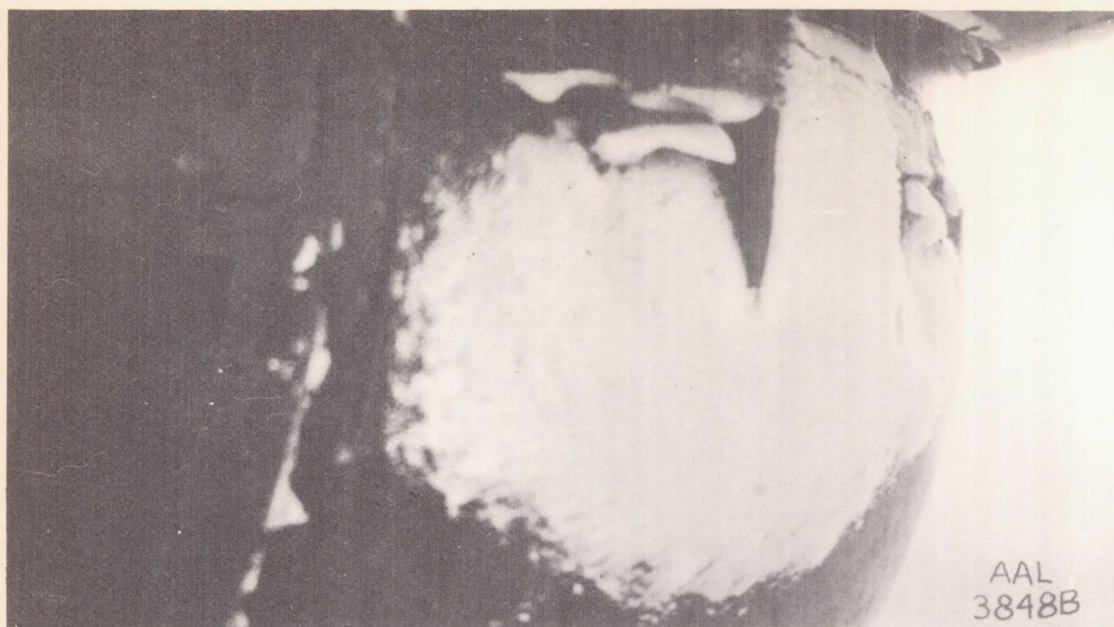
Figure 36.- Rime-ice accumulation on the forward edge of the ball turret during test 7. (Photograph taken after landing.)

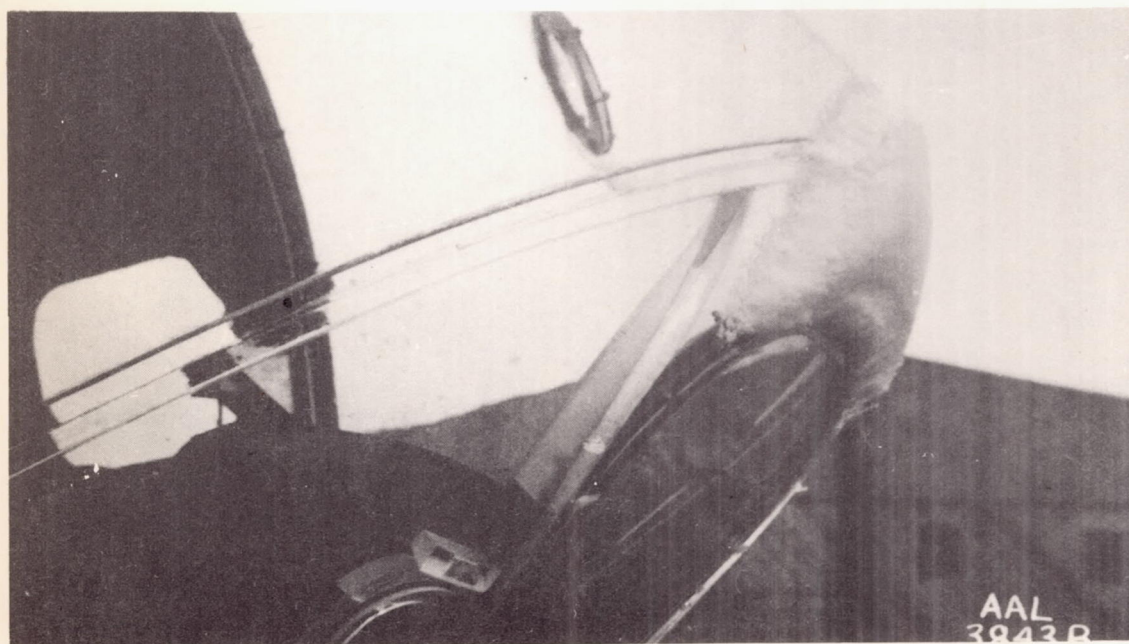
Figure 37.- Rime-ice accumulation on the front of the fuselage during test 7. (Photograph taken after landing.)

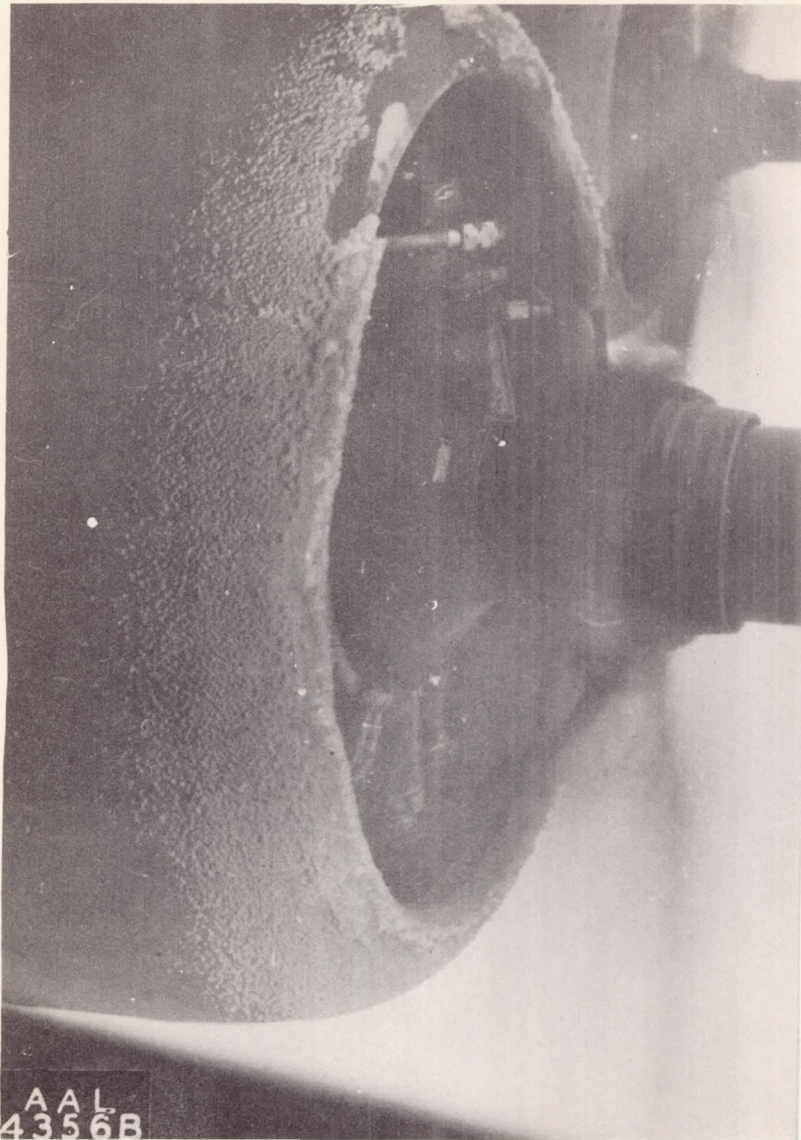
Figure 38.- Ice formation on the left inboard engine cowl accumulated during test 3.

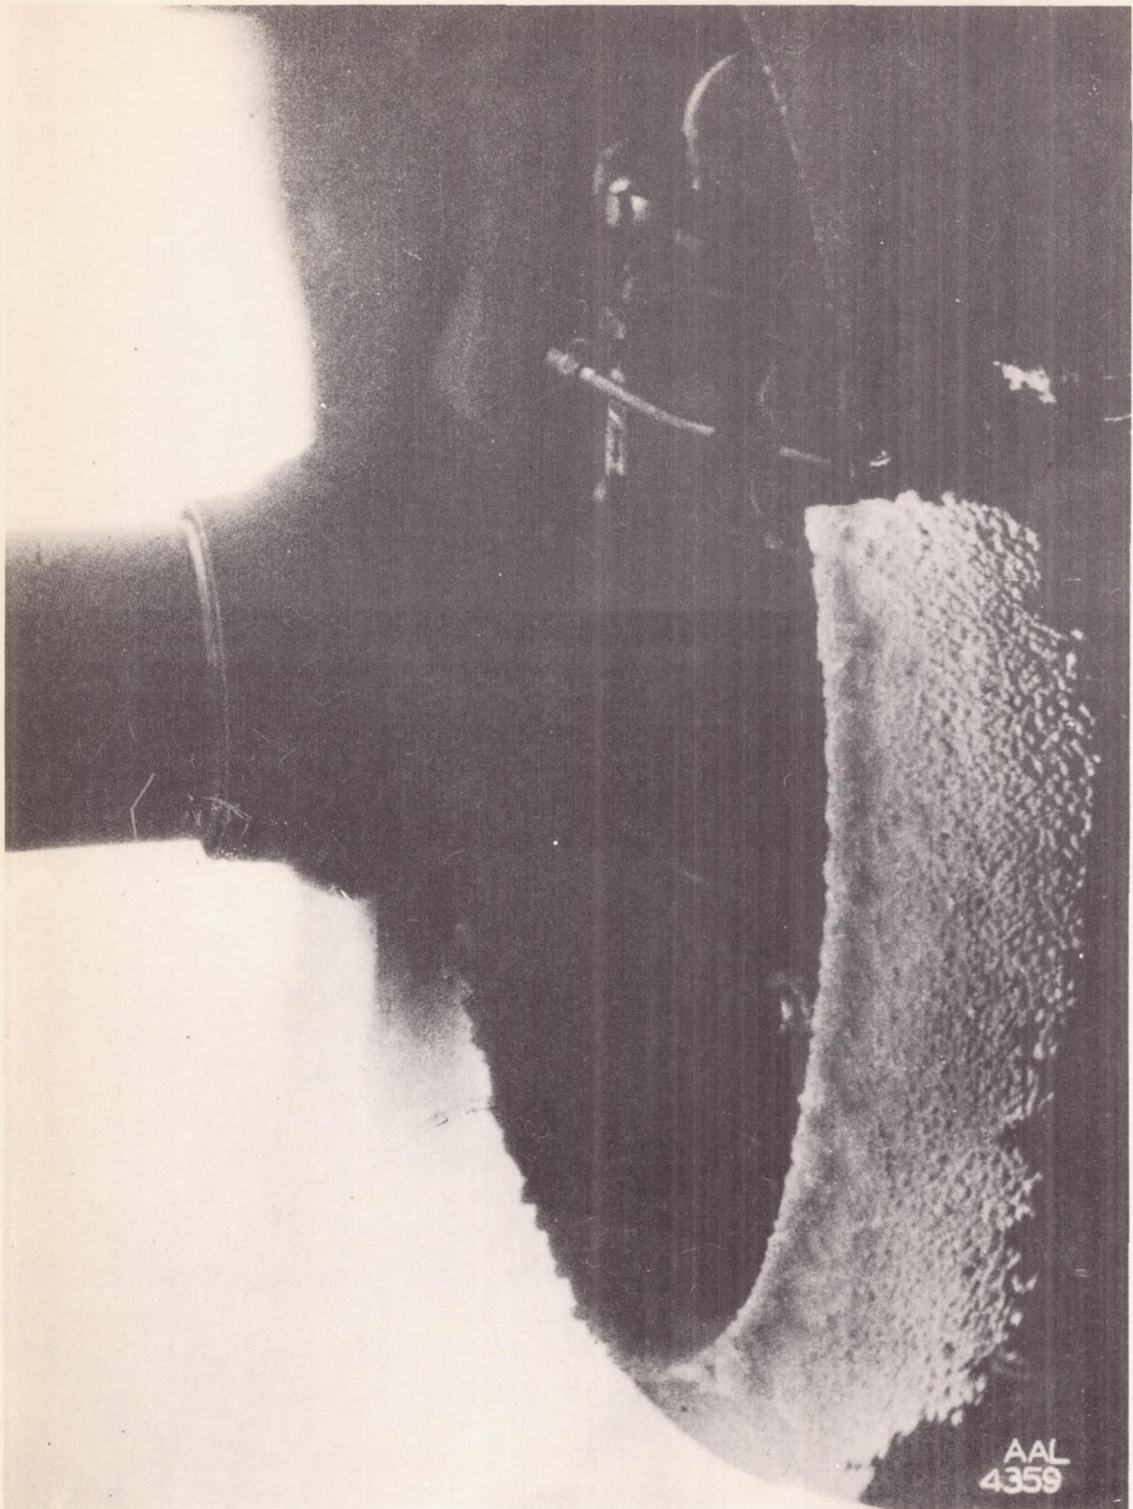
Figure 39.- Ice formation on the right inboard engine cowl accumulated during test 3.

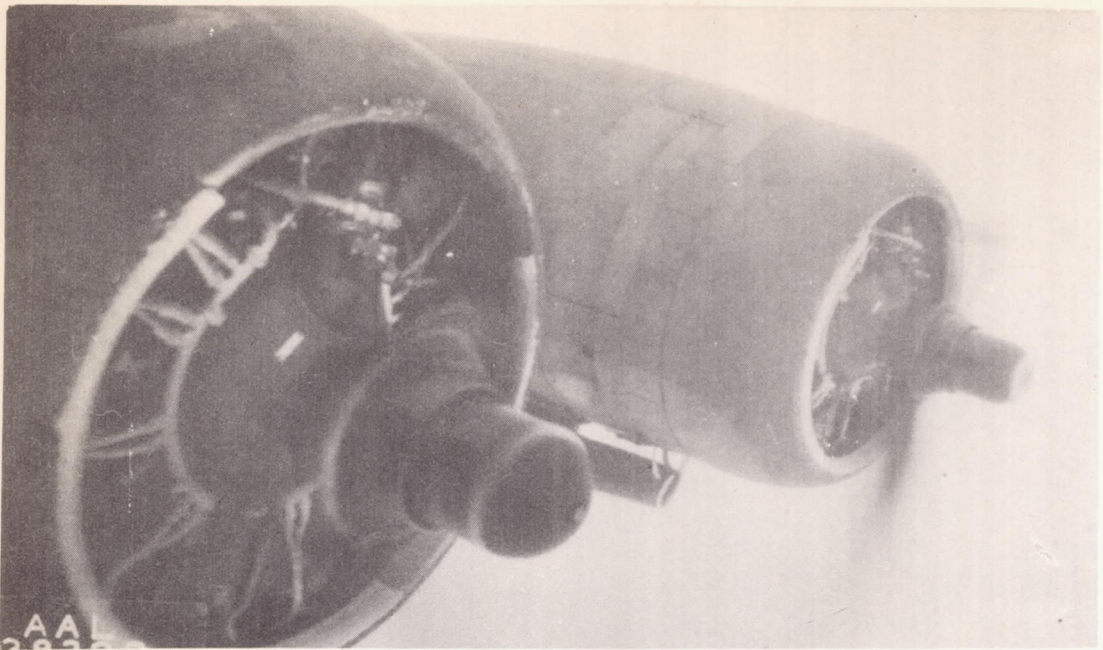
Figure 40.- The left engine nacelles showing ice accumulations on the leading edge of the cowls, and on the lip of the air inlet for the heat exchanger in the out-board nacelle (beneath the right nacelle) during test 7.
