# WARTIME REPORT

FLIGHT TESTS OF THE THERMAL ICE-PREVENTION  
EQUIPMENT ON THE B-17F AIRPLANE

By Bonne C. Look

Ames Aeronautical Laboratory  
Moffett Field, California

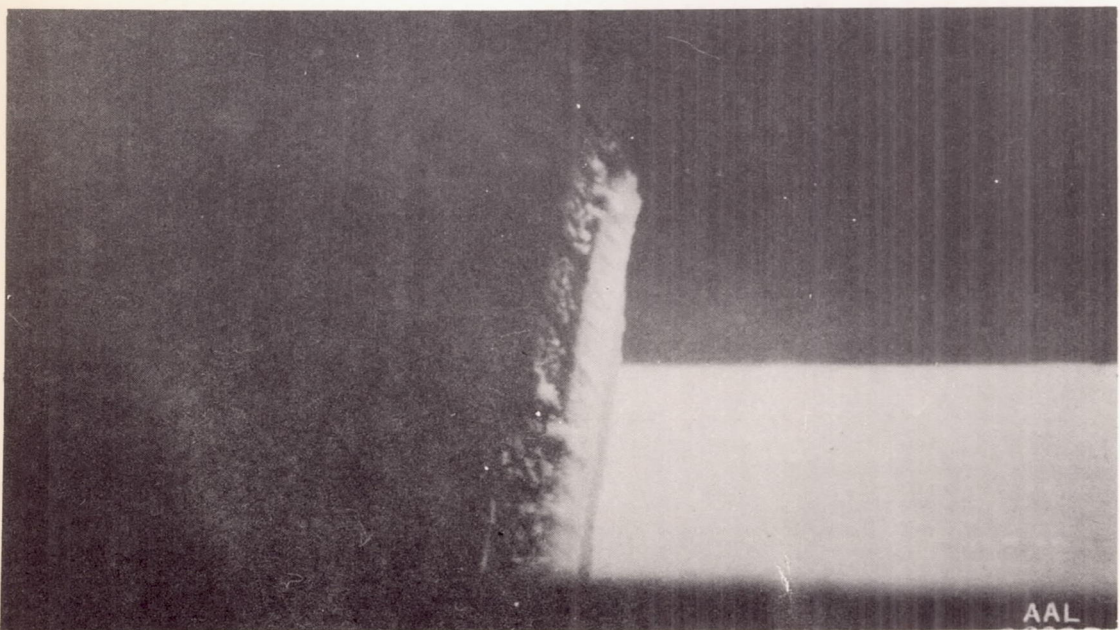
The susceptibility of unprotected surfaces of the airplane to icing is illustrated in figures 20, 27, 33, 42, and 43. The ice accumulations shown resulted from limited flight in icing conditions and indicate the necessity of providing protection for airplanes to be flown in inclement weather.

Figure 42.- Rime-ice accumulation on the unheated wing leading edge between the fuselage and the left in-board nacelle during test 7.

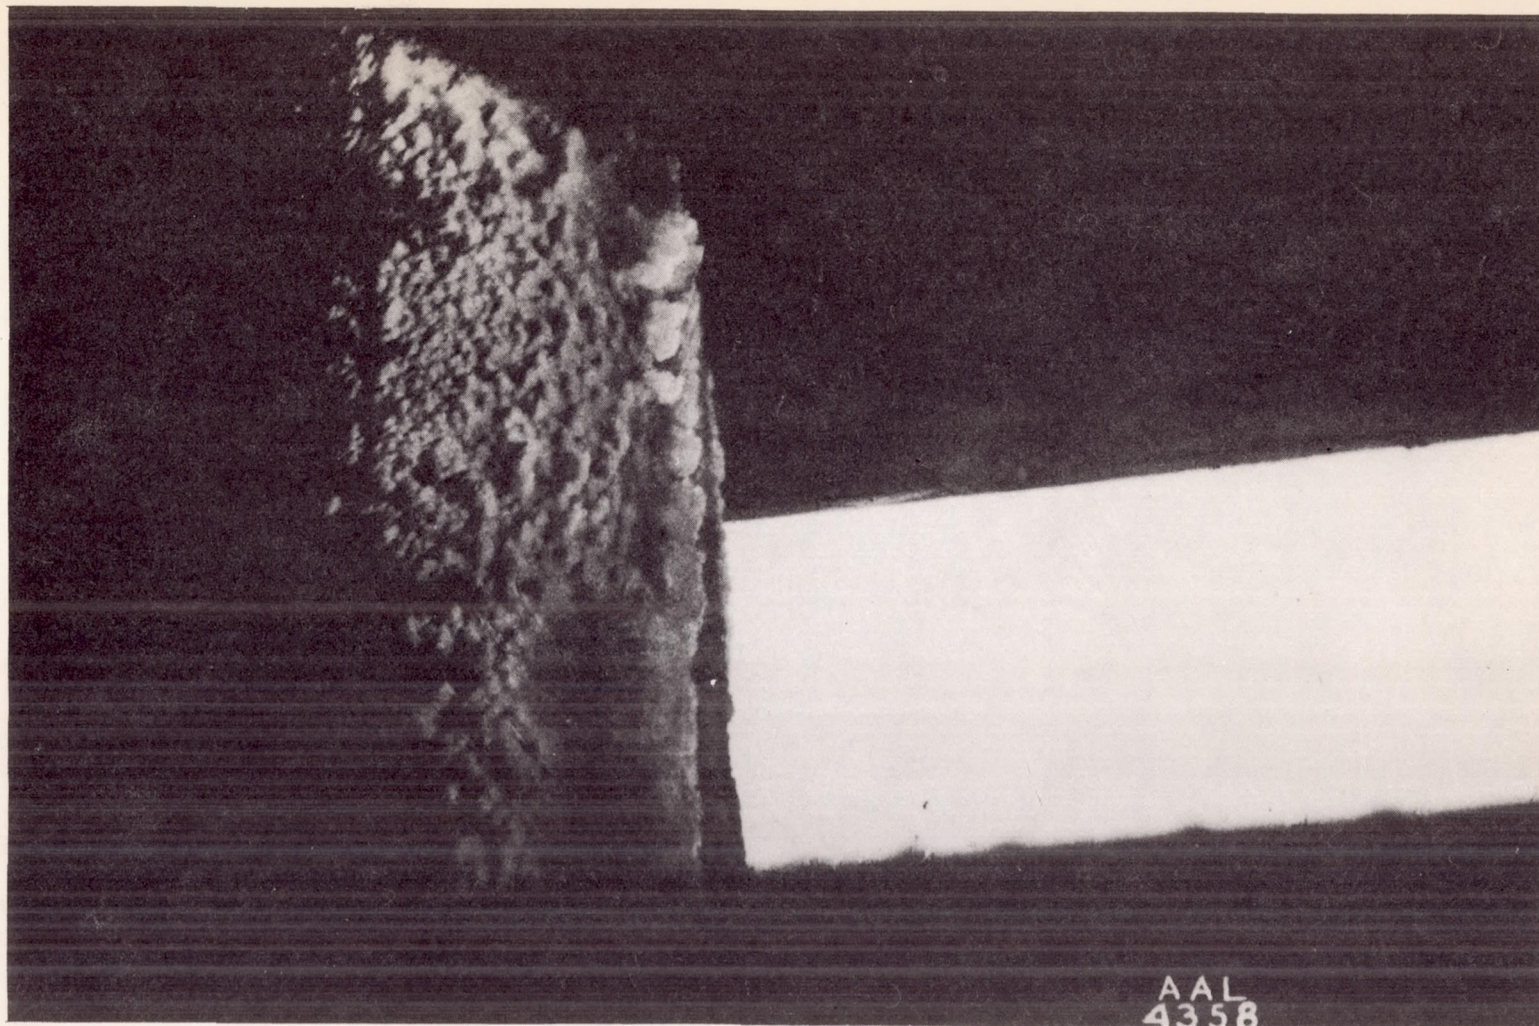
Figure 41.- The unheated wing leading edge, between the fuselage and the left in-board nacelle, showing ice formation accumulated during test 3.

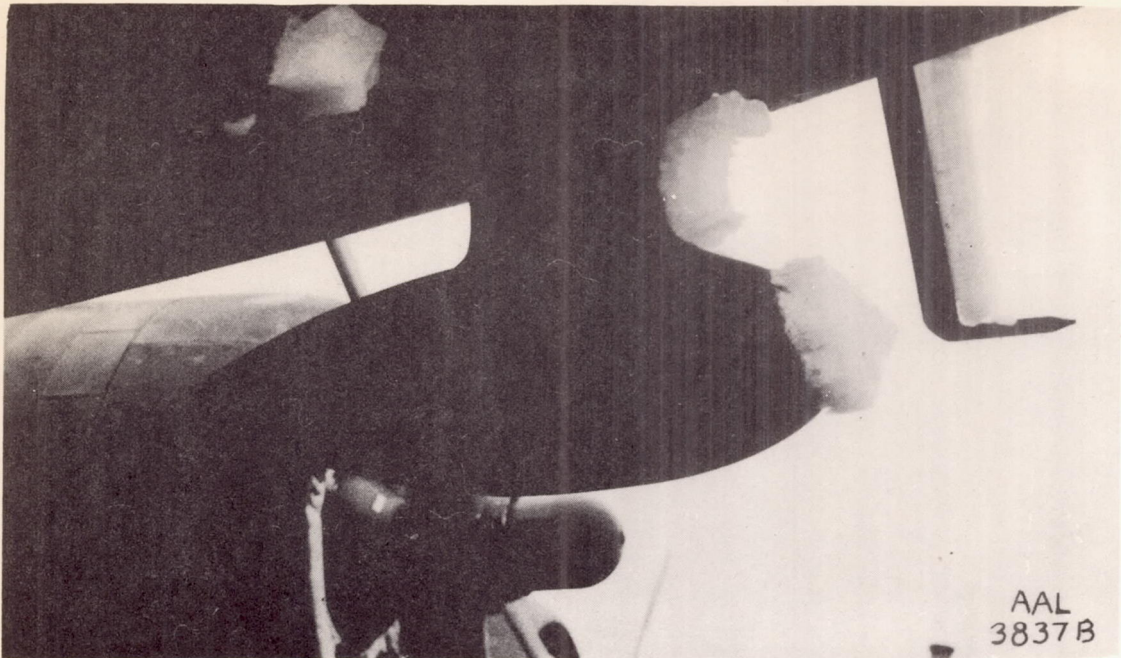
Figure 43.- Ice accumulations on the drift sight (left center in photograph), loop-antenna housing, and the left airspeed mast during test 7. (Photograph taken after landing.)

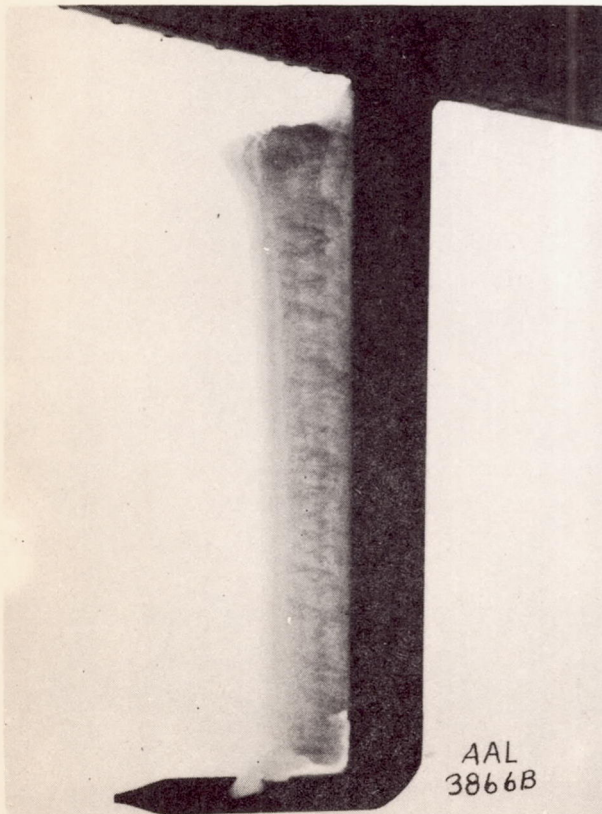
The severity of icing on the airspeed-head support mast is shown in figure 44. This figure is a photograph of the right airspeed-head mast taken at the same time figure 43 was obtained. The static-pressure openings in the airspeed head are located about  $2\frac{1}{2}$  inches forward of the support-mast leading edge. The ice accumulation shown in the figure extended to within  $1/8$  of an inch from the static openings, and is an example of the ice formation accumulated during many of the flights. An accumulation of this magnitude was found to affect the airspeed reading as much as 20 miles per hour at cruising-power conditions.

Figure 44.- Ice accumulation on the right airspeed mast during test 7. (Photograph taken after landing.)

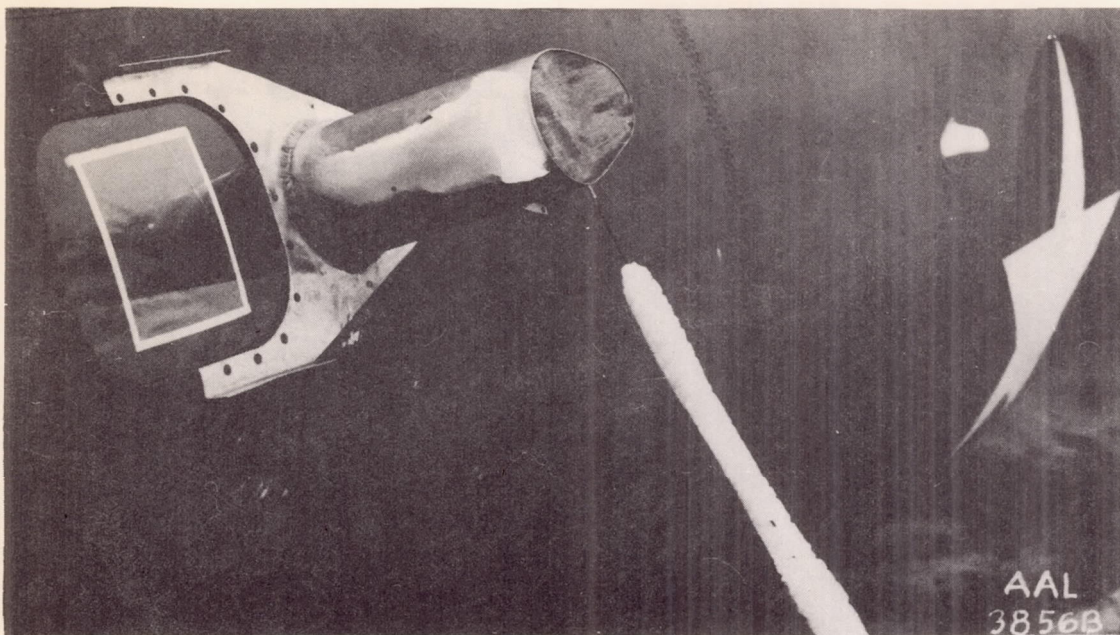
Figure 45 shows the ice-indicating strut which was mounted on the left side of the fuselage at the aft edge of the radio-compartment window. The ice formation on the strut leading edge was accumulated during test 7. Another illustration of icing on the strut is shown in figure 46. The ice formations shown on the strut illustrate the amount of ice which may accumulate on unprotected surfaces during flight in icing conditions. The variation in thickness of the ice on the strut probably was due to interference of the fuselage.

Figure 45.- Ice accumulations on the ice-indicating strut and on the lead-in antenna wire of the liaison radio. Photograph was taken after landing from test 7.

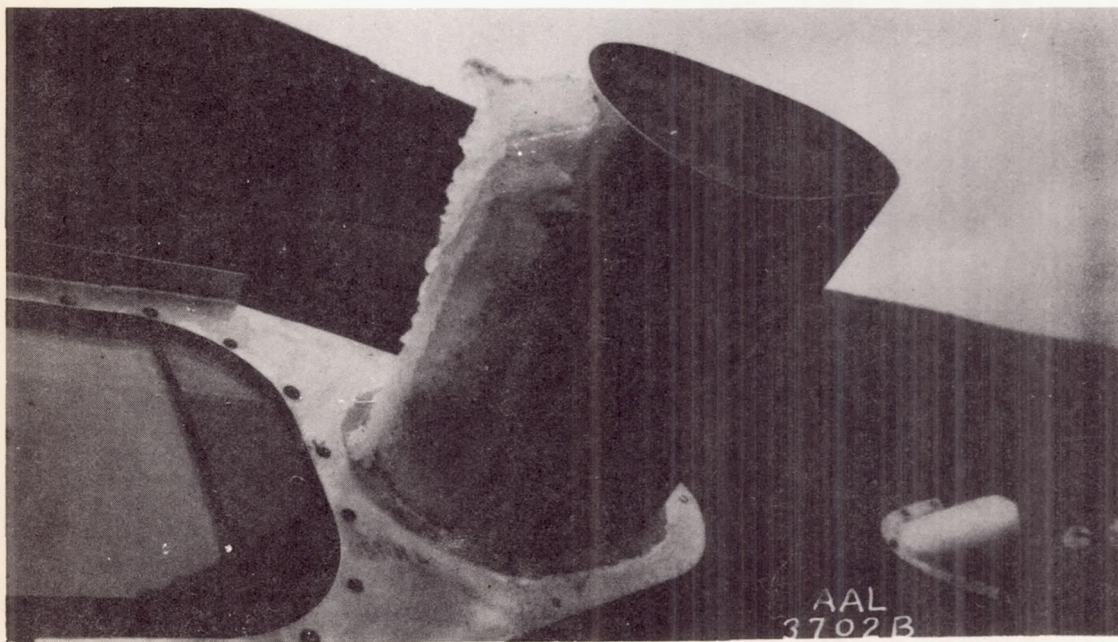
Figure 46.- Ice accumulation on the ice-indicating strut, mounted on the left side of the fuselage at the radio compartment during the flight on February 23, 1943. (Photograph taken after landing.)
