NATIONAL ADVISORY COMMITTEE FOR AERONAUTICS

February 1945 as
Advance Restricted Report E5B07

EFFECT OF PROGRESSIVE RING FAILURE ON PISTON DESTRUCTION

By Max J. Tauschek and Lester C. Corrington

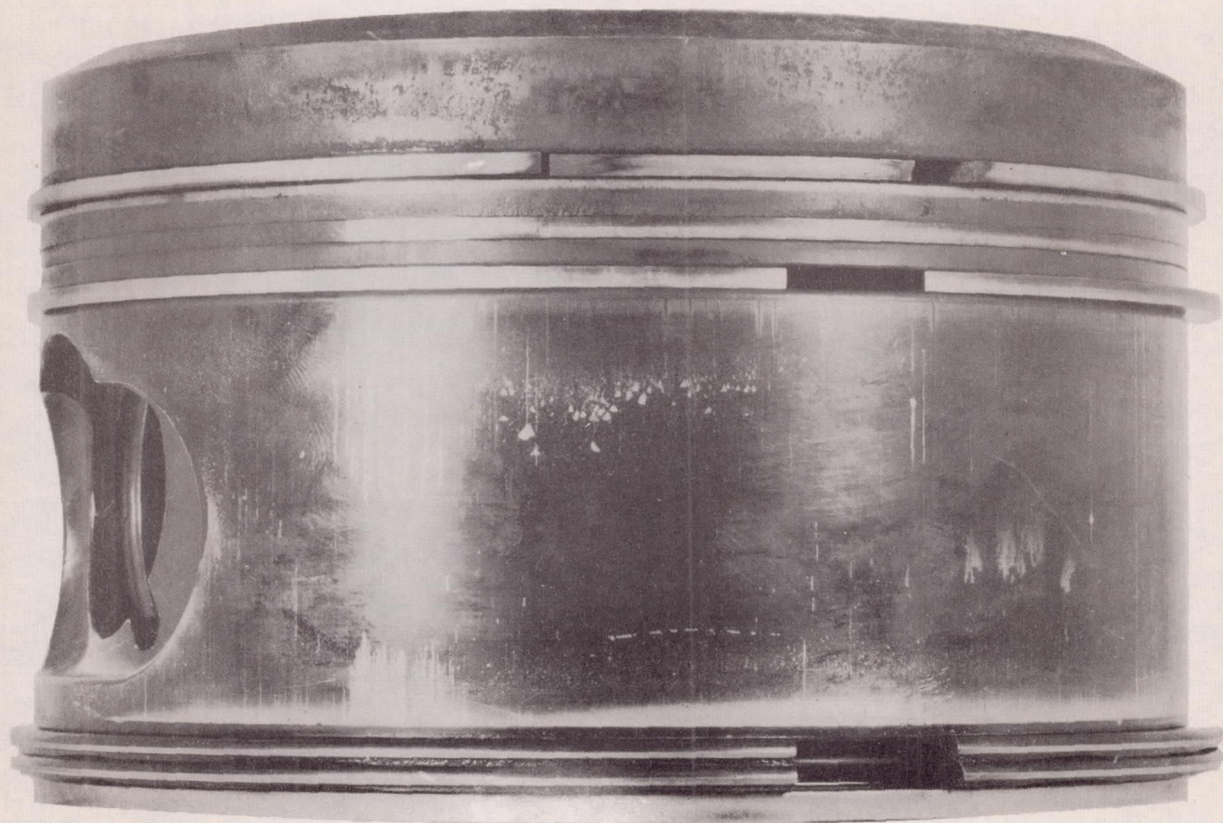
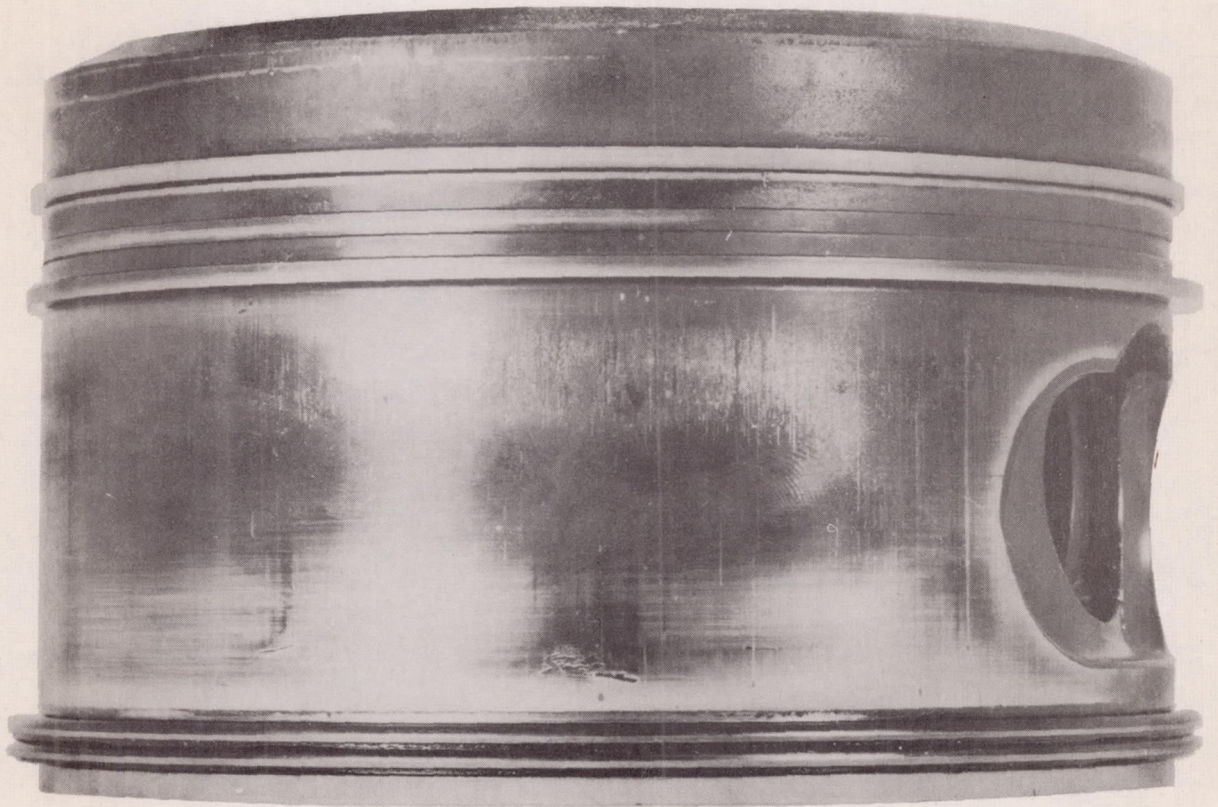
The piston used in the first test had previously been used to obtain preignition data in connection with another project. These tests comprised about 15 hours running time. The severe operating conditions encountered in the preignition tests resulted in breaking of the top ring and sticking of the second ring. Figure 1 shows the piston prior to installation in the cylinder at the beginning of the endurance test. A clean used piston equipped with new piston rings was used for the second test.

Figure 1. - Piston and ring assembly just before the first endurance test. Failure of top and second rings has taken place.

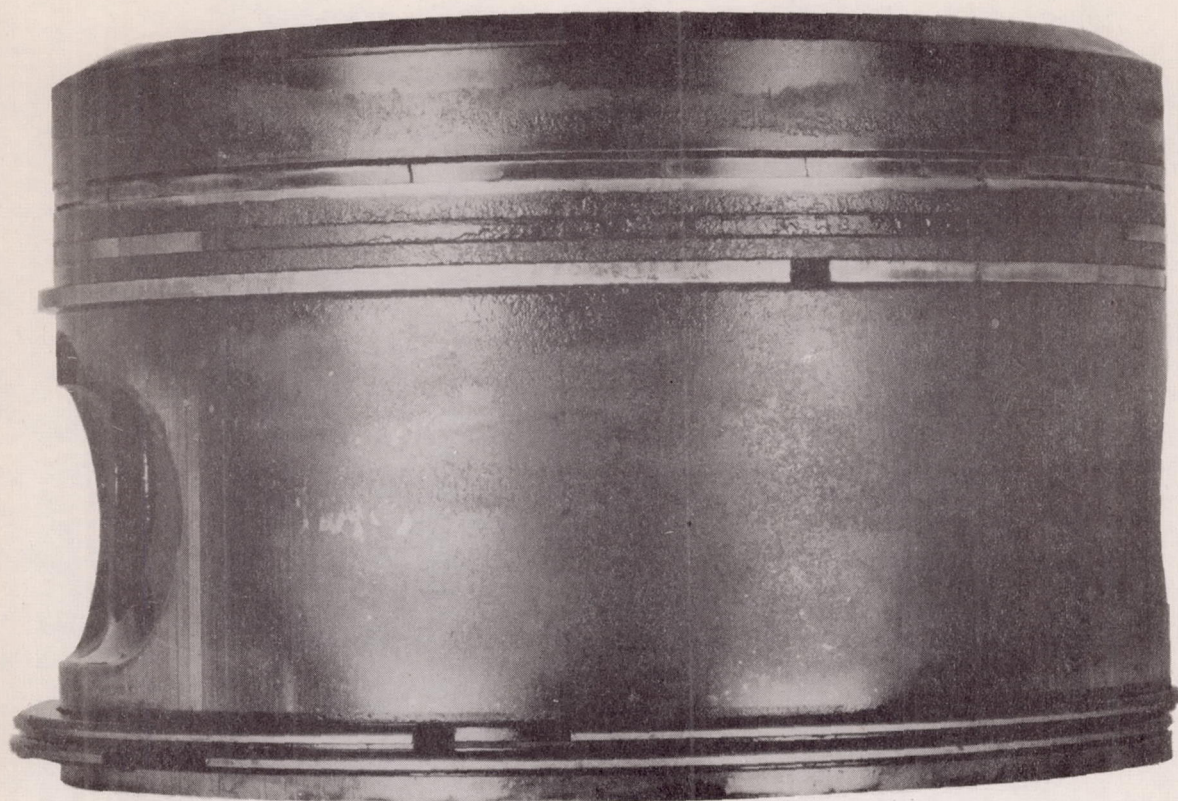
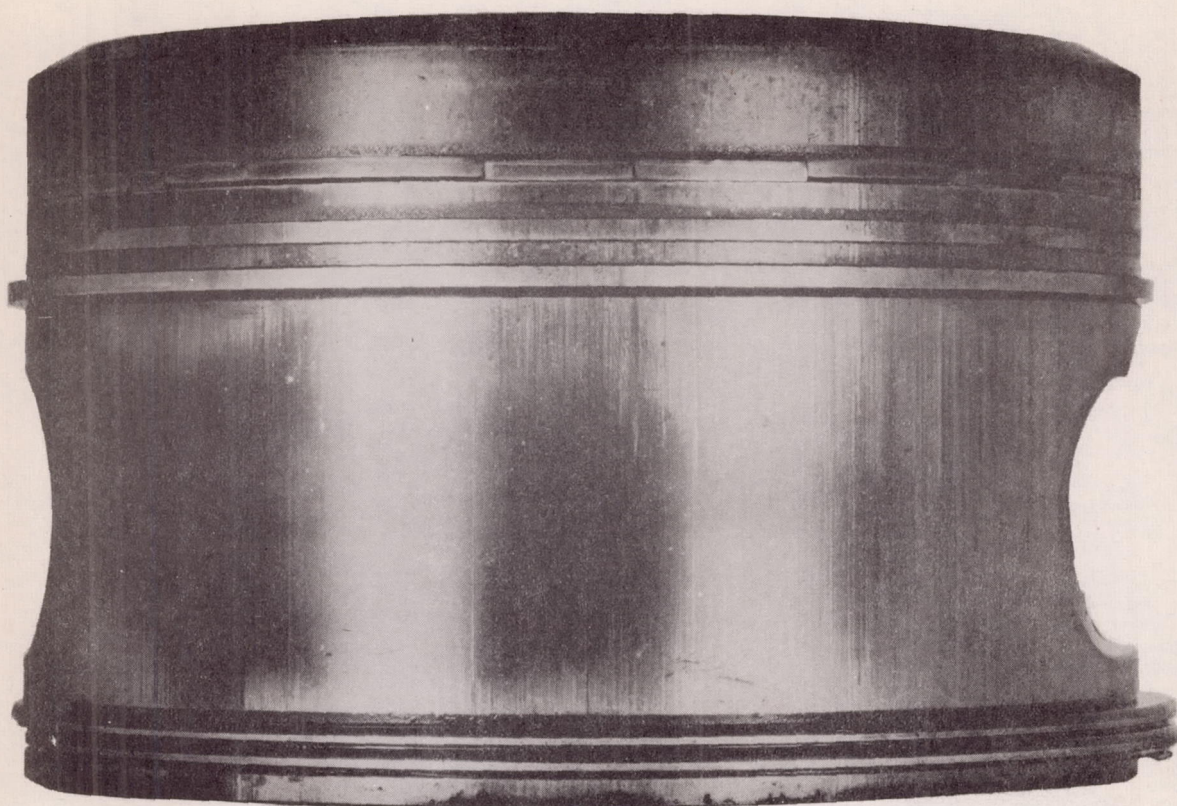
At the end of 7.5 hours the piston was removed for inspection. By this time complete failure of the compression rings had taken place but the oil rings were still in reasonably good condition (fig. 2). The piston and ring assembly was reinstalled and the test continued. After an additional 10.6 hours, the inlet-air pressure was increased to determine the power level at which immediate and complete piston failure would take place. This failure occurred at an inlet-air pressure of 68 inches of mercury absolute with the results shown in figure 3. The total test time was 33.1 hours including the preignition tests conducted previous to the endurance run.

time of the inspection when all the compression rings had failed (fig. 2), which suggests that the oil-control rings had a considerable effect in sealing the combustion chamber.

Figure 2. - Piston and ring assembly after 7.5 hours of first endurance test. All compression rings have failed.

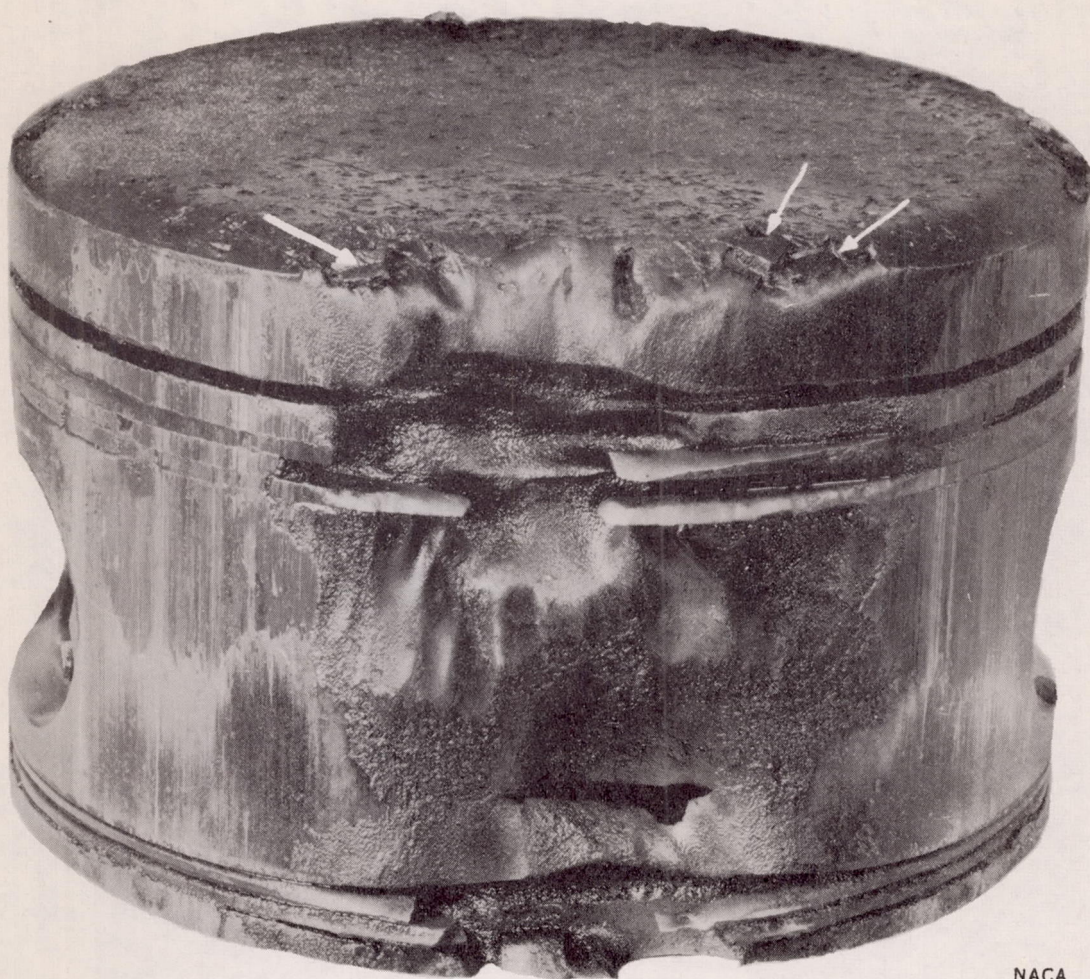
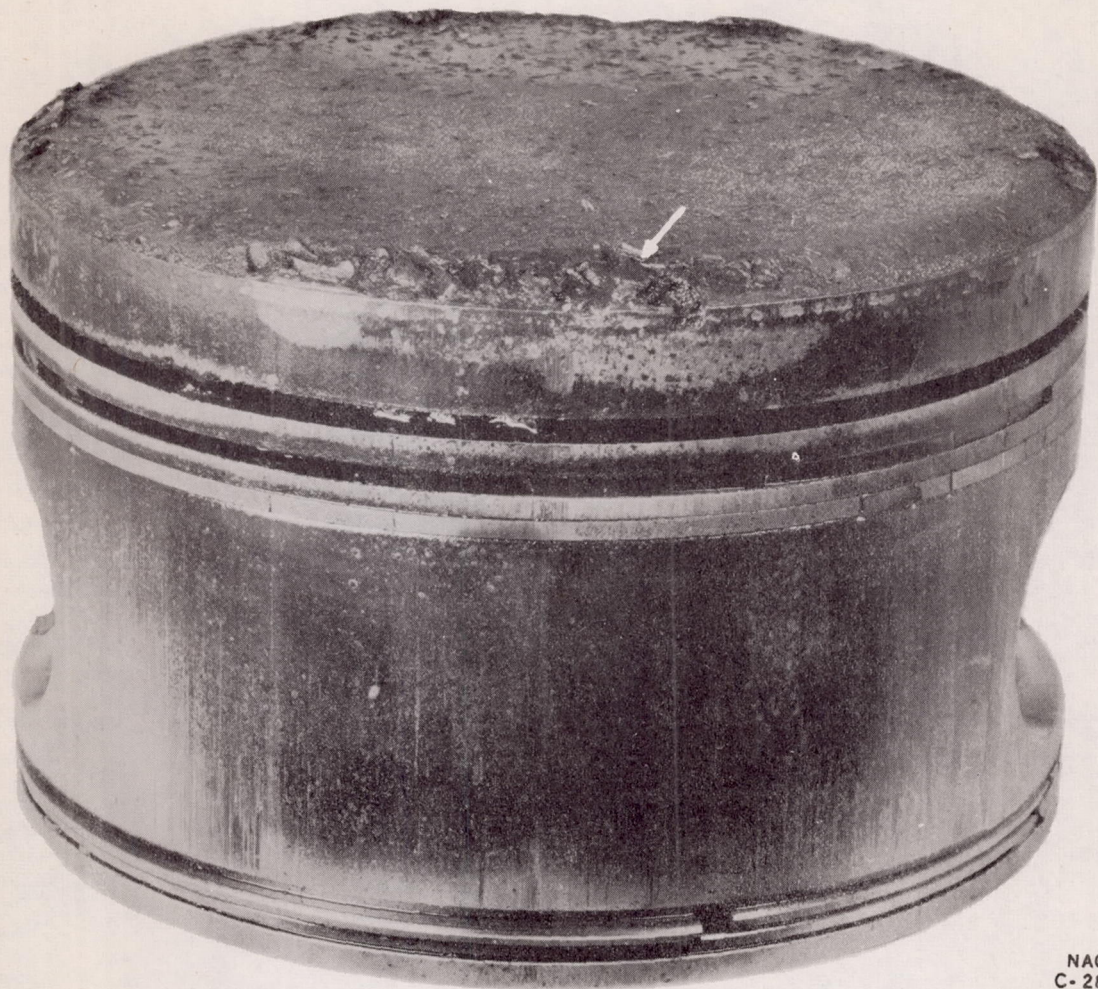
Analysis of failed piston. - Figure 3 shows the piston and ring assembly after the final failure of the first test. A wide deep channel has been burned down the entire length of the piston and a hole has been made through the piston skirt above the oil rings. This damage was confined to the minor thrust face of the piston; the major thrust face remained comparatively unharmed.

The ultimate failure was most likely caused by the action of high-temperature gases against the side of the piston, probably taking place over a relatively long period of time. Figure 7 shows the ring belt of a piston that had been operated under severe conditions in another test program. The large flow of high-temperature gases resulting from compression-ring failure has begun an erosion of one of the ring lands, which probably would have resulted in a large channel similar to figure 3 if operation had been continued long enough. These high-temperature gases are not necessarily all blow-by gases. A portion of these gases leaks by all the rings as blow-by gases, whereas part of them travel down and back up past the ineffective rings as the pressure in the combustion chamber is alternately increased and decreased. The net result is a scouring action, which in all probability causes the erosion shown in figures 3 and 7.

Further evidence that this channeling took place over a prolonged period of time is found in the fact that the entire top ring and parts of the second ring are missing from the piston in figure 3. The channel in the face of the piston provides the only escape path for these ring pieces. Because the broken rings were partly stuck in the grooves, the time required for them to work their way along the grooves to the channel would probably be quite appreciable. The pieces of rings imbedded in the top of the piston at the end of the test (shown by arrows in fig. 3) were covered with a coating of carbon, indicating their presence on the top of the piston for a considerable length of time. The preignition in the engine previously mentioned may have been caused by these ring pieces in the combustion chamber or by the ends of the compression rings left exposed by the formation of the channel down the side of the piston. The fact that particles of aluminum alloy were found lodged in the oil-ring groove, displaced as much as 90° from the channel in the face of the piston, lends further support to the supposition that the channeling of the piston took place over an extended period of time.

The final destruction of the piston occurred without any forewarning other than the high blow-by rates and did not extend beyond a few engine cycles. The piston skirt had been weakened by the channeling and by the increased temperature and the full pressure of the combustion chamber was acting on the sides of the channel.

The stresses in the aluminum became so great and the temperature so high that the skirt collapsed and permitted the free flow of burning gases into the crankcase.

Figure 3. - Piston and ring assembly at end of first endurance test. Total test time 33.1 hours. Arrows indicate pieces of piston rings imbedded in piston.

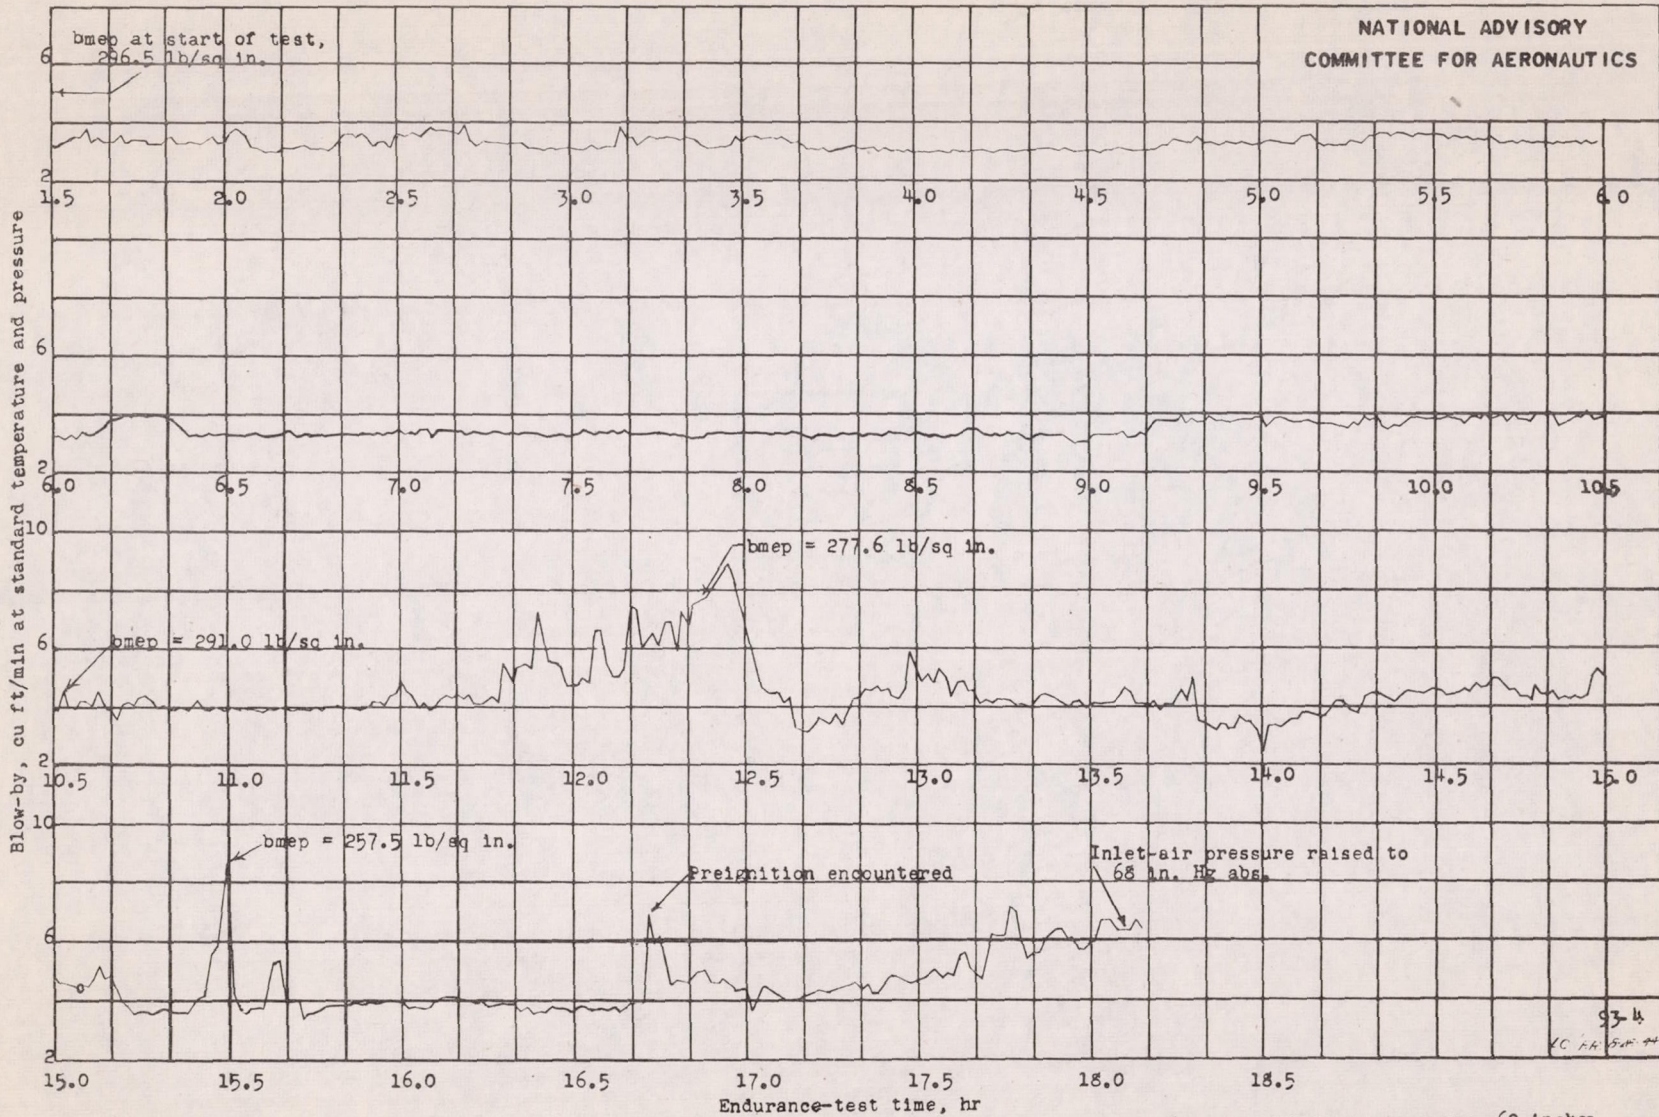
Figures 4 and 5 indicate that, after failure of the top and second rings had taken place (beginning of endurance test), an increasing degree of failure of the compression rings did not affect the sealing qualities of the piston and ring assembly to any marked extent. The rate of blow-by and the crankcase pressure at the beginning of the test were approximately the same as those values at the

A marked rise in the rate of blow-by is evident after 11.5 hours of operation. Immediately after these values reached a maximum, the engine was shut down. When the test was continued on the next day, the blow-by rate was found to have dropped to a relatively low value. Upon examination of the piston at the end of the test, small particles of aluminum alloy were found lodged in the oil-ring groove. These aluminum-alloy particles suggested that the marked rise in the rate of blow-by may have been caused by similar particles which served to partly stick the oil-control rings and which were later displaced upon idling the engine to a stop or during the subsequent starting and warming-up operations on the following day. The fact that these deposits were found in the oil-ring groove and displaced as much as 90° from the point of final failure indicates that considerable time was required for their formation and that they were not a result of melted aluminum alloy finding its way into the groove at the time of final failure. The irregularities in the rate of blow-by throughout the rest of the test further substantiate the occasional partial sticking of the oil-control rings.

Instrumentation used with the test engine showed that preignition occurred at 16.7 hours on the endurance test and that it may have occurred again a few seconds before the final piston failure. The preignition at the 16.7-hour point of the endurance run coincides with a large and sudden increase in rate of blow-by. The most pronounced effect of preignition is to increase greatly the maximum combustion-chamber pressures and temperatures, which would considerably increase the rate of blow-by. A smaller effect is the more rapid deterioration of the piston rings caused by these high pressures and temperatures.

The sudden rise in rate of blow-by at 15.5 hours may also have been caused by preignition although none was detected by the time-pressure diagram on the oscilloscope. The loss in power output recorded at this point is somewhat higher than would be expected from blow-by alone (fig. 6), suggesting that preignition may have advanced only a few degrees, become stable, and shortly afterward disappeared. This type of preignition has been known to occur many times in other tests and would probably be unnoticed on the time-pressure diagram.

Figure 4. - Effect of running time on rate of blow-by for first endurance test. Engine speed, 2600 rpm; inlet-air pressure, 60 inches of mercury absolute (except as noted); inlet-air temperature, 100° F; fuel-air ratio, 0.095; oil flow to piston, 2.0 pounds per minute.

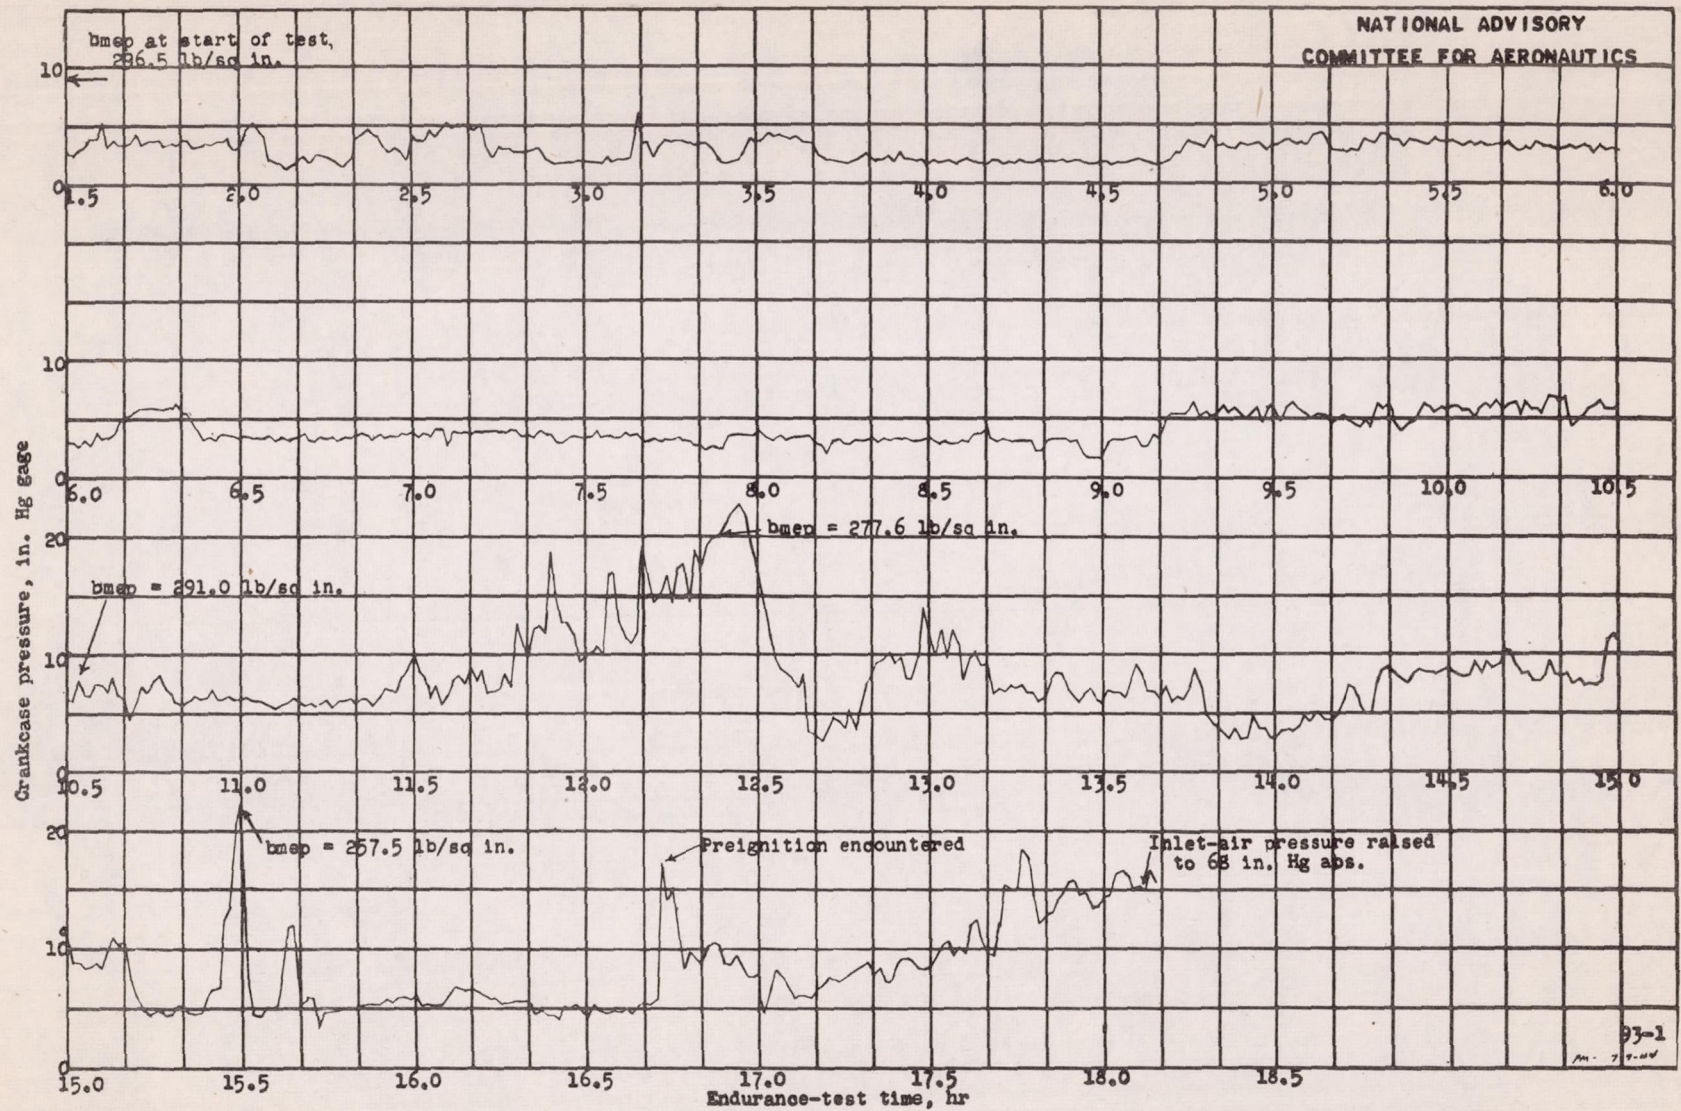
Blow-by and crankcase pressure. - The curves of the rate of blow-by and the crankcase pressure are shown in figures 4 and 5. Because the crankcase pressure is directly related to the blow-by rate, these curves are similar. It must be borne in mind, in the interpretation of the results of the crankcase-pressure curve, that the magnitudes of the crankcase-pressure values are entirely dependent upon the system used for the removal of the blow-by gases from the crankcase; a system having many restrictions, such as small piping, a flowmeter, and numerous valves, will result in high pressures, whereas a system having fewer obstructions to the gas flow will result in low pressures. The actual pressure in the crankcase was somewhat higher than the values measured because the manometer was connected to the blow-by line some distance from the crankcase.

Figure 5. - Effect of running time on crankcase pressure for first endurance test. Engine speed, 2600 rpm; inlet-air pressure, 60 inches of mercury absolute (except as noted); inlet-air temperature, 100° F; fuel-air ratio, 0.095; oil flow to piston, 2.0 pounds per minute.

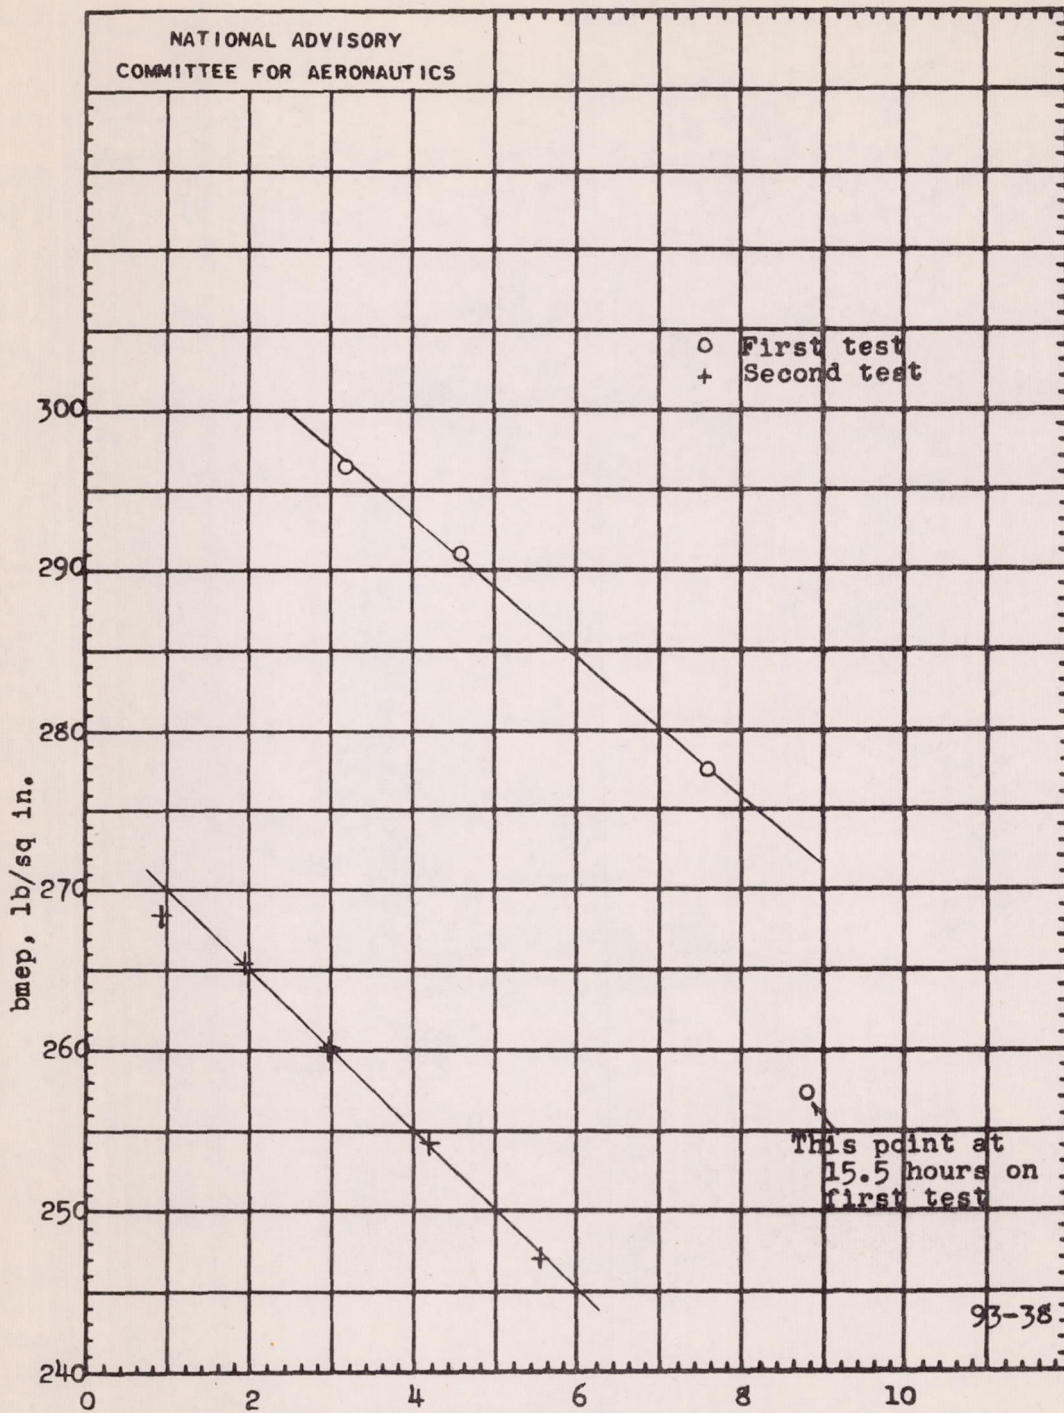
The two curves of figure 6 are straight lines and are roughly parallel. Calculations based on the slopes of these curves indicate that the power loss for a given rate of blow-by is about three times what would be expected if the weight of blow-by gases were considered as an equivalent weight loss of fresh charge. An Orsat analysis of the blow-by gases showed an oxygen content of about 15 percent, and unpublished data taken at this laboratory confirm this value for the

blow-by gases of another engine. The blow-by gases therefore probably consisted of about two-thirds unburned charge and one-third burned charge and the rates of blow-by shown in figure 6 should account for somewhat less than one-third of the power loss on the basis of gas leakage alone. The rest of the power loss can be accounted for only by possible increases in piston and ring friction and by pumping losses caused by the high crankcase pressure.

Blow-by, cu ft/min at standard temperature and pressure
 Figure 6. - Effect of rate of blow-by on brake mean effective pressure.
 Engine speed, 2600 rpm; inlet-air temperature, 100° F for first test,
 200° F for second test; fuel-air ratio, 0.095 for first test, 0.085
 for second test; oil flow to piston, 2.0 pounds per minute for first
 test, 0.5 pound per minute for second test.

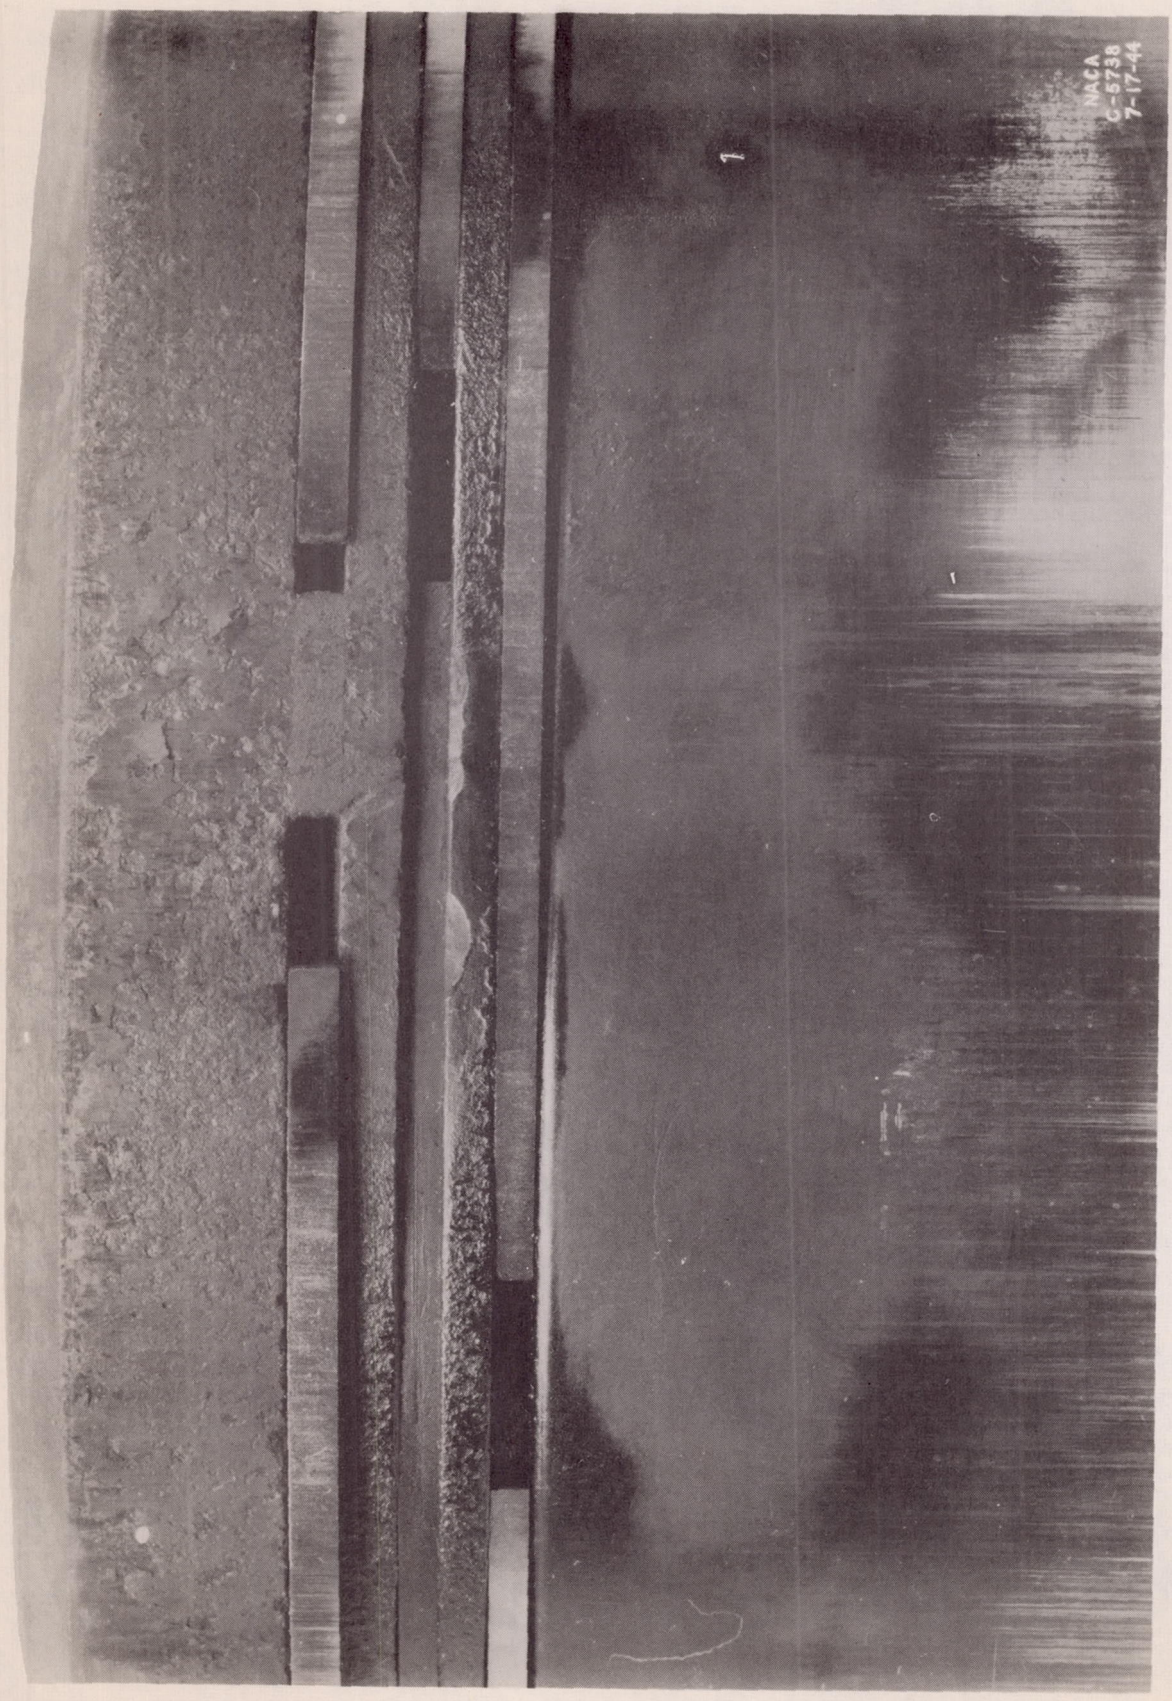
Figure 7. - Beginning of piston erosion as caused by high rate of gas flow past piston rings from another test program.

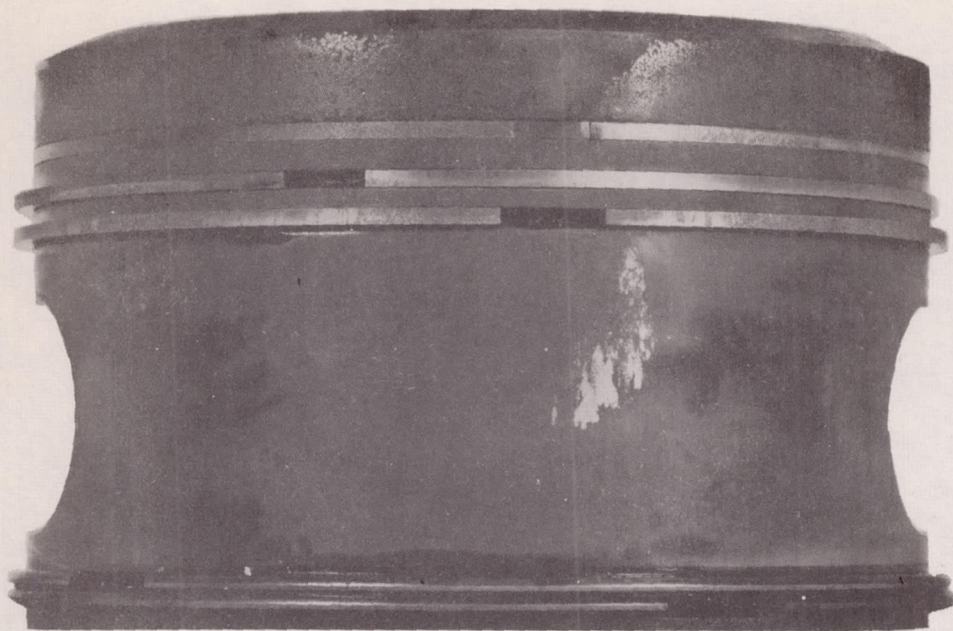
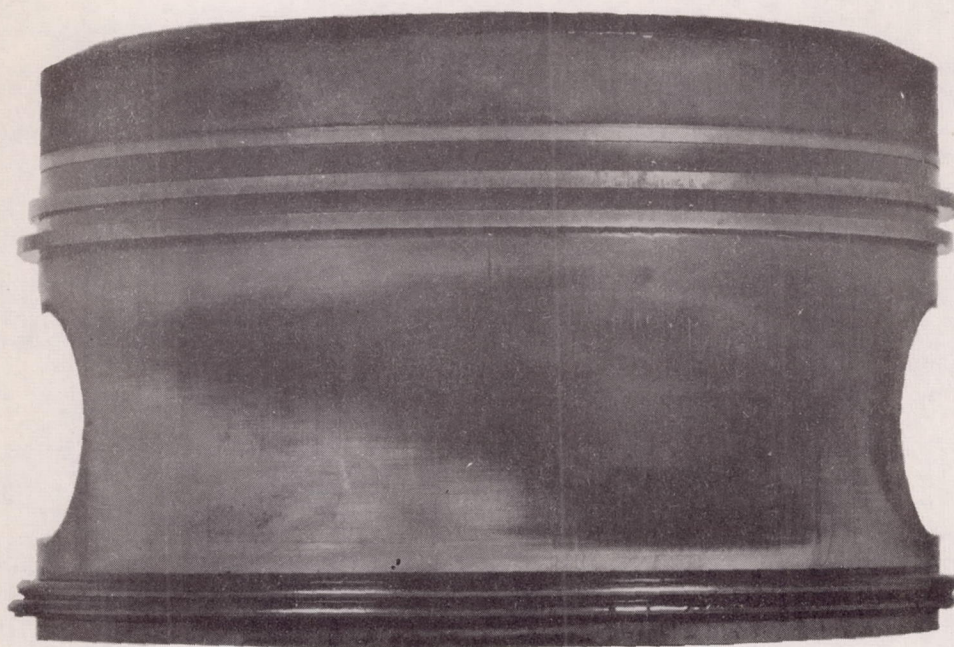
After 12.5 hours of operation the rings were examined. (See fig. 8.) The top ring was stuck and broken a short distance from the gap; the second ring was stuck for a part of its length. All the rings were considerably worn and had an etched appearance. After 42.0 additional hours of running the cylinder was again removed and a visual inspection showed all the compression rings to be broken. Upon reassembly the inlet-air pressure was raised to 56 inches of mercury absolute and the test was continued until complete piston failure occurred at a total running time of 84.25 hours (fig. 9).

From the time the top ring became stuck until the first inspection, the rate of blow-by showed a gradual upward trend, probably indicating the rapid rate of deterioration to the condition shown in figure 8. Between the first and the second inspections the rate of blow-by was quite irregular but, after the second inspection, began an upward climb continuing almost to the end of the test. A similar upward climb, which may be associated with the gradual channeling of the piston, occurred during the last 1.5 hours of the first test. Such channeling would provide a more unrestricted path for the blow-by gases past the broken compression rings.

Figure 8. - Piston and ring assembly after 12.5 hours of second endurance test. Top ring broken and stuck; second ring partly stuck.

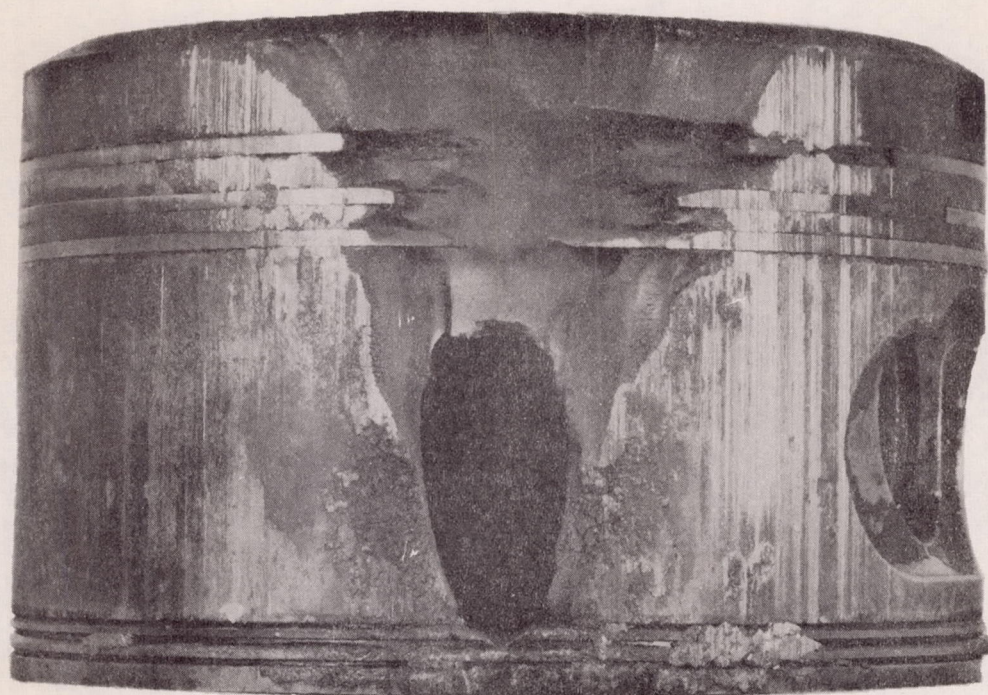
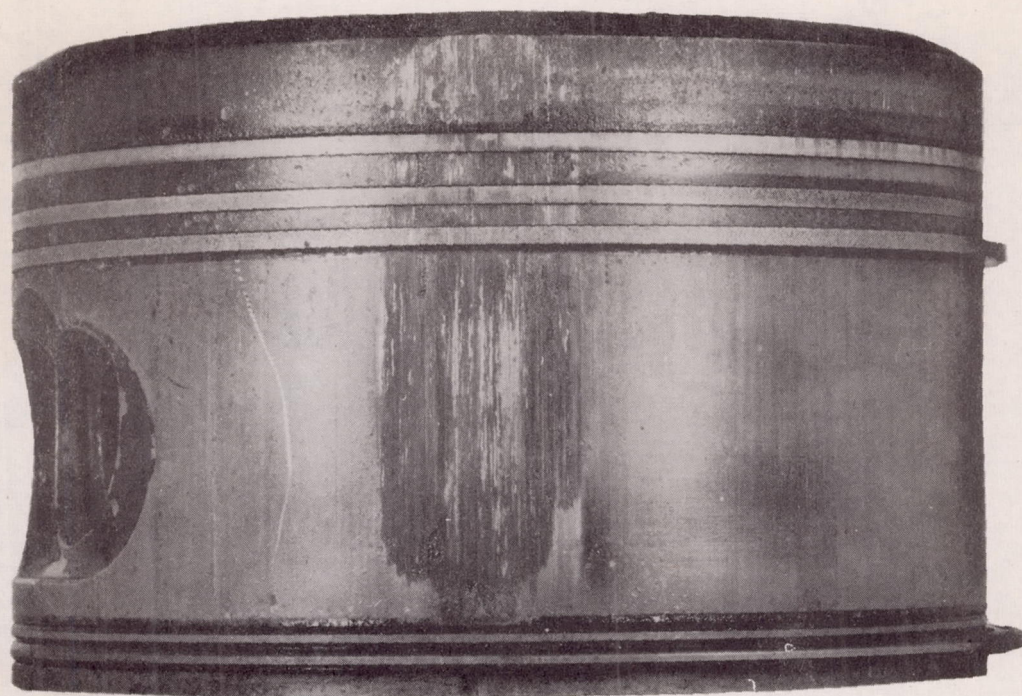
Analysis of failed piston. - Figure 9 shows the piston at the end of the second test. The failure was quite similar to that of the first test. In this case, however, much of the top two compression rings was still in the ring grooves, probably caused by the rings' being more severely stuck than in the first test and therefore not so free to rotate in the grooves.

Particles of aluminum alloy were found in the oil-ring groove displaced a considerable distance from the point of failure. Here again is evidence that the channeling of the piston took place over an appreciable period of time. It appears unlikely that these aluminum particles could have moved so far along the groove at the instant of final failure.

Figure 9. - Piston and ring assembly at end of second endurance test. Total test time, 84.25 hours.

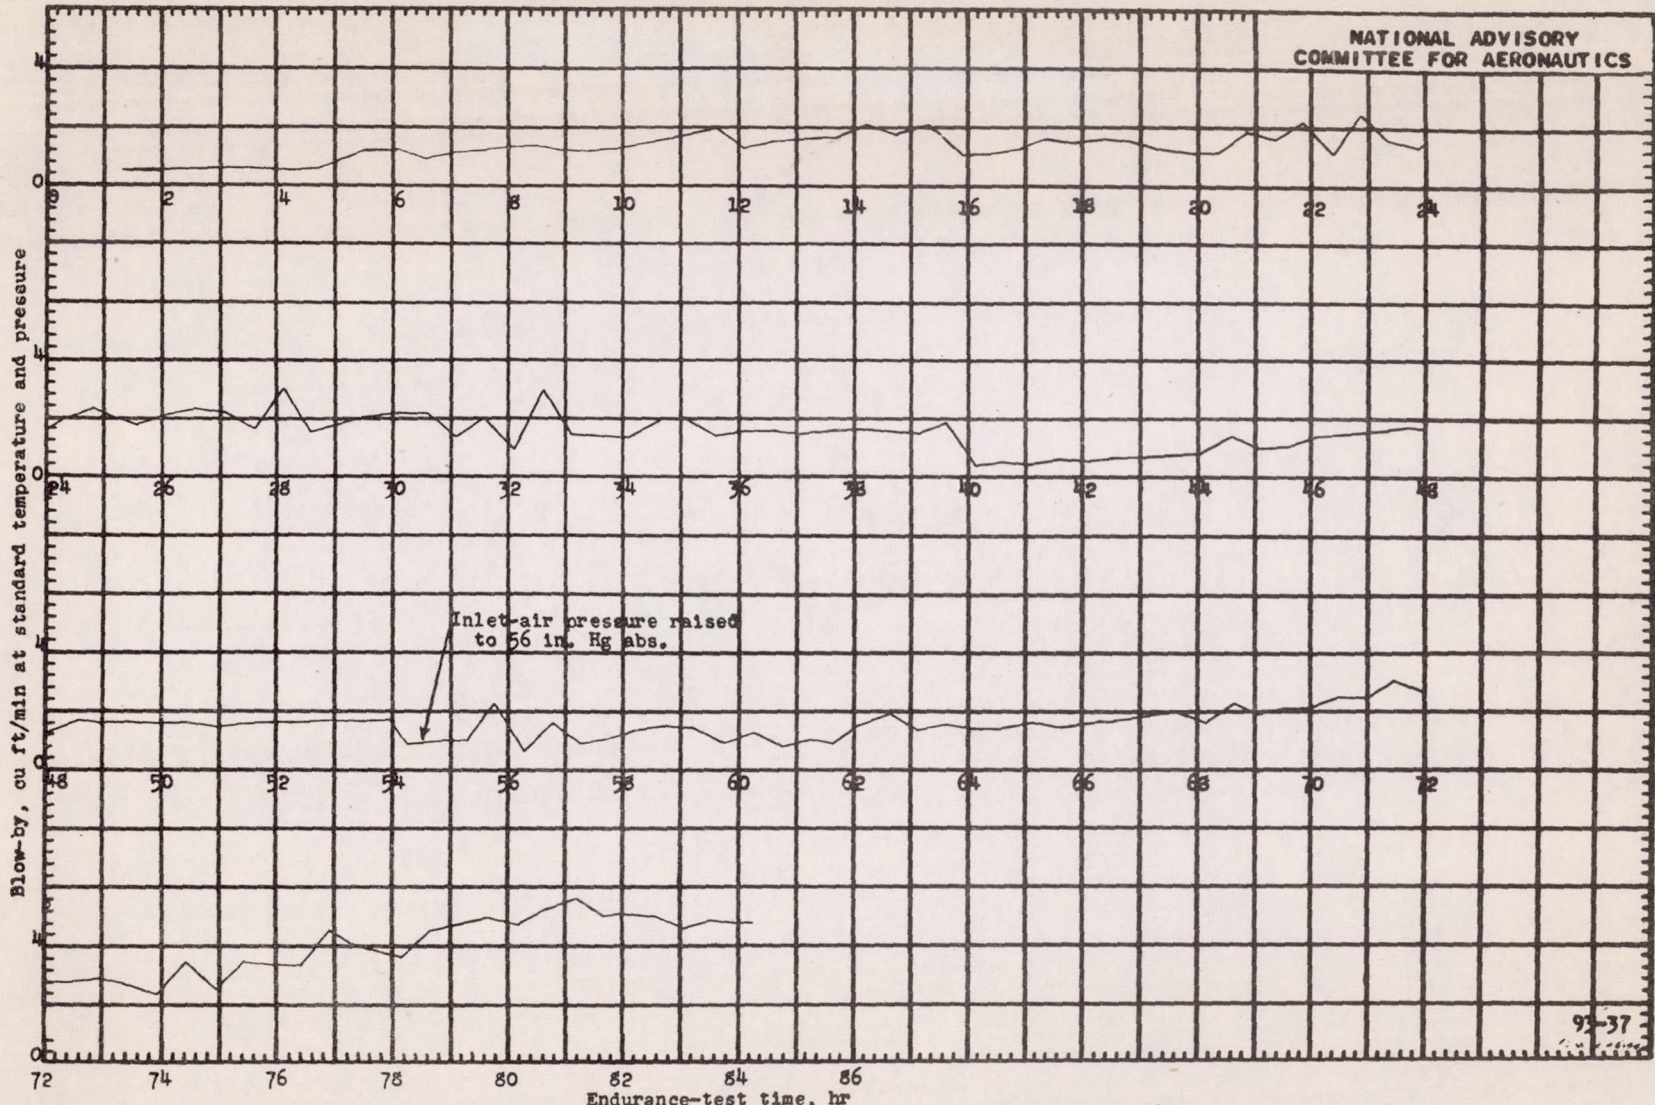
Blow-by and crankcase pressure. - The curves of rate of blow-by and crankcase pressure for the second test are shown in figures 10 and 11. These curves show a marked increase in the blow-by rate and the crankcase pressure after the first 4.5 hours of running, which indicates the beginning of compression-ring failure probably by sticking of the top ring. Unpublished data taken on this engine have shown that 0.5 cubic foot per minute is an average value for the rate of blow-by with a new piston and ring assembly when operating

under conditions similar to normal rated power. An increase to about 1.0 cubic foot per minute usually indicates sticking of the top ring.

Figure 10. - Effect of running time on rate of blow-by for second endurance test. Engine speed, 2600 rpm; inlet-air pressure, 50 inches of mercury absolute (except as noted); inlet-air temperature, 200° F; fuel-air ratio, 0.085; oil flow to piston, 0.5 pound per minute.
