FLIGHT MEASUREMENTS OF HORIZONTAL TAIL LOADS ON A
TYPICAL PROPELLER-DRIVEN PURSUIT AIRPLANE DURING
STALLED PULL-OUTS AT HIGH SPEED

By Lawrence A. Clousing and William N. Turner

Ames Aeronautical Laboratory
Moffett Field, California

MEMORANDUM REPORT

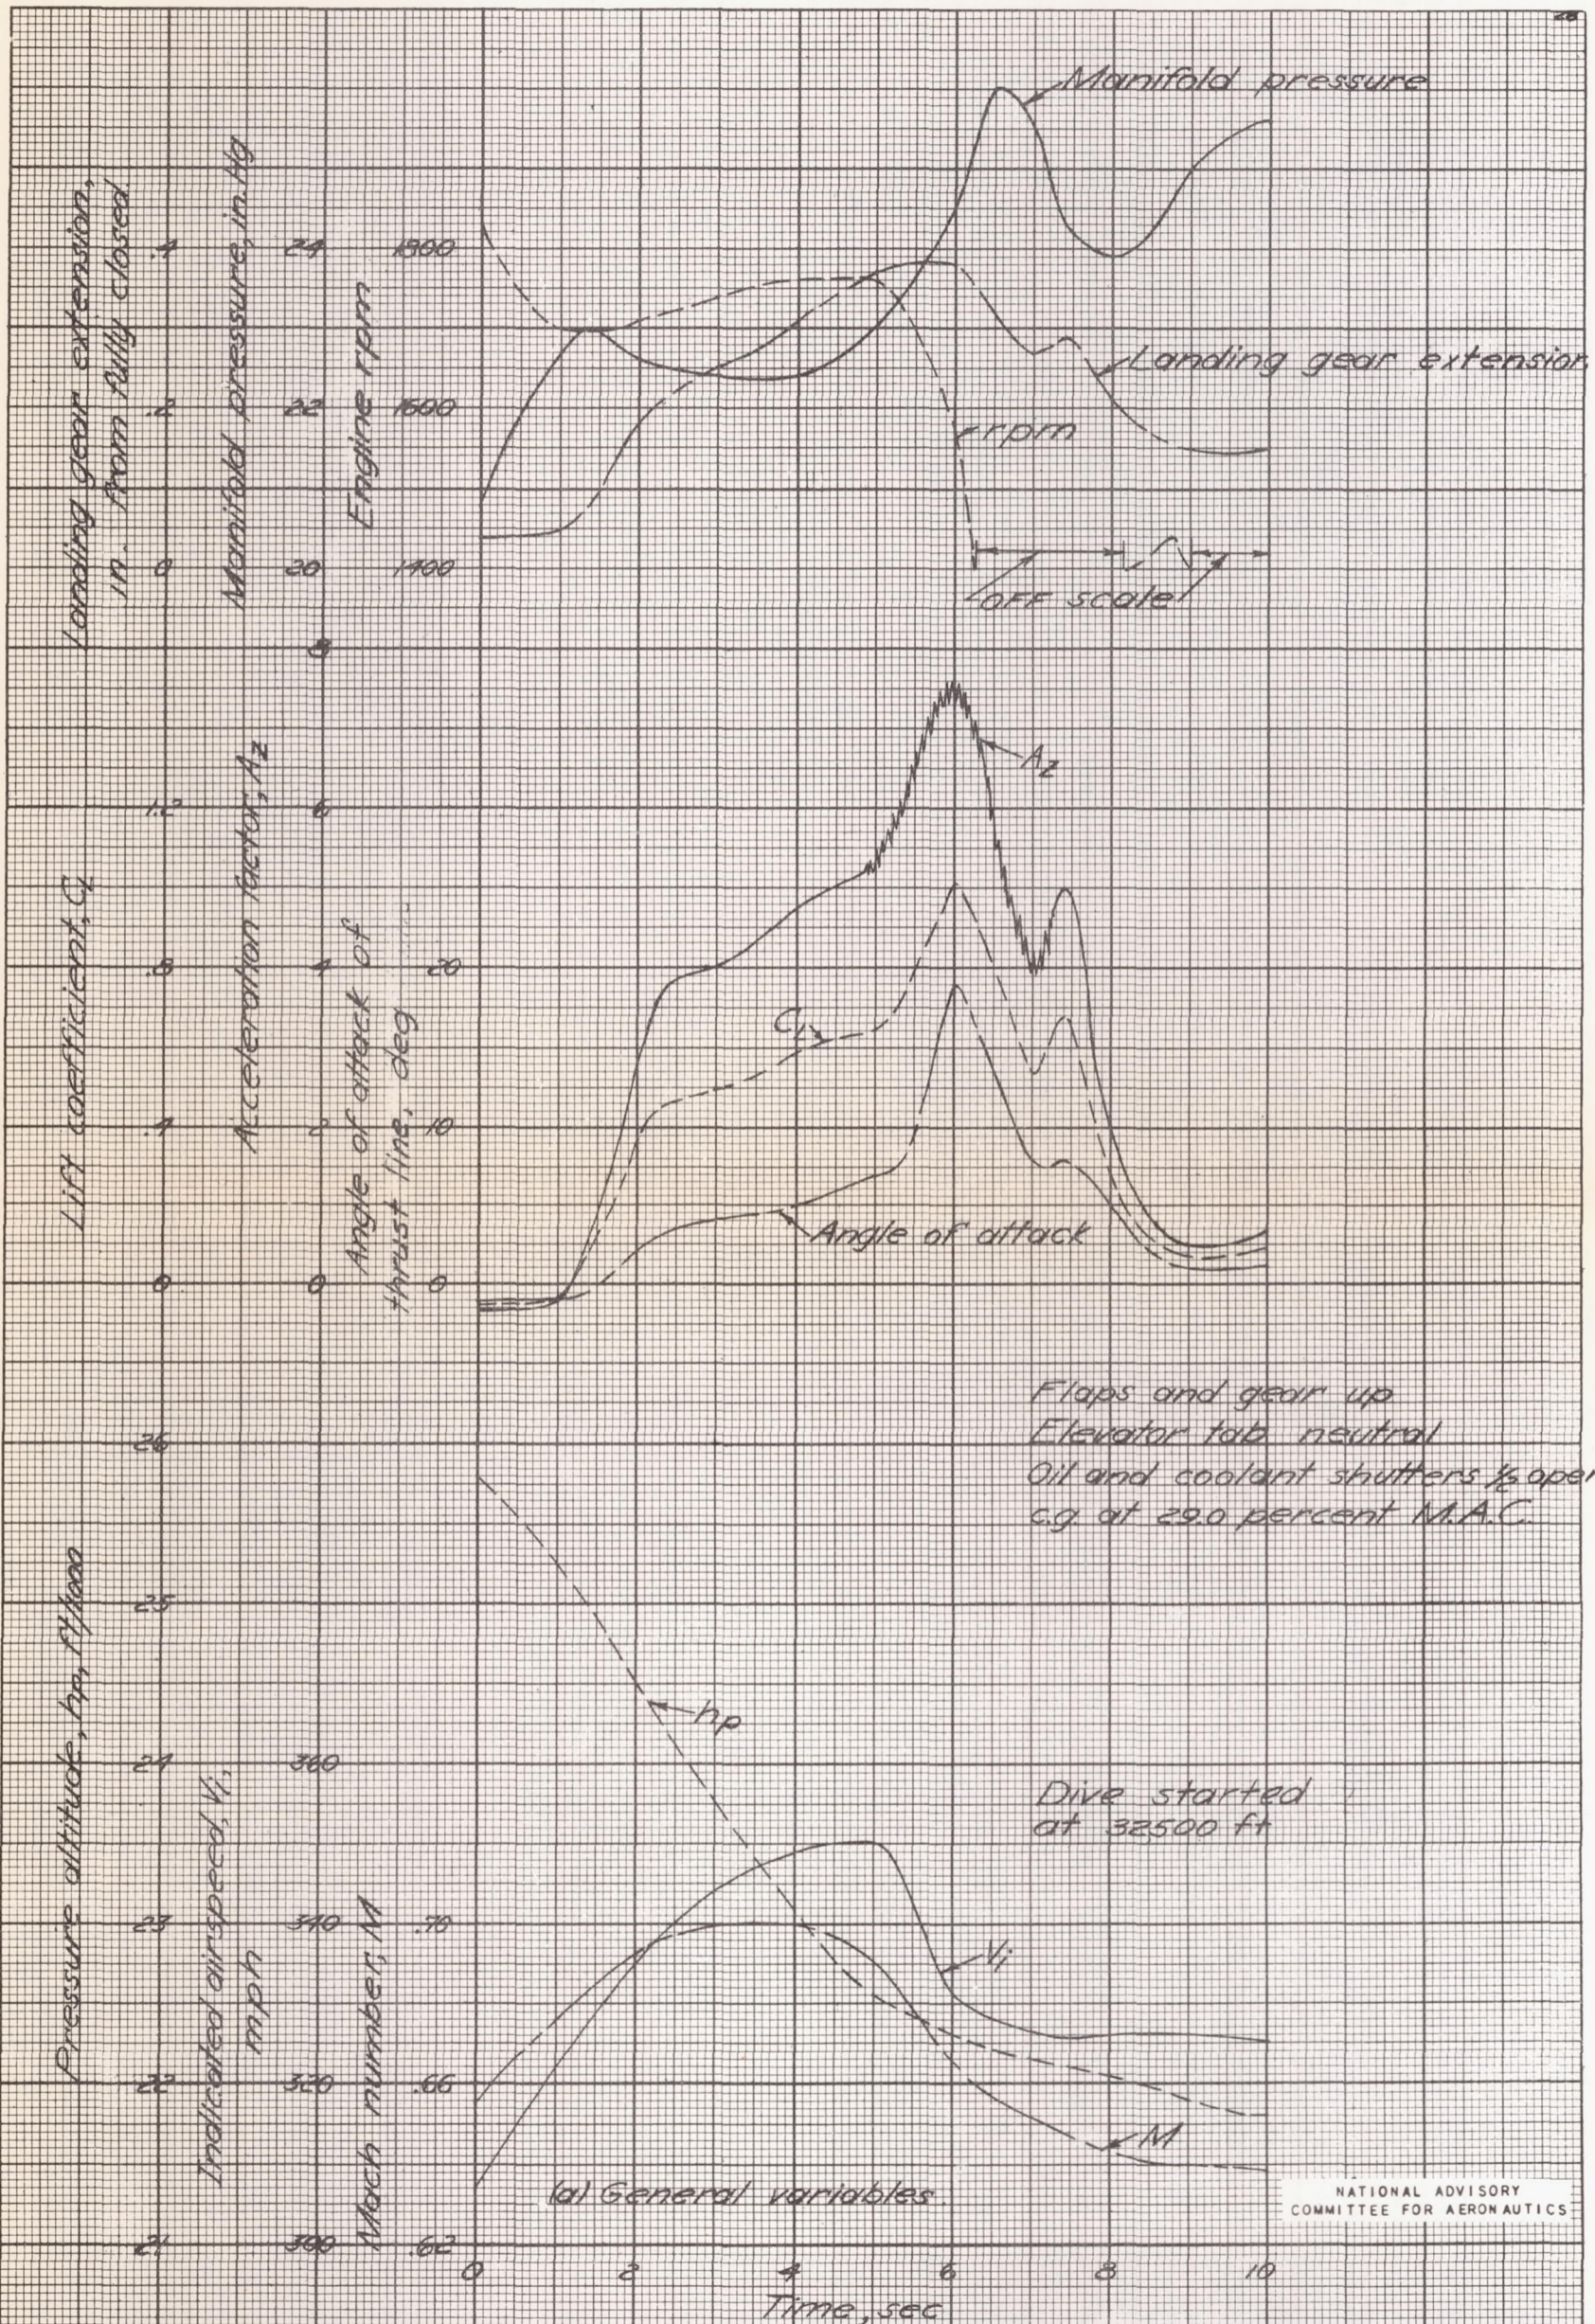
In figures 13, 14, and 15 it is seen that the airplane was pulled in until a very violent stall occurred at a lift coefficient of 1.01 and a Mach number of 0.67. The maximum acceleration factor reached was 7.5 at an angle of attack of 19° . The maximum elevator angle used was 11.5° up. The buffeting was apparently about the same on both sides of the tail in this run. Rapid fluctuations of pressure of 300 to 400 pounds per square foot occurred at the leading edge of the stabilizer during the buffeting. The maximum recorded pressures and unit span loads in this run are listed in the following table:

During this run structural failure of the horizontal tail occurred. Since the airplane was operating within maneuvering limits which were considered safe by design specifications in use at the time the airplane was designed, it is of interest to examine the nature of the tail failure in relation to the loads measured, and in relation to the necessity for revision of air load requirements and the manner of specifying safe maneuverability limits to a pilot.

Figure 13 - Time history of a power-off dive pull-out at $M \approx 0.67$ in which partial failure of the reinforced horizontal tail structure occurred.

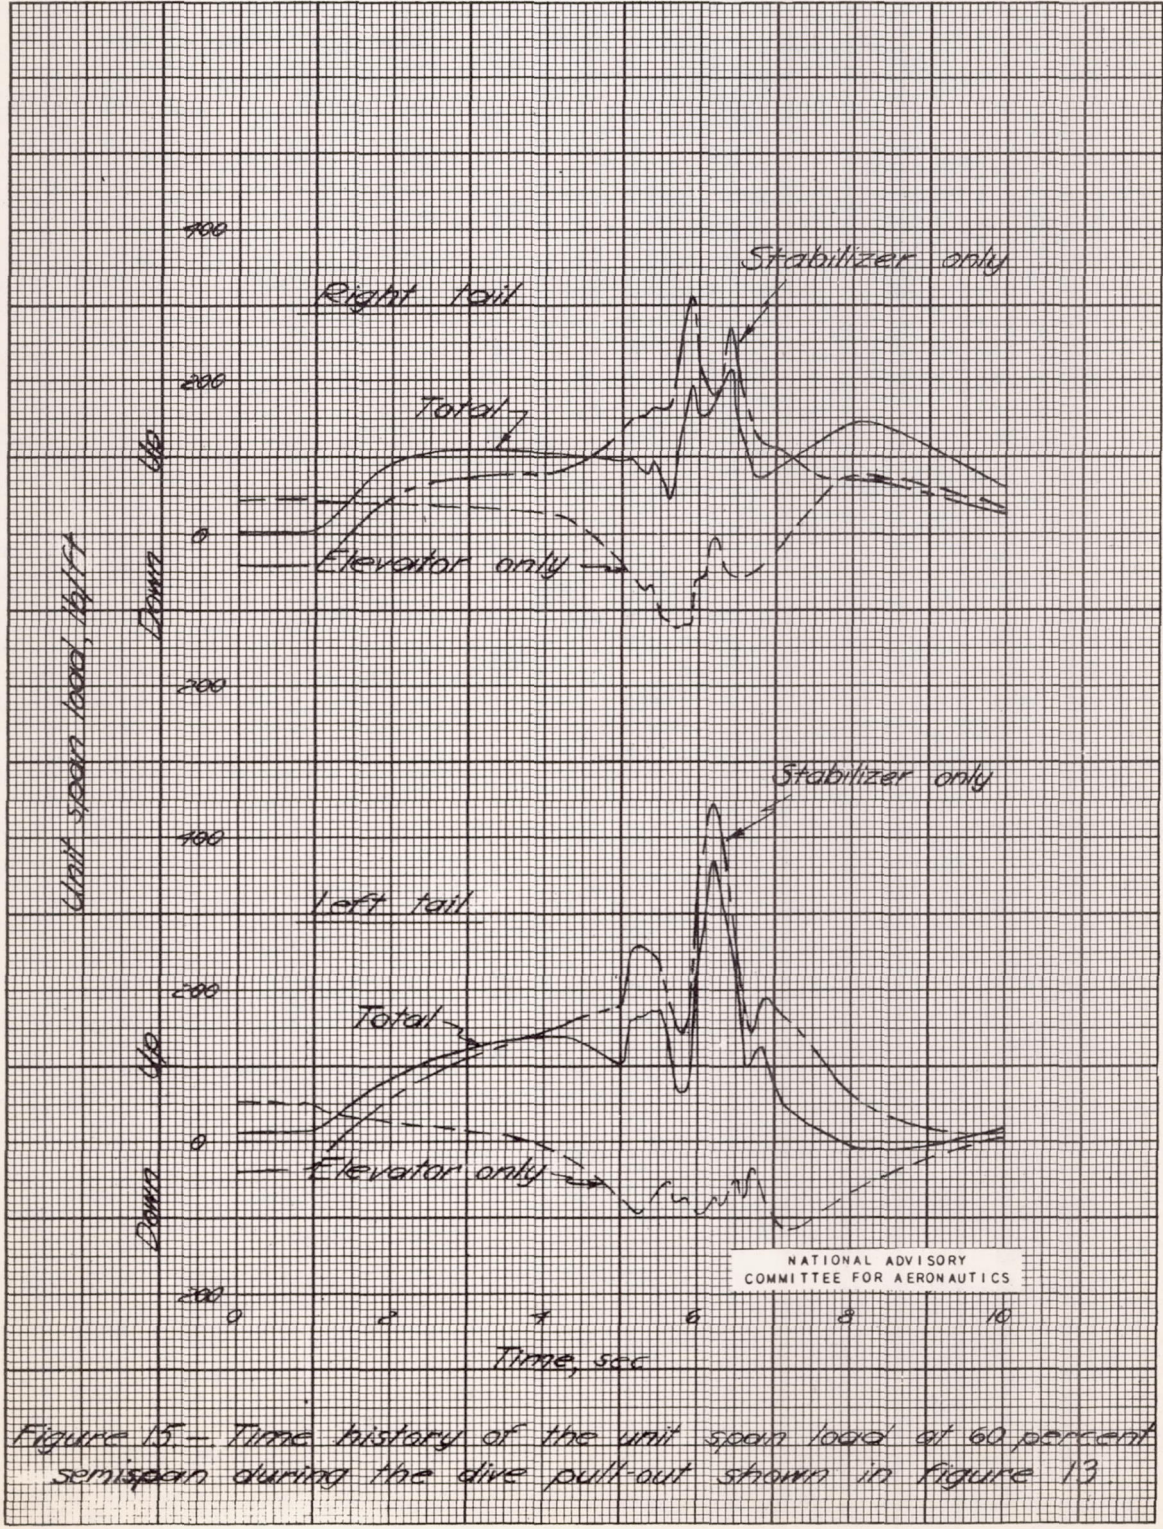
loads caused much more severe structural strain than the same loads would have caused if applied under static conditions. In the last pull-out, in which the structural failure occurred (figs. 13, 14, and 15), the buffeting was more severe than in any previous maneuver. In this pull-out an attempt had been made to insure absolutely that the maximum acceleration factor possible to attain had been obtained. A strong pull force was exerted on the stick even after heavy buffeting had set in. A slightly greater elevator angle was used than in the previous pull-outs. It should be realized, too, that the loads which were measured during the buffeting condition may actually have been somewhat greater than those recorded, due to lag in the pressure lines.

Figure 15 - Time history of the unit span load at 60 percent semispan during the dive pull-out shown in figure 13

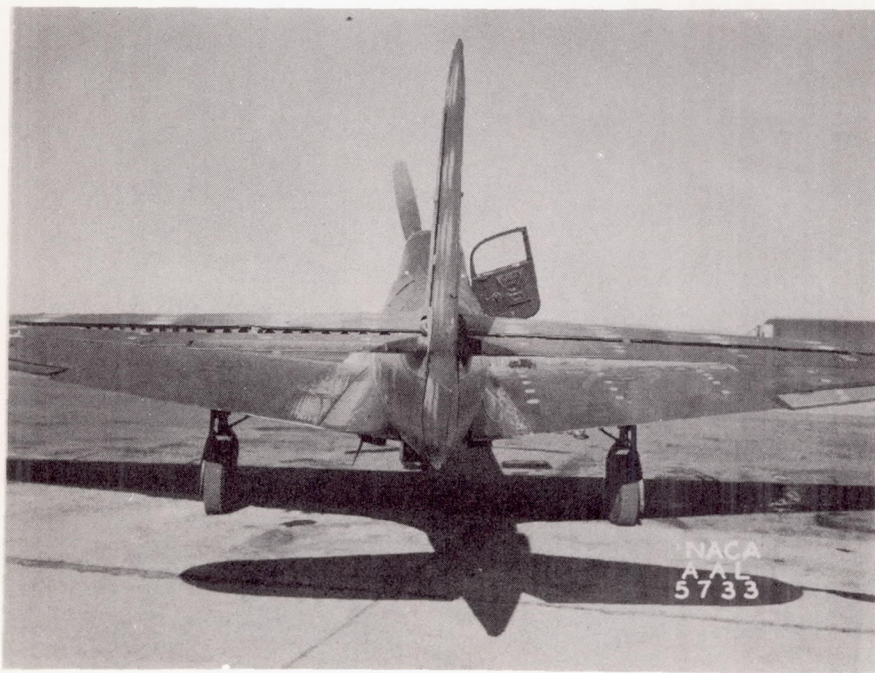
The principal failures were on the left side of the tail, although failure had also started on the right side. A rear view of the airplane with undamaged tail is shown in figure 16, and views of the principal failures are presented in figures 17 to 23. The left elevator had buckled downward at about the third outboard row of orifices (figs. 17, 18, and 19), cracking the elevator spar (fig. 20). The elevator nose balance had been forced downward severely enough to break the elevator nose rib on each side of the tail just inside the outboard hinge fitting (figs. 21 and 22). The left stabilizer rear beam was cracked at the inboard hinge bracket, and the two top bolts holding the bracket to the stabilizer rear beam had been sheared completely (fig. 23). Other miscellaneous failures of various degrees of severity occurred to both the stabilizer and elevator structure in the immediate vicinity of all the hinge brackets.

Figure 17.- Rear view showing damaged horizontal tail surfaces.

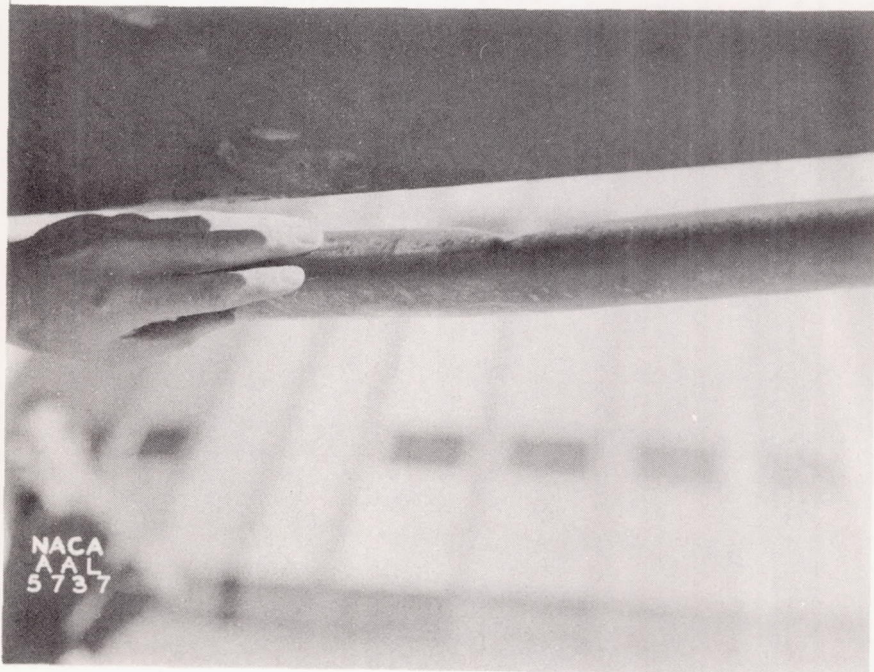
Figure 19.- Lower front view of the buckled left elevator.

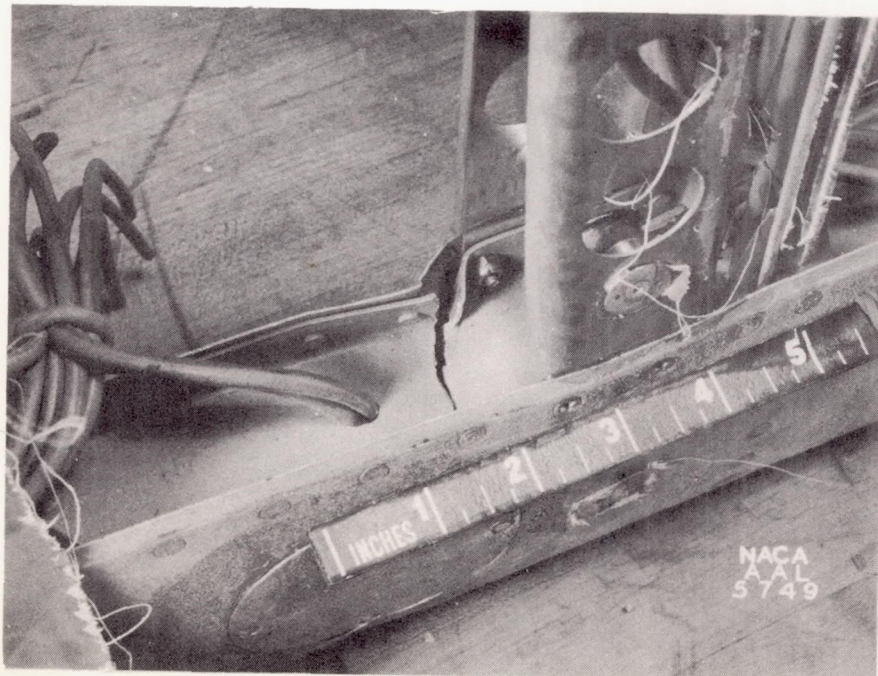
It is possible that fatigue of the elevator structure may have contributed to the failure of the elevator and stabilizer fitting, inasmuch as many flights had been made during which the airplane had been flown at high accelerations with severe buffeting. It is also possible that the dynamic loads caused by buffeting may have been responsible for the elevator failure. No doubt the buffeting

Figure 20.- Detail of cracked elevator spar.

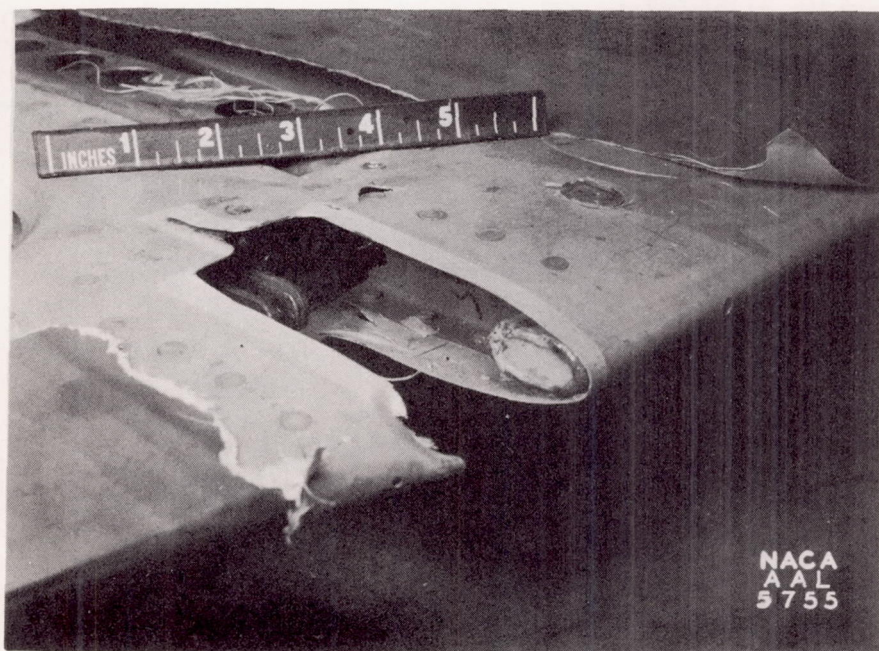
A minor, but perhaps not negligible, additional load which may have contributed to the failure was that caused by a bar weighing about 2.4 pounds per foot which extended along the leading edge of the elevator between the two hinge brackets. This bar was used as a mass balance for the elevator. The acceleration reached in the last run increased the effective weight of the bar to about 18 pounds per foot. Under the dynamic conditions accompanying heavy buffeting this weight may have added appreciably to the stresses set up in the nose structure.

Figure 21.- Lower surface of left elevator showing failure of elevator nose rib at left outboard hinge fitting.

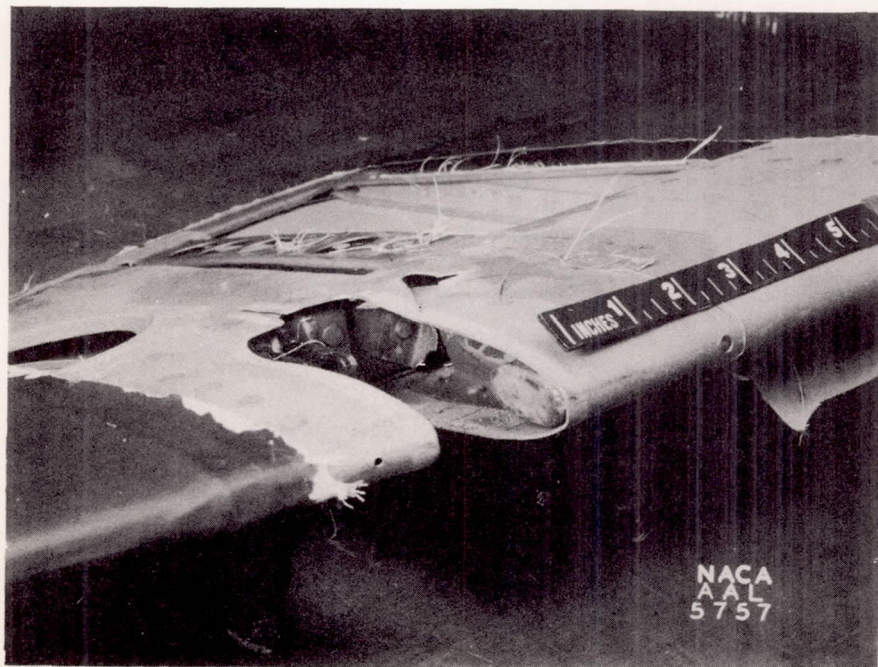
Figure 22.- Upper surface of right elevator showing failure of elevator nose rib at right outboard hinge fitting.

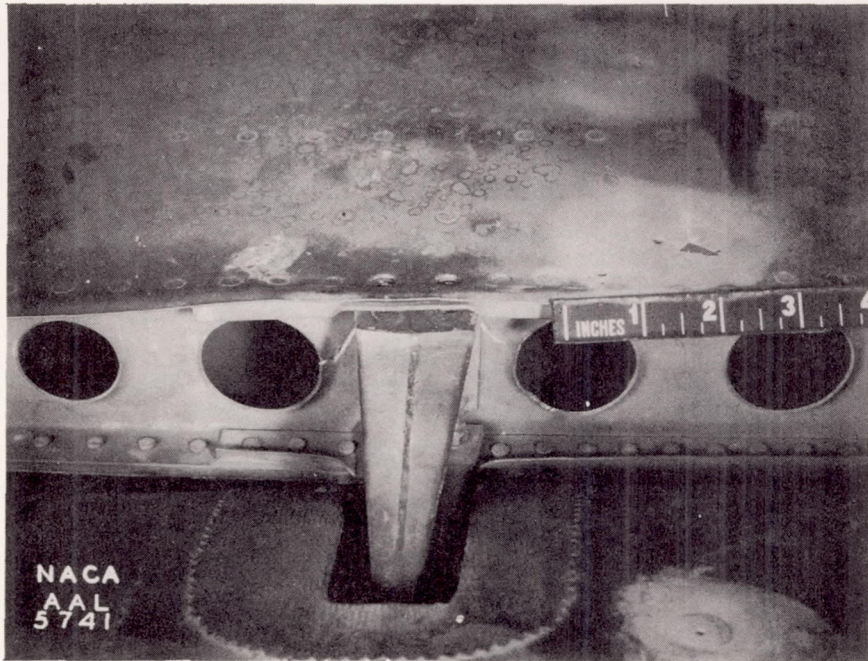
Figure 23.- Detail of cracked stabilizer rear spar at left inboard elevator hinge bracket.

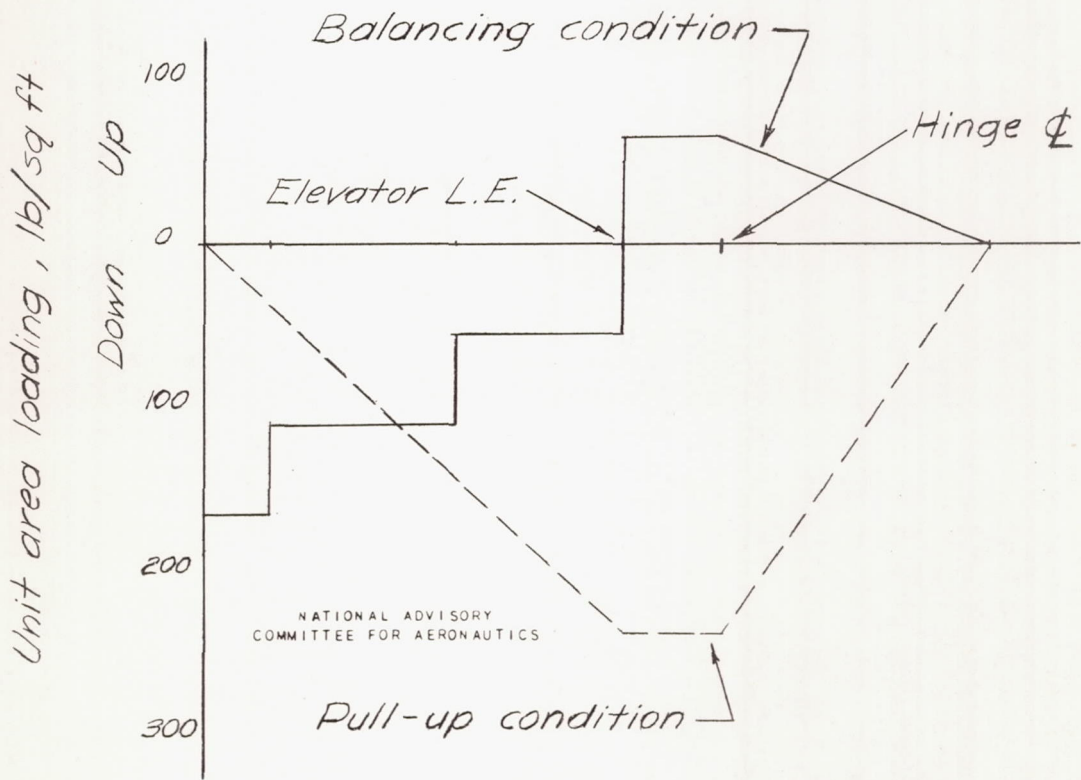
Figure 24 shows the loading conditions for which the horizontal tail surface was designed. Comparison of this figure with the actual flight measurements (figs. 5, 8, 11, and 14) shows that in many instances the unit loads actually measured on the stabilizer in flight were not only considerably in excess of the design unit loads, but that they occurred in a direction opposite to the design loads. At the leading edge of the elevator, the design unit loads were not exceeded in the pull-outs, at least not at the particular spanwise stations at which measurements were made. However, it was the elevator and a fitting supporting the elevator that failed and not the stabilizer.

Inasmuch as the elevator loads at the time of failure did not appear to have been in excess of those for which the surface was designed, the reasons for the failure of the elevator are not entirely clear. Also, higher elevator down loads had been encountered on a previous flight (fig. 9) at least at the spanwise location at which measurements were made.

Figure 24 . - Horizontal tail design load conditions.

Revision of the tail-load design requirements and of the manner of specifying safe maneuverability limits to pilots appears necessary.
