February 1945 as
Advance Confidential Report L5A30

A SUMMARY OF DRAG RESULTS FROM RECENT
LANGLEY FULL-SCALE-TUNNEL TESTS OF
ARMY AND NAVY AIRPLANES

By Roy H. Lange

Langley Memorial Aeronautical Laboratory
Langley Field, Va.

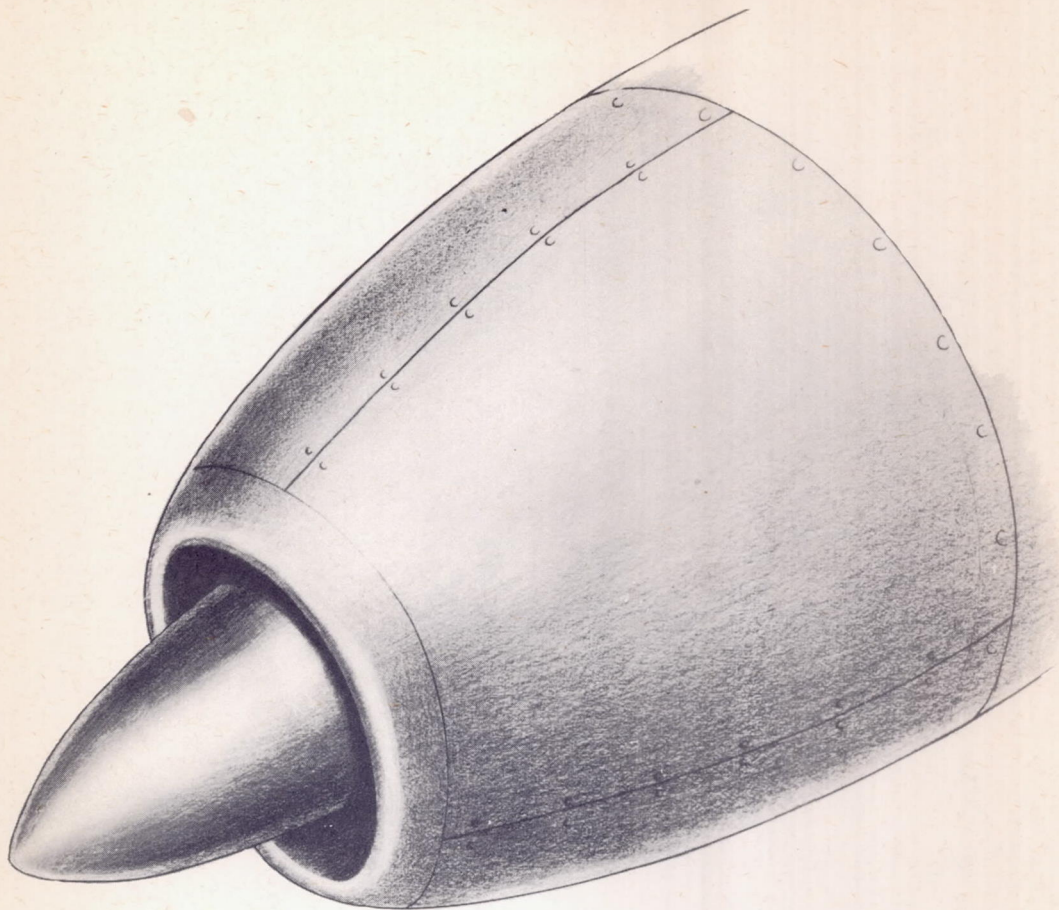
Figure 3.- Cowling drag on airplane 1.

The original long-nose cowling on airplane 1, which had a 20-inch propeller-shaft extension to permit a cowling shape of higher fineness ratio, included an inlet that was too small and leading edges that were too sharp. The sudden change in direction and the extreme expansion of the high-velocity cooling air into the large volume ahead of the engine resulted in a total-pressure recovery in front of the engine cylinders of only 0.40 q_0 . The drag coefficient was 0.0040 greater for the original installation with an exit area of 167 square inches (cooling flaps in closed position) and an air-flow quantity of approximately 16,000 cubic feet per minute at 350 miles per hour than for the sealed and smooth cowling with the scoop removed. Cowlings were developed in the Langley full-scale tunnel (figs. 3(b) and 3(d)) to reduce the drag of the original cowling.

ΔC_D , 0.0027 Q , 17,000 cu ft per min
 ΔV , 13 mph $H - p_0$, $0.90q_0$

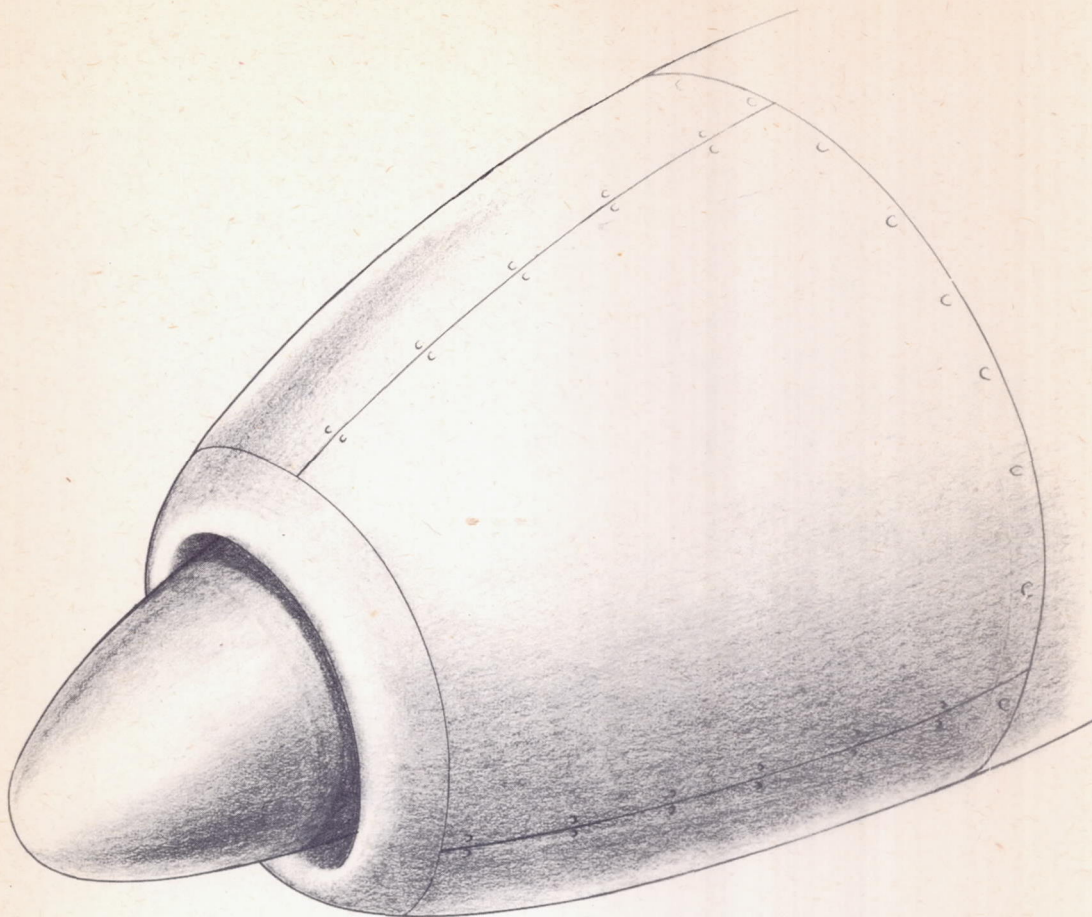
Figure 3.- Continued.

The drag of the annular-inlet cowling with spinner A was considered excessive and the outlet was next investigated (reference 3). Removing the cowling-flap gear and exhaust collector ring and installing a smooth outlet decreased the drag of the cowling by 0.0007 with an air flow of approximately 13,000 cubic feet per minute. In addition, a bottom exit was provided by removing the oil cooler and enlarging the oil-cooler exit to allow an engine-cooling-air flow of approximately 13,000 cubic feet per minute with the cowling flaps sealed. This arrangement further reduced the drag by 0.0004.

ΔC_D , 0.0012 Q , 21,000 cu ft per min
 ΔV , 6 mph $H - P_0$, 0.97 q_0

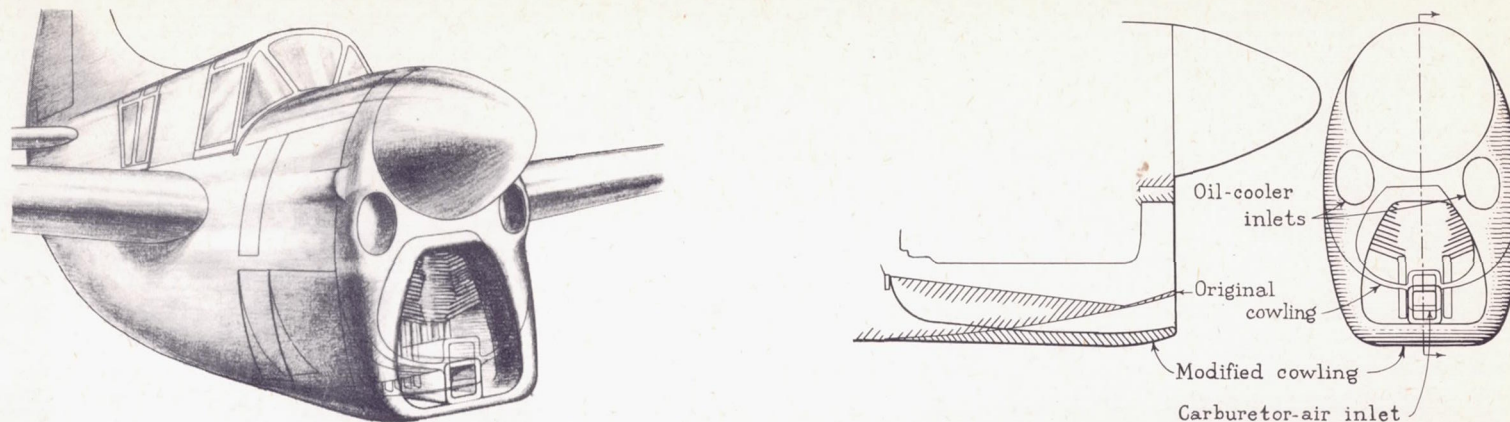
Figure 5.- Cowling modification on airplane 2.

Flight tests showed that the inline air-cooled engine of airplane 2 did not cool satisfactorily in any flight attitude in the original condition. Tests in the Langley full-scale tunnel revealed that losses in the cooling system were excessive because of restricted inlet and outlet openings. The inlet was accordingly lowered and its area increased from 188 square inches to 241 square inches and additional outlet openings of 75 square inches were installed on each side of the cowling. These modifications increased the power-on inlet total pressure 25 percent in the climb attitude, principally because the inlet was lowered into a region of higher slipstream velocity. In addition, the average total pressure in front of the engine cylinders was increased. The drag coefficient with propeller removed was decreased 0.0004 by the cowling modification. This reduction is attributed mainly to the improved shape of the cowling lip and the greater efficiency of the internal flow.

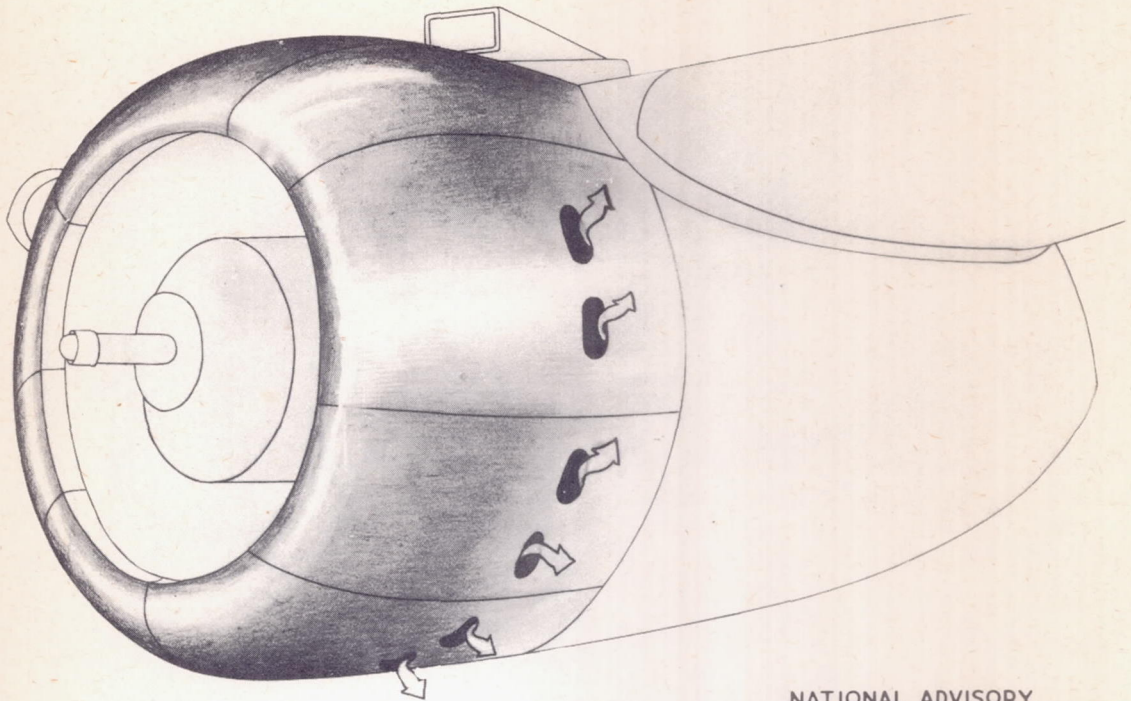
ΔC_D , 0.0041
 ΔV , 13 mph

Some makeshift methods of controlling the air-flow quantity have been found to cause excessive drag. On airplane 3, for example, the designers cut eight holes, each with an area of 12.5 square inches, in the periphery of the cowling just behind the cylinder baffles in order to remedy unsatisfactory cooling of the engine in the climb condition. Tests by the Army and the manufacturer indicated that the cooling problem was not remedied for the climb condition and the flow disturbances caused by the holes resulted in an increase in drag coefficient of 0.0041 for the cowlings of the two engines, which corresponds to a decrease in the airplane high speed of about 13 miles per hour.

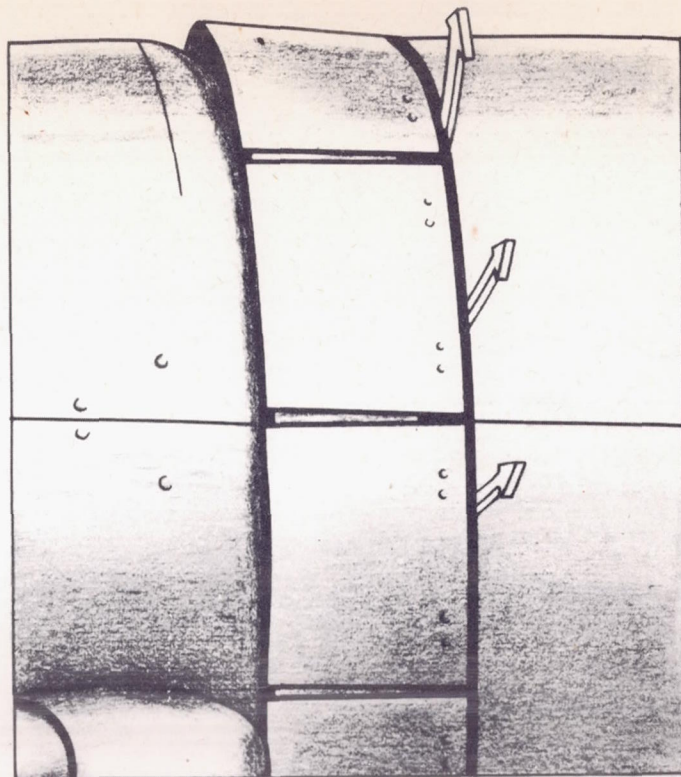
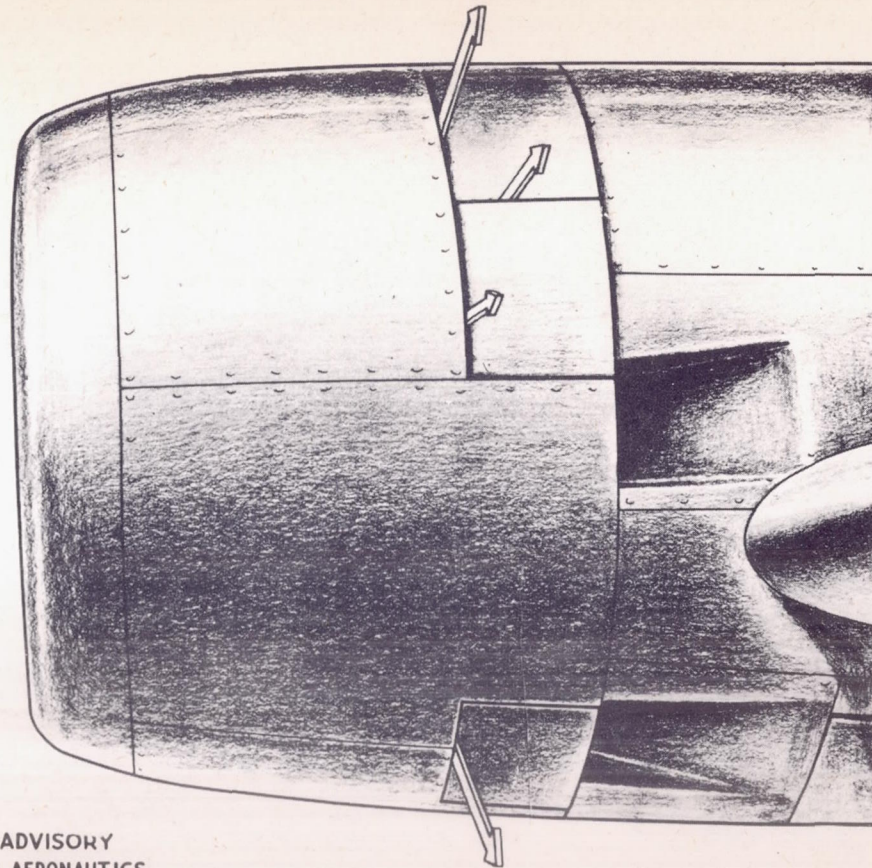
Drag increases were measured when the doped-tape seals were removed from the gaps at the hinge line of the closed cowling flaps of airplanes 6, 8, and 10. The arrows show points of leakage that disturbed the external flow and resulted in an increase of drag. More complete sealing or directing the air flow backward would tend to eliminate this drag increment.

$\Delta C_D, 0.0005$

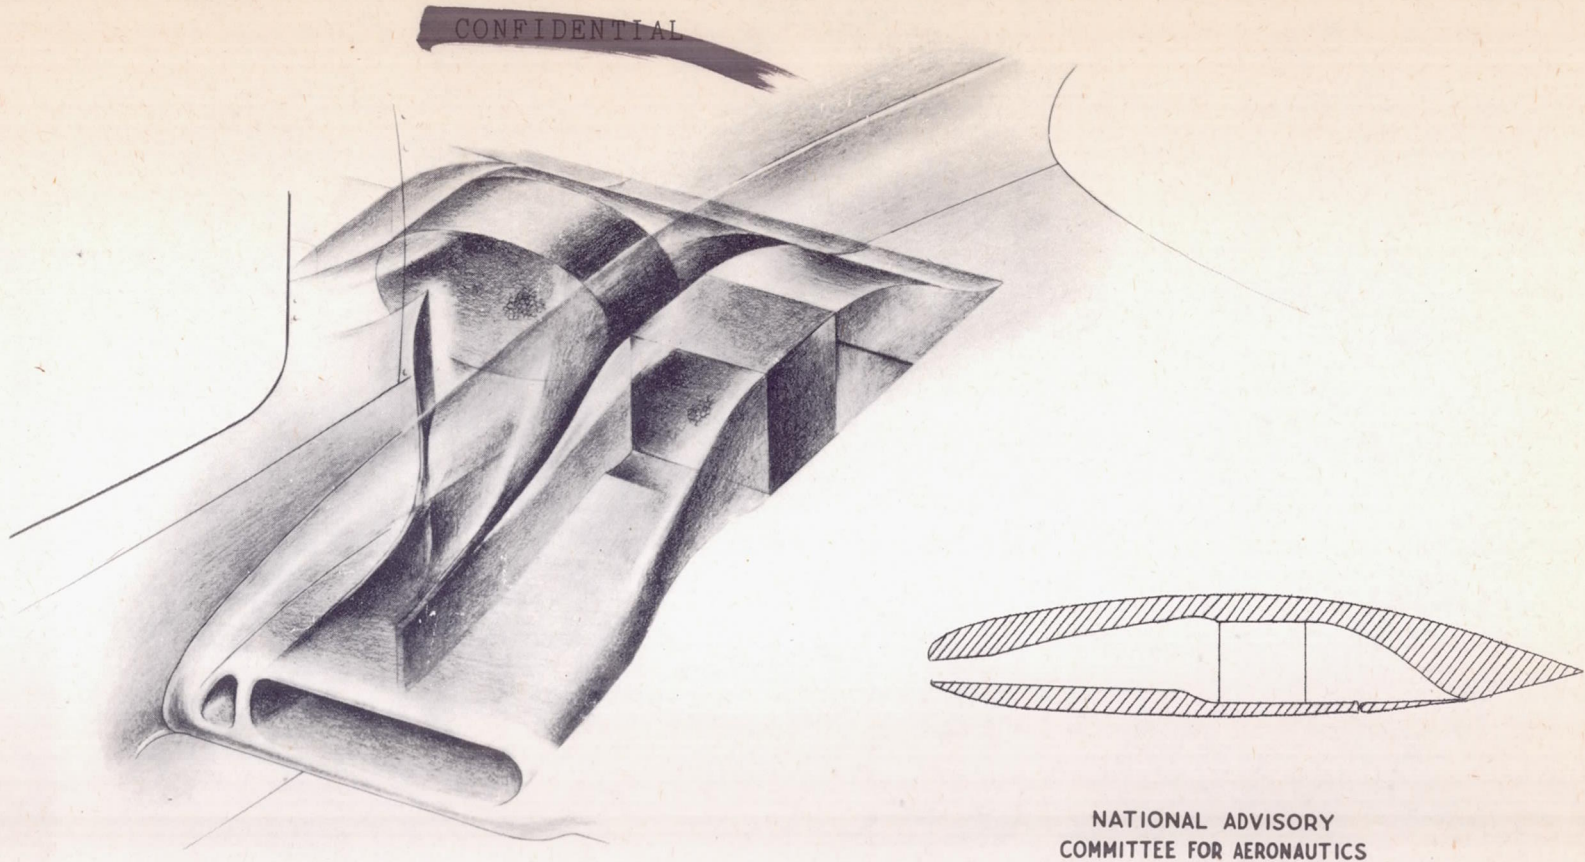
Figure 10.- Wing-duct inlet on airplane 11.

A drag-coefficient increment of 0.0013 was measured when the seals were removed from the wing-duct inlets and exits with the exit flaps at 0° for airplane 11 in the high-speed condition. Removing seals from holes in the top of the duct exits for flap-control push rods added an increment of 0.0004, which made the total-drag coefficient 0.0017 for the original installation with a large quantity of air flowing through the duct because of air leakage at the exit flap. Tests with the propeller operating showed that serious losses in total-pressure recovery occurred as a result of the misalignment of the duct lips to the air stream caused by the slipstream rotation. In order to remedy this condition, modified inlets were installed (fig. 11) with the plane of the inlet on the side of the upgoing propeller blade tilted 15° farther downward than the plane of the inlet on the side of the downgoing propeller blade. A further modification, which consisted of an increase in area of the right and left inlets from 55 to 73 square inches, was made to lower the inlet-velocity ratio. For the high-speed condition, with the exit flaps at 0° , the modified inlets decreased the drag coefficient 0.0005 and increased the total pressure at the faces of the radiators 15 percent. The cooling was improved for both the high-speed and climb conditions with the modified inlets.

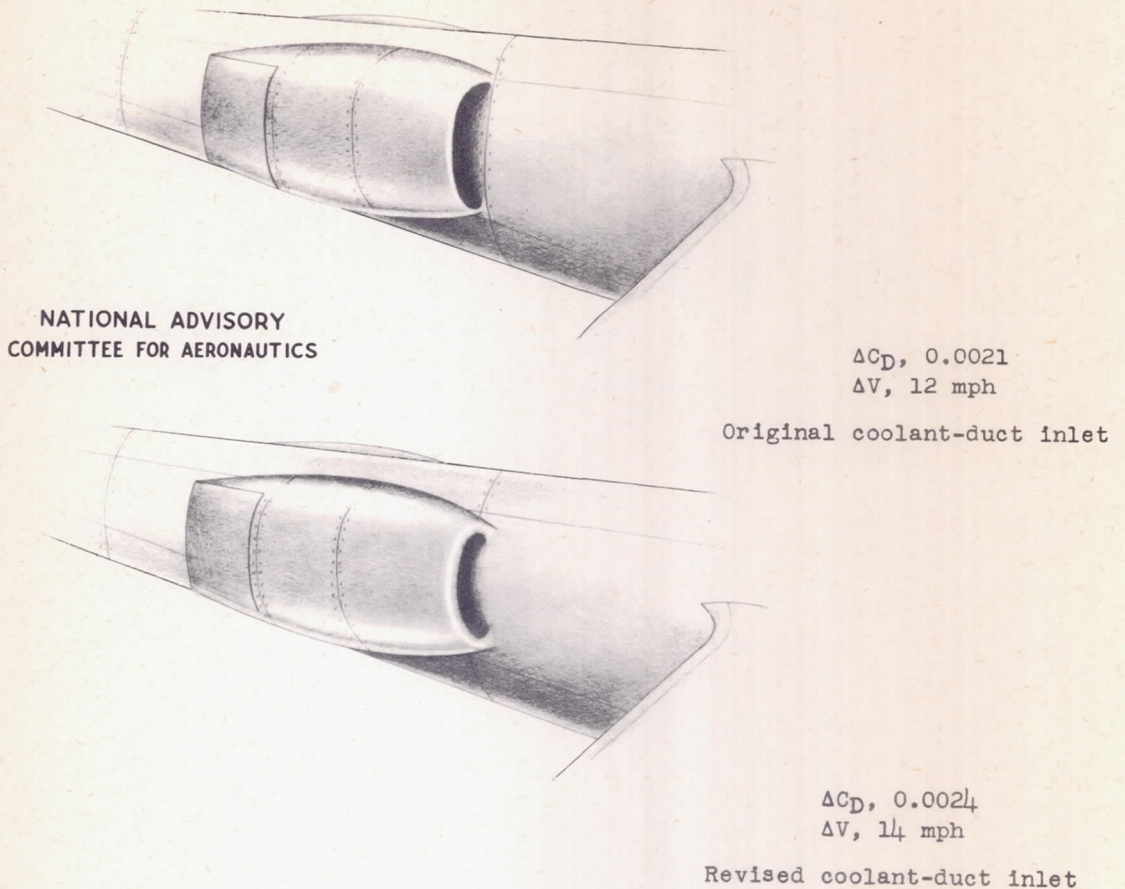
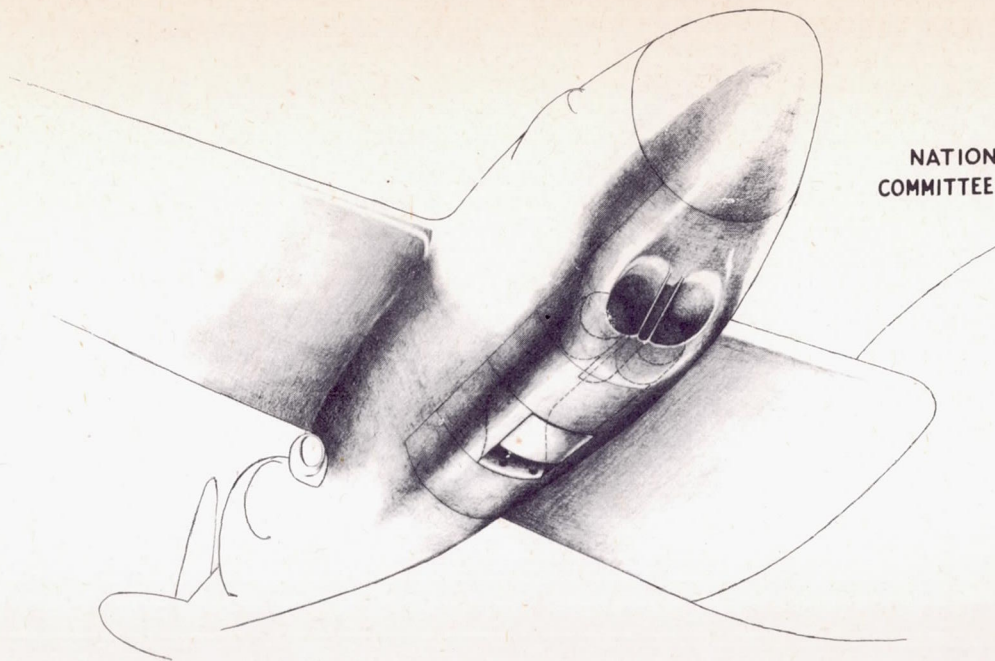
Figure 12.- Duct installations on airplane 4.

The drag coefficient of the experimental airplane 4 with the four original coolant radiator ducts installed and with the outlet flaps open (exit seals removed) for the high-speed condition was 0.0021 greater than for the airplane with the ducts removed. Revised ducts for the production airplane were installed with a smaller inlet area and higher inlet-velocity ratio. The increase of drag coefficient due to the revised ducts was 0.0024 but the air-flow quantity was increased 9 percent as compared with that of the original duct. With the revised inlets and with the outlet flaps full open, however, the air-flow quantity was 6 percent less than with the original ducts for the same condition and the drag was 0.0051 as compared with 0.0043 for the original ducts. Since the ducts are in a region of low-energy air, sufficient cooling cannot be obtained with low drag.

ΔC_D , 0.0008

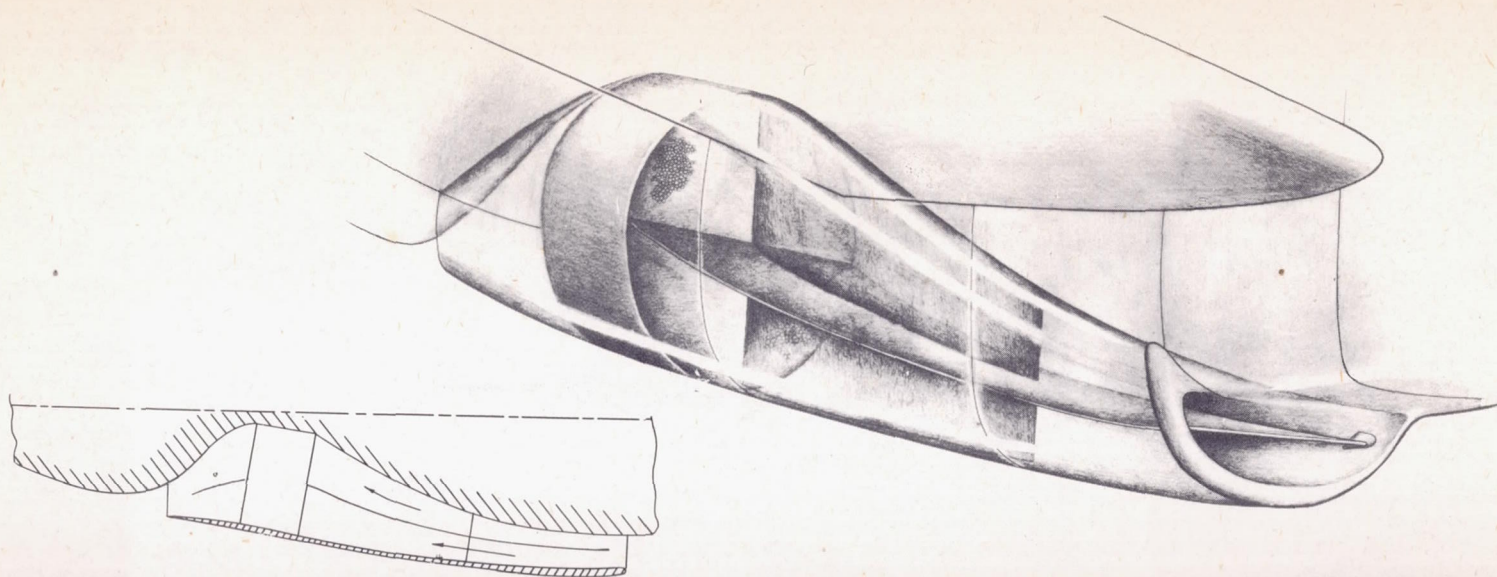
$\Delta C_D, 0.0004$

Vanes were installed in the rear underslung duct of airplane 7 to reduce the pressure losses at the radiator face as a result of separation caused by a thick boundary layer at the inlet. The drag coefficient was 0.0004 less with the guide vanes installed in the diffuser and the outlet than without the vanes. In addition, the pressure recovery at the radiator face was increased by the vane installation from $0.69q_0$ to $0.83q_0$ at $\alpha_T = 0.2^\circ$ and from $0.84q_0$ to $0.92q_0$ at $\alpha_T = 10.4^\circ$.

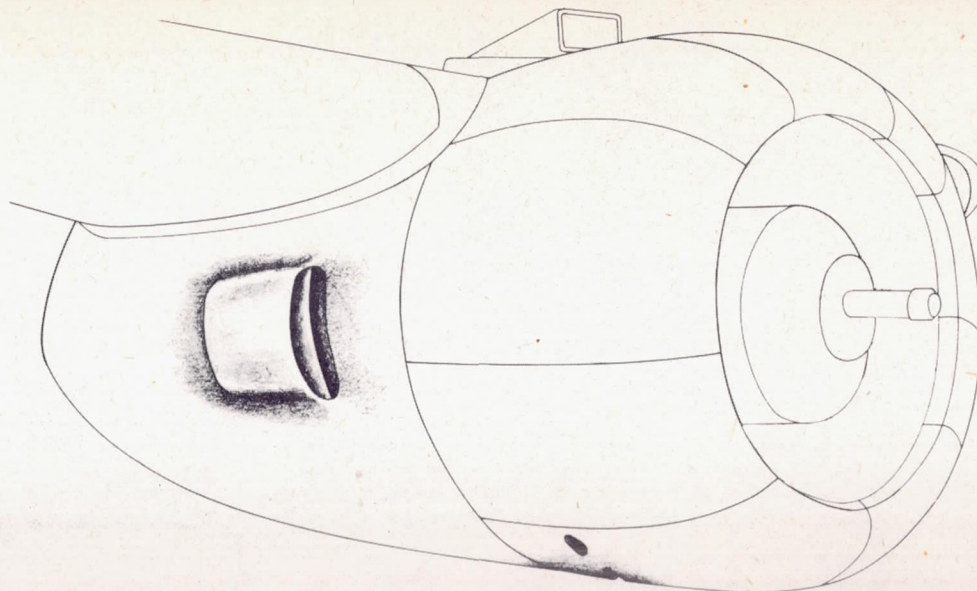
(a) Original duct inlet.

$$\begin{array}{ll} \Delta C_D, 0.0018 & Q/V_0, 0.12 \\ \Delta V, 7 \text{ mph} & H - p_0, 0.40q_0 \end{array}$$

The total-pressure recovery measured at the face of the oil cooler of airplane 3 for the high-speed condition was only $0.40q_0$. This low recovery of total pressure is attributed to the thick boundary layer at the duct inlet. The drag due to ducts on both nacelles with the outlets open for the high-speed condition was 0.0018 greater than with the ducts removed. The Langley full-scale-tunnel modification to improve this installation is described in figure 14(b).

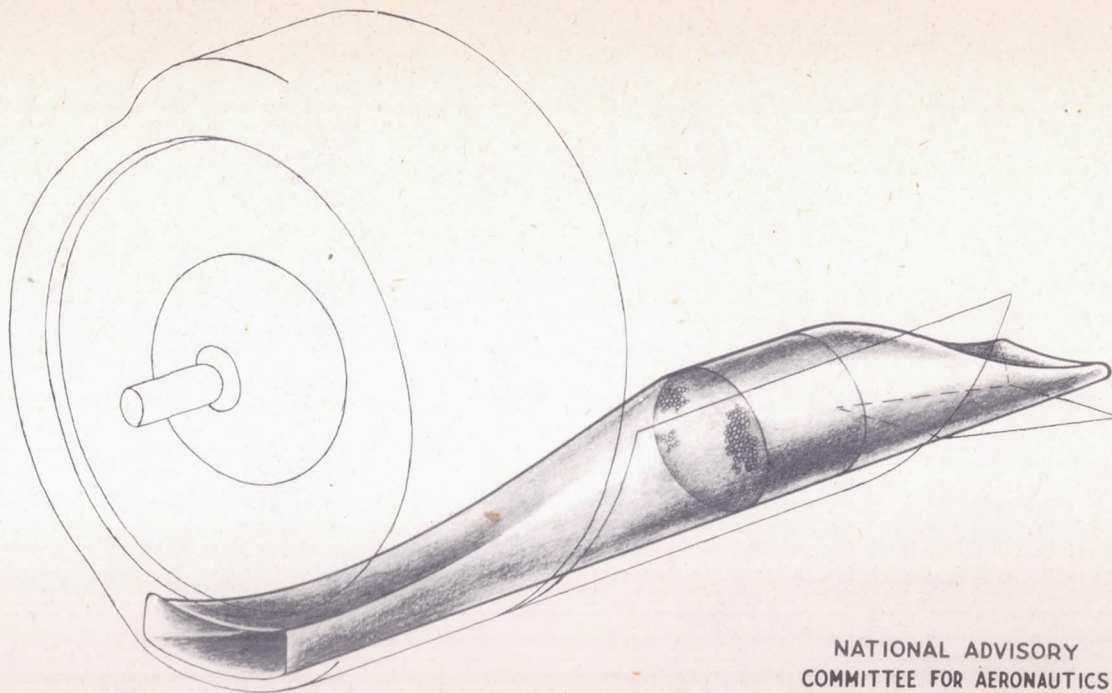
Fig. 14b

ΔC_D , 0.0010 Q/V_0 , 0.13
 ΔV , 5 mph $H - p_0$, 0.95 q_0

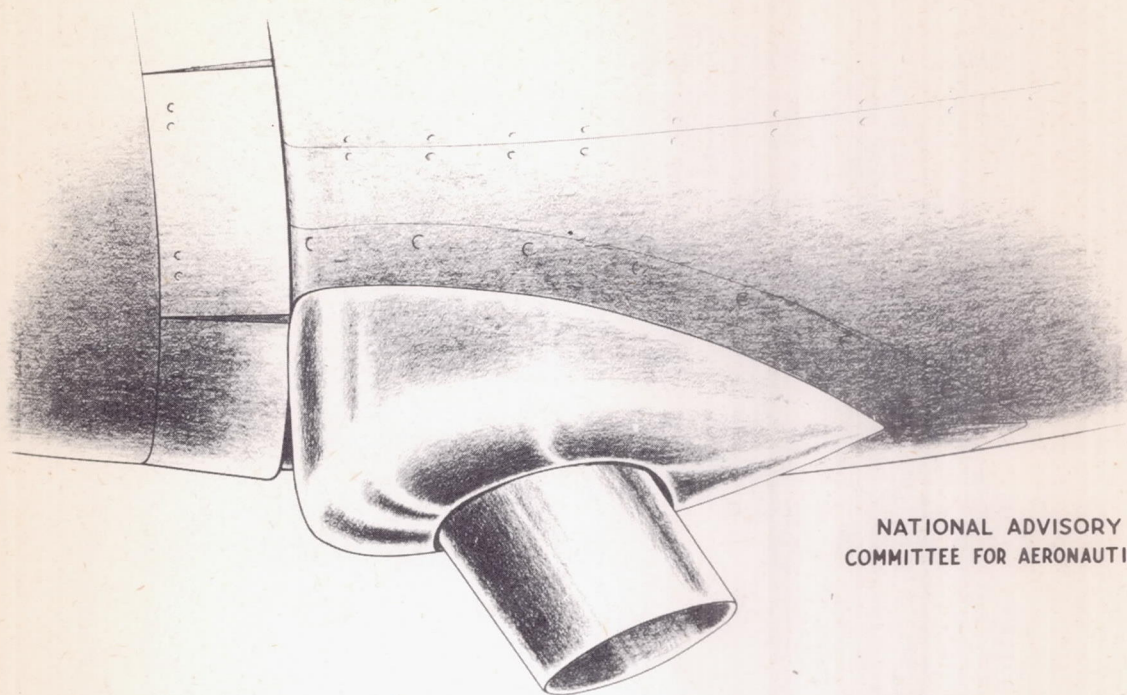
ΔC_D , 0.0021

The large protrusion and the air leakage around the large-bore stovepipe exhaust stacks on airplane 8 account for a drag-coefficient increment of 0.0021. Engine-operating tests at low speed were made both with the original exhaust stacks installed and with individual jet exhaust stacks installed. The tests indicate that the increase in thrust due to the individual jet exhaust stacks would increase the airplane speed by approximately 13 miles per hour over the speed with the original exhaust stacks installed. This thrust increase includes the difference in drag between the original exhaust stacks and the individual jet exhaust stacks. Calculations based on the methods of reference 8 indicate that with the use of optimum-size jet exhaust stacks a further increase of 3 miles per hour would be possible.

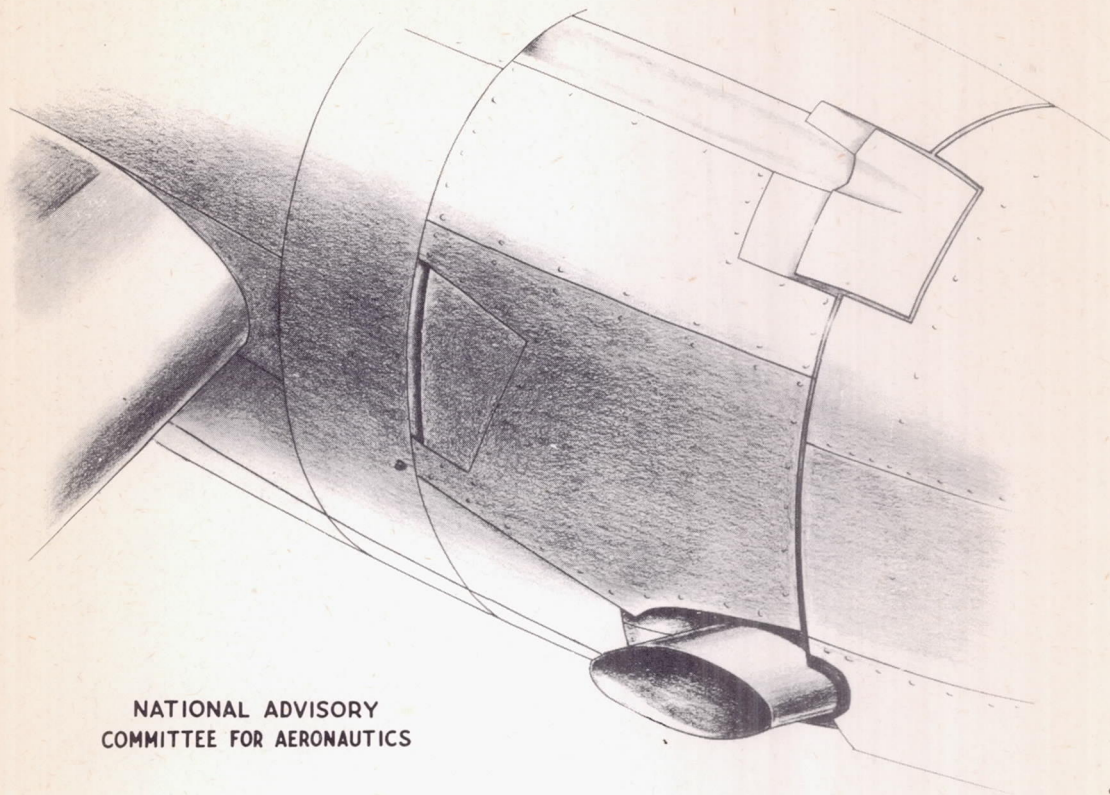
ΔC_D , 0.0008
 ΔV , 3 mph

The installation of this large-bore exhaust stack with large leakage gaps around the stack increased the drag by 0.0008. The use of stovepipe exhaust stacks of this type and of the type used on airplane 8 (fig. 17) should be avoided because of the large form drag.

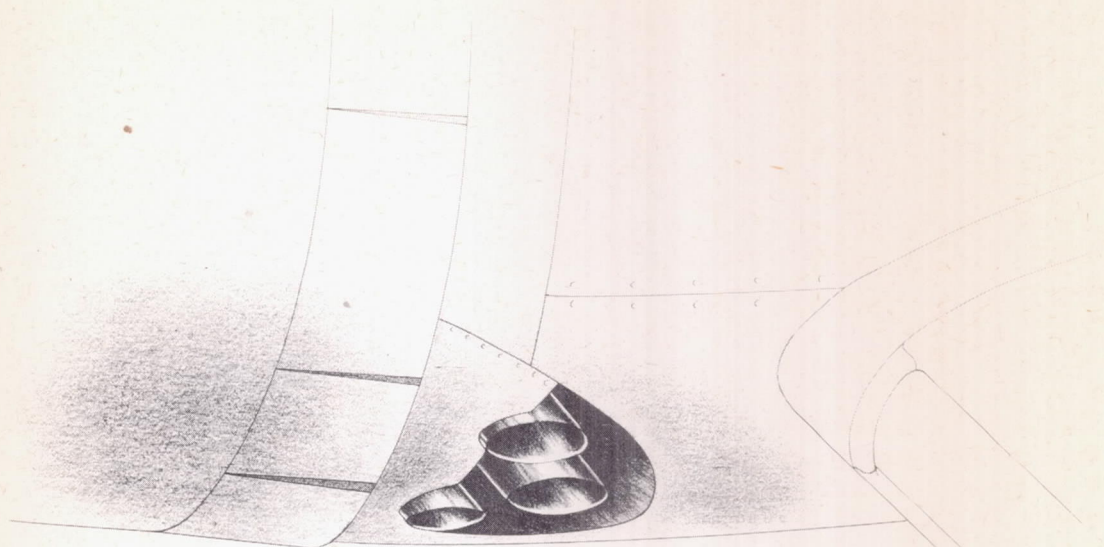
ΔC_D , 0.0010

Removing the seal from the exhaust opening of airplane 9 increased the drag by 0.0010. The form drag of the installations shown in figures 17 and 18 has been avoided in this design; however, the large amount of air leakage from the compartment behind the engine out through the large opening around the exhaust stacks accounts for the excessive drag of the installation. Some of this drag would be reduced by directing the leakage flow rearward. Much larger gains can be obtained by the use of individual jet exhaust stacks.

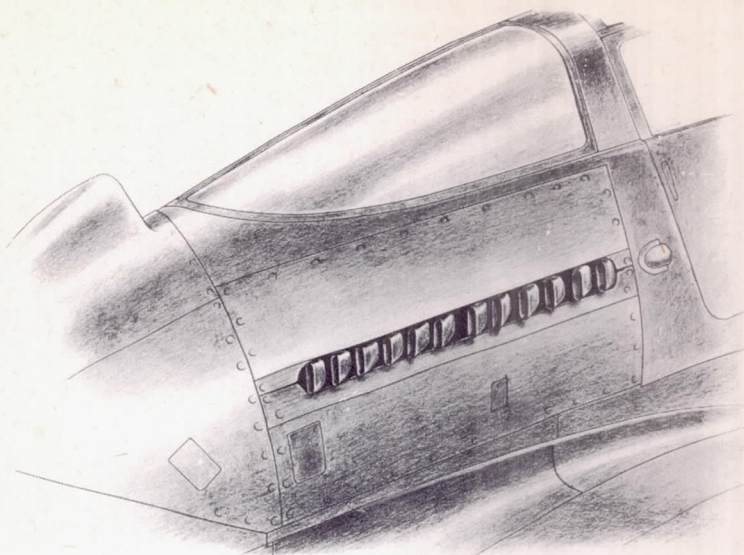
(a) Airplane 11.

ΔC_D , 0.0005
 ΔV , 3 mph

Removing the sealed metal fairings that enclosed the exhaust stacks of airplanes 11 and 12 increased the drag coefficient 0.0005 for airplane 11 and 0.0007 for airplane 12. These exhaust stacks are relatively good installations.

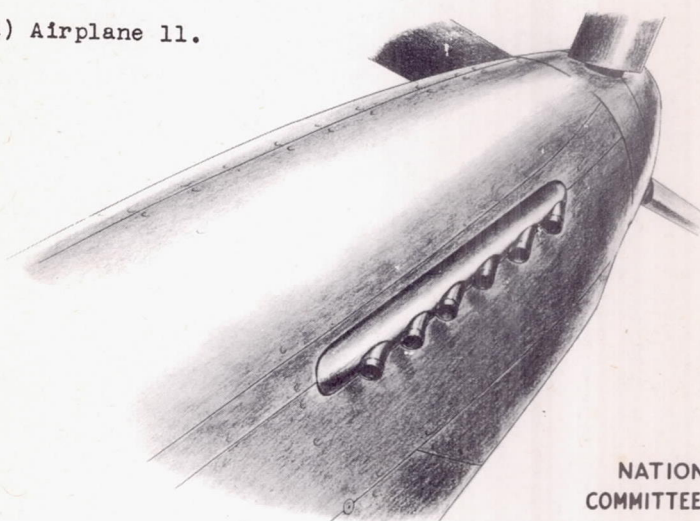
ΔC_D , 0.0007
 ΔV , 4 mph

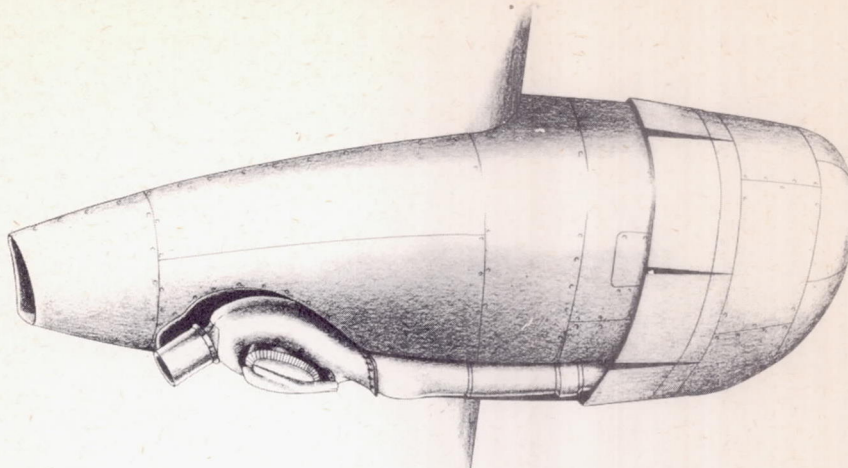
(a) Original installation.

ΔC_D , 0.0040
 ΔV , 11 mph

An increment of drag coefficient of 0.0040 was measured for the exposed supercharger of the original installation of airplane 5 (fig. 21(a)). Submerging the supercharger and sealing the opening at the end of the nacelle as shown in figure 21(b) decreased the drag coefficient of the installation to 0.0027. For the propeller-operating condition, the difference in drag will be much greater because the submerged installation will direct the exhaust gases rearward. The submerged installation would require shroud cooling. The drag increments are given for four nacelles and are based on the airplane wing area.

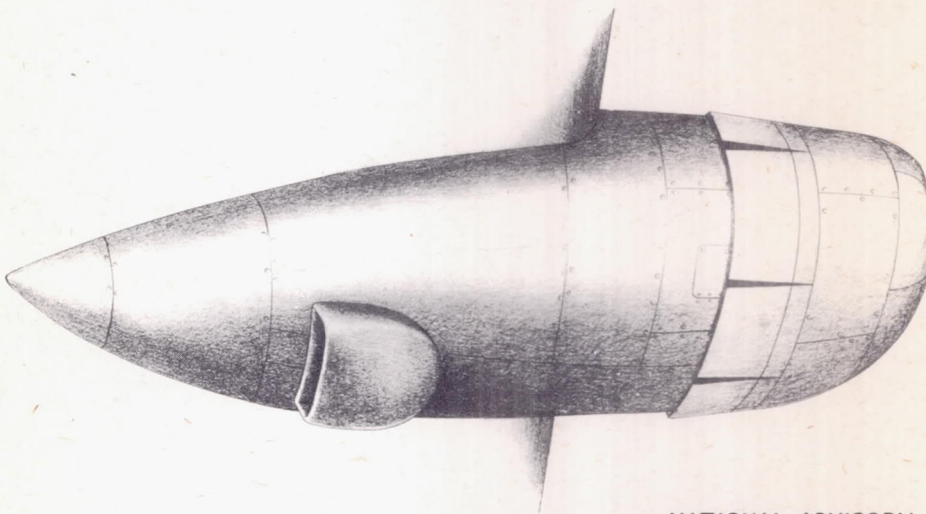
(b) Submerged installation.

ΔC_D , 0.0027
 ΔV , 8 mph

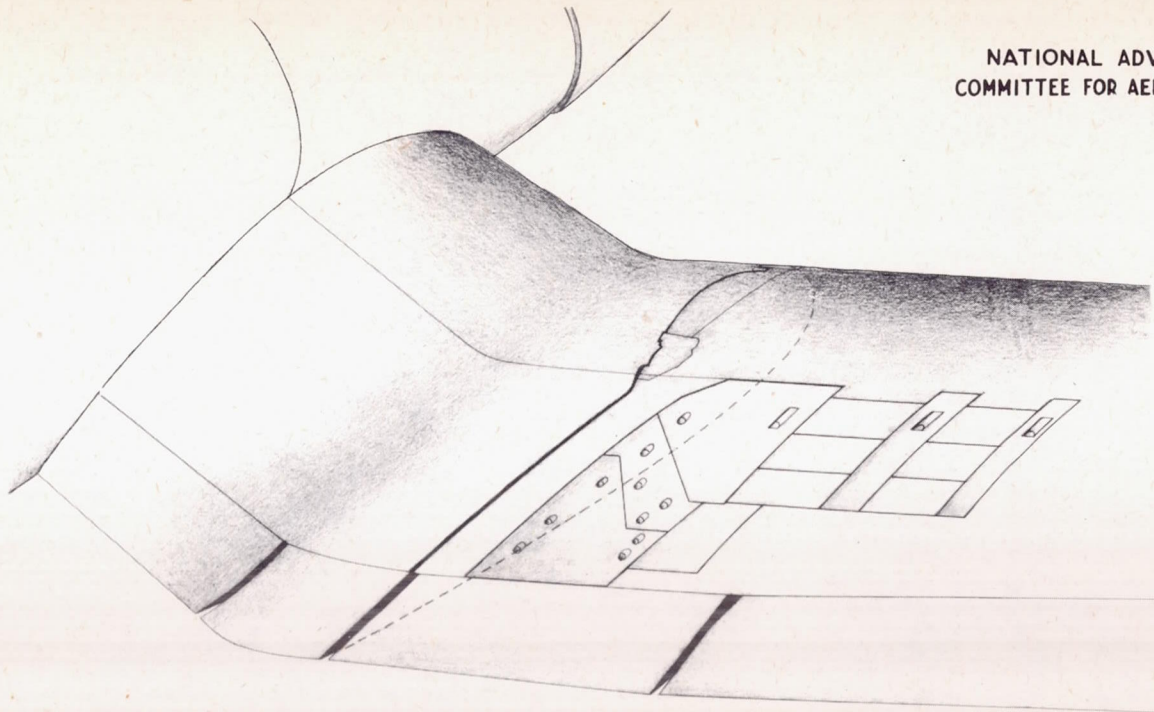
Figure 22.- Effect on wing drag of irregularities and leakage on airplane 9.

ΔC_D , 0.0012
 ΔV , 6 mph

The unusually large number of cover plates, access doors, butt joints, and air-leakage points on the wing of airplane 9 caused a drag increase of 0.0012. Most of this drag could have been avoided by better fitting and elimination of air leakage.

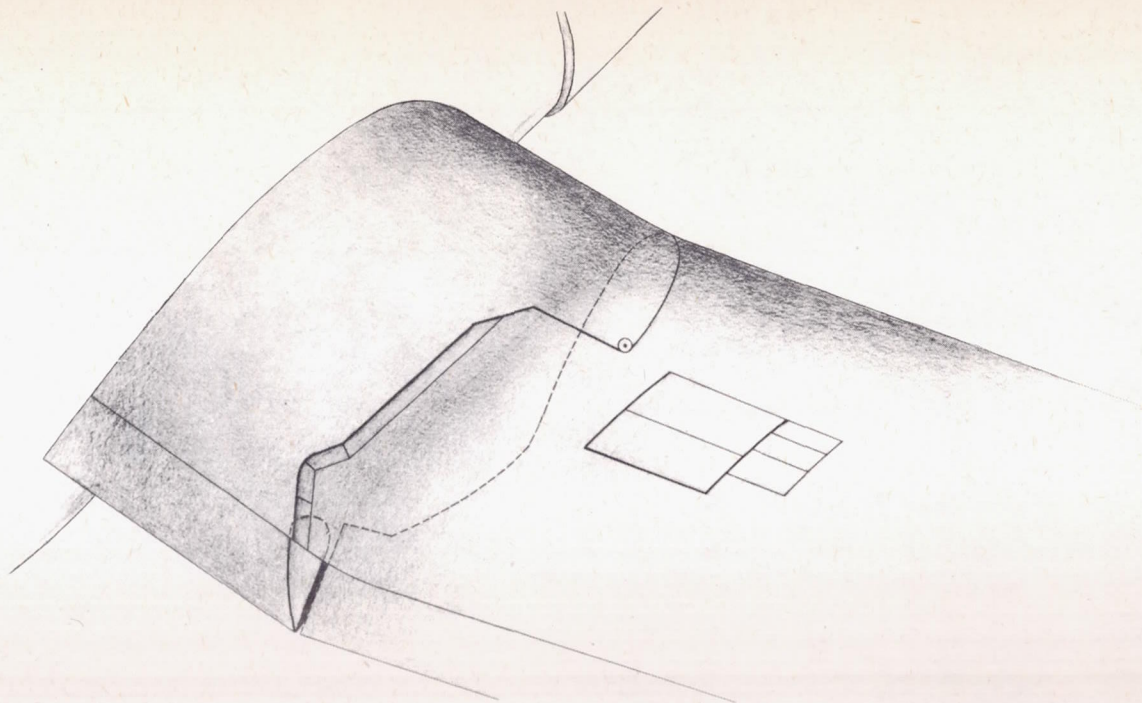
Figure 23.- Effect on wing drag of irregularities and leakage on airplane 10.

ΔC_D , 0.0007
 ΔV , 4 mph

An increase in drag coefficient of 0.0007 was measured when the doped-tape seals were removed from the gaps at the wing-fold joint and gun-access and ammunition doors. Considerable leakage drag can be eliminated by sealing these gaps.

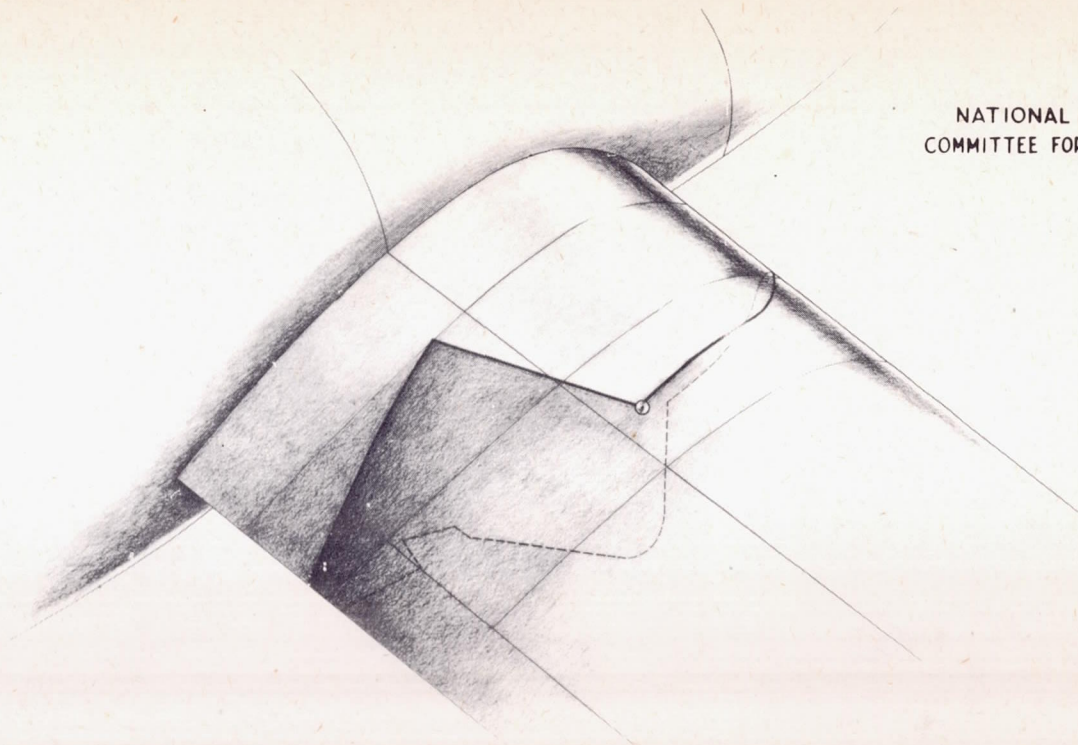
Figure 24.- Effect on wing drag of leakage on airplane 6.

ΔC_D , 0.0004
 ΔV , 2 mph

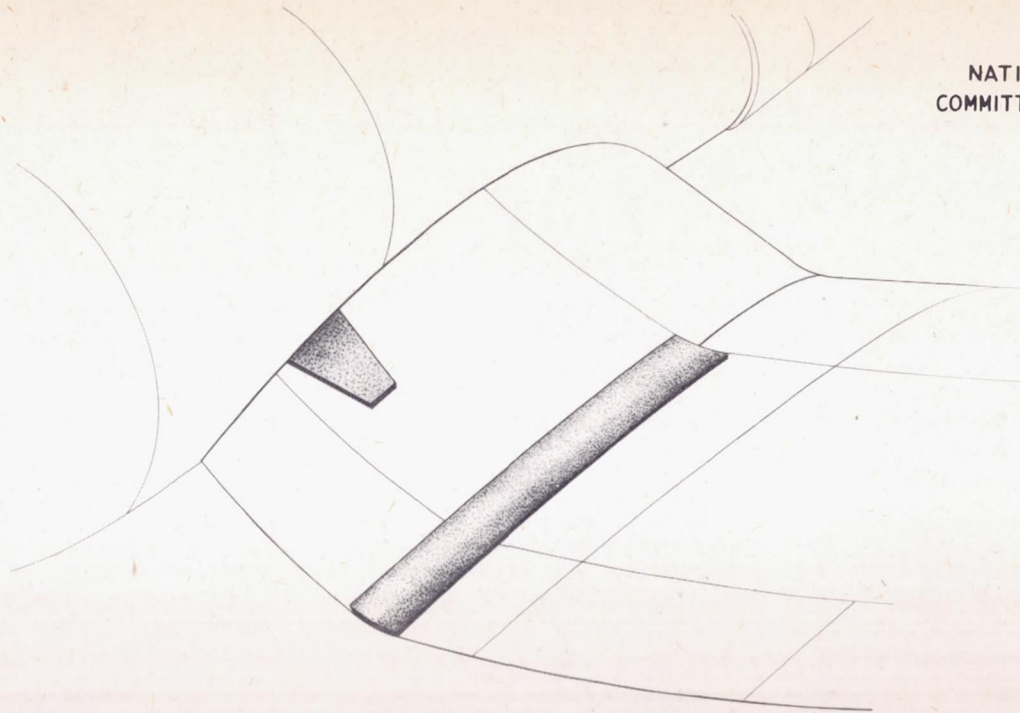
Figure 26.- Effect on wing drag of sanded walkway on airplane 9.

ΔC_D , 0.0010
 ΔV , 5 mph

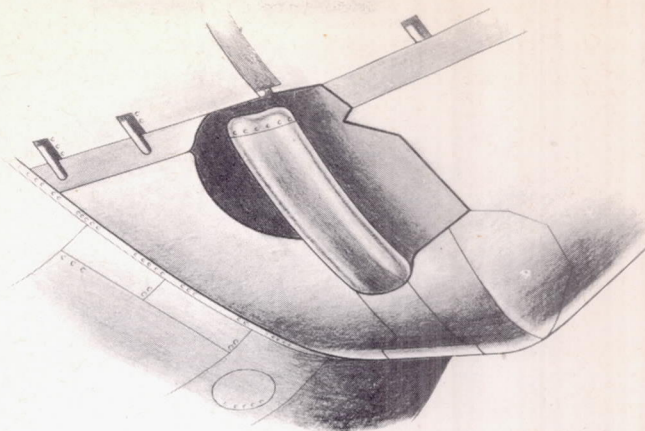
(a) Original full-length fairing.

$\Delta C_D, 0.0009$
 $\Delta V, 4 \text{ mph}$

Removal of seals from the edges of the original full-length fairing over the retracted landing gear on airplane 10 increased the drag coefficient by 0.0009, thereby indicating that air was leaking through the $\frac{1}{8}$ -inch cracks at these points. The short-length fairing, adopted for the production airplane, increased the drag coefficient 0.0012 over that measured for the completely sealed fairing. This drag is due both to air leakage and the air-flow disturbance of the exposed parts. These results show the importance not only of installing a fairing over the wheel but also of completely sealing the wheel-well opening.

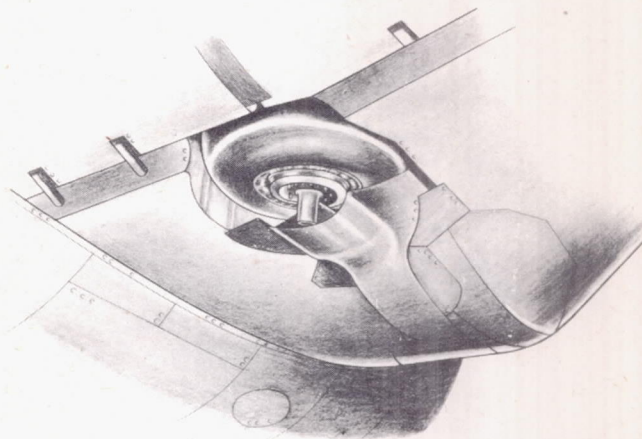
(b) Short-length fairing.

NATIONAL ADVISORY
COMMITTEE FOR AERONAUTICS
 $\Delta C_D, 0.0012$
 $\Delta V, 5 \text{ mph}$

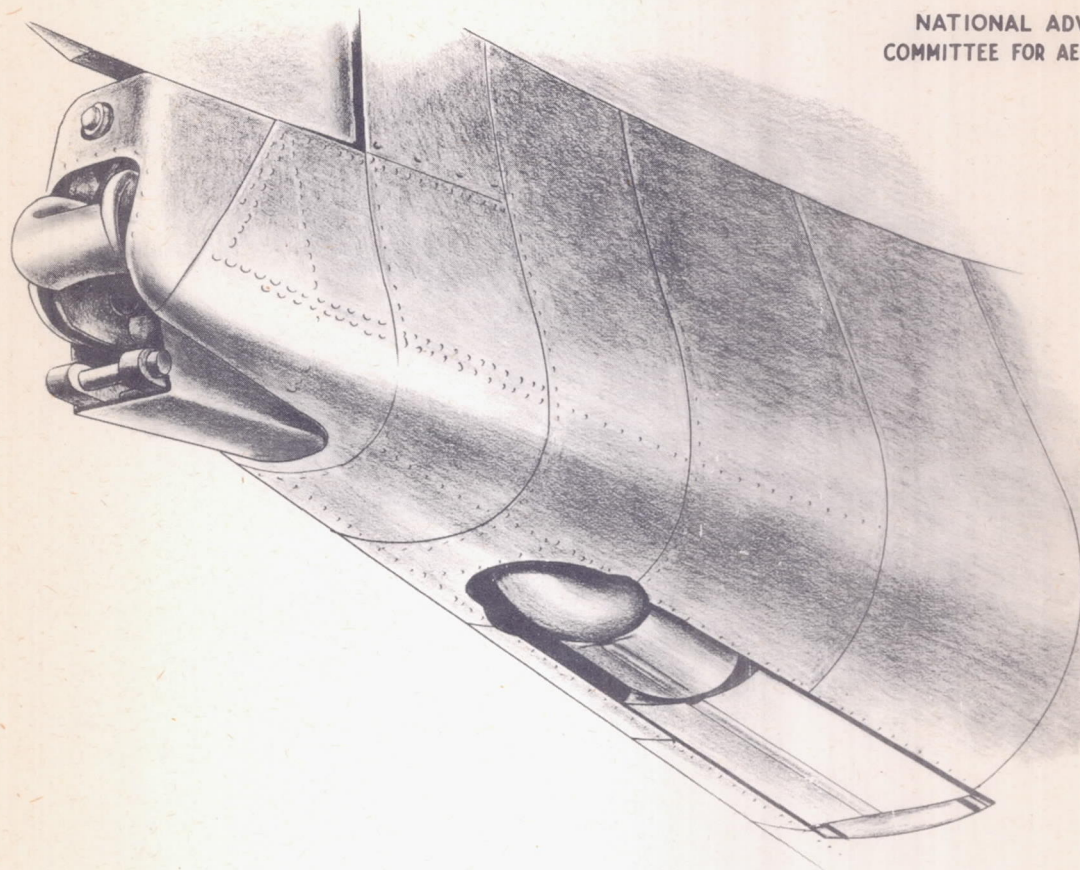
Figure 31.- Drag of tail wheel and arresting hook on airplane 10.

$\Delta C_D, 0.0005$ $\Delta V, 3 \text{ mph}$

Removing seals and fairings from the openings at the tail wheel and arresting hook of airplane 10 increased the drag coefficient by 0.0005. This increment is largely due to leakage through these openings. The drag of these items can be reduced by external fairing and sealing or by internal sealing of the bulkhead in front of the tail-wheel well.

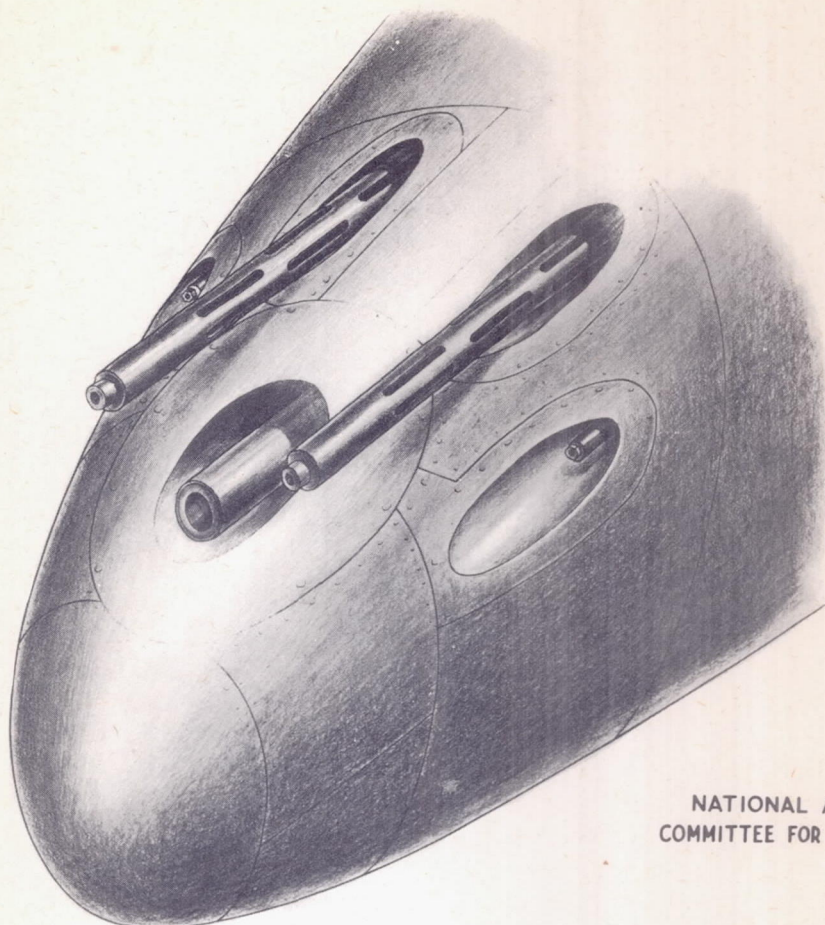
ΔC_D , 0.0008

The drag-coefficient increment due to the installation of one 37-millimeter cannon, two .50-caliber machine guns, and two .30-caliber machine guns in the nose of this airplane was 0.0008. This drag was measured as the difference between the smooth nose and the nose with guns installed. Internal sealing by means of close-fitting plates around the guns at the bulkhead through which the guns project should eliminate a large part of this drag.
