February 1945 as
Advance Confidential Report L5A30

A SUMMARY OF DRAG RESULTS FROM RECENT
LANGLEY FULL-SCALE-TUNNEL TESTS OF
ARMY AND NAVY AIRPLANES

By Roy H. Lange

Langley Memorial Aeronautical Laboratory
Langley Field, Va.

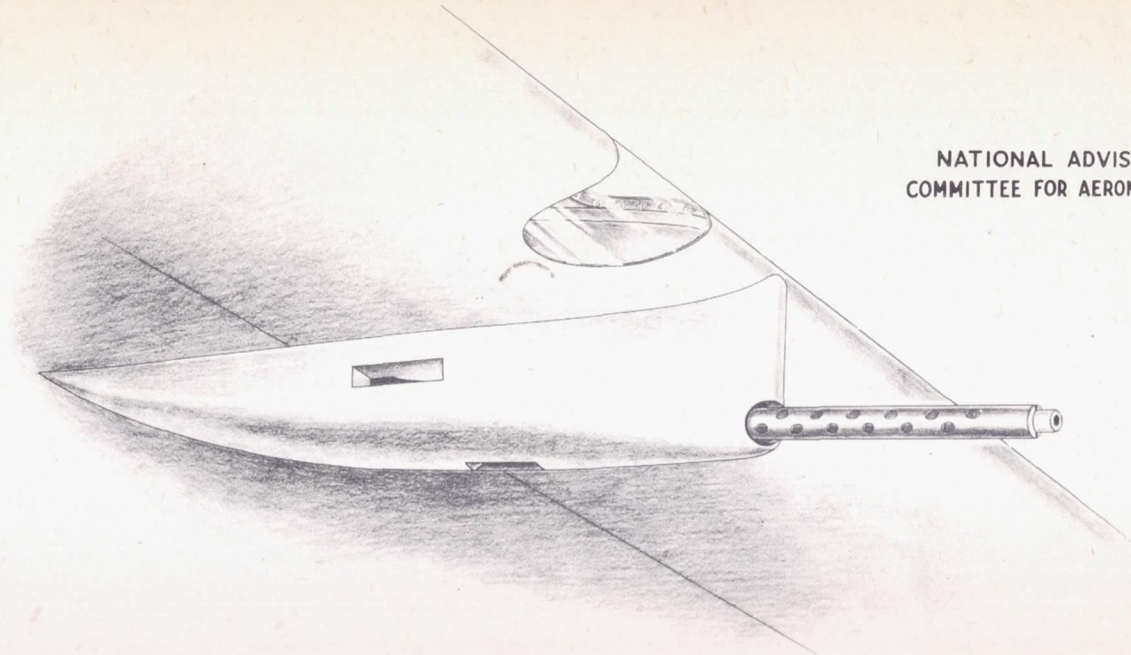
Figure 34.- Armament drag on airplane 11.

$\Delta C_D, 0.0010$
 $\Delta V, 6 \text{ mph}$

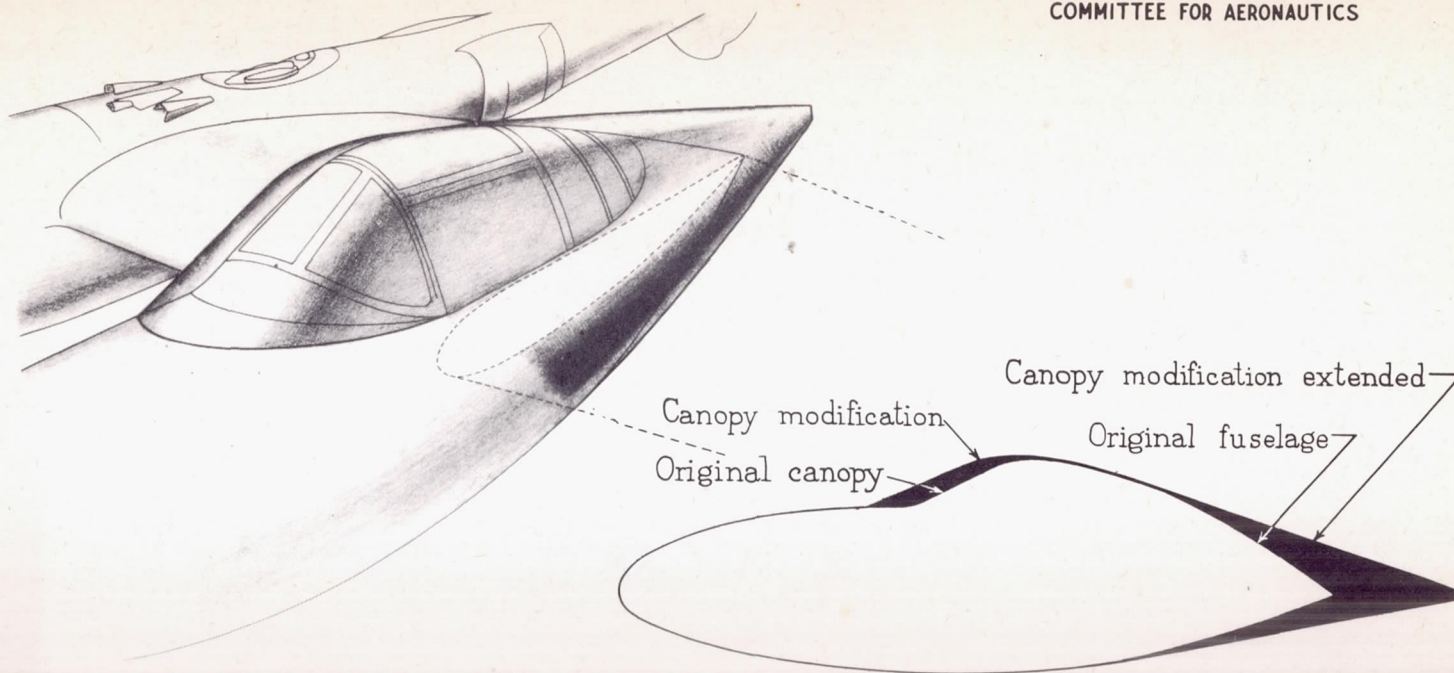
Figure 38.- Canopy modification on airplane 4.

The canopy modification for airplane 4, which included a 3-foot extension of the afterbody, was designed to reduce the high negative pressures over the canopy peak and to prevent flow separation at the rear of the canopy. The critical speed of the canopy was increased by 44 miles per hour as a result of this modification. Drag results are unavailable for these configurations.
