EXPERIMENTAL INVESTIGATION OF AIR-COOLED TURBINE BLADES  
IN TURBOJET ENGINE

XIII - ENDURANCE EVALUATION OF SEVERAL PROTECTIVE  
COATINGS APPLIED TO TURBINE BLADES OF  
NONSTRATEGIC STEELS

By Edward R. Bartoo and John L. Clure

NACA RM E53E18

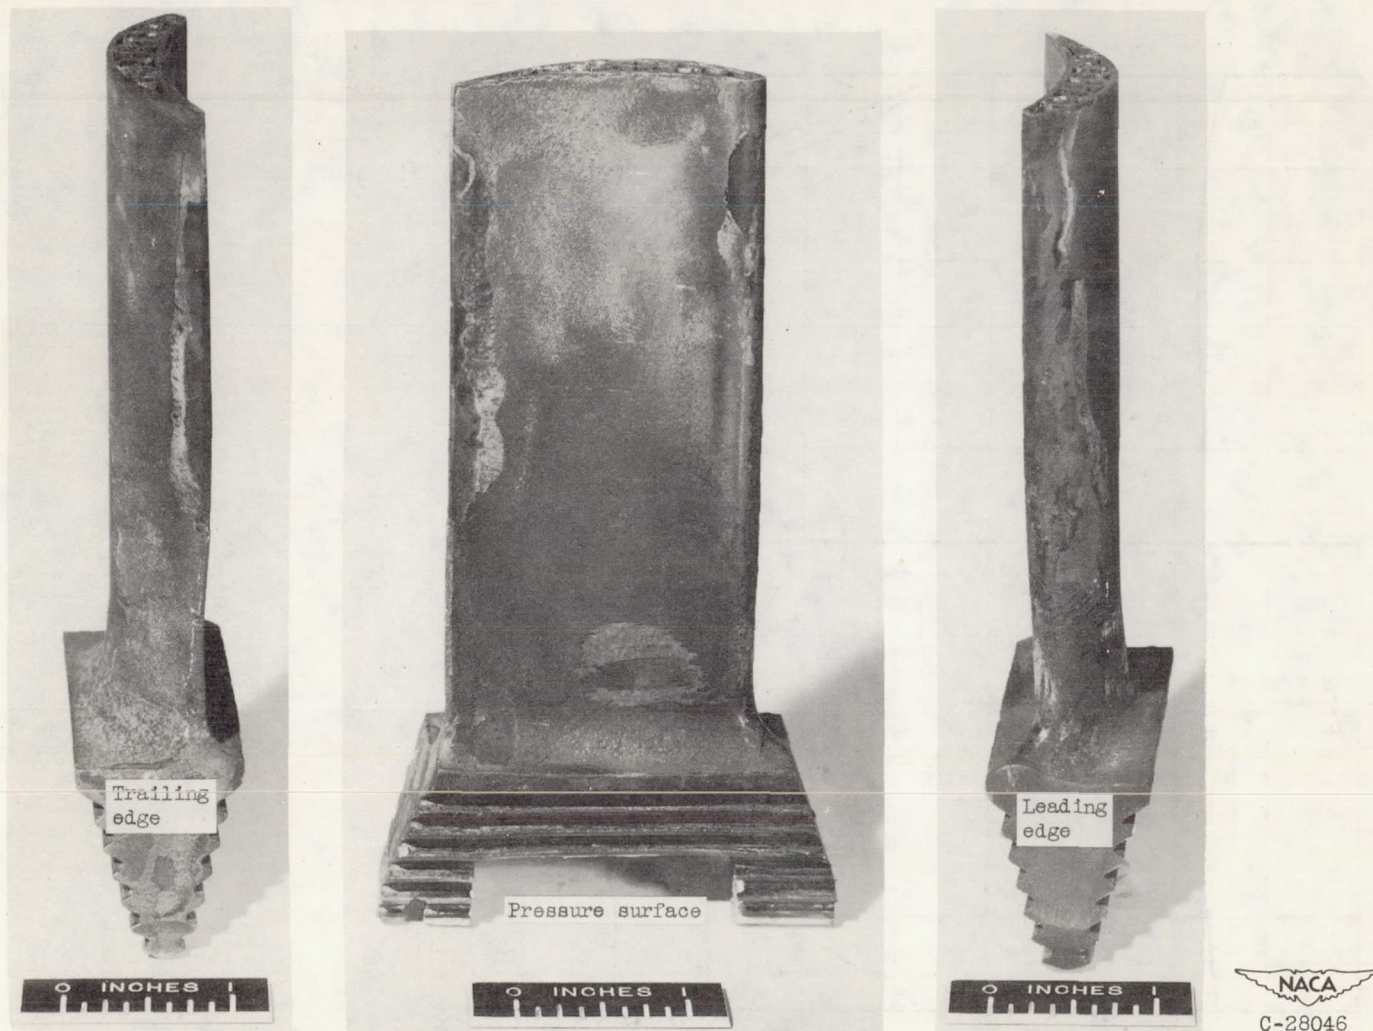
Blade 1. - The coating on blade 1 was considered a failure after 7.3 hours of rated engine speed operation, and investigation of the blade was concluded at the end of that time. Figure 3(a) shows several views of the blade at the conclusion of the tests and it can be seen that the coating chipped away from the leading- and trailing-edge regions of the blade. There is also an area near the root in the midchord region of

the blade where the coating flaked off. The failure of the coating apparently was a function of the metal temperature, as the greatest damage to the coating occurred at the leading- and trailing-edge regions where the metal temperatures are the highest (see fig. 2). More coating was removed from the leading edge than from the trailing edge, probably because the high-velocity combustion gases impinge directly upon the leading edge and their erosive action is greatest in this area.

(a) Blade 1 after 7.3 hours (20 cycles plus 2.3 hours at rated test conditions) with coolant-flow ratio of 0.048. Complete breakdown of coating along leading and trailing edges evident.

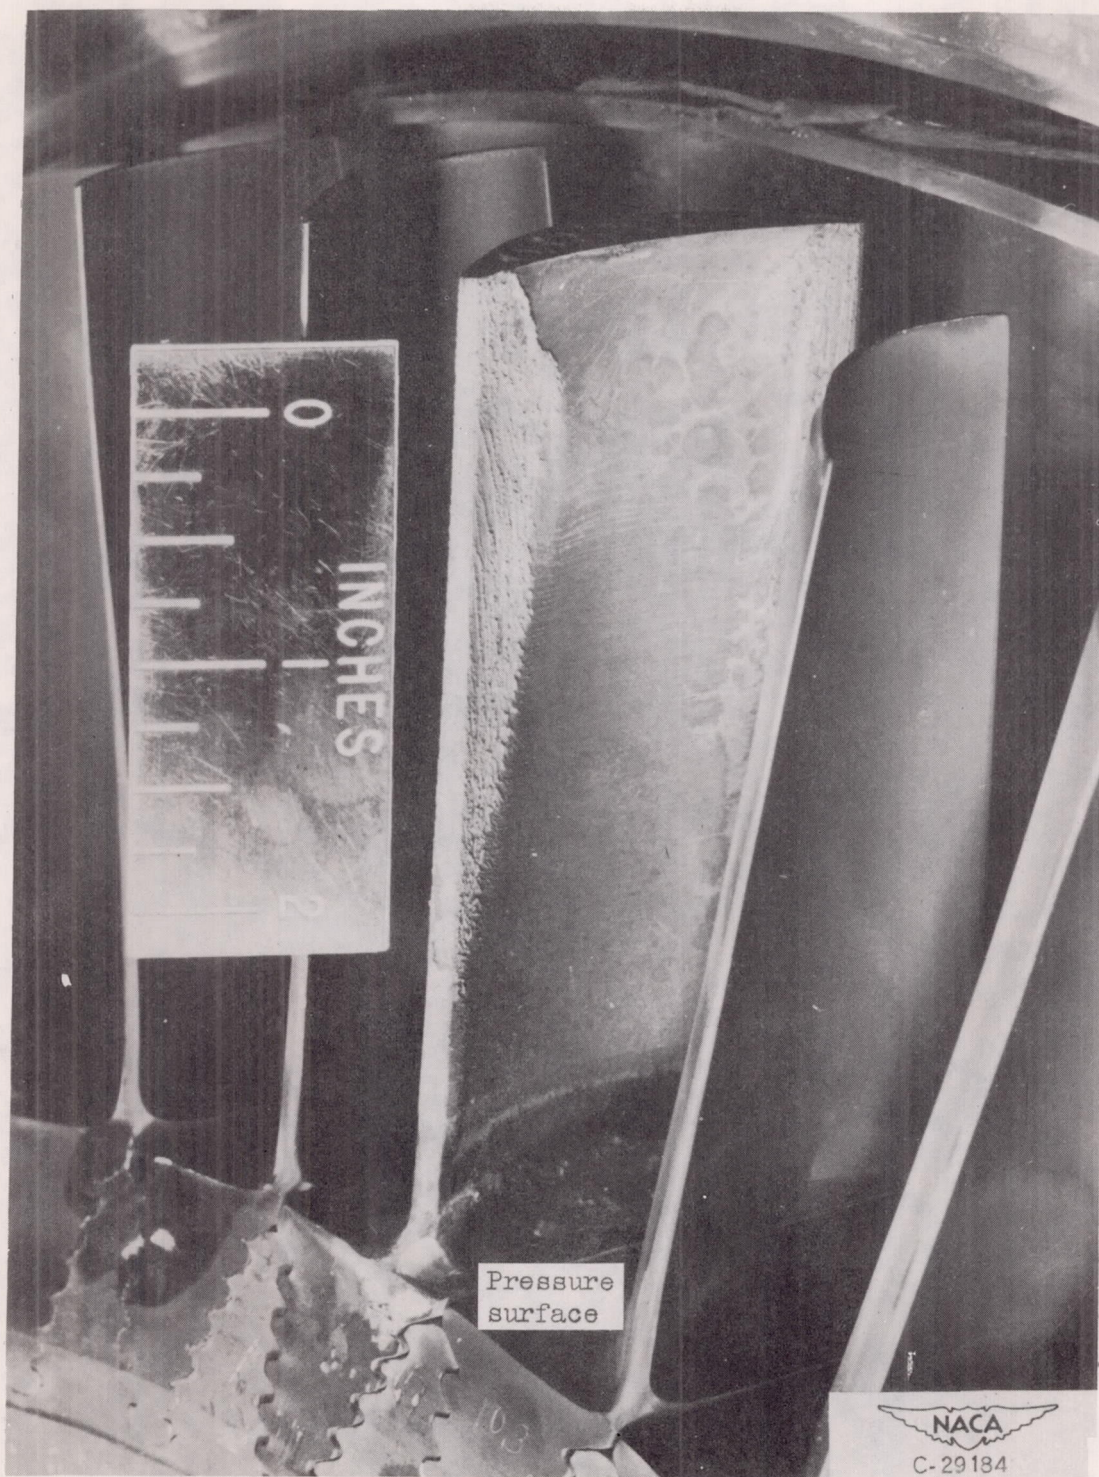
Blade 2. - Blade 2 was considered a failure after about 4.7 hours of operation. Inspection at this time indicated that the coating apparently softened when heated and flowed toward the blade tip under the influence of the high centrifugal forces. A photograph of this blade is shown in figure 3(b). The flow lines were essentially parallel to the blade base over the relatively cool midchord region on both the pressure and suction surfaces. In the leading- and trailing-edge regions, which operate hotter than the midchord region, the flow lines were nearly radial and were very pronounced as shown in figure 3(b). Bare metal was visible in the valleys between flow lines in the leading- and trailing-edge areas. Inasmuch as the blade was not heat-treated, there was no possibility of damage from this source, and it must be assumed that the coating lacked the necessary physical properties for the application in question.

(b) Blade 2 after 4.8 hours at rated test conditions with coolant-flow ratio of 0.048. Coating softened and flowed toward tip.

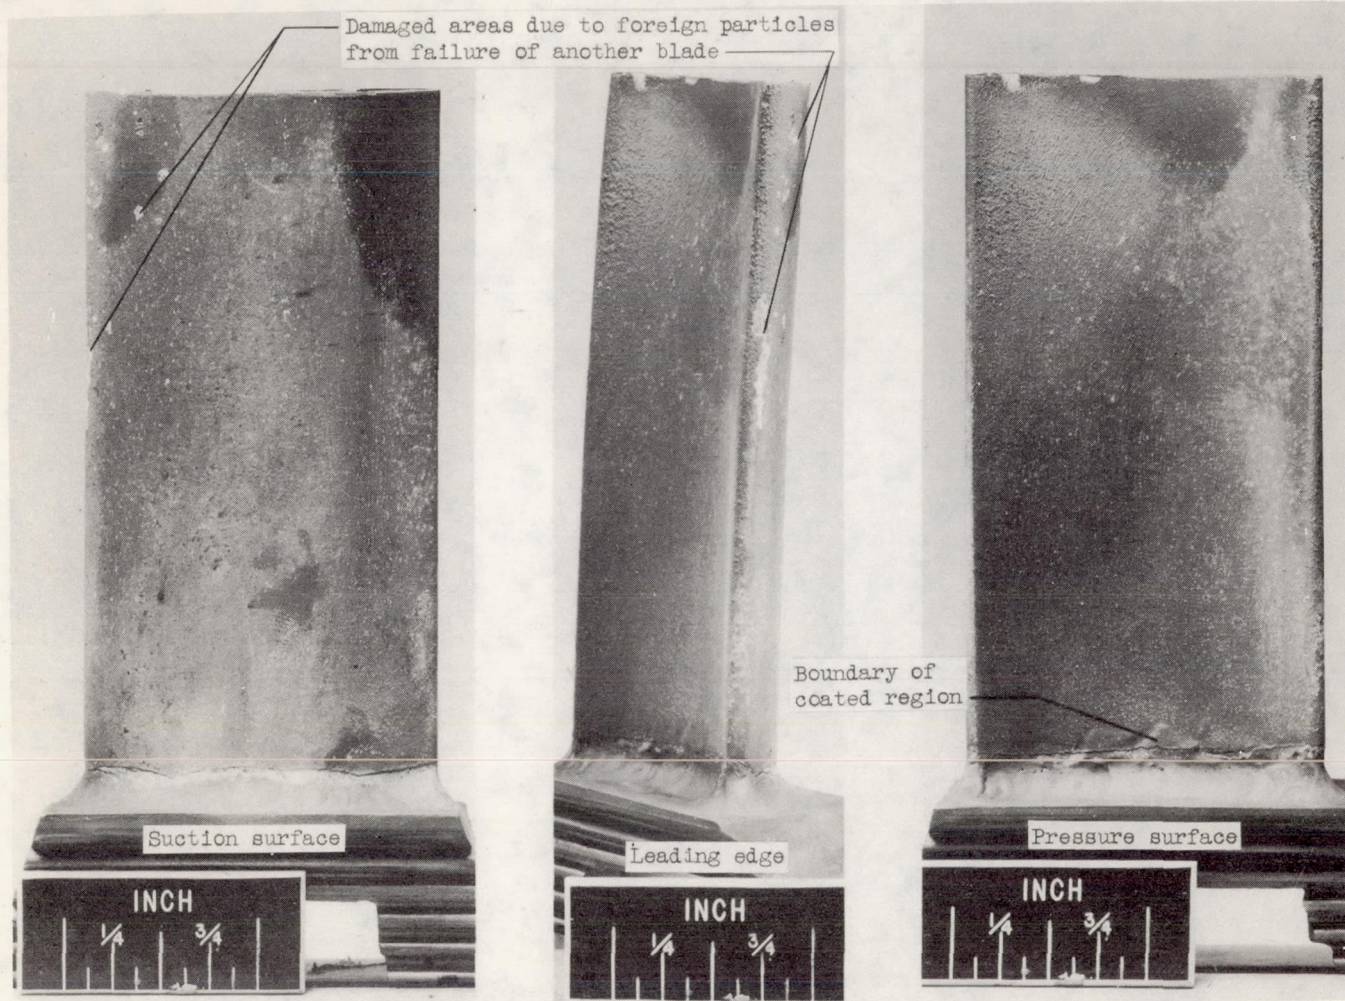
the blade was chipped off and bare metal appeared to be exposed. Operation was continued, however, and after 34.3 hours the blade was again struck by a foreign object and damaged in about the same area as previously. This damage can be seen on the leading edge of the blade in figure 4(a). Several smaller chipped areas were observed in the coating on the forward portion of the suction surface near the blade tip and can also be seen in figure 4(a). Investigation of the coating was continued until the blade was operated for 100 hours at rated test conditions. Figure 4(b) shows the blade upon completion of 100 hours of operation. (The damage to the coating along the trailing edge of the blade which is visible in the view of the pressure surface in fig. 4(b) was caused by mishandling of the blade after completion of the tests.) Microscopic examination of a section through the damaged area at the leading edge indicated that some ceramic still clung to the metal and apparently provided complete corrosion protection since no corrosion could be observed under the microscope. During the investigation of blade 5 no softening or flowing of the coating was observed. No chipping or flaking other than that caused by foreign particles passing through the turbine was observed. Slightly raised markings that became evident on the surface of the coating after heat treating were still visible after 100 hours of running, indicating that the coating had not eroded to any great extent. After 100 hours of operation the coating was in excellent condition except where it had been hit and appeared to provide complete protection for the blade shell even in those areas. Corrosion was observed on the uncoated inner surfaces of the shell and on the cooling-air tubes to depths of 0.003 to 0.005 inch. These observations were made in the immediate vicinity of the leading edge.

(a) Blade 5 after 34.3 hours at rated test conditions with coolant-flow ratio of 0.048. Coating in excellent condition except where damaged by foreign objects striking blade.

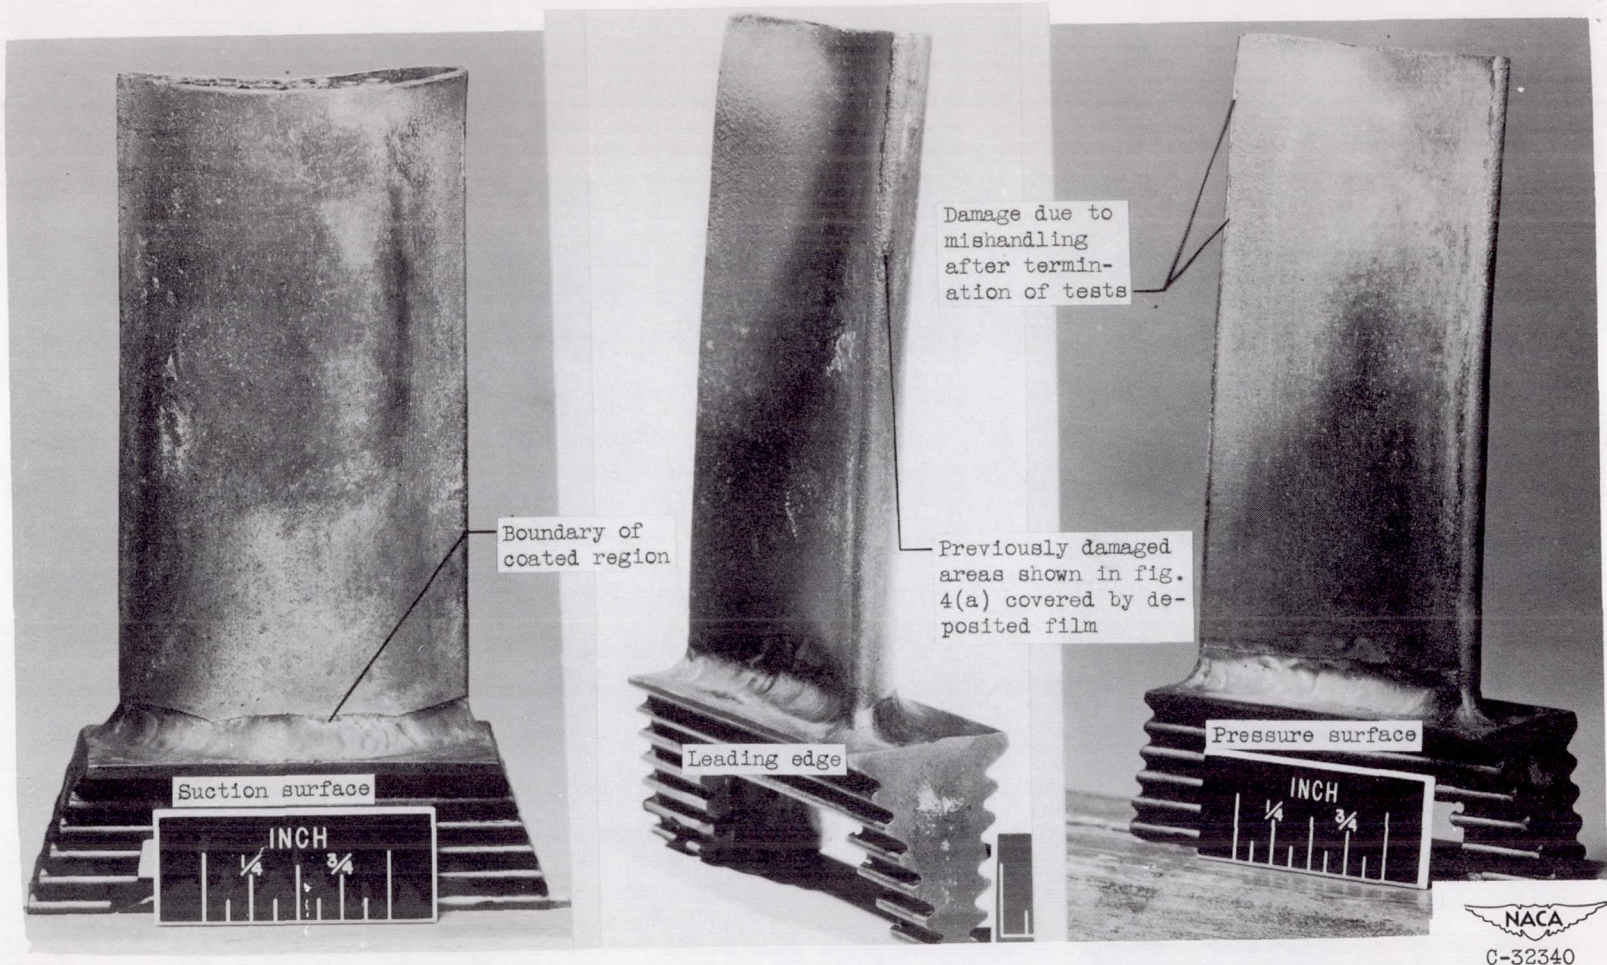
(b) Blade 5 after 100 hours at rated test conditions with coolant-flow ratio of 0.048. Coating in excellent condition except where hit by foreign objects.

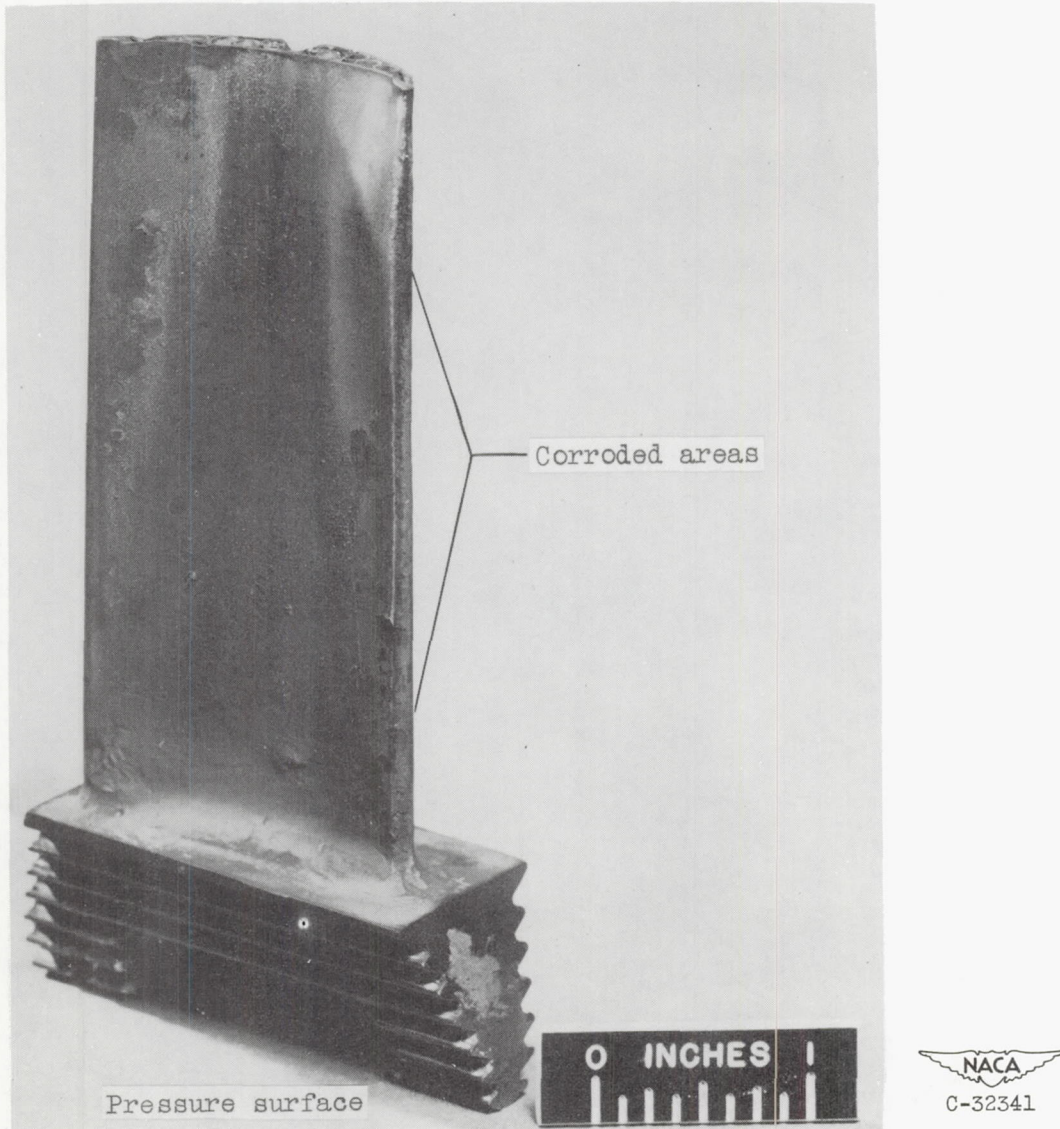
Blades 6, 8, 9, 11, 12, 14, and 15 were operated at rated test conditions for periods of time ranging from about 11.5 hours to as much as 25 hours before the coatings were considered failures. The failures of the nickel coatings were all similar, that is, the nickel began to blister and chip away from the leading- and trailing-edge regions of the blades as shown in figure 5(a). As operation of the blades was continued, corrosion of the parent metal in the leading and trailing edges occurred and the nickel coating also began to fail in the midchord region of the blade. The coatings generally began to fail first in the tip region of the blade after about 11 to 15 hours of rated engine speed operation. Temperature and centrifugal force are both factors in the breakdown of the coating. Failure usually progressed rapidly along the leading edge of the blade, where erosion also seemed to be a factor in removal of the coating. A blade that exhibited extensive erosion and corrosion at the leading edge is shown in figure 5(b), which is a photograph of blade 6 at the completion of 44 hours at rated test conditions. The failure of the coating along the trailing edge was generally less extensive than that at the leading edge, probably because the scouring action of the combustion gases is not so great in this region. Also, trailing-edge temperatures are somewhat lower than those at the leading edge. The temperature level of the blade material influences the life of the nickel coating; failure of the coating in the cooler midchord region was much more infrequent than at the leading and trailing edges (see fig. 2). Frequently, no evidence of failure was observed in the midchord region. The lower temperature apparently enables the nickel to adhere and provide the necessary corrosion resistance.

(a) Blade 12 after 55.3 hours at rated test conditions with coolant-flow ratio of 0.03 to 0.048. Coating completely eroded away at leading edge and blistered and flaked in scattered areas over entire blade.

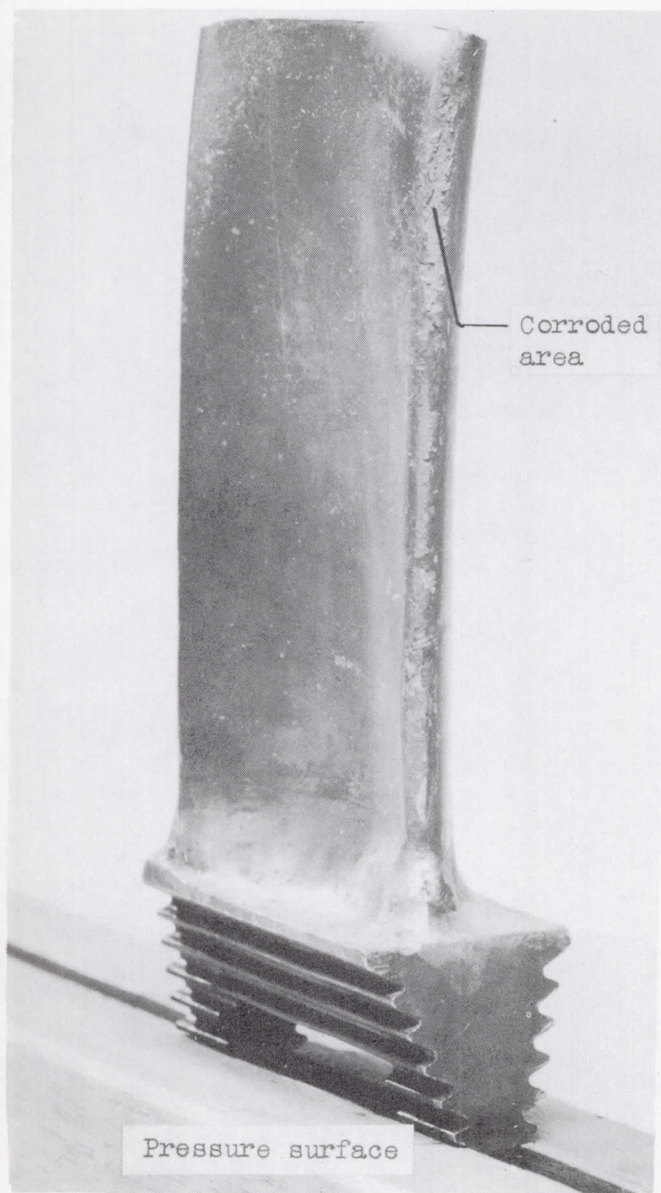
(b) Blade 6 after 44 hours at rated test conditions with coolant-flow ratio of 0.048. Coating chipped and eroded on leading edge and eroded along trailing edge. Leading edge corroded near tip.

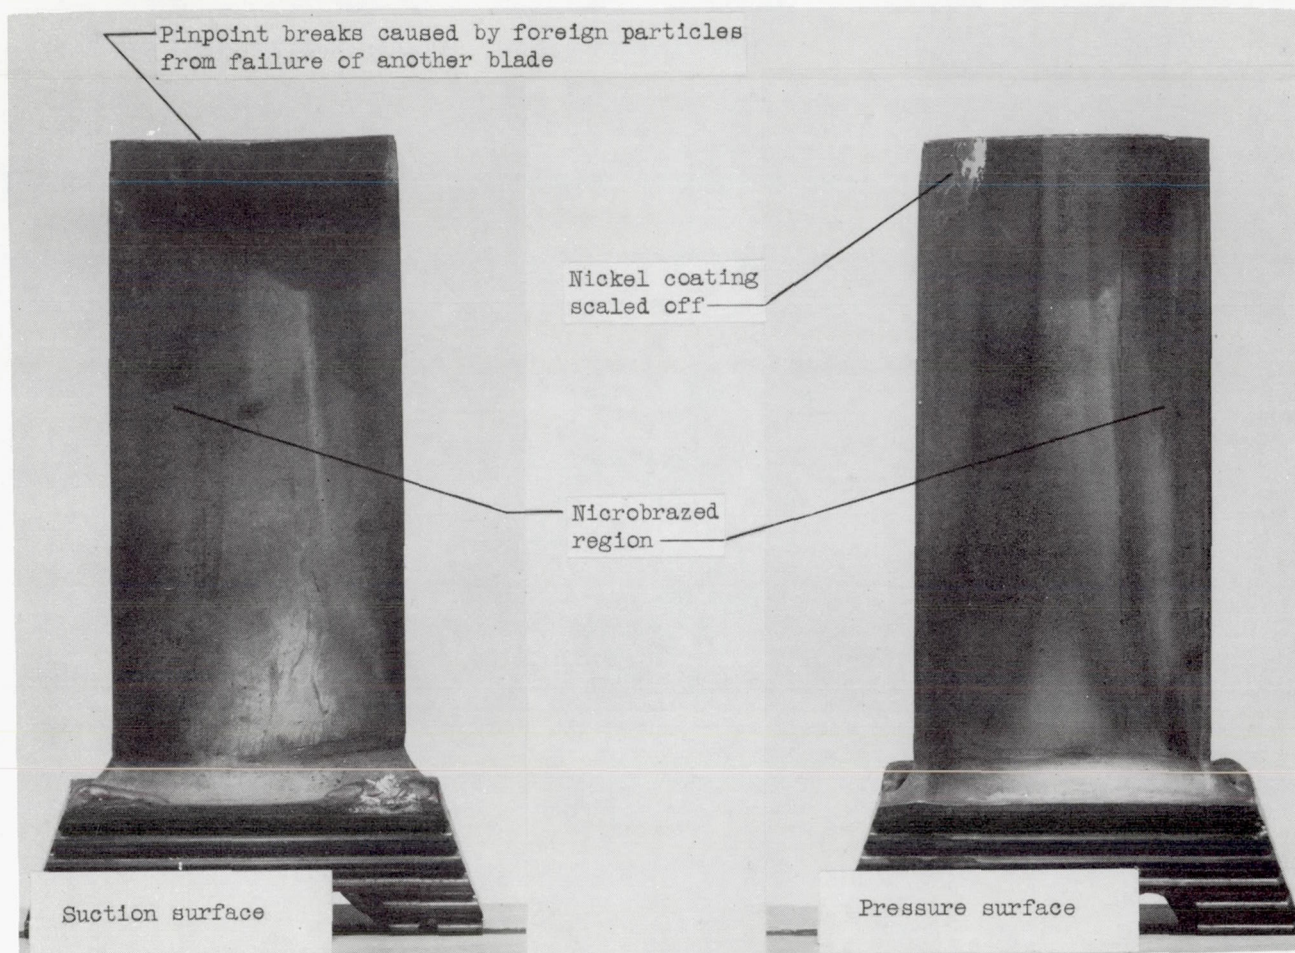
Figure 6. - Nickel-coated blade 20 with Microbraz along leading edge. Blade after 100 hours at rated test conditions with coolant-flow ratio of 0.048. Leading edge and midchord region in excellent condition.

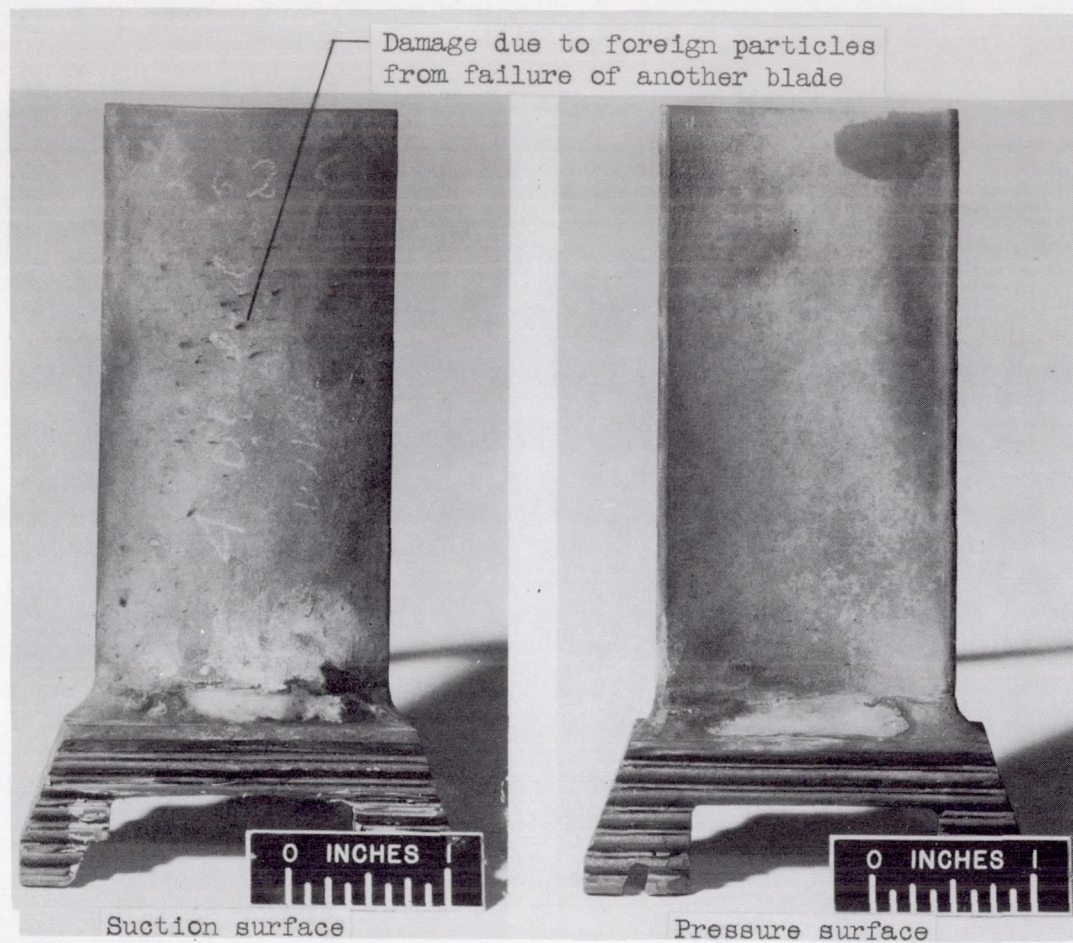
The suction surface of blade 24 was struck by fragments of a failed blade after 50 hours of operation and a number of shallow scratches resulted (see fig. 7(a)). The aluminized layer was sufficiently tough to withstand the impact and no damage was sustained other than the scratches themselves. Upon further running the scratches disappeared and were presumably filled in by iron-aluminum compounds from the adjacent surfaces. The surface of the blade after an additional 50 hours of operation showed no traces of the damage (see fig. 7(b)).

(a) Blade after 50 hours at rated test conditions with coolant-flow ratio of 0.048. Blade surfaces in excellent condition except where hit by foreign particles.

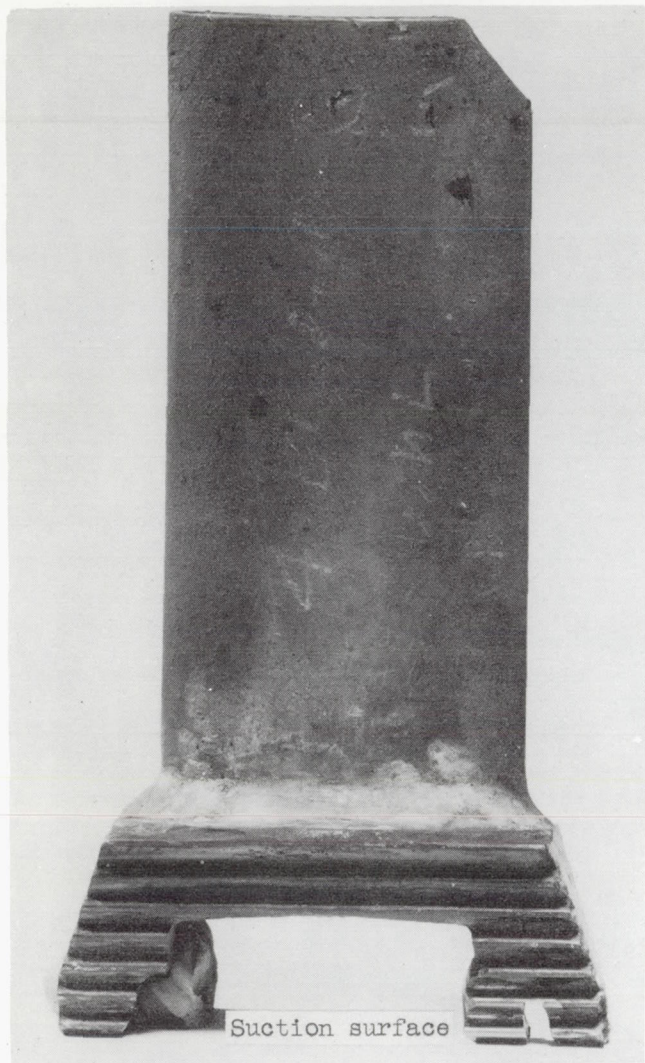
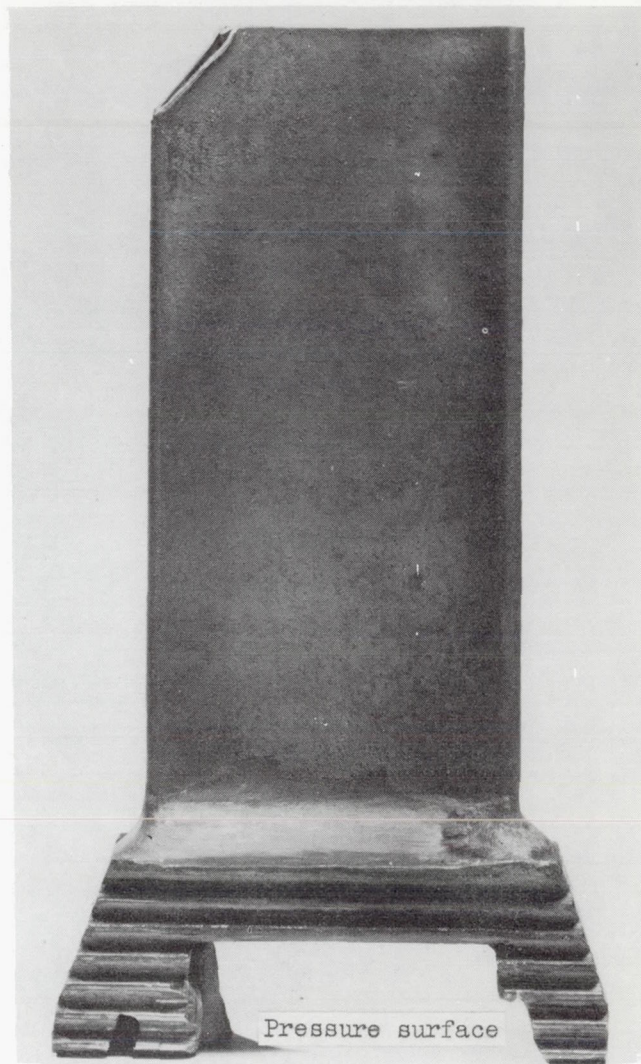
(b) Blade after 100 hours at rated test conditions with coolant-flow ratio of 0.048. Surfaces in excellent condition. Previously damaged areas shown on figure 7(a) indistinguishable from adjoining surfaces.

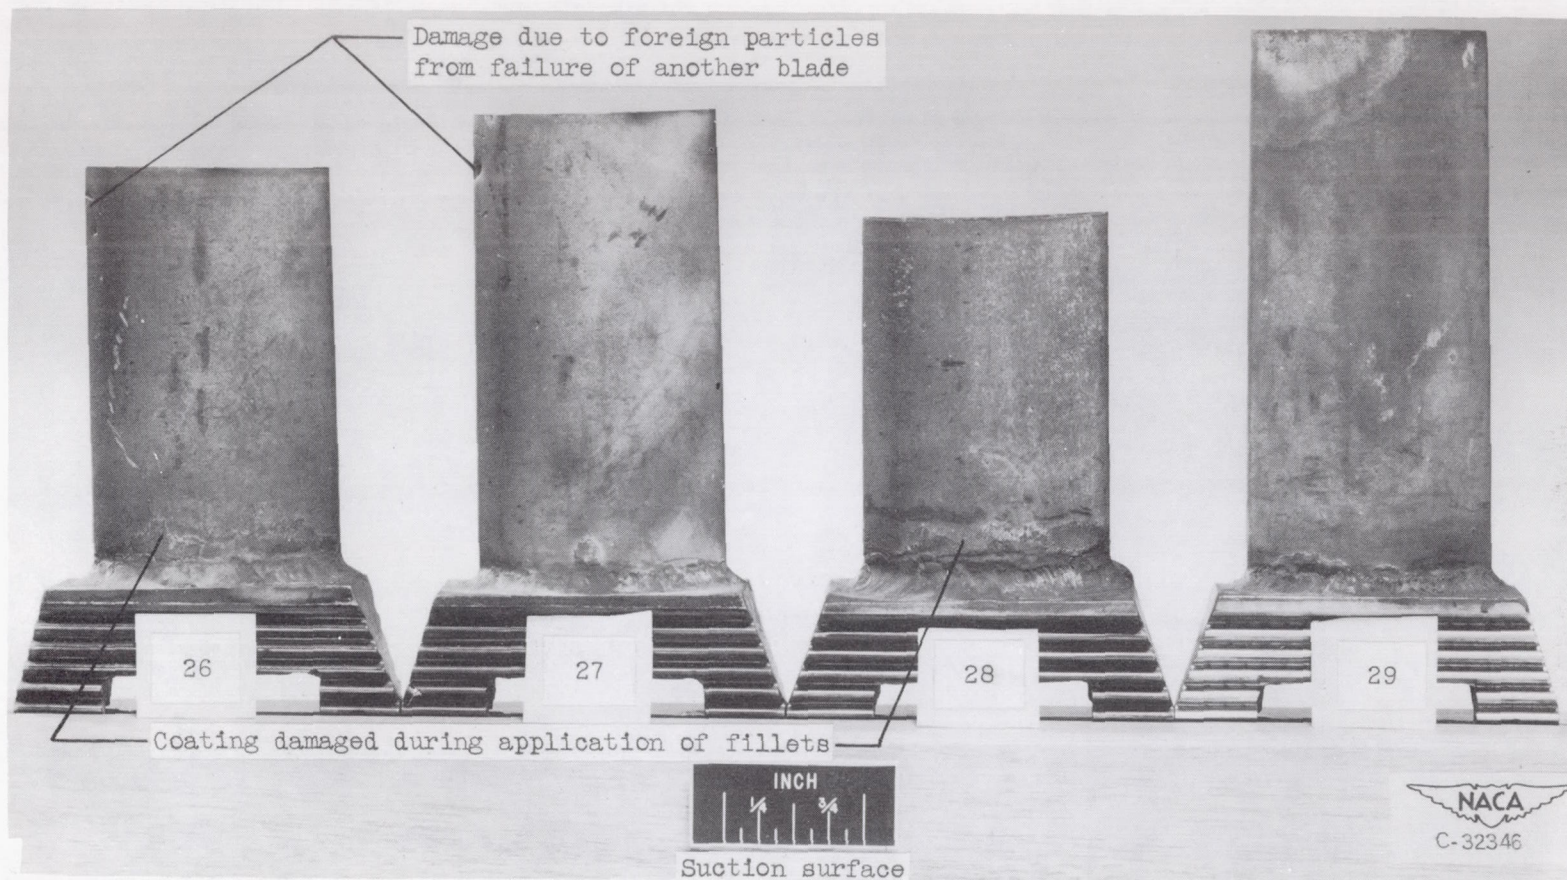
Figure 8(a) shows the suction surfaces of blades 26, 27, and 28 early in the investigation and of blade 29 prior to operation. Figure 8(b) shows both the pressure and suction surfaces of the blades at the completion of the investigation. Comparison of the suction surfaces shown in figures 8(a) and 8(b) indicates that there was little change in the condition of the coating on the blades, even though the blades of figure 8(b) have about 100 hours more operating time than in figure 8(a). With one exception, the entire surface of each blade including the leading- and trailing-edge regions, which were the first to exhibit failures on the ceramic and nickel coatings, was in excellent condition at the completion of the tests. Surface scratches and abrasions showed no tendency to progress and no corrosion developed in them as the investigation continued. The tip regions of blades 26 and 27 were damaged when struck by fragments of another blade, but the aluminized coatings continued to protect the surrounding areas. No corrosion was evident except on blade 27, where the metal was actually torn and the bare steel was exposed to the action of the gases.

(a) Blades during early stages of endurance running with coolant-flow ratio of 0.03. Time on blades 26 and 27, 23.8 hours; on blade 28, 18.1 hours; on blade 29, no time. Surfaces in excellent condition.

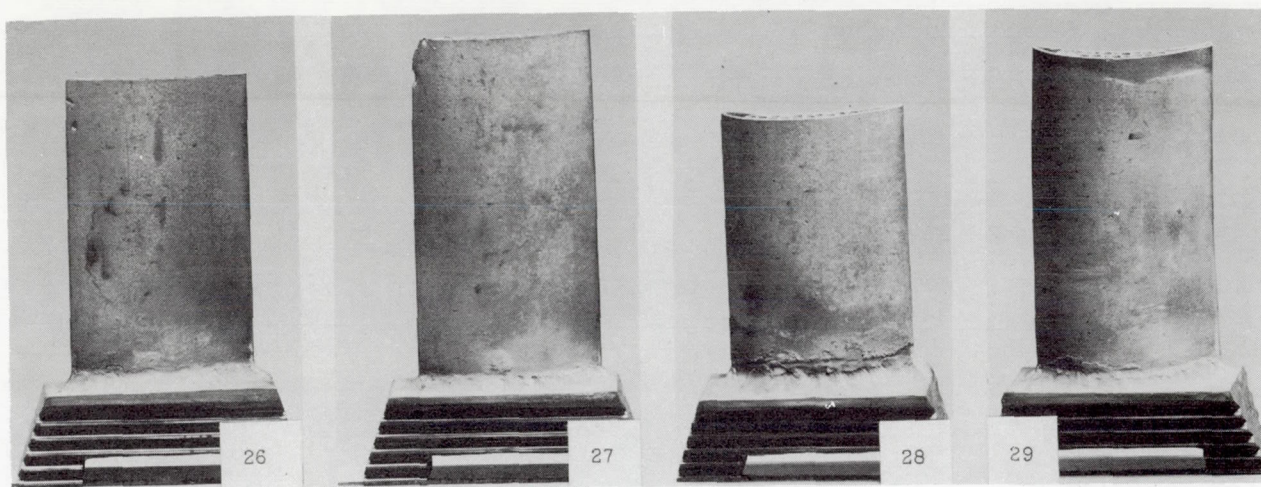
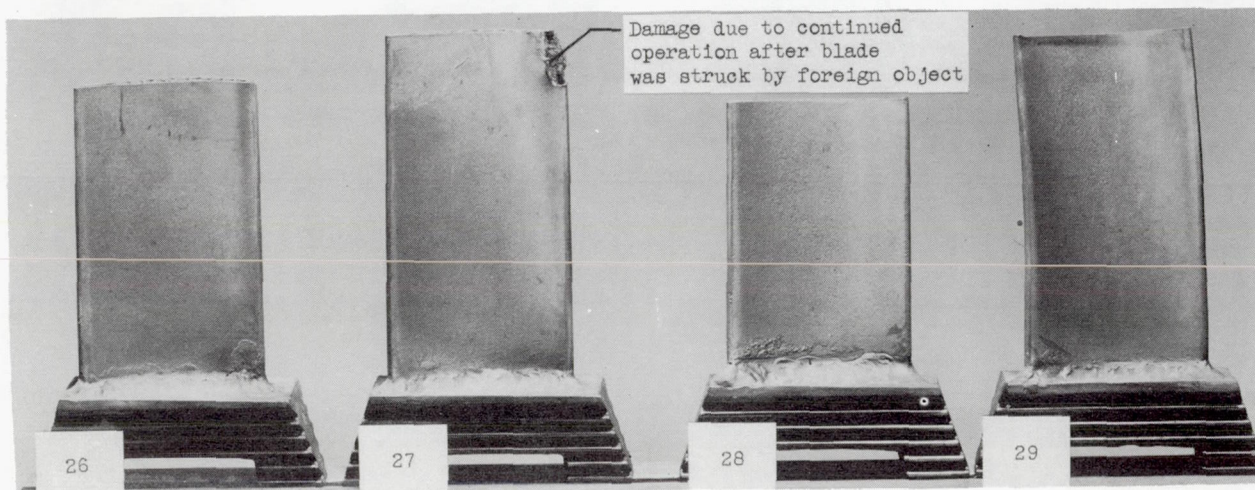
The one exception to the general excellent condition of the blade surfaces was along the leading edge of blade 28, where several short, fine cracks were visible to the unaided eye. The surfaces from the leading edge as far back as the first cooling-air tube were a different color from the rest of the blade, being a muddy gray without red or orange tinges noted elsewhere on the same blade and on the other blades of this group, including the leading edges. Examination showed that the cooling passage along the leading edge had been almost completely blocked by loose scale, presumably from the external cooling-air system, which had wedged into a restricted region at the blade root. Complete blockage would have given a leading-edge temperature of the order of 1400° F. Microscopic examination of sections along the leading edge and at 90° to the leading edge about 1.8 inches from the blade base brought out the following facts: The Timken 17-22A(S) steel in the leading-edge region of the blade shell had softened because of its higher temperature; the hardness near the leading edge was less than Rockwell C-10 as contrasted with Rockwell C-28 in the region opposite the first cooling tube. The coating at the leading edge showed a Rockwell C-19 hardness as compared with a C-28 hardness opposite the first cooling-air tube. The aluminized layer contained a series of fine cracks over the entire section. In the cooler region near the cooling-air tubes, these were hairline cracks which did not penetrate the coatings; near the leading edge they occurred with about the same frequency but were heavier and sometimes penetrated the aluminized layer. When the coating was penetrated, a corroded region mushroomed out from the crack into the underlying steel. At the section examined the coating was thicker on the inside than on the exterior of the blade shell; possibly the greater erosive action of the exhaust gases accounts for this effect. The SAE 1020 steel cooling-air tubes of blade 28 were aluminized almost completely through; the aluminum penetrated all except a 0.001- to 0.0015-inch-thick region in the center of the tube wall.

The coatings in the root regions of this group of blades were rough and the blades themselves appear to be damaged. This condition arose when the fillets were applied at the blade roots subsequent to the aluminizing operation. The affected areas did not increase in size as the endurance operation progressed and the blade shells were protected adequately. Within the filleted area itself, however, the shell of blade 28 was damaged, presumably during the filleting process, and cracks developed after 118 hours of operation; reducing the blade length by cutting off damaged portions near the tip undoubtedly forestalled an early blade failure in this case.

(b) Blades at conclusion of endurance running with a coolant-flow ratio of 0.03. Time on blades 26 and 27, 124.4 hours; on blade 28, 118.7 hours; on blade 29, 100.6 hours. Surfaces in excellent condition.
