RESEARCH MEMORANDUM

ENGINE PERFORMANCE OF PRECISION-FORGED, ELECTROPOLISHED
AND MACHINED BLADES OF NIMONIC 80 AND 80A ALLOYS

By Paul F. Sikora and James R. Johnston

April 5, 1955
Declassified February 8, 1957

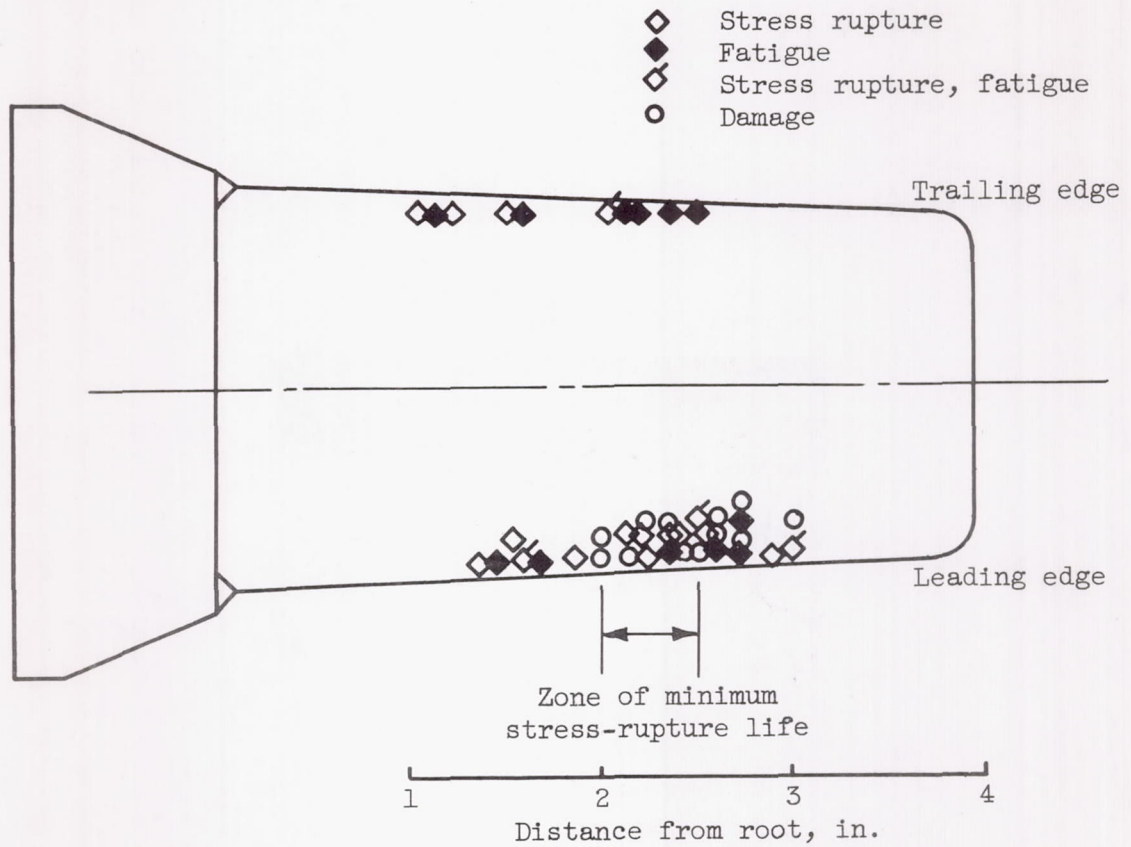
The location of failure origin and the mechanism of blade failure are shown in figure 6. Exclusive of the damage failures, it was determined that:

(1) A total of 45 percent of the blades failed by fatigue, 17 percent failed by stress rupture followed by fatigue, and 38 percent failed by stress rupture.

(2) Of all the blade failures, 65 percent originated at the leading edge.

(3) Of the blade failures originating at the leading edge, 42 percent were by stress rupture, 37 percent by fatigue, and 16 percent by stress rupture followed by fatigue.

(4) Of the blade failures originating at the trailing edge, 60 percent were by fatigue, 20 percent by stress rupture followed by fatigue, and 20 percent by stress rupture.

Exclusive of the damage failures, the majority (65 percent) of failures originated at the leading edge of the blade and the balance at the trailing edge. Altogether 16 percent of the blades failed above the critical zone, 38 percent failed below, and 46 percent failed within the critical zone. From the macroexaminations and microexaminations of the fracture edges, the blade failures were classified as follows: 46 percent by fatigue, 38 percent by stress rupture, and 16 percent by stress rupture followed by fatigue. However, since the majority of failures in the critical zone, as well as in the zones above and below this portion of the airfoil, had fatigue characteristics, it may be concluded that fatigue played a predominant role in the failure mechanism of the various groups of blades.

Figure 6. - Location of blade-failure origins and mechanism of blade failures.

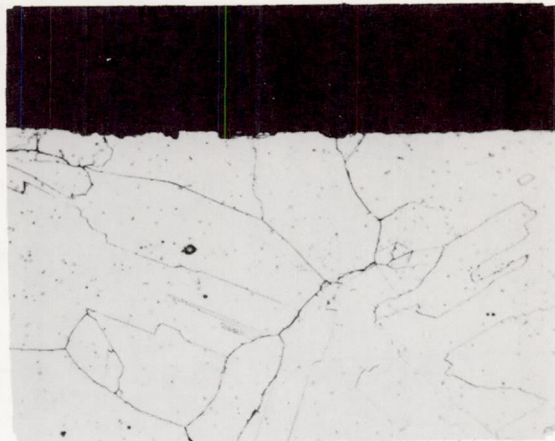
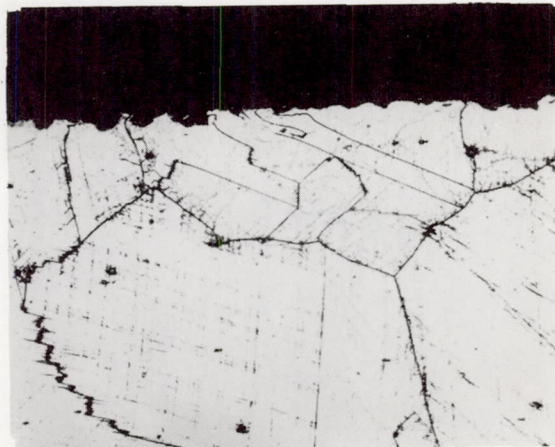
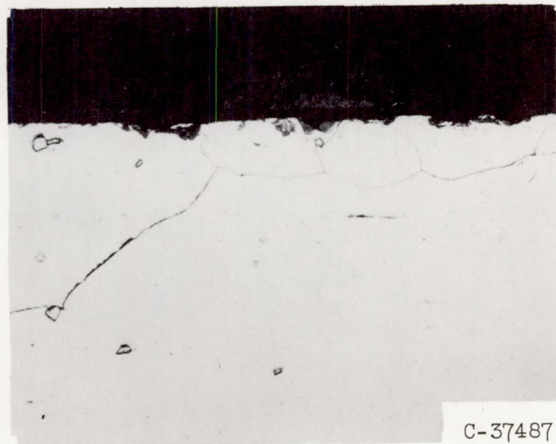
Figure 7. - Typical blade edges prior to engine operation. X500.

Photomicrographs of the edges of the various groups of blades prior to engine operation are presented in figure 7. The blades that were precision forged show a slightly oxidized, irregular surface 0.0005 inch thick (figs. 7(a) to (c)). These irregularities appear to be the result of external oxidation rather than intergranular oxidation. Typical edges of commercially electropolished blades of each lot are shown in figures 7(d) to (f). These blades were not sufficiently electropolished to remove the oxides completely and to smooth out the irregular surface. However, when the same blades were further electropolished (figs. 7(g) to (i)), the oxide was completely removed and the surface was smooth. The blades that were machined from oversize forgings had a clean and smooth surface free of distortion (fig. 7(j)).

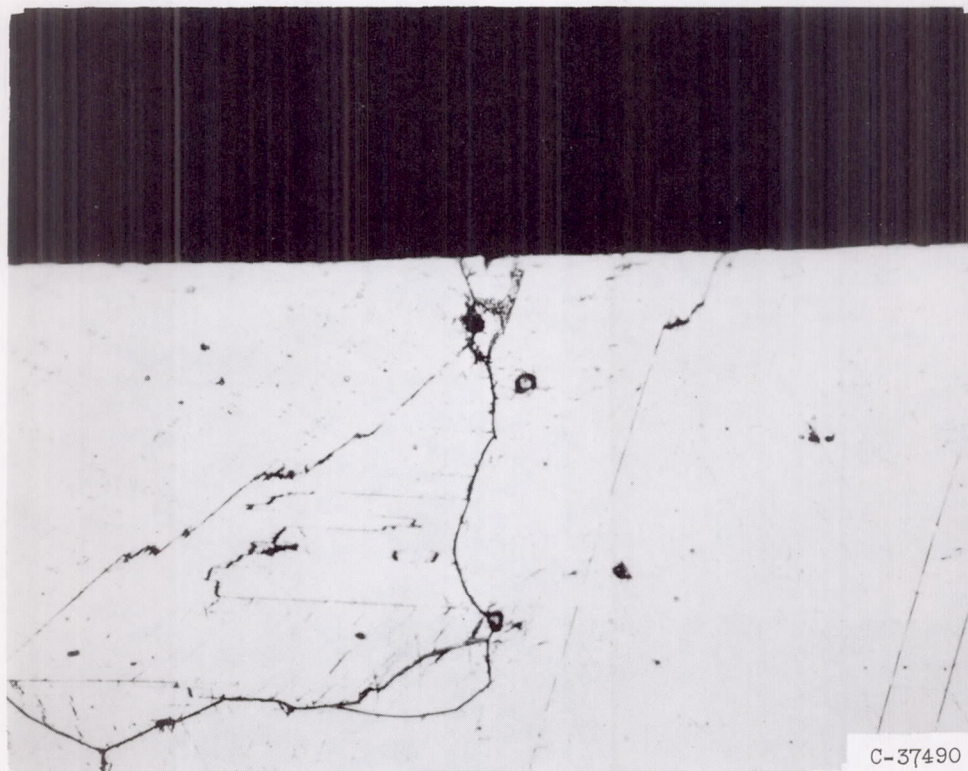
(j) Nimonic 80 (lot 2); etchant: 20 parts hydrofluoric acid, 20 parts glycerin, and 5 parts water; forged oversize and machined.

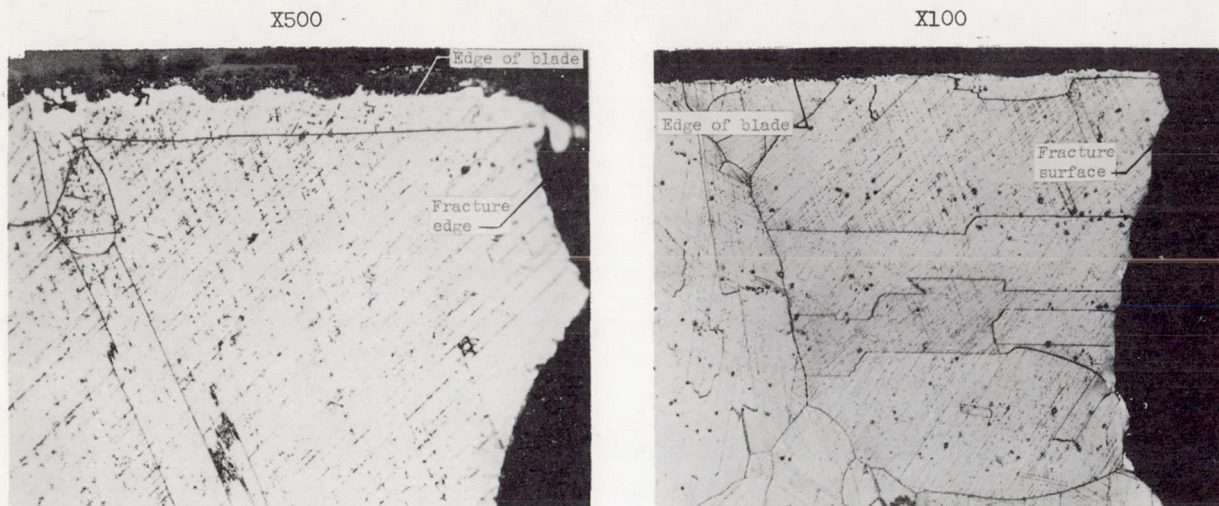
Photographs of the fracture edges of typical blade failures are presented in figure 8. An example of a fatigue-type failure is shown in figure 8(a), where the fracture follows a transcrystalline path, whereas the intercrystalline path of the fracture shown in figure 8(b) is typical of a stress-rupture failure.

(a) Fatigue-type failure.

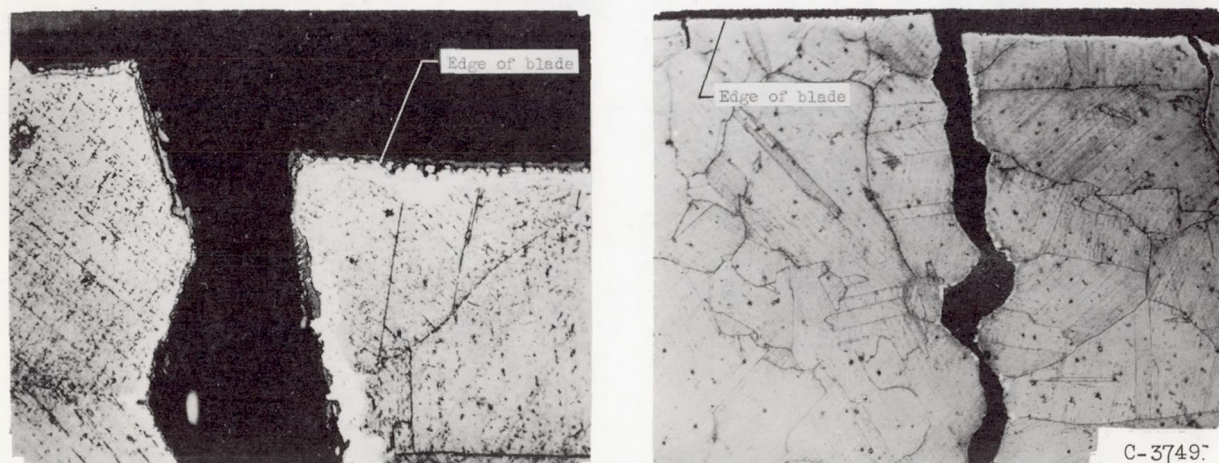
(b) Stress-rupture-type failure.

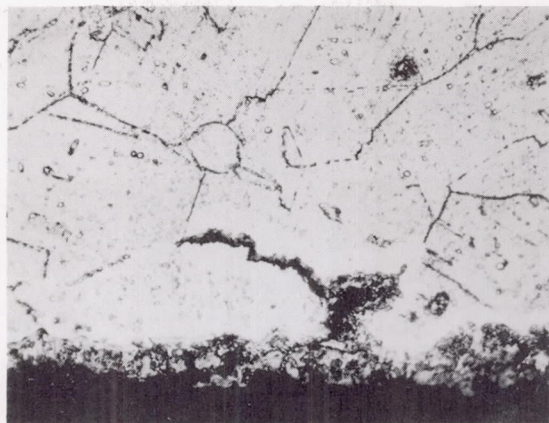
Measurements of oxide penetration and depletion zones made on the last blade to fail in each group are presented in table IV, and several examples of the edges studied are shown in figure 9. The maximum oxide penetration and/or depletion zone appeared to be greatest in the blades that were electropolished. However, the typical or average depths of oxide penetration and depletion zone are not appreciably different.

Although the electropolished blades were clean and smooth prior to engine operation, the intergranular oxidation during engine operation appeared to penetrate electropolished blades to a greater maximum depth than precision-forged blades, as shown in figure 9 and table IV.

(a) Maximum oxide penetration.

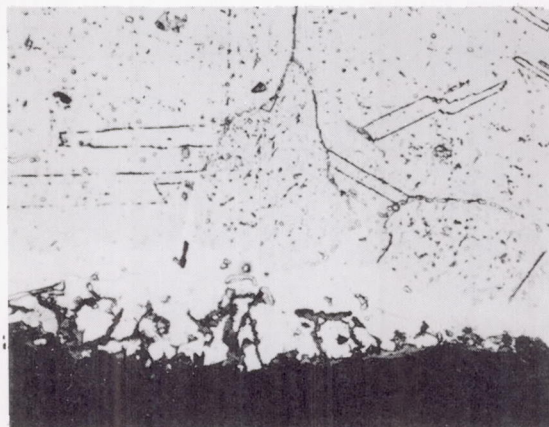
(b) Typical depletion zone and oxide penetration.

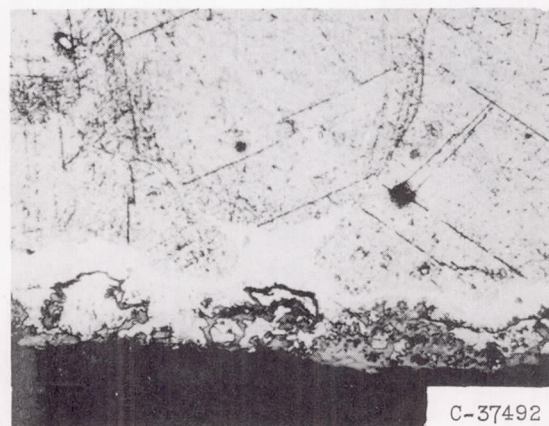
(c) Maximum depletion zone.
