EFFECT OF FORGING TEMPERATURE AND HEAT TREATMENT
ON THE PERFORMANCE OF INCONEL 700 BUCKETS AT
1625° F IN A J33-9 TURBOJET ENGINE

By C. A. Gyorgak, D. F. Springsteen, and J. R. Johnston

Lewis Flight Propulsion Laboratory
Cleveland, Ohio

February 18, 1958
Declassified March 18, 1960

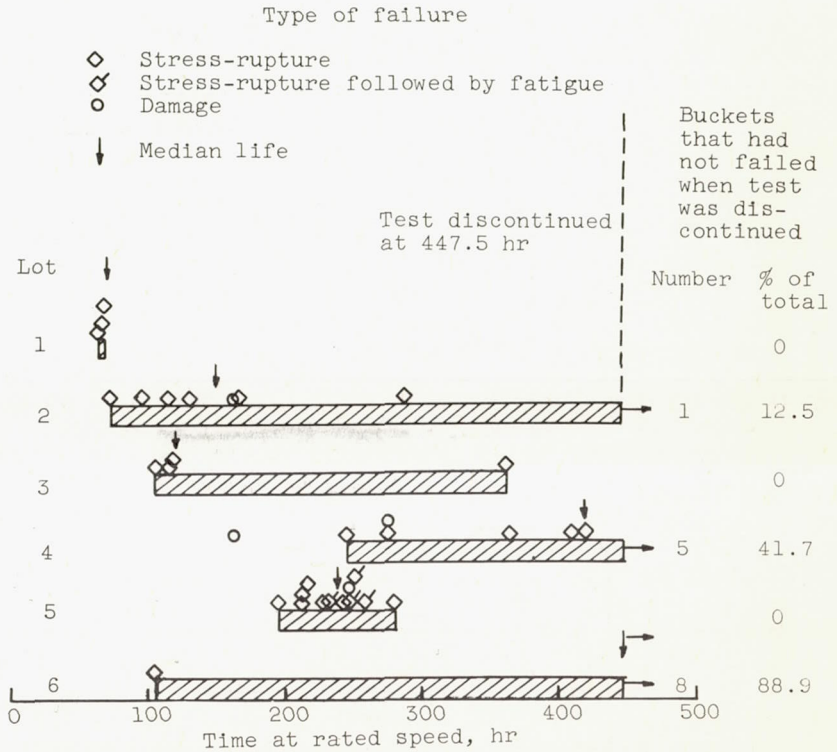
Best performance was obtained from the lot 6 buckets. Eighty-nine percent (8 out of 9) of these buckets were still usable when the test was discontinued after 447.5 hours of rated-speed operation. The only failure in this lot occurred after 105 hours and probably was not representative of the lot.

Good performance also was obtained from the lot 4 buckets. When the test was terminated, 42 percent (5 out of 12) of these buckets were still good. The first of the seven failures of this lot was a damage-induced

Macro-examination of failed buckets revealed that failures occurred by several different mechanisms - stress-rupture, stress-rupture followed by fatigue, and damage. The classification of failure mechanisms as determined visually is reported in table II and figure 6.

Figure 6. - Effect of forging temperatures and solution treatments on performance of Inconel 700 turbine buckets in a J33-9 engine at material temperature of 1625° F.

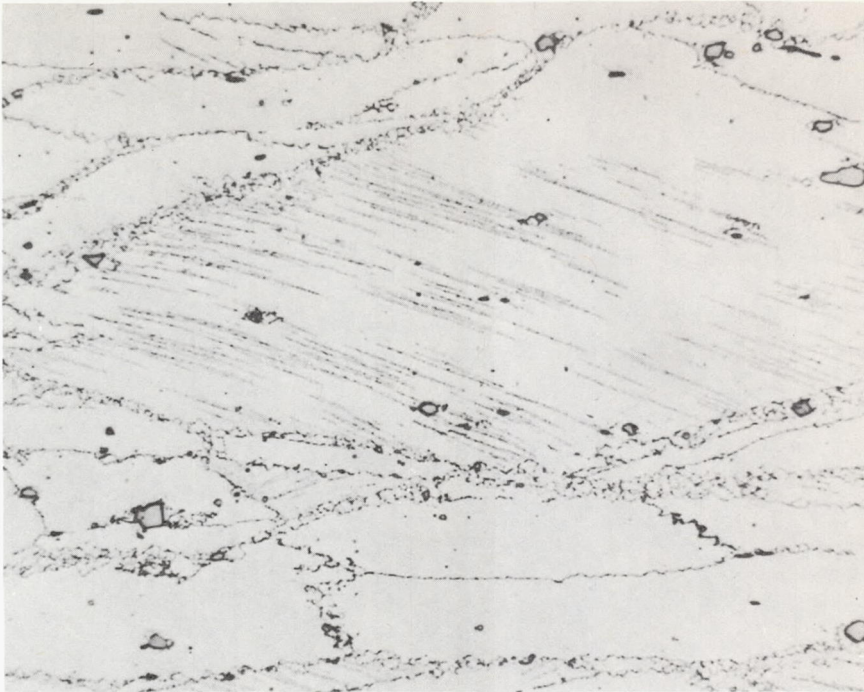
While the structures shown in figure 10 are typical, there were isolated regions within buckets that differed. Examples of these microstructures are presented in figure 11. Figures 11(a) and (b) show slipline precipitates present in the leading and trailing edges of buckets that were forged and aged only (not solution-treated). Various degrees of grain-boundary precipitation in the buckets of all lots are presented in figure 11(c). Precipitation of the magnitude shown in the lower part of figure 11(c) was very rare. The development of void formation at the interface between titanium carbonitride and the matrix in the buckets that were solution-treated at $2275^{\circ}F$ can be seen in figure 11(d). Figure 11(e) shows a region with sawtooth grain boundaries.

(a) Slipline precipitate found in the leading and trailing edges of lot 1 and lot 5 buckets.

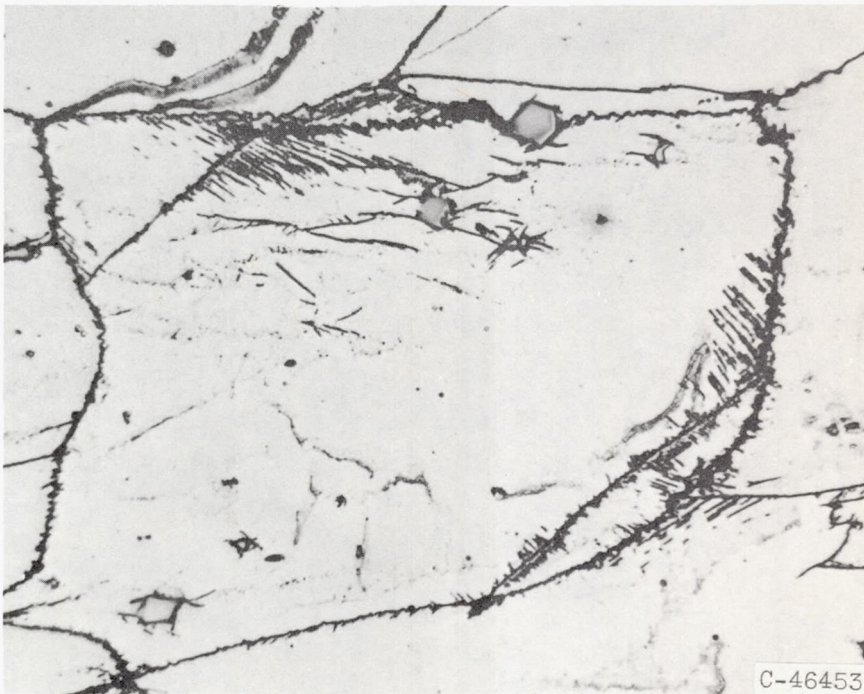
(b) Feathery precipitate found in lot 1 and lot 5 buckets.

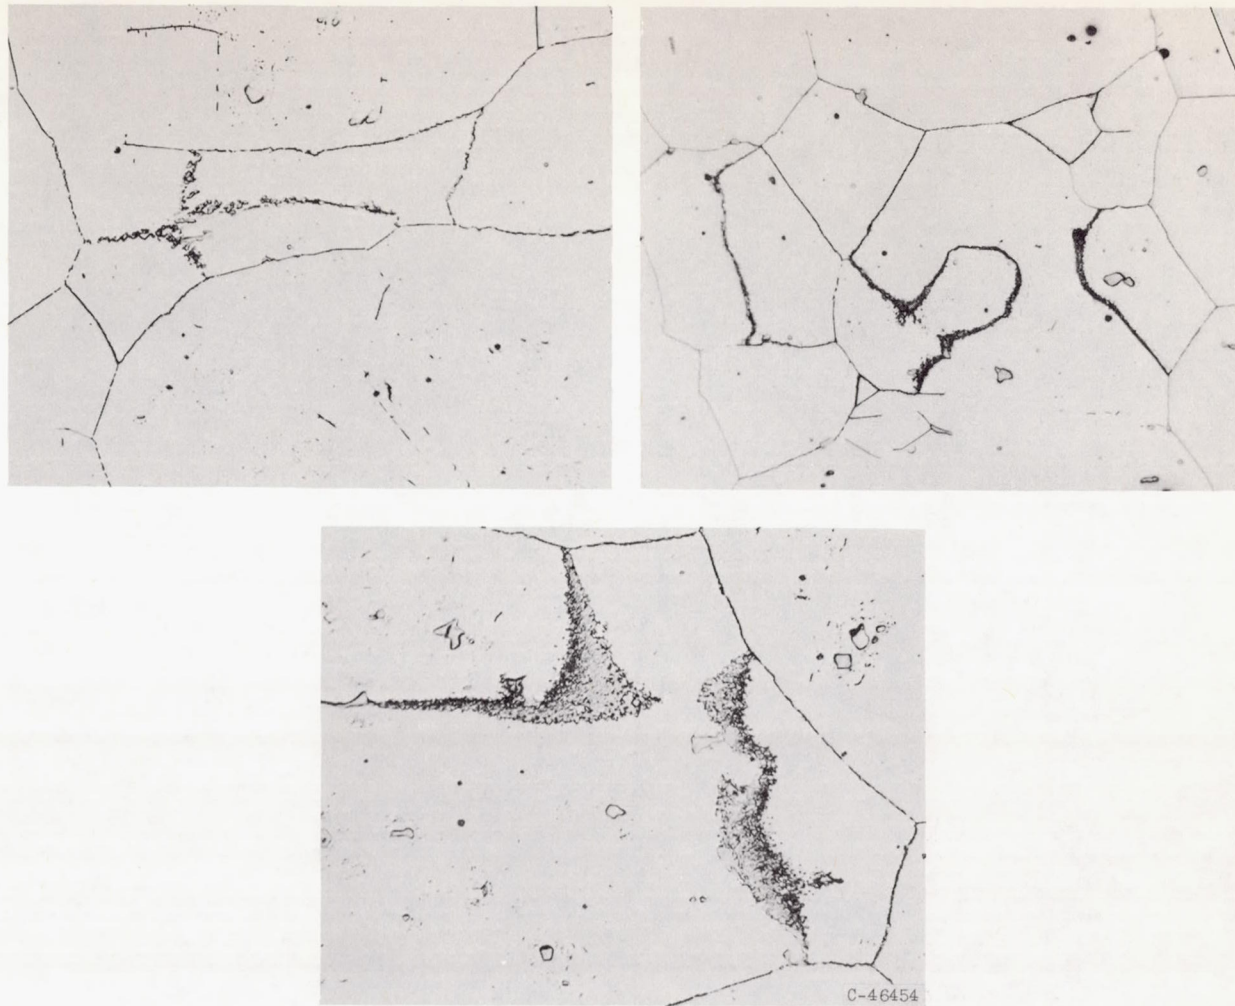
(c) Types of grain-boundary precipitation found in Inconel 700 buckets.

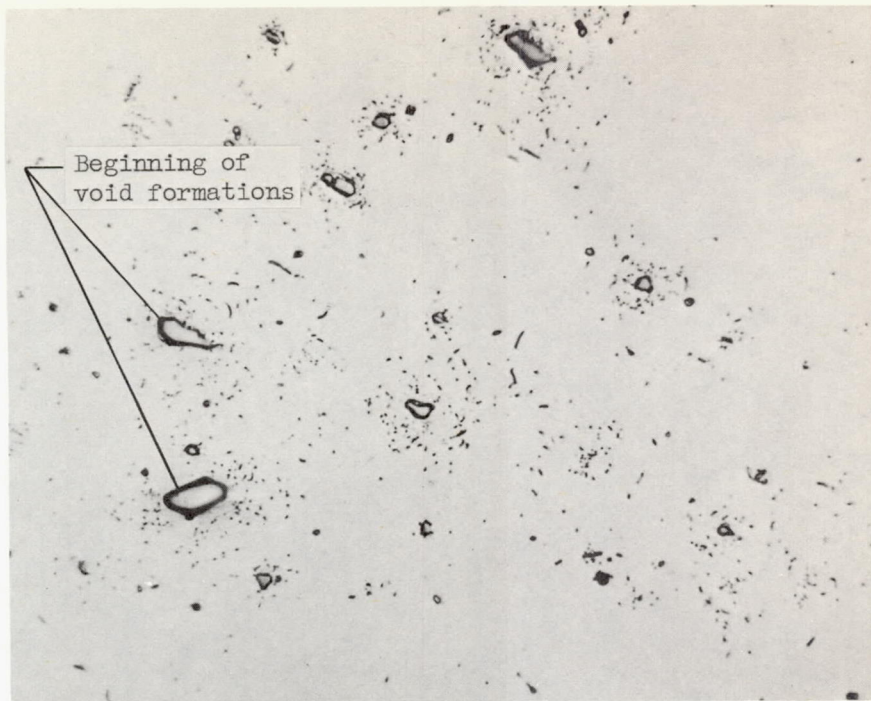
(d) Beginning of void formation in Inconel 700 buckets solution-treated at 2275° F.

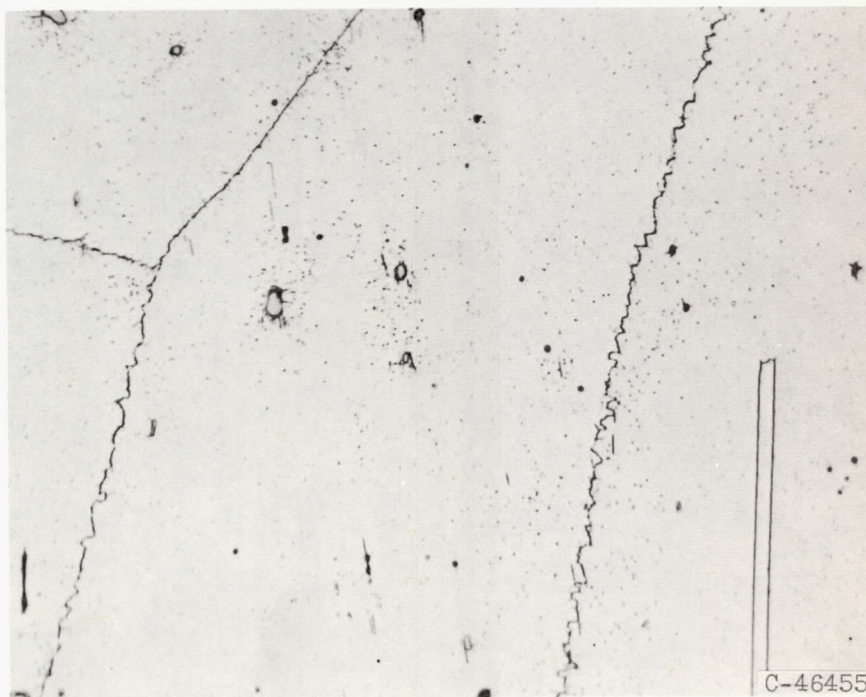
(e) Sawtooth grain boundaries found in Inconel 700 buckets.

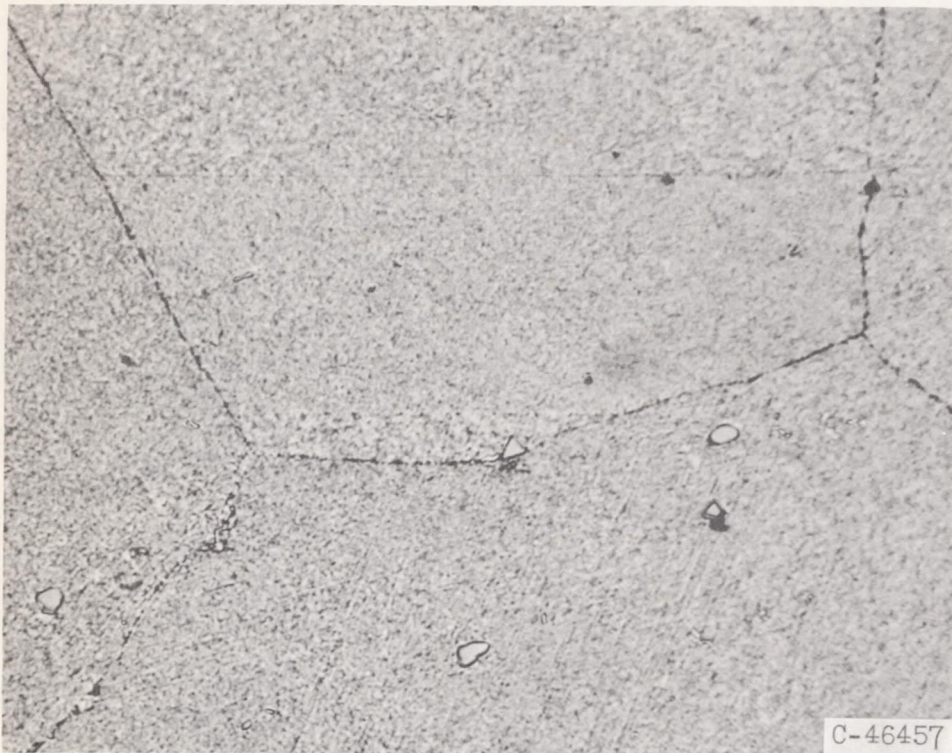
The micro-examination of the failed buckets revealed that appreciable precipitation occurred in the alloy during engine operation. An example of the typical precipitation is presented in figure 12. Occasionally, agglomeration of precipitates occurred in localized sections of buckets. An example of the precipitate agglomeration is shown in figure 13.

Figure 12. - Typical microstructure of failed buckets. (Lot 3 bucket operated 421 hours.) Original magnification, X750.

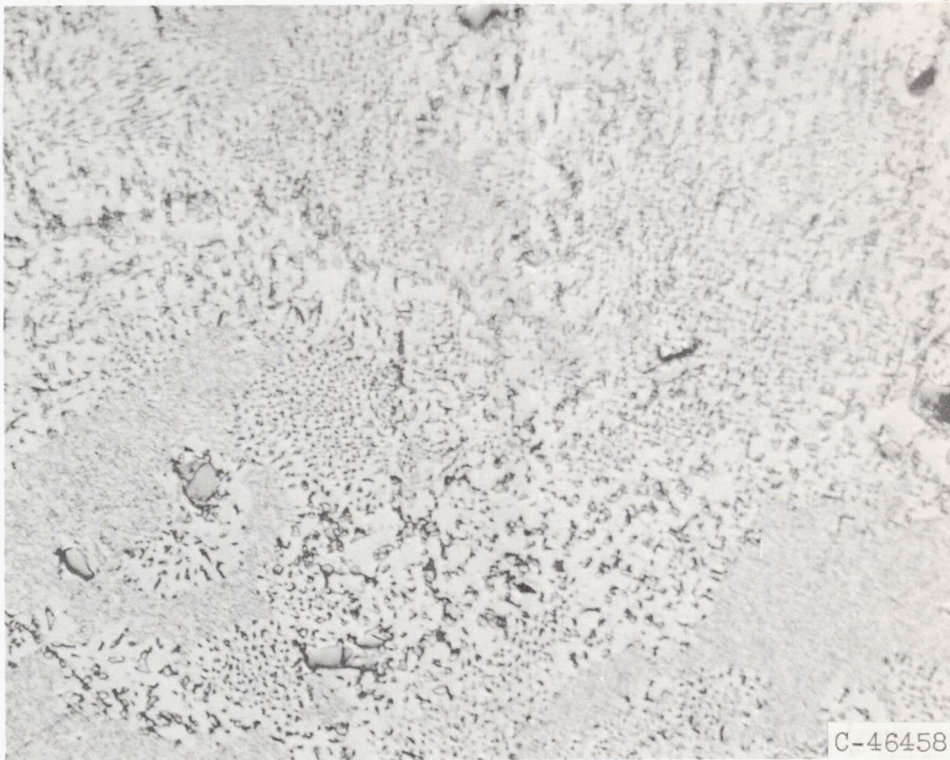
Figure 13. - Agglomeration of precipitates in a failed bucket. Original magnification, X750.

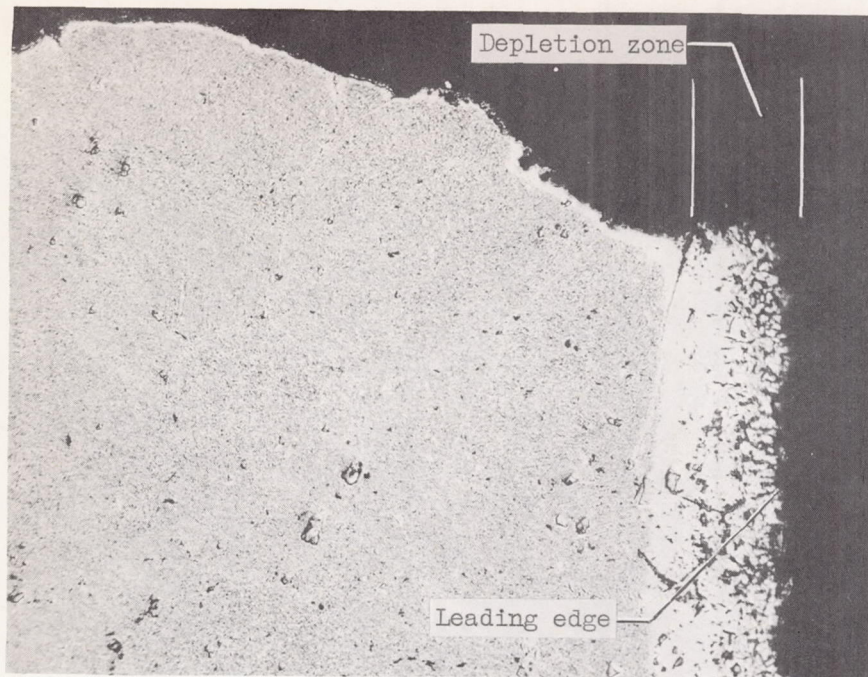
The microstructural studies also revealed that all operated buckets exhibited various degrees of surface depletion that appeared to be related to the operating time. An example of a depletion zone is shown in figure 14(a). Occasionally, needle-like structures (possibly chromium nitrides) were noted in the depletion zones, as shown in figure 14(b).

(a) Depletion zone in bucket that fractured after 245 hours of operation. Original magnification, X250.

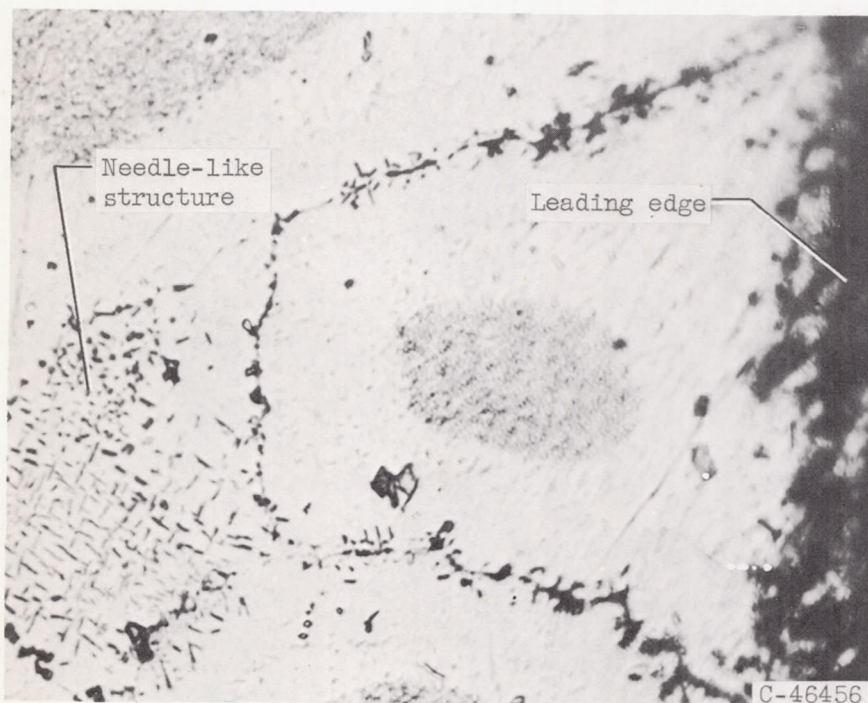
(b) Needle-like structure associated with the depletion zone of operated buckets. Original magnification, X1000.
