RESEARCH MEMORANDUM

AN EXPERIMENTAL EVALUATION OF SEVERAL DESIGN
VARIATIONS OF HOLLOW TURBINE BLADES FOR
EXPENDABLE ENGINE APPLICATION

By W. C. Morgan and R. H. Kemp

NATIONAL ADVISORY COMMITTEE
FOR AERONAUTICS

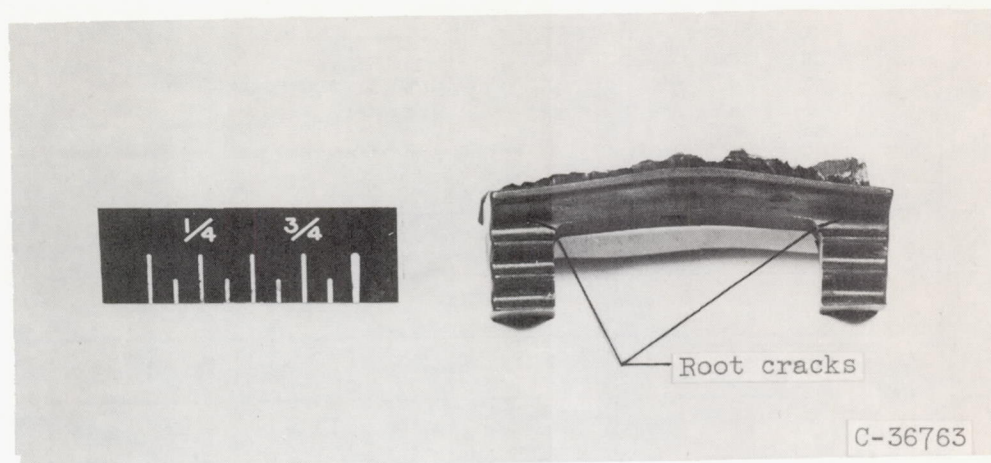
Group 1. - (L-605, 0.030-in. wall, all-welded, fig. 3, base D.) All of the six specimen blades failed in less than 10 hours. The immediate cause of failure was deformation in the base. Figure 9 shows the type of failure. It was noted also that the weld penetration was not uniform

in the base attachment. The results indicated that this type of base is of insufficient strength and that the relative disparity in mass between the airfoil and the base is unfavorable for welding.

Figure 9. - Failure of Group 1 sheet-metal blade showing the excessive base deformation and location of root cracks.

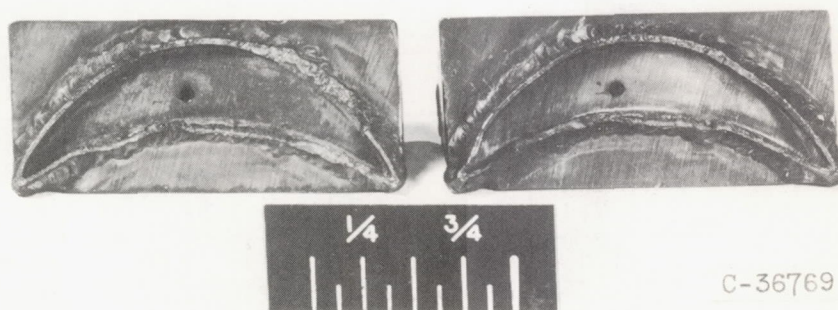
Group 2. - (L-605, 0.030-in. wall, all welded, fig. 3, base C.) In this group of blades the importance of sound welding was exemplified. All six blades failed because of imperfect weld penetration; four blades failed in less than five hours. Figure 10 shows typical failed specimens. Automatic machine weld might prove to be more effective in making joints of this type.

Figure 10. - Two failures of Group 2 sheet-metal blades showing the imperfect weld penetration.

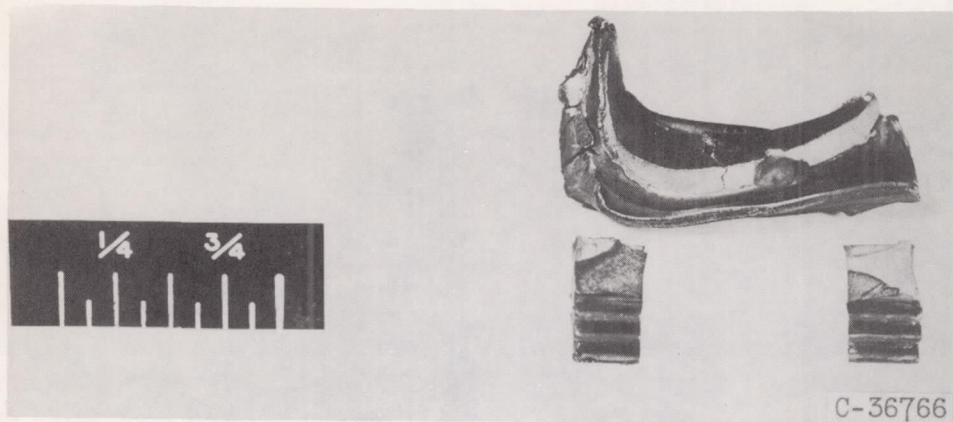
Group 3. - (L-605, 0.030-in. wall, welded airfoil brazed to stub, fig. 3, base B.) The failure of three blades was attributed to improper fabrication. Excessive clearance between the pressure side of the airfoil and the stub resulted in an inadequate braze. Another blade failed because of a crack that originated in the trailing edge. Two blades were operated for about 18 hours before failure occurred due to base deformation. The failures were similar to those that were characteristic of the group 1 tests. The stub section did not provide sufficient stiffness to the modified base. Location of the root supports at points nearer the center of the blade platform would result in a more favorable stress distribution. One of the base failures is shown in figure 11.

Figure 11. - Complete root failure produced by deformation of Group 3 sheet-metal blade.

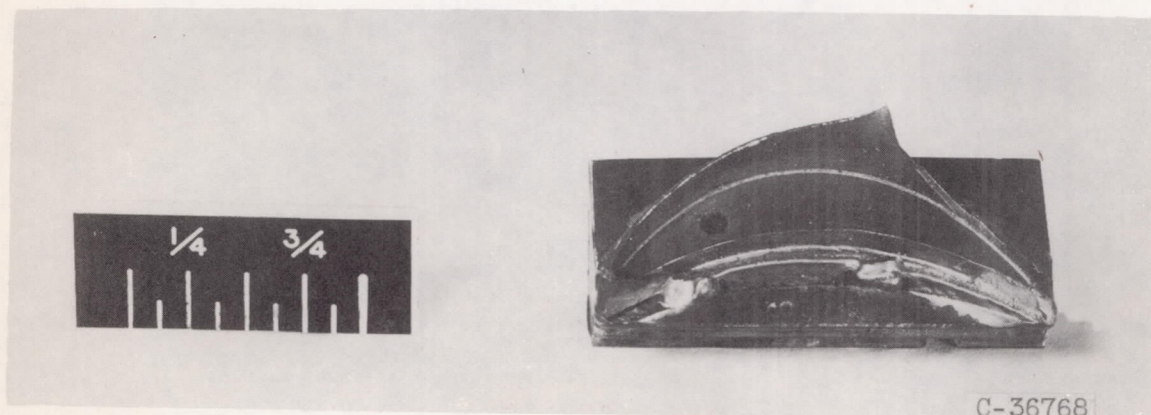
Group 4. - (L-605, 0.030-in. wall, brazed tip cap, welded airfoil brazed to stub, fig. 3, base A.) Two blades of this group failed because of improper fabrication. The remaining four specimen blades completed 30 hours. The failure presented in figure 12 shows a typical example of excessive clearance, approximately 0.060 inch between surfaces. Clearance should be 0.001-0.004 inch for best results. The results indicate that attachment of a tip cap by brazing is feasible. The failures caused by excessive clearance between brazing surfaces are not of great significance; in subsequent fabrication the technique was changed and there was only one recurrence.

Figure 12. - Premature failure of Group 4 sheet-metal blade caused by excessive clearance between surfaces to be brazed.

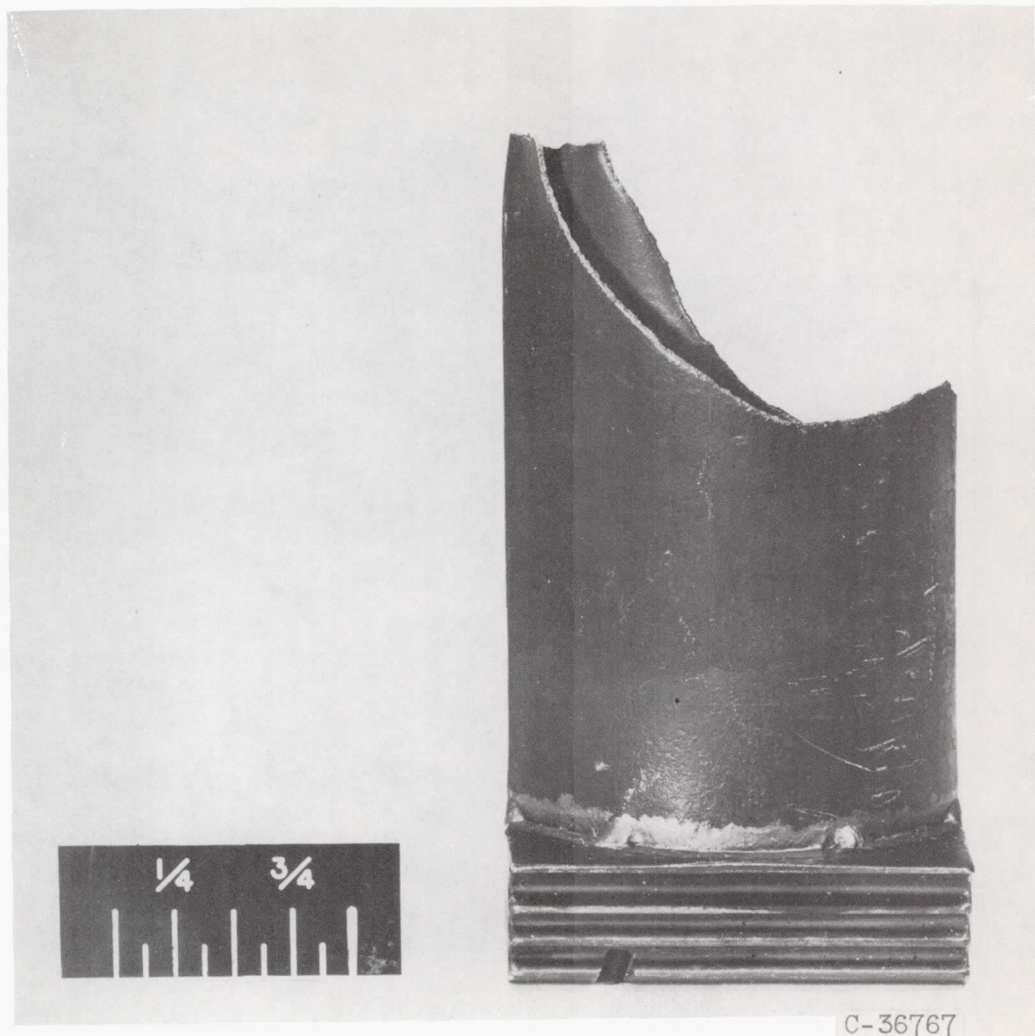
Group 5. - (L-605, 0.025-in. wall, welded airfoil brazed to stub, fig. 3, base A.) One blade failed as a result of excessive clearance in the brazed attachment. Three blades were removed from testing because of failure in the airfoil at the midsection. Two blades were still intact after 30 hours of operation. The failures appeared to be the result of fatigue. Figure 13 shows a representative failure in the airfoil midsection.

Figure 13. - Mid-section airfoil failure in Group 5 sheet-metal blade suspected to have been caused by fatigue.

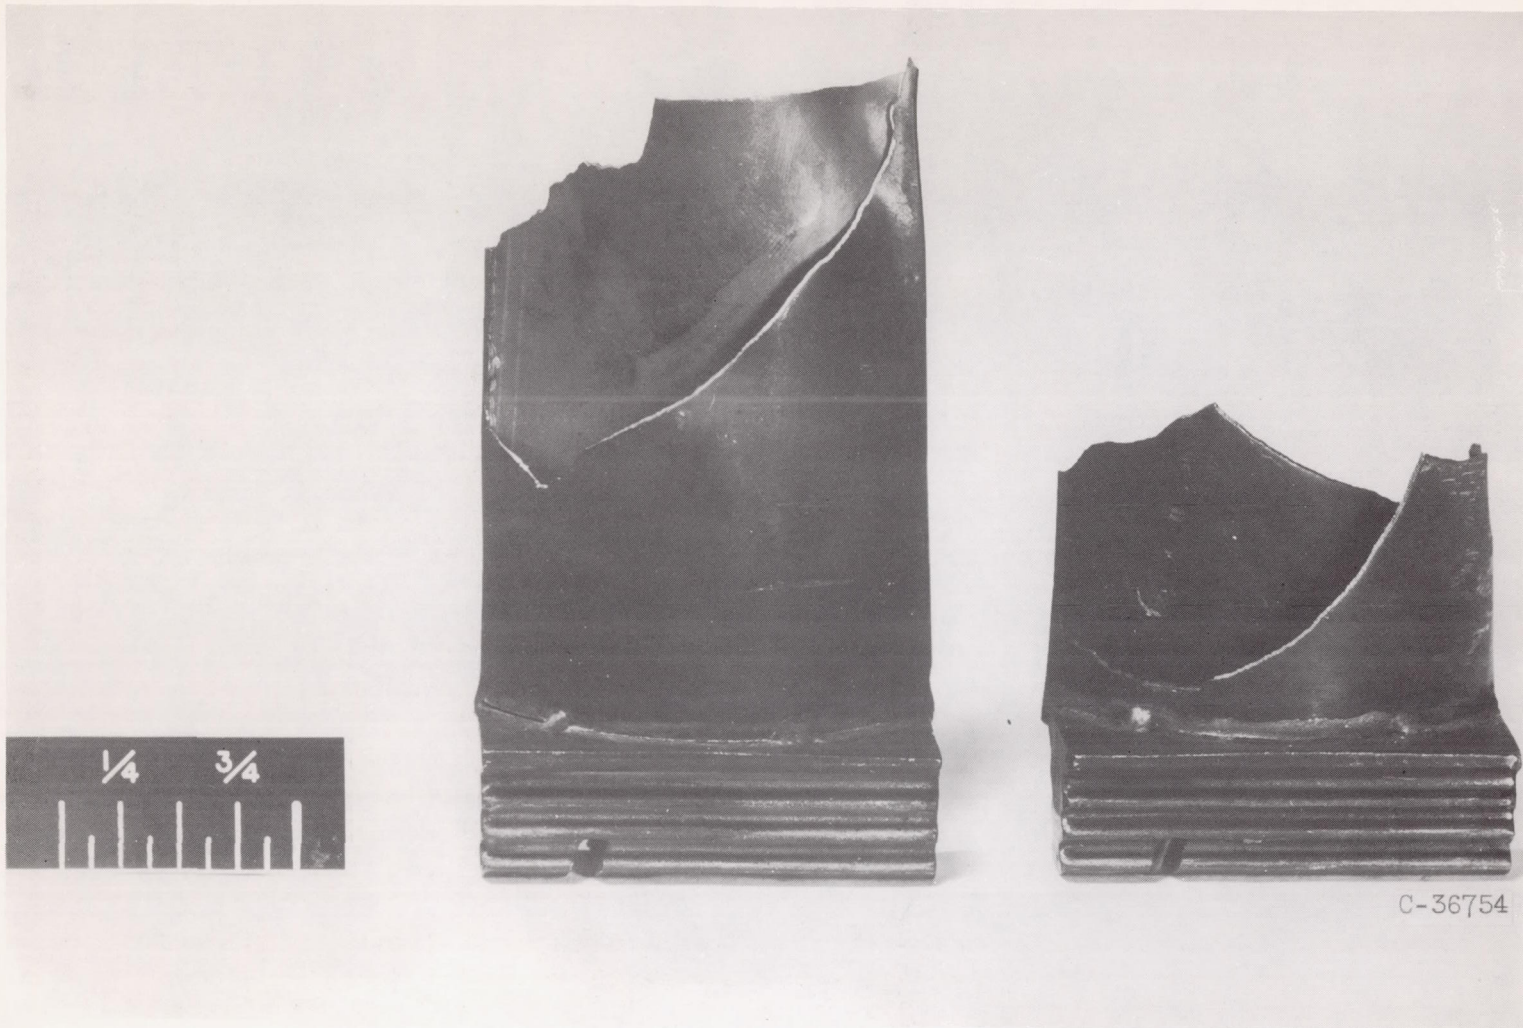
Group 6. - (L-605, 0.022-in. wall, welded airfoil brazed to stub, fig. 3, base A.) Failure occurred in less than 10 hours of operation for the six blades of this group. Serious cracking or actual rupture in the airfoils occurred near the base, the midsection, and the tip. Figure 14 presents typical failures. It is probable that the decrease in structural rigidity caused by the relatively thin airfoil wall made this type of blade particularly susceptible to vibration.

Figure 14. - Typical failures of Group 6 sheet-metal blades suspected to have been caused by fatigue.

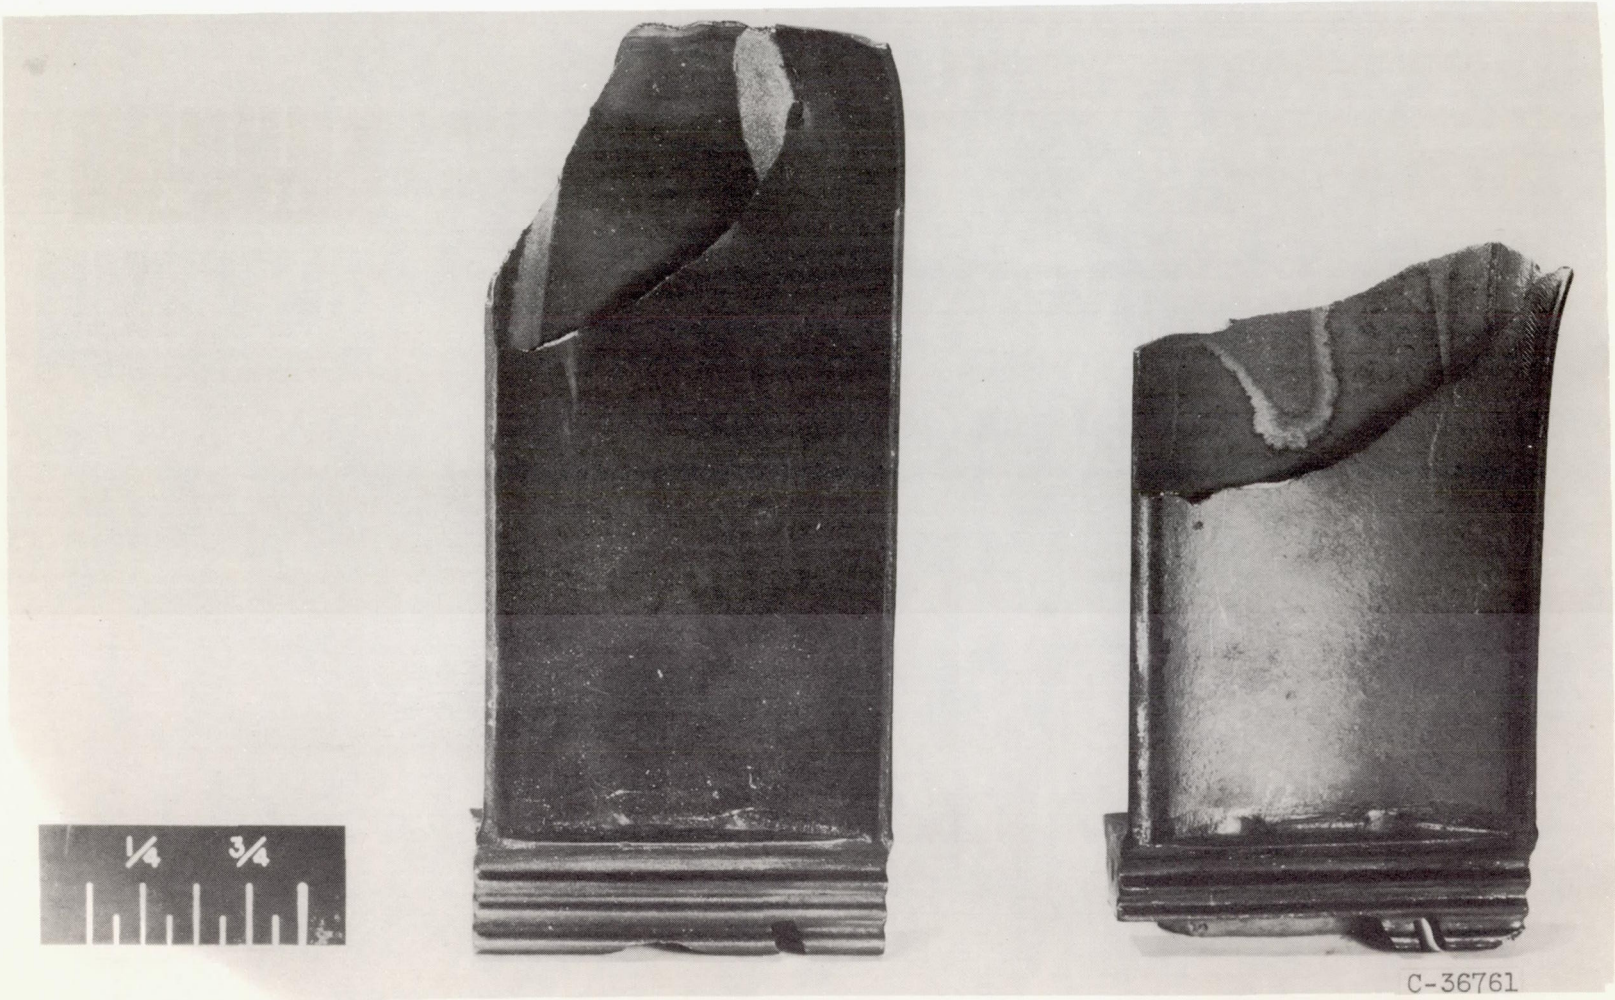
Group 8. - (L-605, 0.030-in. wall, airfoil formed from tubular stock brazed to stub, fig. 3, base A.) Five of the blades tested were undamaged after 30 hours of operation. Seven were withdrawn from the test after sustaining tip failure. Two blades failed near the base, and another blade received excessive impact damage. The majority of the failures originated in the leading or trailing edge, probably as a result of severe bending during fabrication or of inadequate trailing-edge brazing. Two of the failures are shown in figure 15.

Figure 15. - Airfoil failures of Group 8 sheet-metal blades attributed to cracking caused by the forming operation and to imperfect edge brazing.

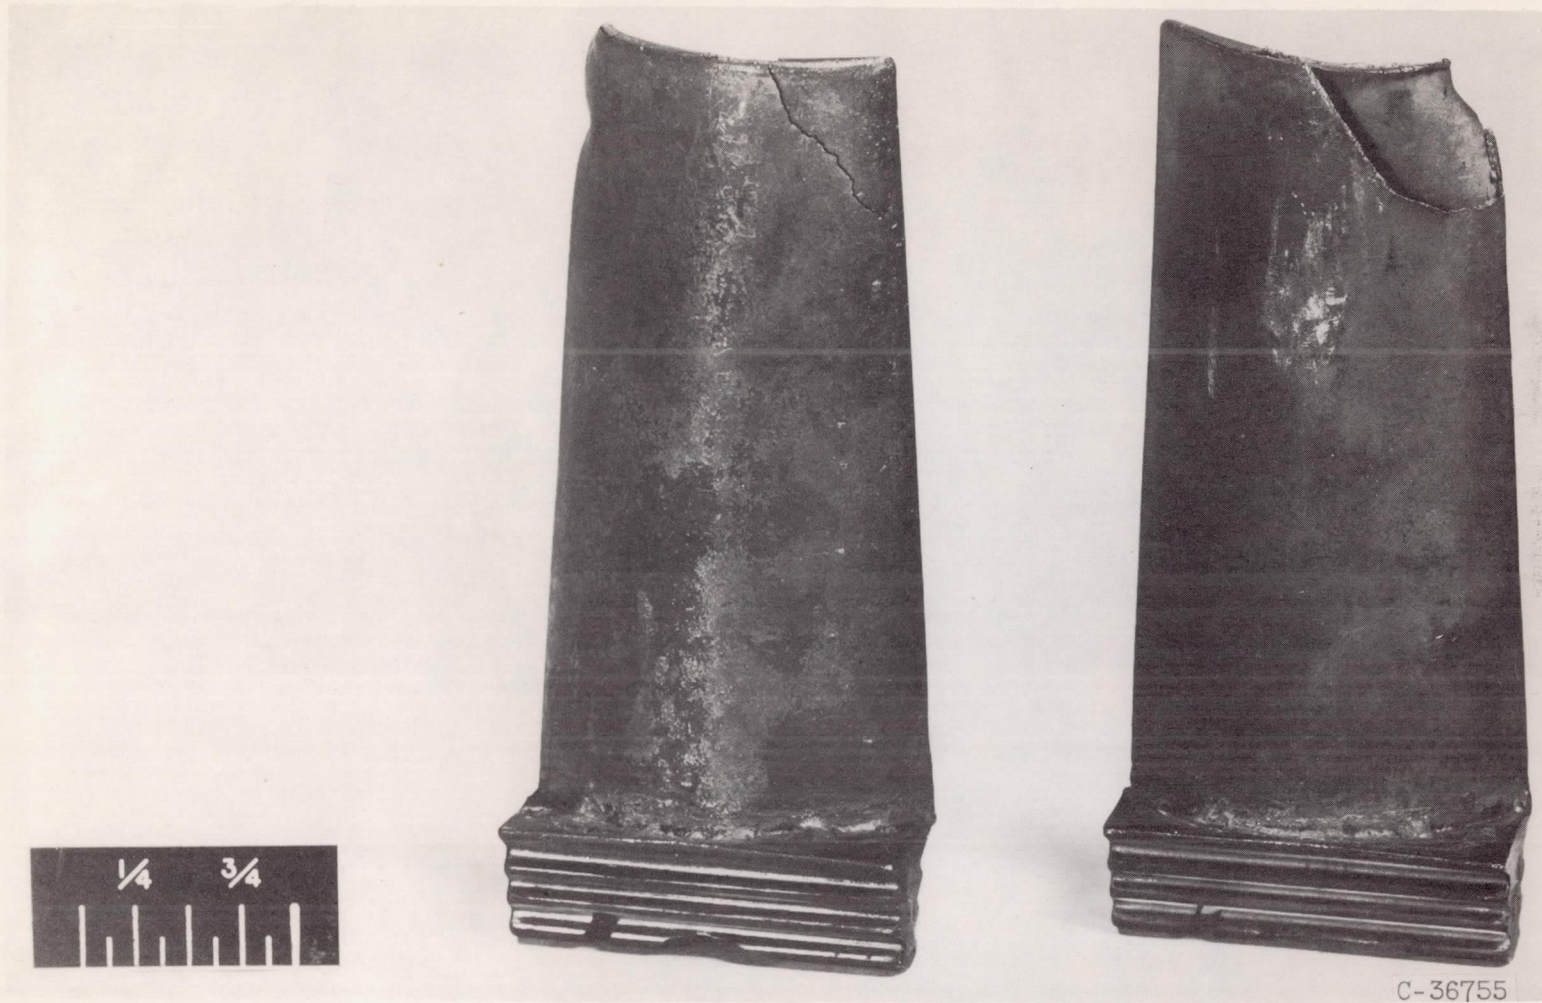
Group 10. - (A-286, 0.030-in. wall, welded airfoil salt-bath brazed to stub, fig. 3, base A.) One blade survived 29 hours of operation before removal from the test because of cracks in the airfoil tip. Three other blades sustained similar failure in shorter operation times. One blade failed in the base as a result of defective brazing. The clearance between parts was correct but the braze material had not filled the joint. The results show that A-286 blades are relatively susceptible to tip fatigue. In addition, it is probable that special welding and brazing techniques are required. The salt-bath brazing was not entirely satisfactory. Figure 16 shows typical failures.

Figure 16. - Tip failure in Group 10 sheet-metal blades showing fatigue cracks.

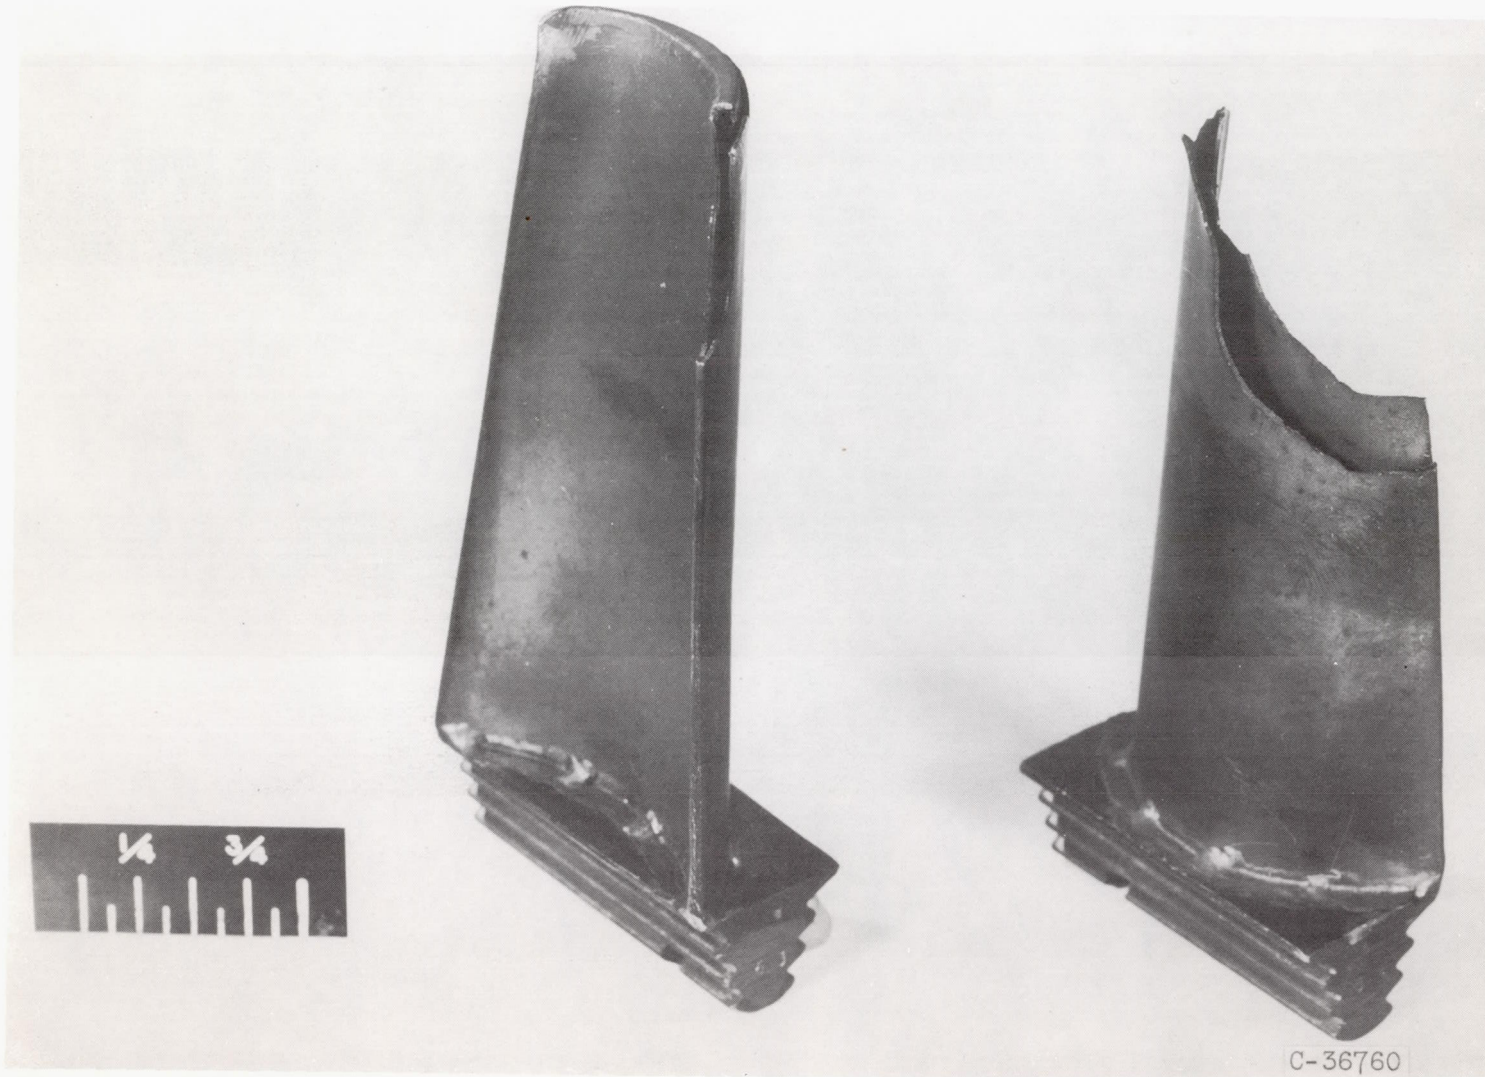
Group 11. - (L-605, 0.030 to 0.020 in. tapered wall, welded airfoil brazed to stub, fig. 3, base A.) Cracking in fatigue after short engine life characterized the failures of the six sample blades. Typical examples are shown in figure 17. The failures occurred at several locations along the airfoil. It appeared that the tapered wall was of insufficient thickness to resist vibration.

Figure 17. - Fatigue failures in Group 11 tapered-wall sheet-metal blades. (0.030-.020-in wall)

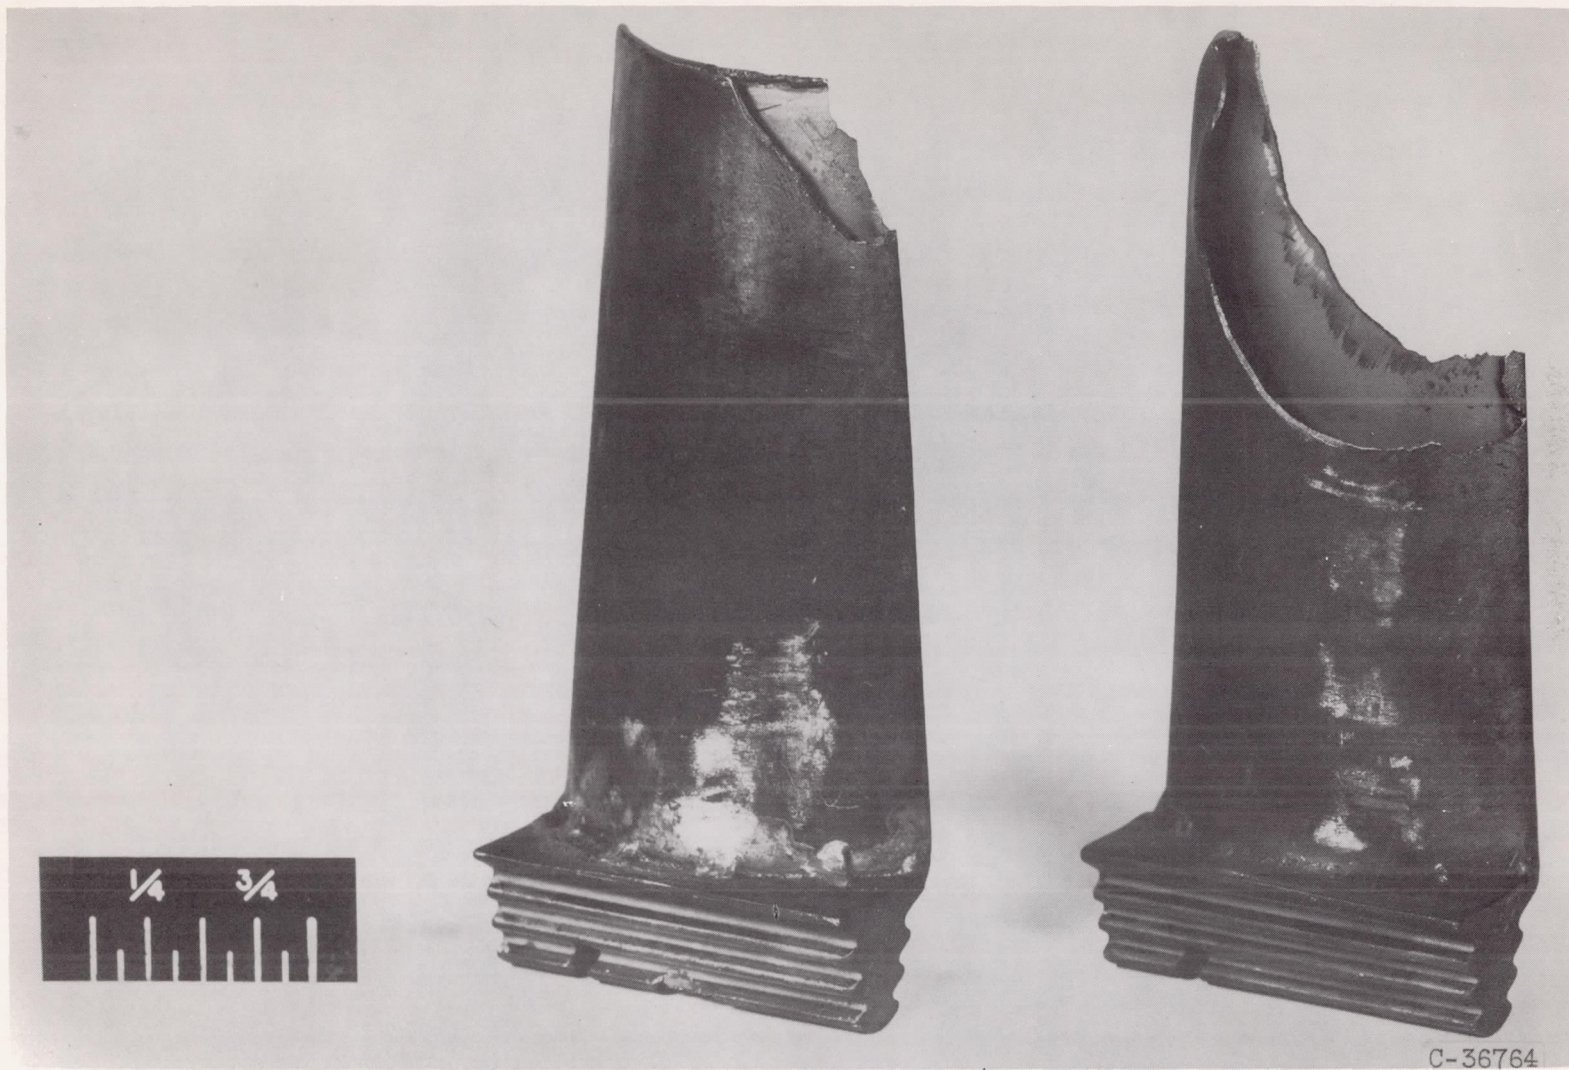
Group 12. - (L-605, 0.035 to 0.020 in. tapered wall, welded airfoil brazed to stub, fig. 3, base A.) Three blades of this group failed in less than 10 hours of operation. The failures were all in the tip region, and were attributed to fatigue. It is possible that a welding problem exists where it is necessary to join comparatively thin sheet. On the other hand, slight variations in the machined taper may have been a critical factor. Figure 18 shows the type of failure encountered in

operation. The other three blades were still in good condition at the end of 30 hours in the engine. On the basis of these results it appeared that the wall thickness in the tip is an important factor in a design that employs tapered airfoil walls.

Figure 18. - Failures in Group 12 tapered-wall sheet-metal blades attributed to fatigue. (0.035-.025-in wall)

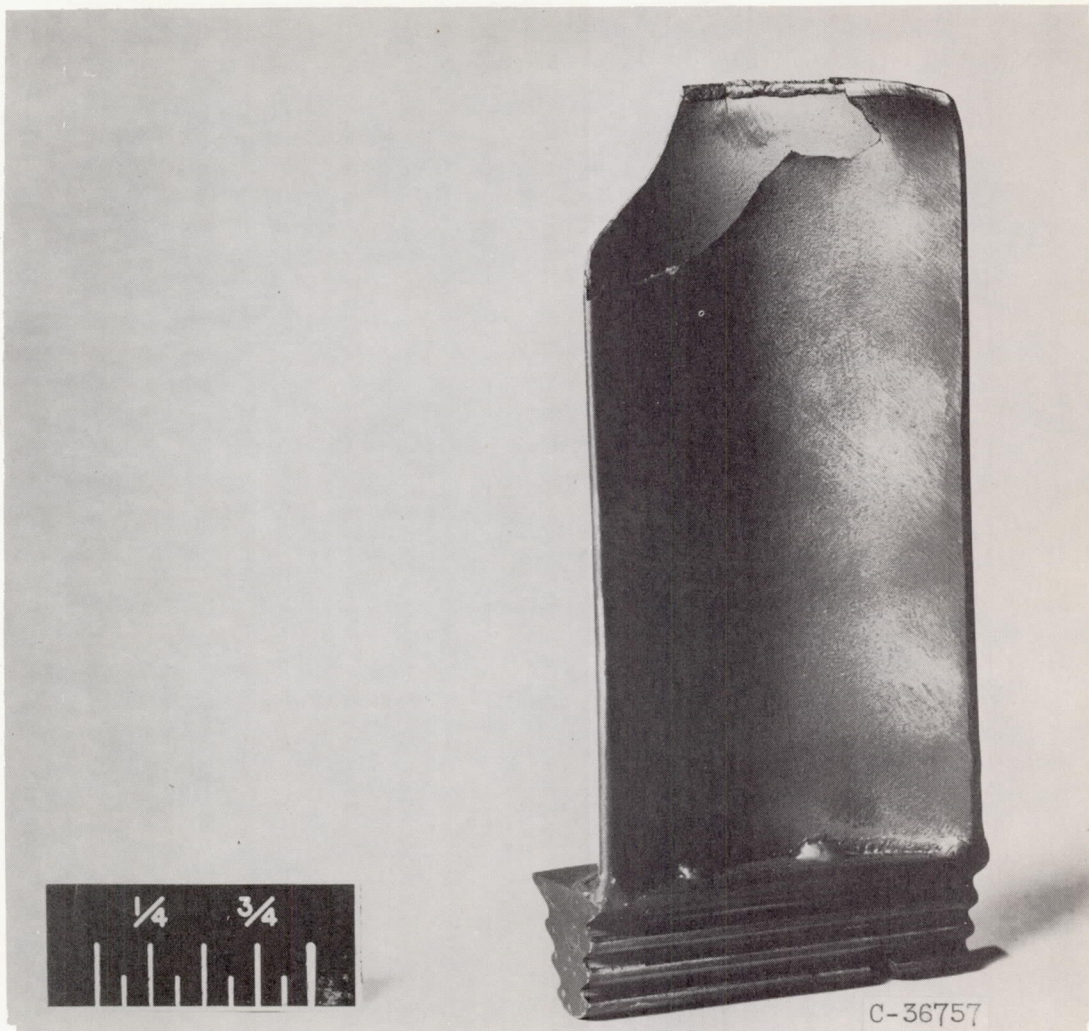
Group 13. - (L-605, 0.040 to 0.020 in. tapered wall, welded airfoil brazed to stub, fig. 3, base A.) There were five blades in this sample group; only one blade failed within the 30-hour test period. This failure occurred in the tip region after more than 29 hours and appears in figure 19. From the appearance of the failure it appeared that the crack originated in the weld. The results indicate that the proper design of tapered airfoil walls may produce satisfactory turbine blades.

Figure 19. - Group 13 tapered-wall sheet-metal blade failure attributed to fatigue.
(0.040-.020-in wall)

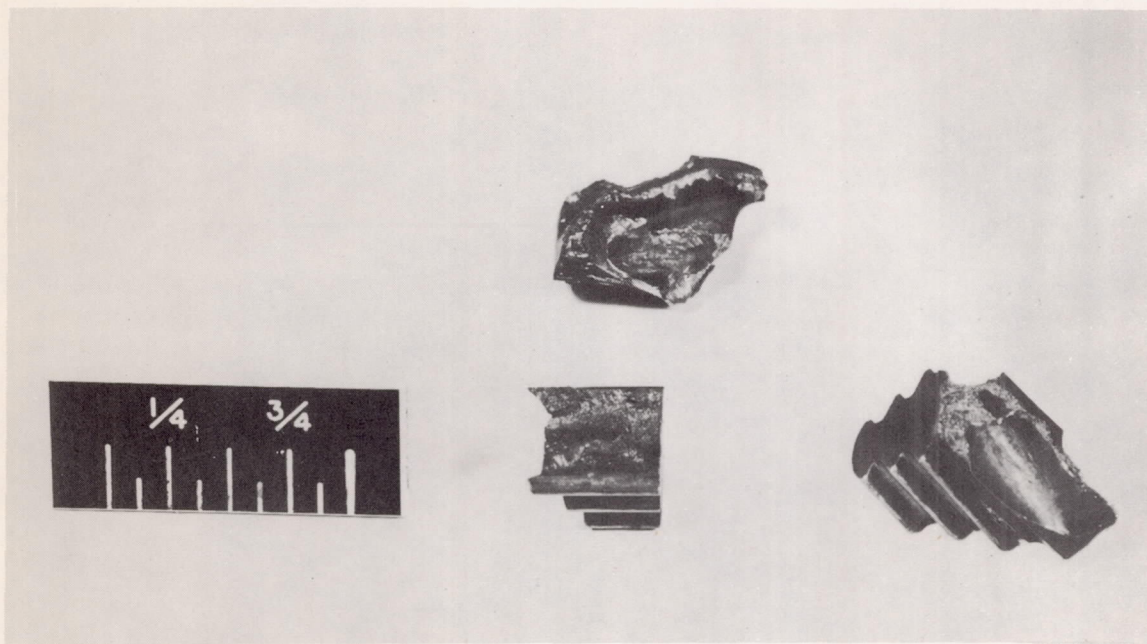
Group 15. - (X-40, 0.055 to 0.030 in. tapered wall, cast, modified base.) The six blades of this group were removed after 9 hours. One blade had failed in the root serration and three others showed serious cracking in this region. The two remaining blades had developed cracks in the airfoil as well as in the root. The evidence indicated that the blades of this group were subject to fatigue failure. Figure 20 shows the root-serration failure.

Figure 20. - Root serration failure in a Group 15 hollow X-40 cast blade with a modified root.

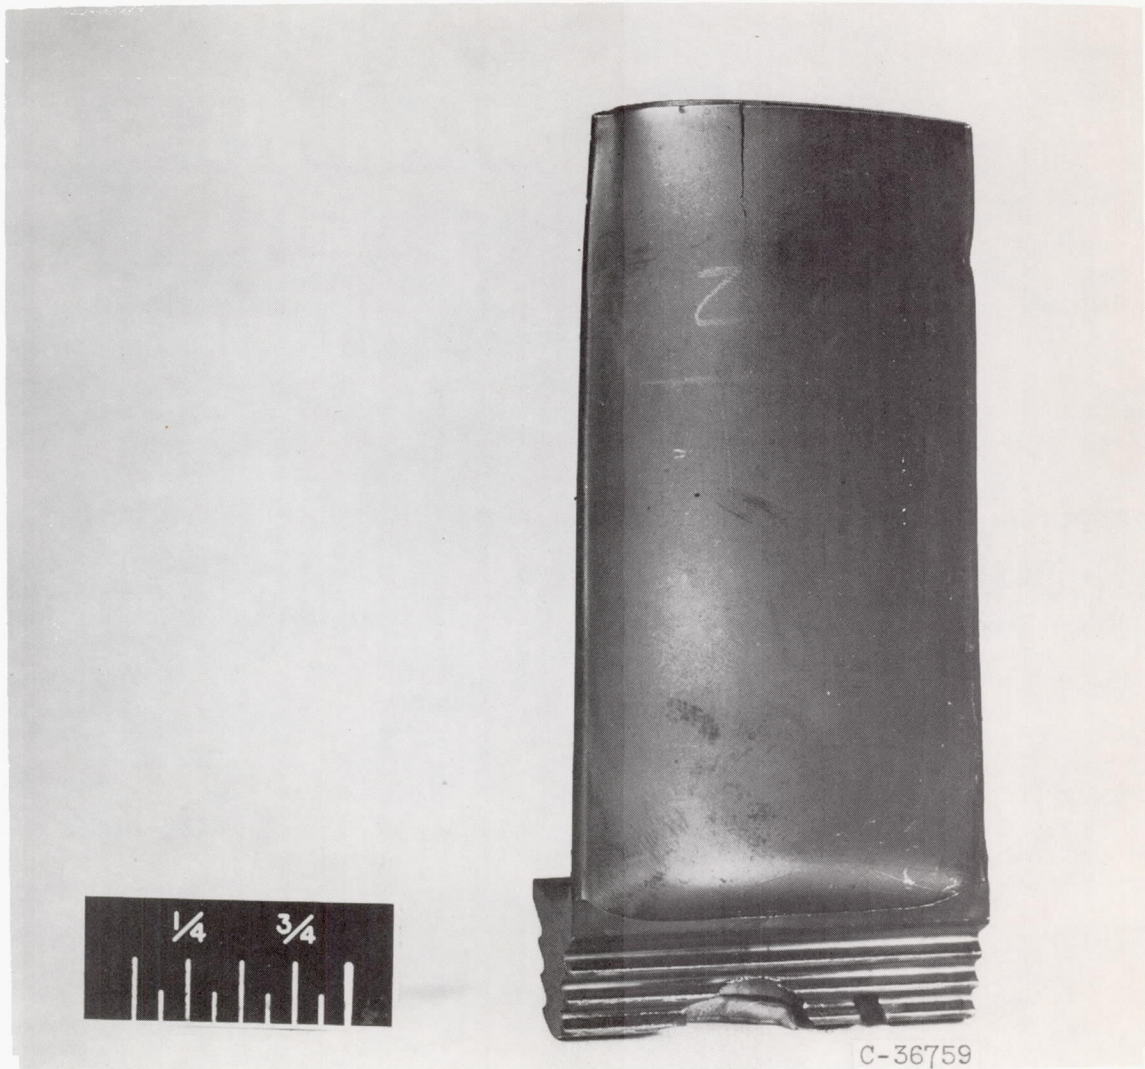
Group 16. - (X-40, 0.055 to 0.030 in. tapered wall, cast, standard base.) At the end of 20 hours of engine life the sample of four blades was removed. Three of the blades had developed fatigue cracks in the tips; the fourth blade also appeared to be cracked by vibration, but may have been damaged by impact. Typical failure is shown in figure 21. The X-40 blades in the as-cast condition are susceptible to fatigue.

Figure 21. - Fatigue crack in a Group 16 hollow X-40 cast blade.

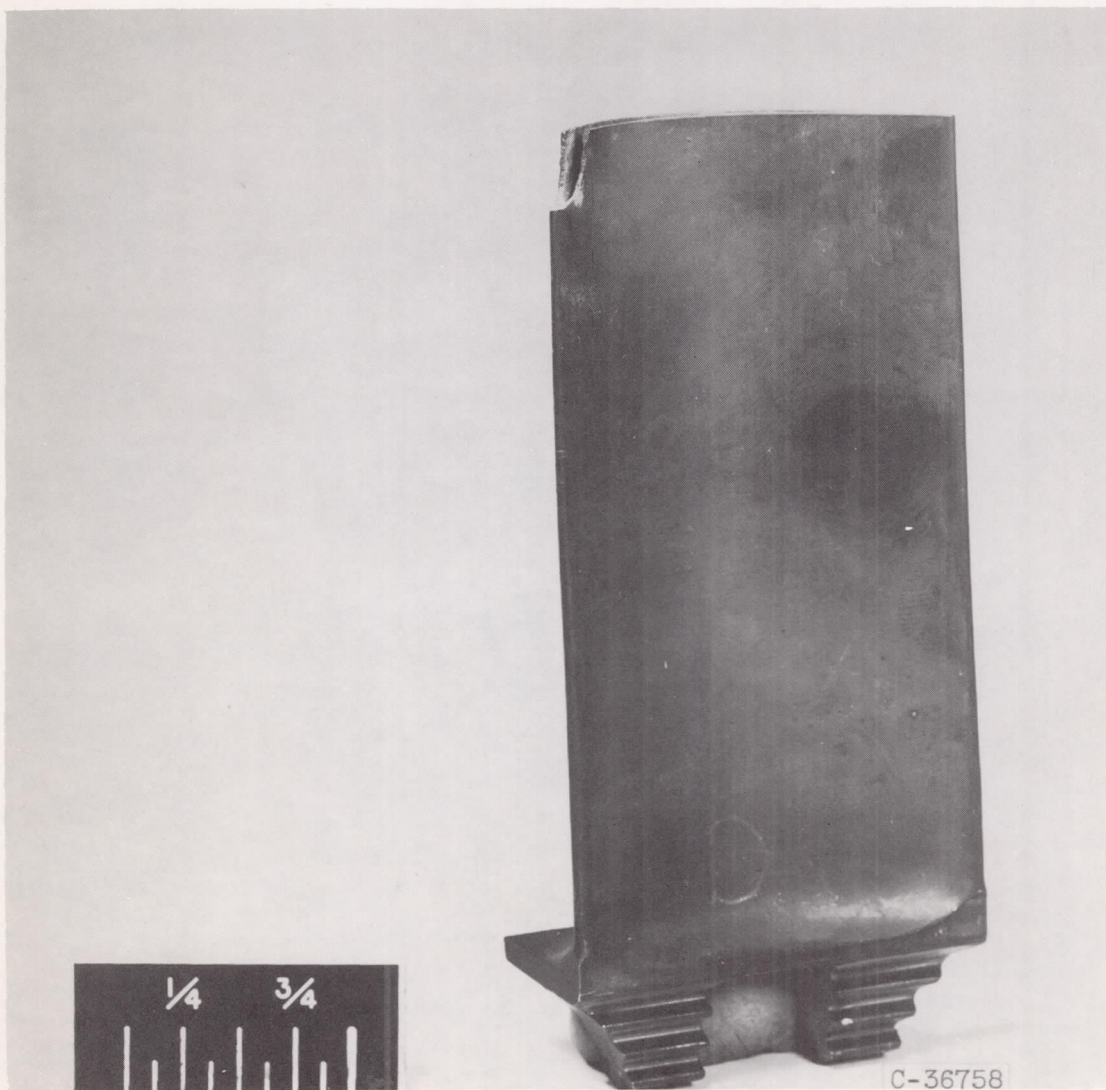
Group 17. - (X-40, 0.055 to 0.030 in. tapered wall, cast, heat-treated, shot-peened modified base.) After 24 hours of operation four of the eight sample blades were removed. These blades had fatigue cracks in the tips. The remaining four blades survived 30 hours of operation, although inspection of the bases revealed evidence of cracking in the root serrations. Figure 22 shows one of the failures. A comparison of these results with those obtained from the group 15 tests indicates that considerable improvement in the quality of X-40 cast blades can be obtained by proper heat-treatment and work-hardening of the root. There was less tendency toward tip failure by fatigue, and root-cracking was reduced.

Figure 22. - Fatigue failure in the tip of a Group 17 hollow X-40 cast blade that had been heat treated and shot-peened in the root section.
