FULL-SCALE PERFORMANCE STUDY OF A PROTOTYPE CRASH-
FIRE PROTECTION SYSTEM FOR RECIPROCATING-
ENGINE-POWERED AIRPLANES

By Dugald O. Black and Jacob C. Moser

NATIONAL ADVISORY COMMITTEE
FOR AERONAUTICS

November 15, 1955

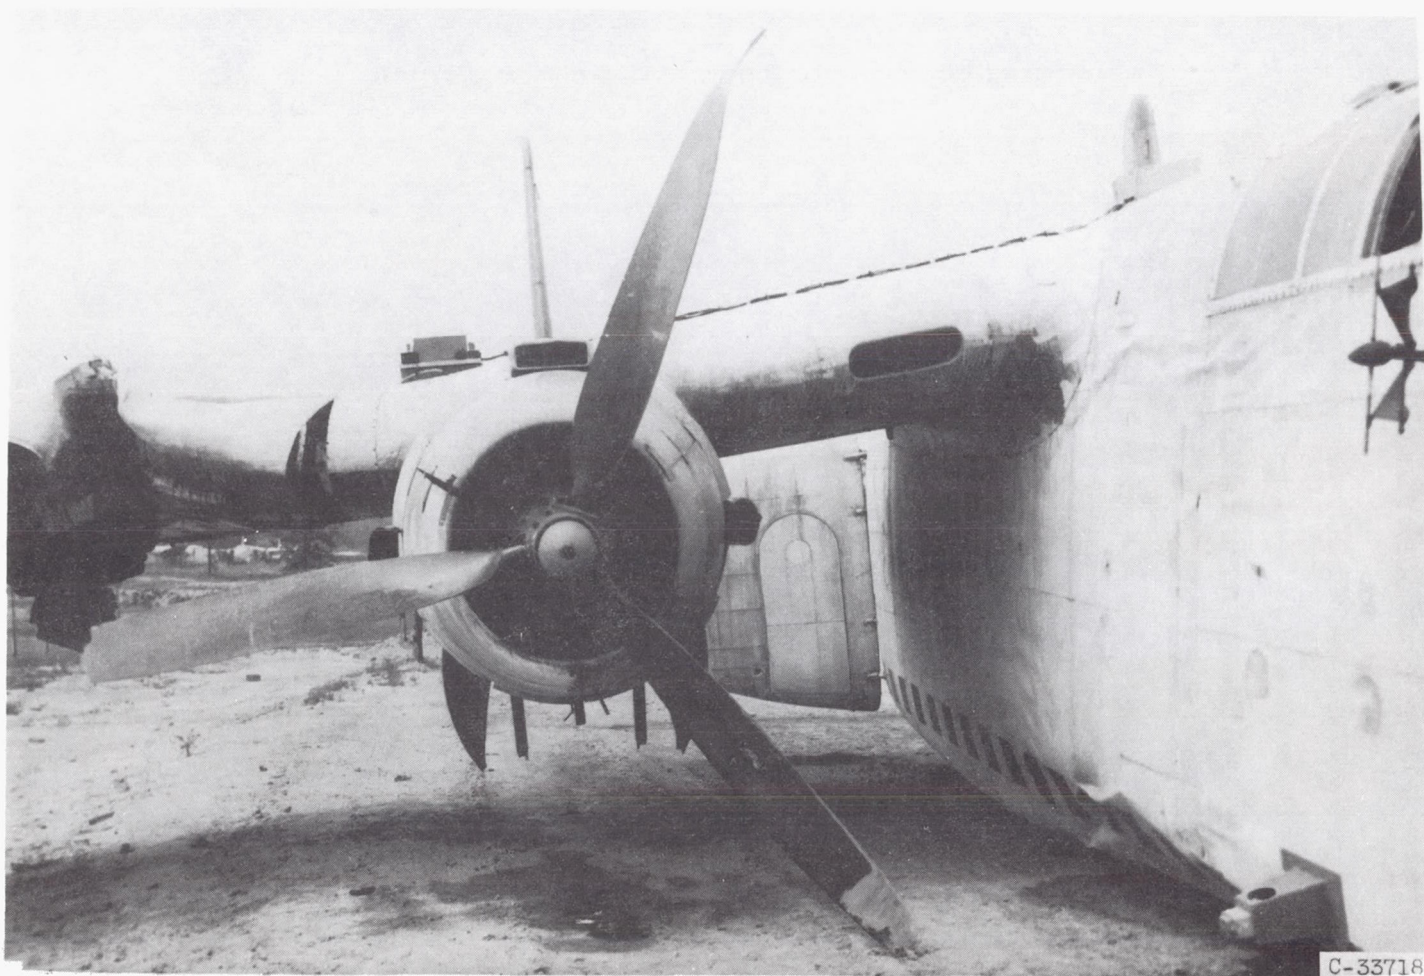
(a) Right engine.

The propellers of both the right and the left engines were bent from impact with the crash barrier as shown by photographs in figures 3(a) and (b), respectively.

Figure 3. - Propeller damage produced by crash barriers.

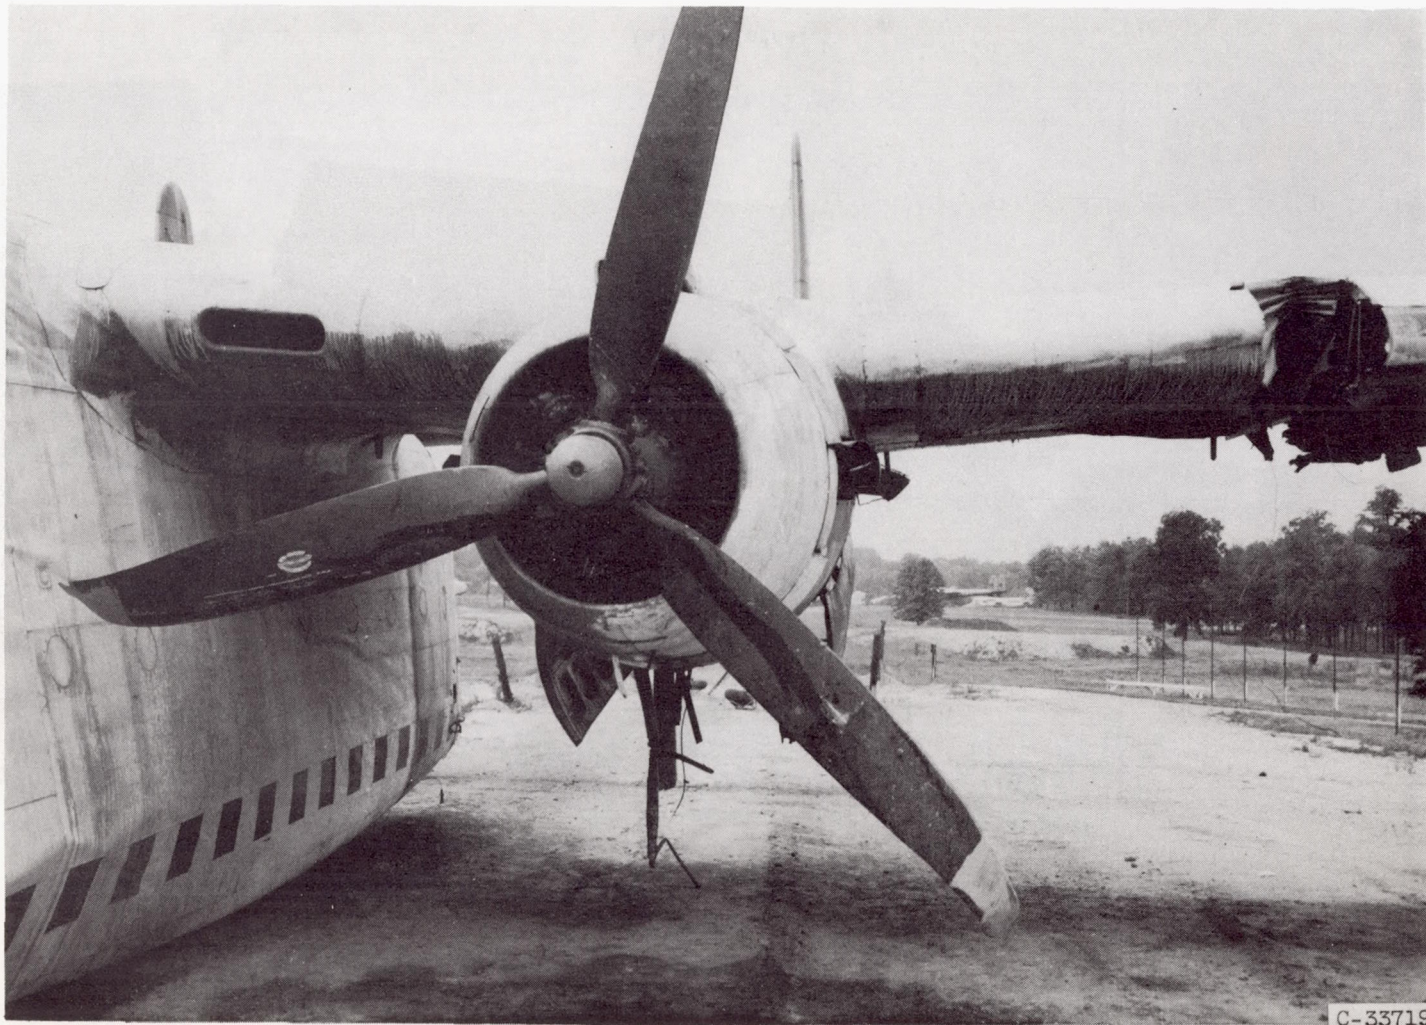
(b) Left engine.

Figure 3. - Concluded. Propeller damage produced by crash barriers.

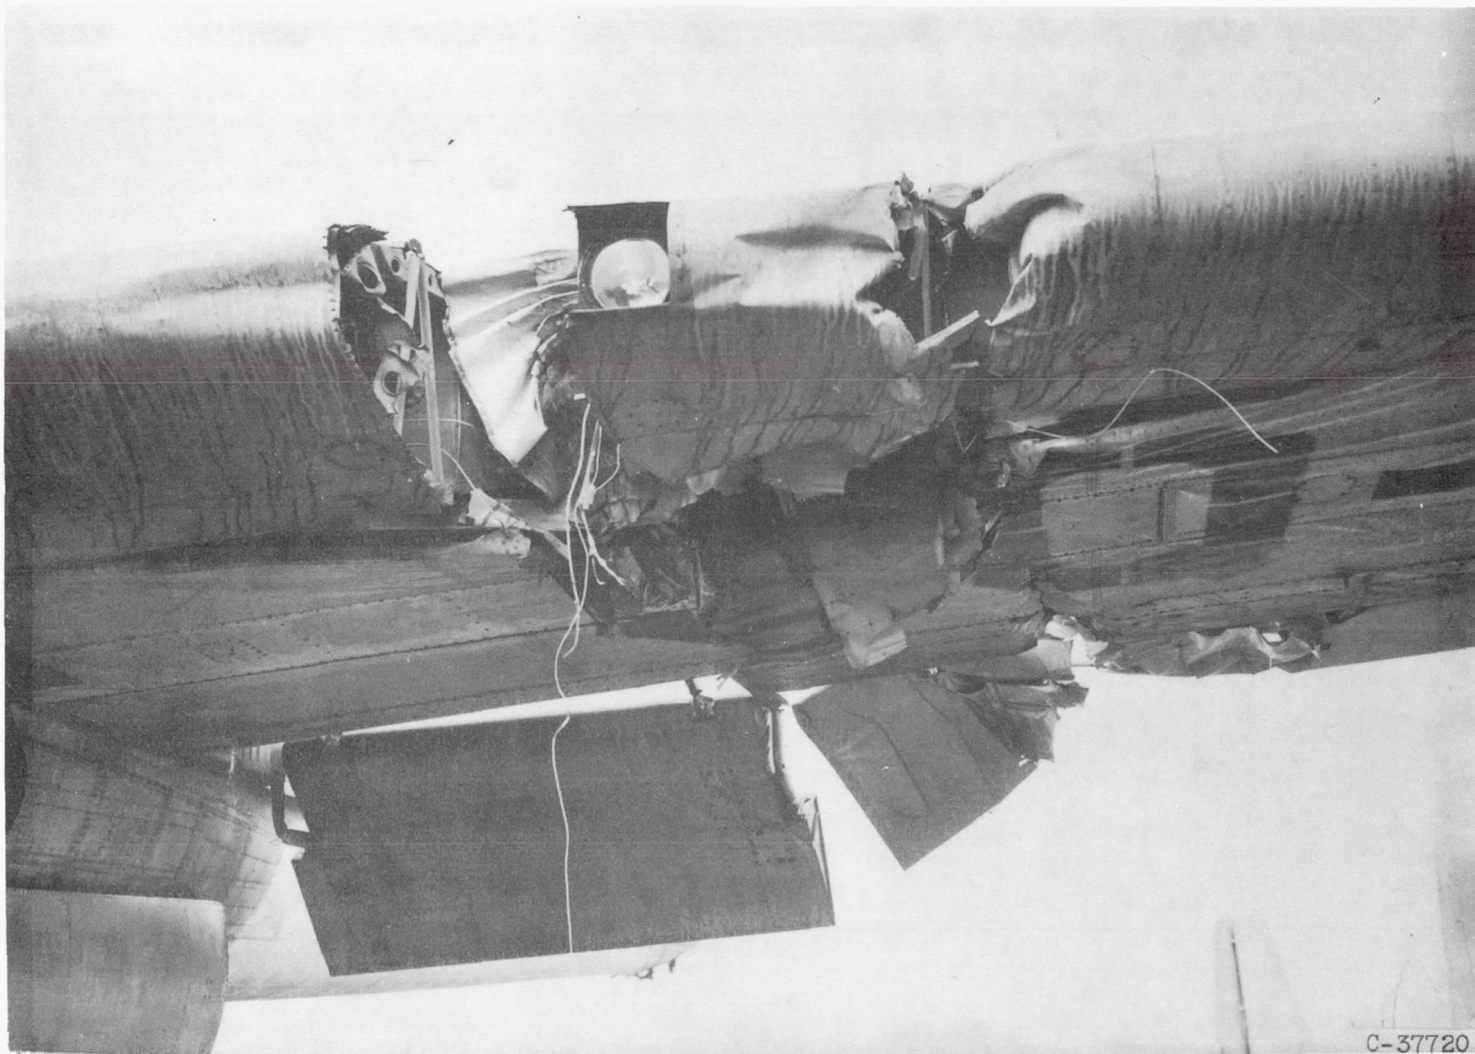
(a) Left side.

Fuel tanks 2 and 5 in both wings were pierced by the pole barriers. The extent of the damage to the left and right fuel tanks and wings is shown in figures 4(a) and (b), respectively.

Figure 4. - Damage to wing and fuel tanks produced by pole barriers.

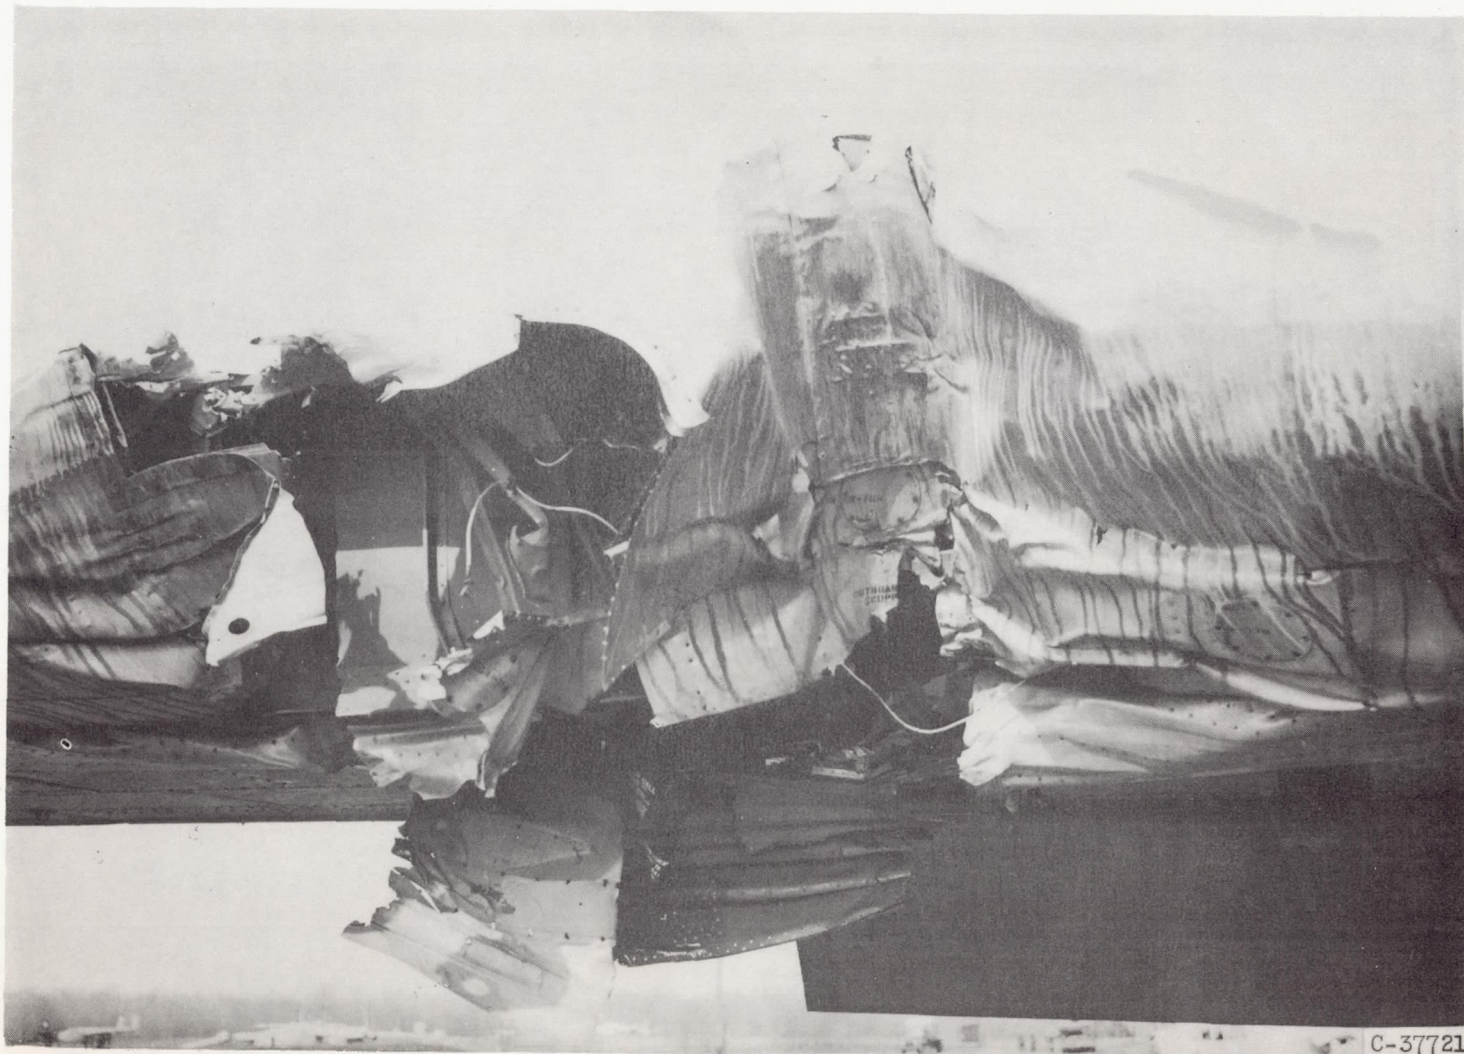
(b) Right side.

Figure 4. - Concluded. Damage to wing and fuel tanks produced by pole barriers.

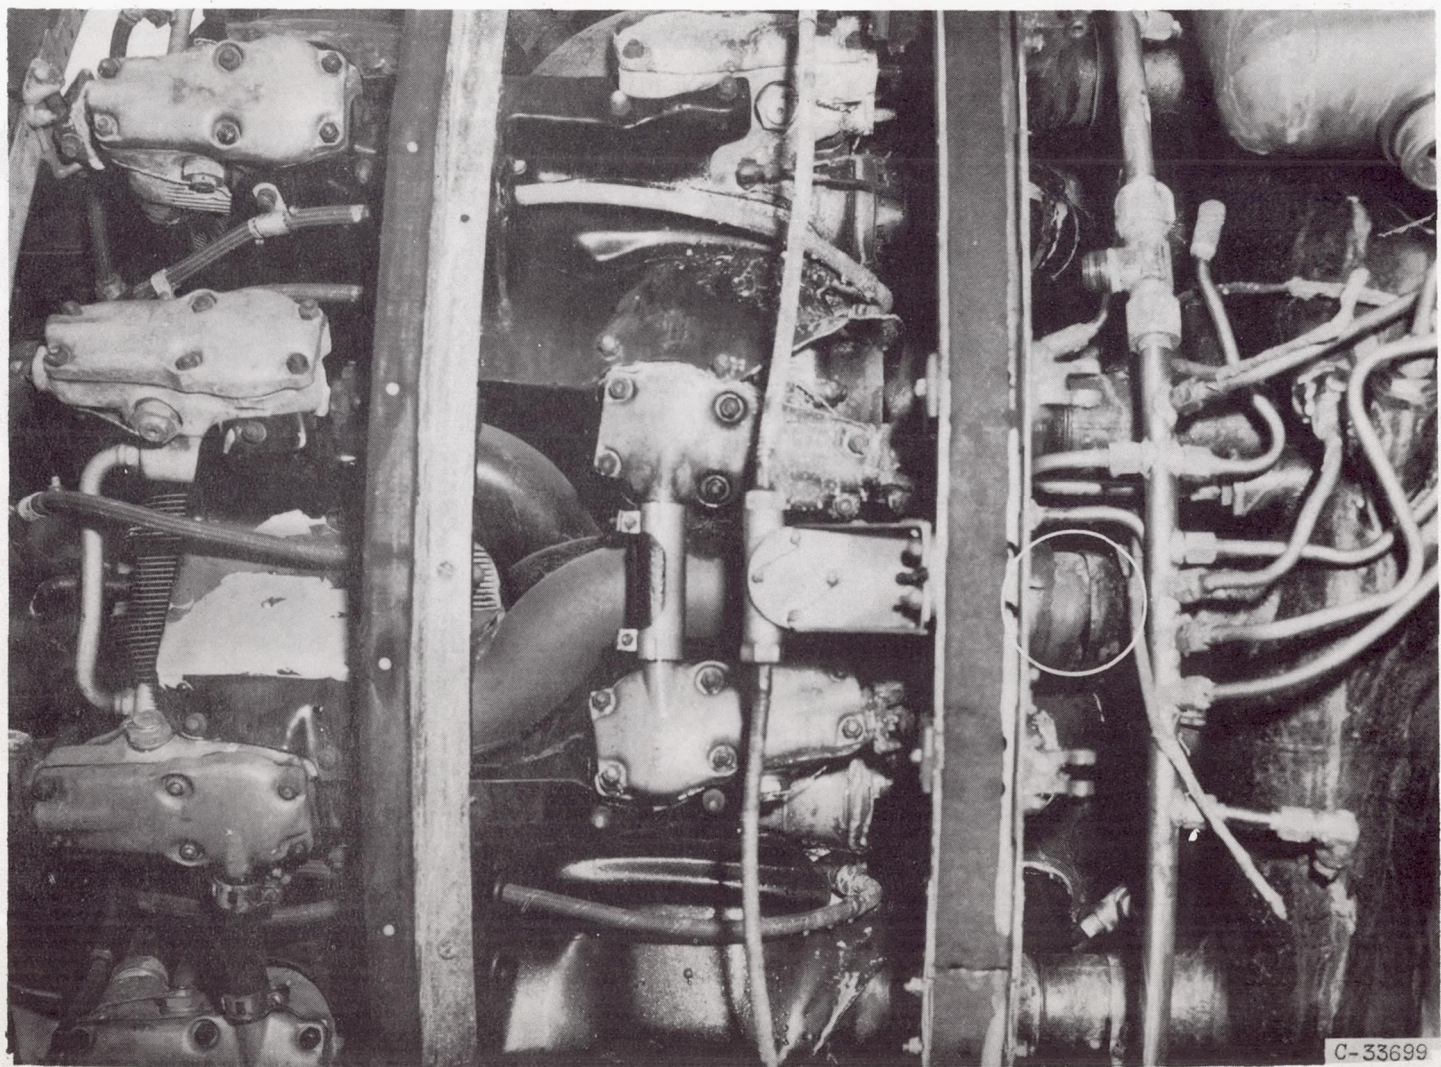
(a) Cylinder 14.

Figure 6. - Gap in right-engine exhaust-stack connecting sleeve.

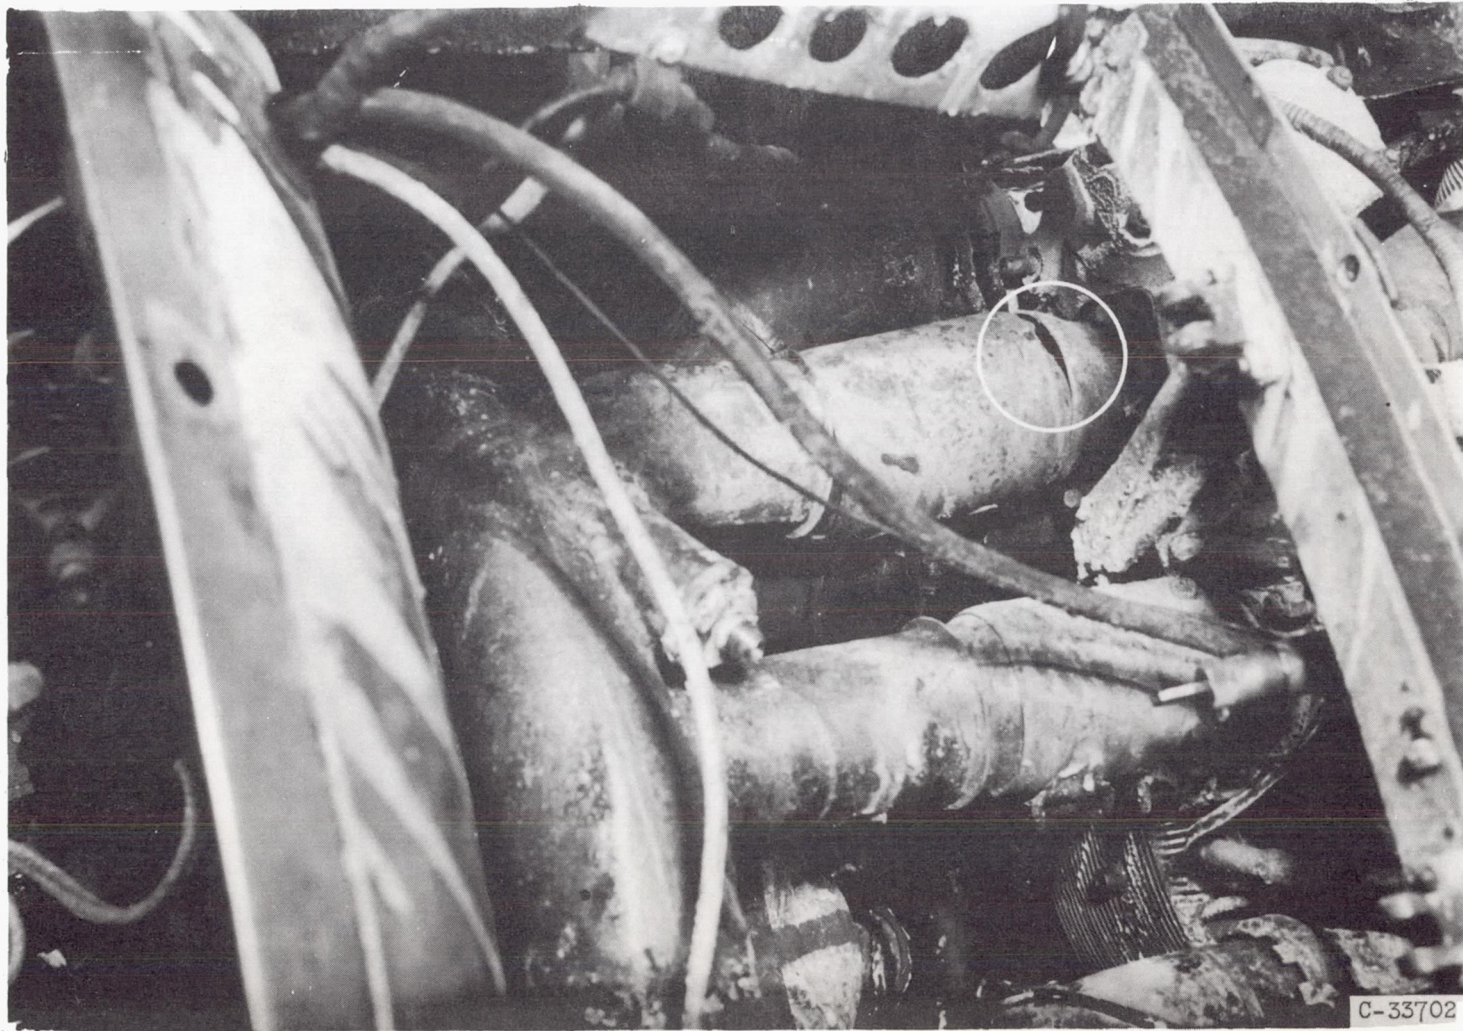
(b) Cylinder 2.

Figure 6. - Concluded. Gap in right-engine exhaust-stack connecting sleeve.

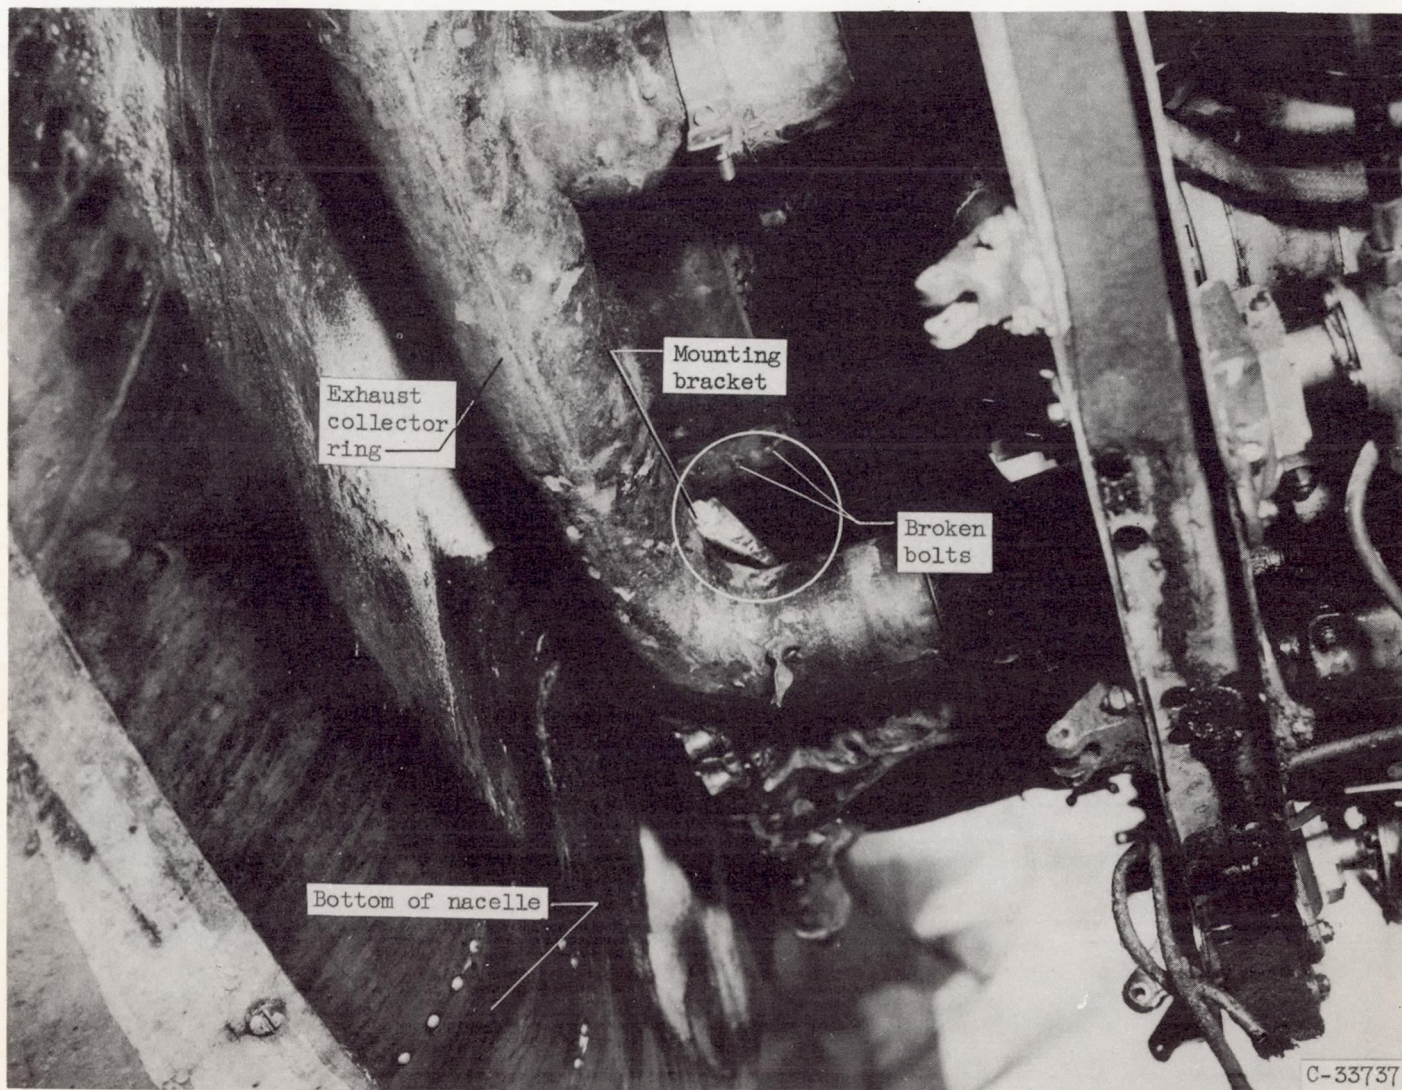
Figure 7. - Exhaust-collector-ring mounting bracket broken from its support.

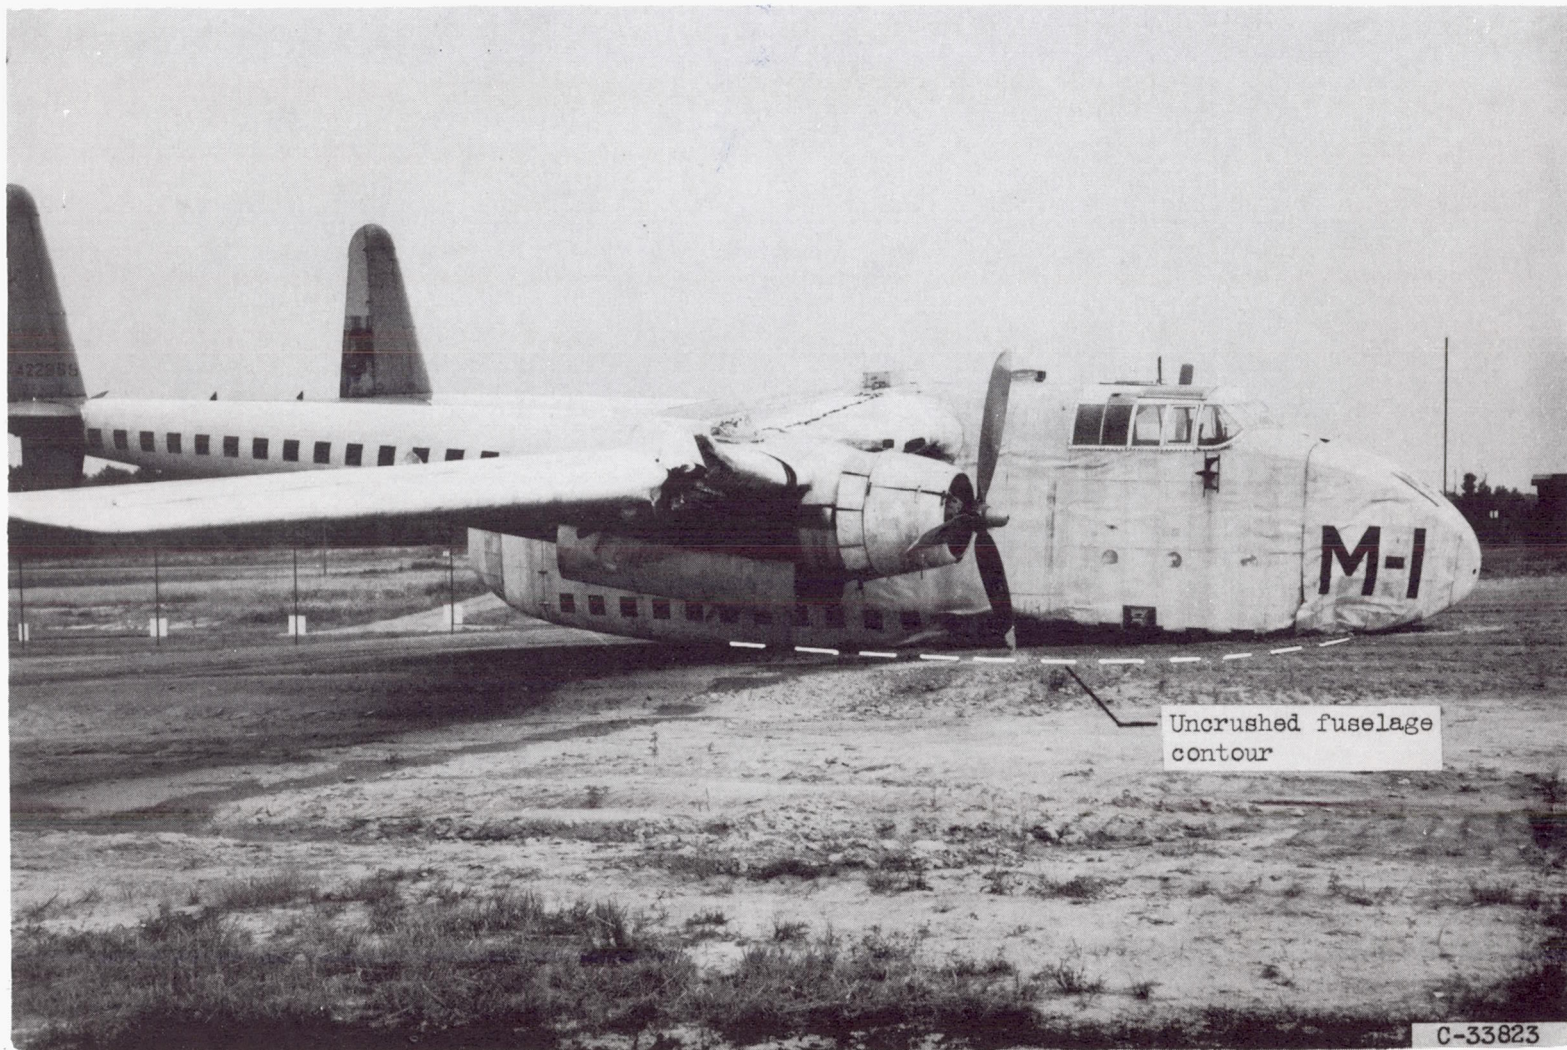
(a) Right side.

The amount of fuselage crushing that occurred during the crash is shown in the photographs of the right and left sides of the airplane in figures 8(a) and (b), respectively. The dotted lines in each figure define the original contour of the fuselage before the crash. In order to determine the extent of the crash damage to the skin and structure on the belly of the airplane, the fuselage was jacked up and examined. Figure 9 is a front view of the fuselage belly showing the damage to the skin and structure. The large opening in the center of the fuselage belly is the nose-gear well. The damage directly behind this opening was caused by the nose-gear strut's being driven rearward by impact with the ground and by the subsequent slide of the airplane. The skin and structure on each side of this opening was twisted and ripped. A front view of the nose gear and front bulkhead in figure 10 shows the structural damage to the bulkhead to which the nose-gear assembly was attached. This entire bulkhead was torn loose by the nose gear as it was driven rearward for approximately 9 feet by the force of the crash. Figure 11(a) shows the buckled floor and the structural damage in the left front portion of the cargo compartment. Damage to the structure in the right front portion of the cargo compartment is shown in figure 11(b).

Figure 8. - Crash-damaged fuselage of airplane.

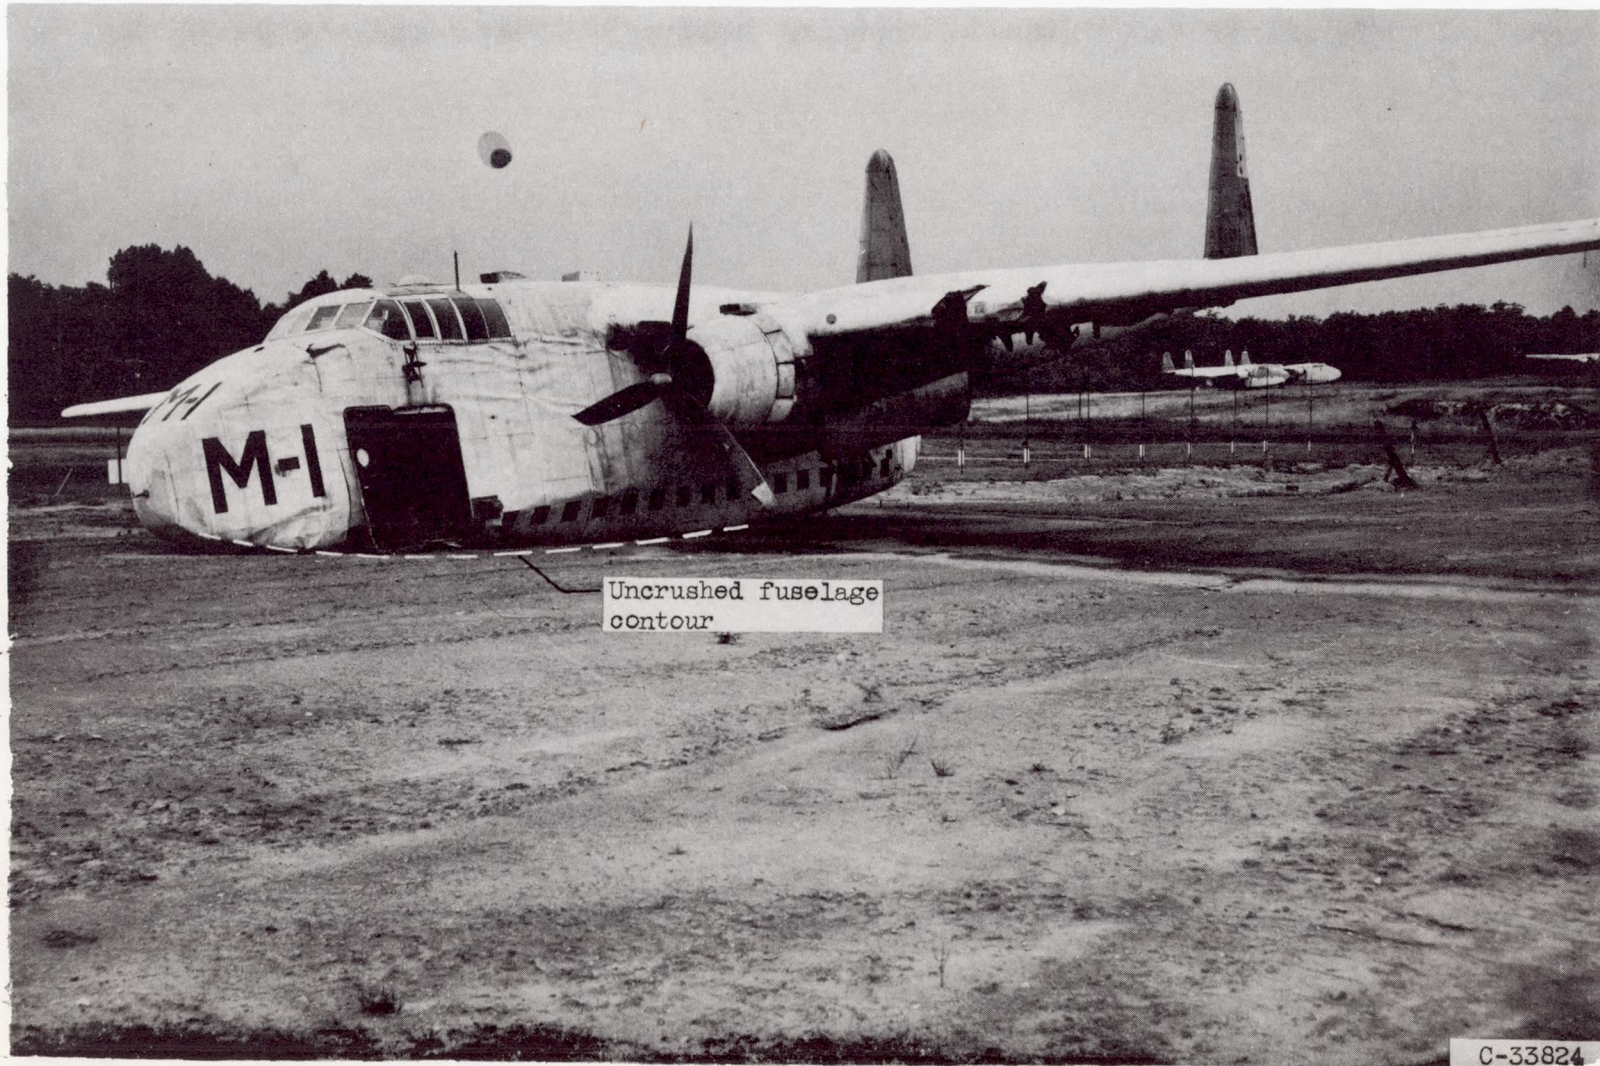
(b) Left side.

Figure 8. - Concluded. Crash-damaged fuselage of airplane.

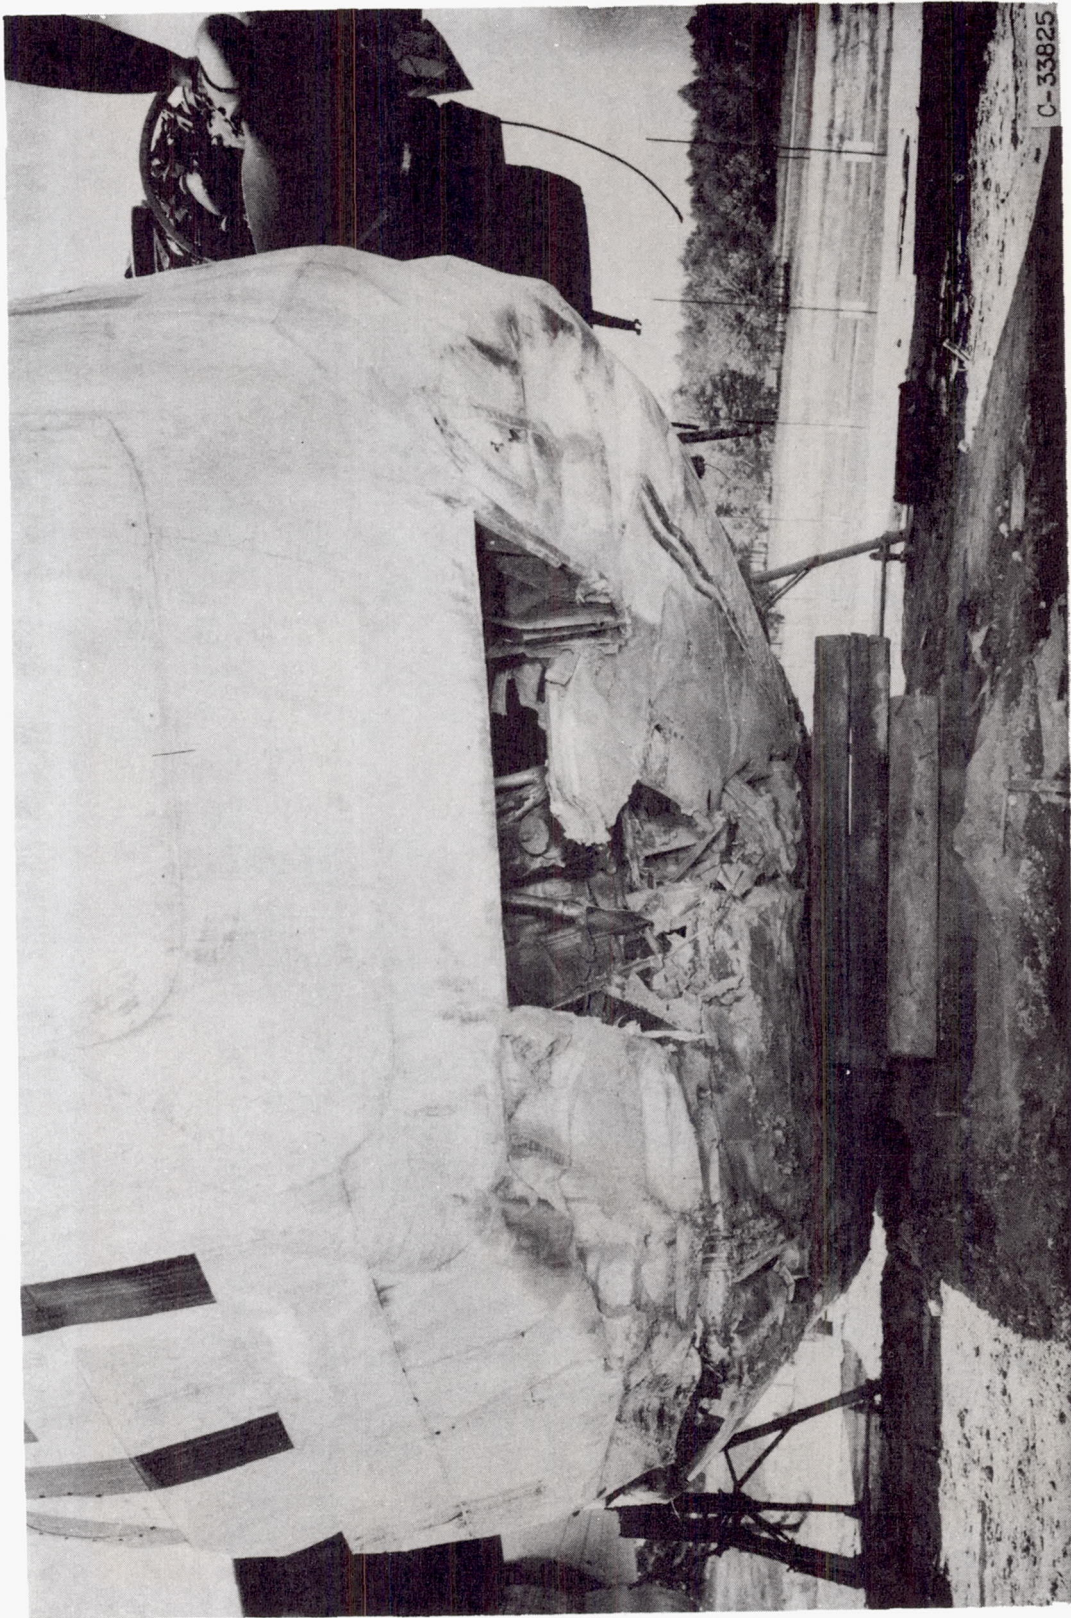
Figure 9. - Crash-damaged belly of airplane.

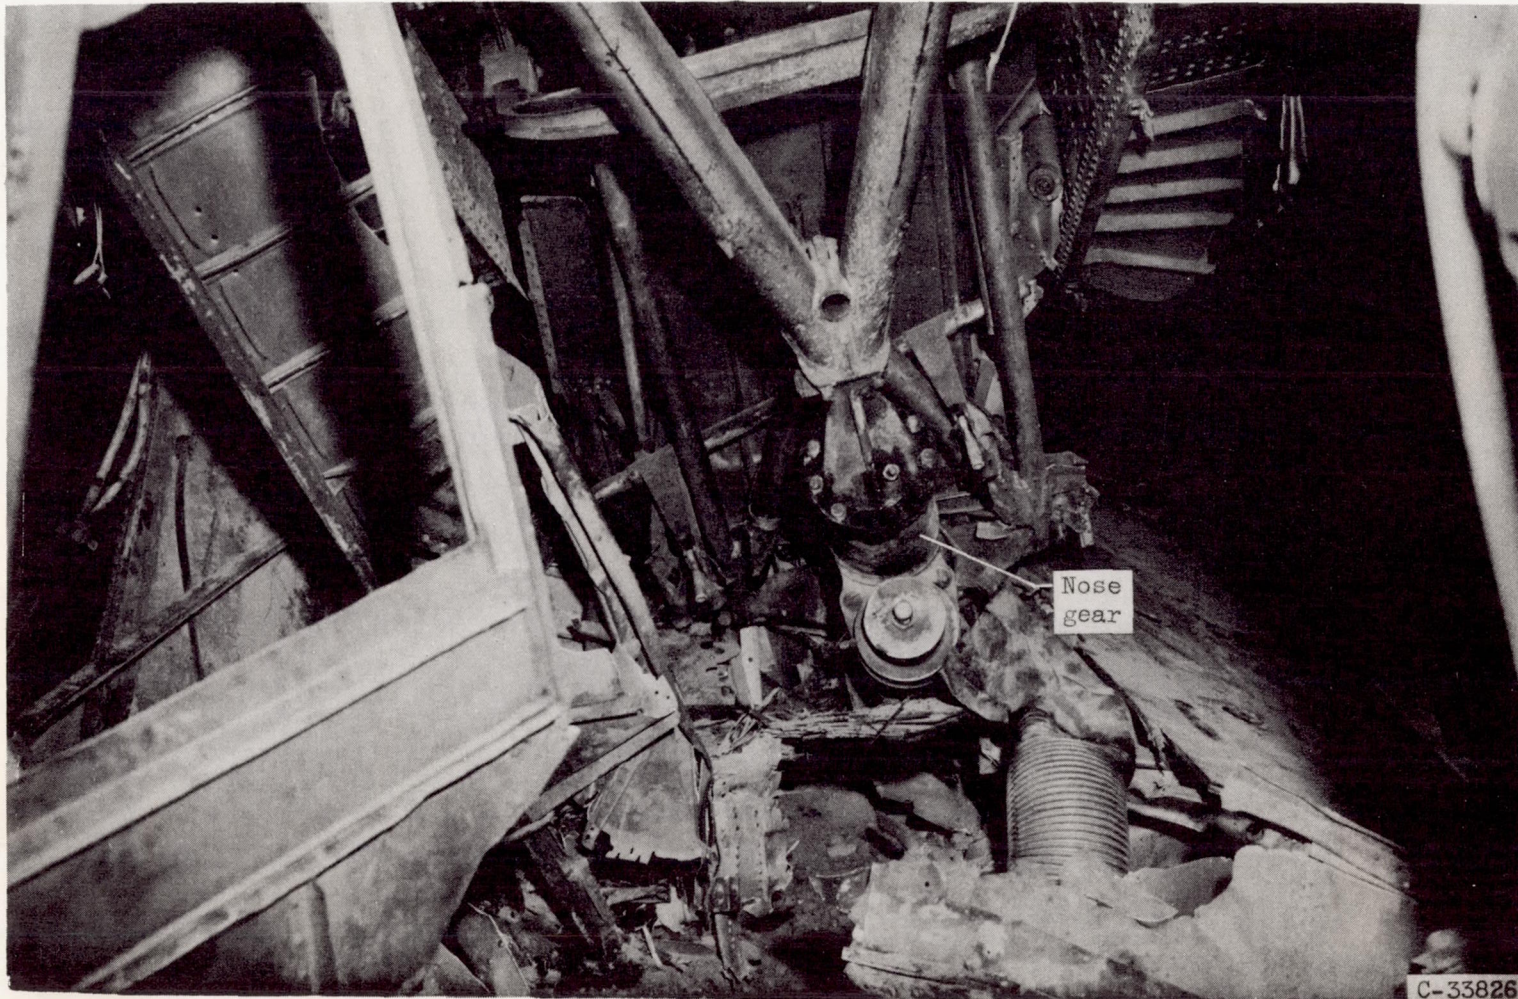
Figure 10. - Crash-damaged interior of nose-gear well.

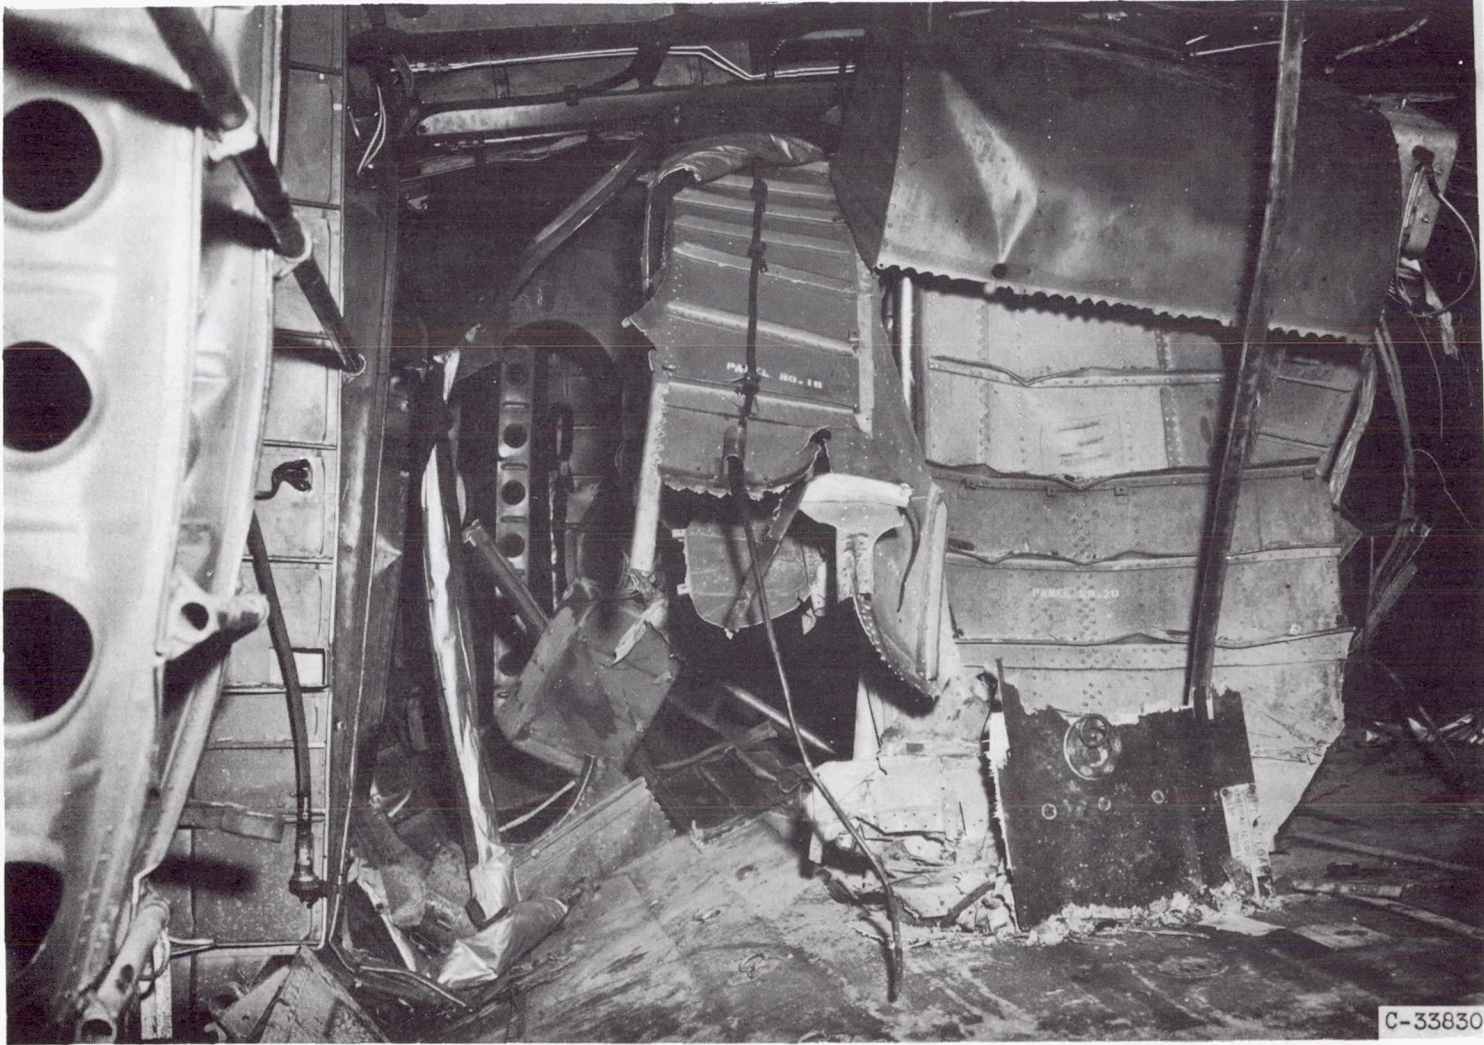
(a) Left front.

Figure 11. - Crash-damaged interior of cargo compartment.

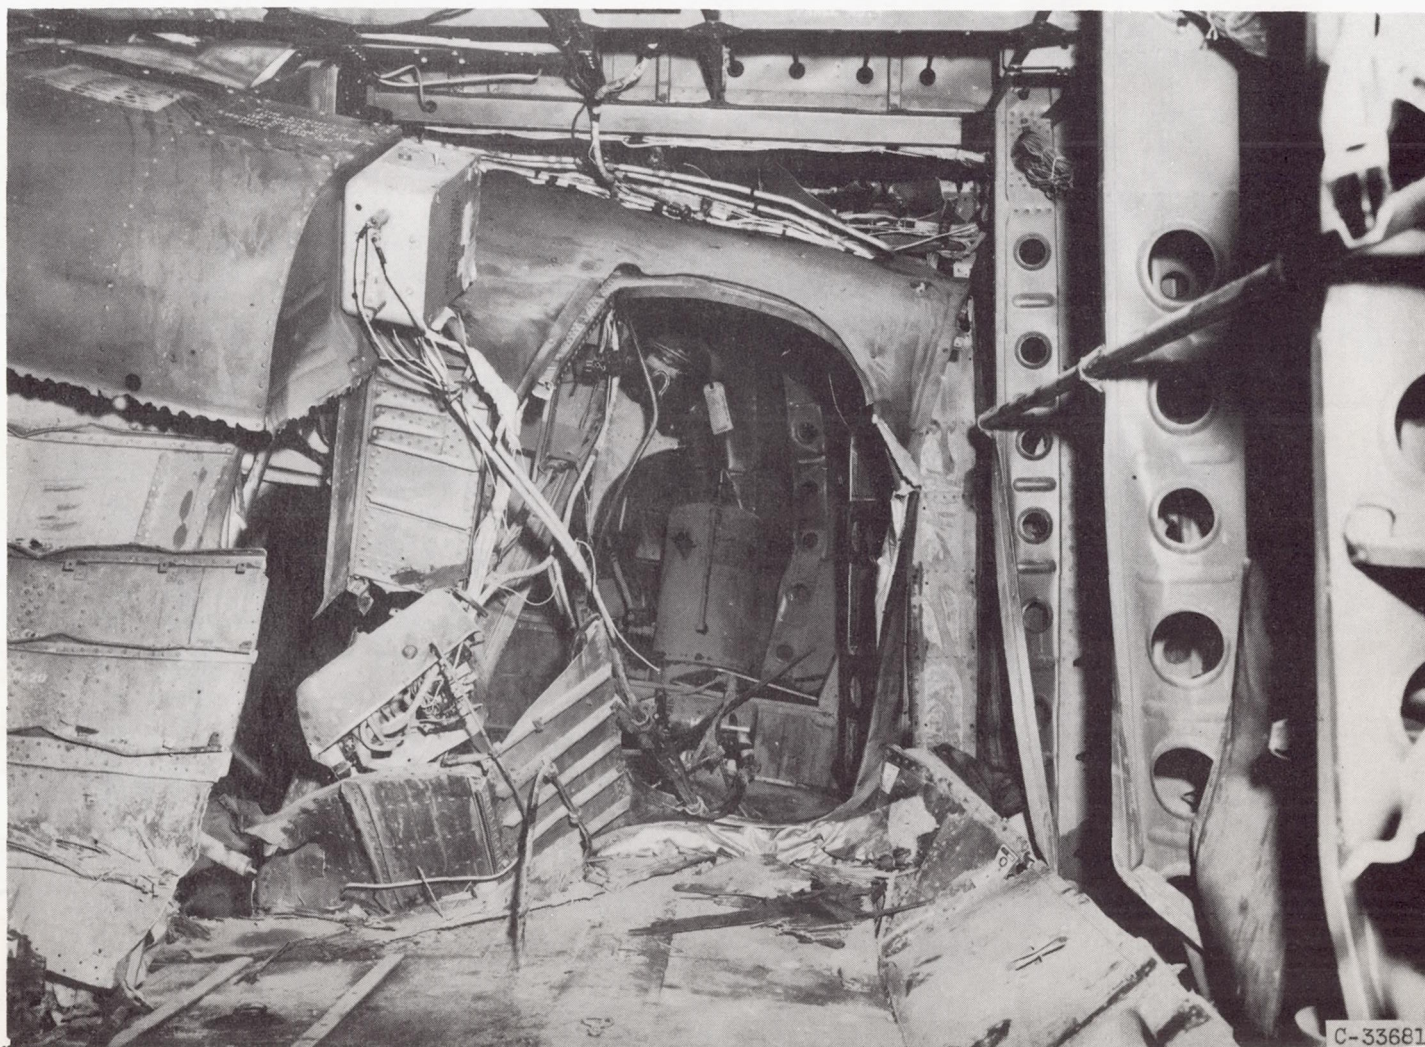
(b) Right front.

Figure 11. - Concluded. Crash-damaged interior of cargo compartment.

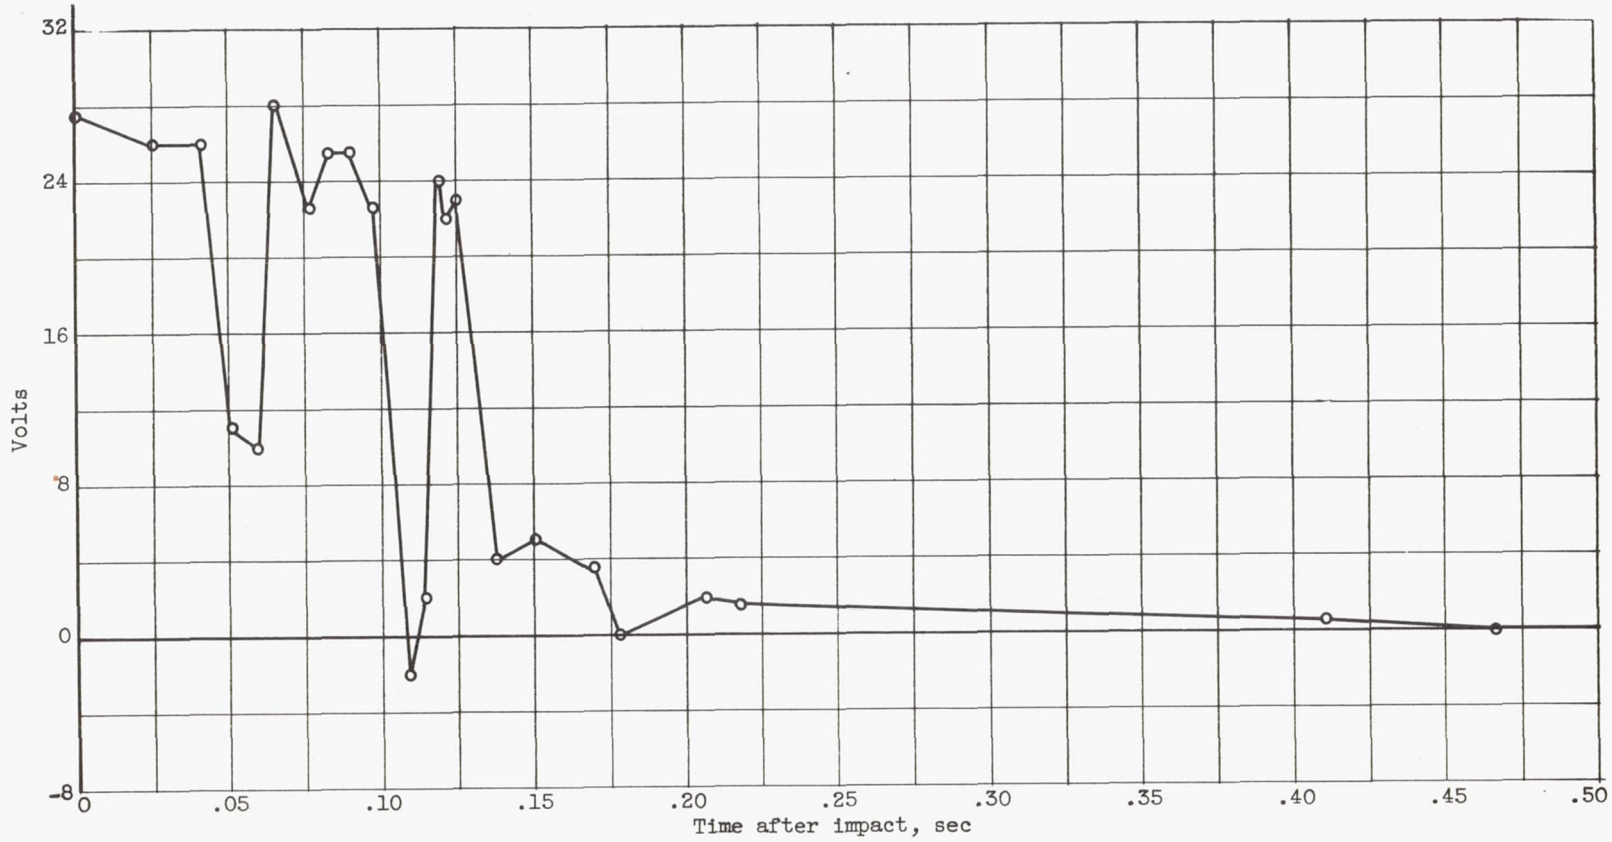
Electrical system de-energizing. - The variation of voltage in the airplane electrical system during the crash is presented in figure 12. Impact of the airplane with the first crash barriers occurred at time zero. Two sharp reductions in voltage occurred at approximately 0.05

and 0.11 second after impact. These reductions in voltage were caused by short circuits when the generators were torn from their mountings. The relays in the inerting system that disconnect the generators and battery from the airplane electrical system opened at 0.12 second after impact. The airplane voltage began to drop immediately thereafter. Part of the voltage drop after 0.12 second was the result of this relay action. Closing of a relay that grounds the power circuit (shortly after the batteries and generators are disconnected) hastened this voltage reduction. The grounding relay is actuated by the inerting system.

The electrical de-energizing action was complete when the voltage (fig. 12) reached zero at 0.178 second after impact. The 2-volt rise in potential thereafter could have been caused by the generator effect of coasting motors. Although the energy represented by this resurgence of voltage may be marginal as an ignition source, it should be prevented by means of a better grounding system, as discussed in the following paragraph.

Figure 12. - Variation of voltage in airplane electrical system.

Short circuits, such as occurred in this crash, could prevent proper functioning of the fire-prevention system. For this reason, a suitable method should be devised to prevent short circuits in the airplane electrical system from influencing the output of the battery to the inerting system. If the battery is disconnected from the airplane electrical system before take-off or landing, short circuits in the airplane electrical system could not damage the battery. Therefore, the battery will have full potential to operate the fire-prevention system. Disconnecting the battery would not appreciably affect the airplane electrical system because the generators are generally large enough to meet all electrical requirements.
